INSPECTION REPORT

| Type of Inspection | Compliance Evaluation Inspection (CEI) | | |
| Facility or Site Name | Modern American Recycling Services Inc. | | |
| Type of Operation | Modern American Recycling Services (MARS) decommissions oil field platforms and recycles the scrap metal. | | |

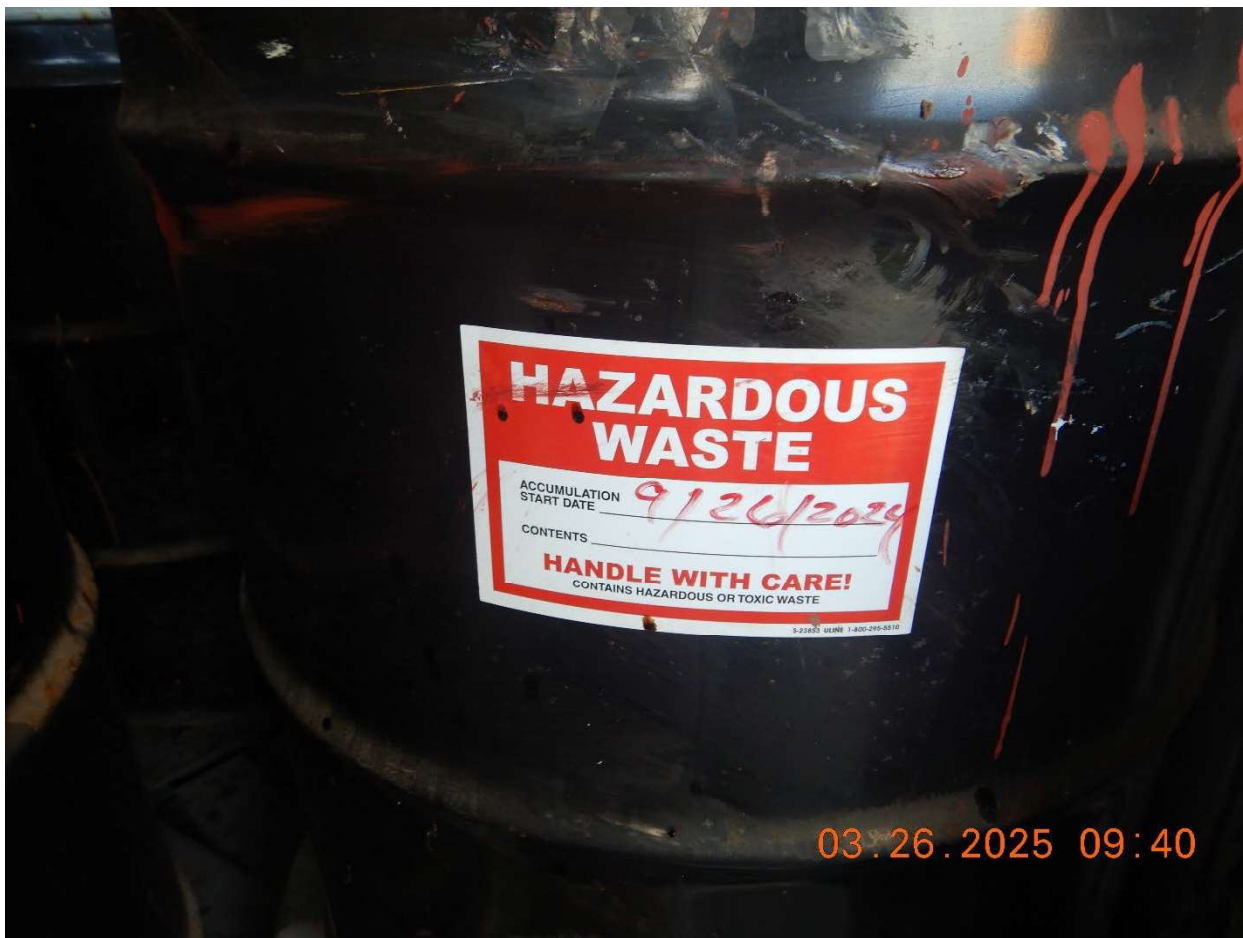
Photo No. 41

(see Appendix 1 – Photos 39, 41, 47, and 49) [**AOC #3** – MARS accumulated hazardous waste for more than 180 days - 40 CFR 262.16(b)]. The inspection team noted that the hazardous waste storage area drains to a sump in the middle of the right side of the building, and the sump drains directly outside of the building onto the ground (see Appendix 1 – Photos 50 and 51). Mr. Stephenson stated weekly inspections of the central accumulation area are not completed weekly [**AOC #4** – MARS did not complete weekly inspections of the hazardous waste central accumulation area - 40 CFR 262.16(b)(2)(iv)]. Overview pictures, including signage indicating the Hazardous waste storage area, and views inside the area, can be seen in Photos 52 to 54.

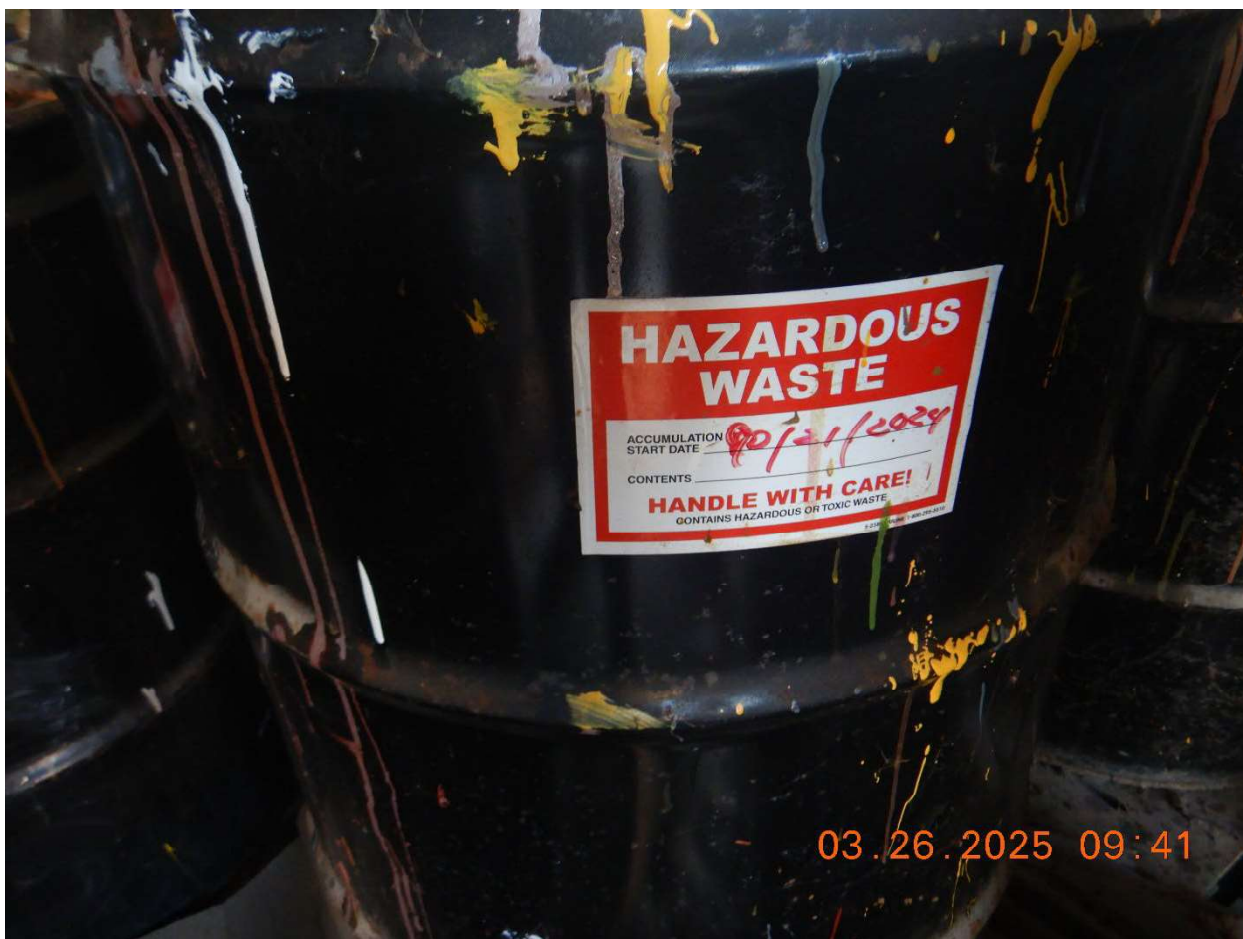
Photo No. 43

Description: View of the label of a full 55-gallon drum inside the hazardous waste storage area with an accumulation start date of 10/21/2024.

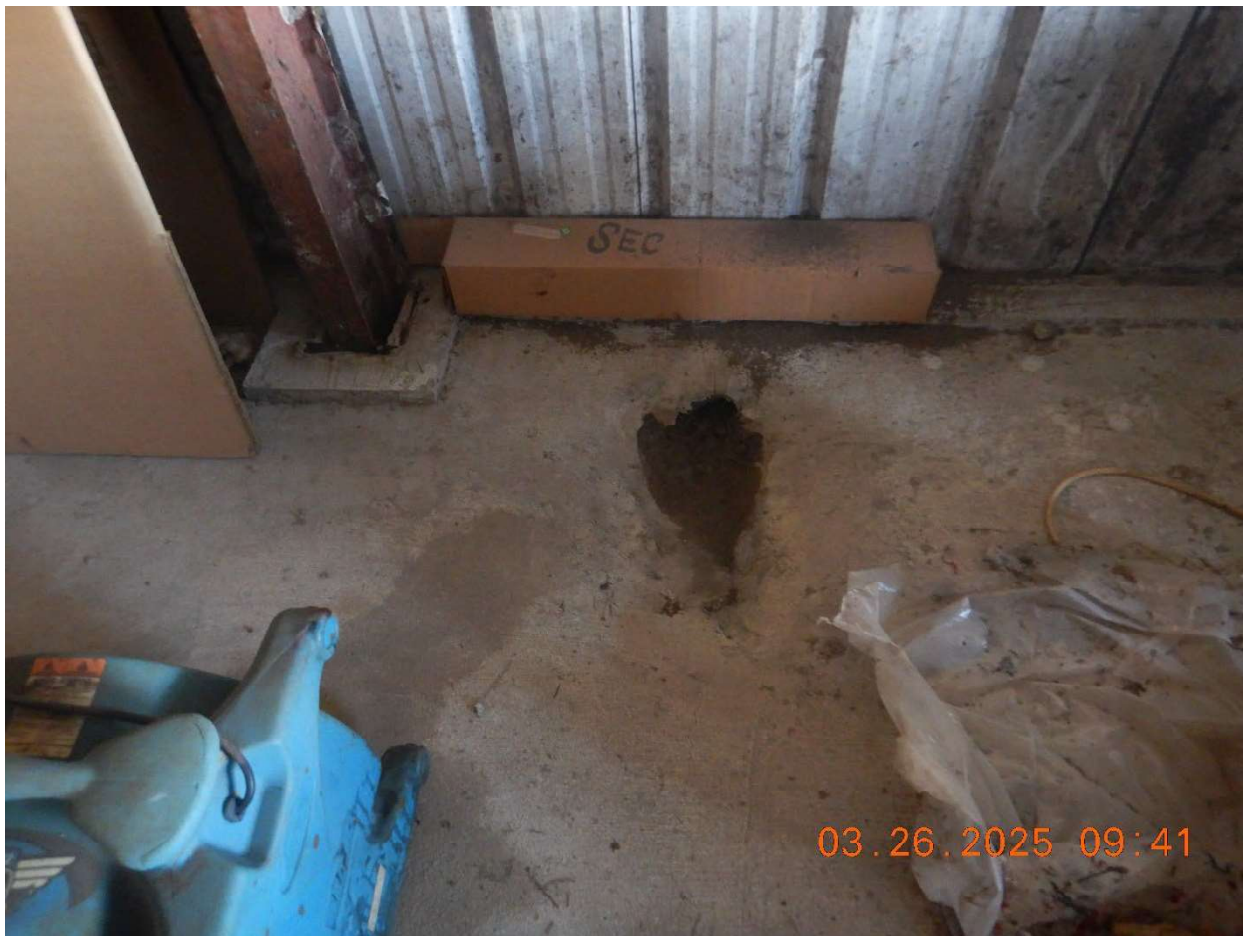
Photo No. 50

Description: View of where the hazardous storage area drains to.

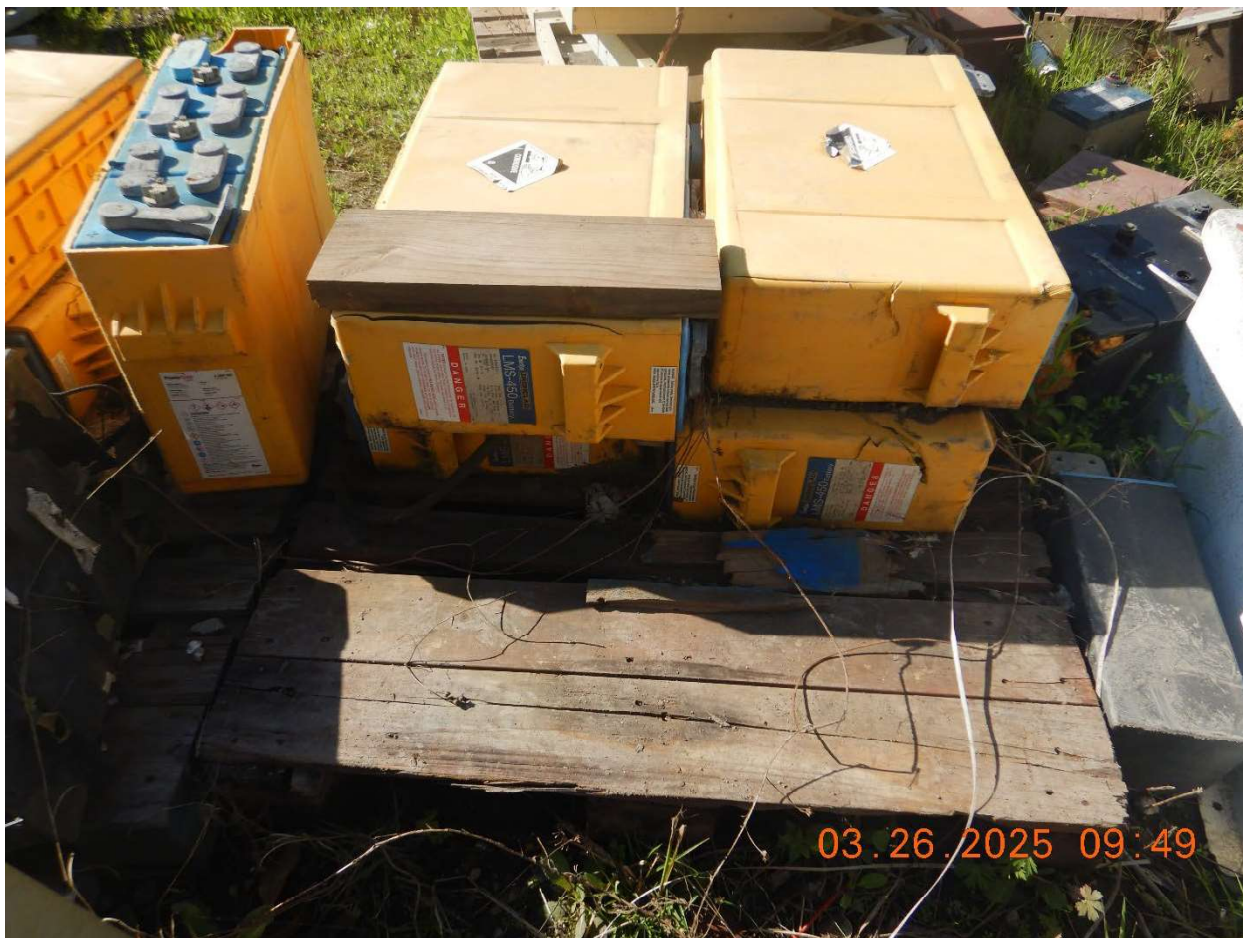
Photo No. 58

Description: View of discarded batteries found outside the universal waste warehouse.

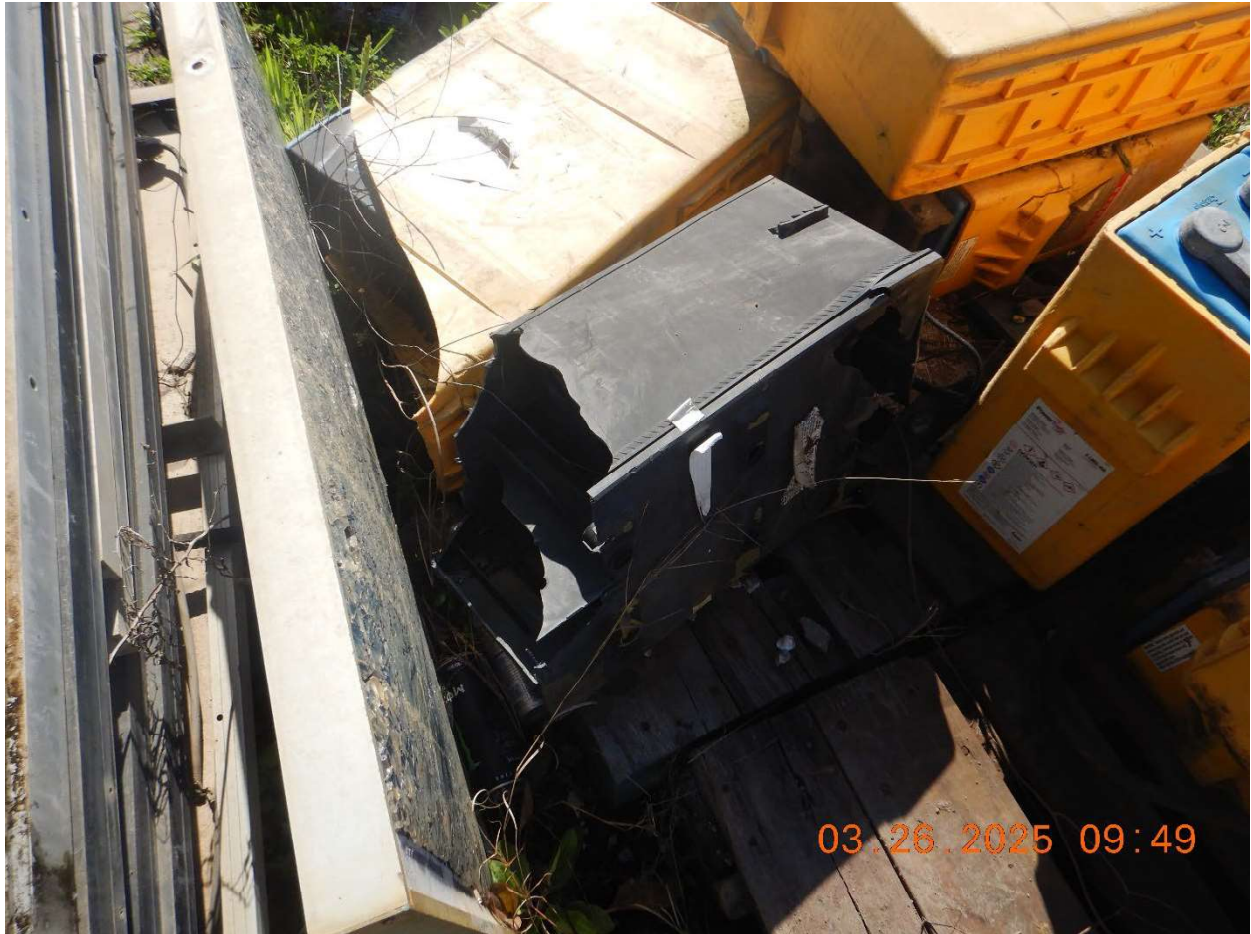
Photo No. 59

Description: View of discarded batteries found outside the universal waste warehouse.

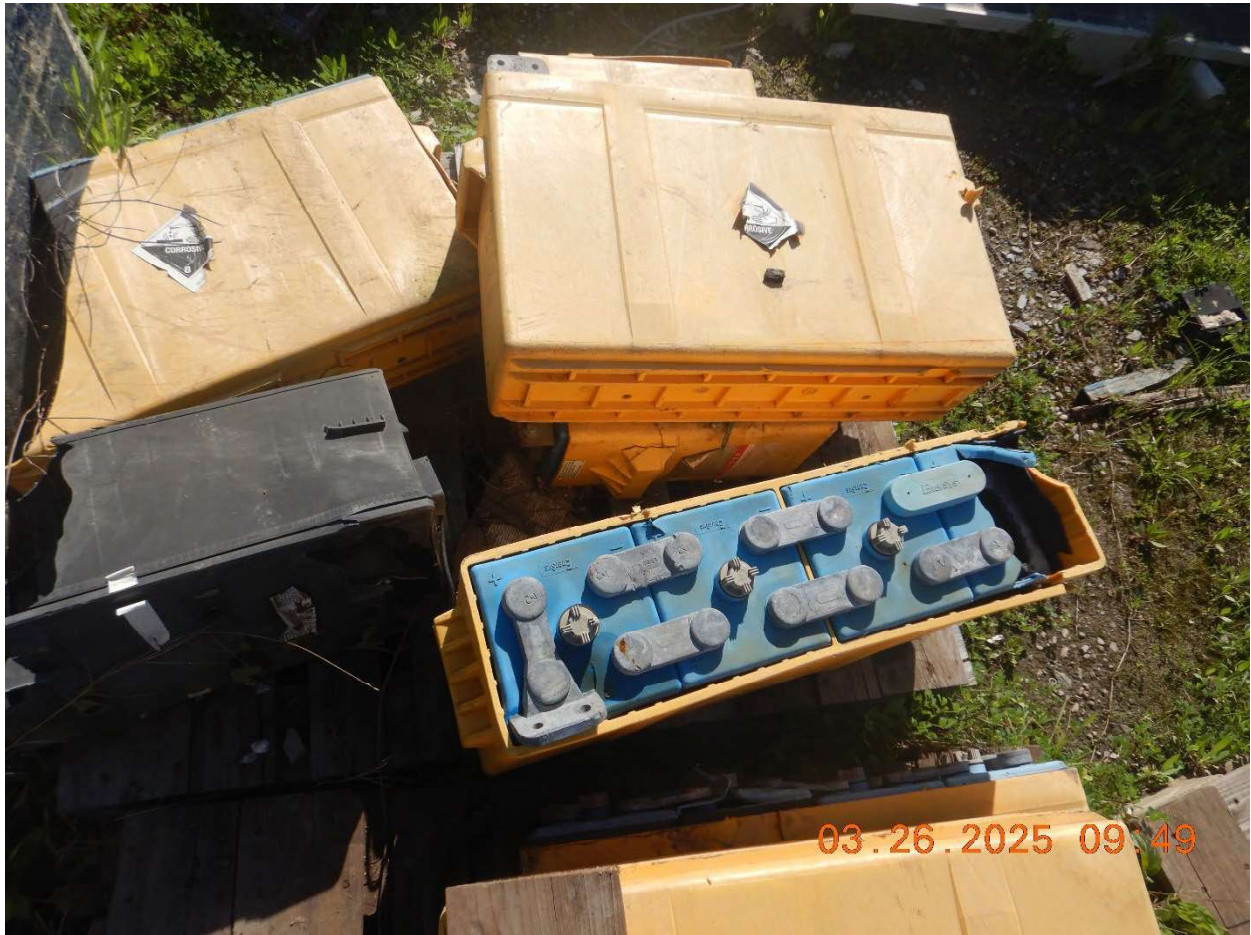
Photo No. 60

Description: View of discarded batteries found outside the universal waste warehouse.

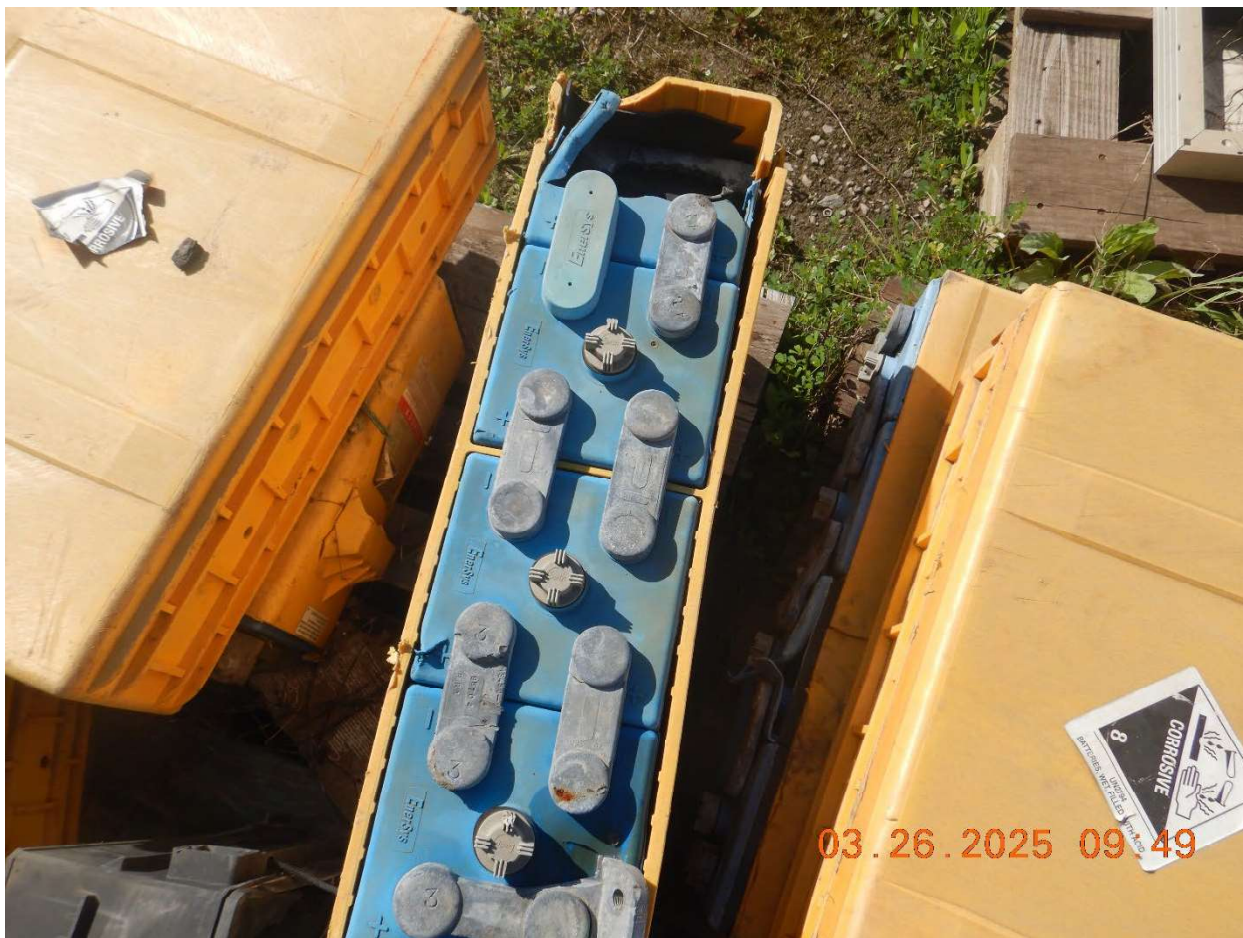
Photo No. 61

Description: View of discarded batteries found outside the universal waste warehouse.

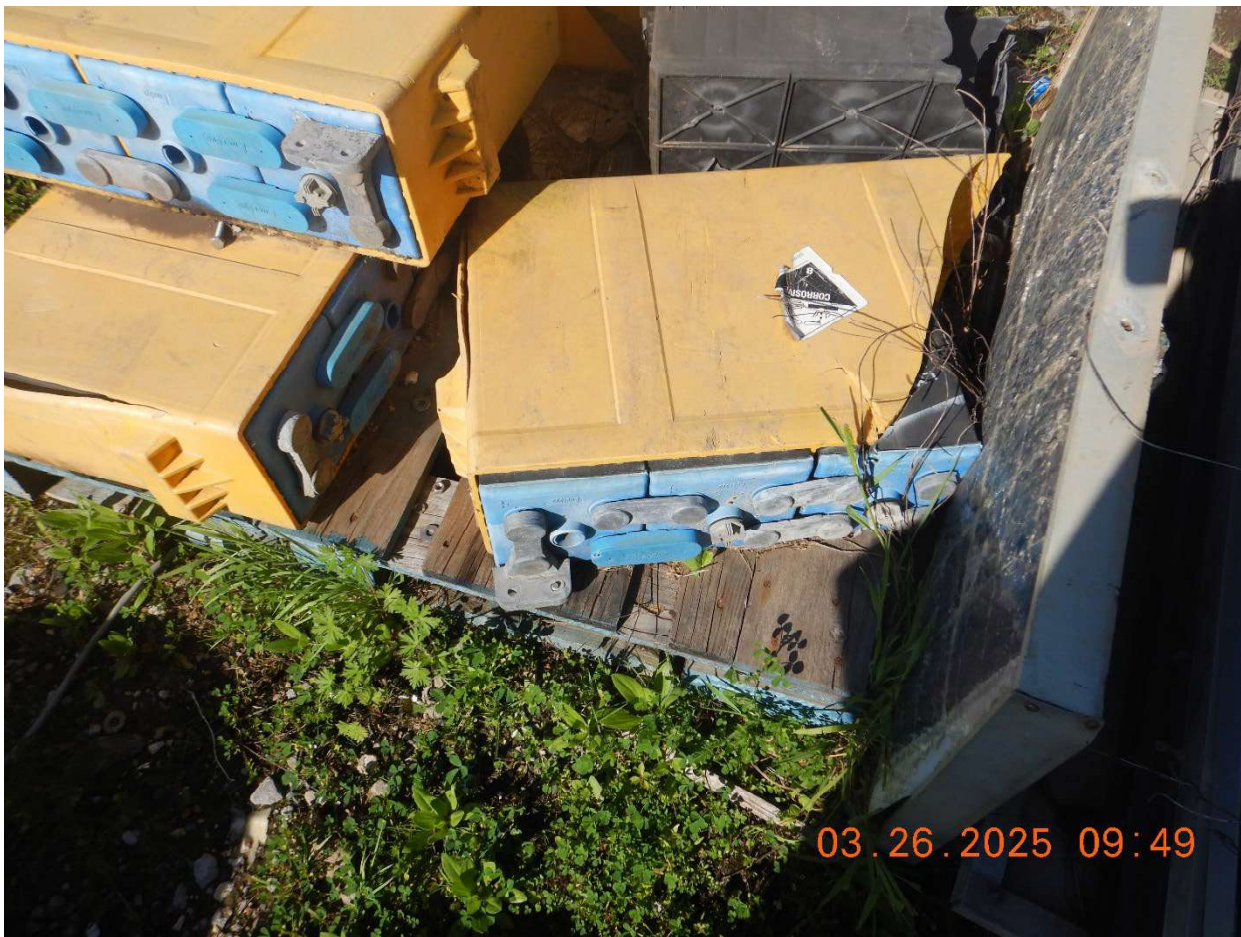
Photo No. 62

Description: View of discarded batteries found outside the universal waste warehouse.

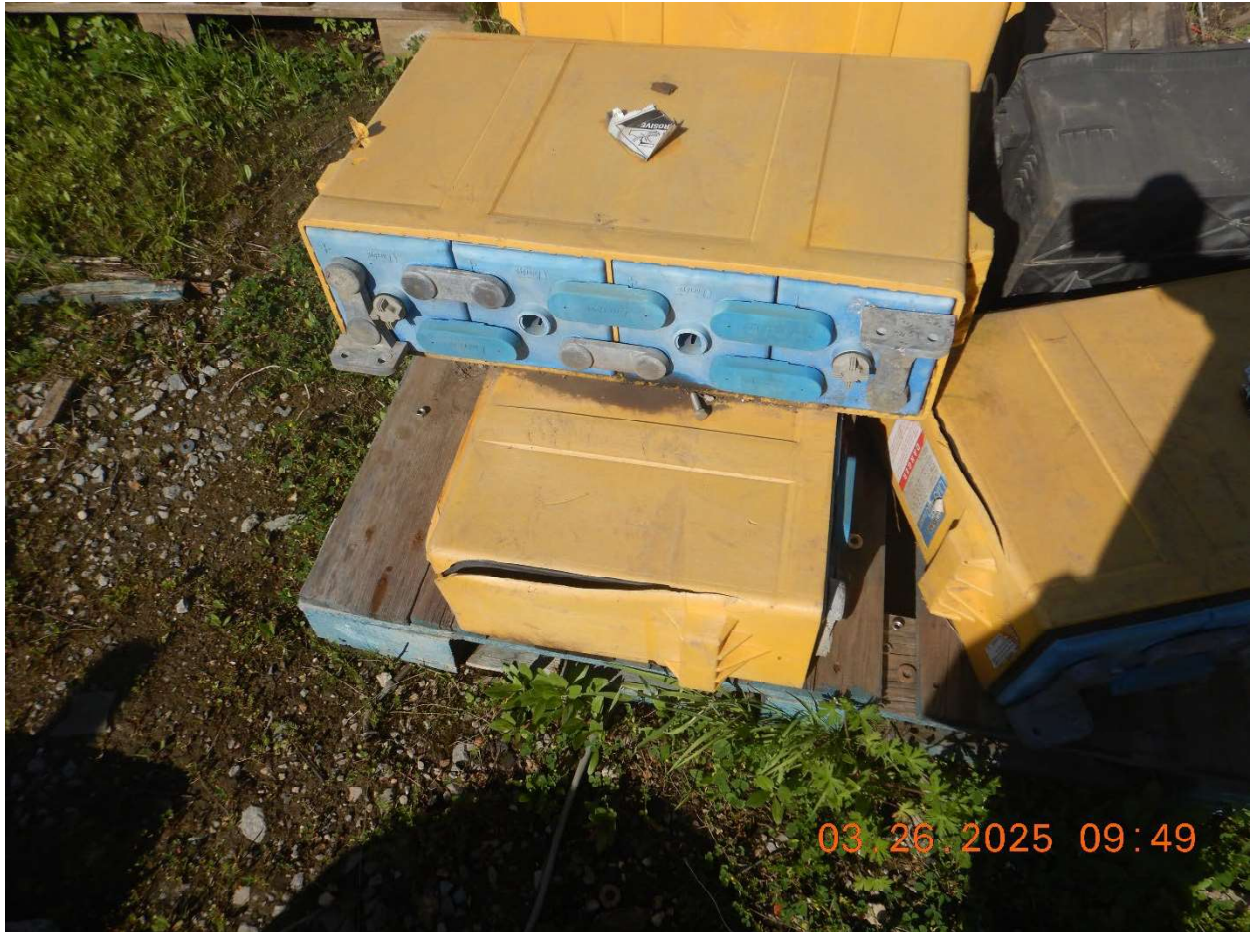
Photo No. 63

Description: View of discarded batteries found outside the universal waste warehouse.

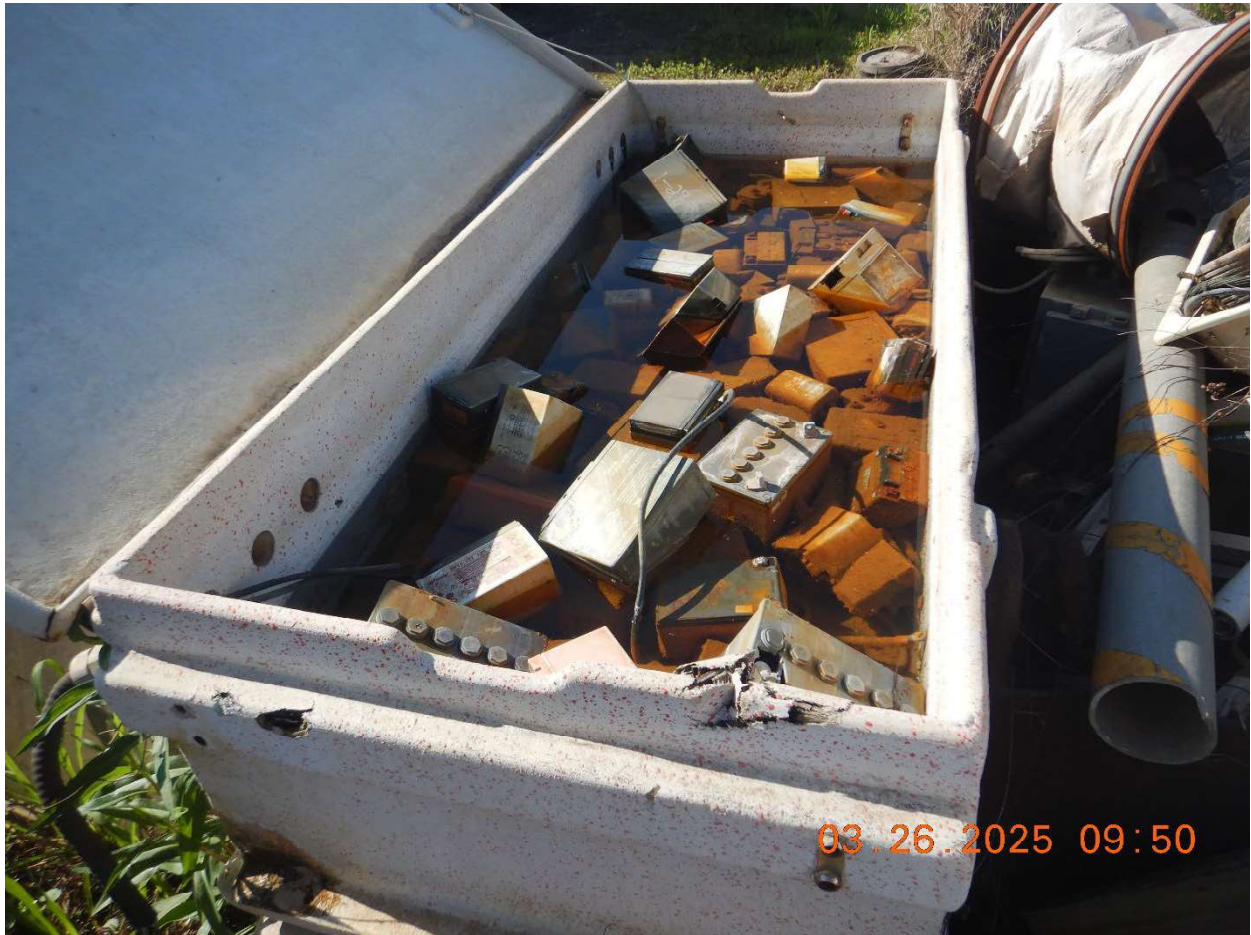
Photo No. 64

Description: View of discarded batteries found outside the universal waste warehouse.

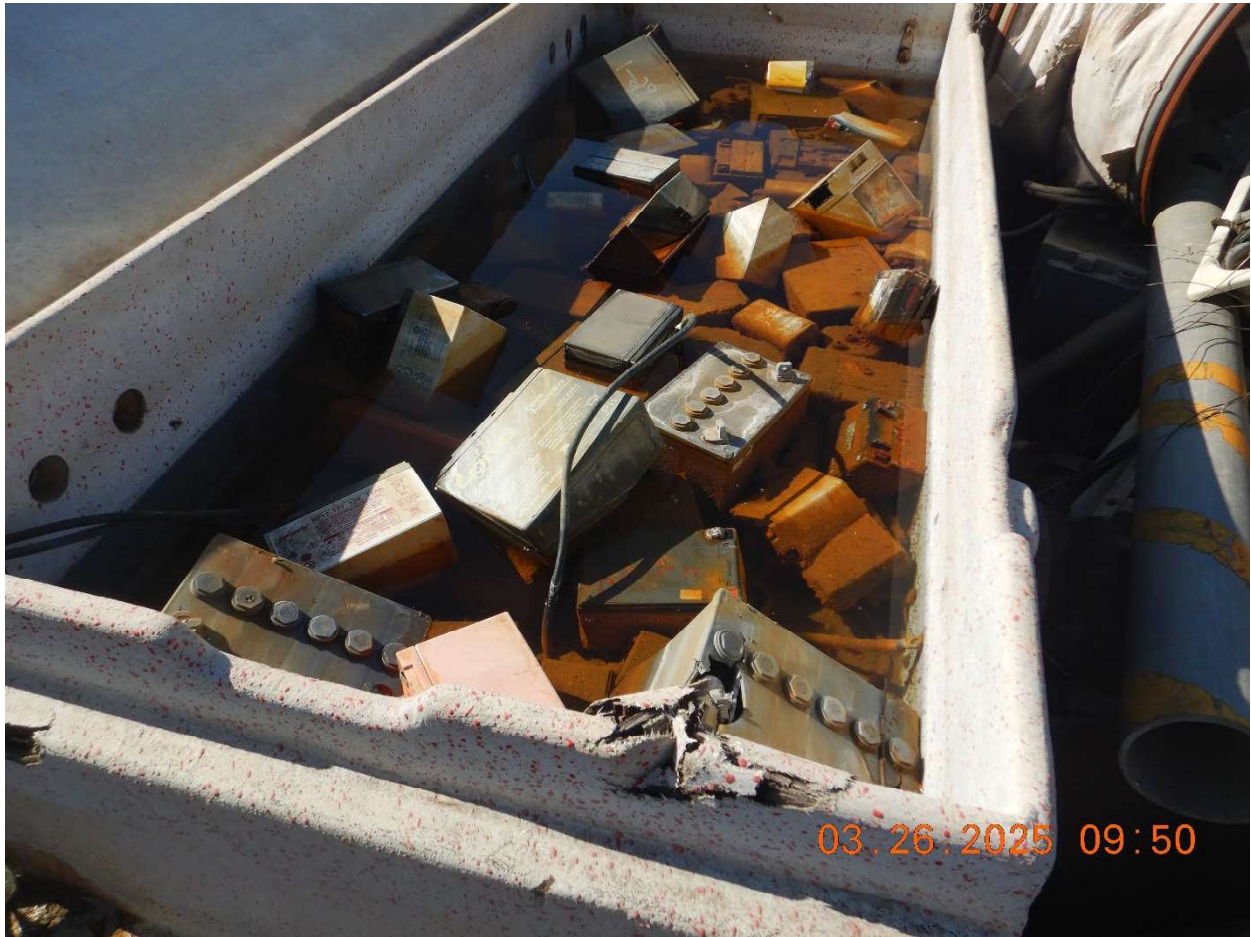
Photo No. 65

Description: View of discarded batteries found outside the universal waste warehouse.

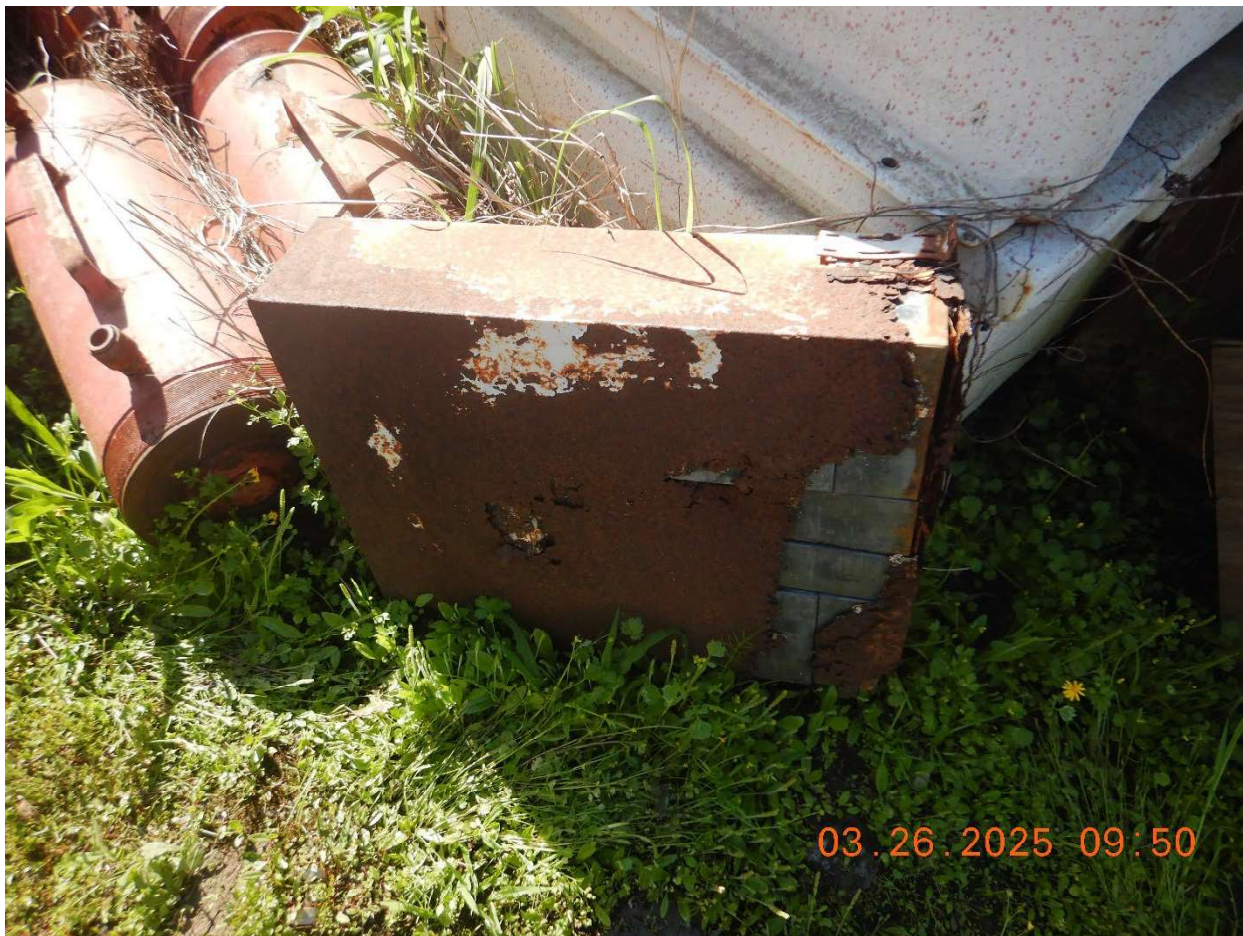
Photo No. 66

Description: View of discarded batteries found outside the universal waste warehouse.

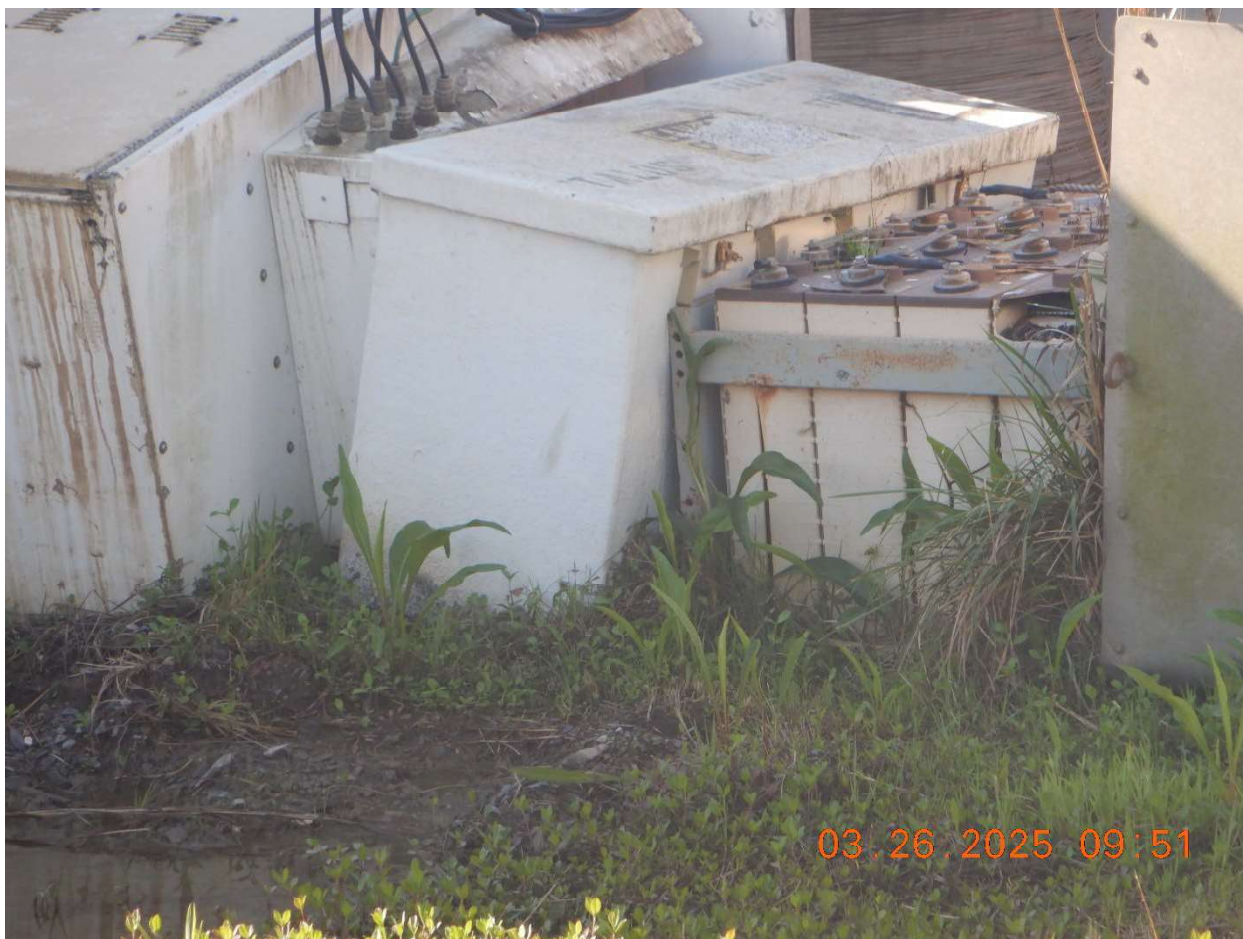
**Photo No. 67**

Description: View of discarded batteries found outside the universal waste warehouse.

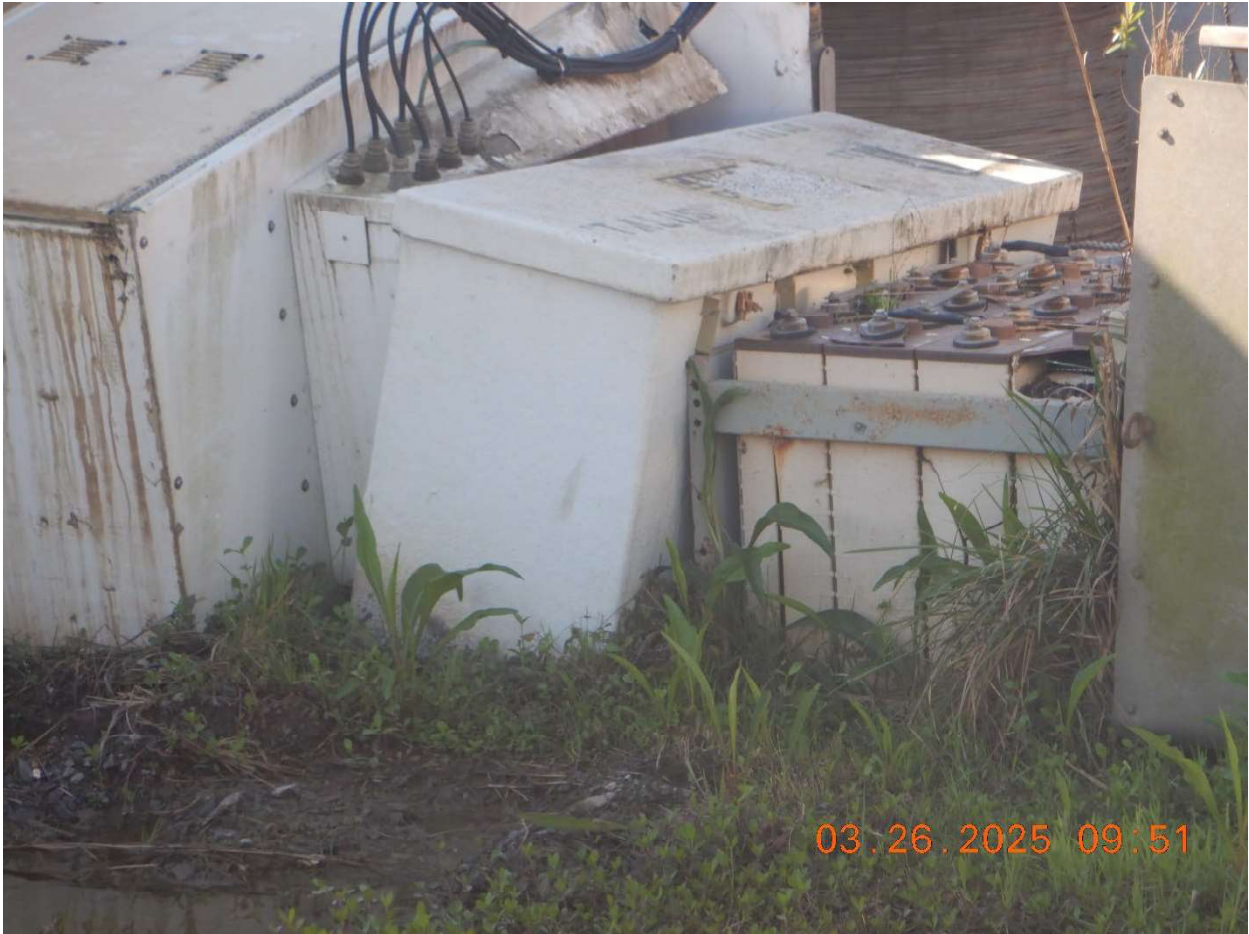
**Photo No. 68**

Description: View of discarded batteries found outside the universal waste warehouse.

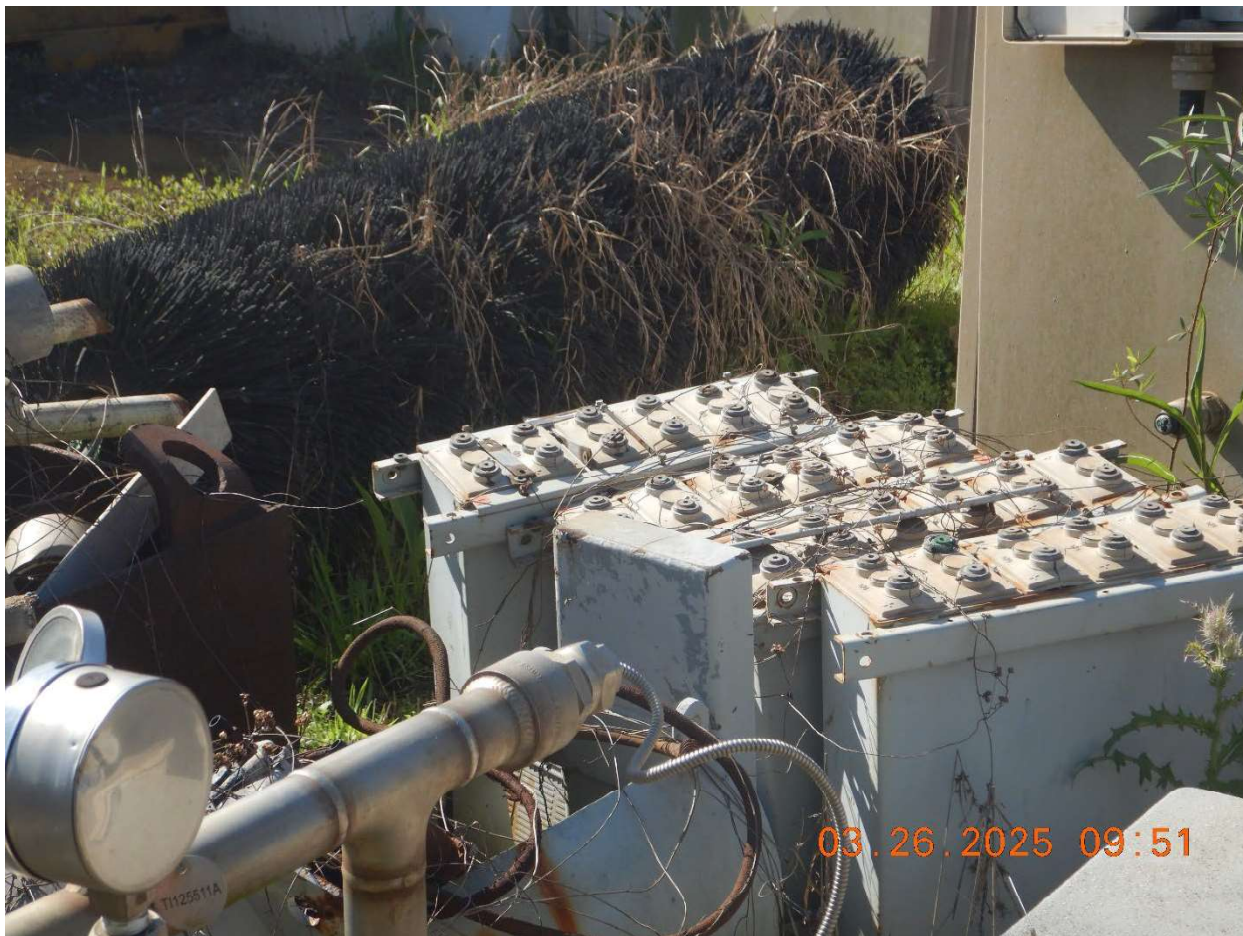
Photo No. 69

Description: View of discarded batteries found outside the universal waste warehouse.

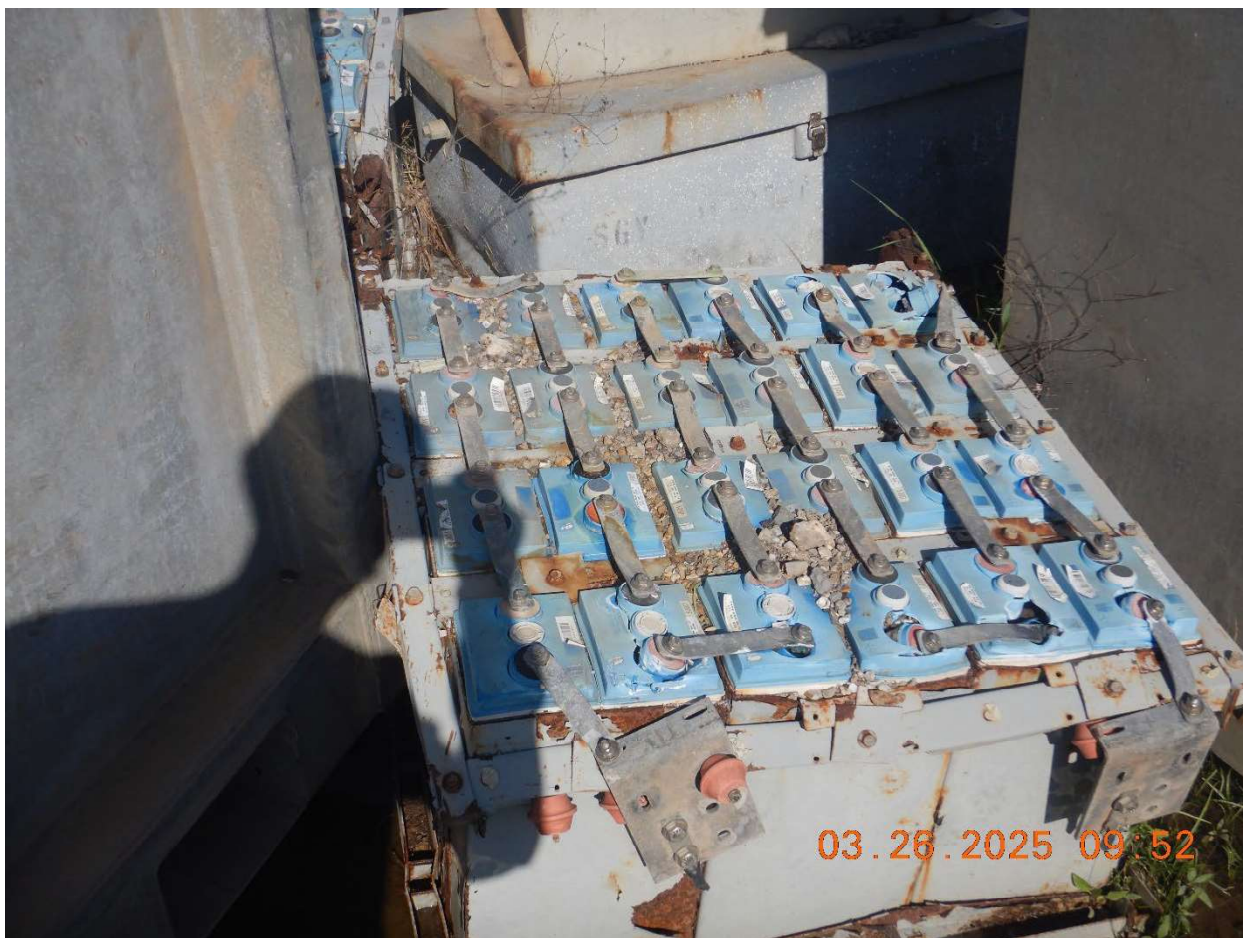
**Photo No. 70**

Description: View of discarded batteries found outside the universal waste warehouse.

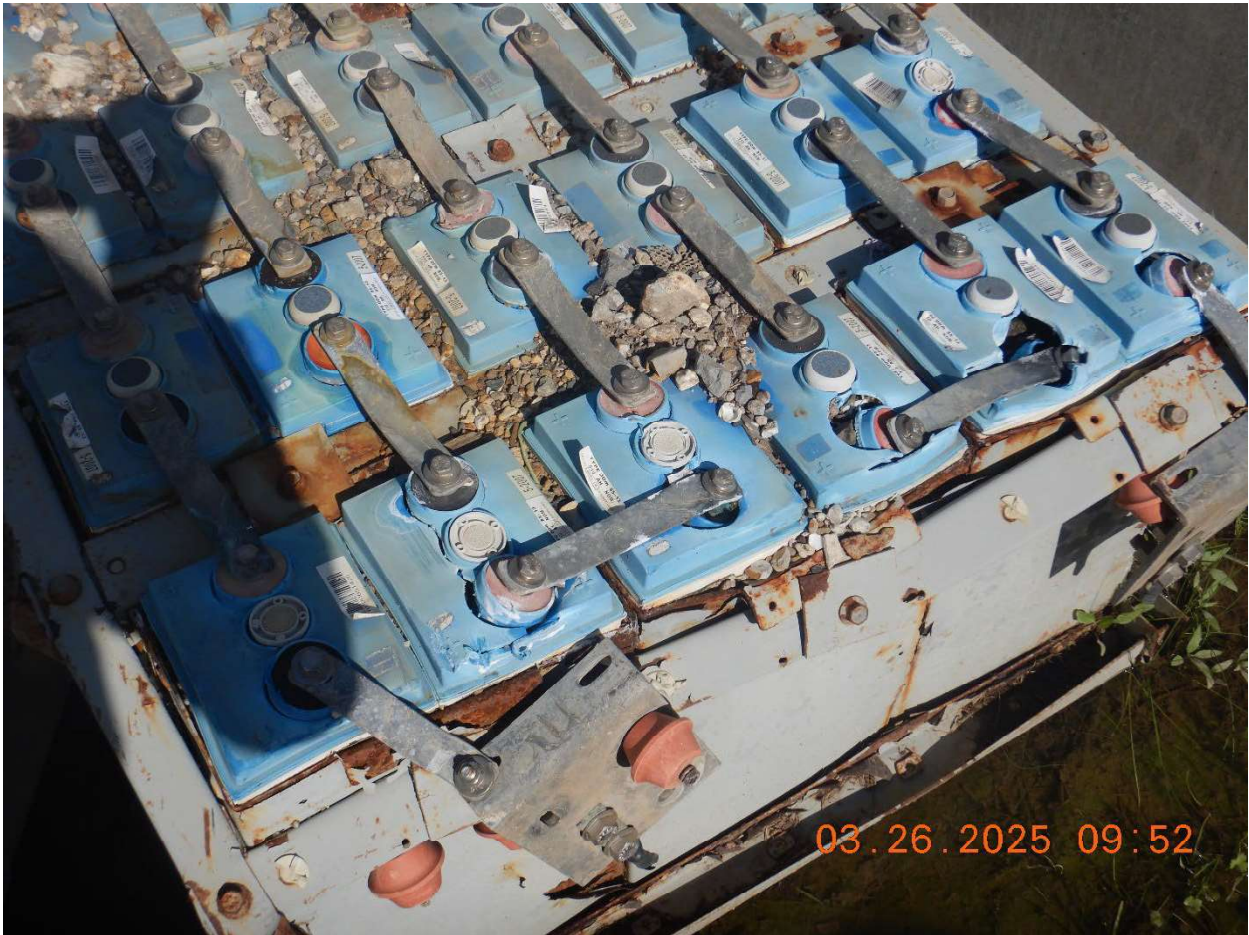
Photo No. 71

Description: View of discarded batteries found outside the universal waste warehouse.

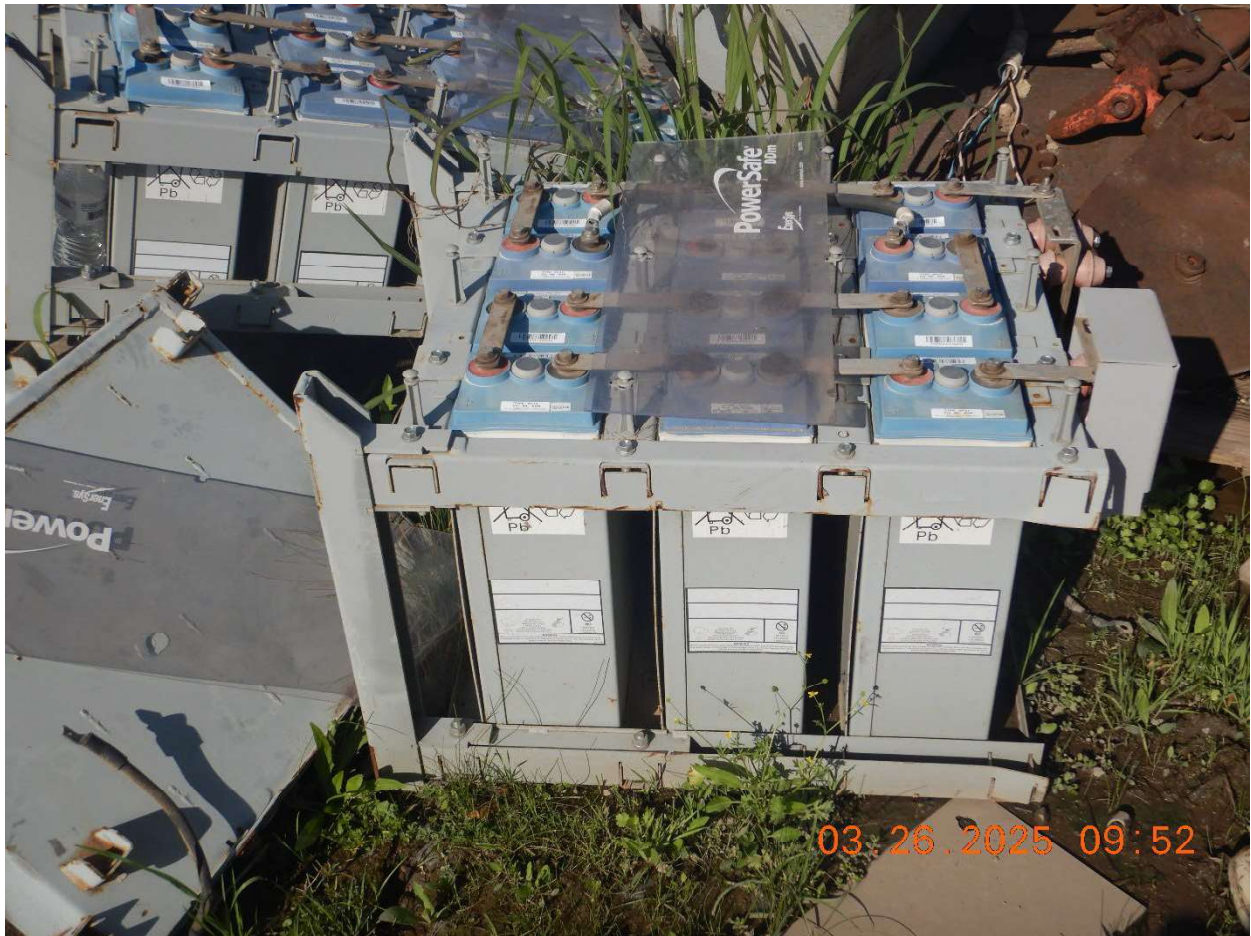
Photo No. 72

Description: View of discarded batteries found outside the universal waste warehouse.

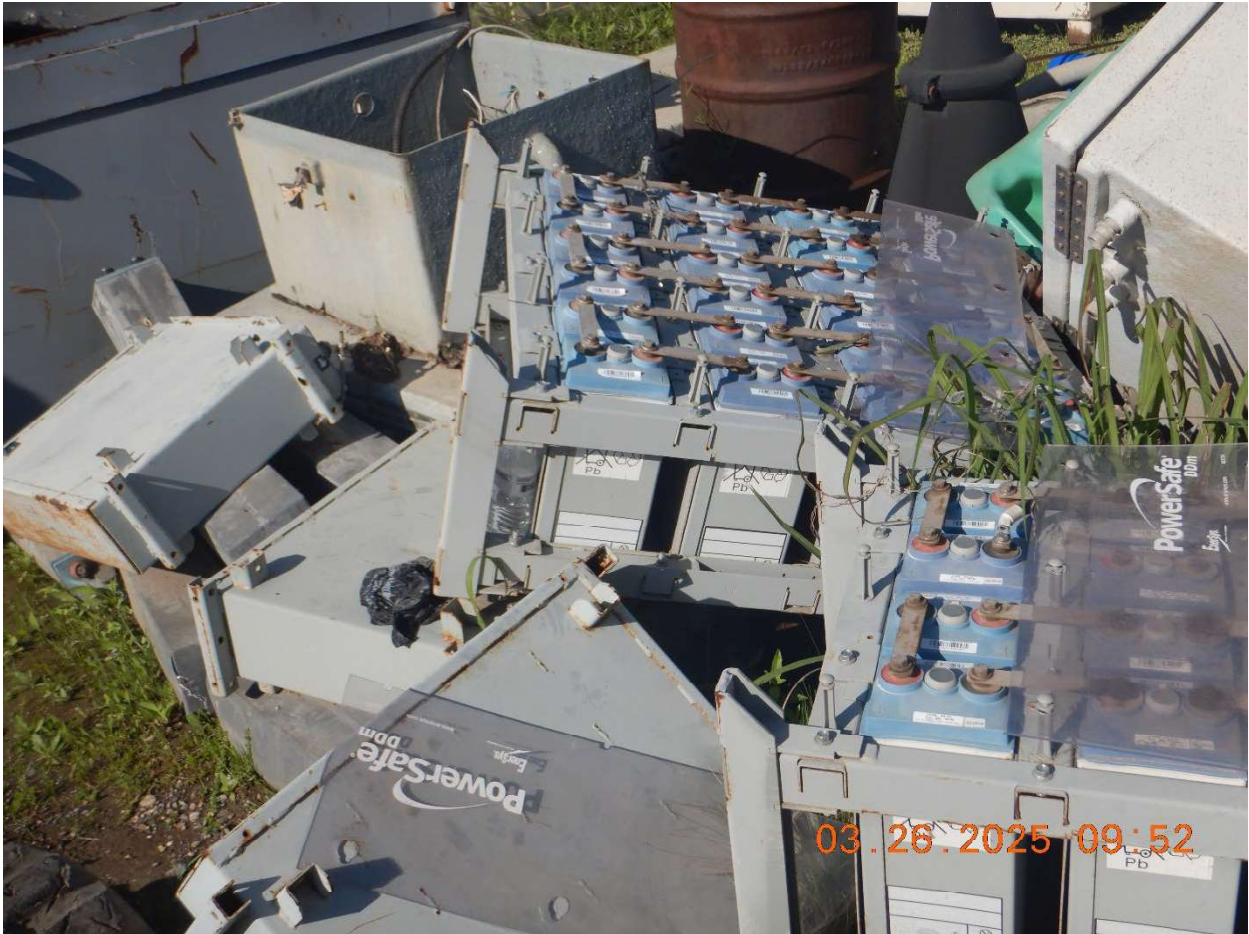
Photo No. 73

Description: View of discarded batteries found outside the universal waste warehouse.
