INSPECTION REPORT

| Type of Inspection | Compliance Evaluation Inspection (CEI) | | |
| Facility or Site Name | Modern American Recycling Services Inc. | | |
| Type of Operation | Modern American Recycling Services (MARS) decommissions oil field platforms and recycles the scrap metal. | | |

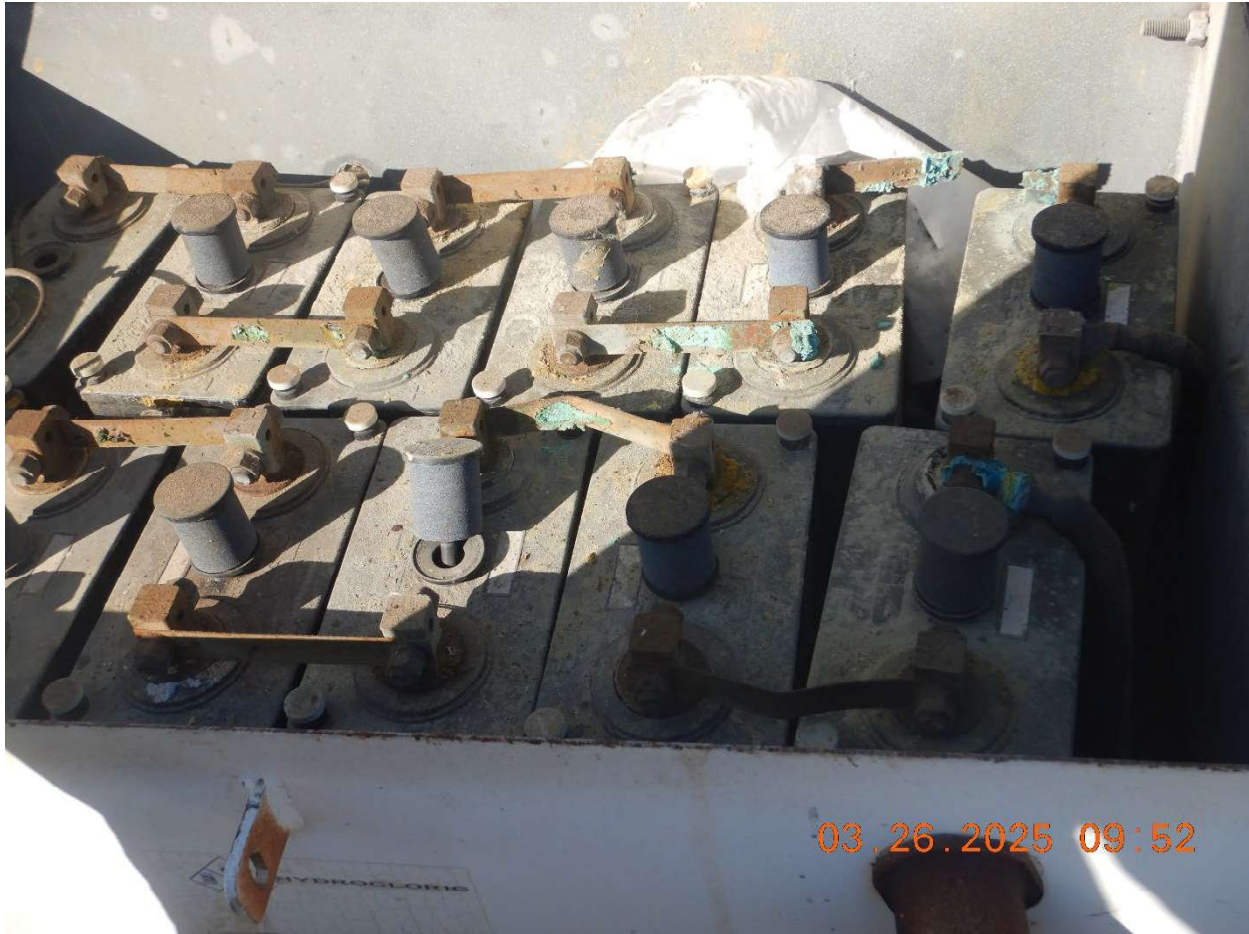
Photo No. 74

Description: View of discarded batteries found outside the universal waste warehouse.

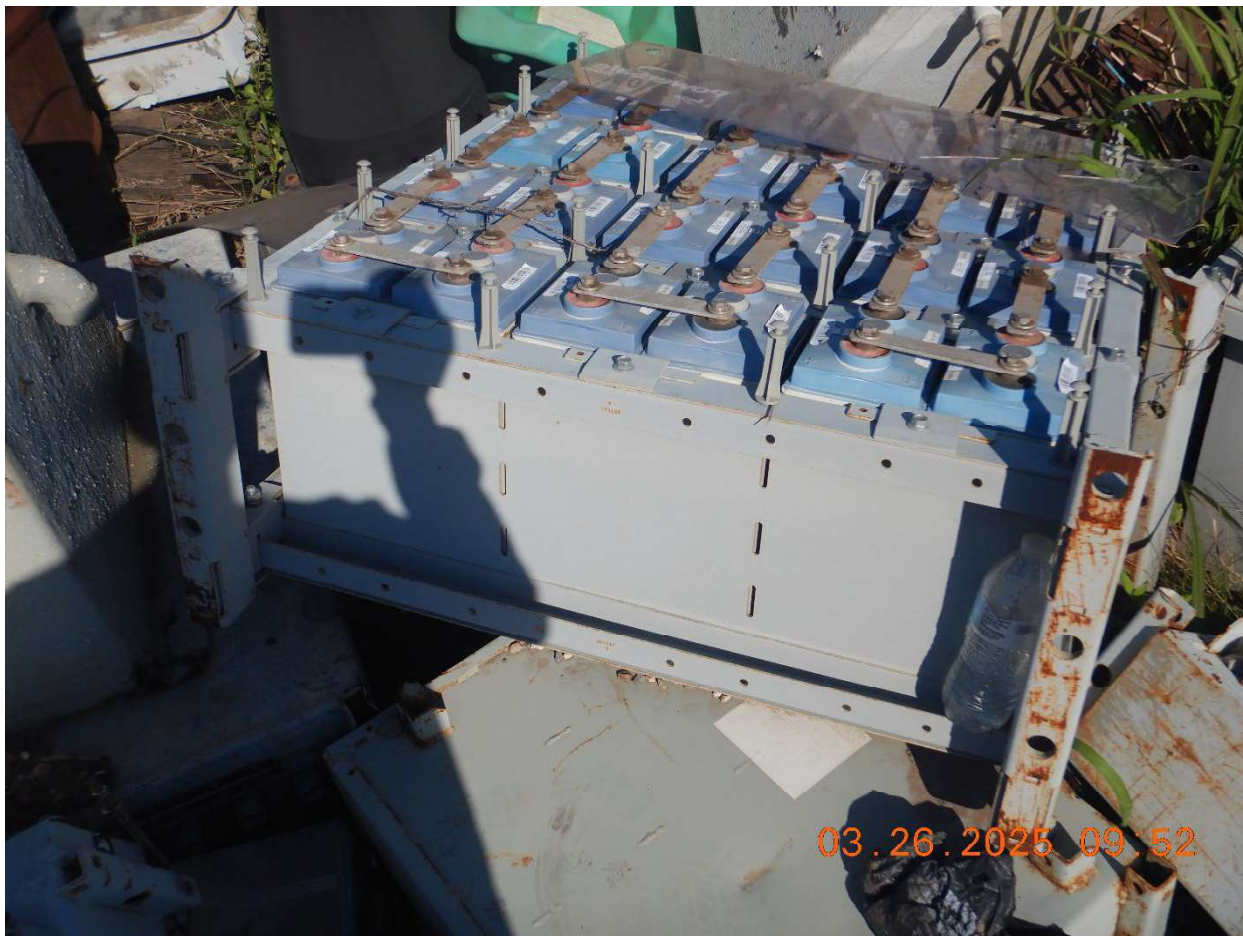
Photo No. 75

Description: View of discarded batteries found outside the universal waste warehouse.

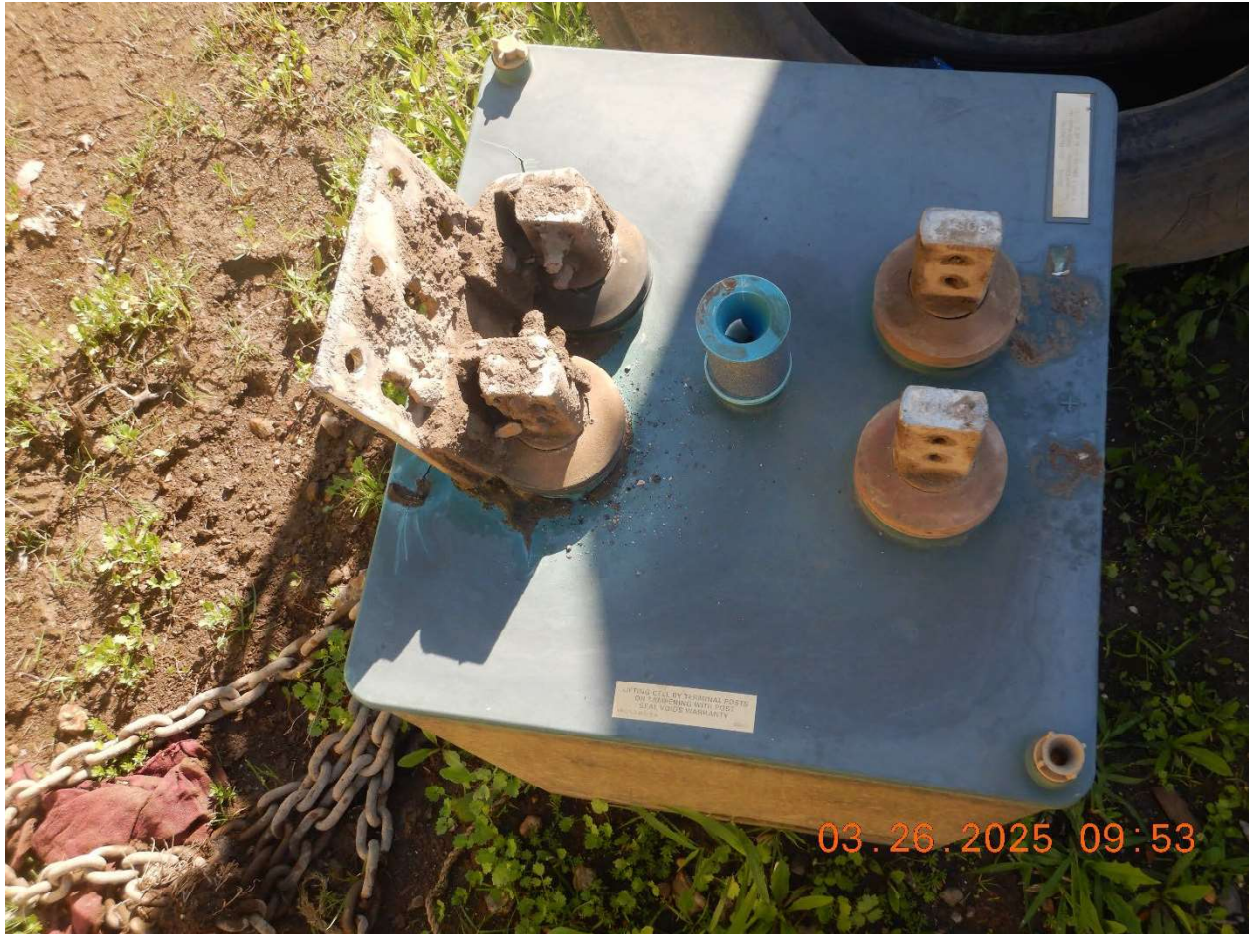
Photo No. 76

Description: View of discarded batteries found outside the universal waste warehouse.

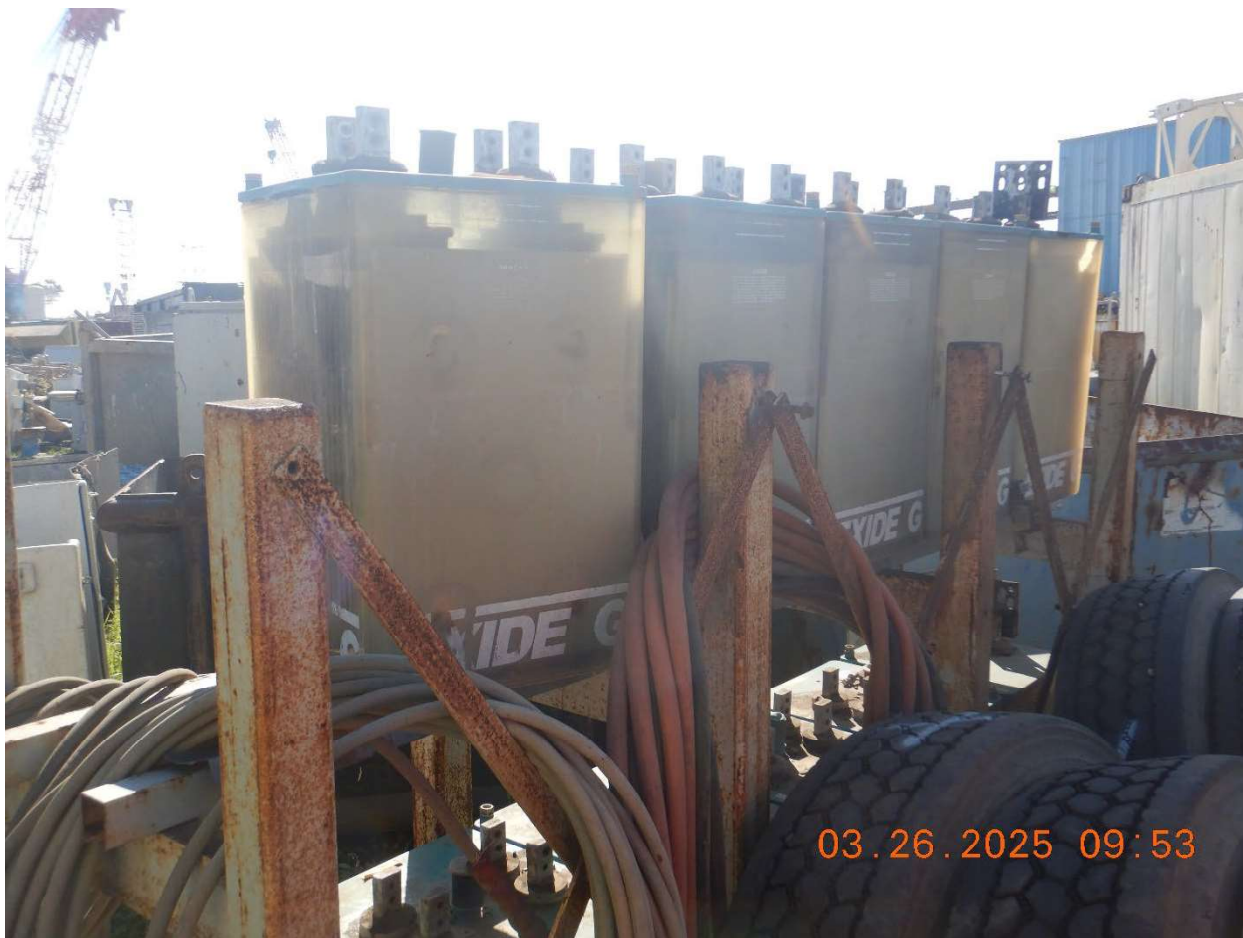
Photo No. 77

Description: View of discarded batteries found outside the universal waste warehouse.

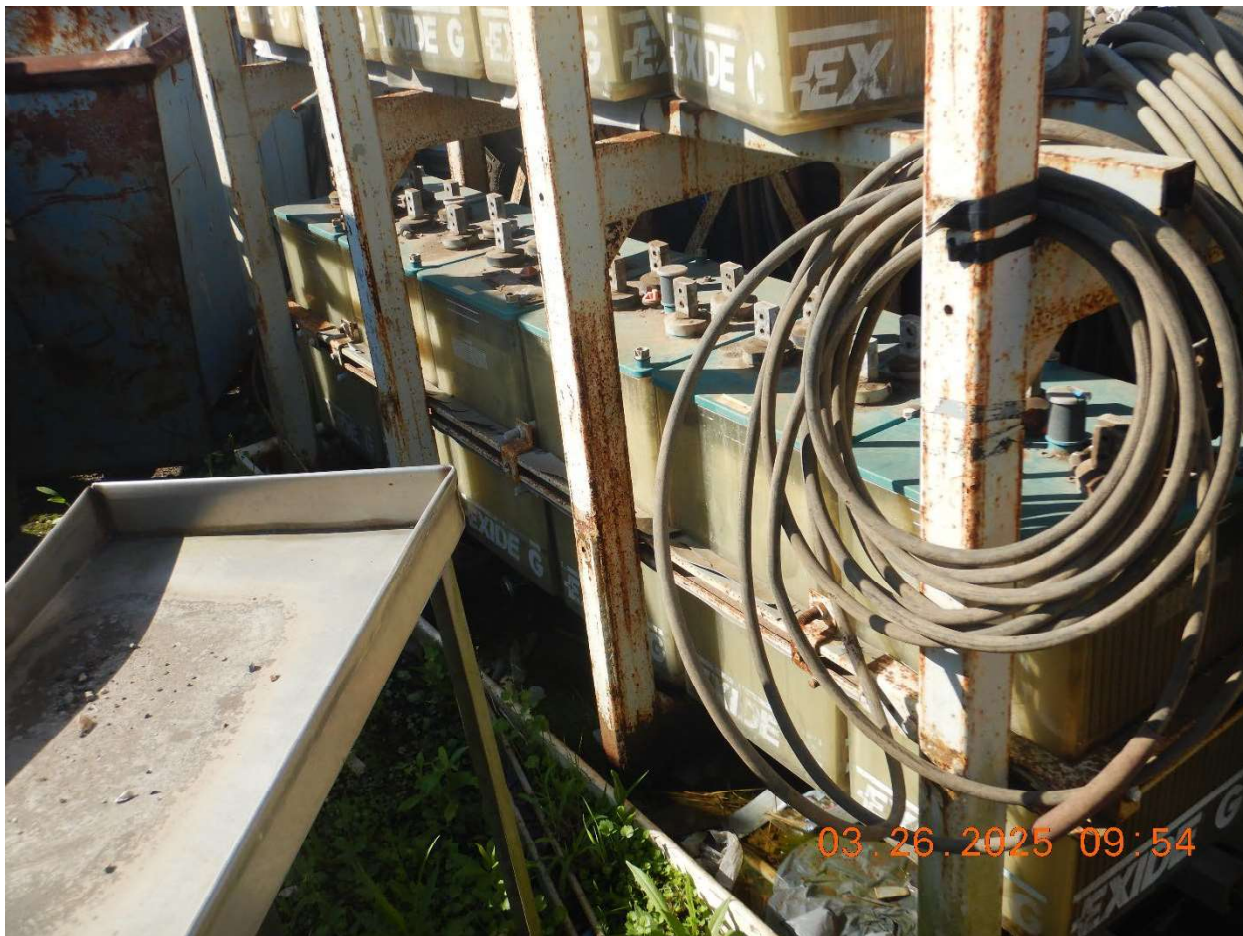
Photo No. 78

Description: View of discarded batteries found outside the universal waste warehouse.

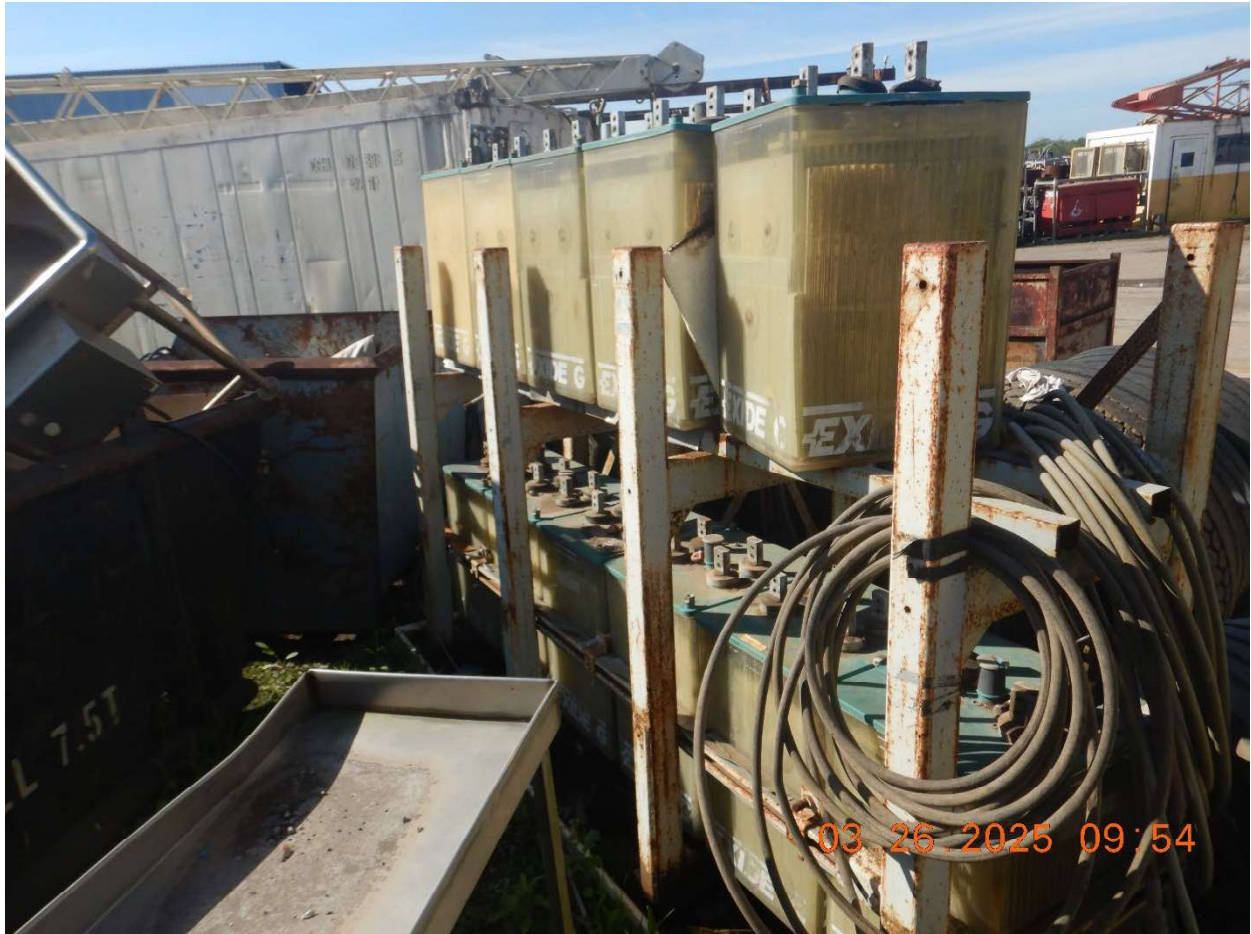
Photo No. 79

Description: View of discarded batteries found outside the universal waste warehouse.

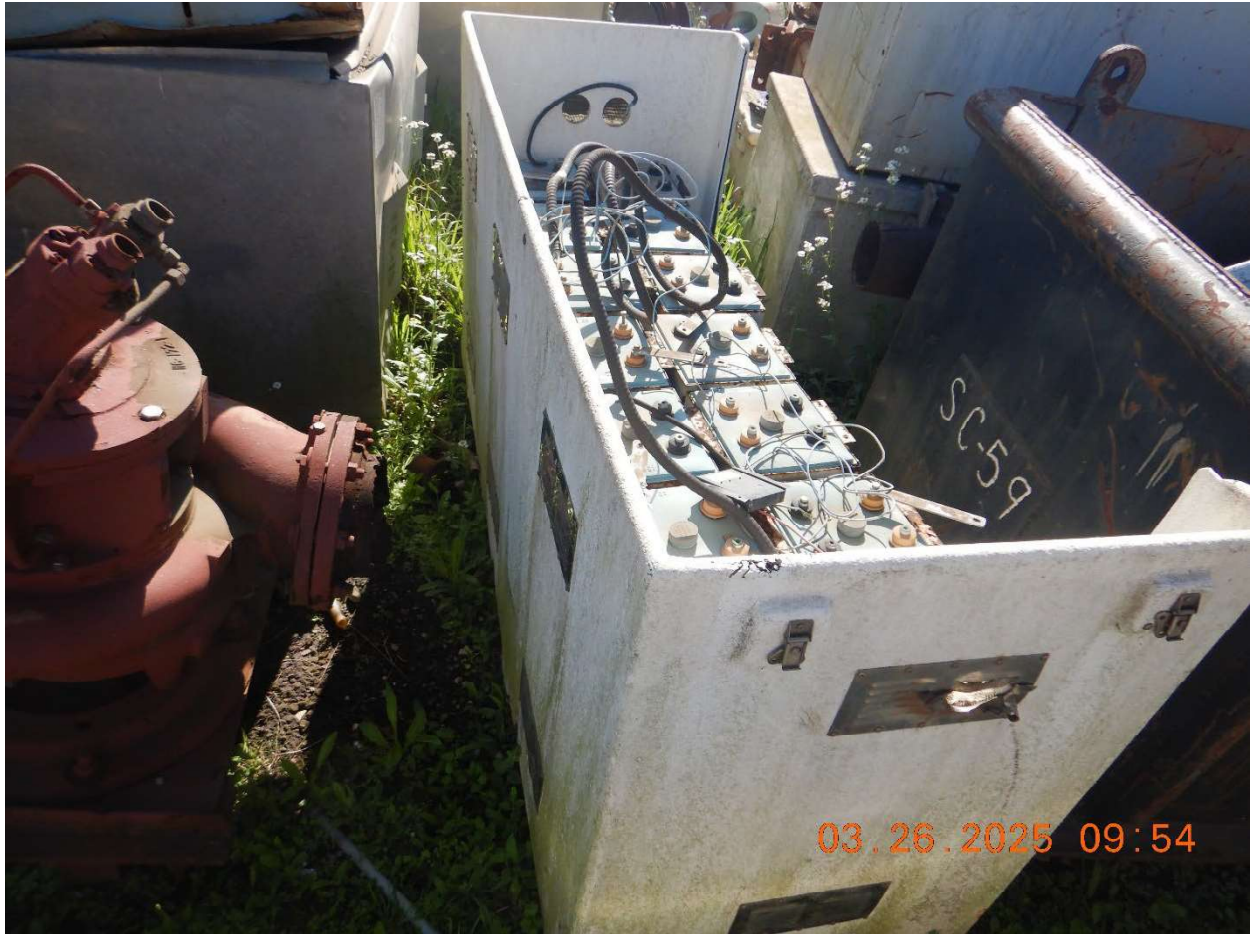
Photo No. 80

Description: View of discarded batteries found outside the universal waste warehouse.

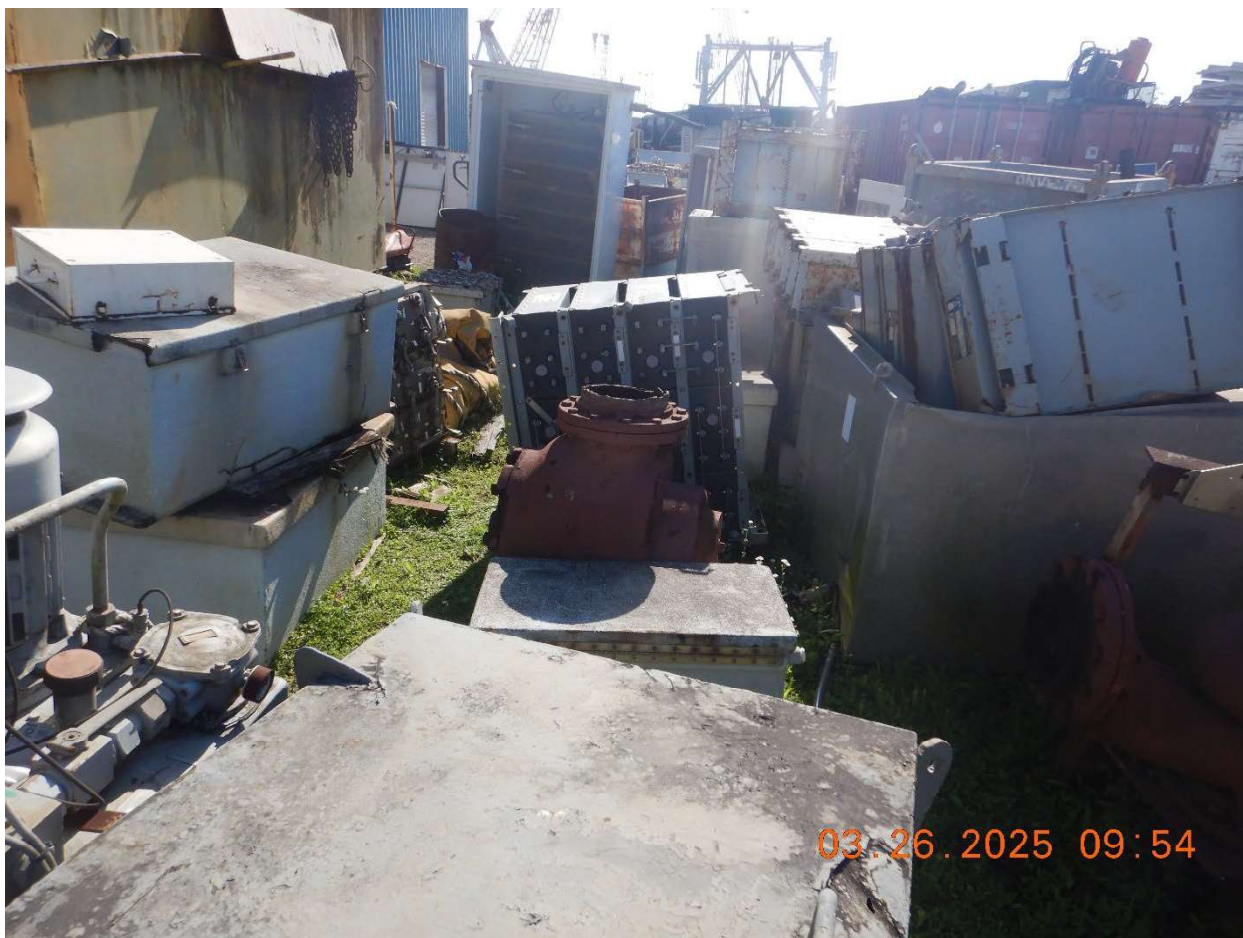
Photo No. 81

Description: View of discarded batteries found outside the universal waste warehouse.

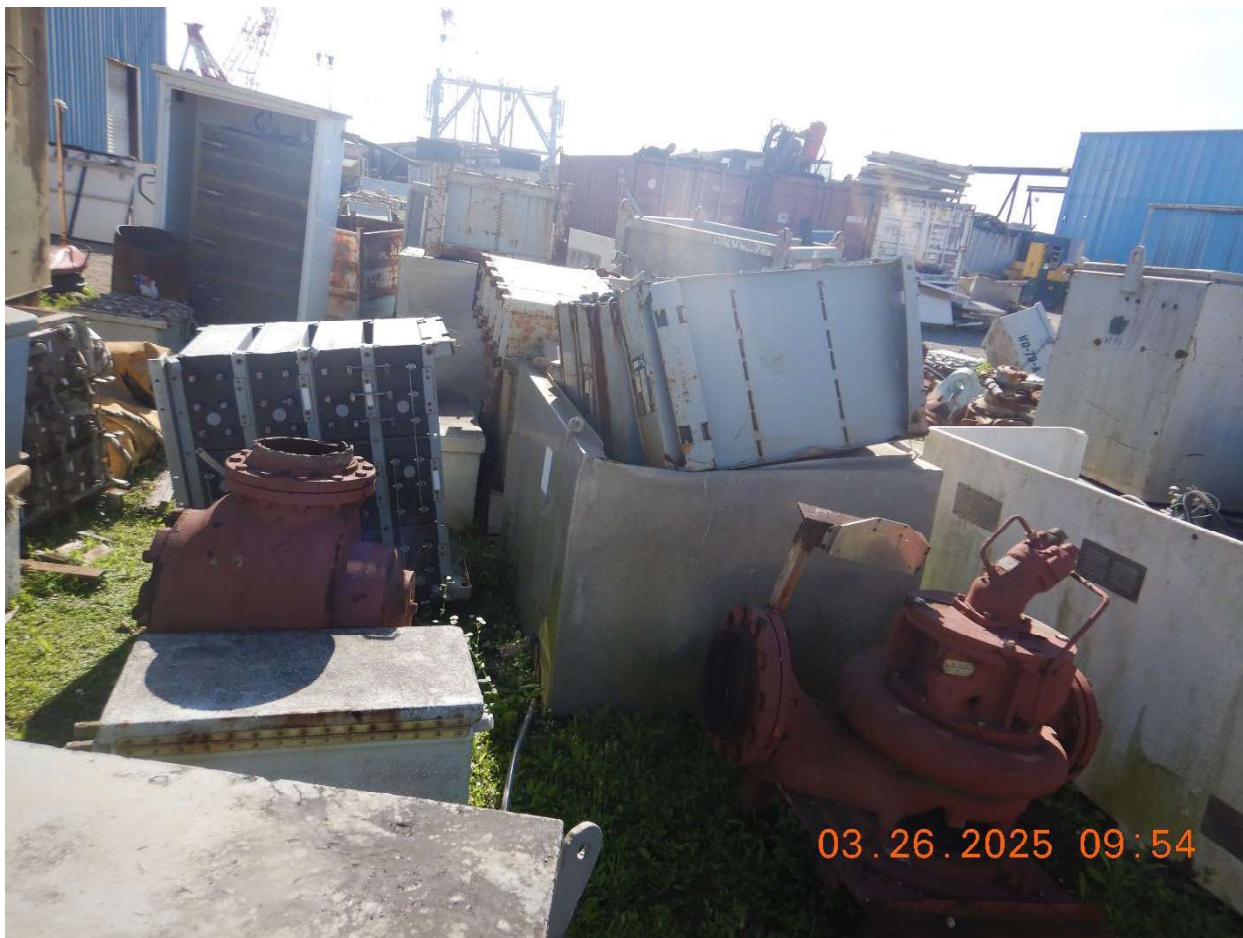
Photo No. 82

Description: View of discarded batteries found outside the universal waste warehouse.

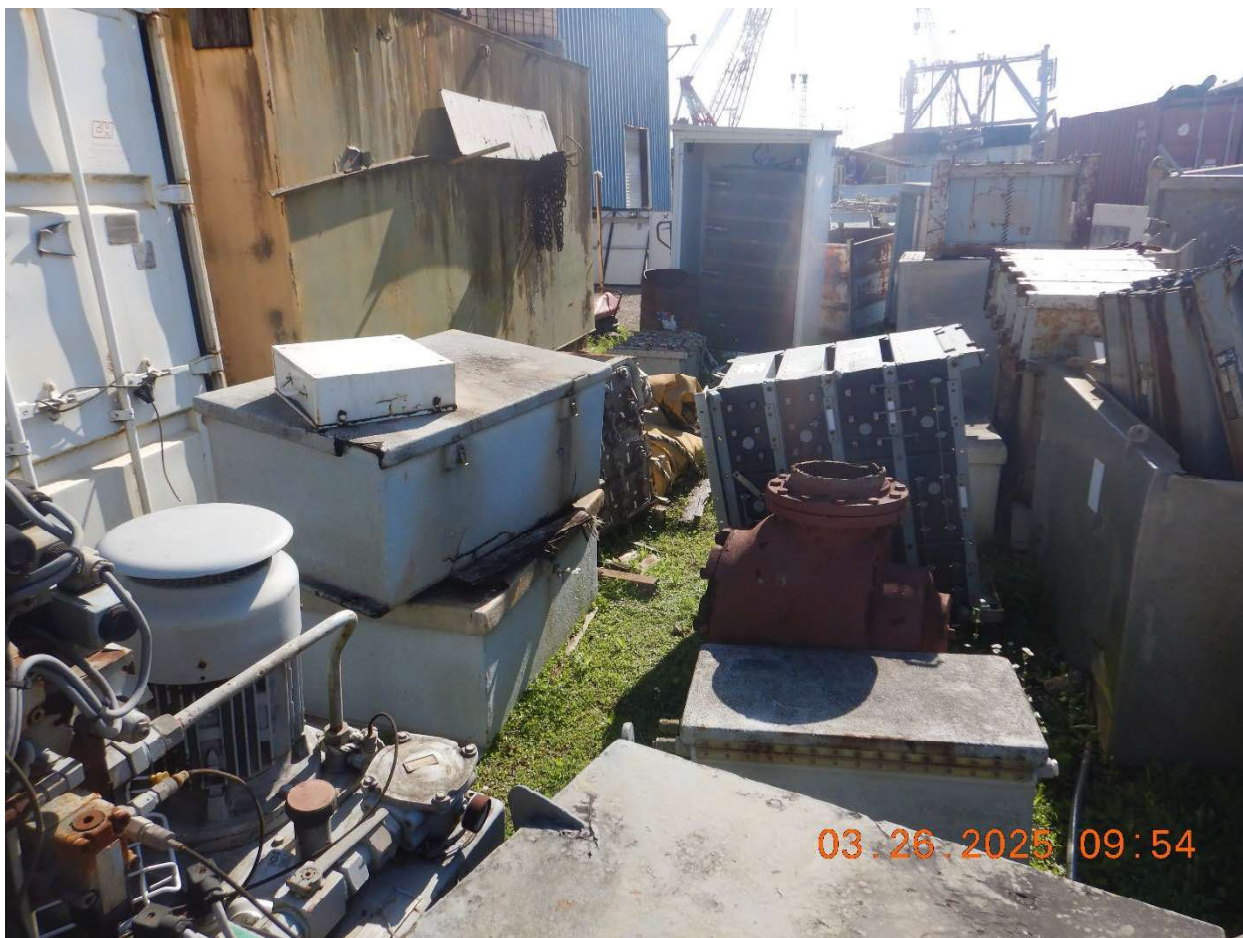
**Photo No. 83**

Description: View of discarded batteries found outside the universal waste warehouse.

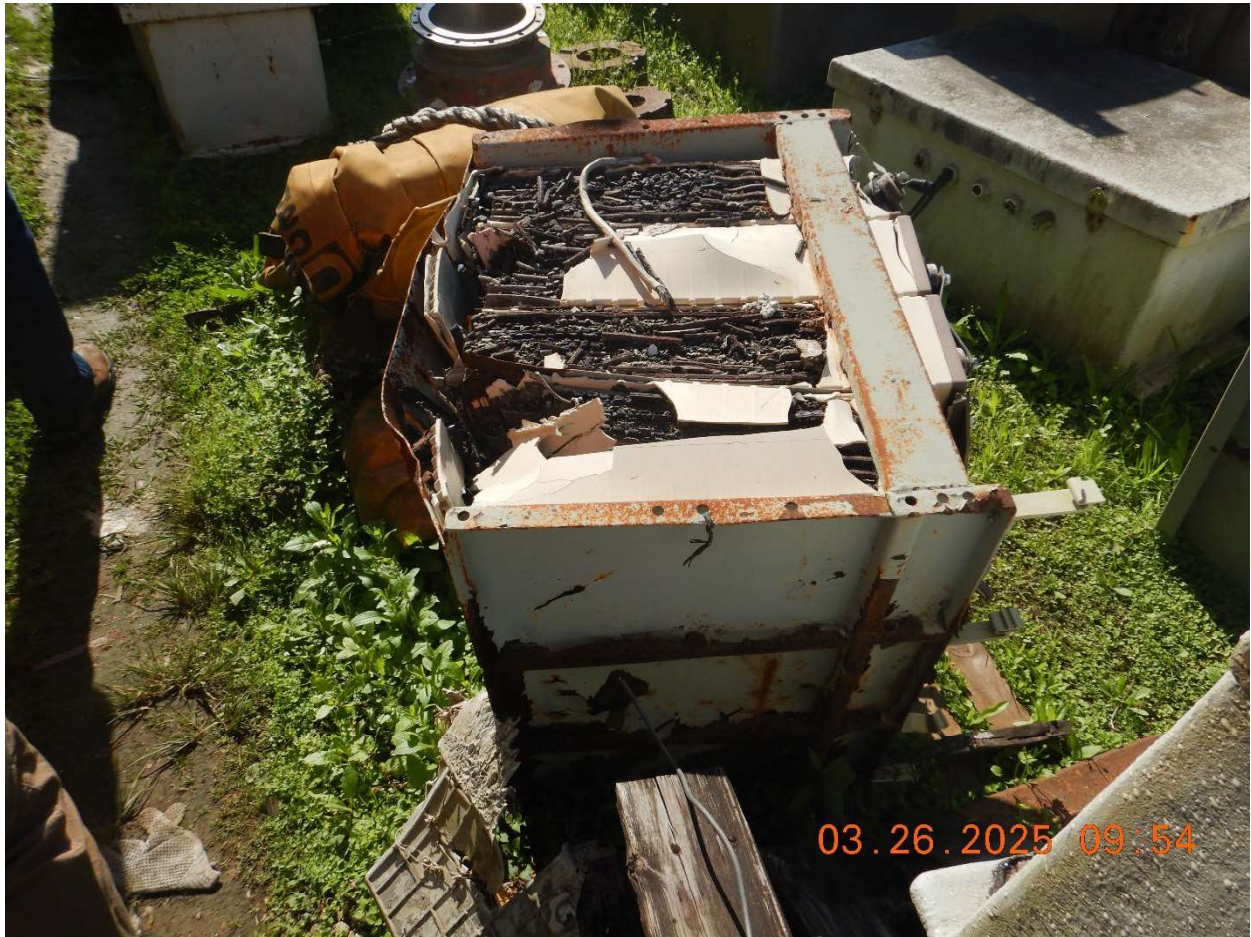
Photo No. 84

Description: View of discarded batteries found outside the universal waste warehouse.

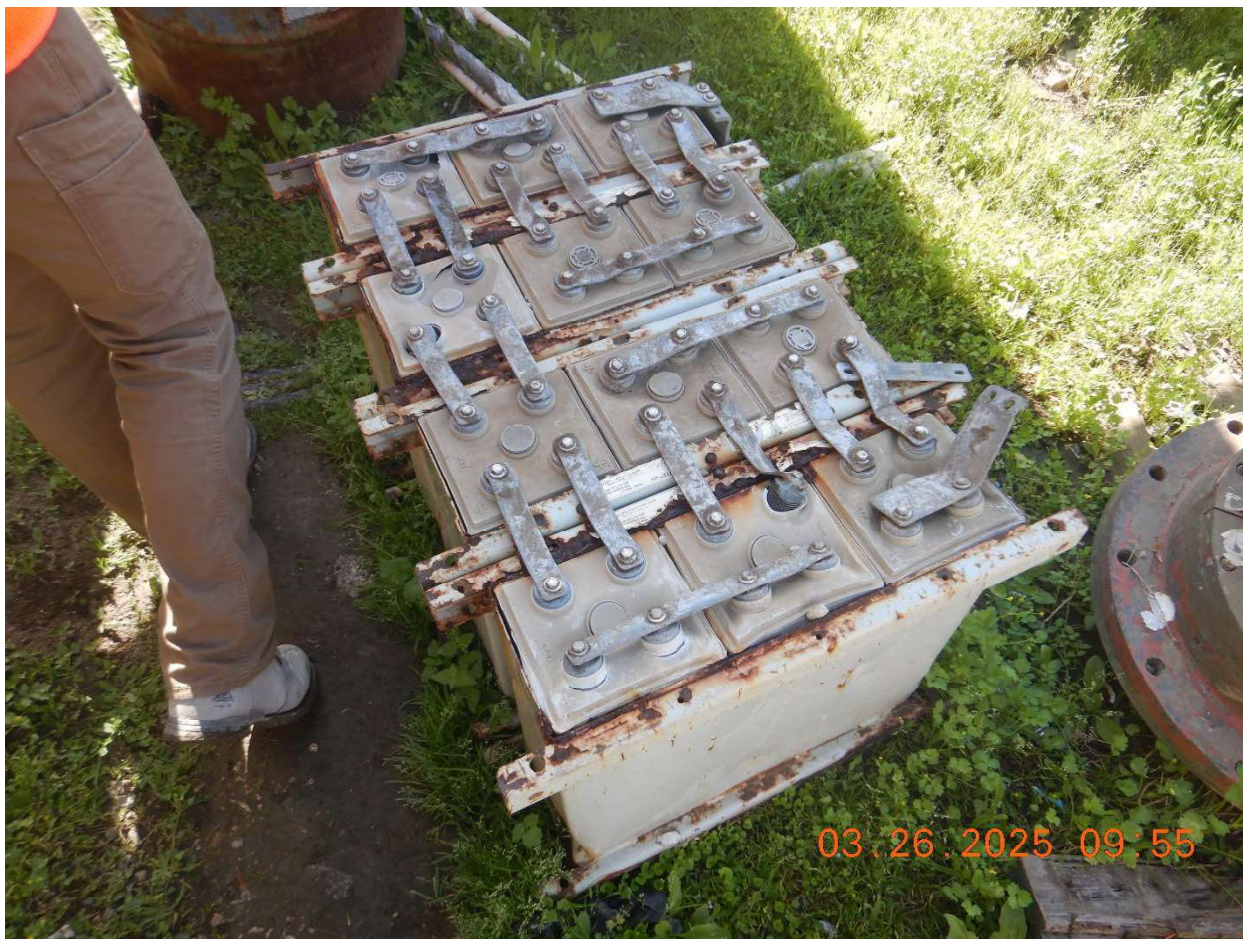
Photo No. 85

Description: View of discarded batteries found outside the universal waste warehouse.

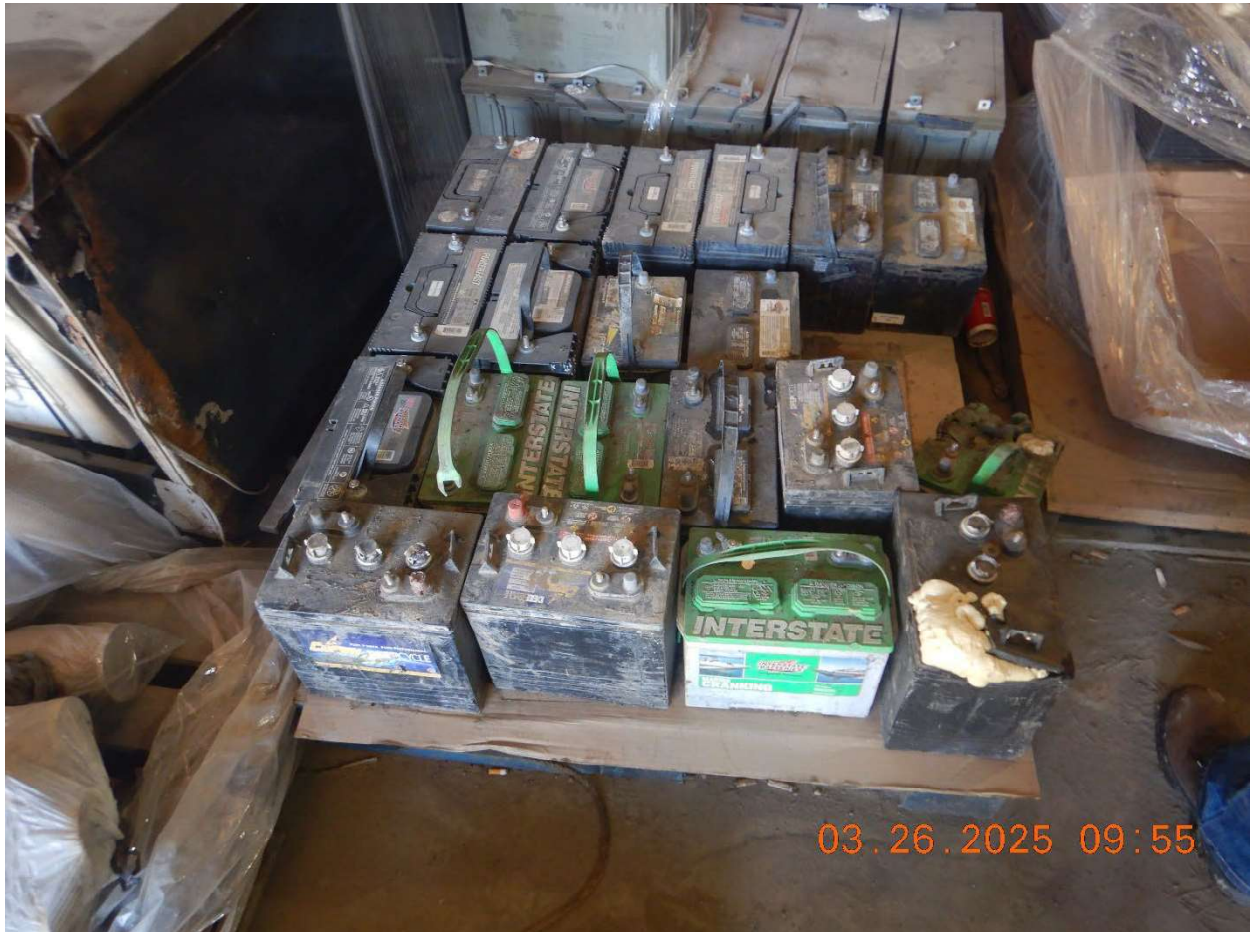
Photo No. 88

Next, the inspection team entered the universal waste warehouse, where the inspection team observed approximately 25 pallets of universal waste batteries (see Appendix 1 – Photos 88 to 107, 110 to 112). The batteries observed were not labeled, and the facility was not able to demonstrate an accumulation start date at the time of the inspection [see **AOC #4** and **AOC #5**]. For the damaged batteries, Mr. Stephenson said they were filling them with expanding foam to prevent leakage (see Appendix 1 – Photo 92). However, the damaged batteries must be contained within a receptacle to prevent any leakage or spillage [**AOC #6** – MARS did not manage damaged universal waste lamps in a way that prevents spillage or leakage by using a closed, structurally sound container - 40 CFR 273.33(a)(1)]. On the shelves of the warehouse, the inspection team observed many (> 50) universal waste lamps, some of which were in open boxes, and some were left out across the warehouse (see Appendix 1 – Photos 107 to 110, 113 to 118). The universal waste lamps were unlabeled, did not display an accumulation start date, and were not stored in containers capable of containing any releases [**AOC #7** – MARS did not label universal waste lamps or a container in which the lamps are contained, with any one of the following phrases: “Universal Waste—Lamp(s),” or “Waste Lamp(s),” or “Used Lamp(s).” - 40 CFR 273.34(e)] and [**AOC #8** – MARS, a large quantity handler of universal waste, did not manage lamps in a way that prevents releases of any universal waste or component of a universal waste to the environment- 40 CFR 273.33(d)] and [see **AOC #5**].

Description: View of a pallet of unlabeled, non-dated universal waste batteries inside the universal storage building. Two of the batteries on this pallet have been damaged.

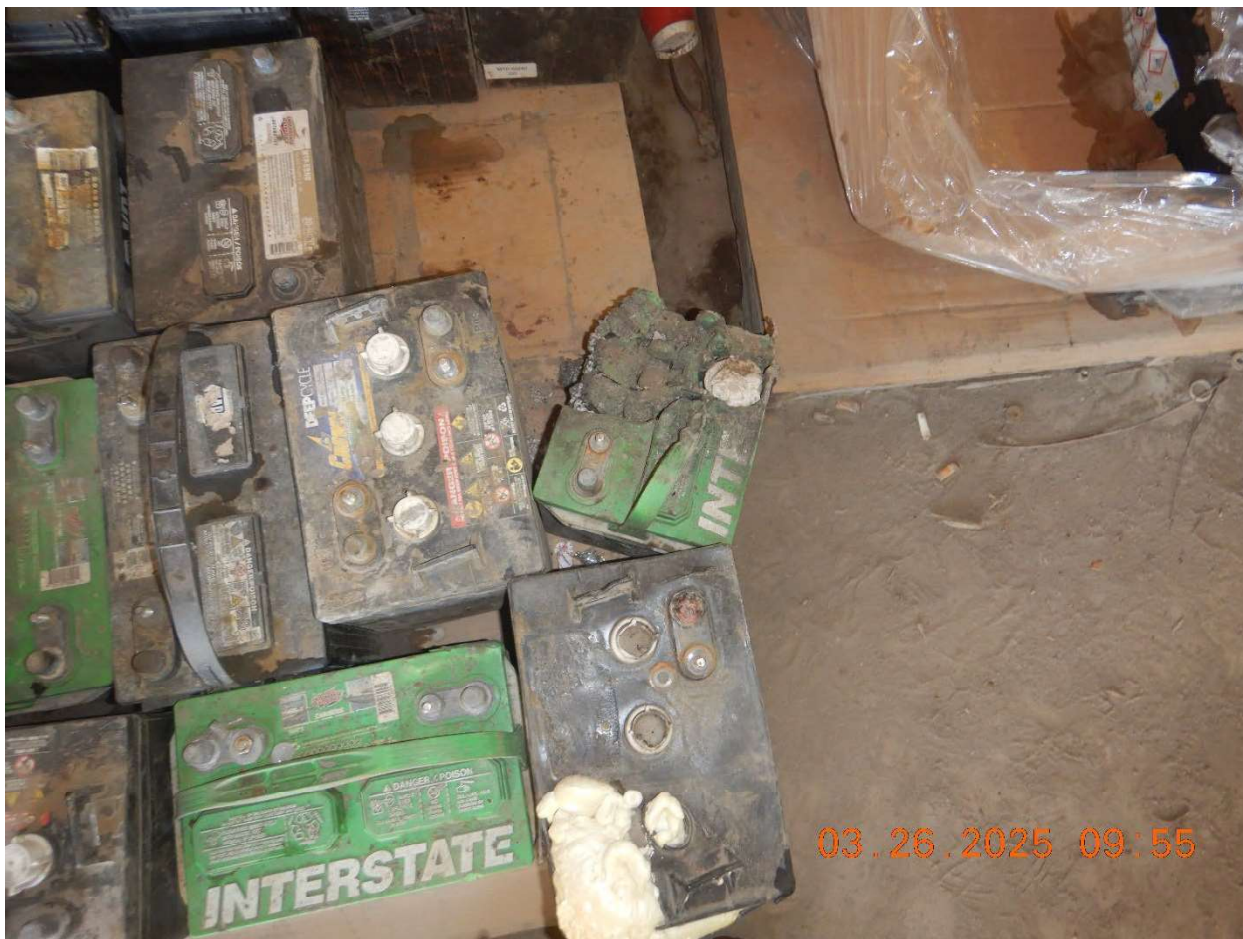
Photo No. 89

Description: Another view of a pallet of unlabeled, non-dated universal waste batteries inside the universal storage building. Two of the batteries on this pallet have been damaged.

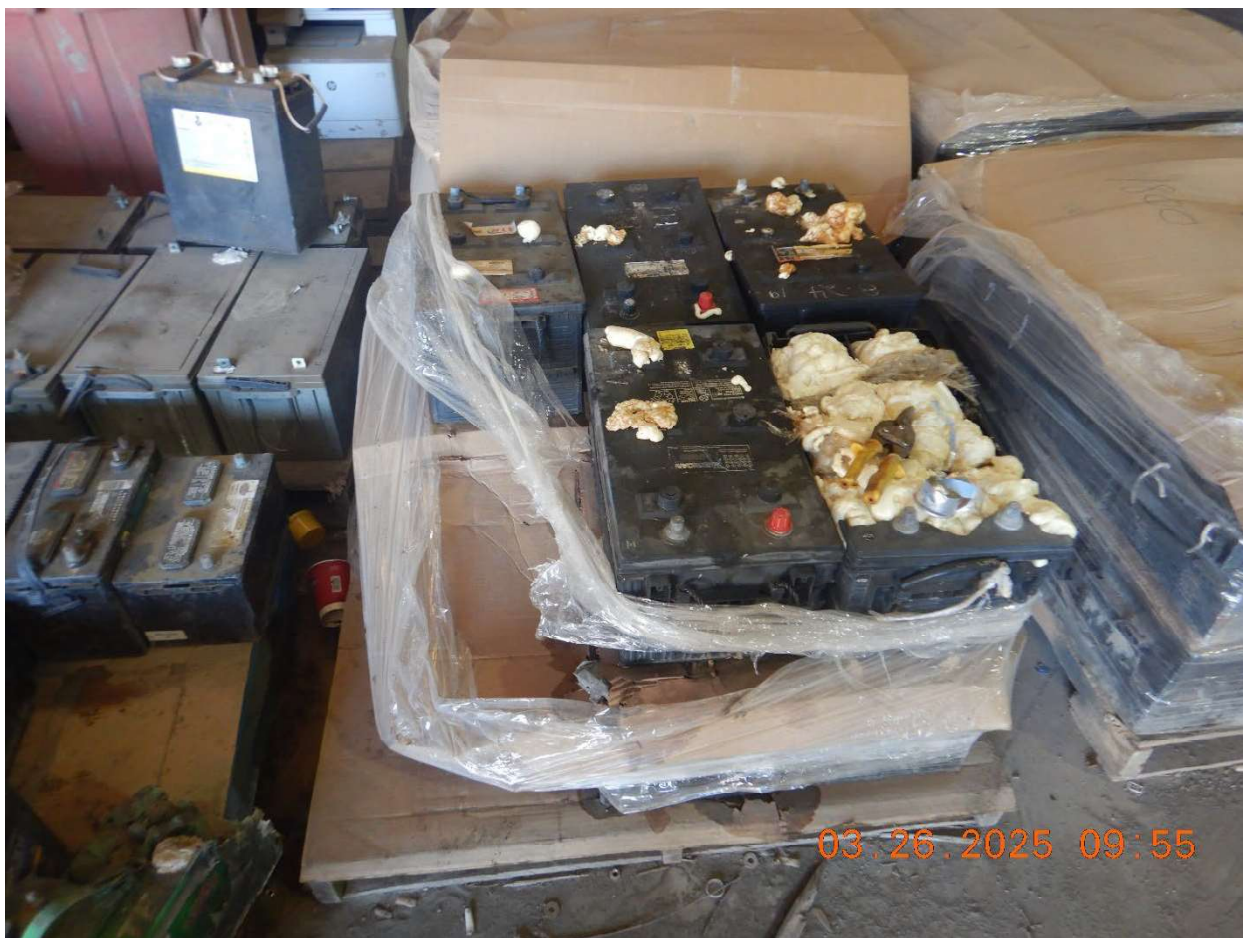
Photo No. 91

Description: View of a pallet of unlabeled, non-dated universal waste batteries inside the universal storage building. Some of the batteries on this pallet have been damaged.

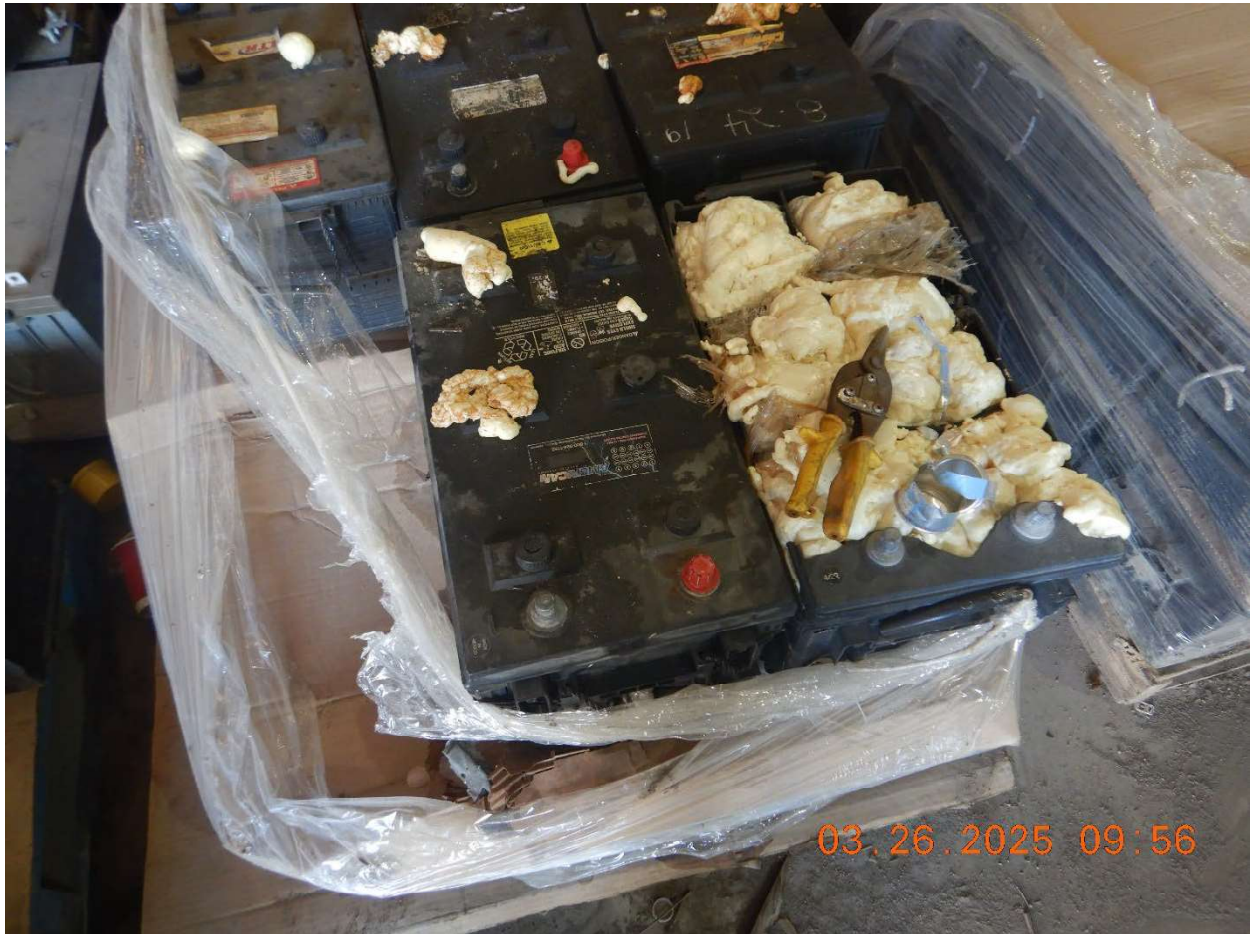
Photo No. 92

Description: Another view of a pallet of unlabeled, non-dated universal waste batteries inside the universal storage building. Some of the batteries on this pallet have been damaged.

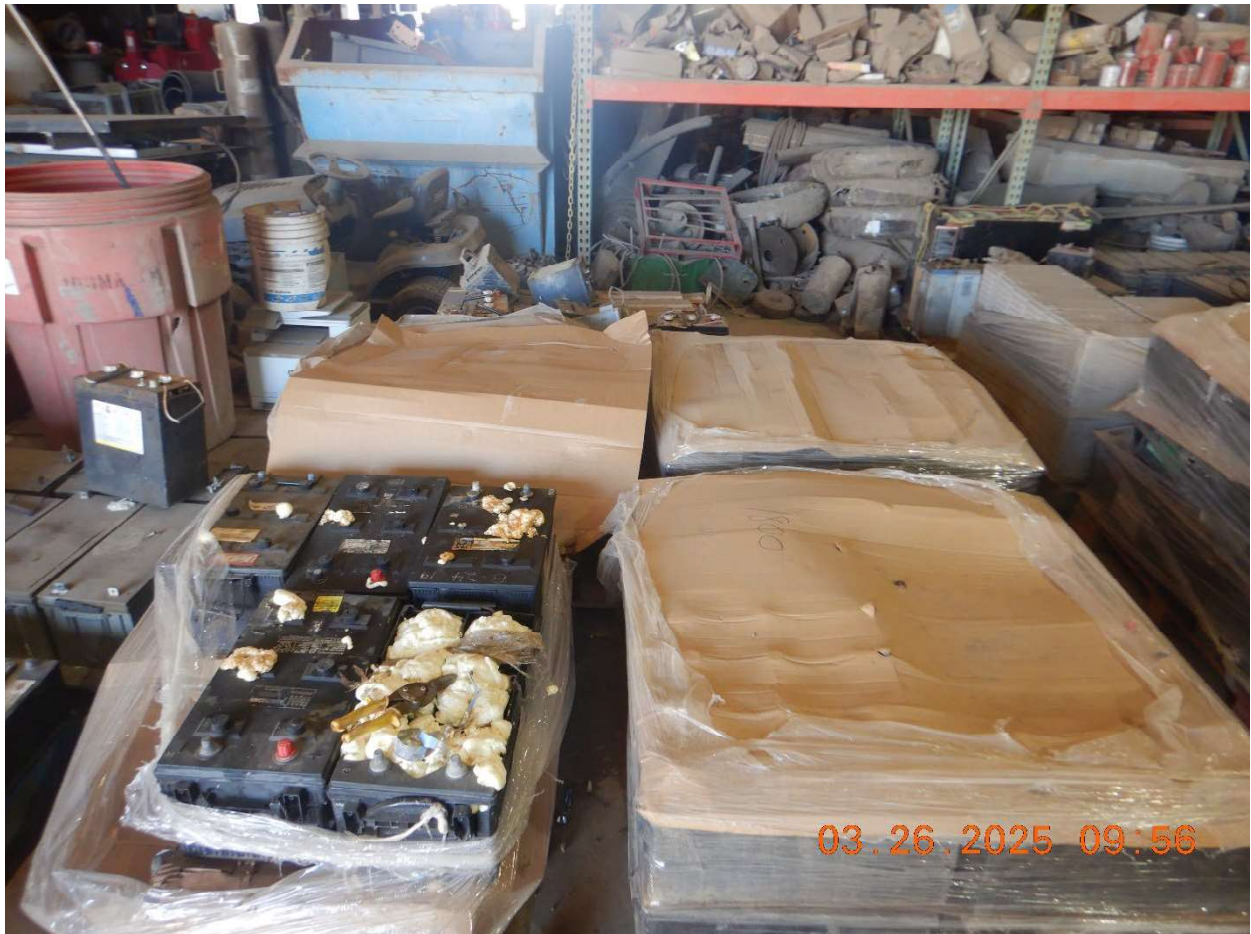
Photo No. 95

Description: Another view of pallets of unlabeled, non-dated universal waste batteries inside the universal storage building. Some of the batteries on this pallet have been damaged.

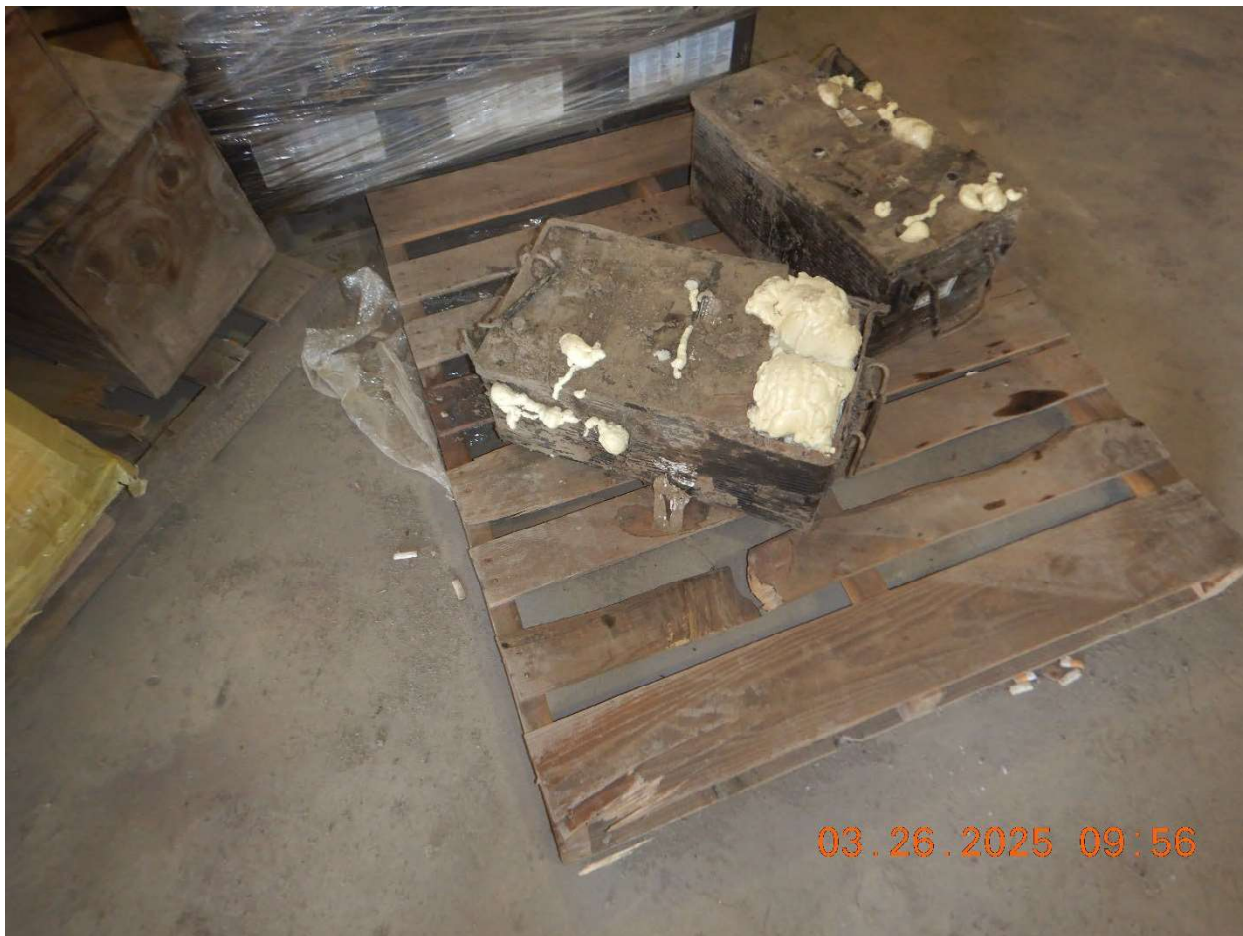
Photo No. 96

Description: View of a pallet of damaged, unlabeled, non-dated universal waste batteries inside the universal storage building.
