INSPECTION REPORT

| Type of Inspection | Compliance Evaluation Inspection (CEI) | | |
| Facility or Site Name | Modern American Recycling Services Inc. | | |
| Type of Operation | Modern American Recycling Services (MARS) decommissions oil field platforms and recycles the scrap metal. | | |

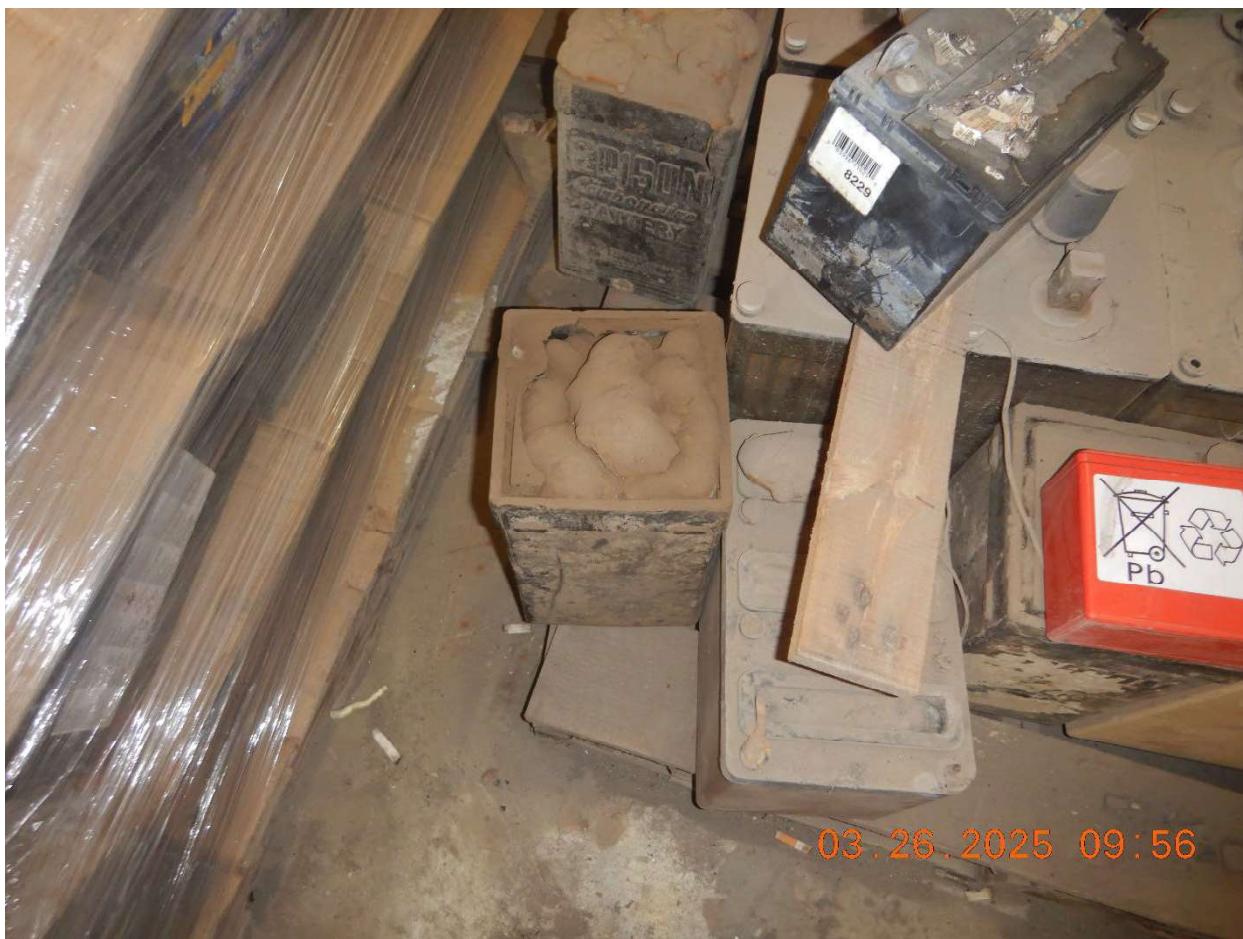
Photo No. 98

Description: View of a pallet of damaged, unlabeled, non-dated universal waste batteries inside the universal storage building.

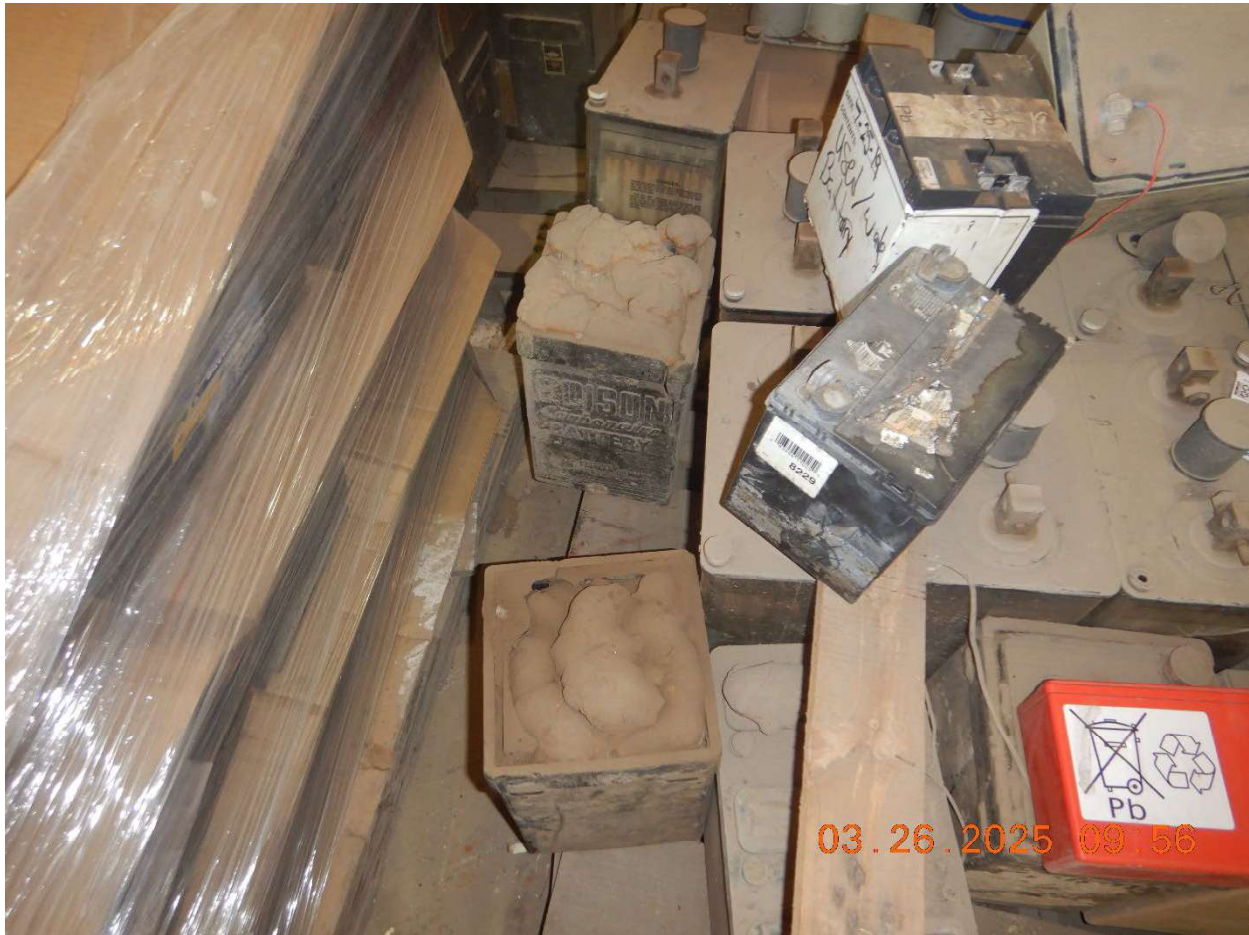
Photo No. 99

Description: Another view of a pallet of damaged, unlabeled, non-dated universal waste batteries inside the universal storage building.

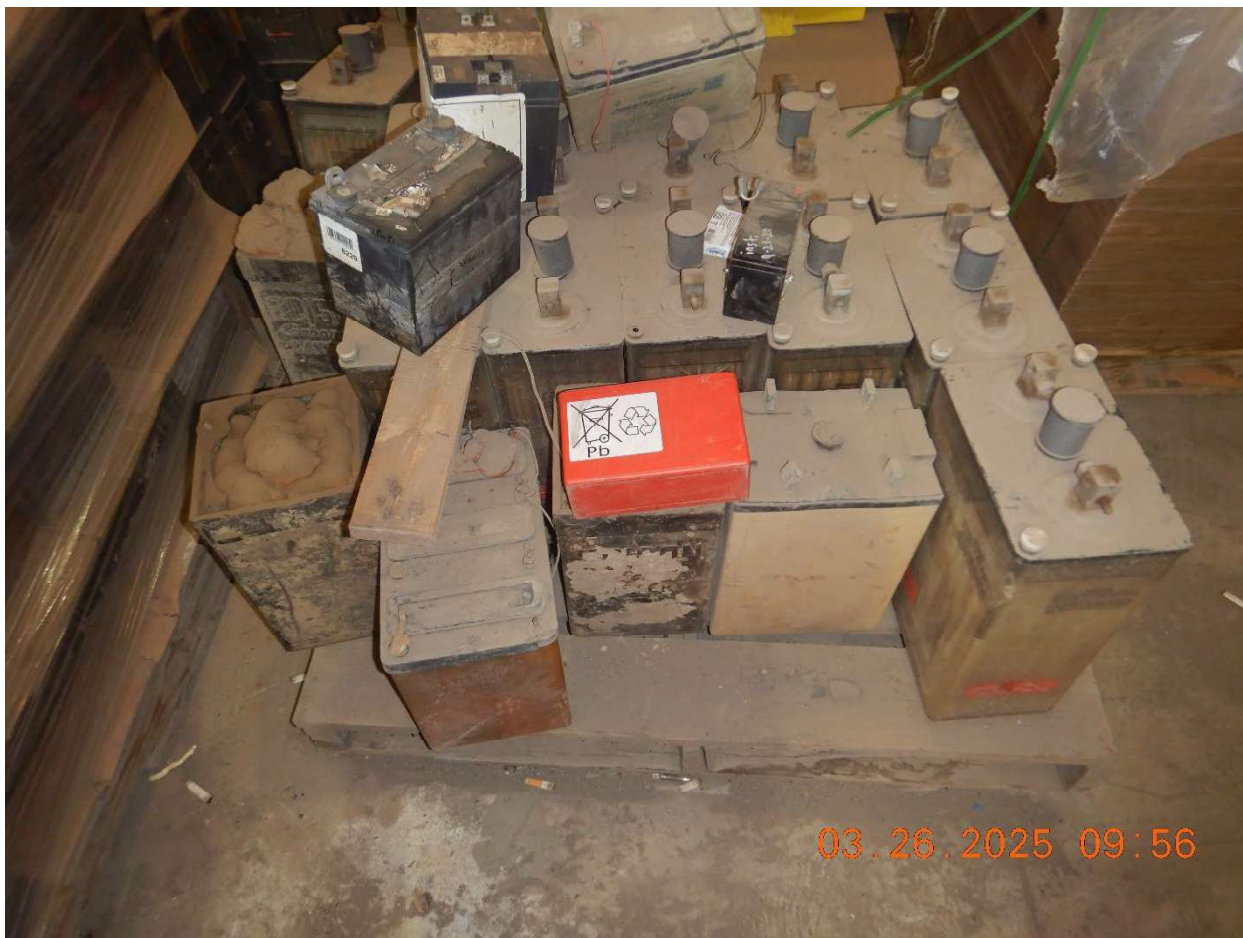
Photo No. 101

Description: Another view of a pallet of unlabeled, non-dated universal waste batteries inside the universal storage building. Some of the batteries have been damaged.

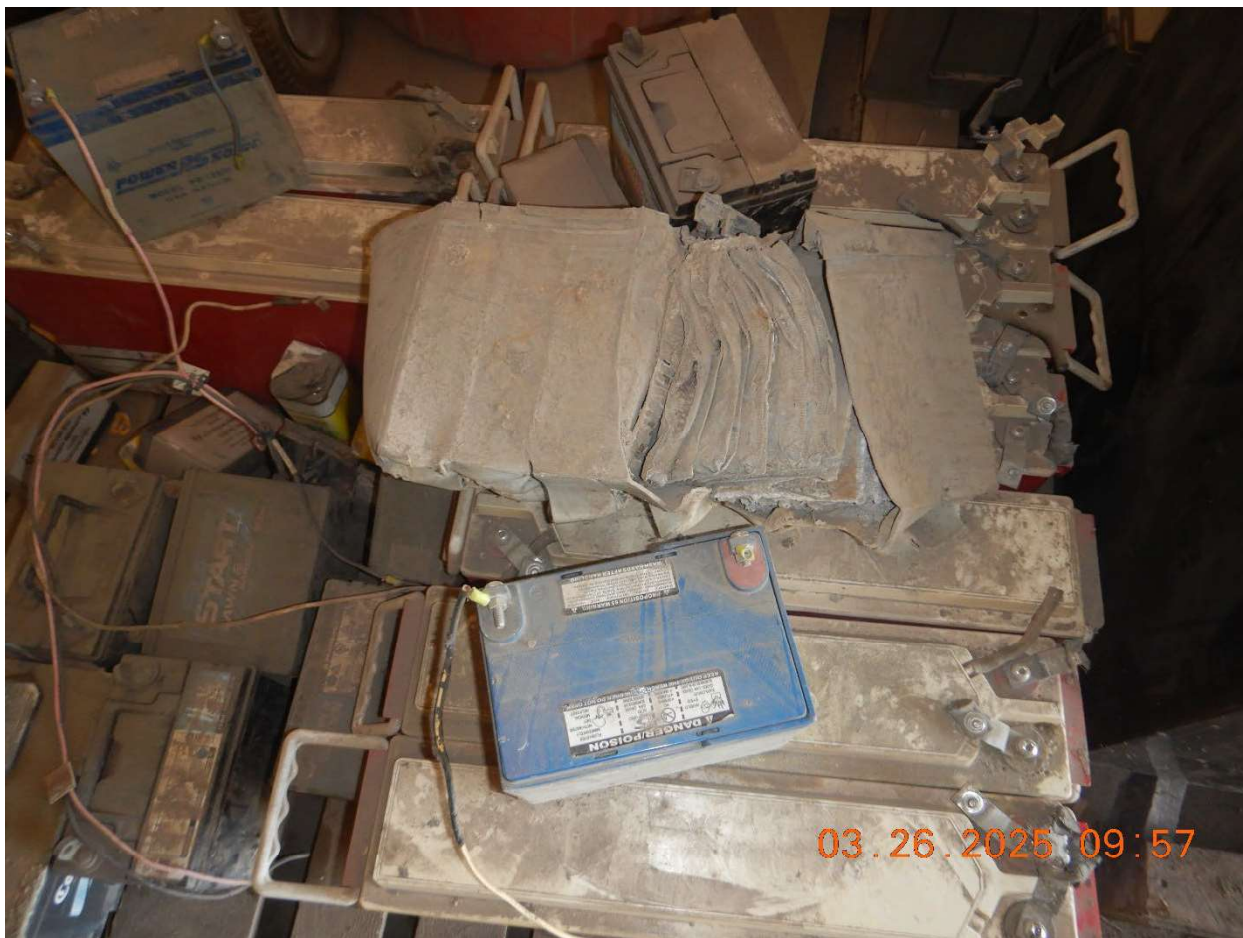
Photo No. 104

Description: View of a damaged, unlabeled, non-dated universal waste battery inside the universal storage building.

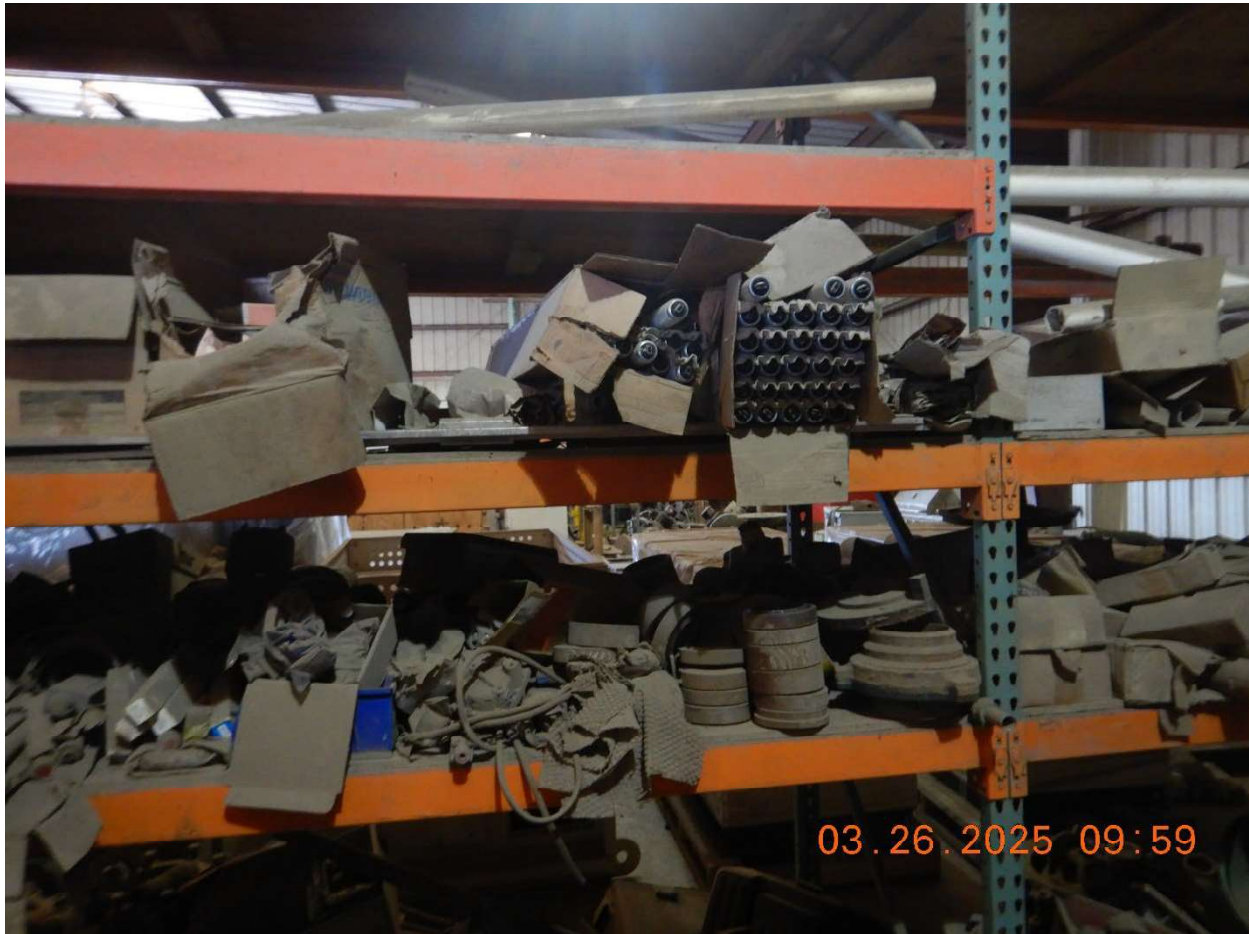
Photo No. 108

Description: View of universal waste lamps, which are not in a closed container, unlabeled, and non-dated, observed in the universal waste storage building.

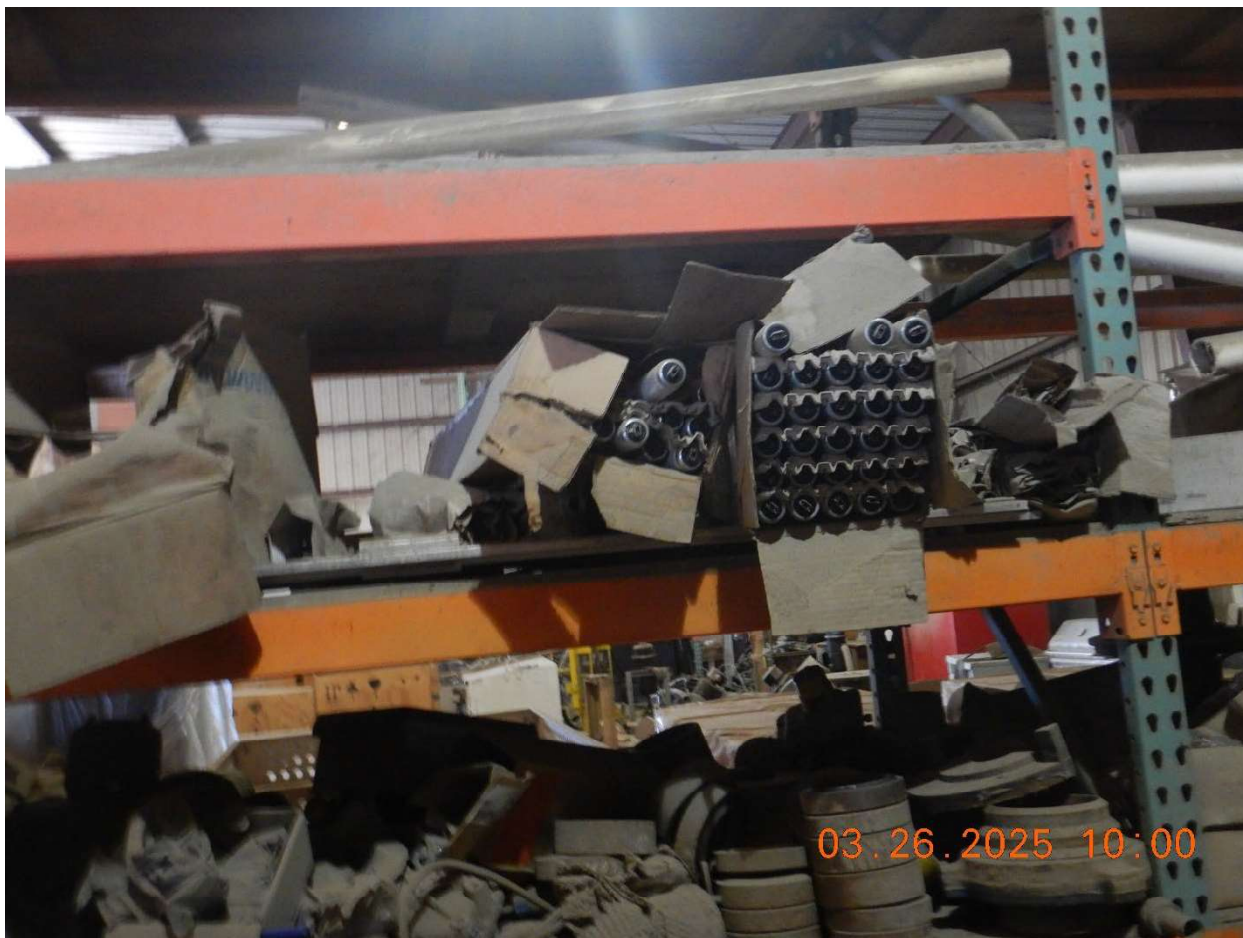
Photo No. 109

Description: Another view of universal waste lamps, which are not in a closed container, unlabeled, and non-dated, observed in the universal waste storage building.

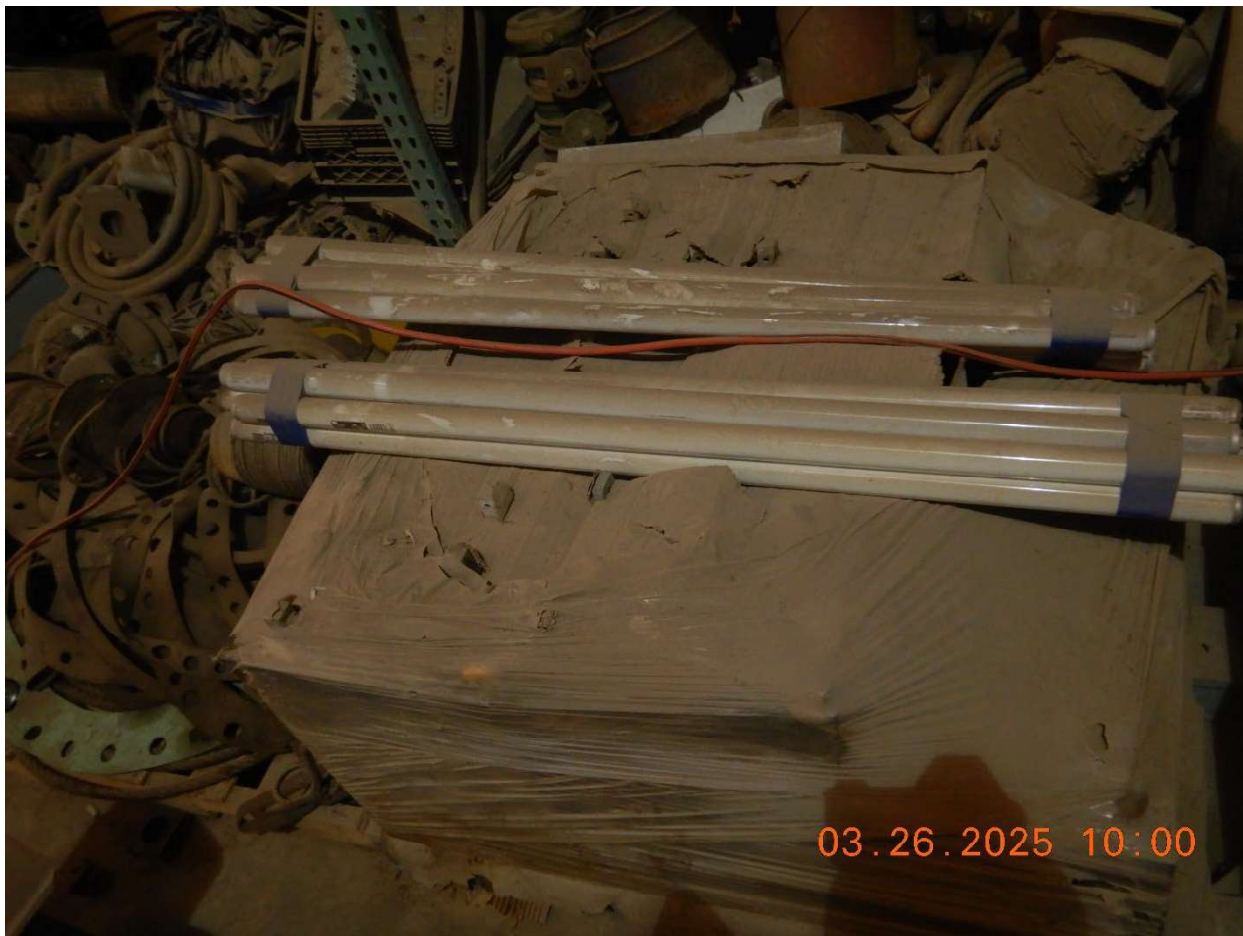
Photo No. 110

Description: View of universal waste lamps, which are not in a closed container, unlabeled, and non-dated, observed in the universal waste storage building.

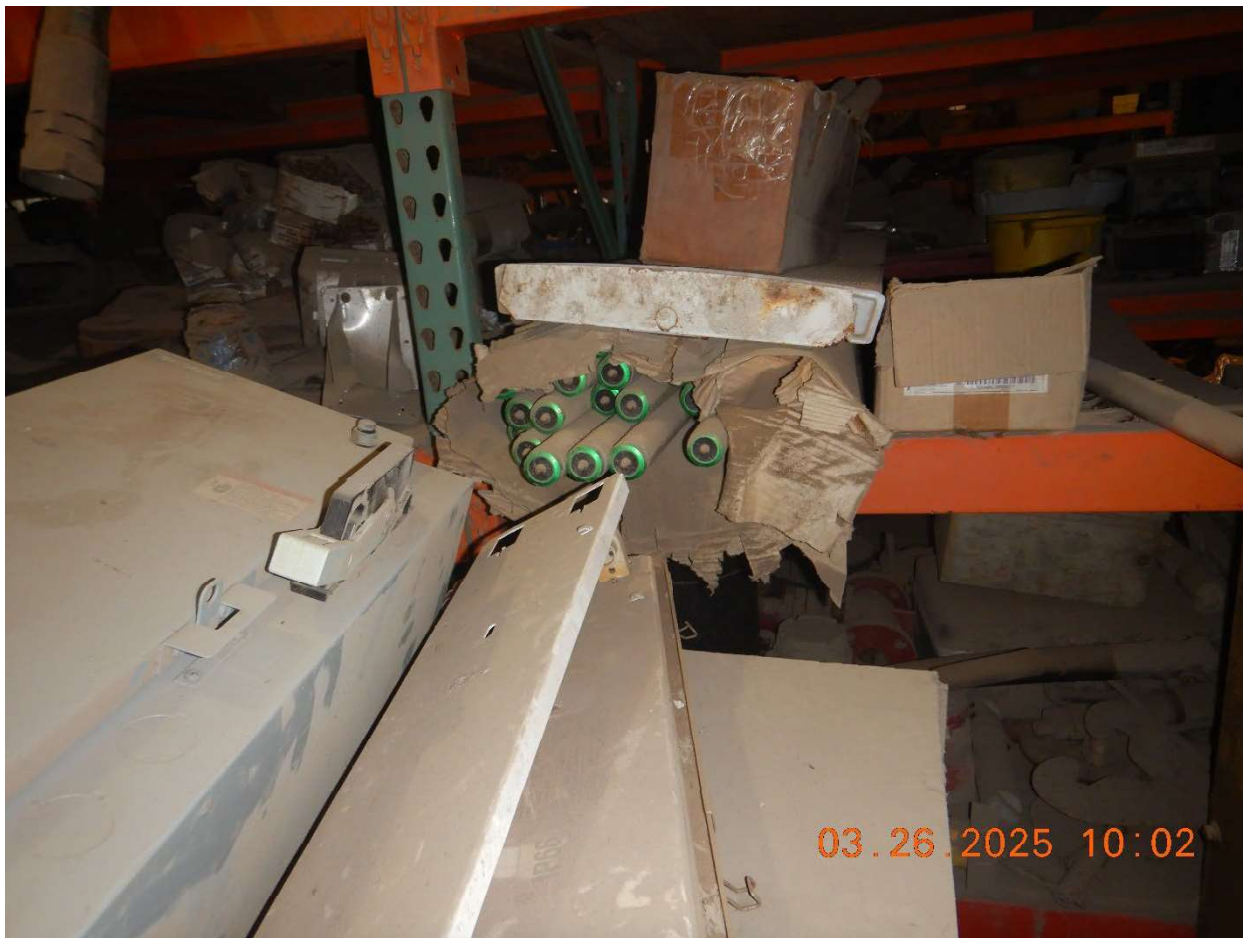
Photo No. 113

Description: View of universal waste lamps, which are not in a closed container, unlabeled, and non-dated, observed in the universal waste storage building.

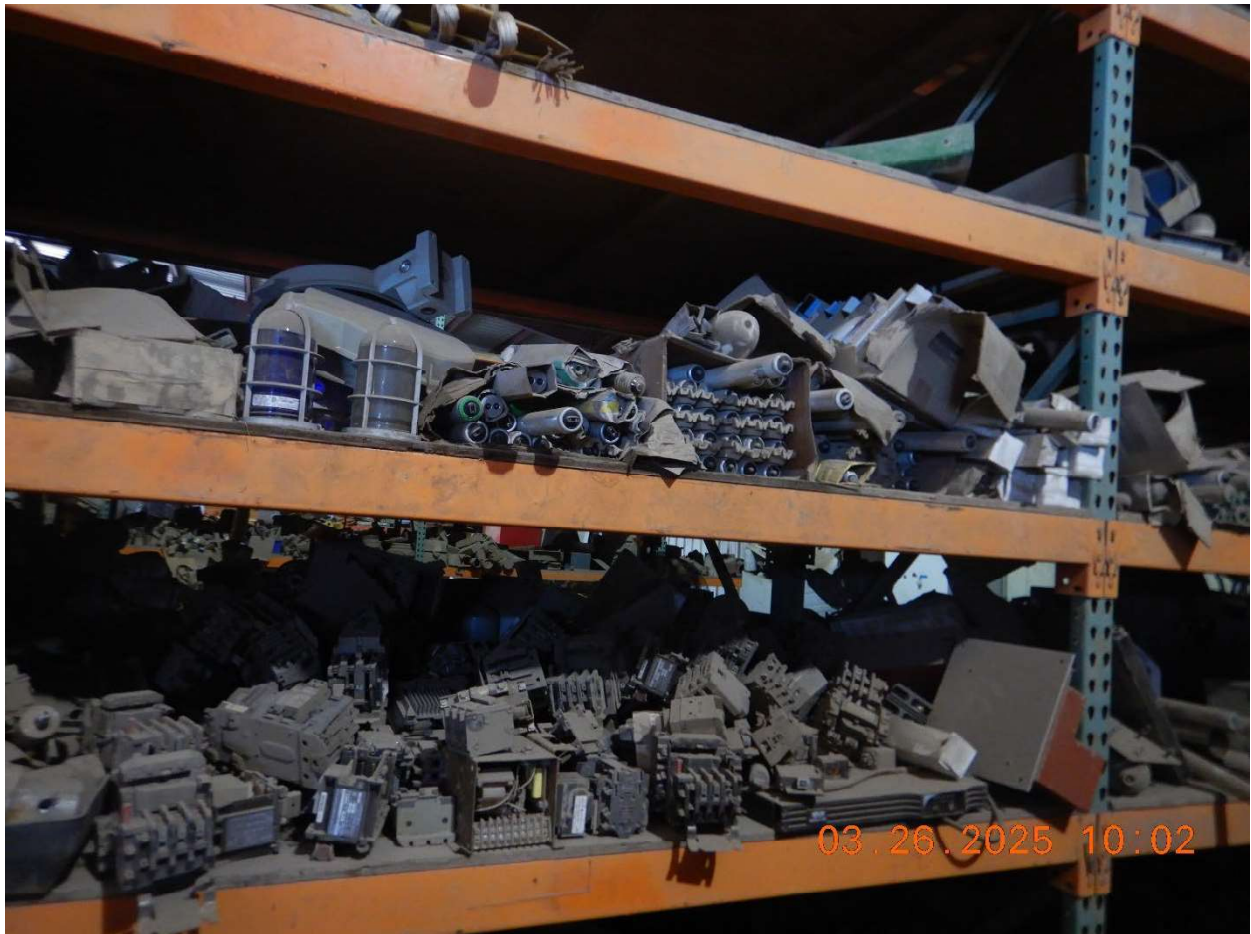
Photo No. 114

Description: View of universal waste lamps, which are not in a closed container, unlabeled, and non-dated, observed in the universal waste storage building.

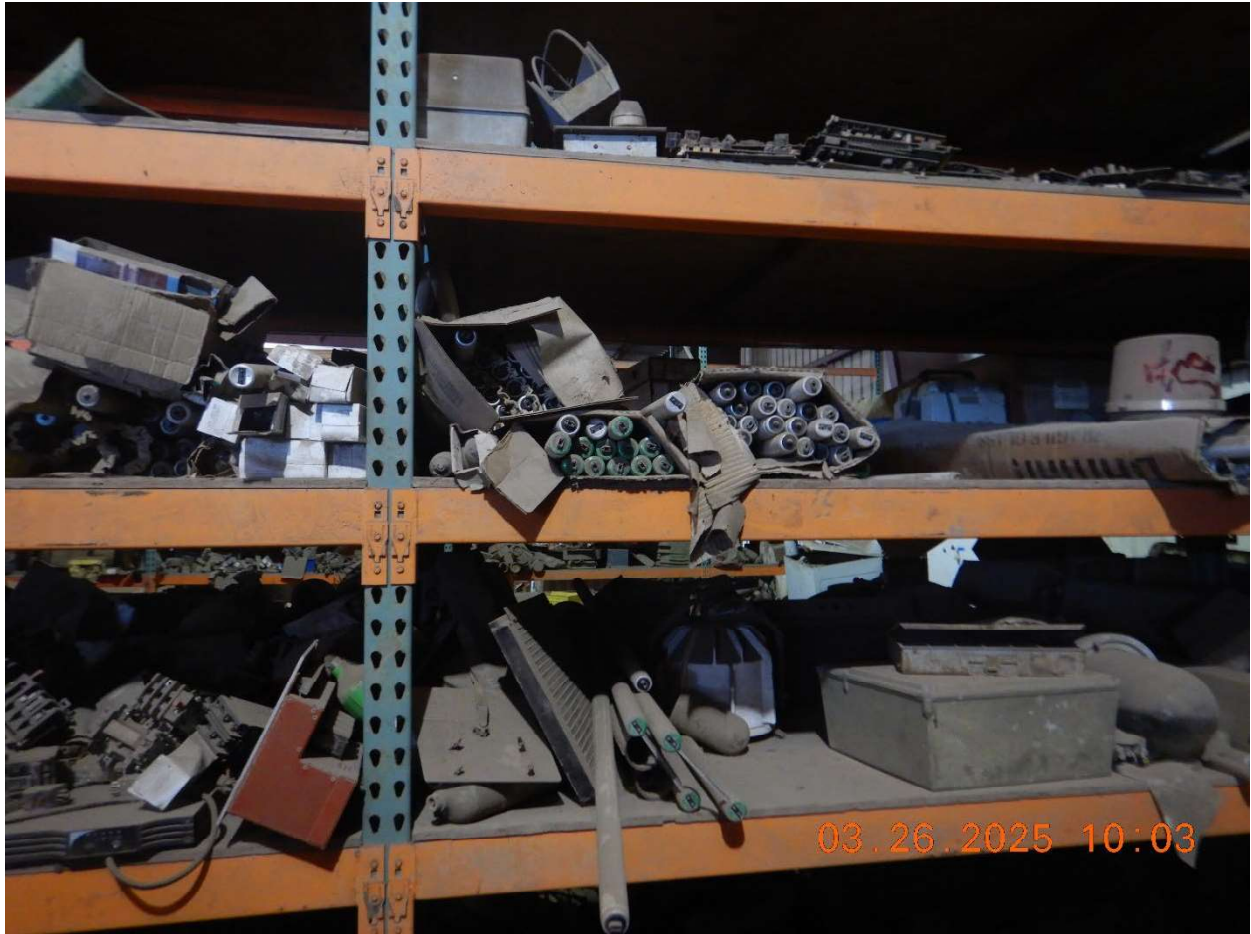
Photo No. 115

Description: View of universal waste lamps, which are not in a closed container, unlabeled, and non-dated, observed in the universal waste storage building.

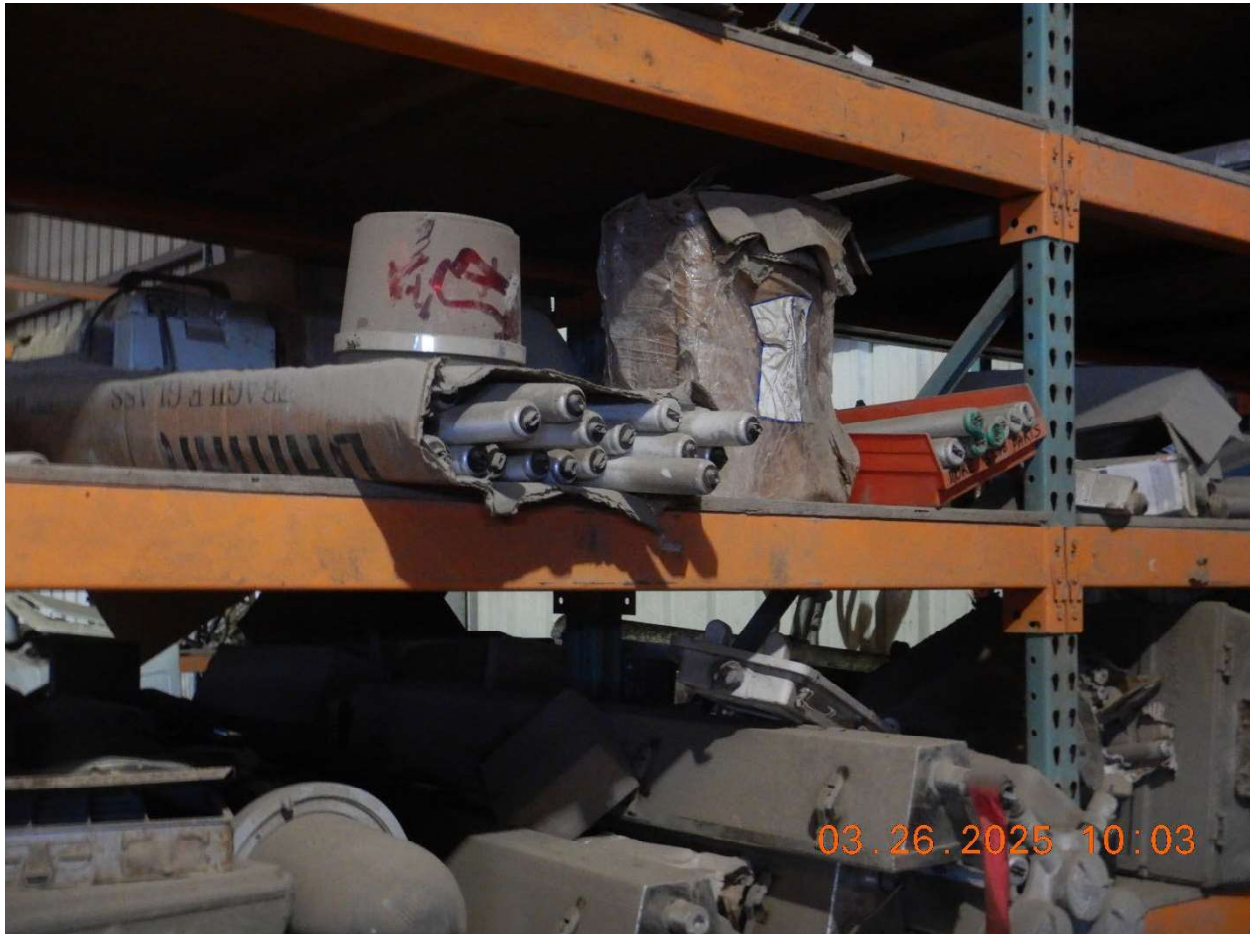
Photo No. 116

Description: View of universal waste lamps, which are not in a closed container, unlabeled, and non-dated, observed in the universal waste storage building.

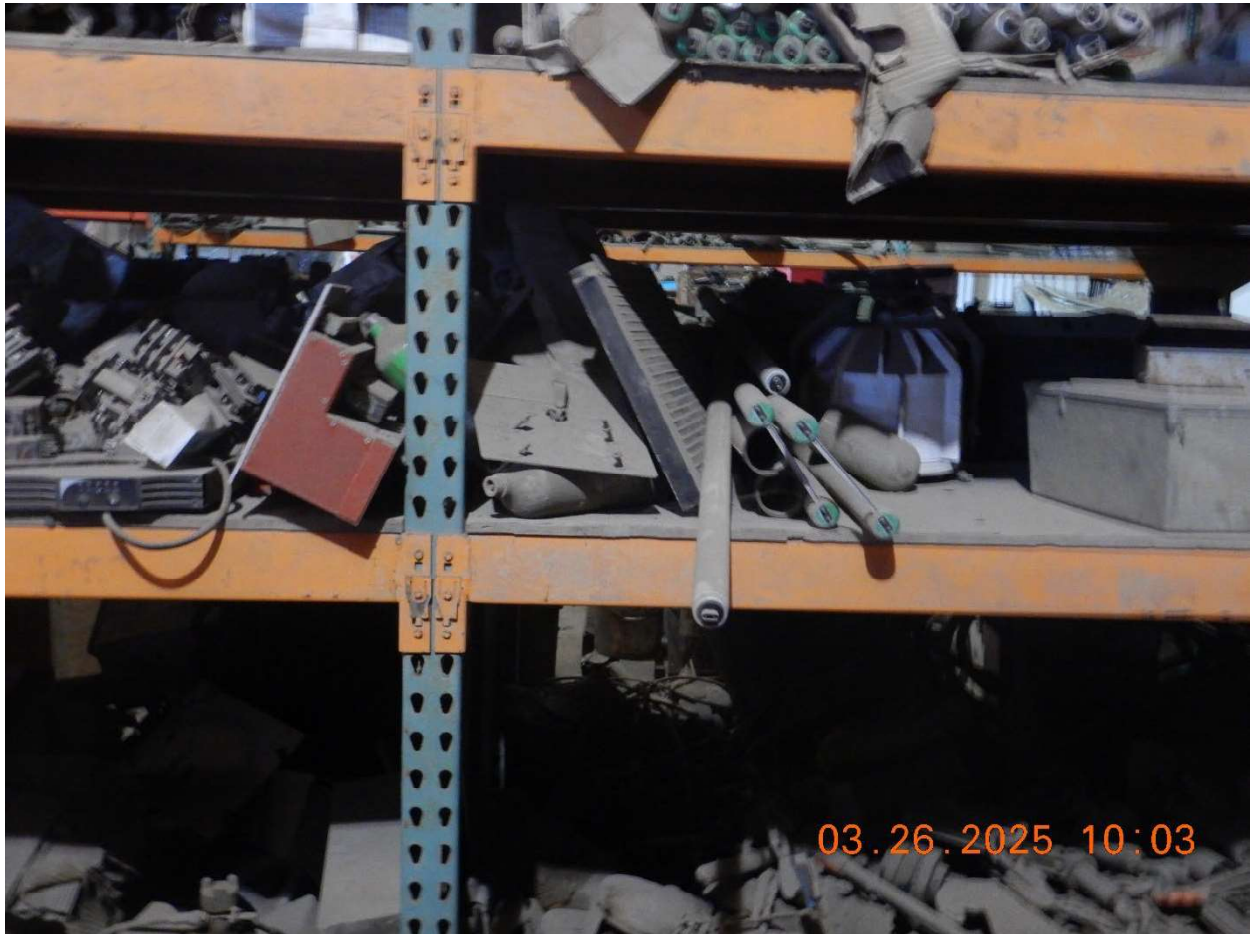
Photo No. 117

Description: View of universal waste lamps, which are not in a closed container, unlabeled, and non-dated, observed in the universal waste storage building.

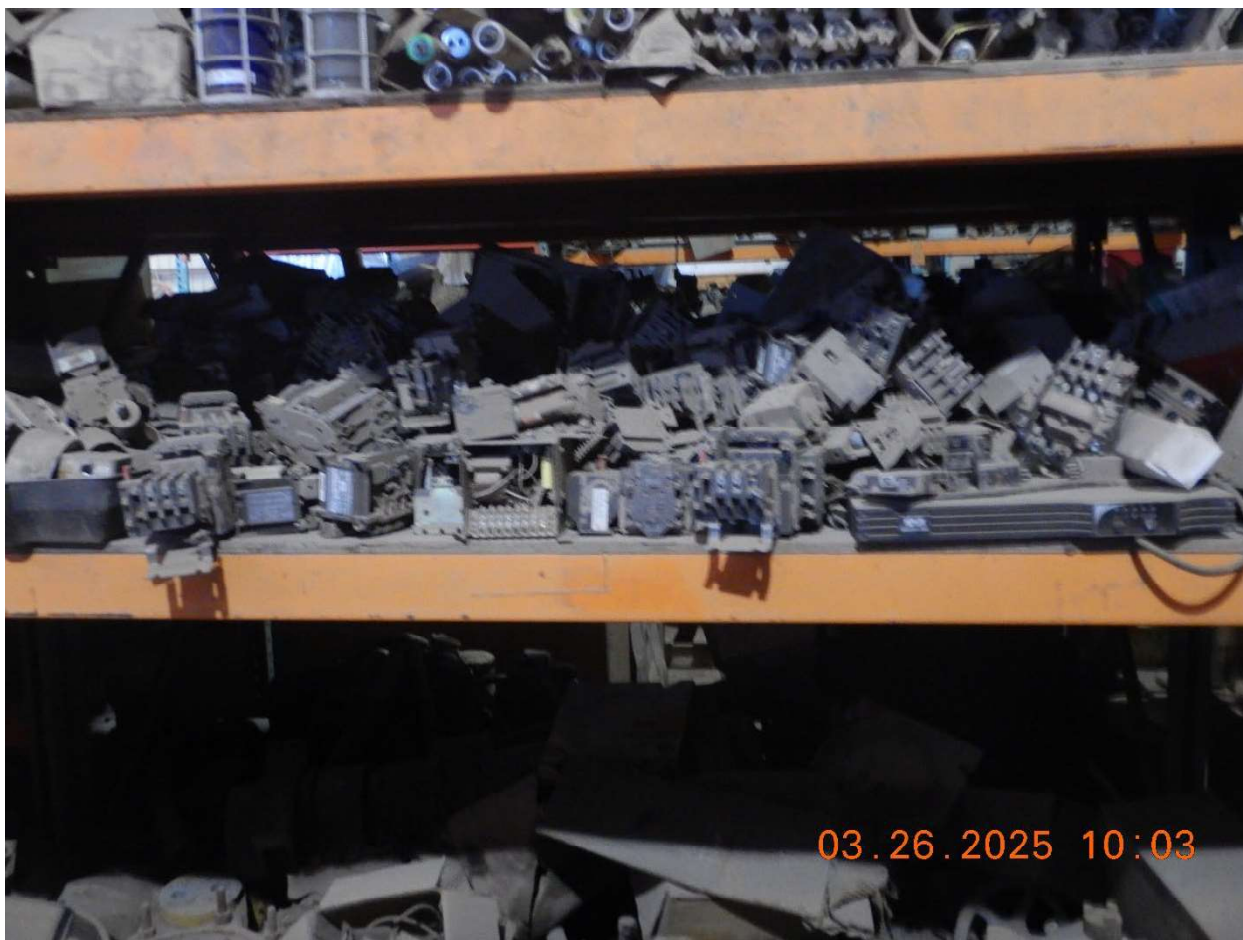
Photo No. 118

Description: View of universal waste lamps, which are not in a closed container, unlabeled, and non-dated, observed in the universal waste storage building.

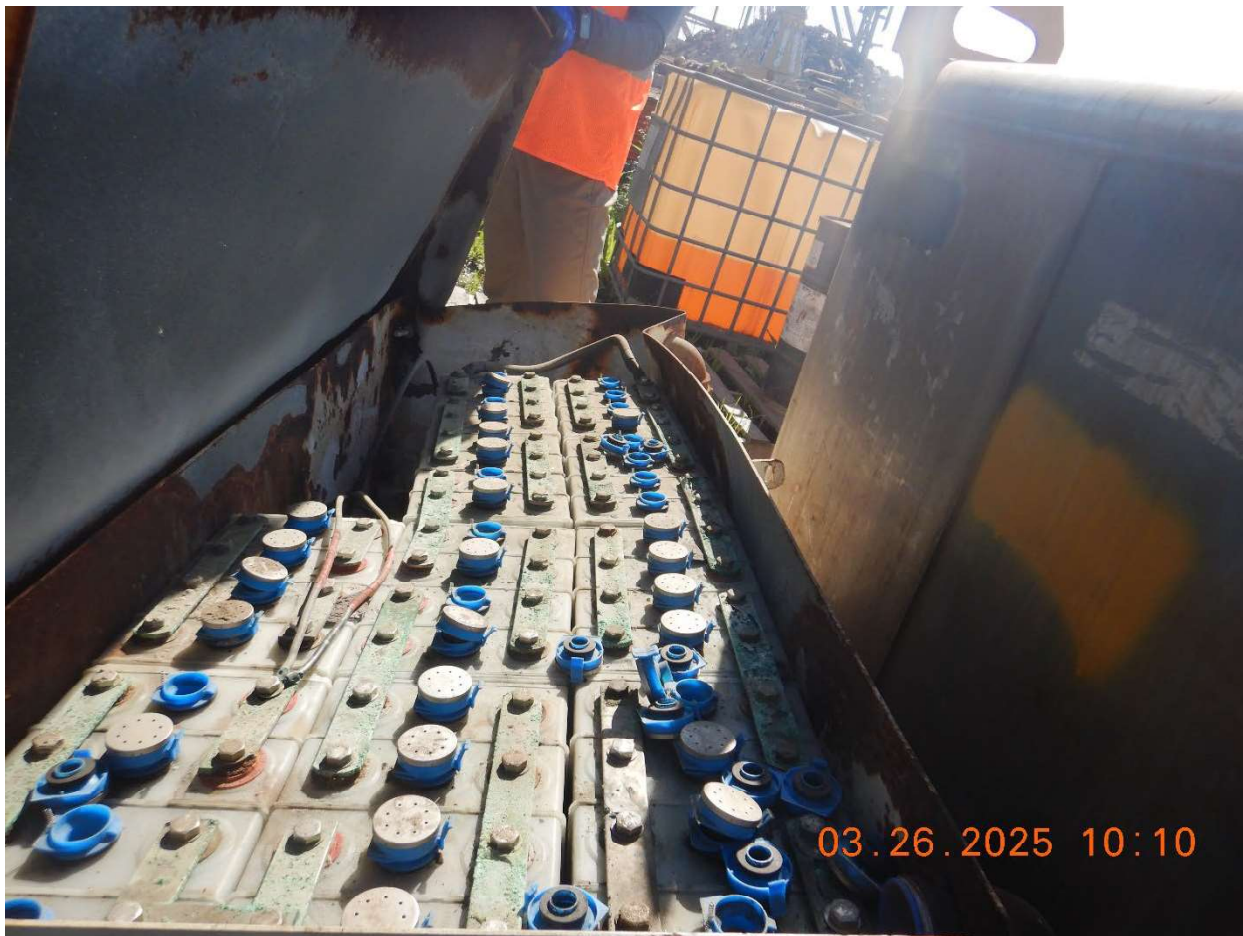
Photo No. 119

Description: View of discarded batteries found outside of the universal waste storage building.

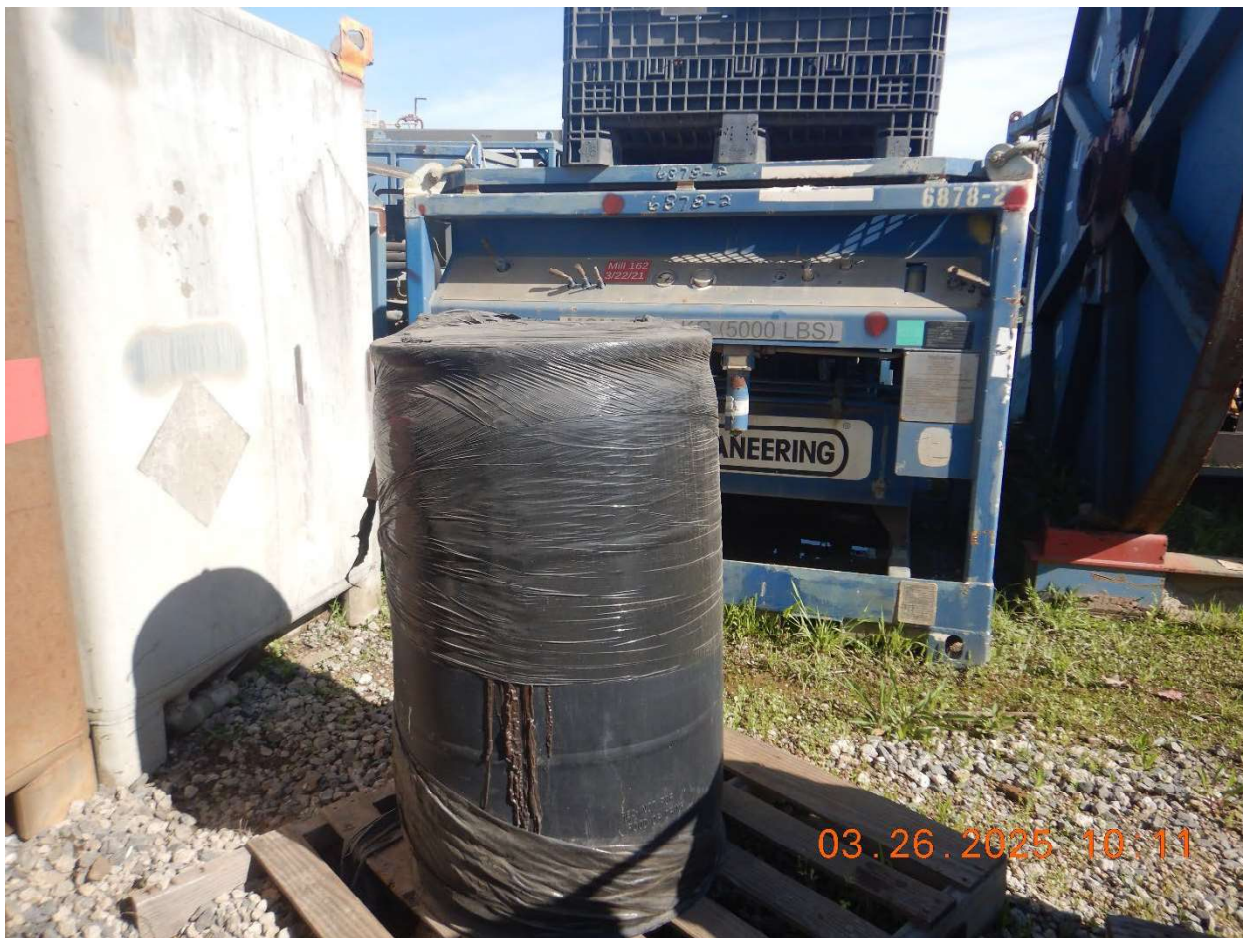
Photo No. 120

The inspection team then observed the used oil storage area, where twenty 55-gallon drums were storing used oil, and used oil with rags/PPE was observed (see Appendix 1 – Photos 120 to 135). No drums displayed “Used Oil” labels at the time of the inspection [**AOC #9** – MARS did not clearly label containers used to store used oil with the words “Used Oil” - 40 CFR 279.22(c)(1)]. Next to the used oil storage area, the inspection team observed a pallet containing six half-full 5-gallon containers of sulfamic acid (see Appendix 1 – Photos 136 to 138). Mr. Stephenson stated that these are considered waste and are to be brought to the hazardous waste storage area. However, they were not labeled as such [see **AOC #1**]. One of the 5-gallon containers of sulfamic acid was open, pictured on the upper right in Photo 136 [**AOC #10** – MARS was storing hazardous

Description: View a full 55-gallon drum of used oil that was not labeled, found in the used oil storage area.

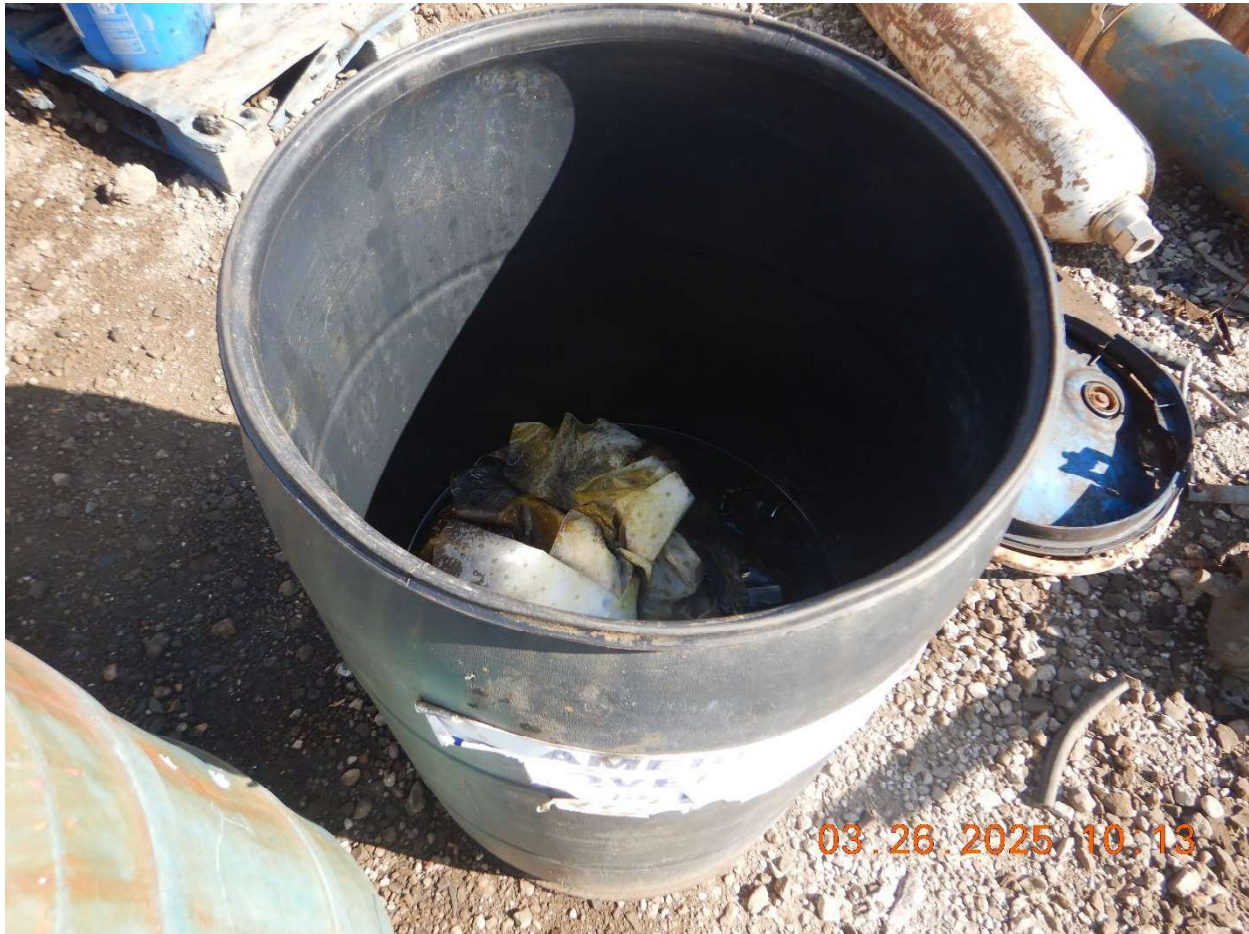
Photo No. 121

Description: View a half-full 55-gallon drum of used oil and PPE that was not labeled, found in the used oil storage area.

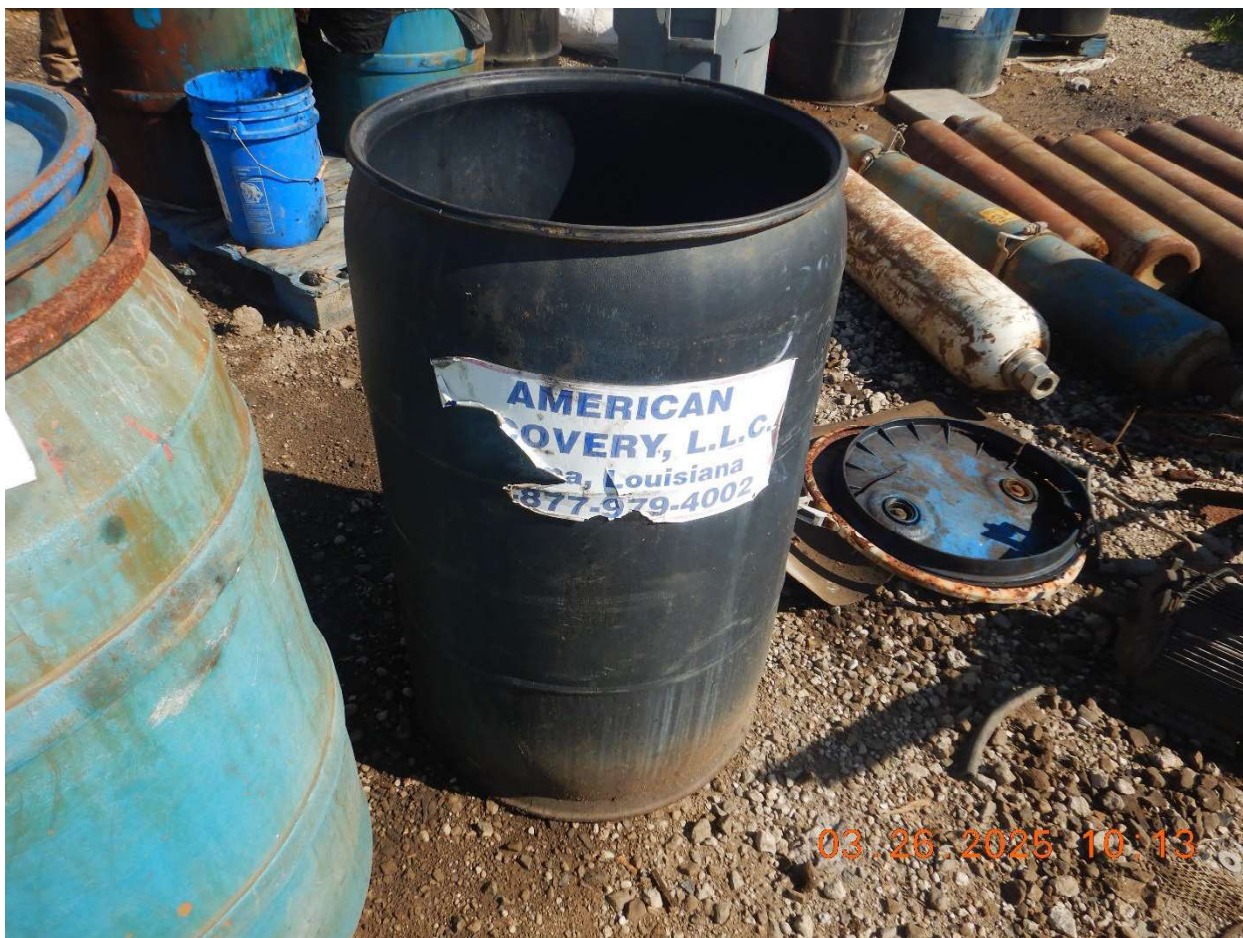
Photo No. 122

Description: Another view a half-full 55-gallon drum of used oil and PPE that was not labeled, found in the used oil storage area.

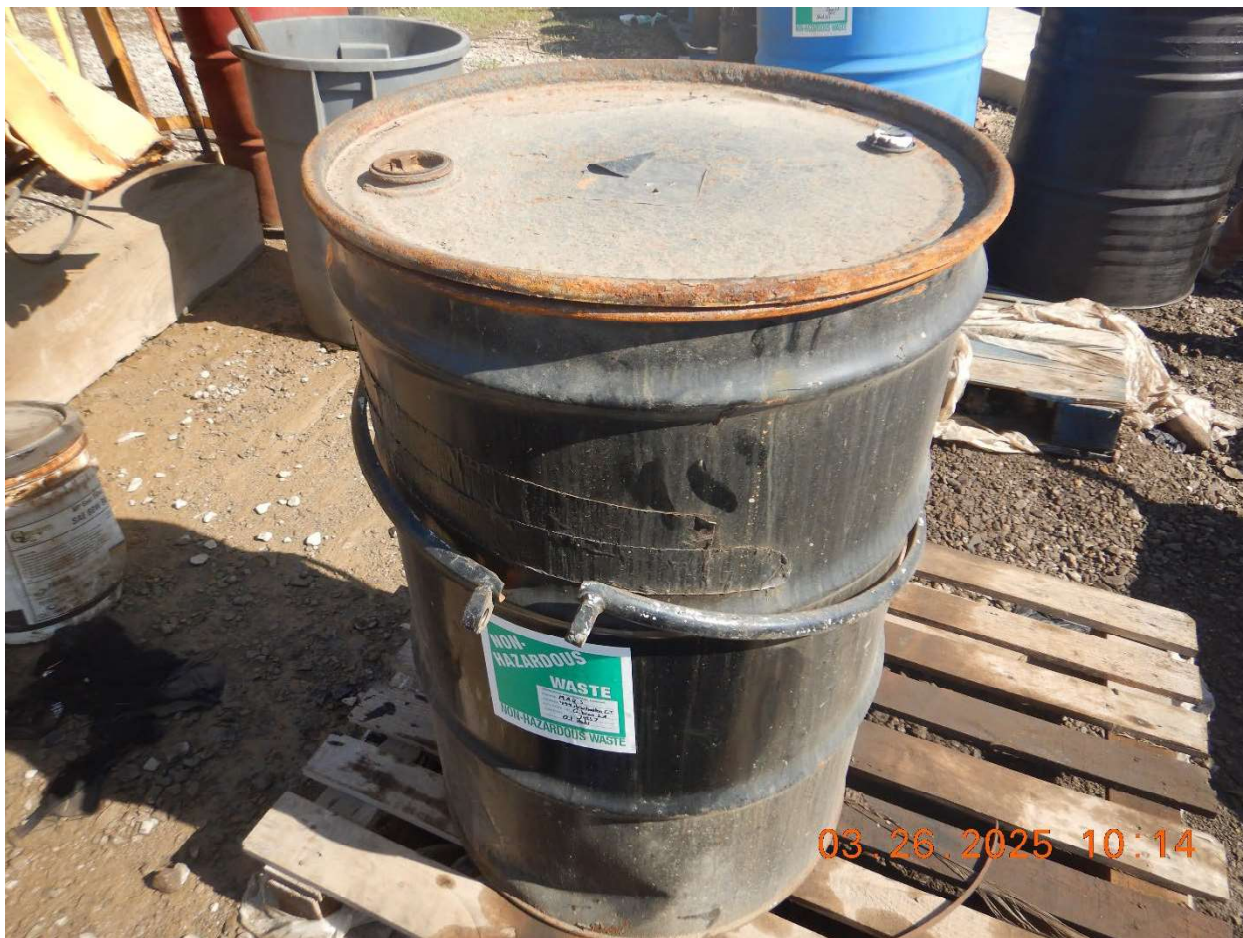
Photo No. 123

Description: View a half-full 55-gallon drum of used oil and PPE that was not labeled as used oil, found in the used oil storage area.

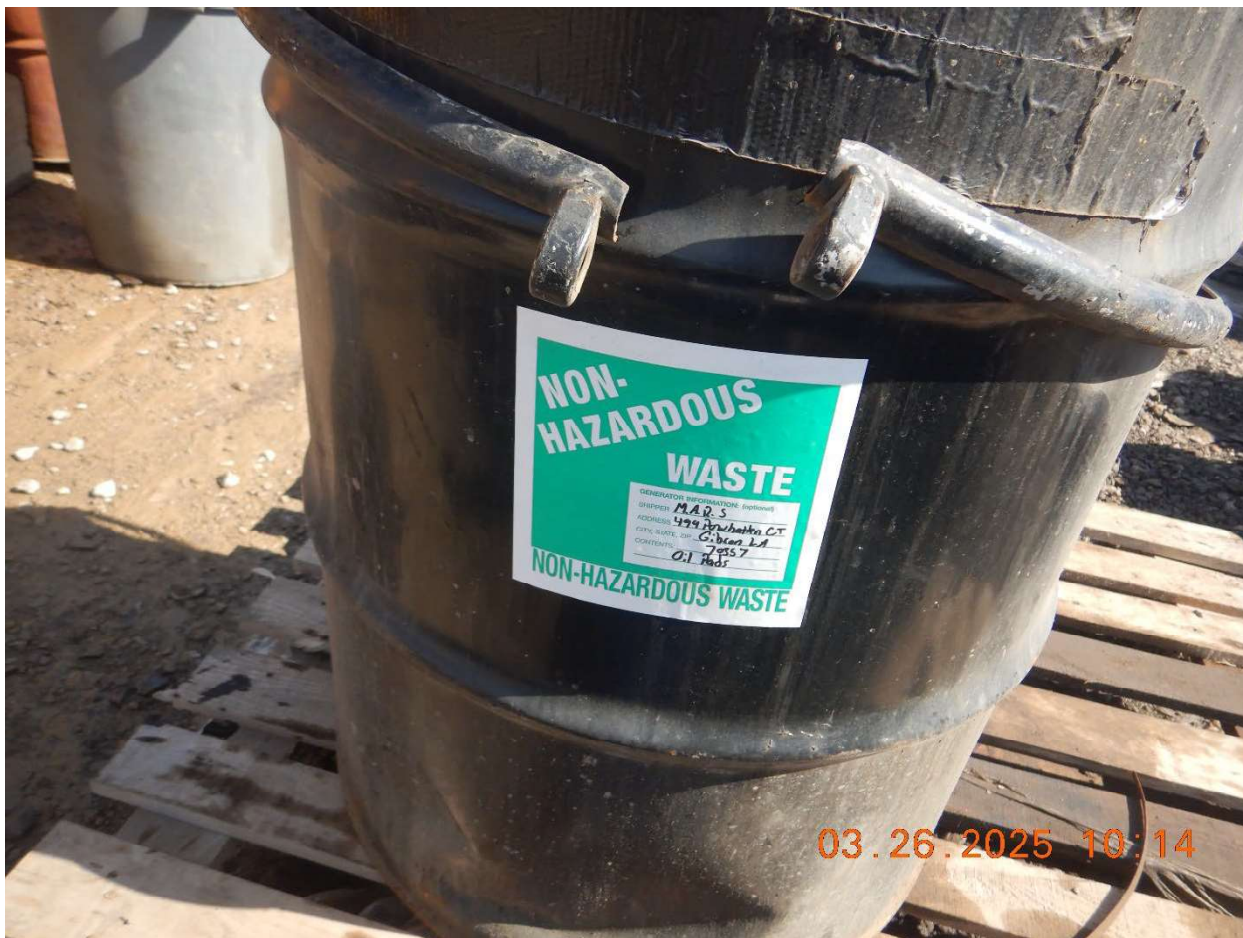
Photo No. 124

Description: View of the non-hazardous waste label of the drum seen in Photo No. 123.
