INSPECTION REPORT

| Type of Inspection | Compliance Evaluation Inspection (CEI) | | |
| Facility or Site Name | Modern American Recycling Services Inc. | | |
| Type of Operation | Modern American Recycling Services (MARS) decommissions oil field platforms and recycles the scrap metal. | | |

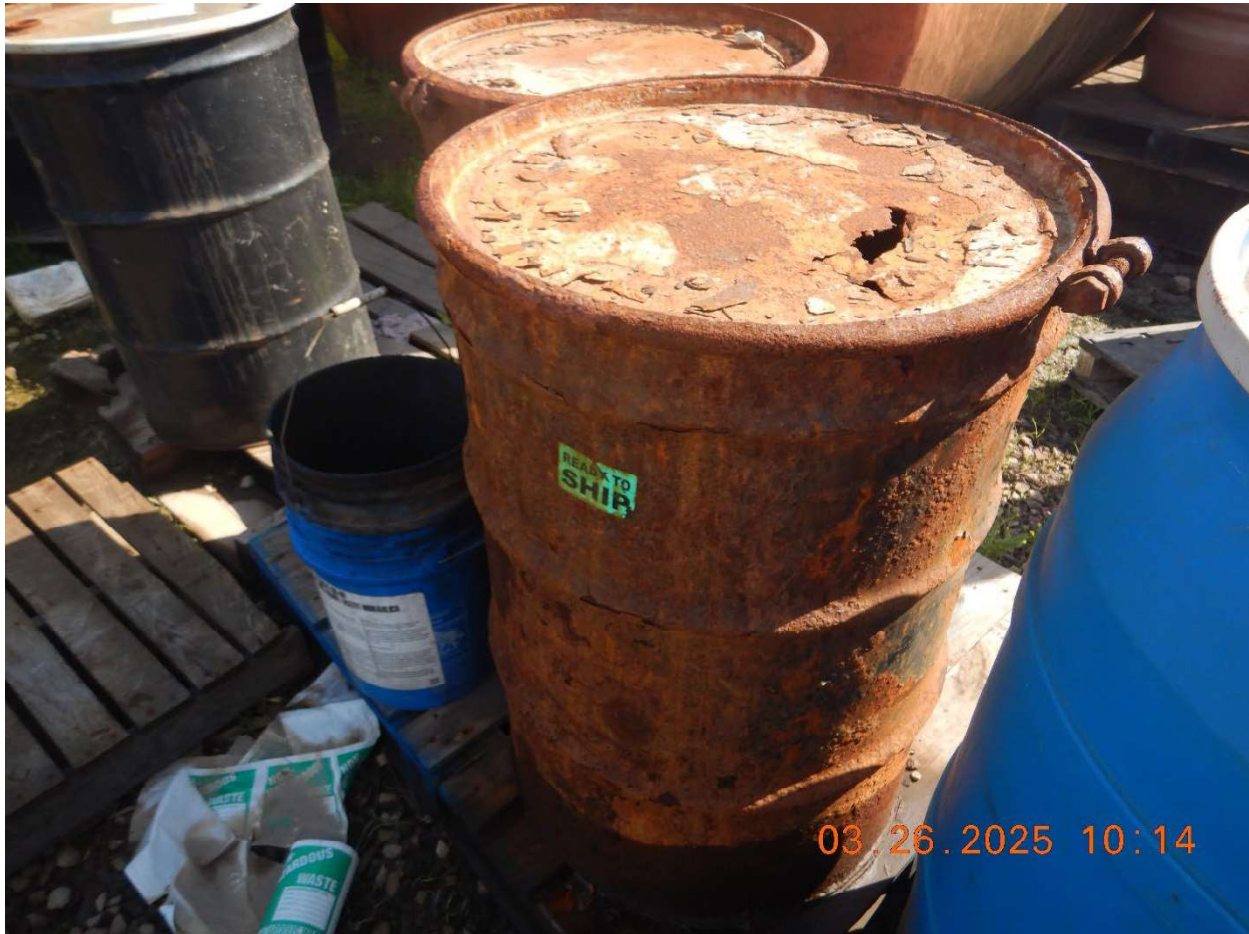
Photo No. 125

Description: View two half-full 55-gallon drums of used oil and PPE that were not labeled as used oil, found in the used oil storage area.

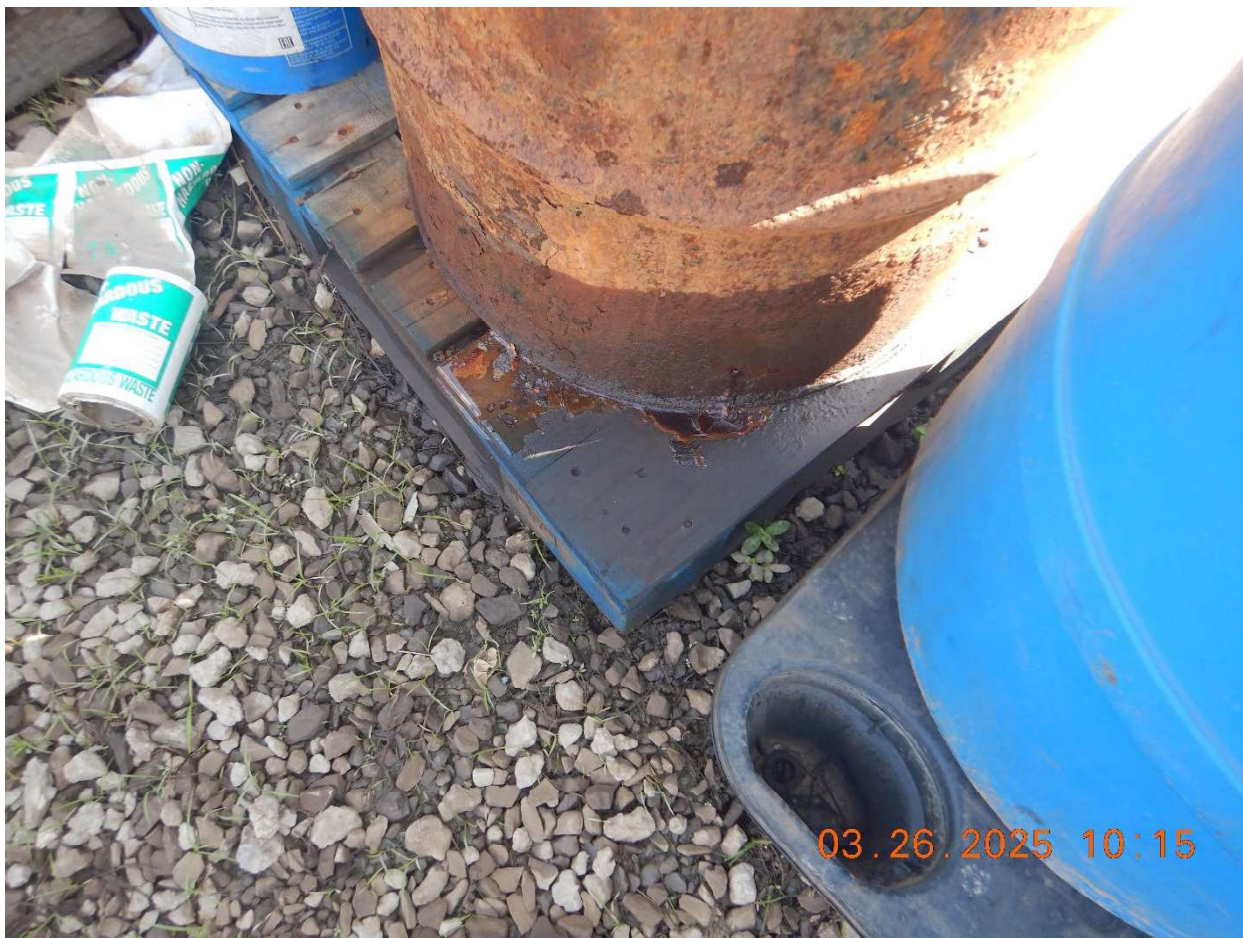
**Photo No. 126**

Description: View of signs of damage on one of the 55-gallon drums seen in Photo No. 125.

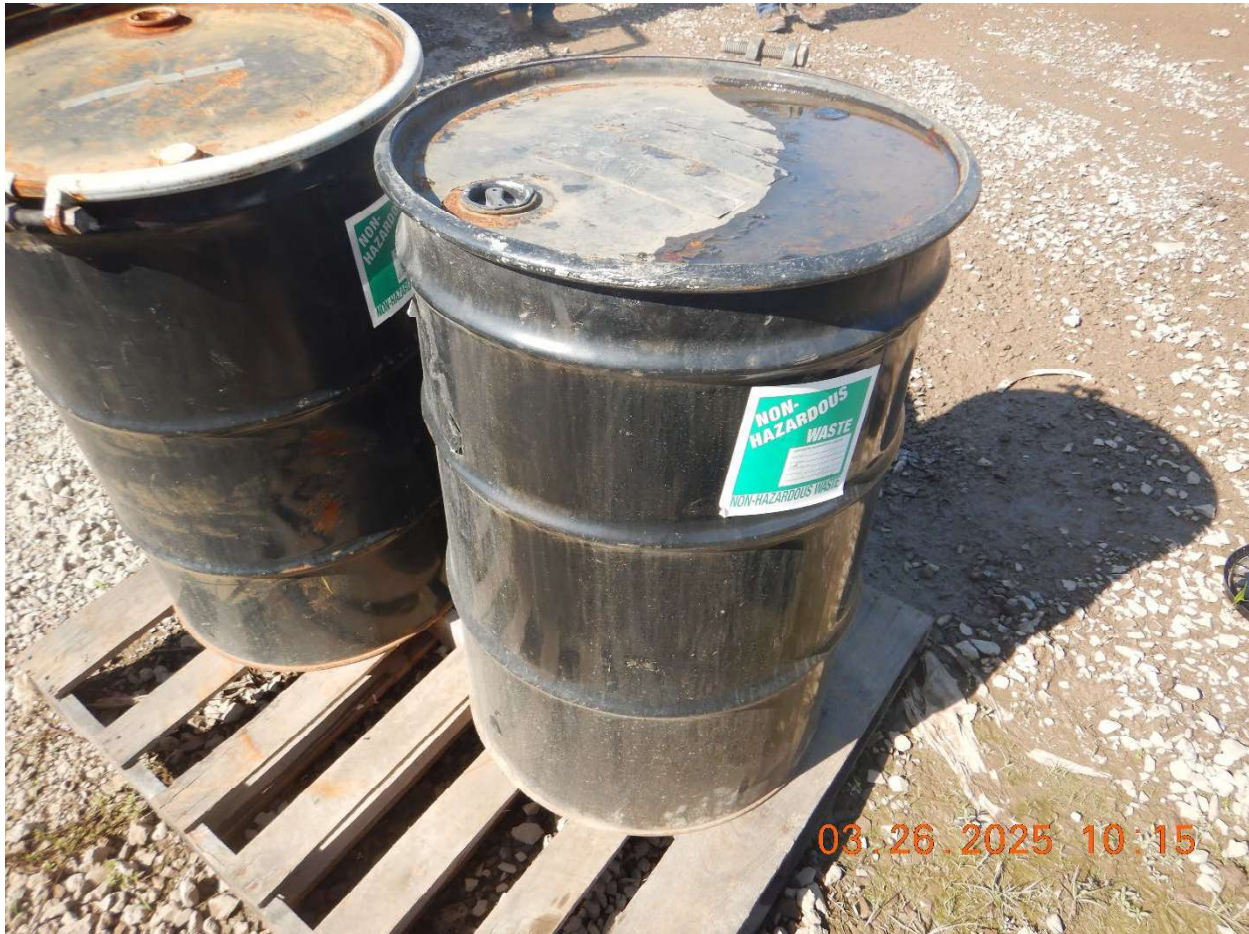
Photo No. 127

Description: View two full 55-gallon drums of used oil and PPE that were not labeled as used oil, found in the used oil storage area.

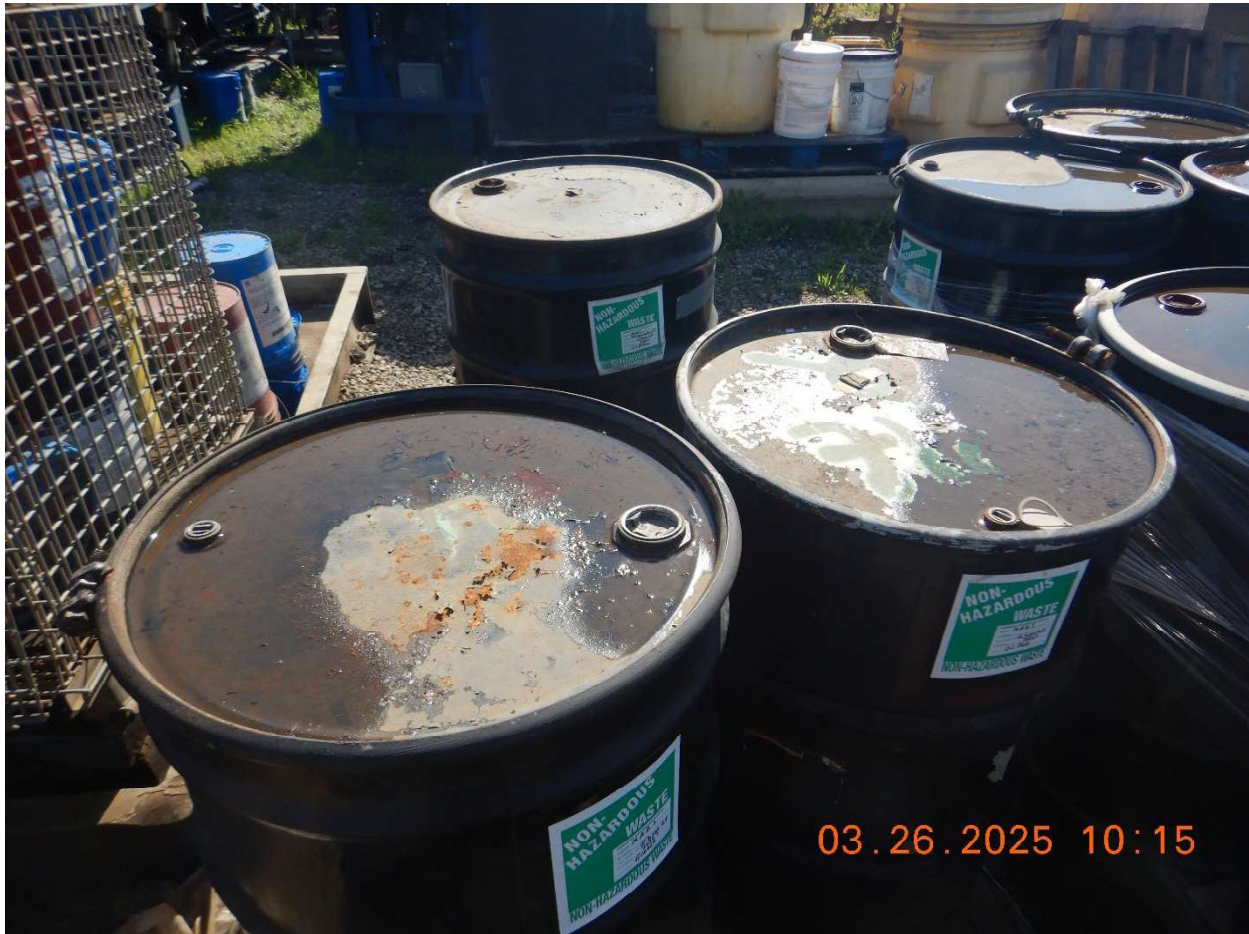
Photo No. 128

Description: View three full 55-gallon drums of used oil and PPE that were not labeled as used oil, found in the used oil storage area.

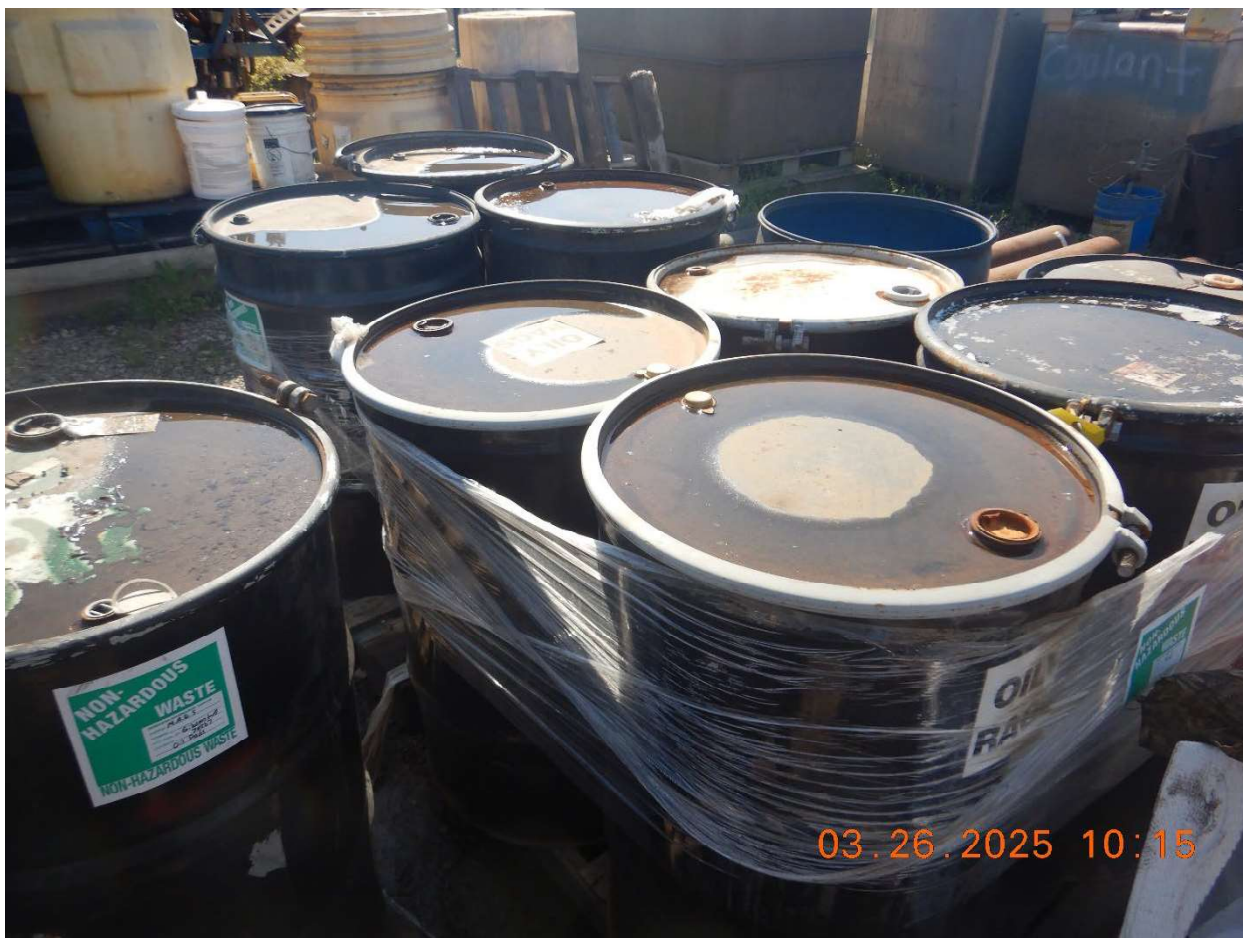
Photo No. 129

Description: View seven full 55-gallon drums of used oil and PPE that were not labeled as used oil, found in the used oil storage area.

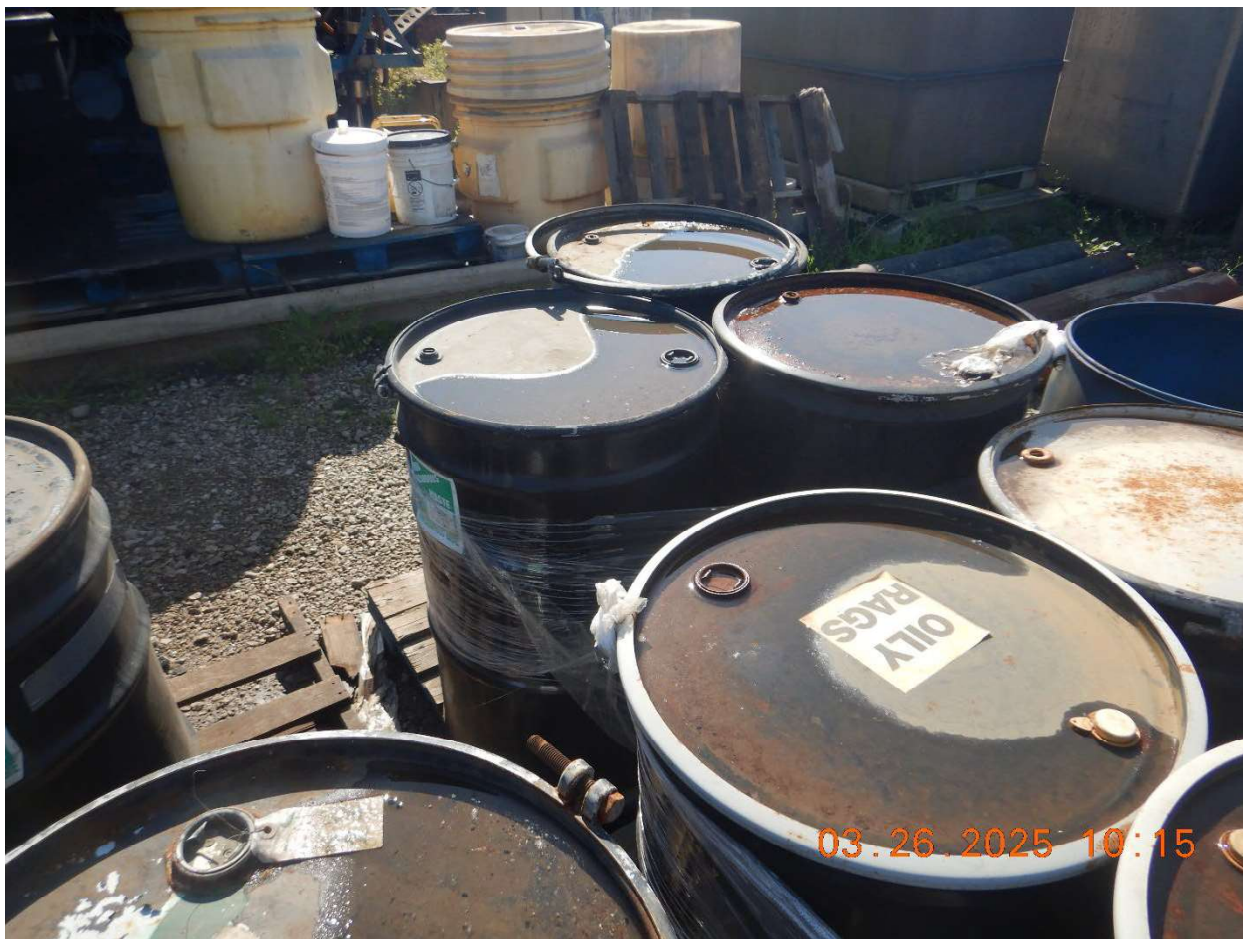
Photo No. 130

Description: Another view seven full 55-gallon drums of used oil and PPE that were not labeled as used oil, found in the used oil storage area..

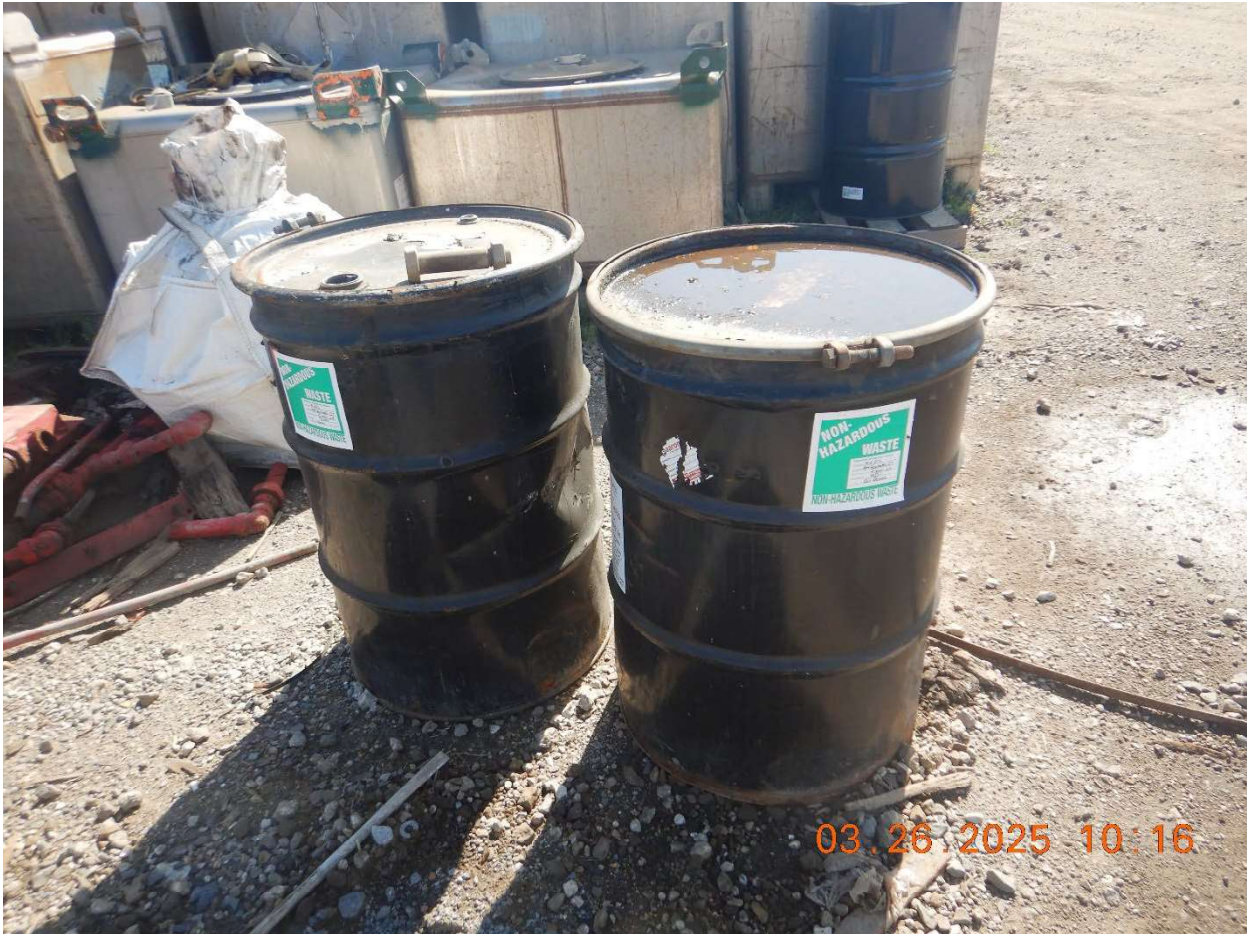
Photo No. 131

Description: View two full 55-gallon drums of used oil that were not labeled as used oil, found in the used oil storage area.

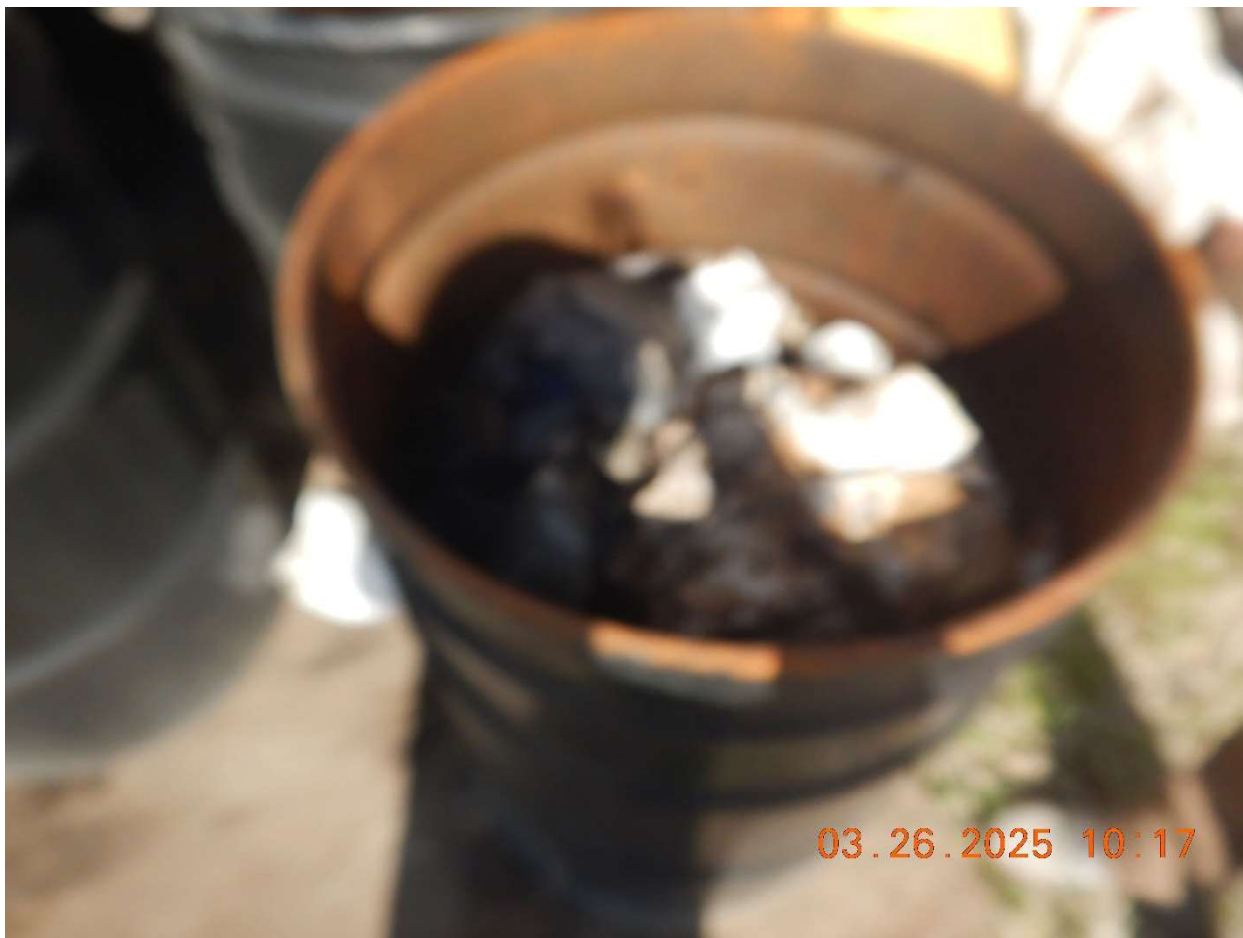
**Photo No. 132**

Description: View of a half-full 55-gallon drum of used oil and PPE that was not labeled as used oil, found in the used oil storage area.

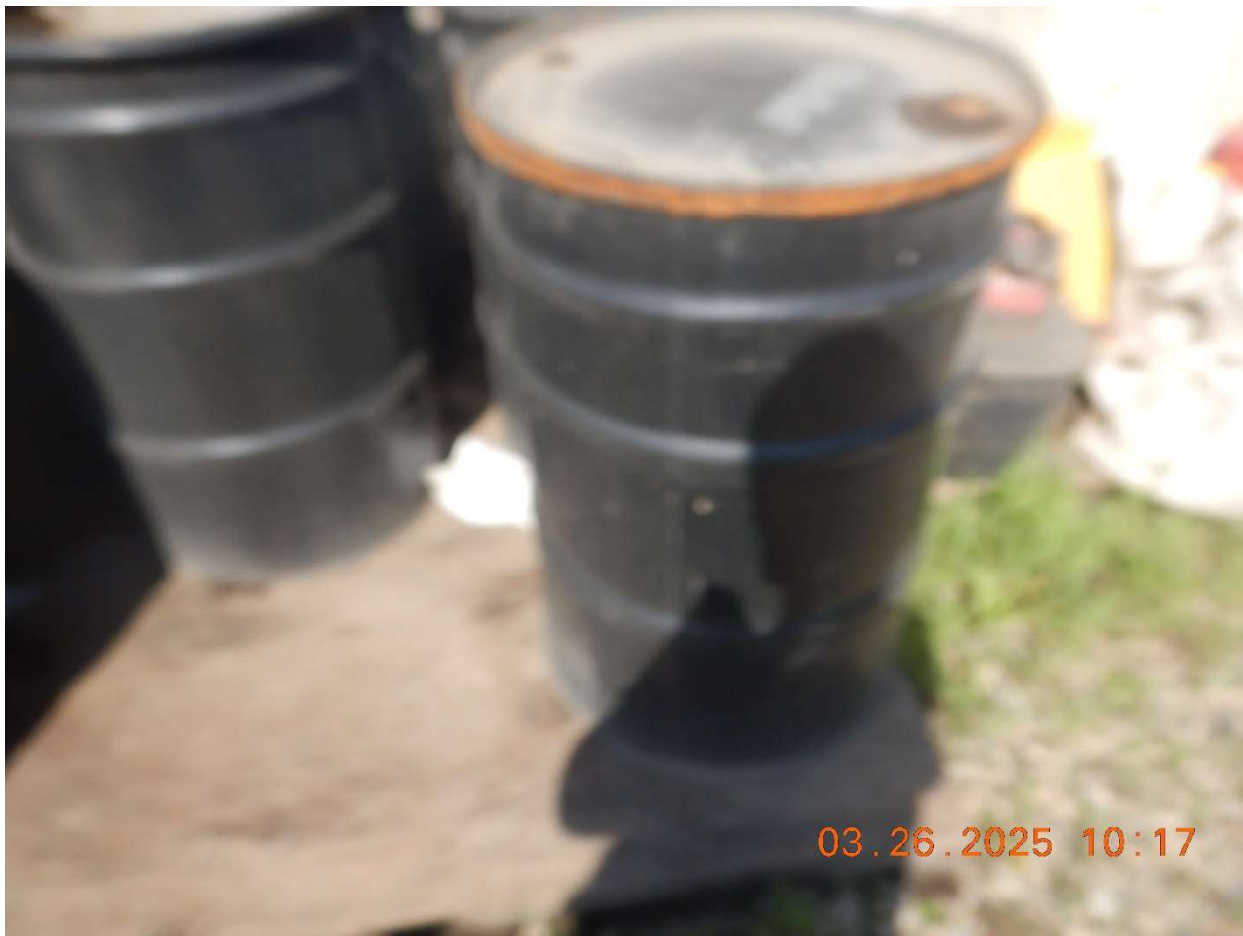
**Photo No. 133**

Description: Another view of a half-full 55-gallon drum of used oil and PPE that was not labeled as used oil, found in the used oil storage area.

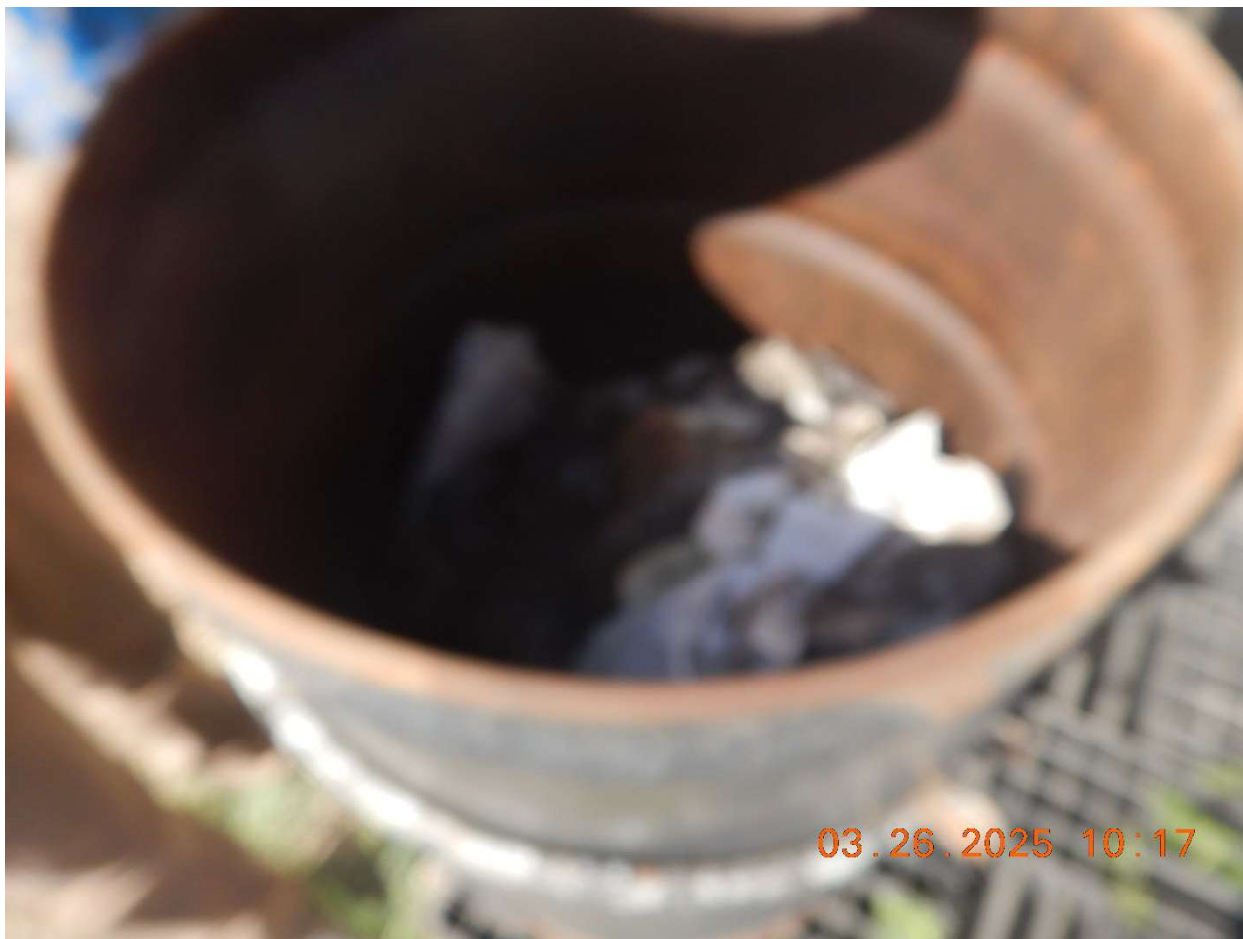
**Photo No. 134**

Description: View of a half-full 55-gallon drum of used oil and PPE that was not labeled as used oil, found in the used oil storage area.

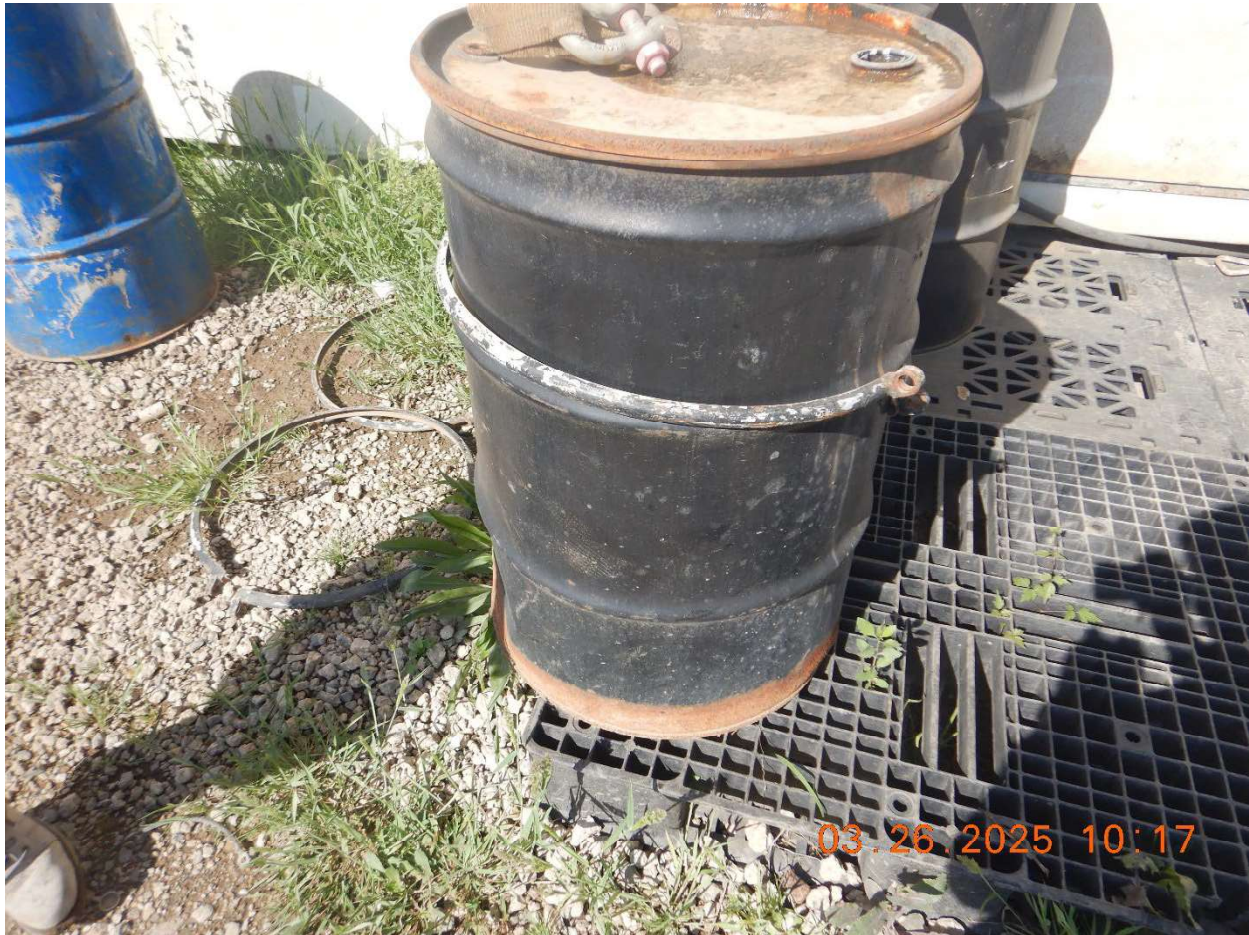
Photo No. 135

Description: Another view of a half-full 55-gallon drum of used oil and PPE that was not labeled as used oil, found in the used oil storage area.

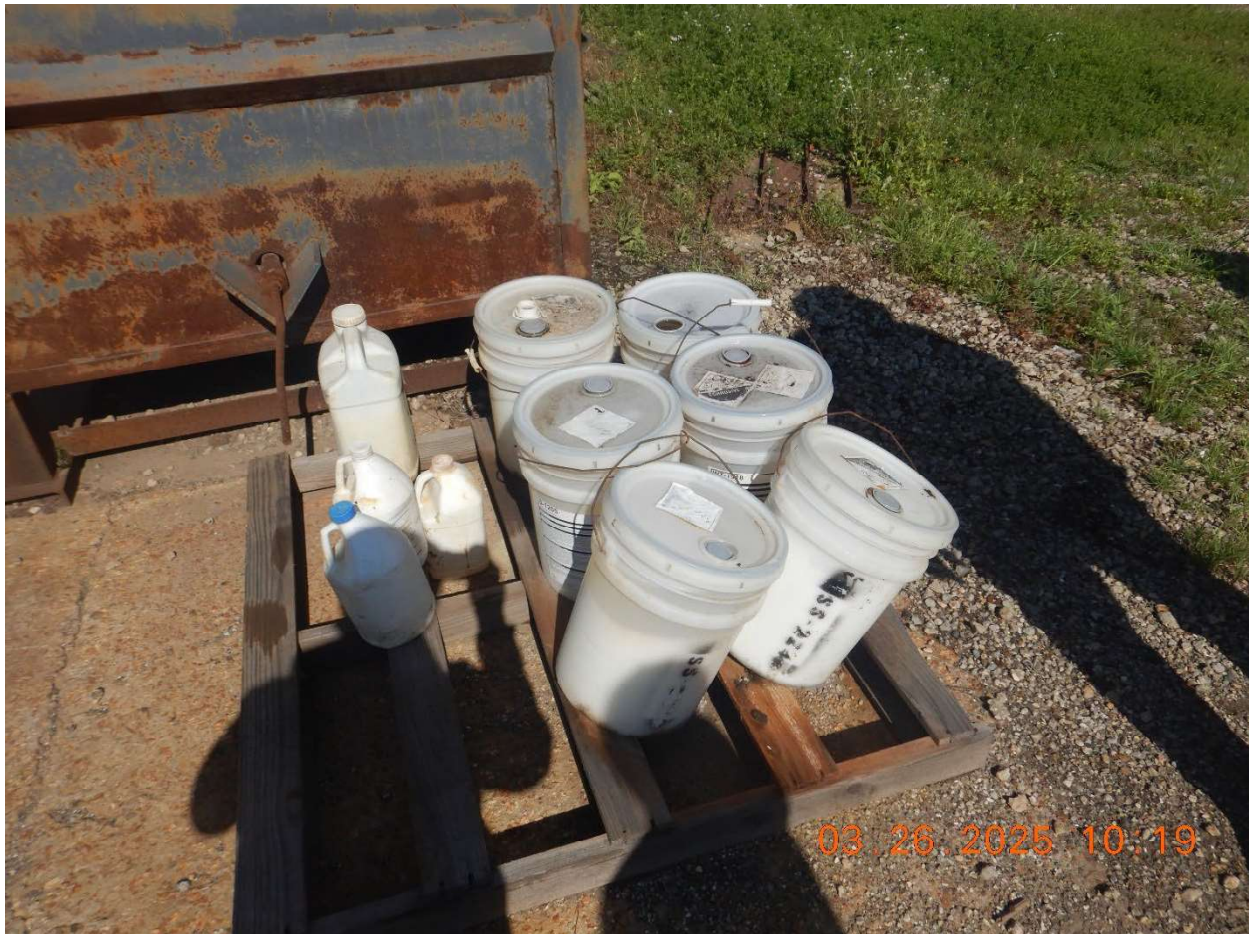
Photo No. 136

The inspection team then observed the used oil storage area, where twenty 55-gallon drums were storing used oil, and used oil with rags/PPE was observed (see Appendix 1 – Photos 120 to 135). No drums displayed “Used Oil” labels at the time of the inspection [**AOC #9** – MARS did not clearly label containers used to store used oil with the words “Used Oil” - 40 CFR 279.22(c)(1)]. Next to the used oil storage area, the inspection team observed a pallet containing six half-full 5-gallon containers of sulfamic acid (see Appendix 1 – Photos 136 to 138). Mr. Stephenson stated that these are considered waste and are to be brought to the hazardous waste storage area. However, they were not labeled as such [see **AOC #1**]. One of the 5-gallon containers of sulfamic acid was open, pictured on the upper right in Photo 136 [**AOC #10** – MARS was storing hazardous

| <b>AOC #10</b> – MARS was storing hazardous waste in a container that was not closed. | <b>Citation:</b> 40 CFR 262.16(b)(2)(iii)(A) | Section: 2.1 |

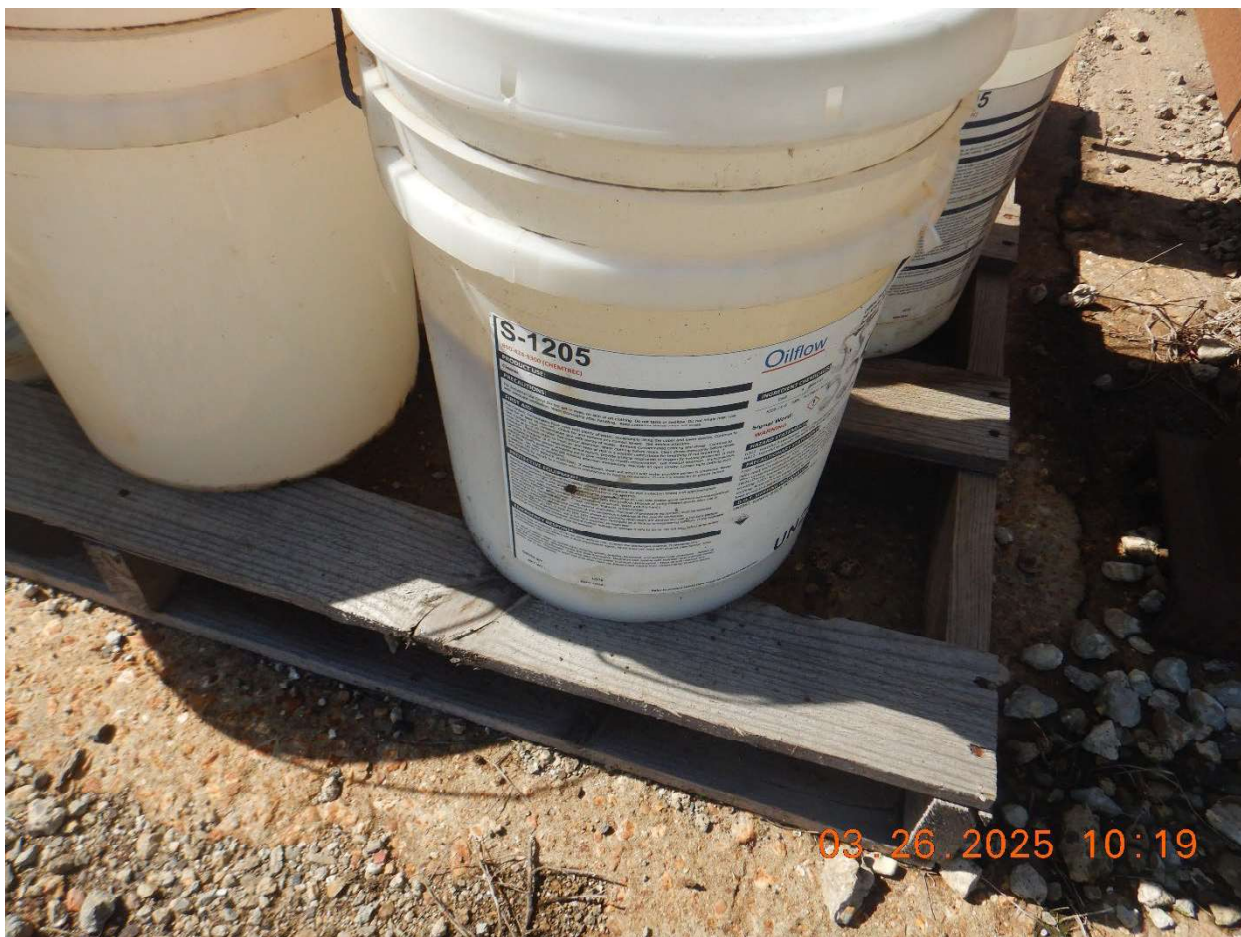
Photo No. 137

Description: View of the product label on the sulfamic acid containers found in Photo No. 136.

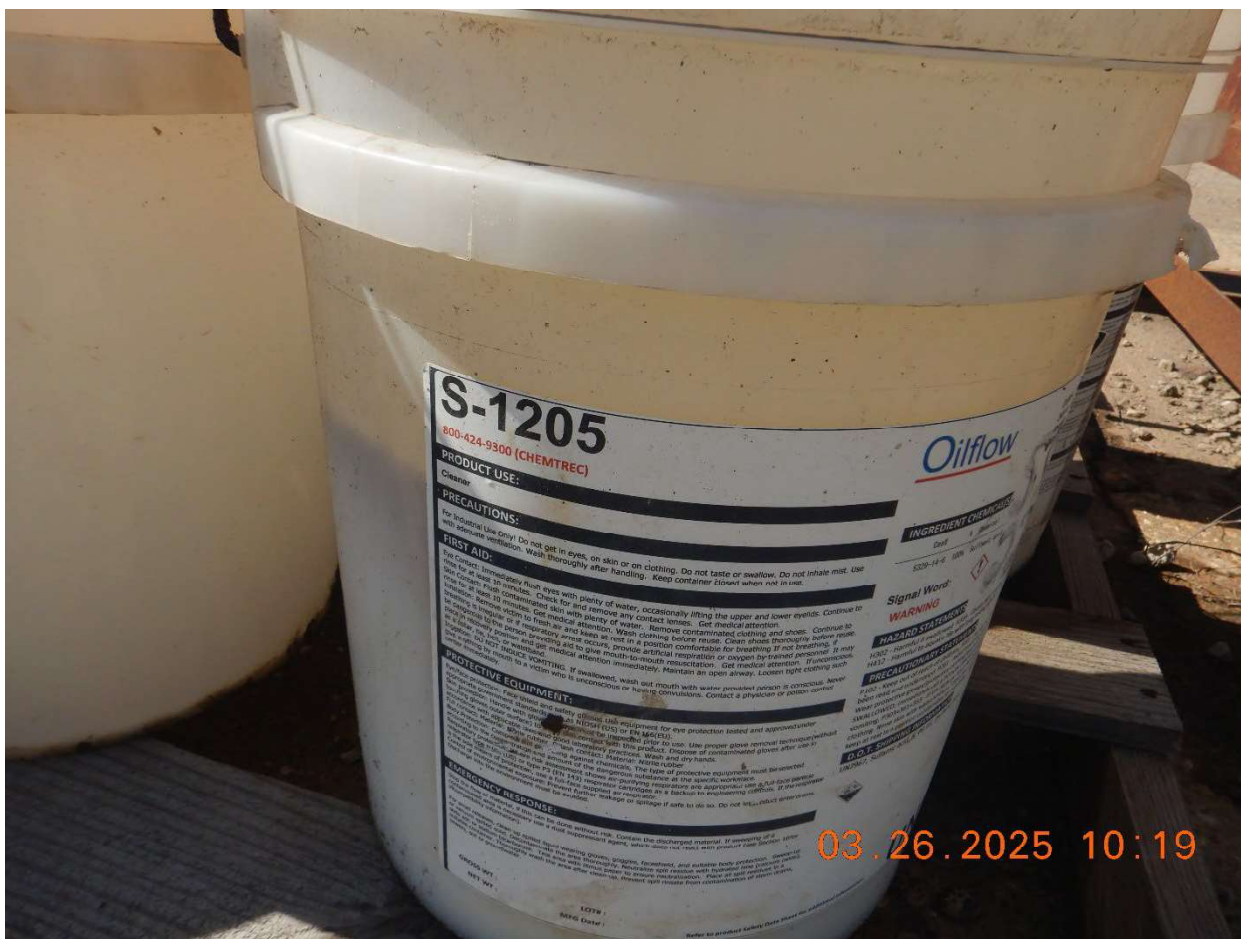
Photo No. 138

Description: View of the product label on the sulfamic acid containers found in Photo No. 136.

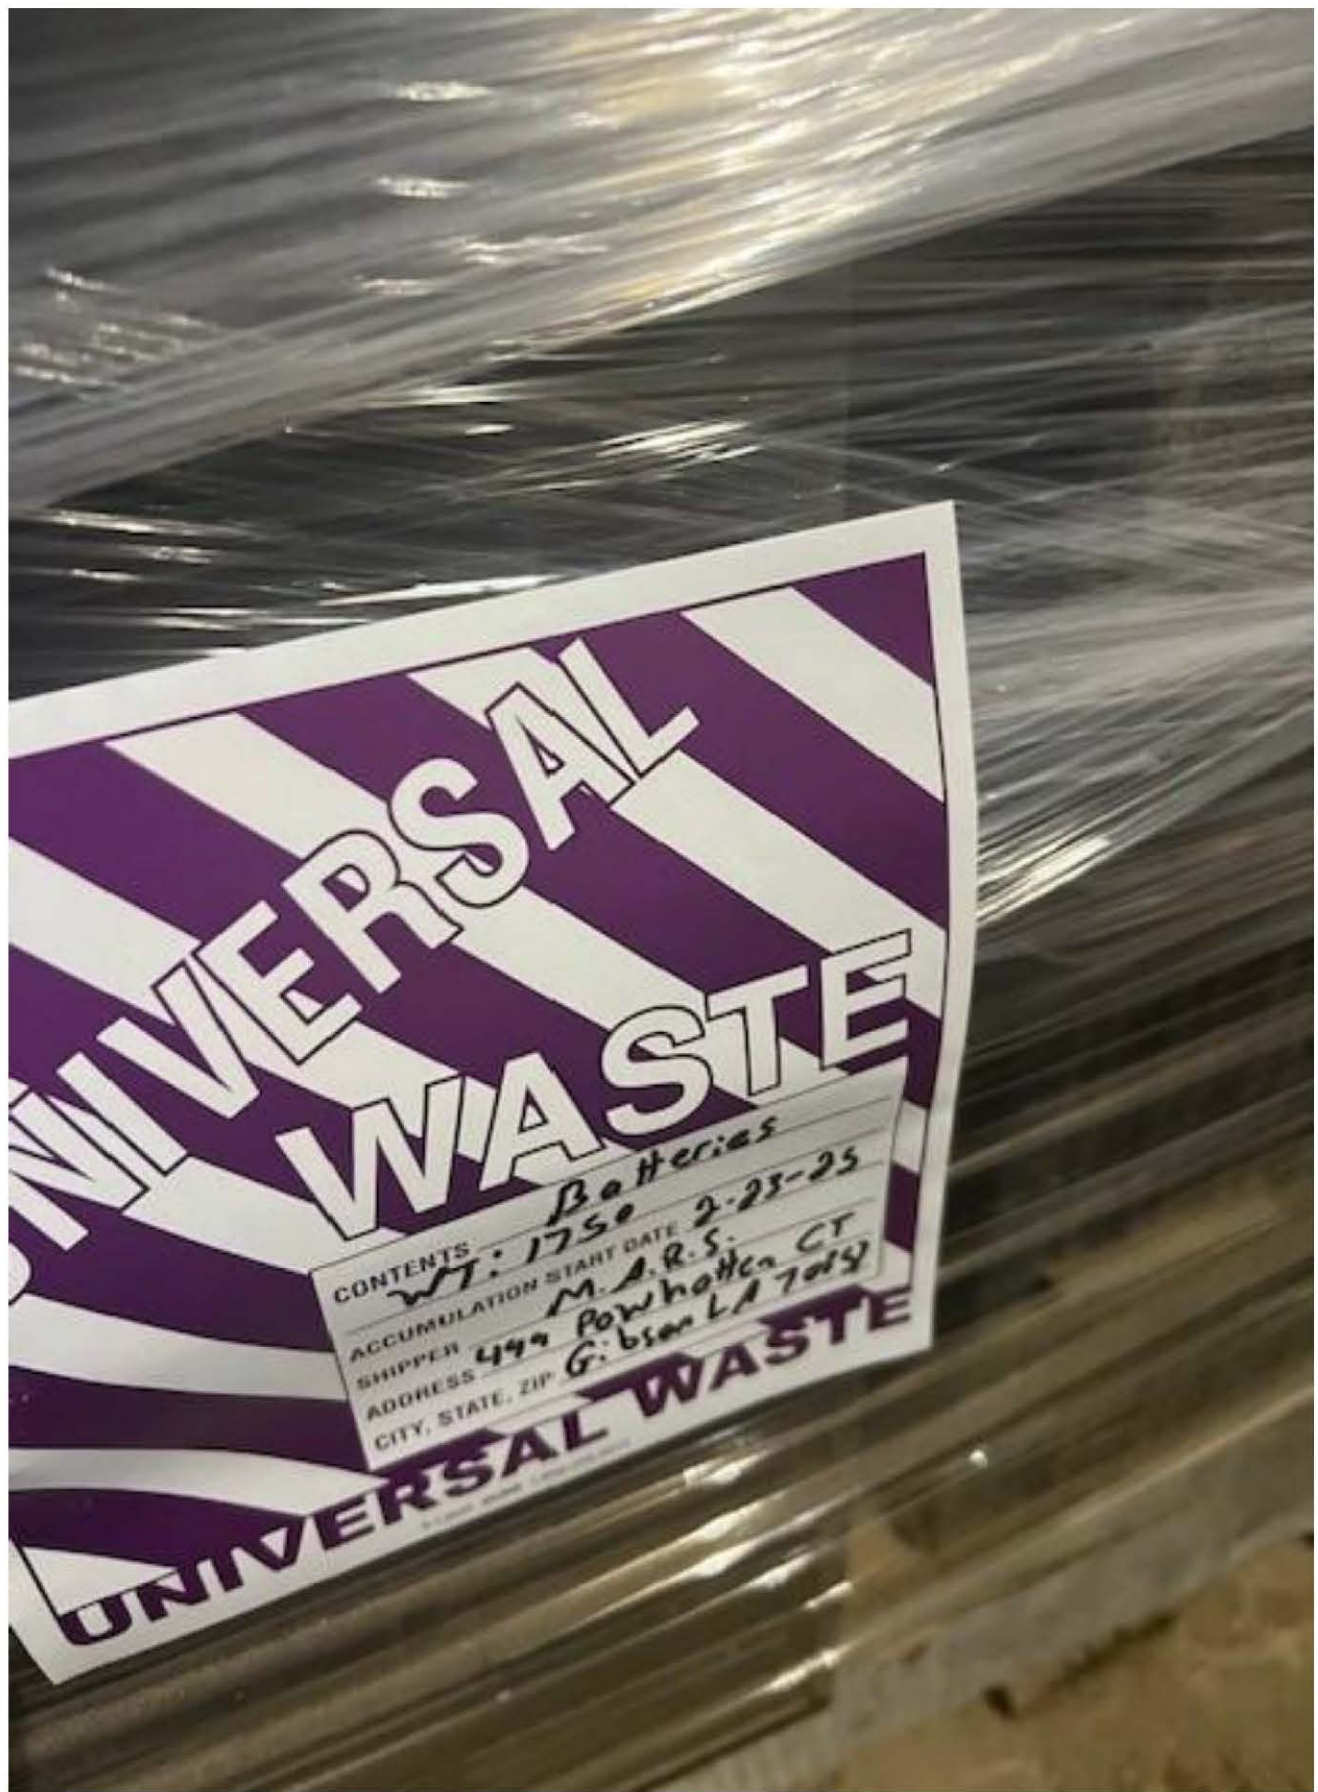
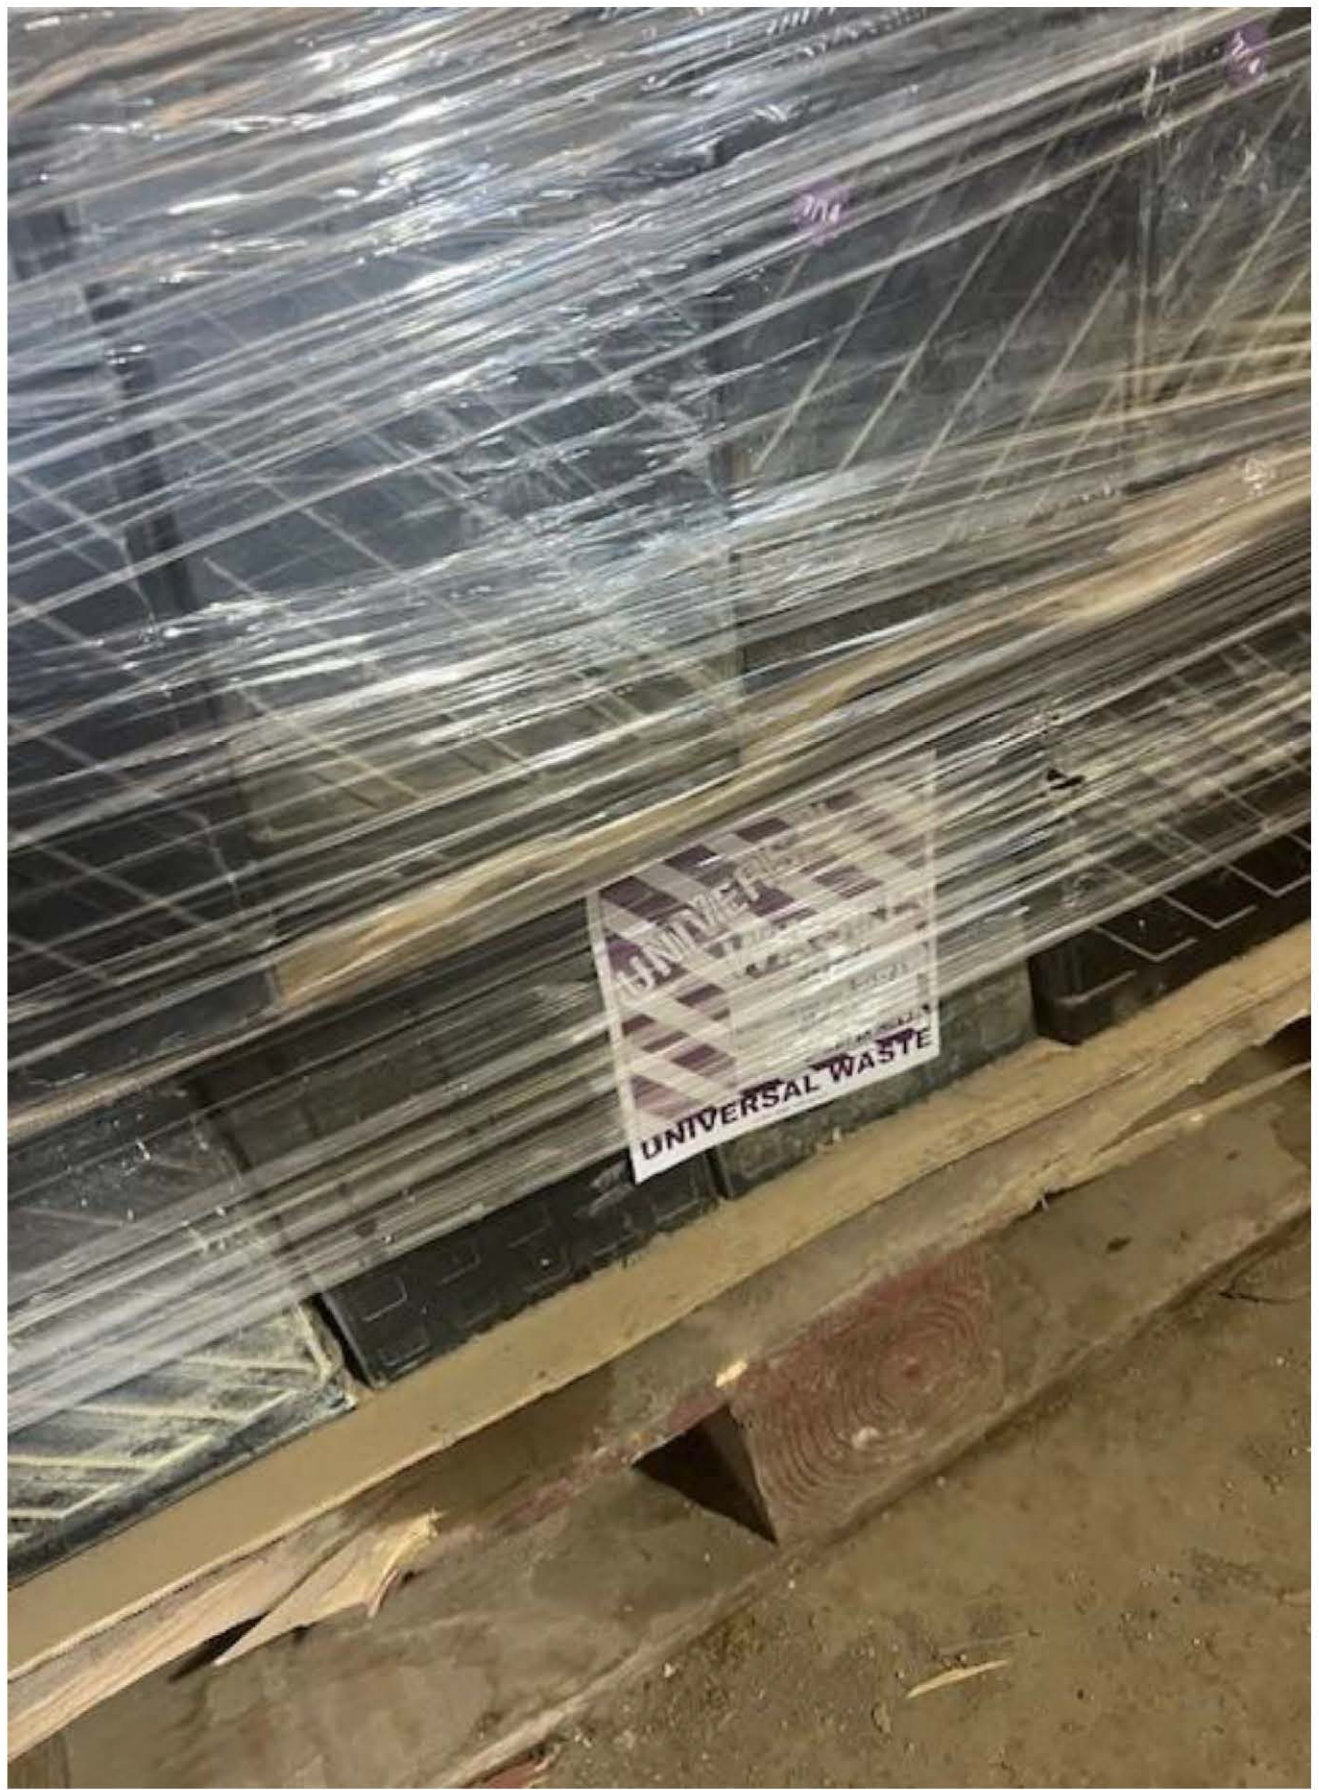
#### APPENDIX 4. PHOTOS OF THE UNIVERSAL WASTE BATTERIES 4/11/2025

CONTENTS Batteries  
WT: 1750  
ACCUMULATION START DATE 2-03-05  
SHIPPER M.A.R.S.  
ADDRESS 499 Powhattan CT  
CITY, STATE, ZIP Gibson LA 70367

- A response letter indicating the steps taken to address the AOCs observed during the inspection (Appendix 2)
- Photos of the hazardous waste storage area and labels on the 55-gallon drums of paint-related material (Appendix 3)
- Photos of universal waste battery labels on eight of the pallets inside of the universal waste warehouse (Appendix 4)
- Photos of used oil containers labeled (Appendix 5).
- Manifests from a hazardous waste shipment in March of 2024 and a CAA weekly inspection example (Appendix 6)

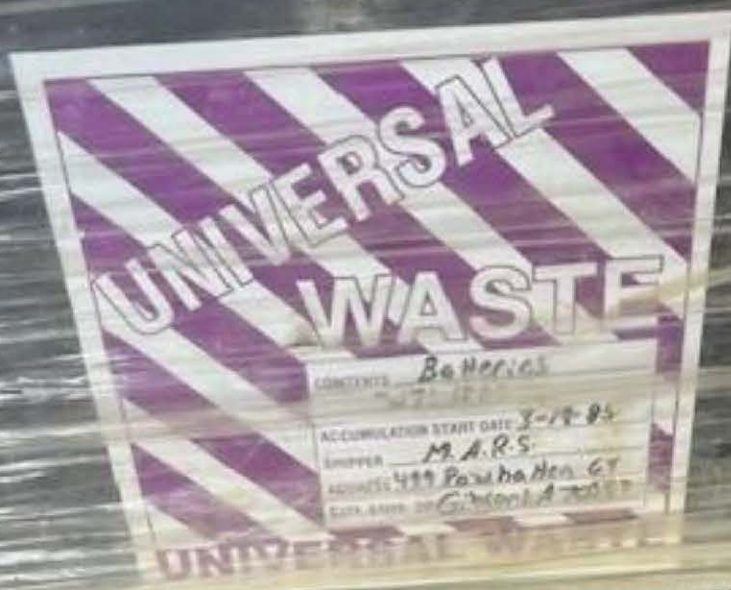
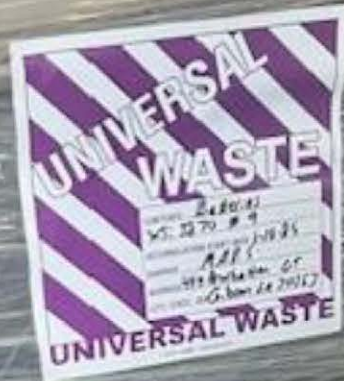
In the large blue ware house we currently have 8 pallets of lead acid batteries that are properly labeled with universal waste sticker and dated with start dates. They are shrink wrapped, weighed ready for shipment. We are continuing to accumulate batteries to get enough for a full load shipment. Pictures are attached. Damaged batteries are being placed in drums and labeled as hazardous waste with dates.

# UNIVERSAL WASTE
