**CWA COMPLIANCE EVALUATION INSPECTION REPORT
U.S. ENVIRONMENTAL PROTECTION AGENCY, REGION 5**

Compliance Evaluation Sampling Inspection

Richter Dairy Farm
14113 St. Rose Road
Breese, Illinois 62230
Clinton County, Illinois
38.62797657159176, -89.55355561706052

Date of Inspection: Site Inspection - September 14th, 2022
Operator Interview – September 27th, 2022

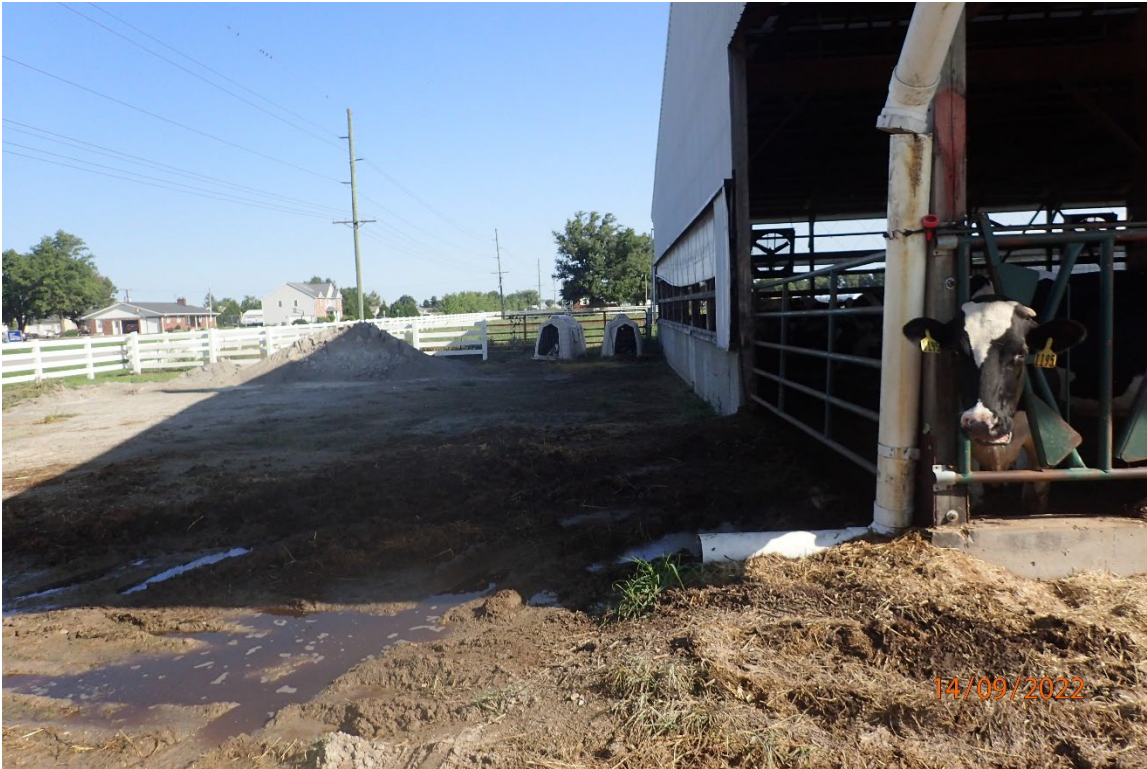
1: P9140092

Description: Looking north along the west side of the Dry Cow Barn. Note there are manure solids around the gate to the animal area as well a downspout outlet in the same area.

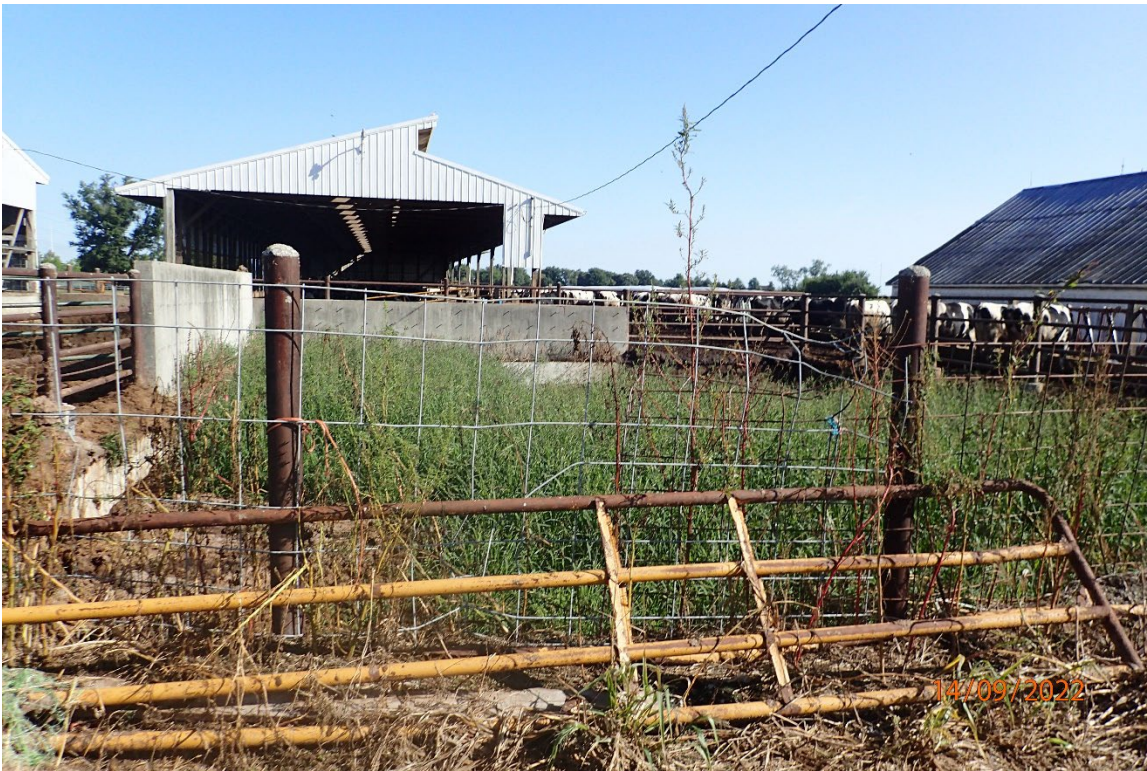
2: P9140093

Description: Looking north across Pit 1 (behind the fence where the vegetation is seen) toward the south end of the Heifer Barn.

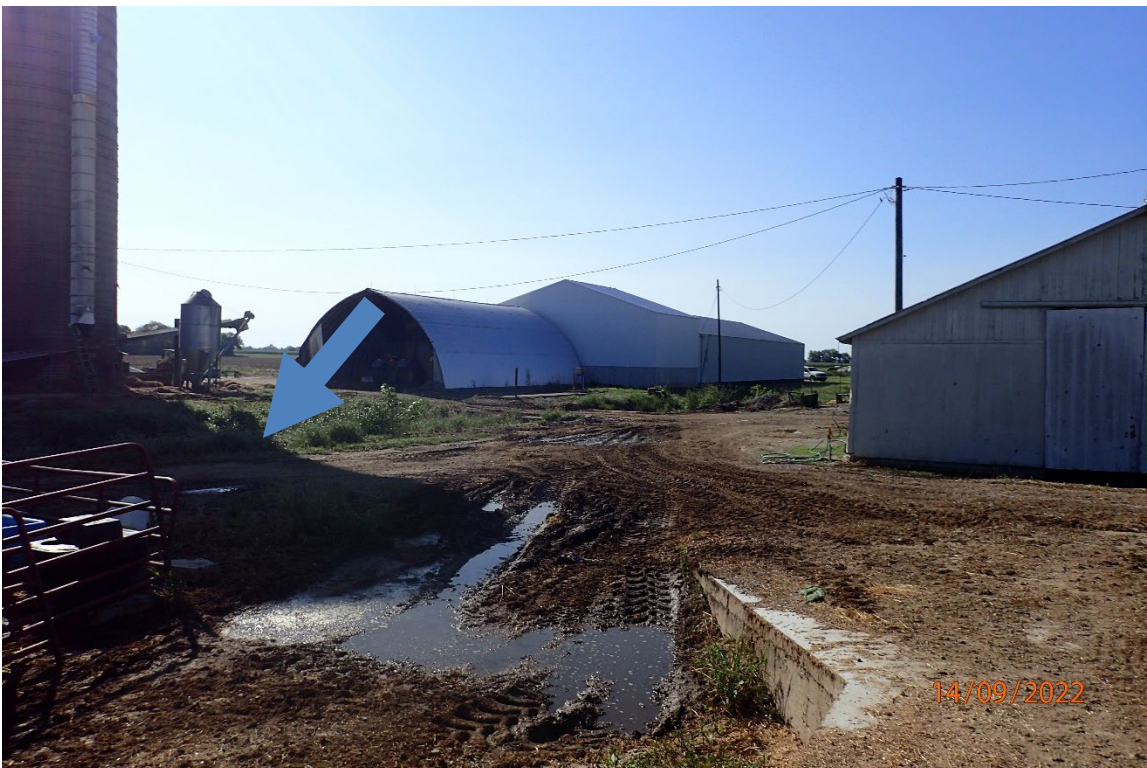
5: P9140096

Description: Looking southeast from the southwest corner of the Hospital Barn. Note that there is no containment around the south end of the Hospital Barn. Also note the proximity of the waterway (blue arrow).

The Inspectors then walked east along the south side of the Dry Cow Barn past manure Pit 1 and observed the Hospital Barn (photos 2 and 3). The Operator stated that manure from the Dry Cow Barn and the Heifer Barn was pushed to Pit 1. The Inspectors observed manure solids and dark brown liquid around the entrance to the Hospital Barn and around the outdoor lot area attached to the south side of the Hospital Barn (photos 4 and 5). There was no containment for any manure or process wastewater around the Hospital Barn Pen. The Inspectors noted that, given the proximity to Bull Branch, it

Hospital Barn, the lack of containment for manure and runoff for the mound of manure north of the Hospital Barn, the paths of organic material and burned vegetation from the denuded earthen lot on the west side of the facility, and manure that had been flowing from the cracked wall into Bull Branch.

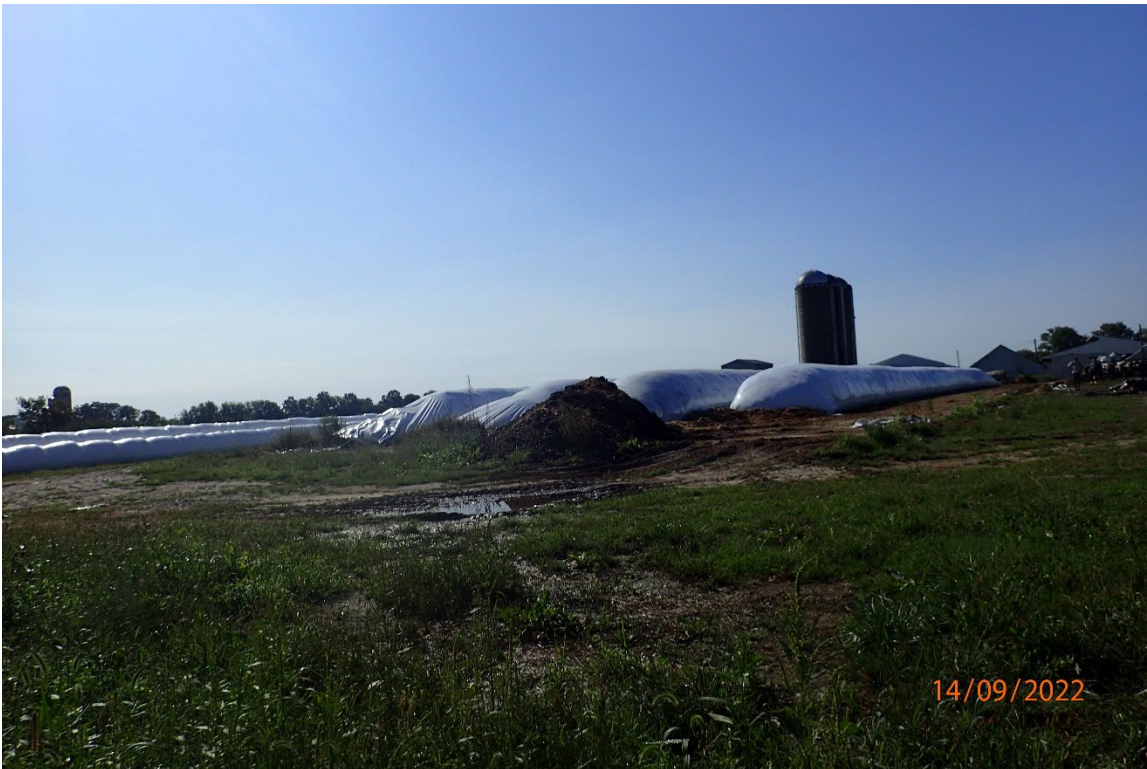
12: P9140103

Description: Looking southeast from the north end of the facility. Note the flow path (red line) originating at the north end of the feed bags.

The Inspectors walked north along the east side of the Heifer barn to the north side of the facility. The Inspectors observed an apparent flow path from the north end of the feed bags toward the north end of the property (photos 12-14). The Inspectors did not observe the flow path continuing into the field to the north.

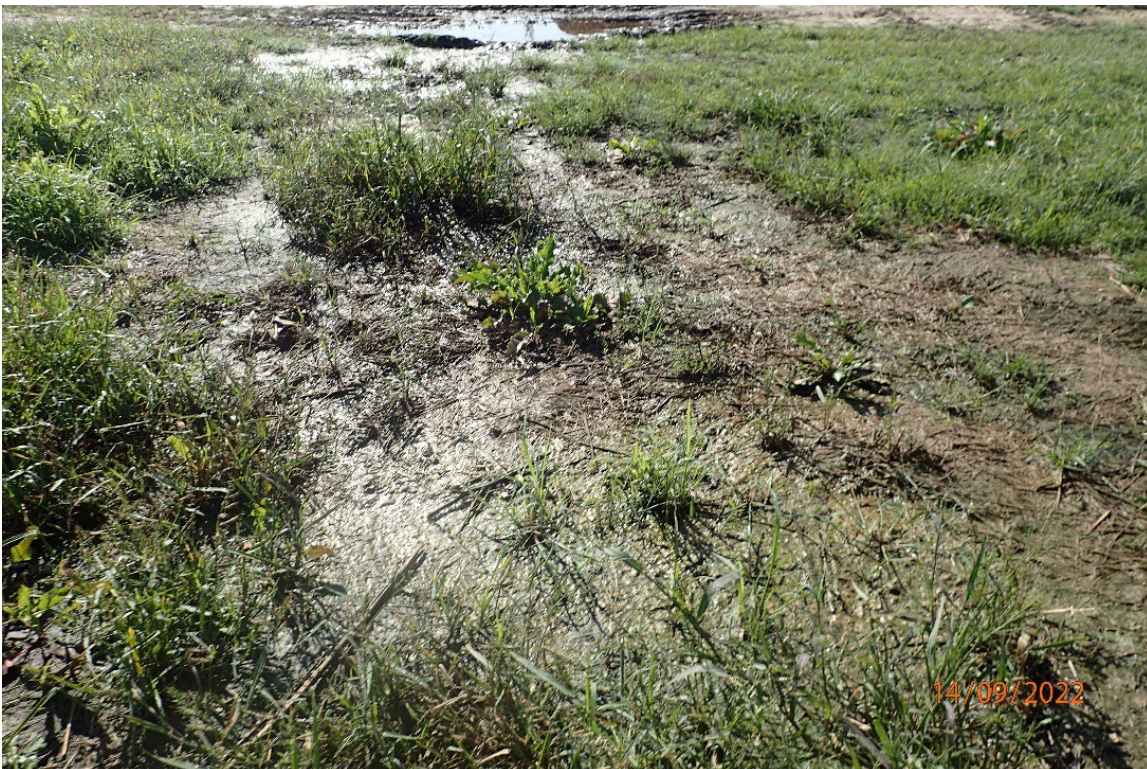
13: P9140104

Description: Close up of the flow path noted in photo 12.

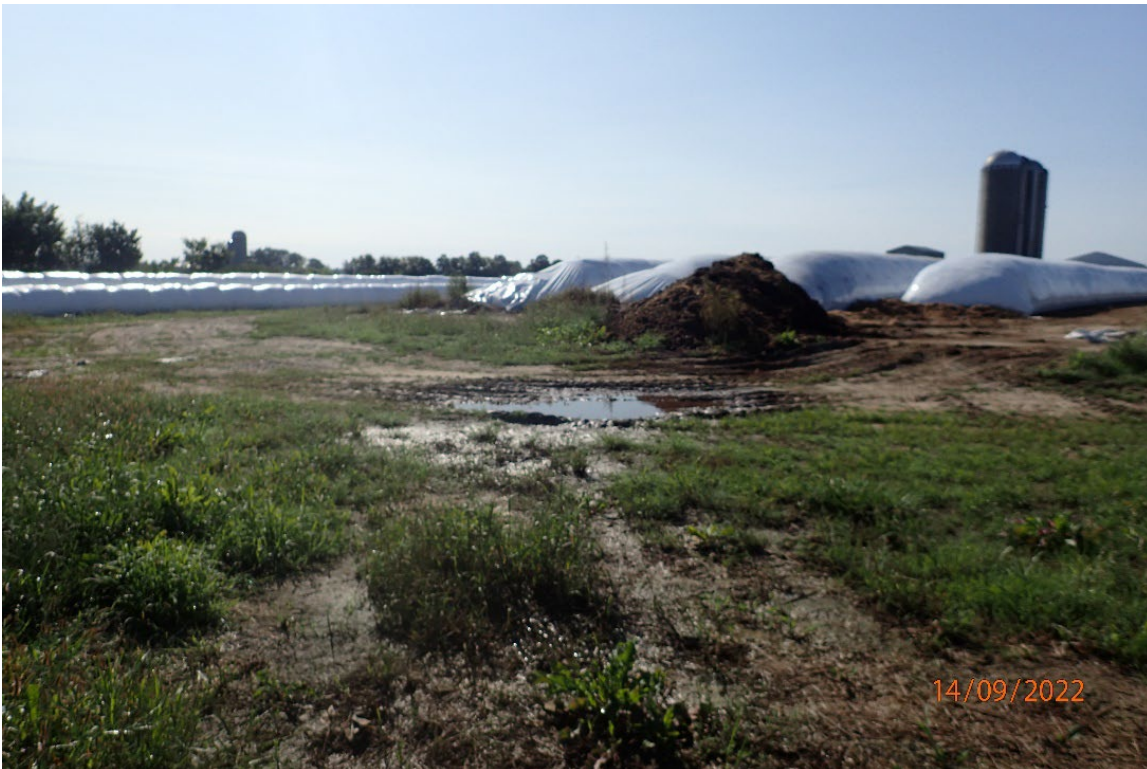
14: P9140105

Description: Looking southeast from the north end of the facility. Note the flow path (red line) originating at the north end of the feed bags.

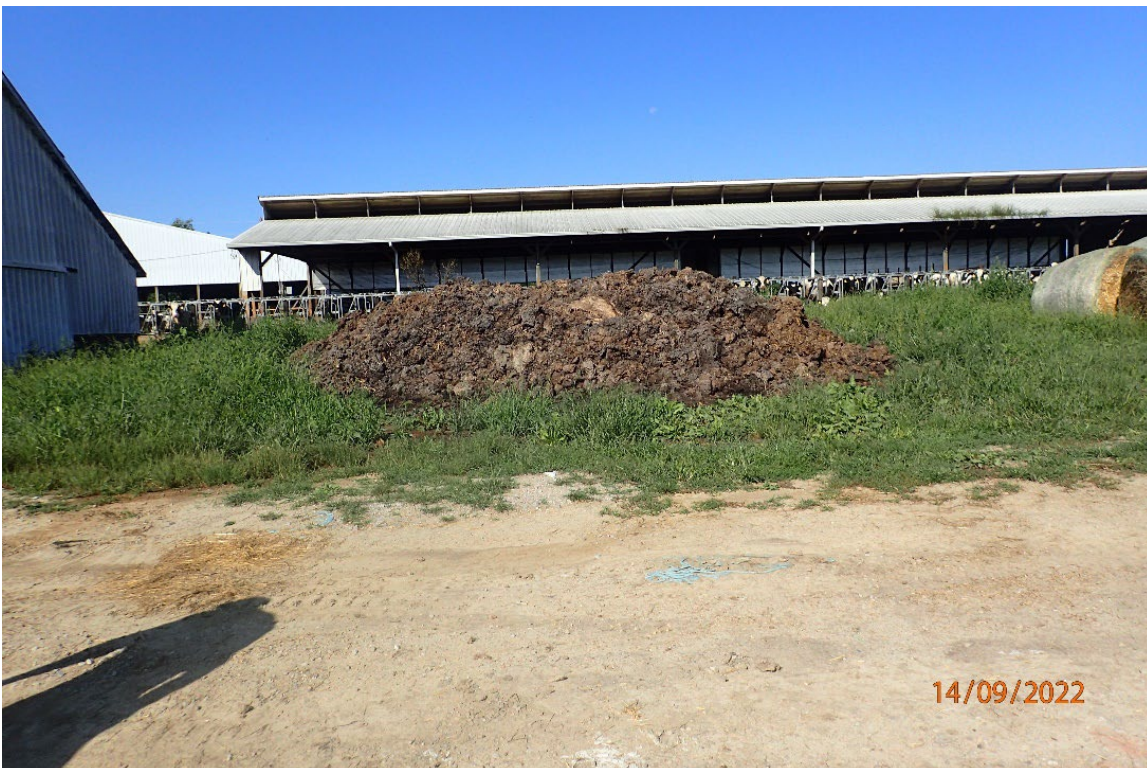
17: P9140108

Description: A mound of solid manure with no runoff containment located north of the Hospital Barn and east of the Heifer Barn.

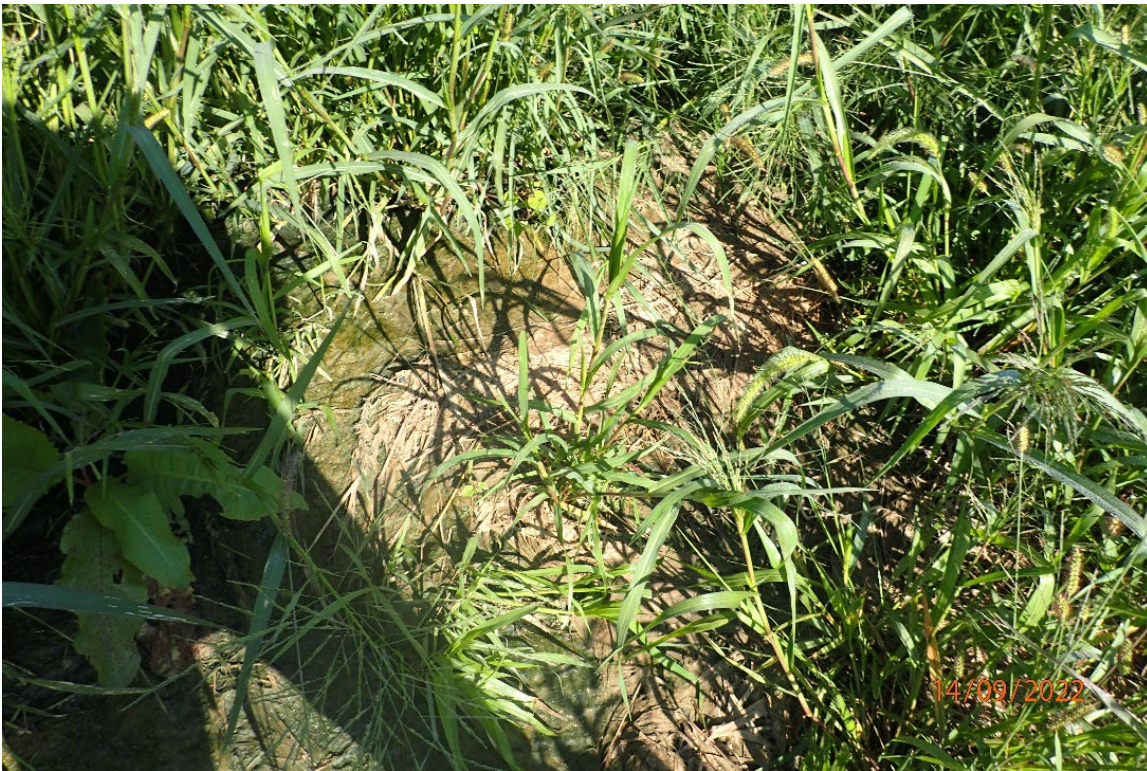
18: P9140109

Description: Manure solids on the west bank of Bull Branch east of the mound of solid manure.

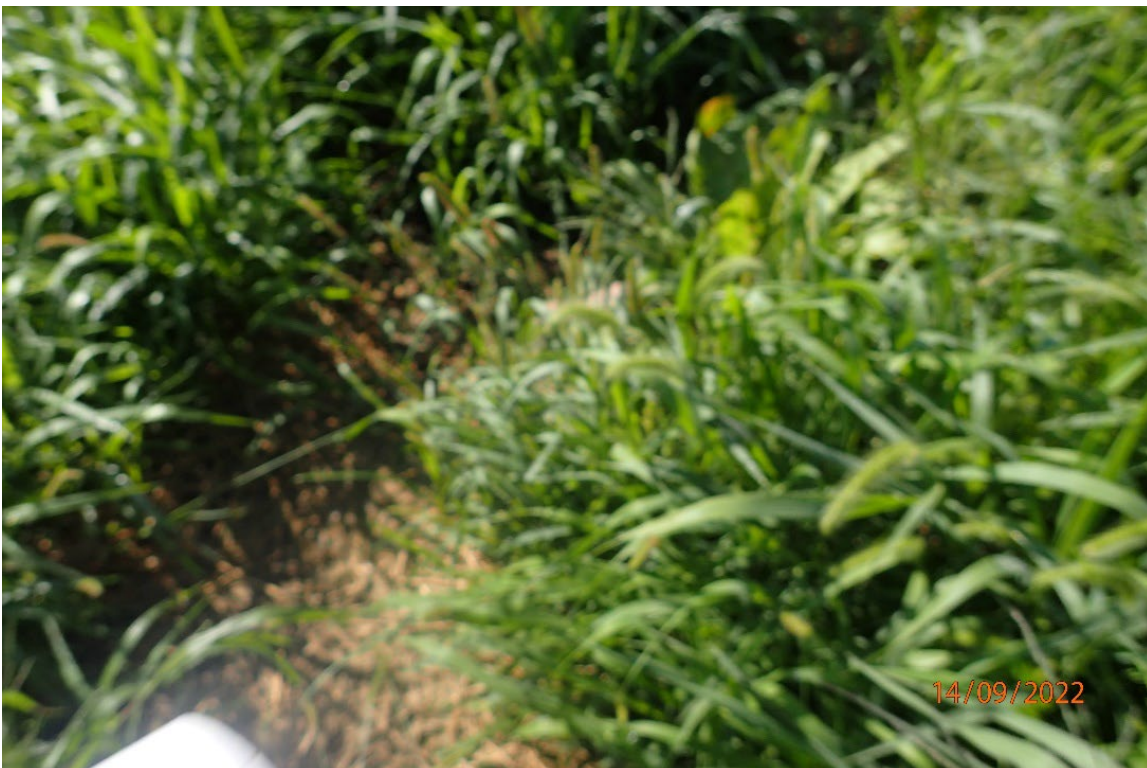
19: P9140110

Description: Manure solids on the west bank of Bull Branch east of the mound of solid manure.

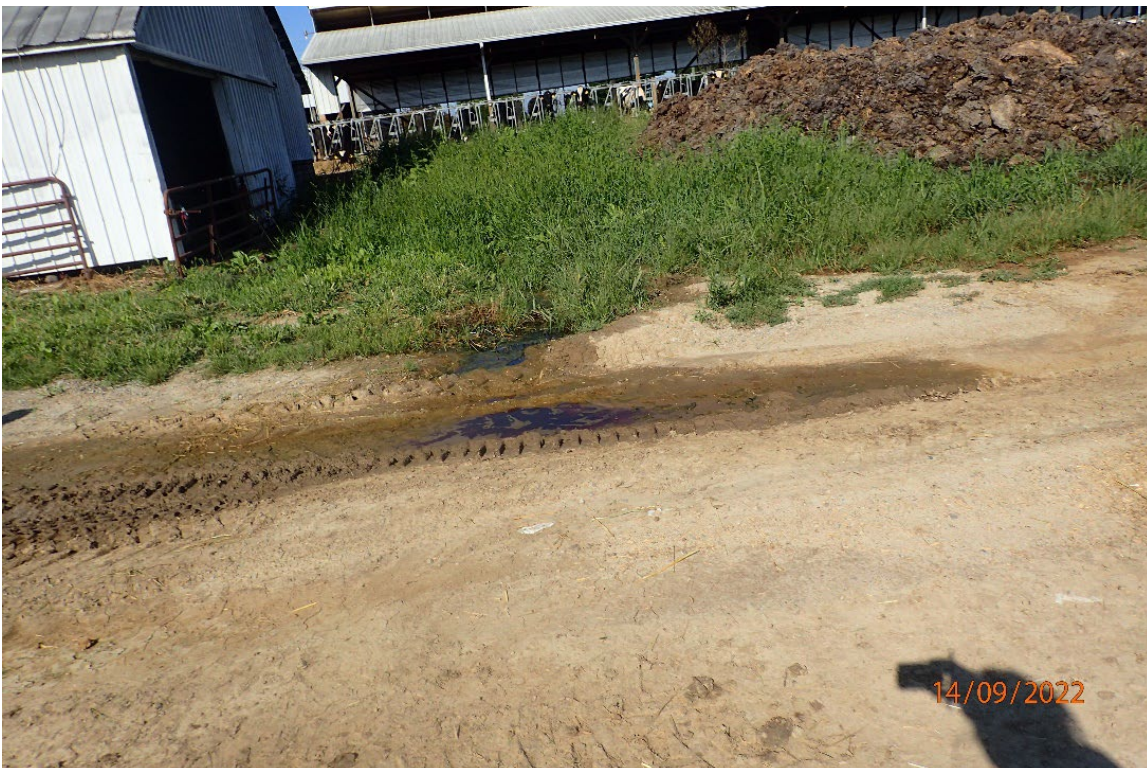
25: P9140116

Description: Dark colored leachate in access road between the solid manure mound and Bull Branch.

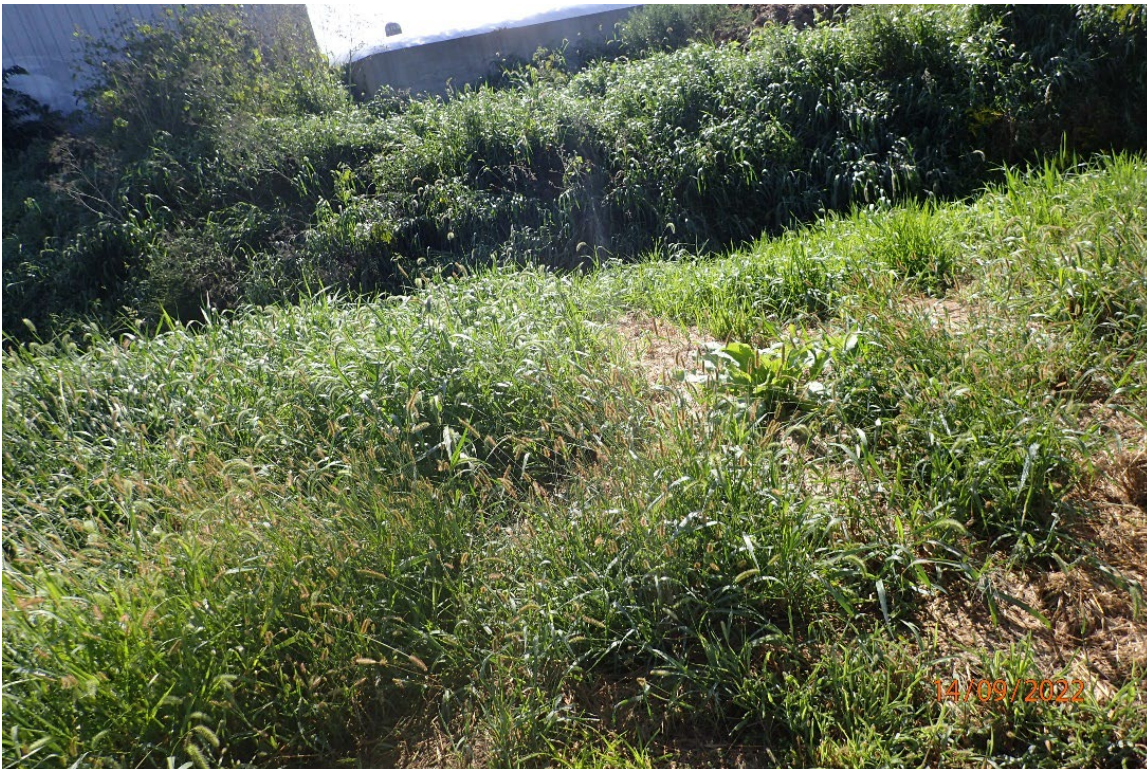
26: P9140117

Description: Solids deposited in grass along the west bank of Bull Branch.

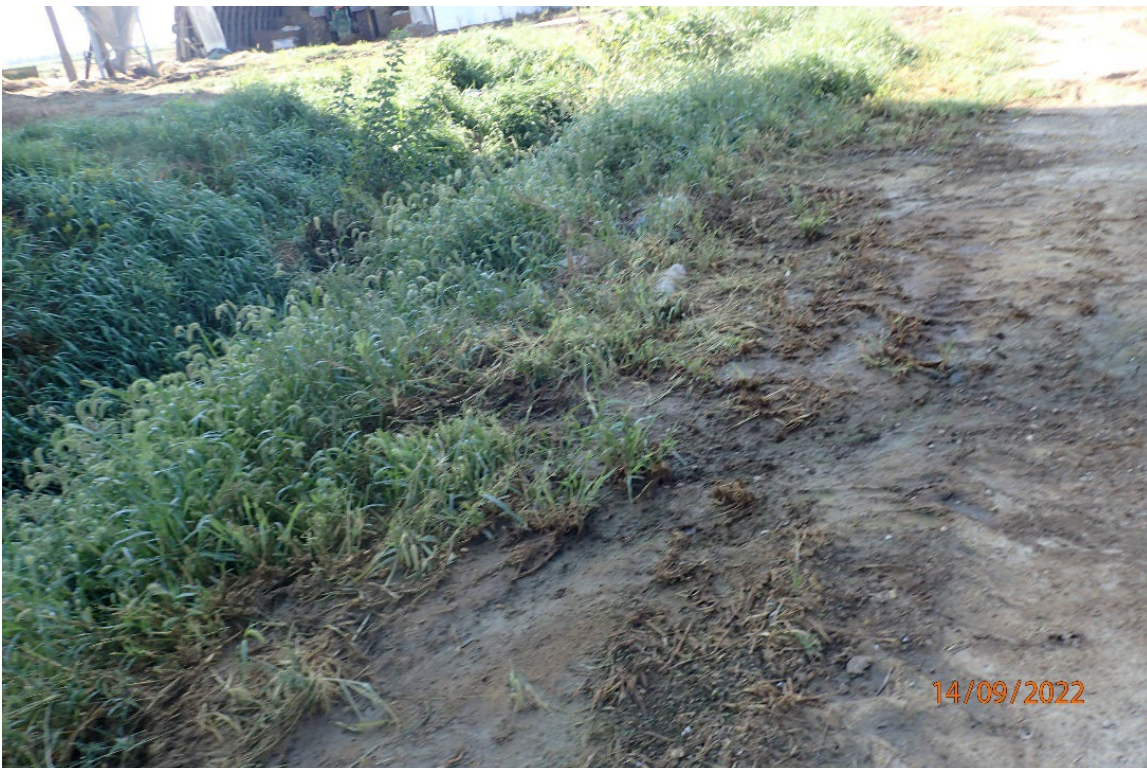
27: P9140118

Description: Manure solids deposited on access road east of the Hospital Barn.

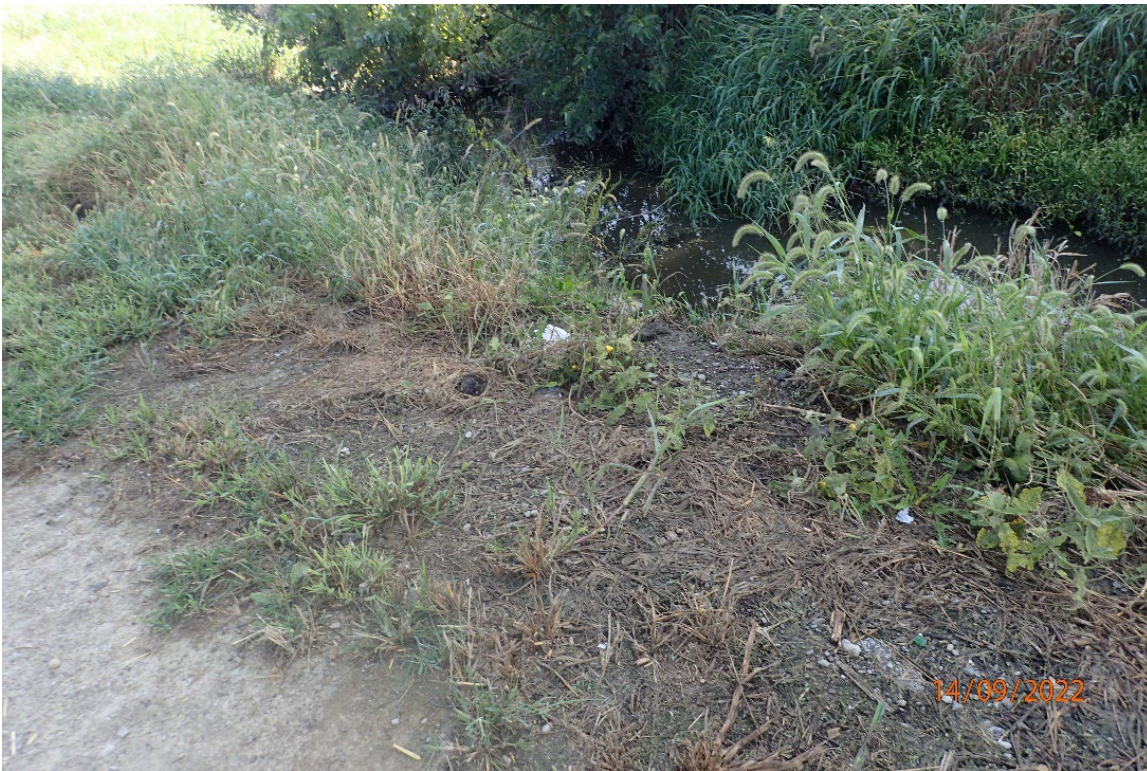
28: P9140119

Description: Dead vegetation and eroded flow paths along the west bank of Bull Branch and the access road.

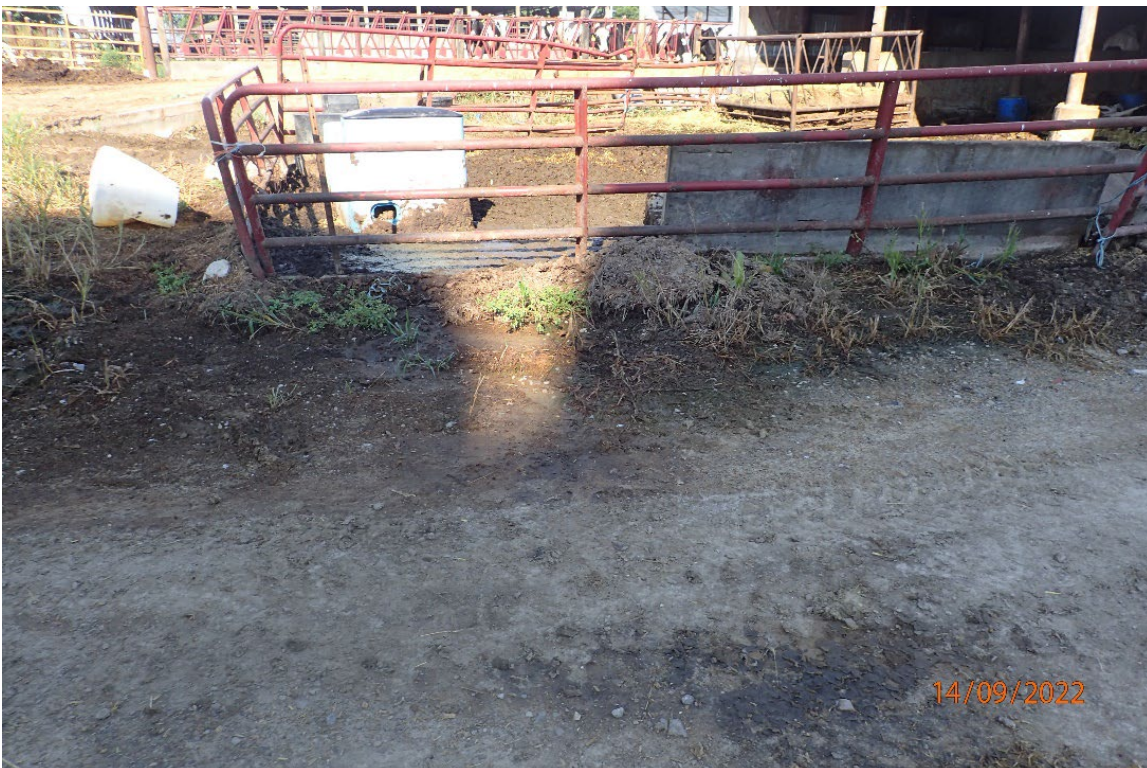
29: P9140120

Description: Manure solids on the ground around the exterior of the pen on the south side of the Hospital Barn.

The Inspectors then walked east along the north side of the facility to the west bank of Bull Branch and observed water within the Bull Branch (photos 15 and 16). The Inspectors then walked south along the west bank of Bull Branch. The Inspectors observed a mound of manure solids north of the Hospital Barn (photo 17). The Inspectors also observed dark colored leachate (photo 25) and manure solids in the access road and along the west bank of Bull Branch (photos 18-28). The Inspectors also observed further manure solids around the outdoor pen on the southside of the Hospital Barn (photos 29-31).

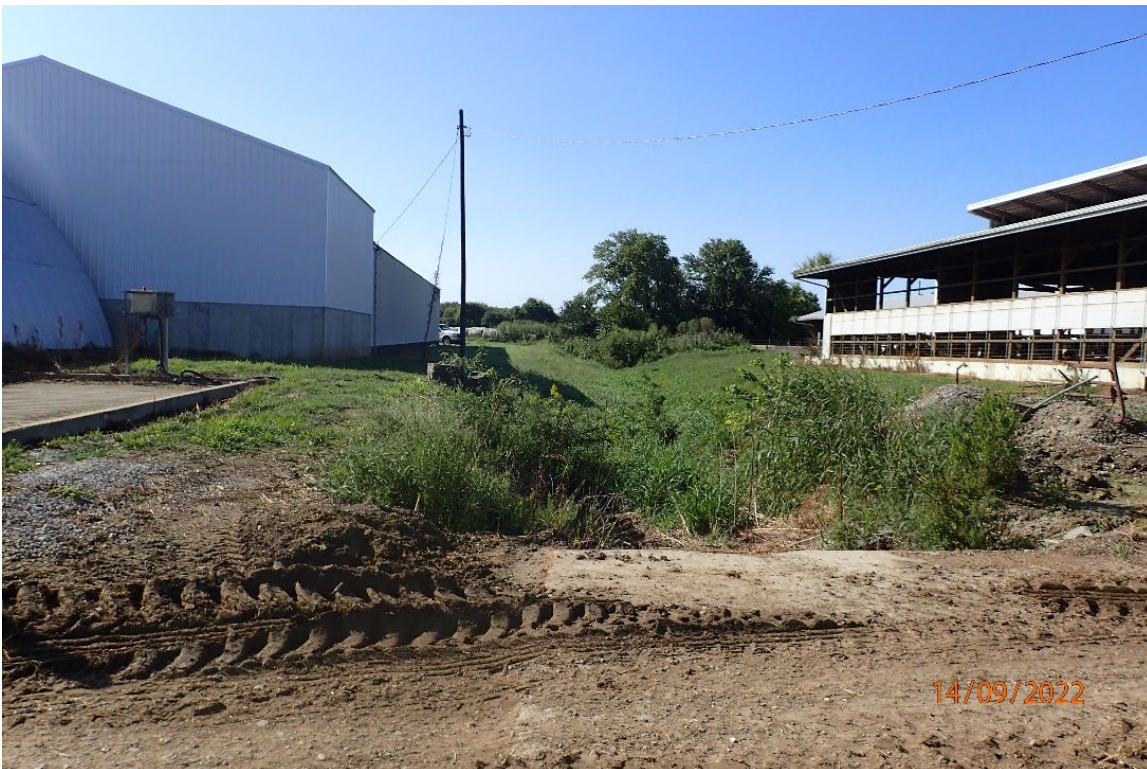
33: P9140124

Description: Looking south along Bull Branch from the access road over the waterway.

The Inspectors then walked east across the access road culvert over Bull Branch to the feed storage area on the east side of Bull Branch. The Inspectors observed fibrous solids on the culvert (photos 33 and 58). The Inspectors observed Pit 2 and Pit 3 which collect the runoff from the feed storage areas on the east side of Bull Branch (photos 34 and 35). The Inspectors walked north along the east bank of Bull Branch and observed a solid manure stack on the northwest corner of the feed storage area (photos 39-41, and 44). It appeared that the runoff from the manure pile was being collected by Pit 2 (photo 40). The Inspectors also observed the Commodity Barn and a mound of organic solids (photos 45 and 46).

8. Manure and feed solids were observed uncontained on and around the culvert over Bull Branch.
9. A pump with a hose from manure Pit 3 was observed directed toward Bull Branch.

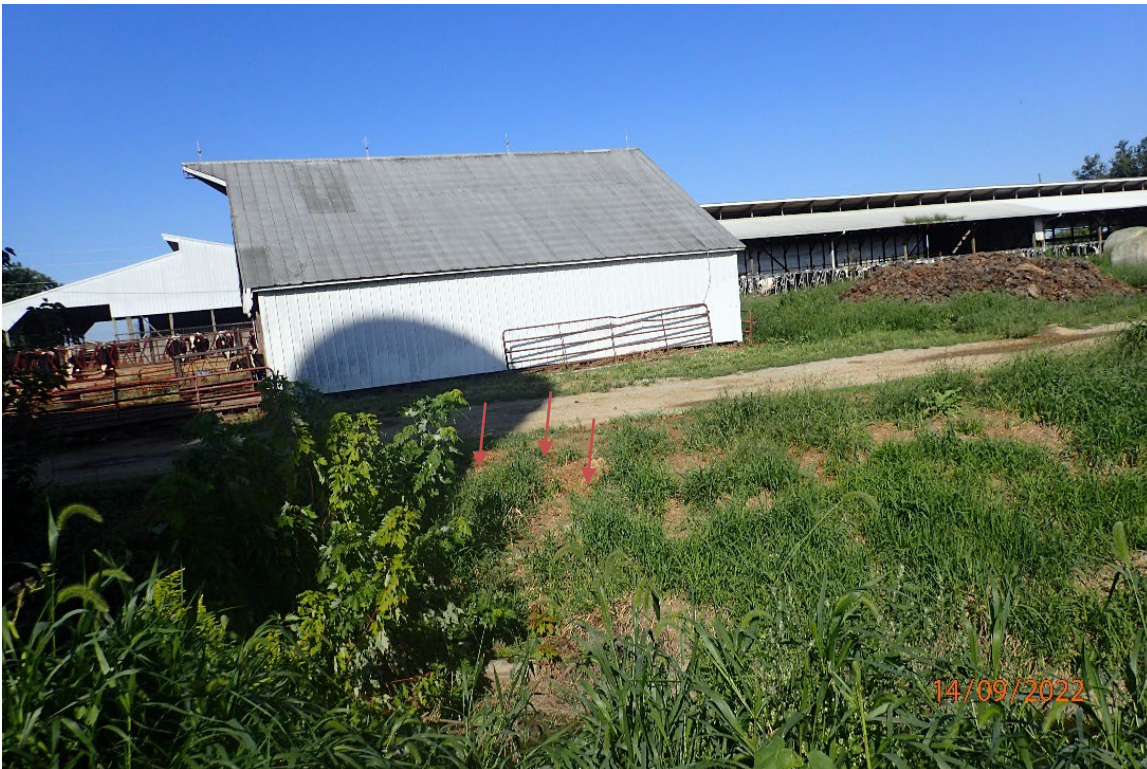
38: P9140129

Description: Looking west across Bull Branch toward the Hospital Barn. The solids deposited along the western bank are visible (red arrows).

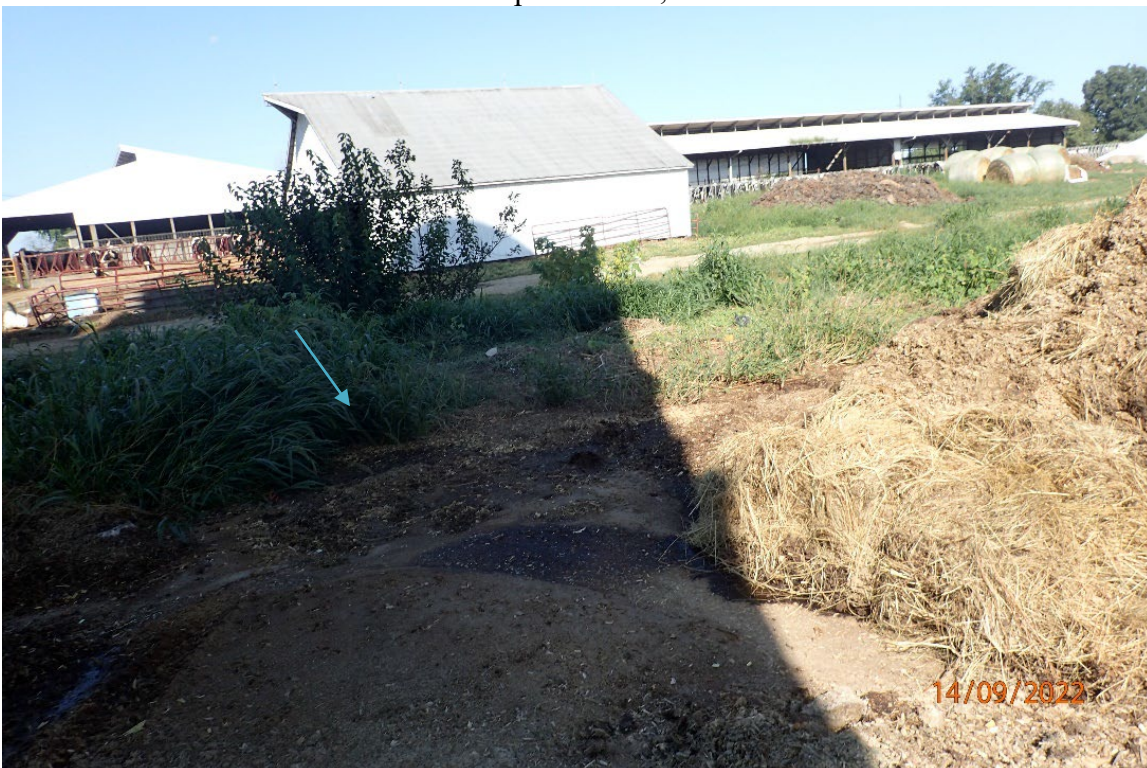
39: P9140130

Description: Looking west from the area northwest of the silos. Note the solid manure stacked (right) and the runoff flowpaths (blue arrow).

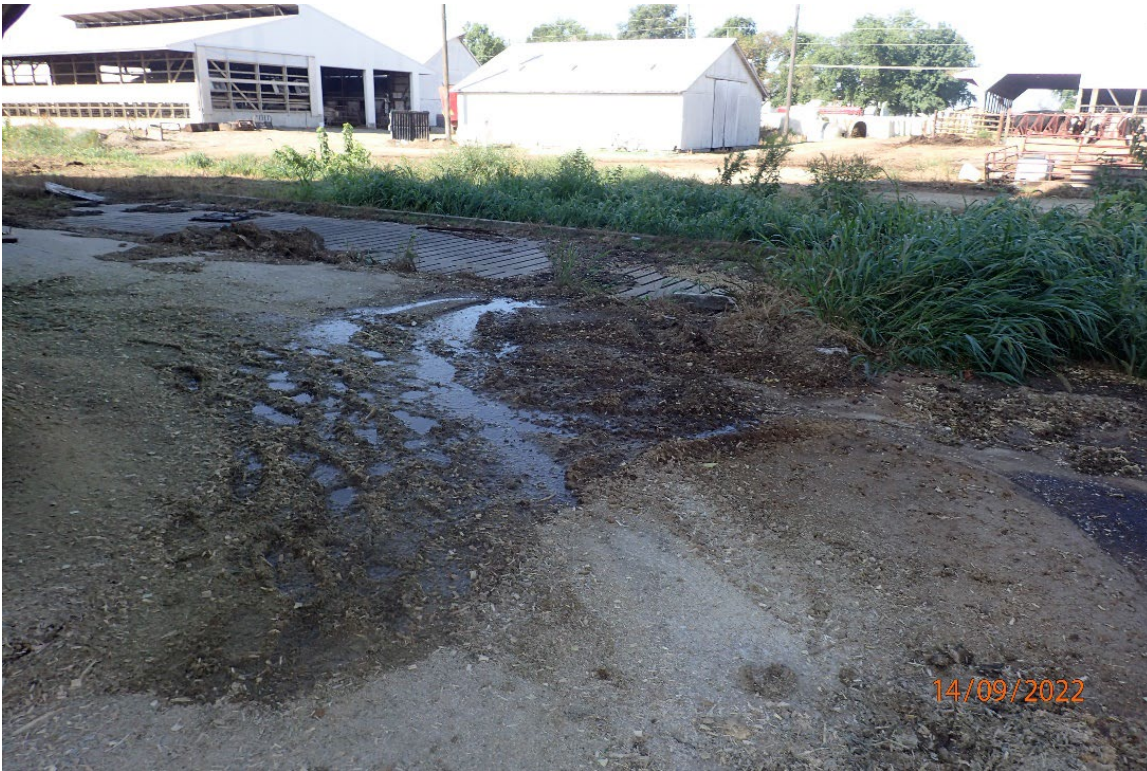
40: P9140131

Description: Looking southwest along the runoff pathways (blue arrows) from the solid manure stacked northwest of the silos to Pit 2.

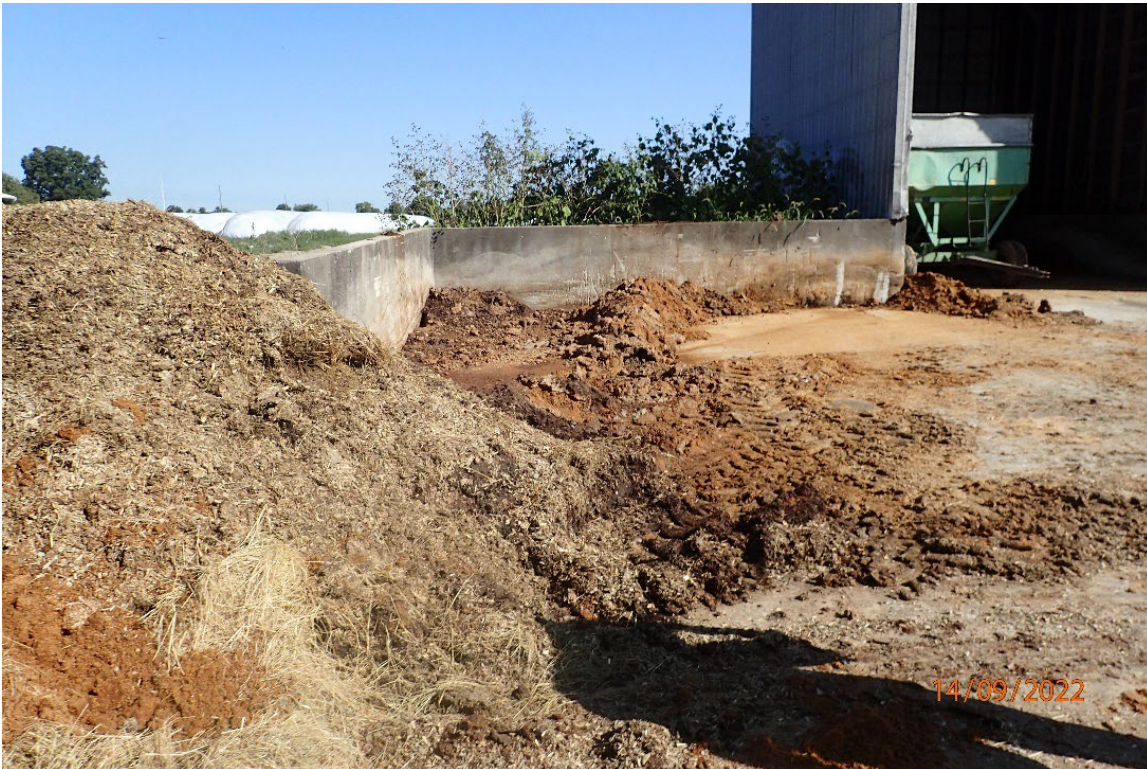
41: P9140132

Description: Solid manure stacked northwest of the silos.

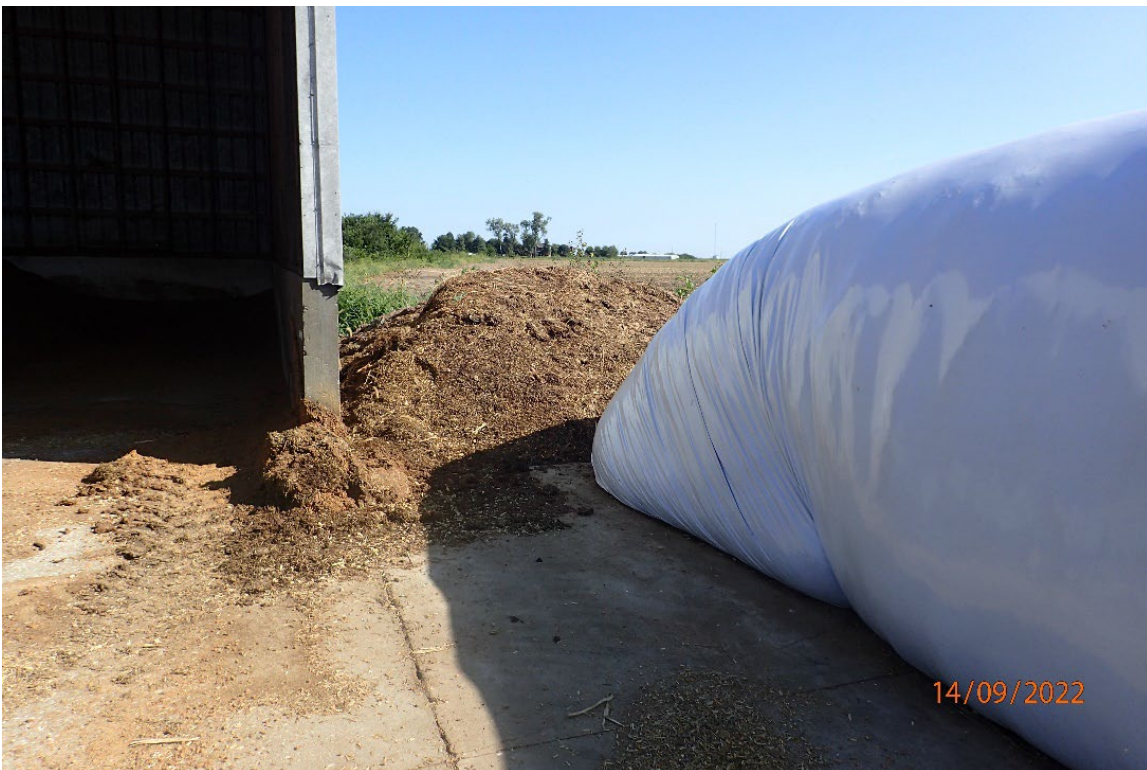
43: P9140134

Description: Looking at the north end of the feed bag east of the silos (right), the north commodity barn (left) and a mound of organic solids.

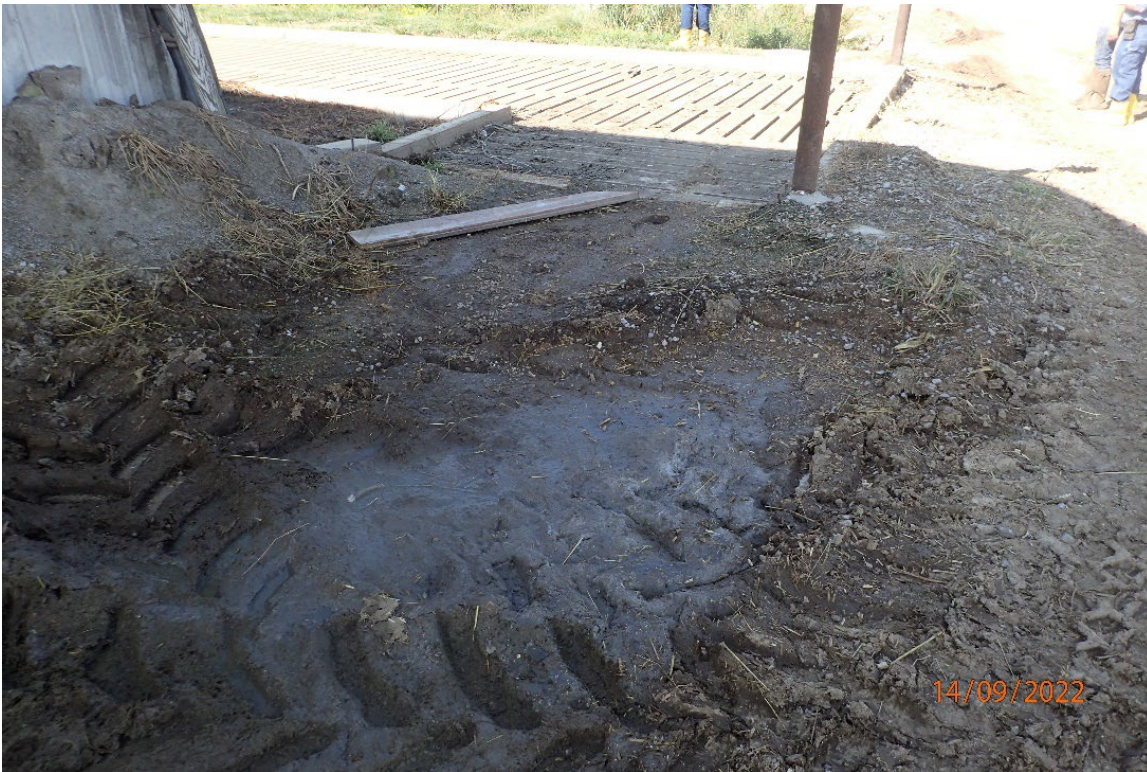
49: P9140140

Description: North side of the Hay Barn (left) and the adjacent Pit 3 (right).

The Inspectors walked south on the east side of the silos and then west to the Hay Barn. The Inspectors observed Pit 3 (photos 49-51). The Inspectors walked south to the south end of Pit 3 and observed a hose attached to a pump sitting at the south end of Pit 3. The opposite end of the hose was lying on the ground and oriented toward Bull Branch (photos 52-56). When asked what the pump was for, the Operator stated that he did not know why it was there and that his father had been put it there. At the Inspectors request, the hose was moved onto the Pit 3 area so it could not discharge to Bull Branch (photo 57).

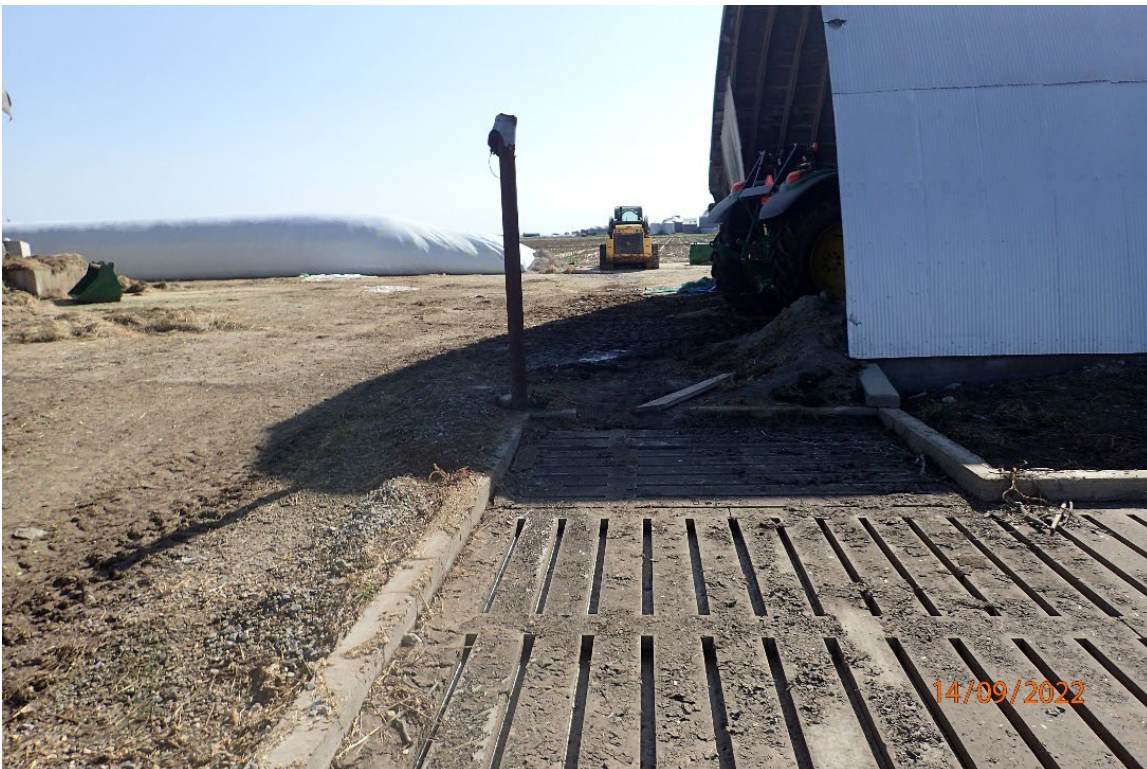
50: P9140141

Description: North side of the Hay Barn (left) and the adjacent Pit 3 (right).

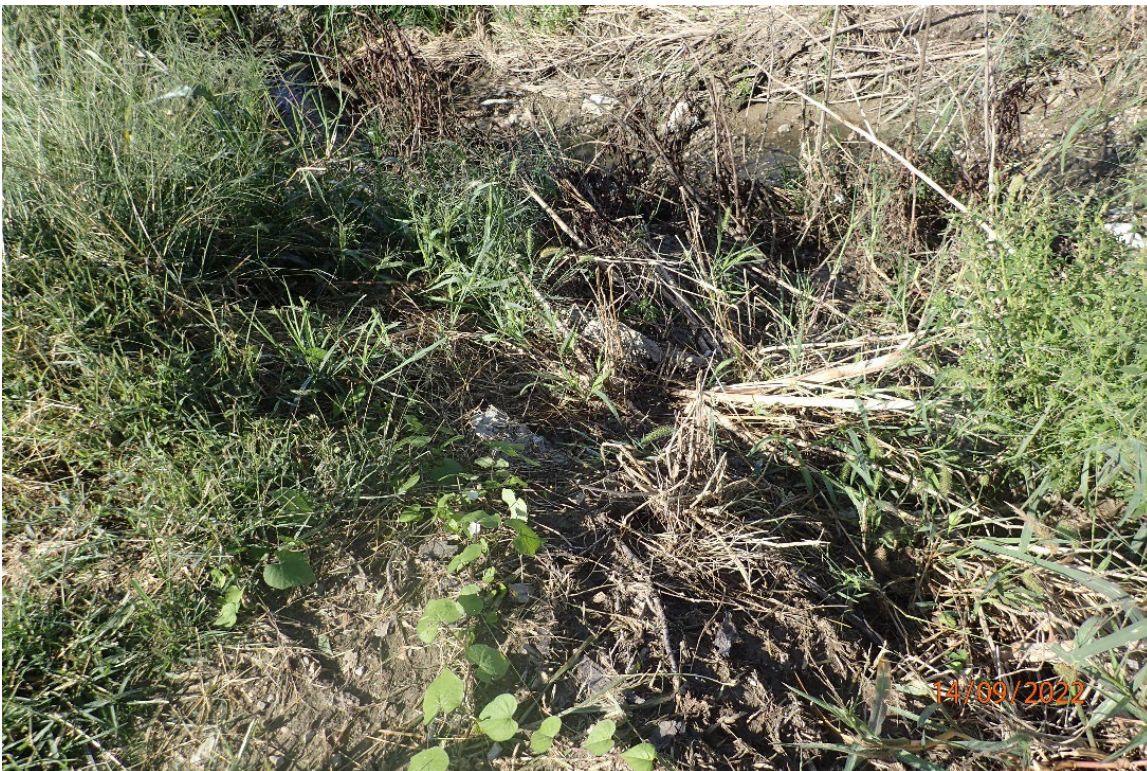
53: P9140144

Description: Potential flow path on the east bank of Bull Branch west of Pit 3.

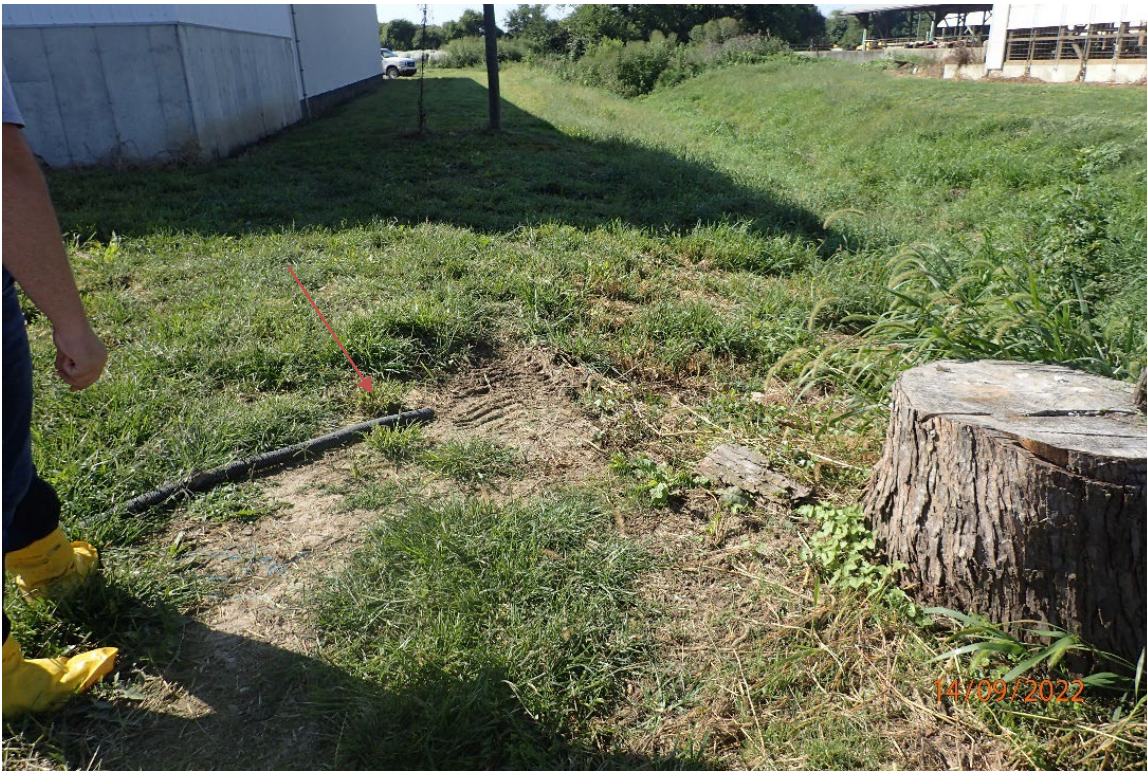
54: P9140145

Description: Area southwest of Pit 3. Note the black hose (red arrow). One end of the black hose is connected to a pump and other end is toward Bull Branch.
