**CWA COMPLIANCE EVALUATION INSPECTION REPORT
U.S. ENVIRONMENTAL PROTECTION AGENCY, REGION 5**

Compliance Evaluation Sampling Inspection

Richter Dairy Farm
14113 St. Rose Road
Breese, Illinois 62230
Clinton County, Illinois
38.62797657159176, -89.55355561706052

Date of Inspection: Site Inspection - September 14th, 2022
Operator Interview – September 27th, 2022

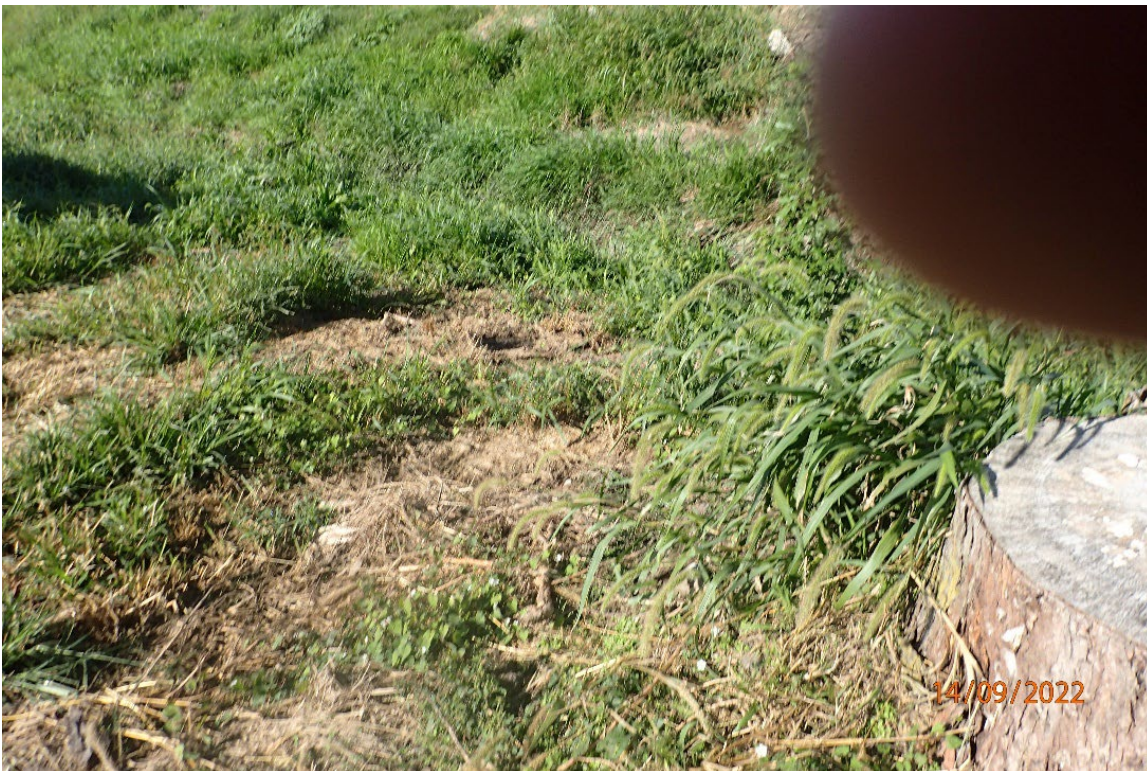
55: P9140146

Description: Potential flow paths on the east bank of Bull Branch west of the the black hose attached to the pump. Location: Southwest corner of Pit 3.

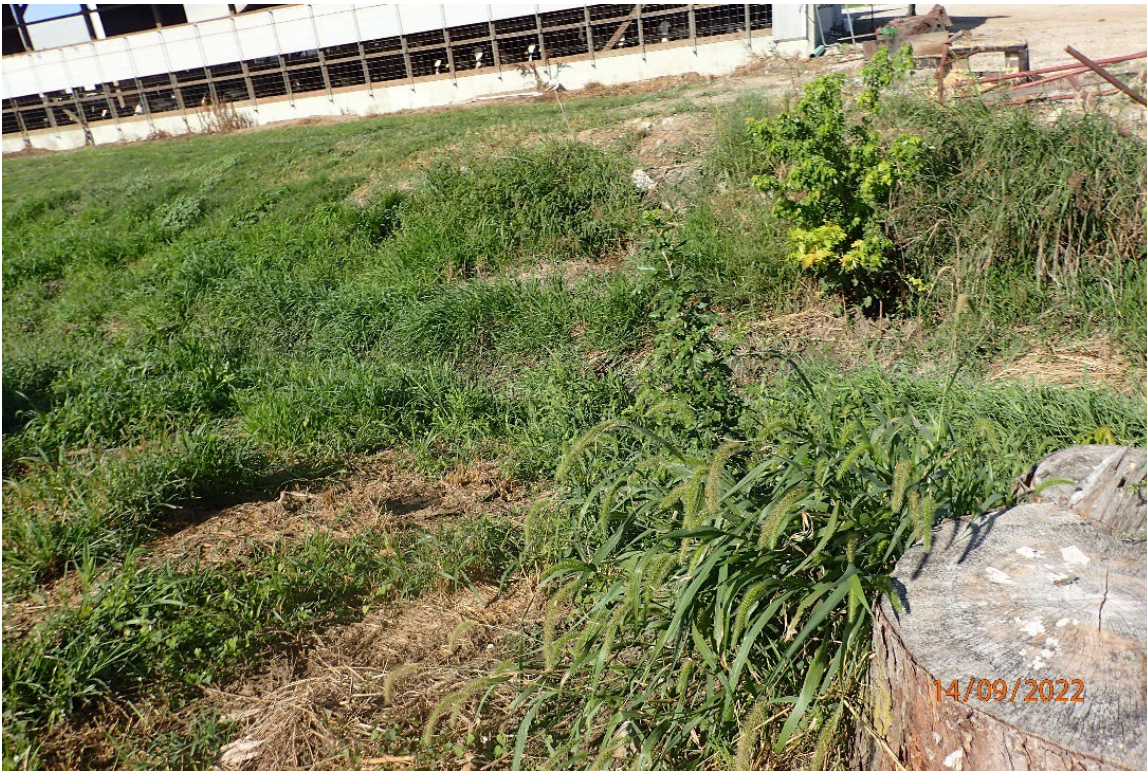
56: P9140147

Description: Potential flow paths on the east bank of Bull Branch west of the the black hose attached to the pump.

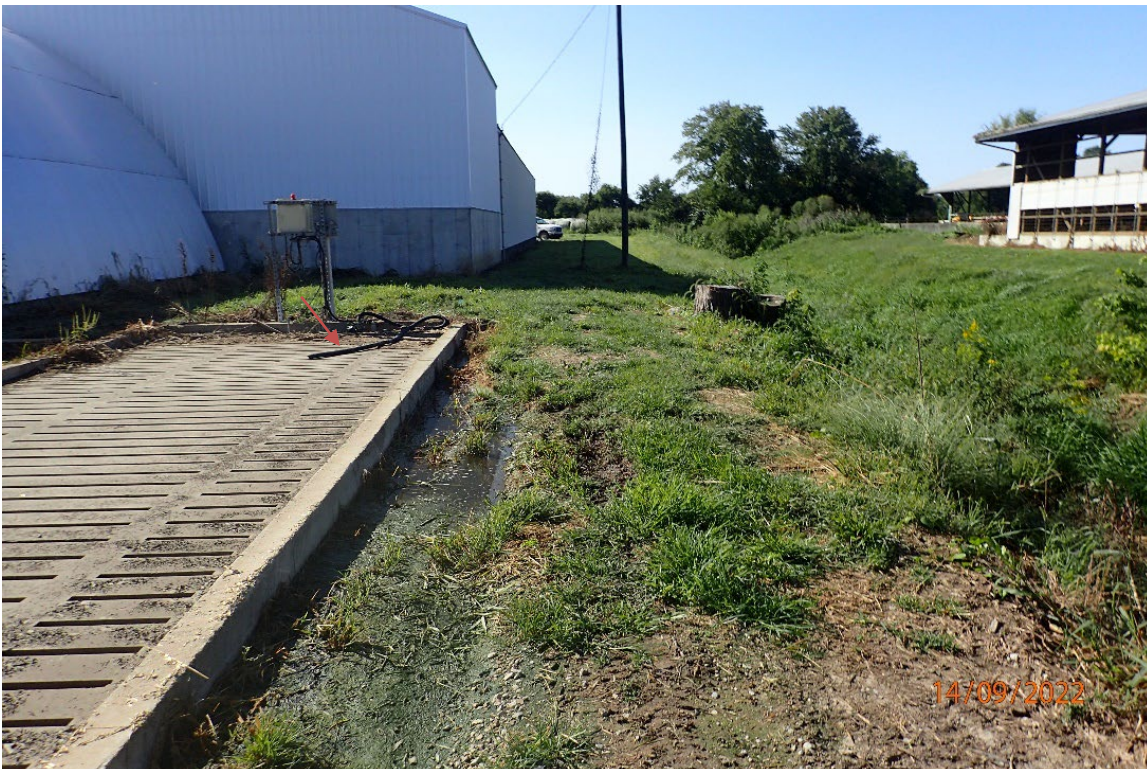
57: P9140148

Description: Looking south along the west side of Pit 3. Note the black hose was picked up and moved over onto Pit 3 (red arrow).

The Inspectors walked south on the east side of the silos and then west to the Hay Barn. The Inspectors observed Pit 3 (photos 49-51). The Inspectors walked south to the south end of Pit 3 and observed a hose attached to a pump sitting at the south end of Pit 3. The opposite end of the hose was lying on the ground and oriented toward Bull Branch (photos 52-56). When asked what the pump was for, the Operator stated that he did not know why it was there and that his father had been put it there. At the Inspectors request, the hose was moved onto the Pit 3 area so it could not discharge to Bull Branch (photo 57).

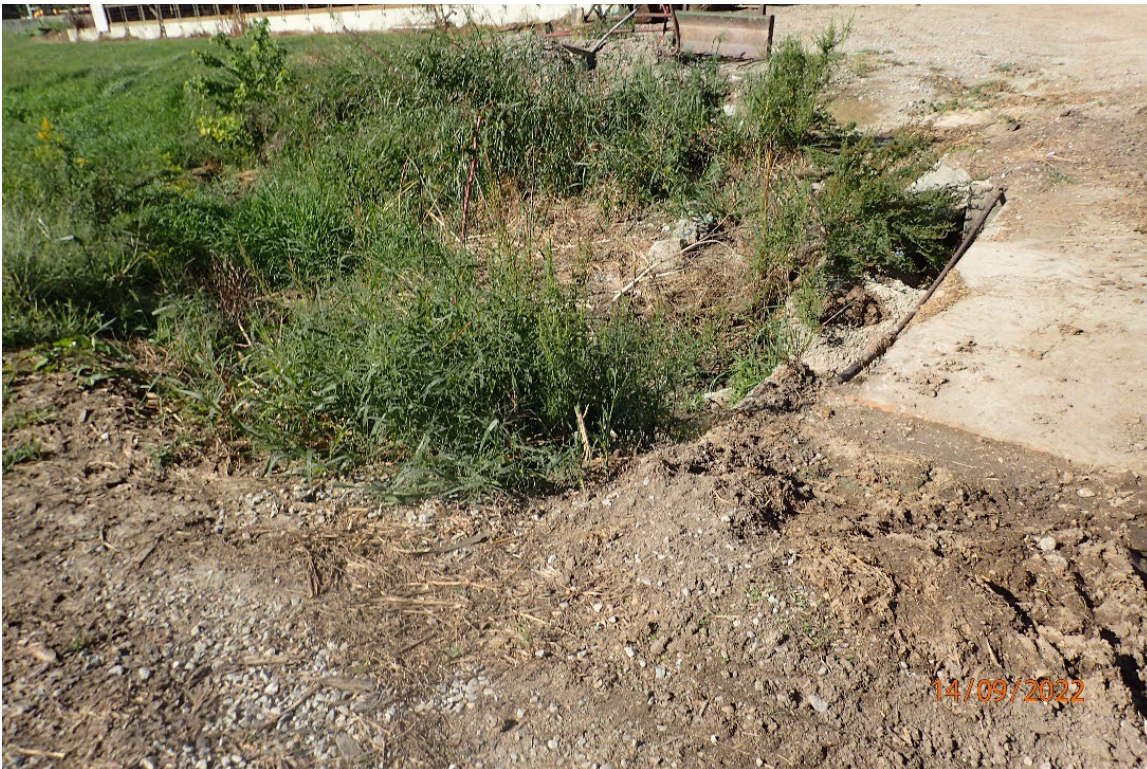
58: P9140149

Description: Organic solids deposited on the road, culvert, and banks of Bull Branch.

Location: East side of the box culvert over Bull Branch.

The Inspectors then walked east across the access road culvert over Bull Branch to the feed storage area on the east side of Bull Branch. The Inspectors observed fibrous solids on the culvert (photos 33 and 58). The Inspectors observed Pit 2 and Pit 3 which collect the runoff from the feed storage areas on the east side of Bull Branch (photos 34 and 35). The Inspectors walked north along the east bank of Bull Branch and observed a solid manure stack on the northwest corner of the feed storage area (photos 39-41, and 44). It appeared that the runoff from the manure pile was being collected by Pit 2 (photo 40). The Inspectors also observed the Commodity Barn and a mound of organic solids (photos 45 and 46).

8. Manure and feed solids were observed uncontained on and around the culvert over Bull Branch.
9. A pump with a hose from manure Pit 3 was observed directed toward Bull Branch.

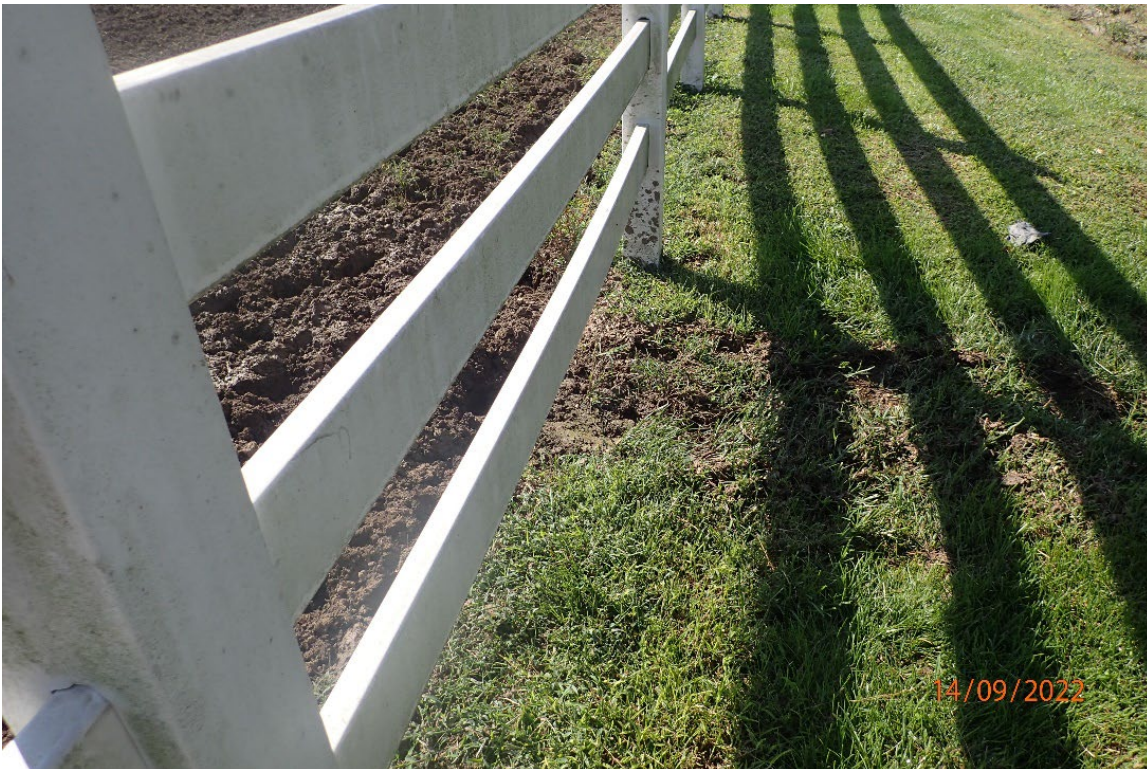
62: P9140153

Description: Potential flow path from outdoor lot on the west side of the West Milk Cow Barn to the roadside ditch.

Location: West side of the facility, west of the West Milk Cow Barn.

fence along the west side of the facility. The Inspectors observed a depression that appeared to be a flow path for runoff from the denuded outdoor lot west of the West Milk Cow Barn (photos 62-64). The Inspectors continued south and observed a blue pipe protruding from the east side of the roadside ditch. The pipe appeared to be in line with a blue pipe connected to the downspout of the roof gutters on the West Milk Cow Barn (photos 65 and 66). The Inspectors observed that the outdoor lot was denuded (photos 68 and 69).

10. The denuded earthen lot west of the West Milk Cow Barn lacked containment.
11. Manure was observed outside of the gate to the Dry Cow Barn in close proximity to the roadside ditch and a roof gutter downspout.

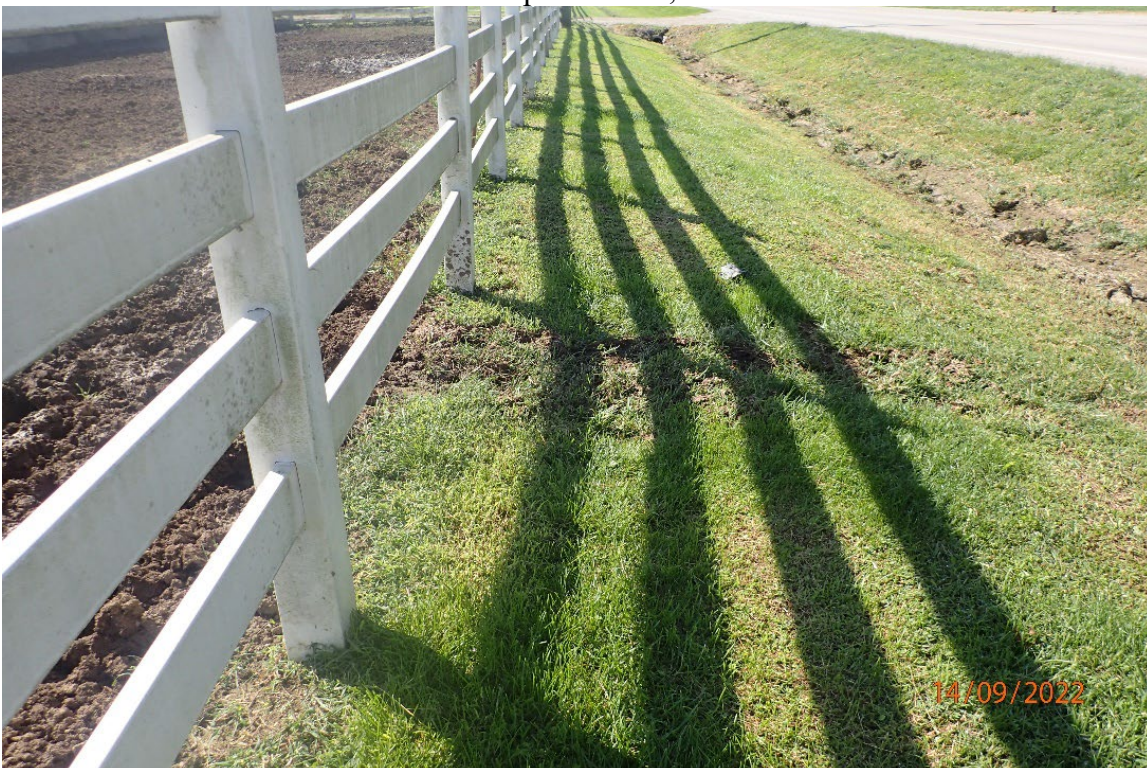
63: P9140154

Description: Potential flow path from outdoor lot on the west side of the West Milk Cow Barn to the roadside ditch.

Location: West side of the facility, west of the West Milk Cow Barn.

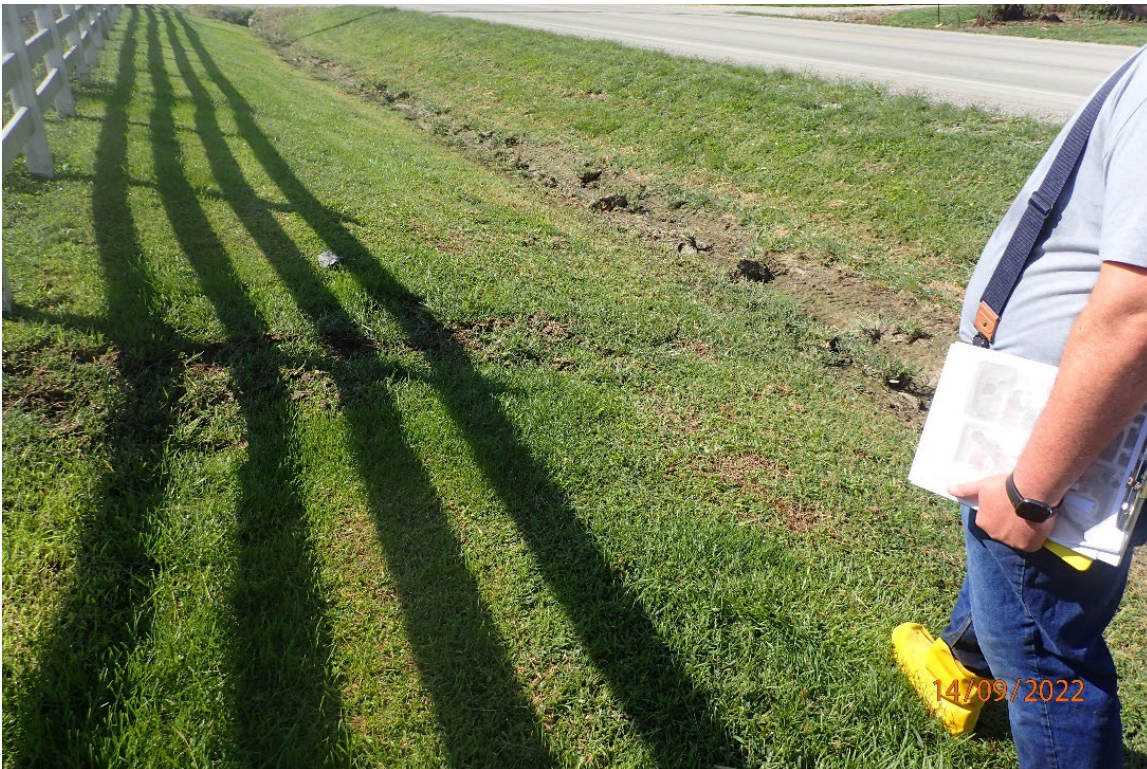
64: P9140155

Description: Potential flow path from outdoor lot on the west side of the West Milk Cow Barn to the roadside ditch.

Location: West side of the facility, west of the West Milk Cow Barn.

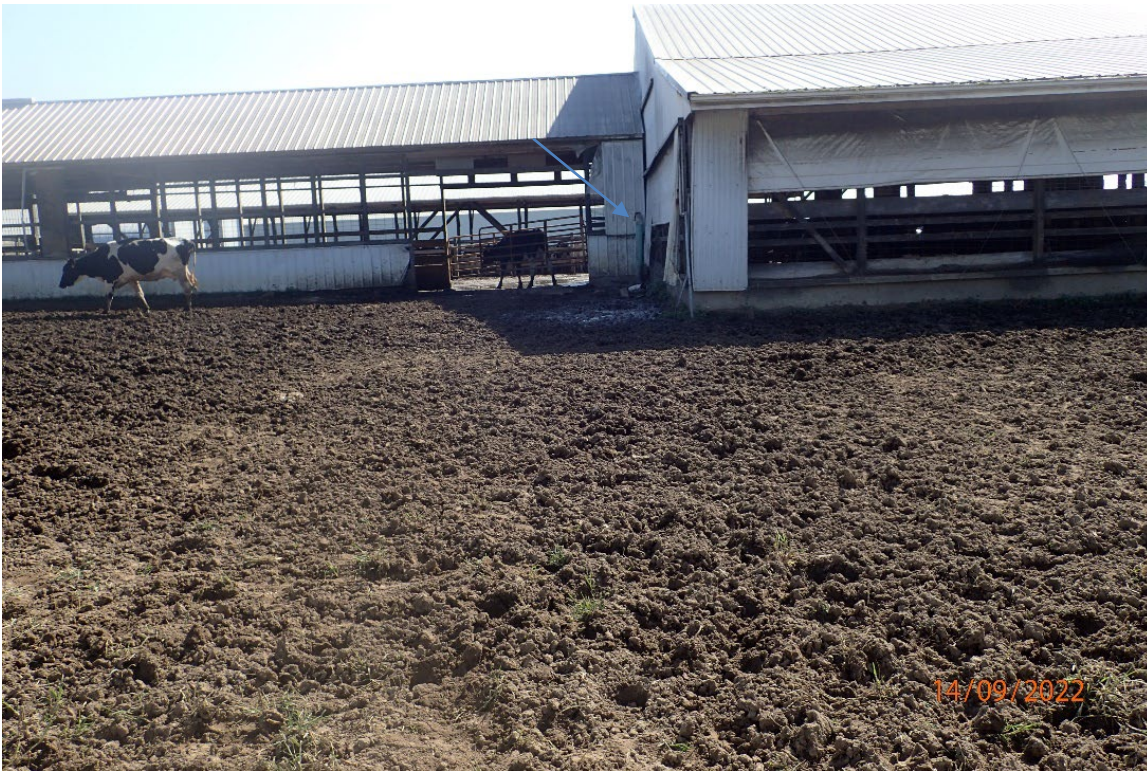
66: P9140157

Description: Looking east toward the West Milk Cow Barn across the denuded outdoor lot. Note the blue pipe receiving roof gutter water (blue arrow).

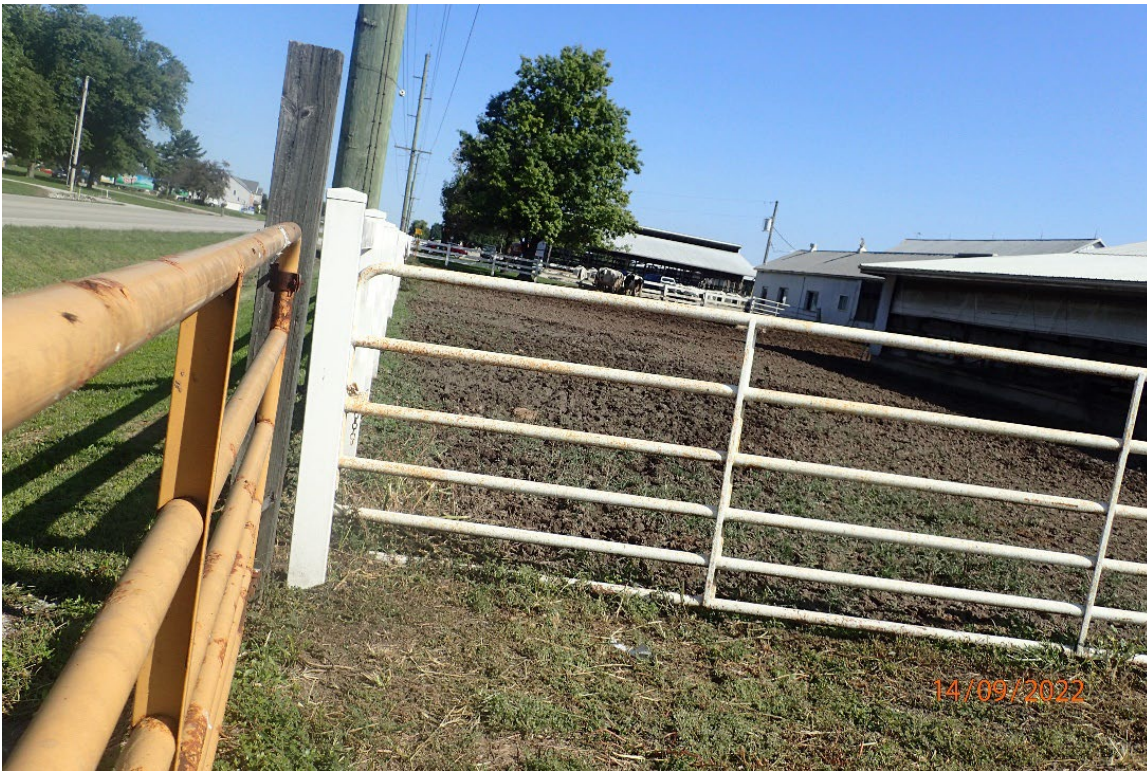
68: P9140159

Description: Looking north across the outdoor lot on the west side of the West Milk Cow Barn.

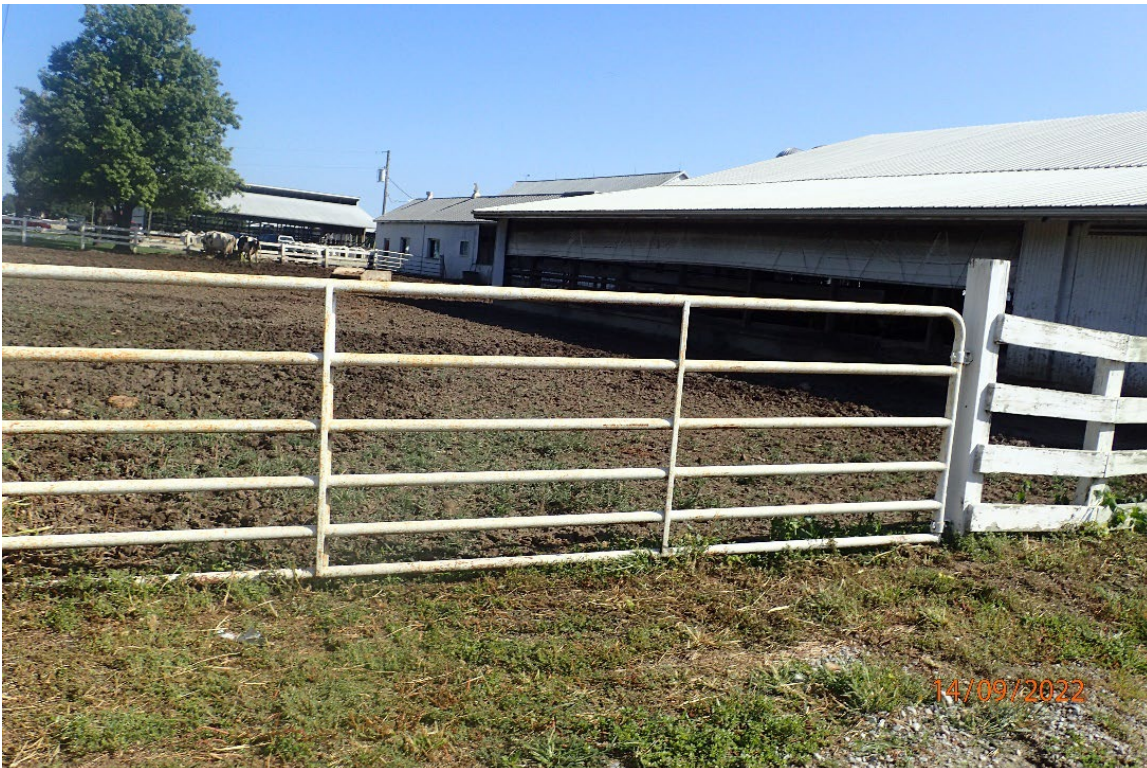
69: P9140160

Description: Looking northeast across the outdoor lot on the west side of the West Milk Cow Barn.

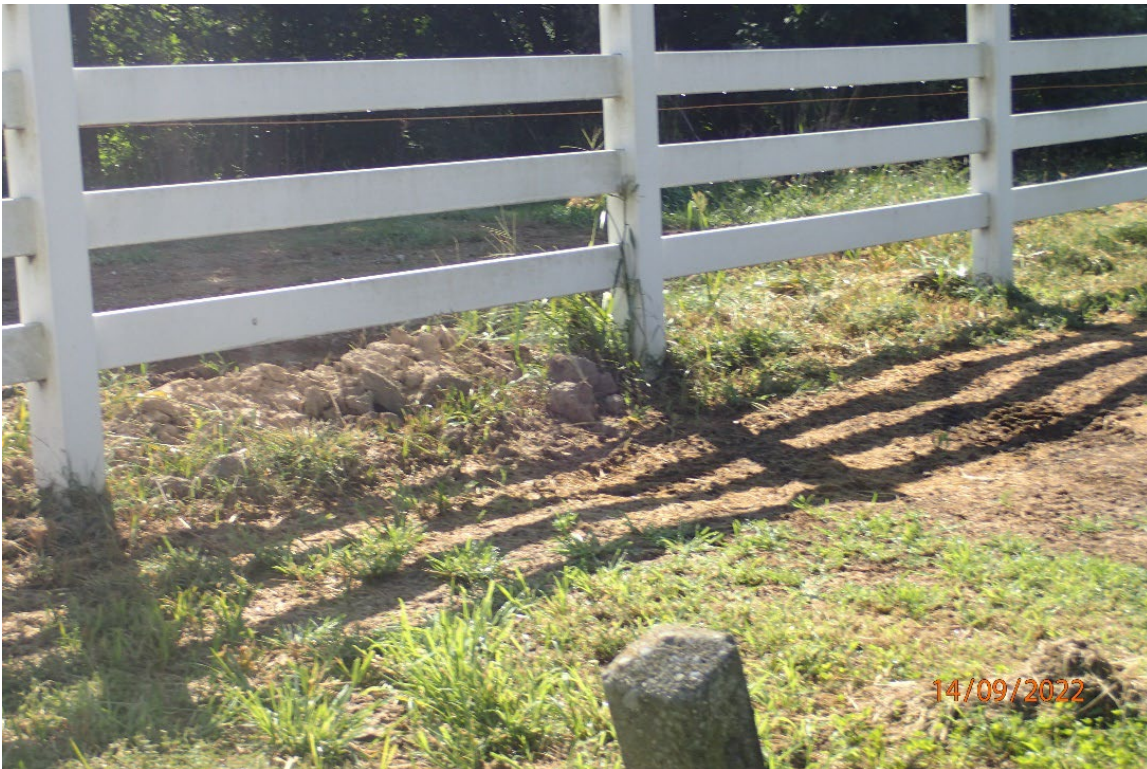
70: P9140161

The Inspectors continued walking south along the west fence and observed burnt vegetation and manure solids in a path from the area west of the Pit 4 ramp down to the roadside ditch (photos 70 – 77).

3. A path of burnt vegetation and organic material was observed from the area west of the Pit 4 ramp to the roadside ditch.
4. A path of burnt vegetation and organic material was observed from the area south of the Pit 4 ramp toward the Bull Branch.

Description: Burnt vegetation and organic solids on ground in path on west side of fence west of Pit 4 ramp.

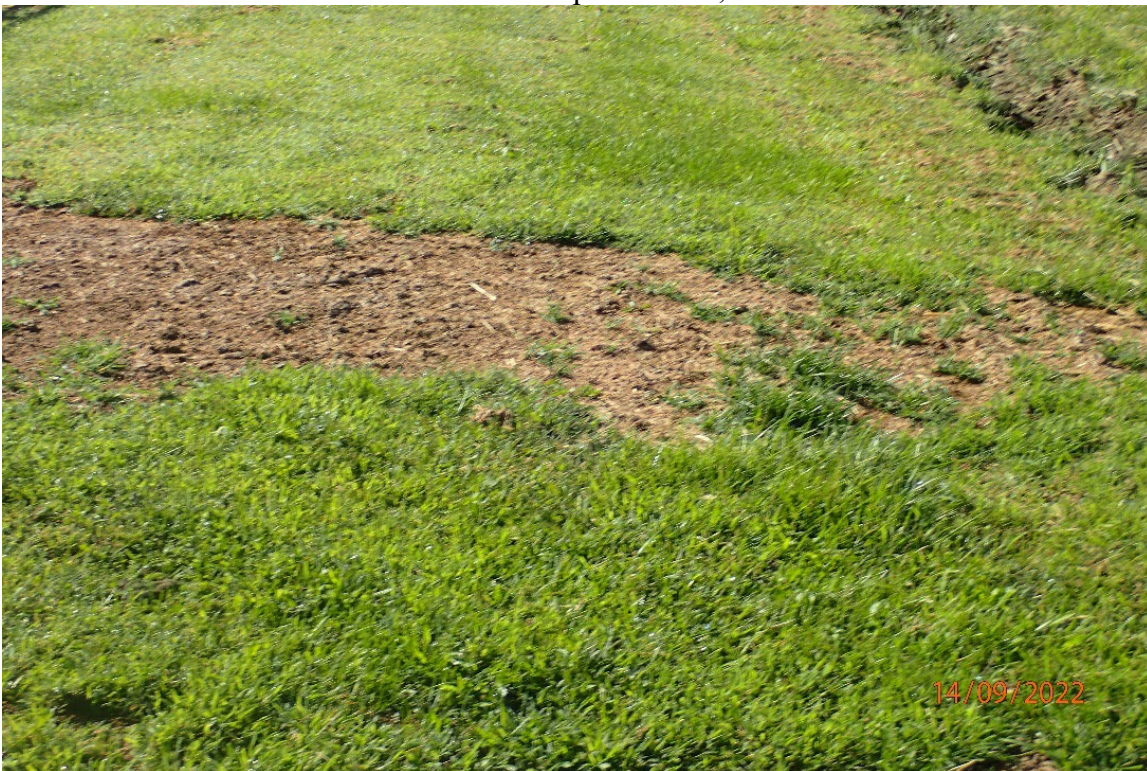
71: P9140162

Description: Burnt vegetation and organic solids on ground in path on west side of fence west of Pit 4 ramp.

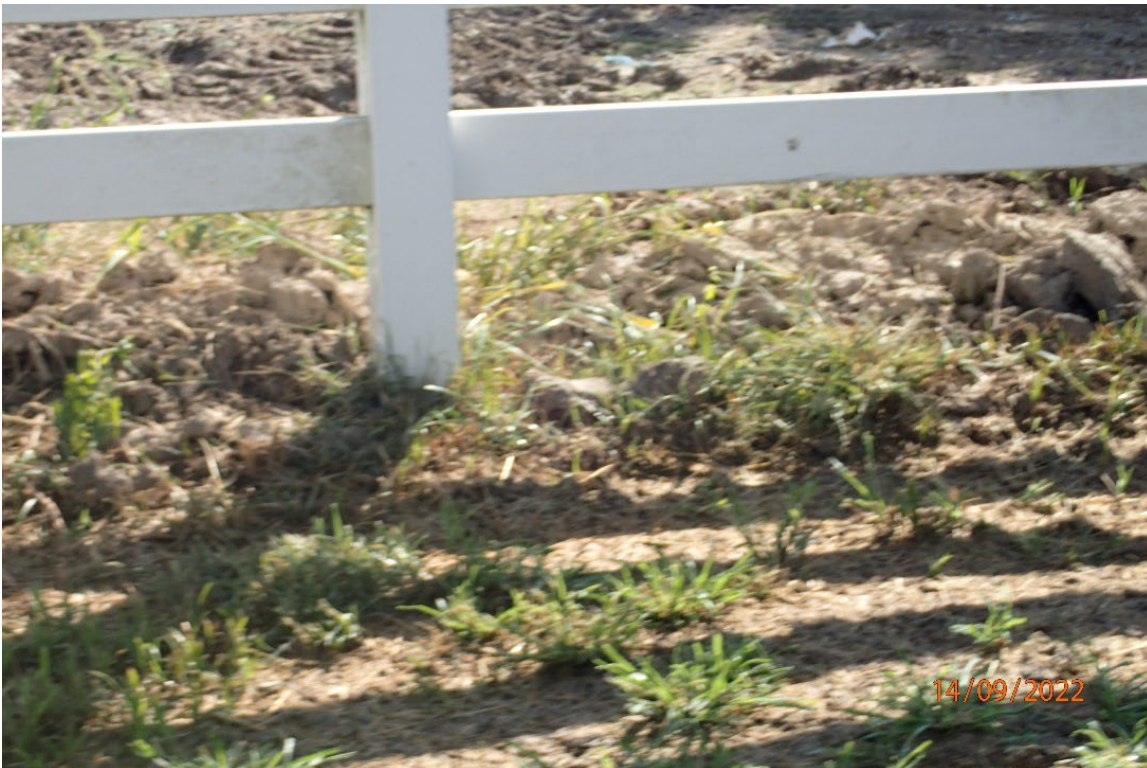
73: P9140164

Description: Burnt vegetation and organic solids on ground in path on west side of fence west of Pit 4 ramp.

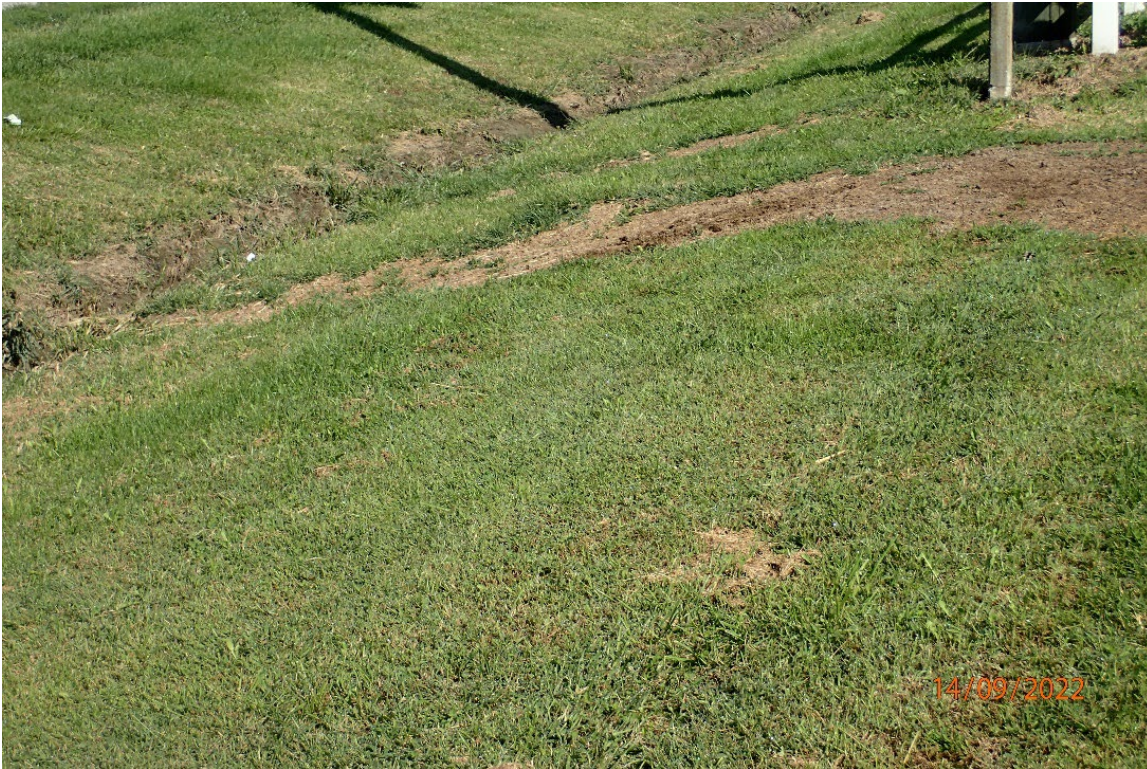
76: P9140167

Description: Organic solids and pathway seen in photos 70 – 73.

Location: Location: West side of the facility approximately 220 feet south of the south entrance.

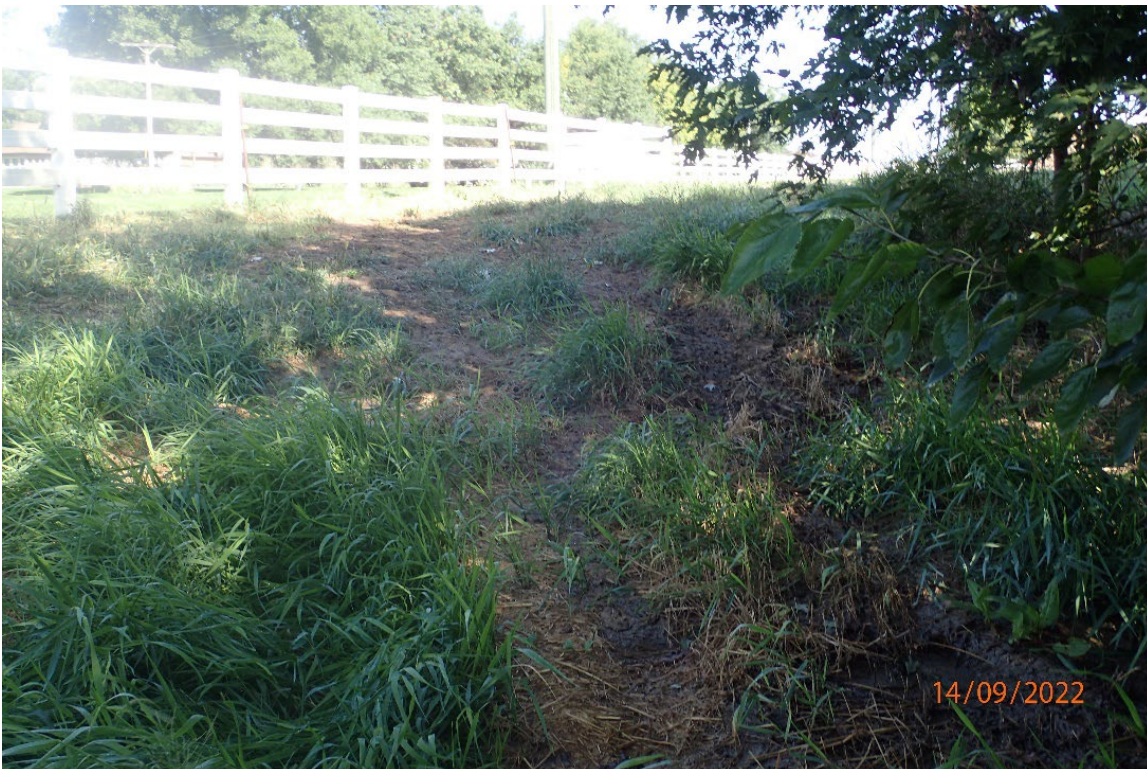
79: P9140170

The Inspectors then walked east toward Bull Branch. The Inspectors observed manure solids and burnt vegetation in a path from the area south of the Pit 4 ramp towards Bull Branch (photos 79-84).

Description: Organic solids and burnt vegetation along a path down to Bull Branch.

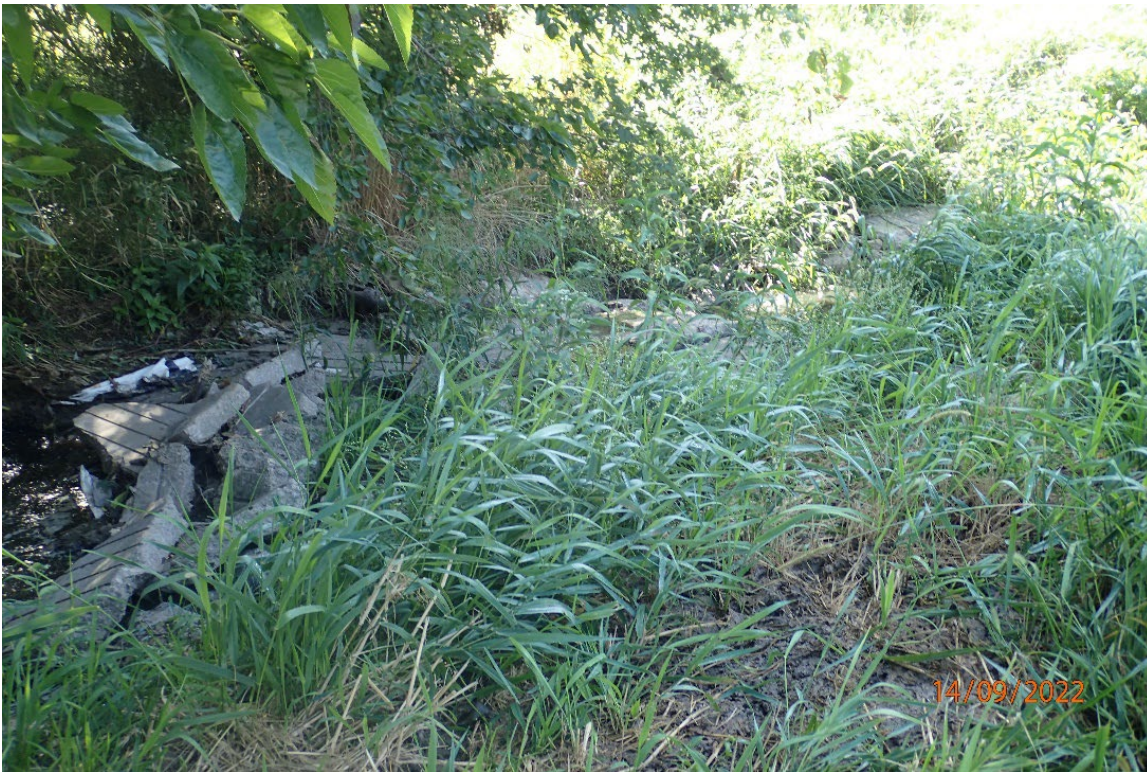
80: P9140171

Description: Potential flow path from photo 79 continuing southeast toward Bull Branch.

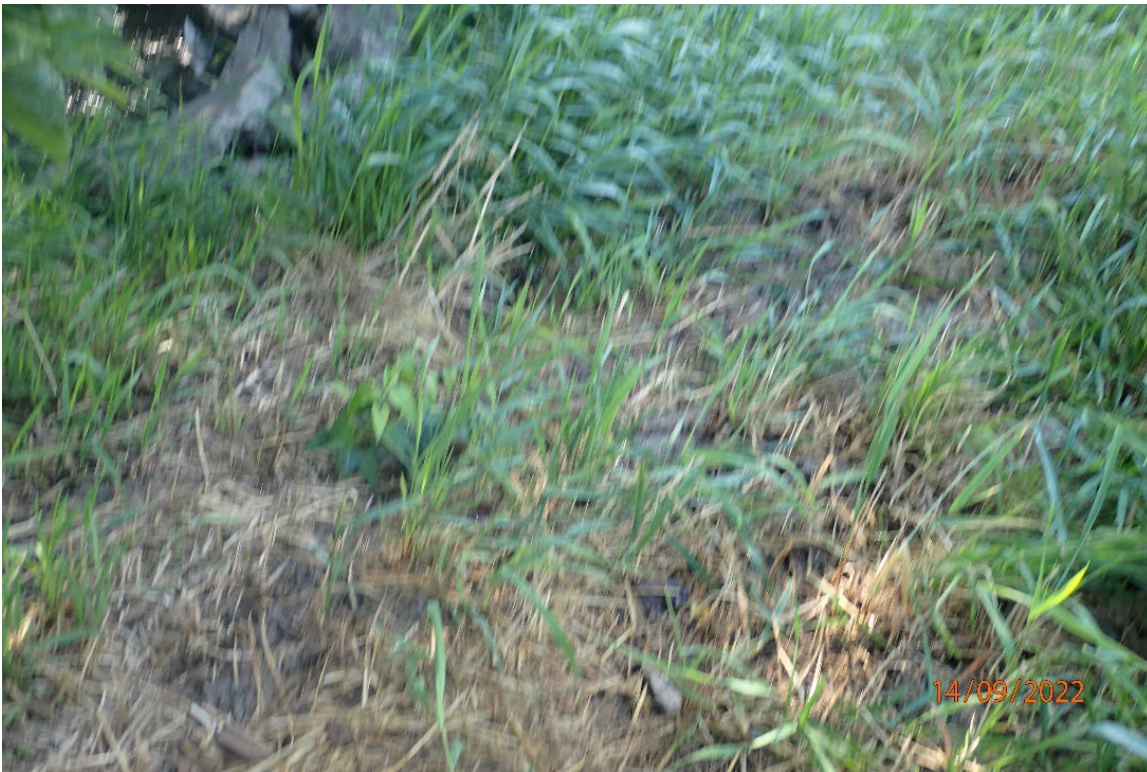
82: P9140173

Description: Potential flow path from photo 79 continuing southeast toward Bull Branch.

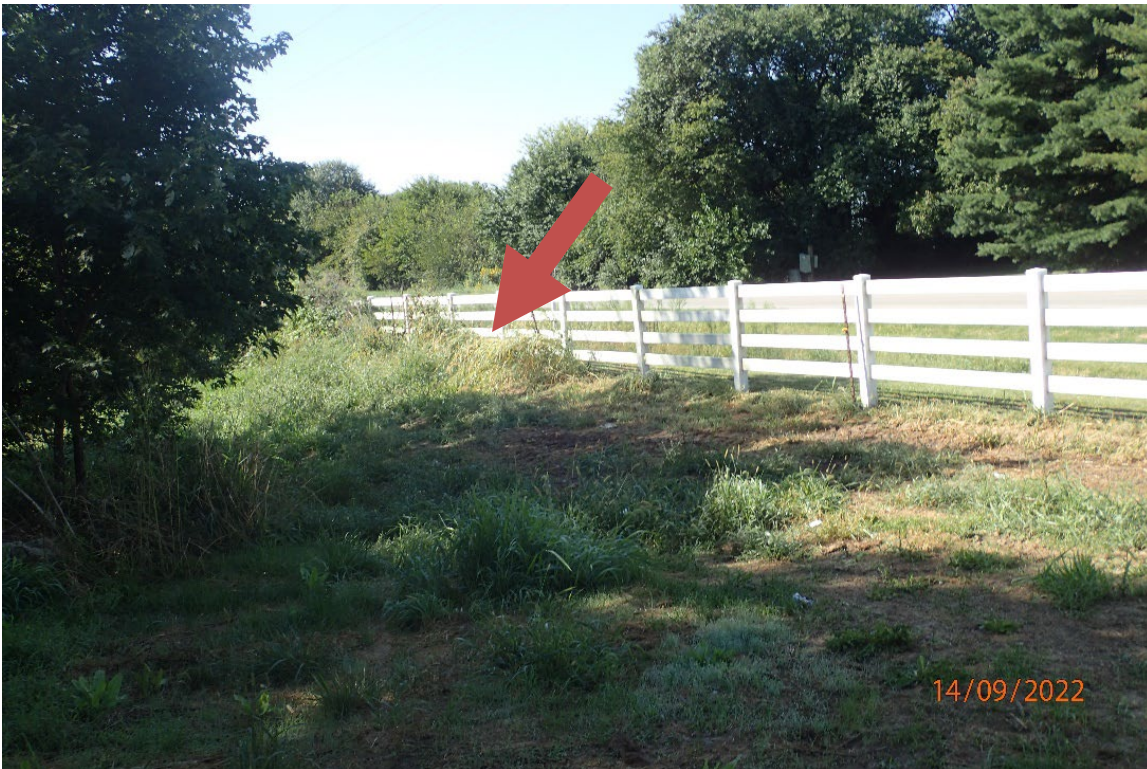
84: P9140175

Description: Looking south toward the upslope portion of the path seen in photos 79-81. Note the organic solids on the ground (red arrow).

Location: South of Pit 4.

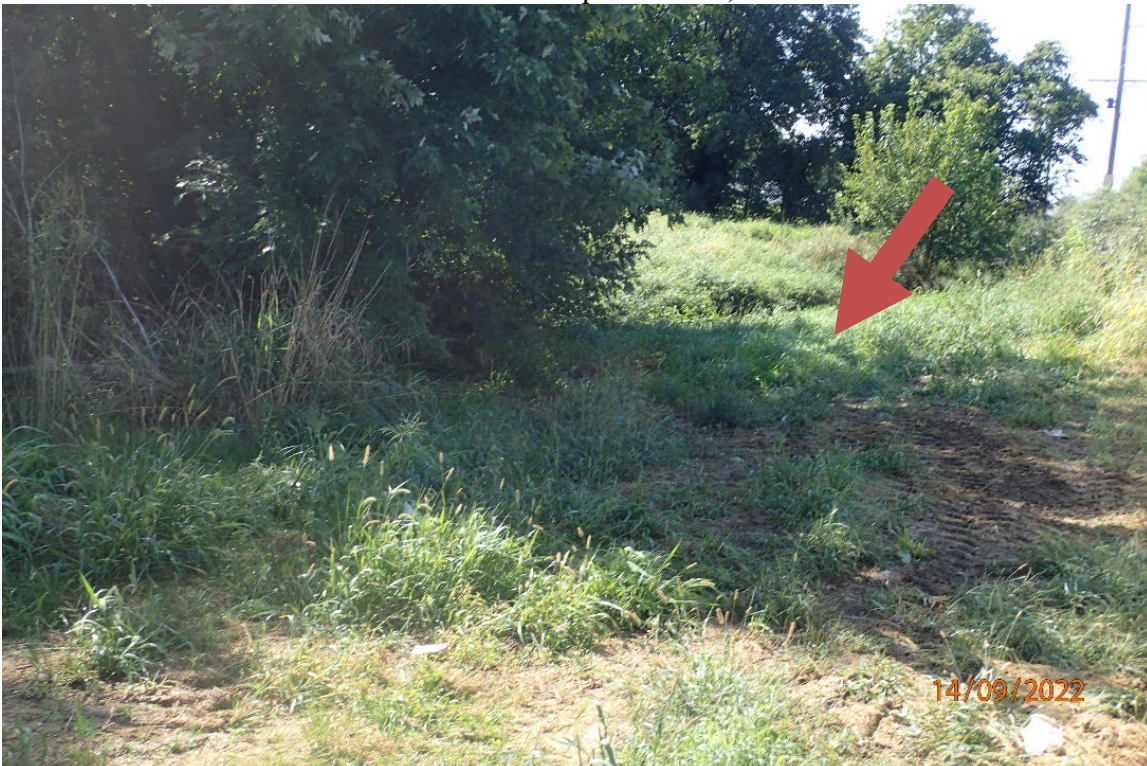
85: P9140176

Description: Looking south toward the upslope portion of the path seen in photos 79-81. Note the organic solids on the ground (red arrow).

Location: South of Pit 4.

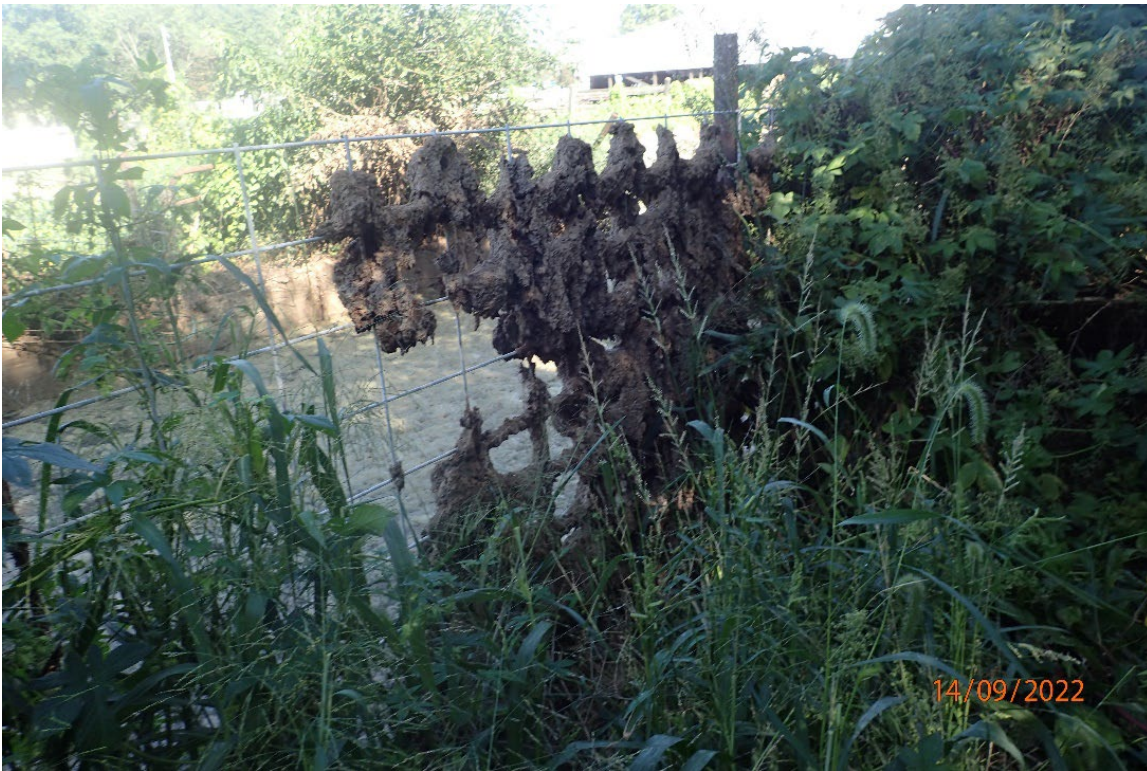
88: P9140179

The Inspectors walked north along the east side of Pit 4 and observed manure solids deposited on the fence along Pit 4 (Photos 88 and 89). The Inspectors also observed Bull Branch was covered in foam (photos 92-97). The Inspectors continued north and observed manure deposited on top and exterior side of the east concrete wall of Pit 4 (photos 99-102).

Description: Organic solids deposited on the fence on the east side of the ramp to Pit 4.

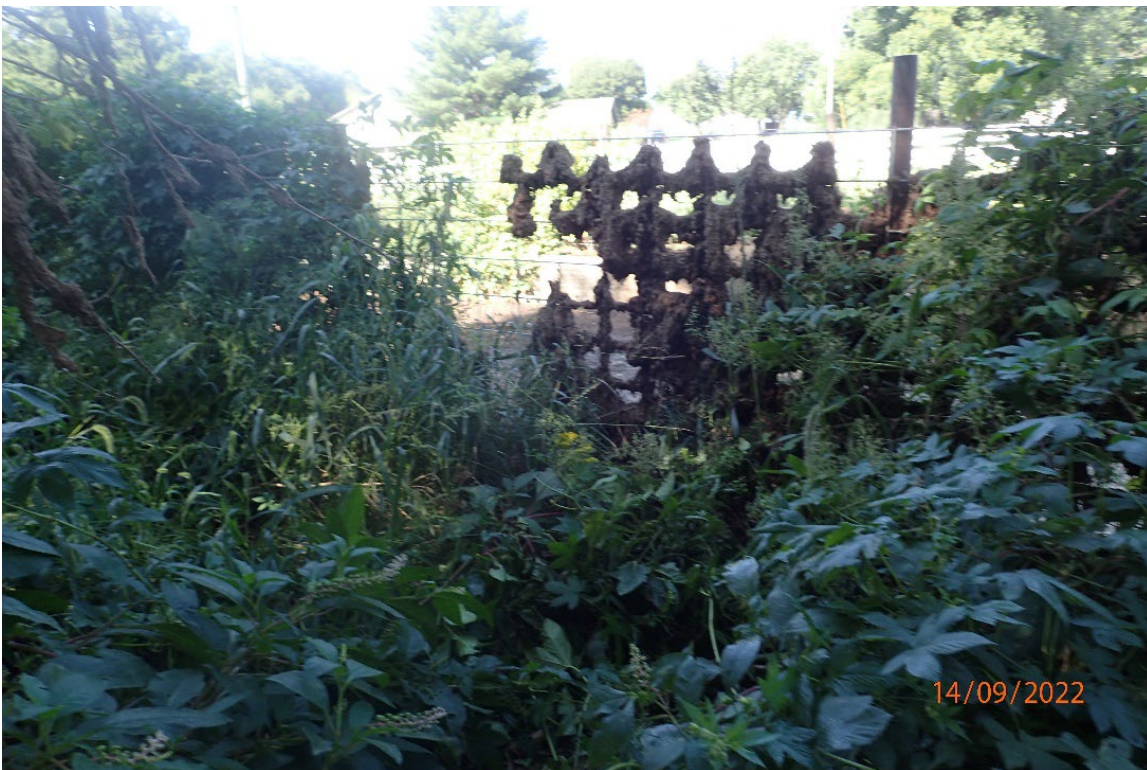
89: P9140180

Description: Organic solids deposited on the fence on the east side of the ramp to Pit 4.

Location: East side of the ramp to Pit 4.

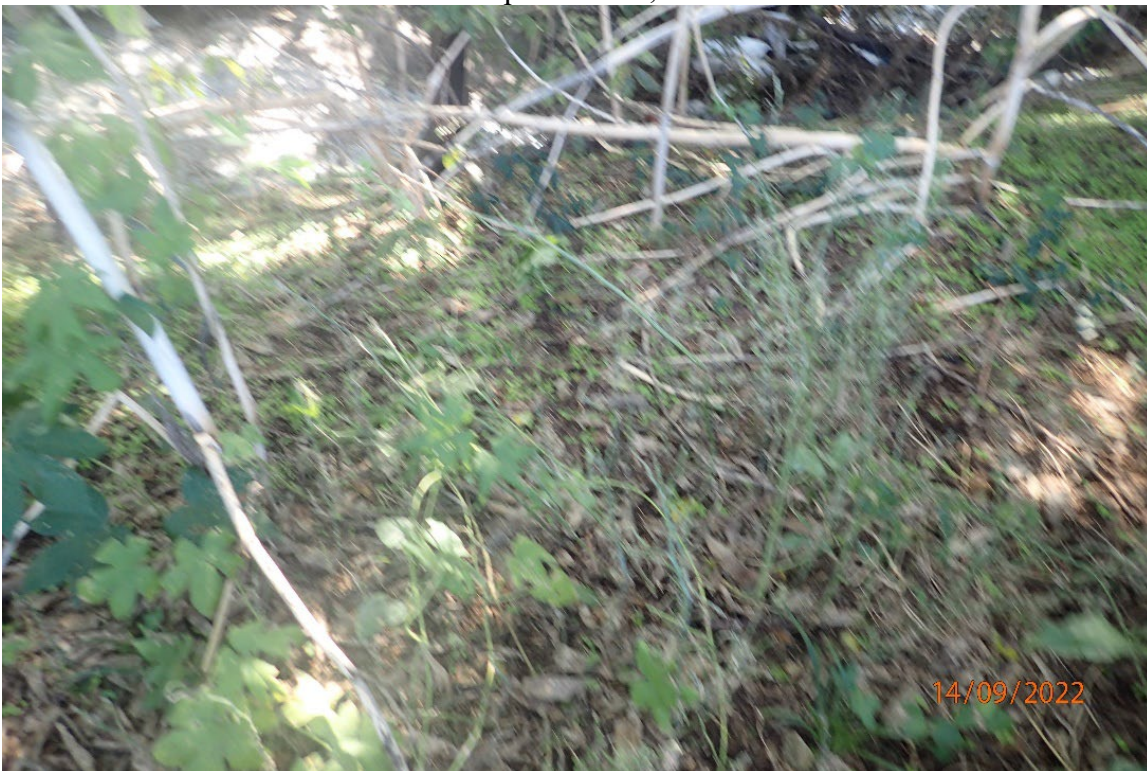
91: P9140182

Description: Potential flow path down the bank Bull Branch from the area on the east side of the ramp to Pit 4.

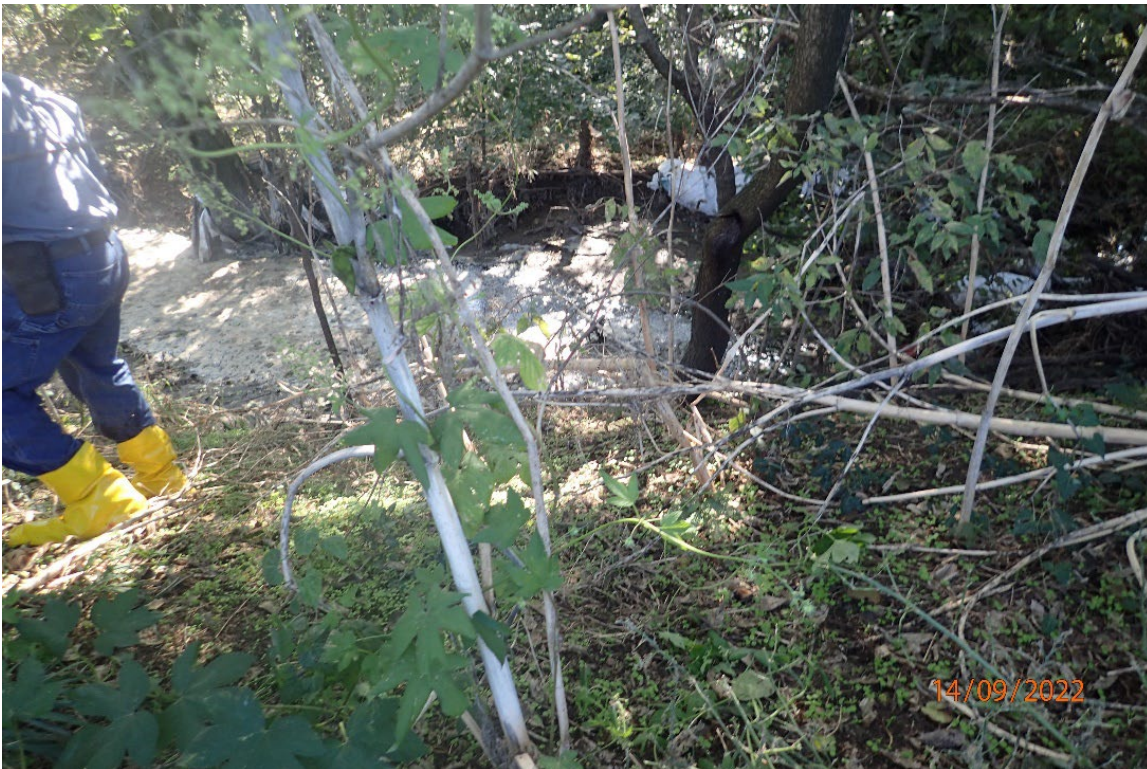
92: P9140183

Description: Potential flow path down the bank Bull Branch from the area on the east side of the ramp to Pit 4. Note the foam on the surface of the water.

Location: East of the ramp to Pit 4 west of Bull Branch.

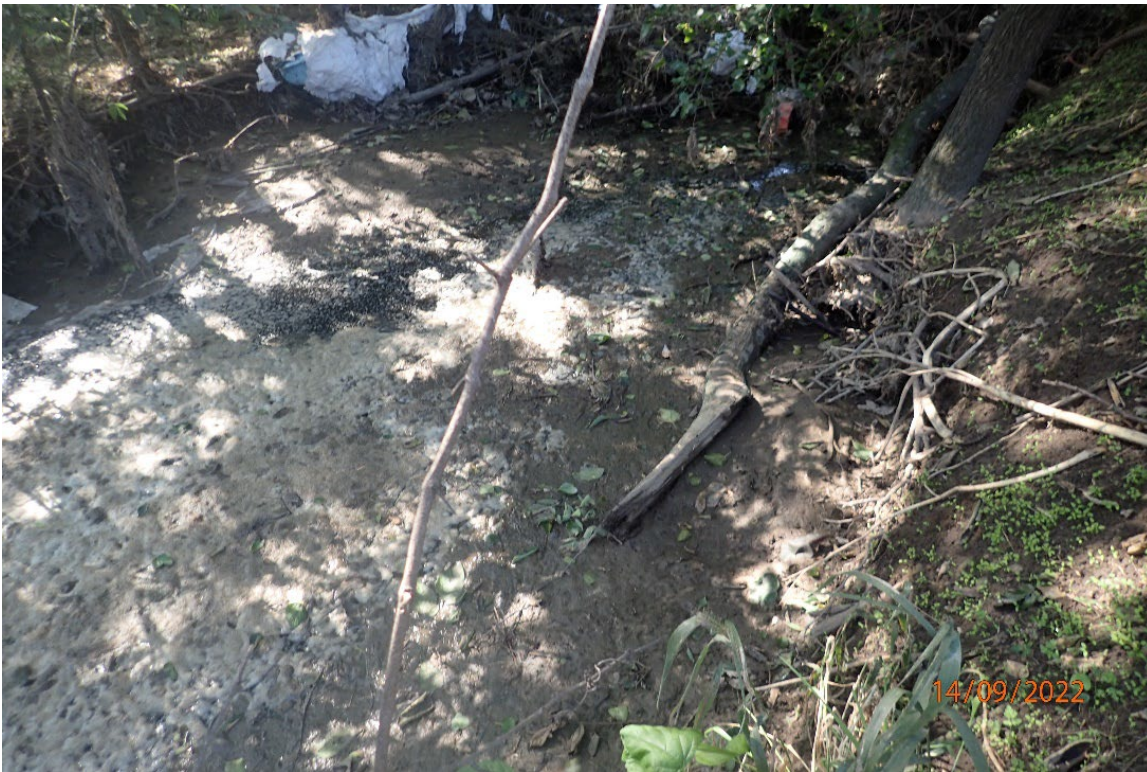
94: P9140185

Description: Downstream on Bull Branch. Note the foam on the surface of the water.
