**CWA COMPLIANCE EVALUATION INSPECTION REPORT
U.S. ENVIRONMENTAL PROTECTION AGENCY, REGION 5**

Compliance Evaluation Sampling Inspection

Richter Dairy Farm
14113 St. Rose Road
Breese, Illinois 62230
Clinton County, Illinois
38.62797657159176, -89.55355561706052

Date of Inspection: Site Inspection - September 14th, 2022
Operator Interview – September 27th, 2022

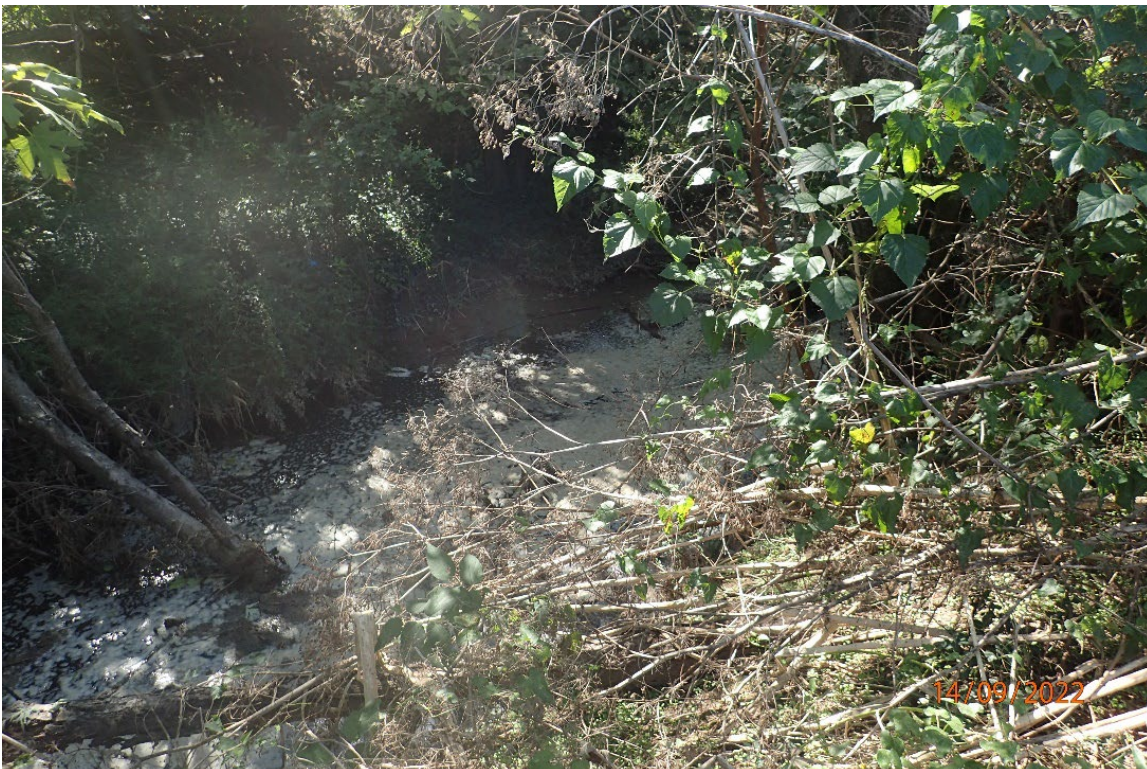
97: P9140188

Description: Looking east into Bull Branch. Note the foam on the surface on the water.

Location: West bank of Bull Branch, East of Pit 4.

The Inspectors walked north along the east side of Pit 4 and observed manure solids deposited on the fence along Pit 4 (Photos 88 and 89). The Inspectors also observed Bull Branch was covered in foam (photos 92-97). The Inspectors continued north and observed manure deposited on top and exterior side of the east concrete wall of Pit 4 (photos 99-102).

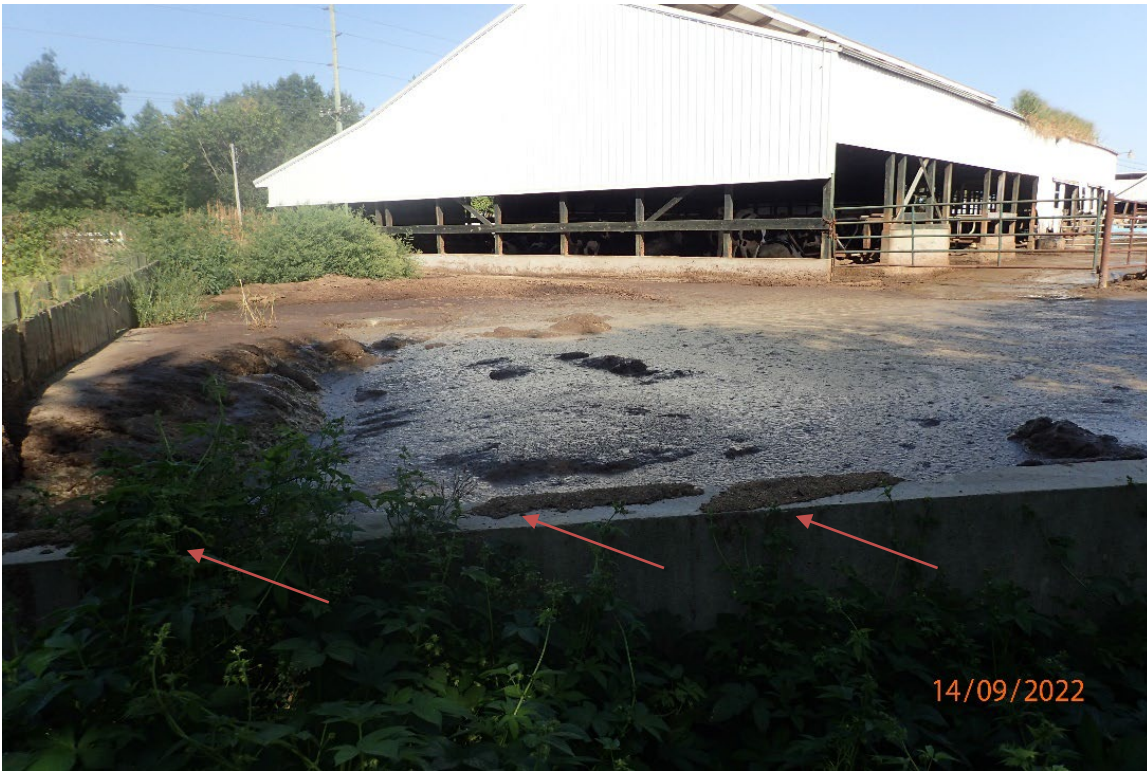
100: P9140191

Description: Looking northwest across the solids settling area north of Pit 4. Note the manure solids on the top of the concrete wall (red arrows).

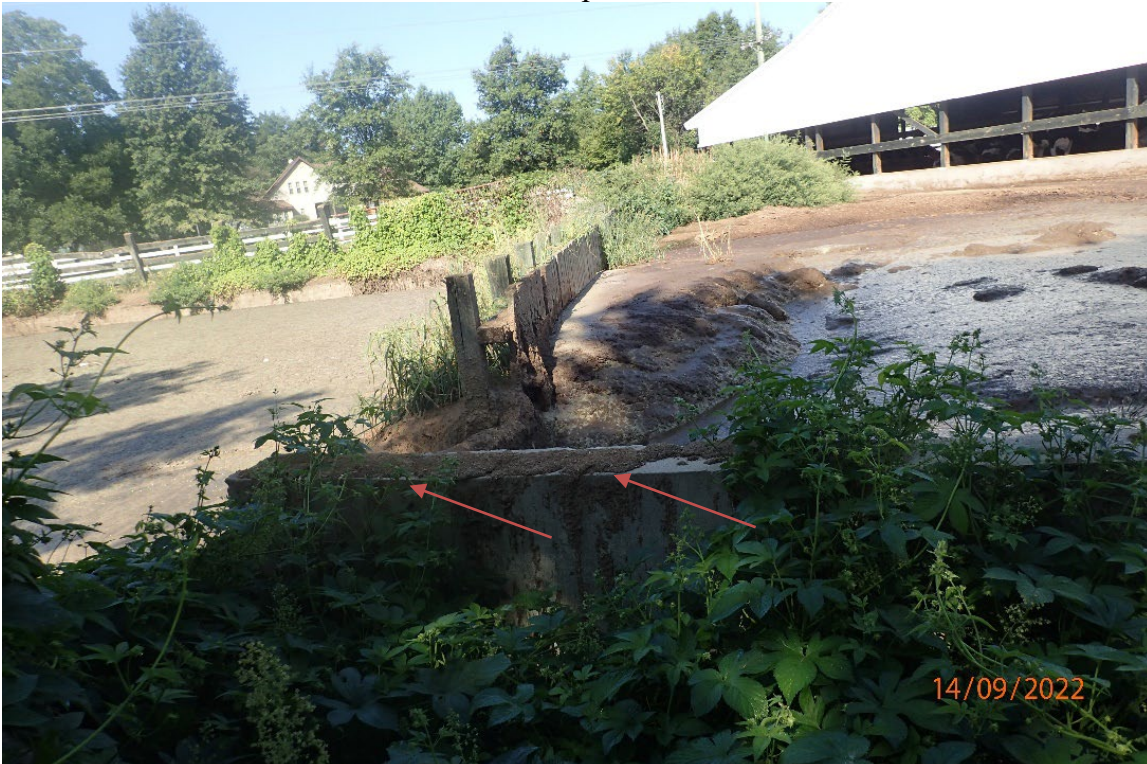
101: P9140192

Description: Looking northwest across the solids settling area north of Pit 4. Note the manure solids on the top of the concrete wall (red arrows).

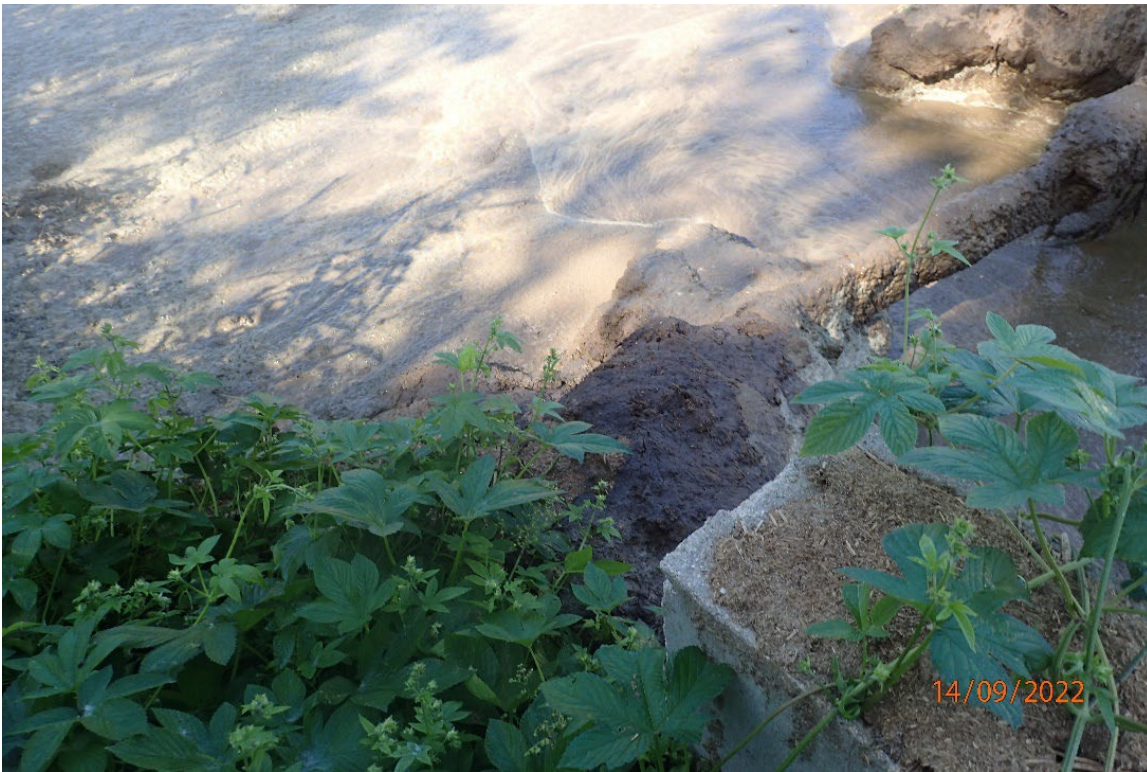
102: P9140193

Description: Manure flowing from the solids settling area into Pit 4.

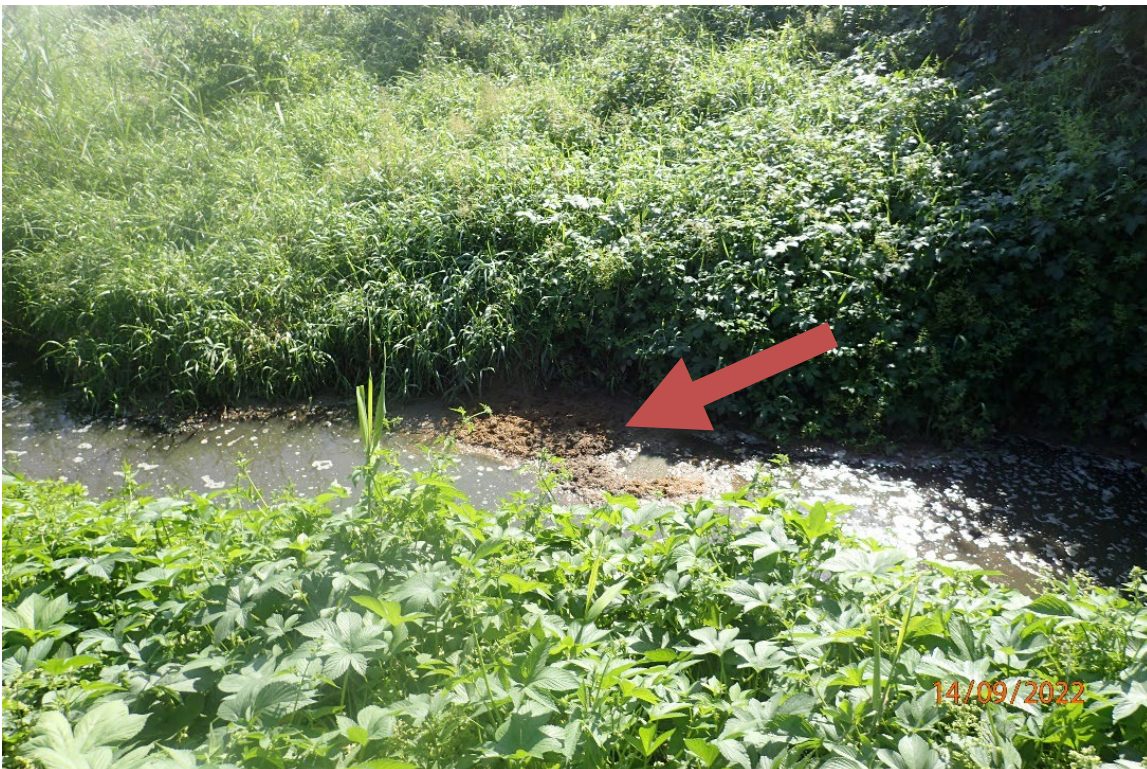
109: P9140200

Description: Looking east into Bull Branch. Note organic solids deposited in the channel (red arrow).

The Inspectors continued north and observed manure solids in the channel of Bull Branch (photos 109 and 110). The Inspectors also observed manure on the top of and along the exterior edge of the concrete wall on the east side of the outdoor lot south of the East Milk Cow Barn (photos 111 – 113).

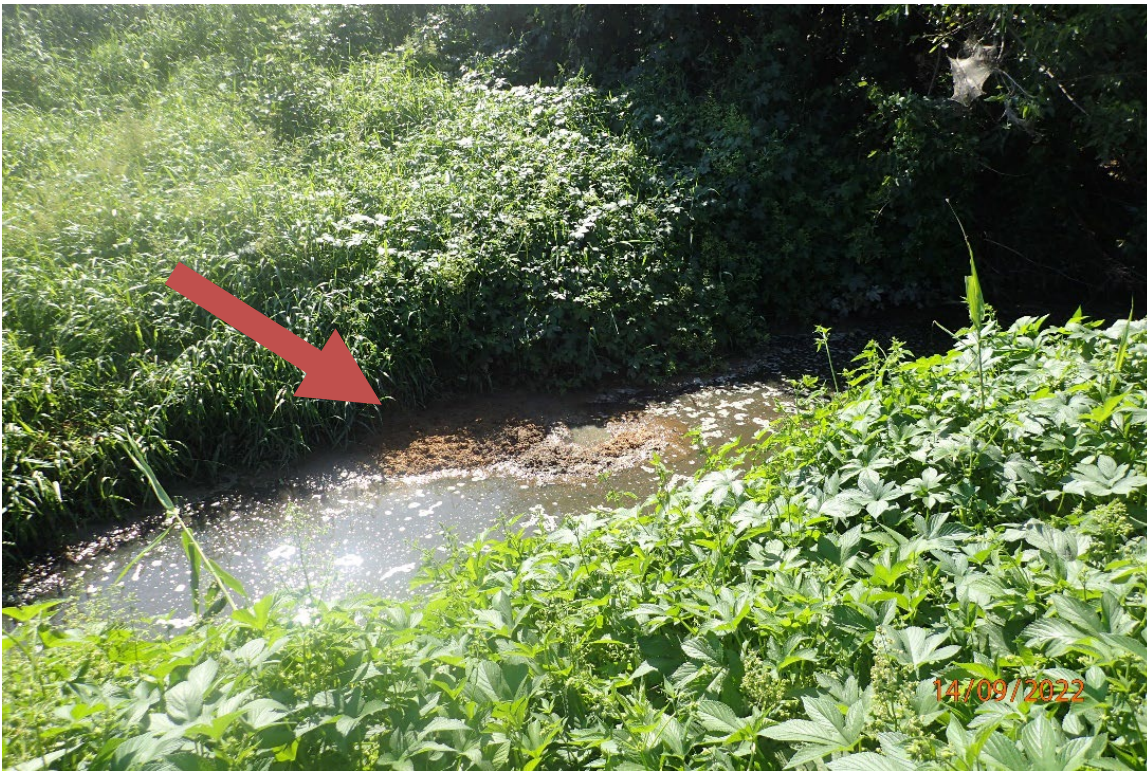
110: P9140201

1. Manure was observed flowing out of a hole in the concrete wall along the east side of Pit 4 in a channel approximately 50 feet into Bull Branch.
2. Manure solids were observed in the channel of Bull Branch.

Description: Looking southeast into Bull Branch. Note organic solids deposited in the channel (red arrow).

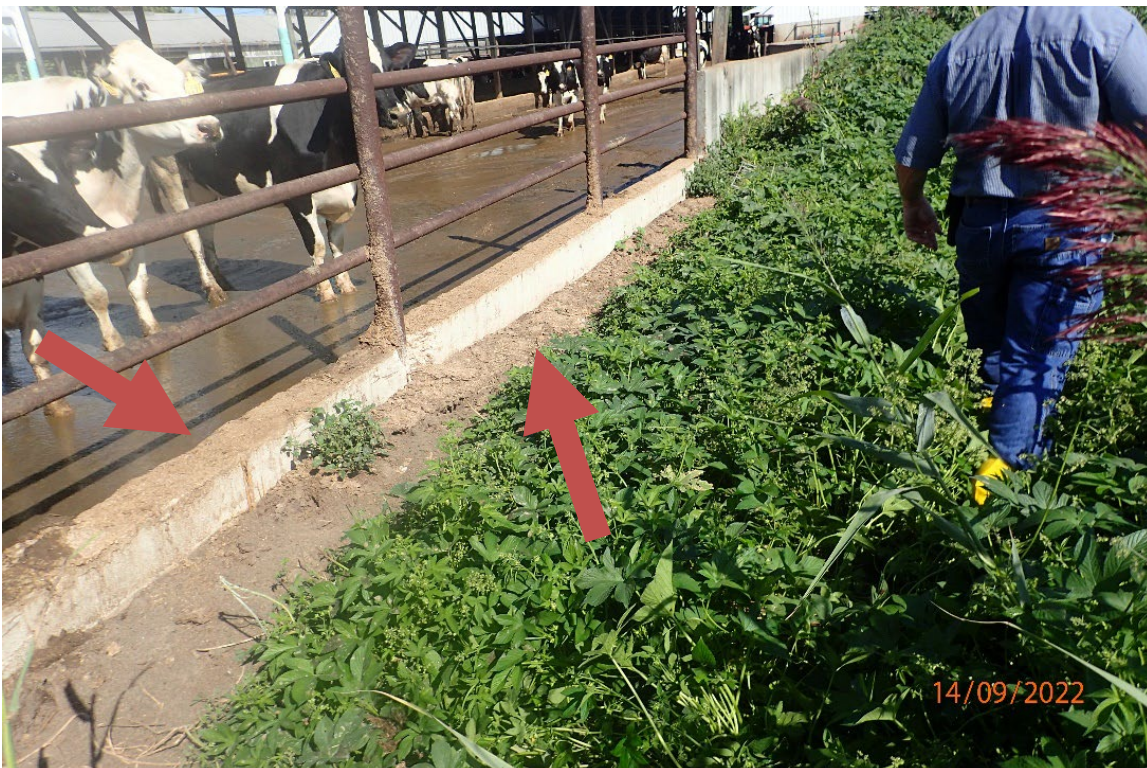
111: P9140202

Description: Looking north along the east side of the outdoor concrete lot east of the East Milk Cow Barn. Note the manure solids on the top of and on the east side of the concrete wall (red arrows).

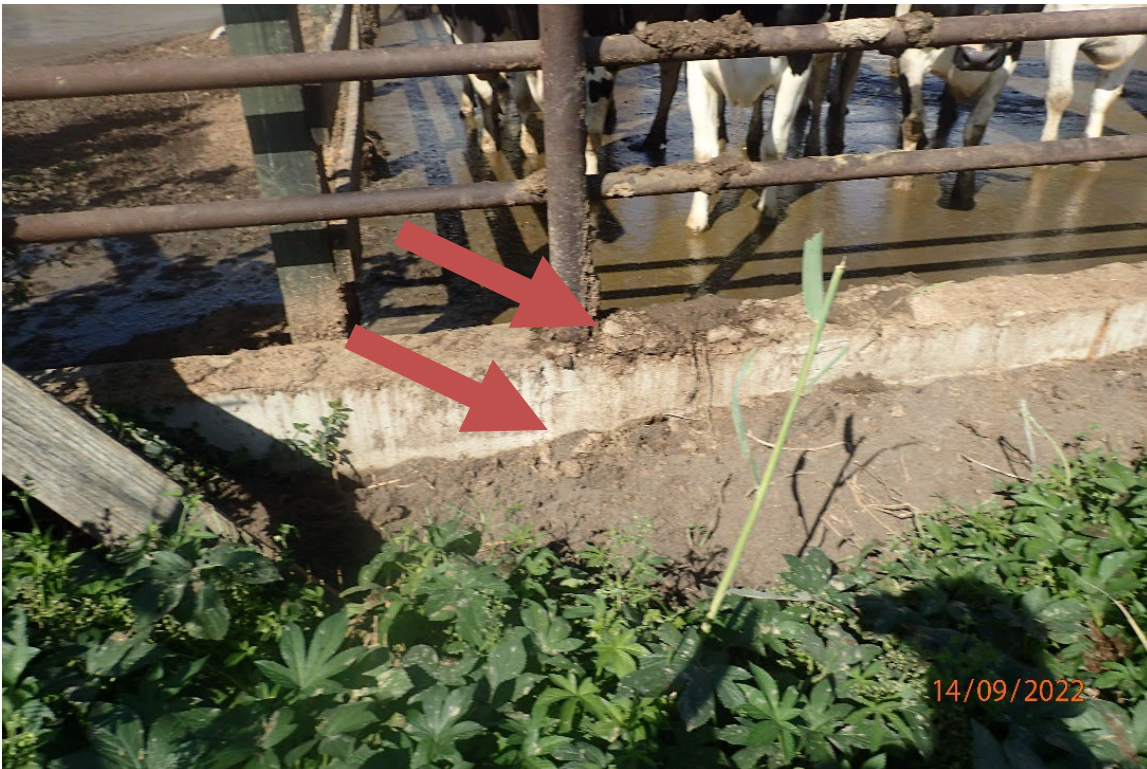
112: P9140203

Description: Looking west at the east side of the outdoor concrete lot east of the East Milk Cow Barn. Note the manure solids on the top of and on the east side of the concrete wall (red arrows).

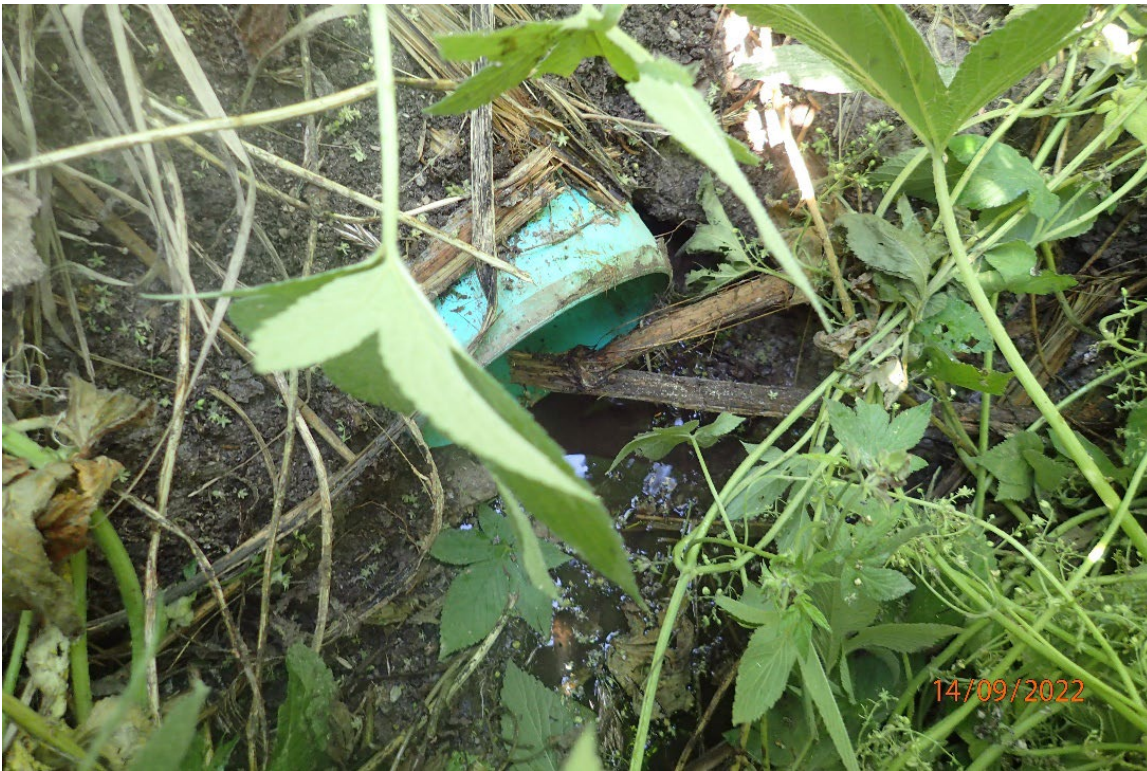
114: P9140205

Description: A blue pipe protruding from the west bank of Bull Branch. There was a small flow of clear water coming from the pipe.

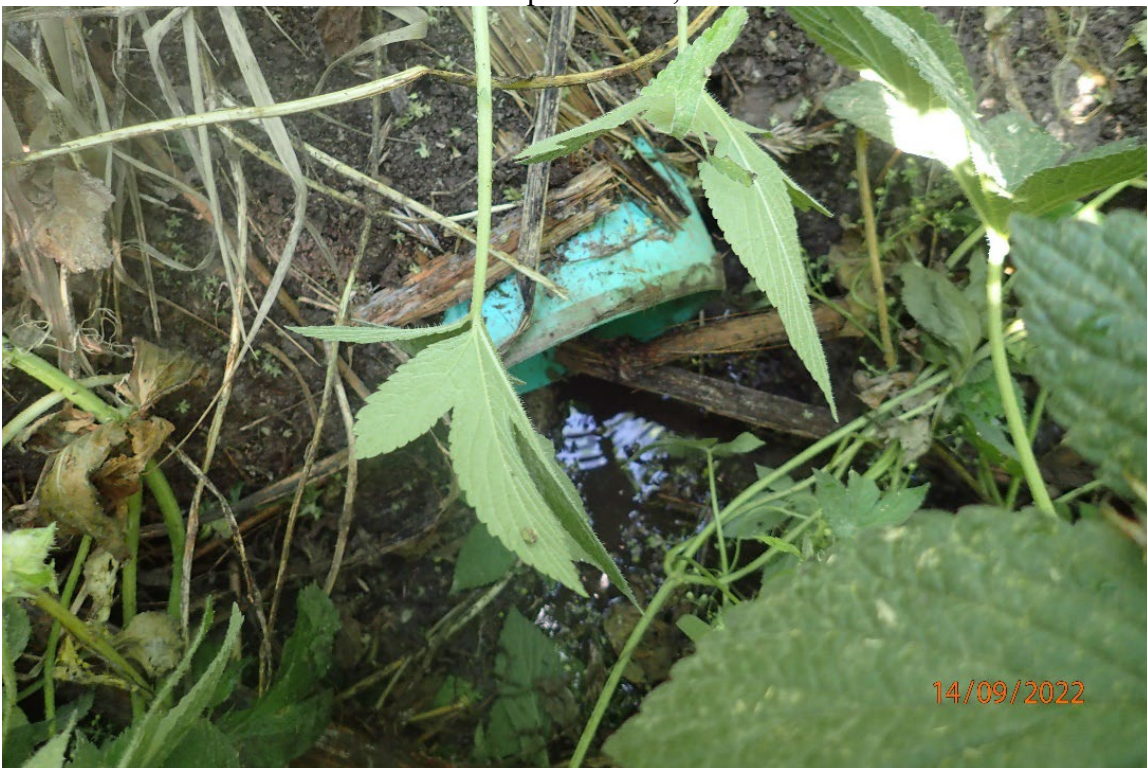
115: P9140206

Description: A blue pipe protruding from the west bank of Bull Branch. There was a small flow of clear water coming from the pipe.

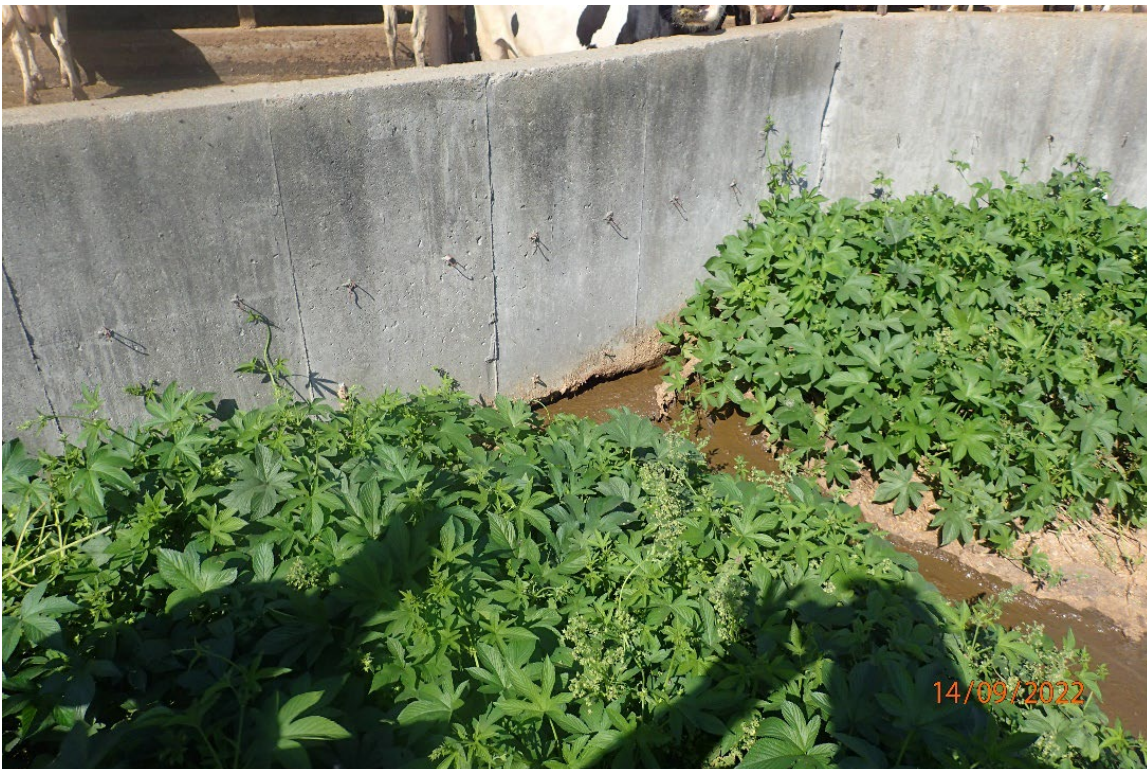
117: P9140208

The Inspectors continued walking north and observed a hole in the concrete wall east of the East Milk Cow Barn which was allowing manure to flow down through a channel into Bull Branch (photos 117 – 131). The Inspectors observed liquid manure flowing in the channel and into Bull Branch.

Description: Cracked concrete wall allowing manure to flow into channelized path to Bull Branch.

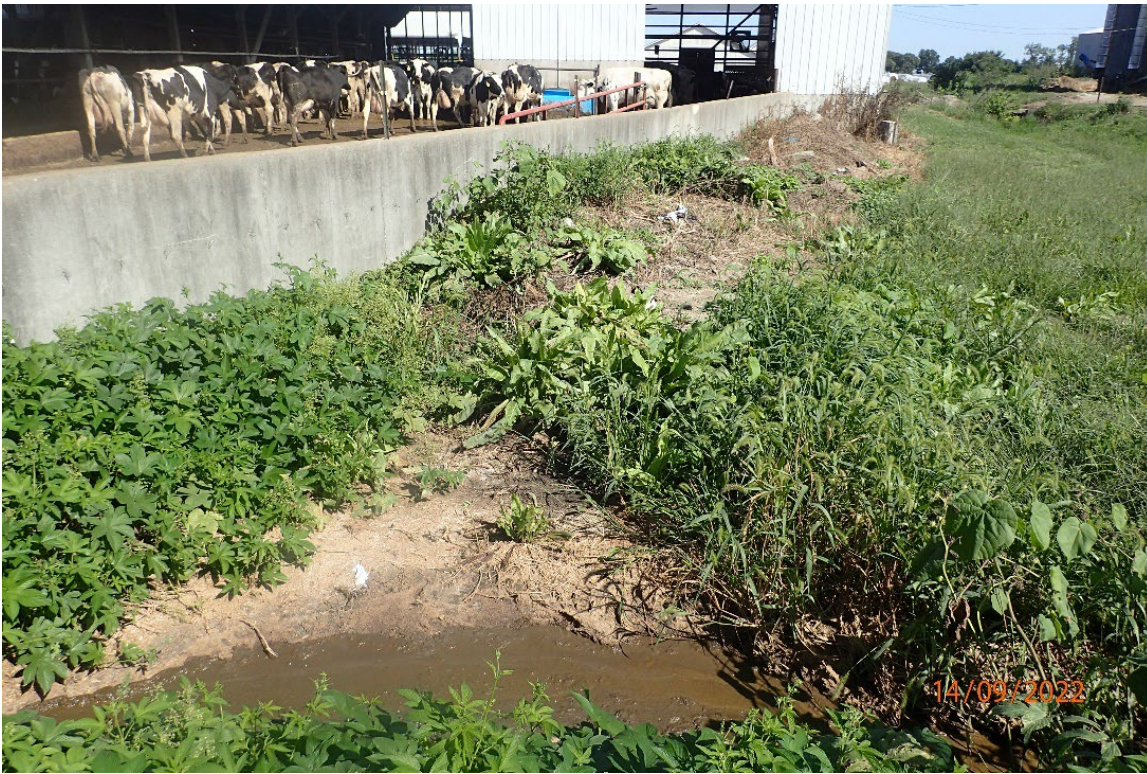
118: P9140209

Description: Channelized flow path conveying liquid manure to Bull Branch.

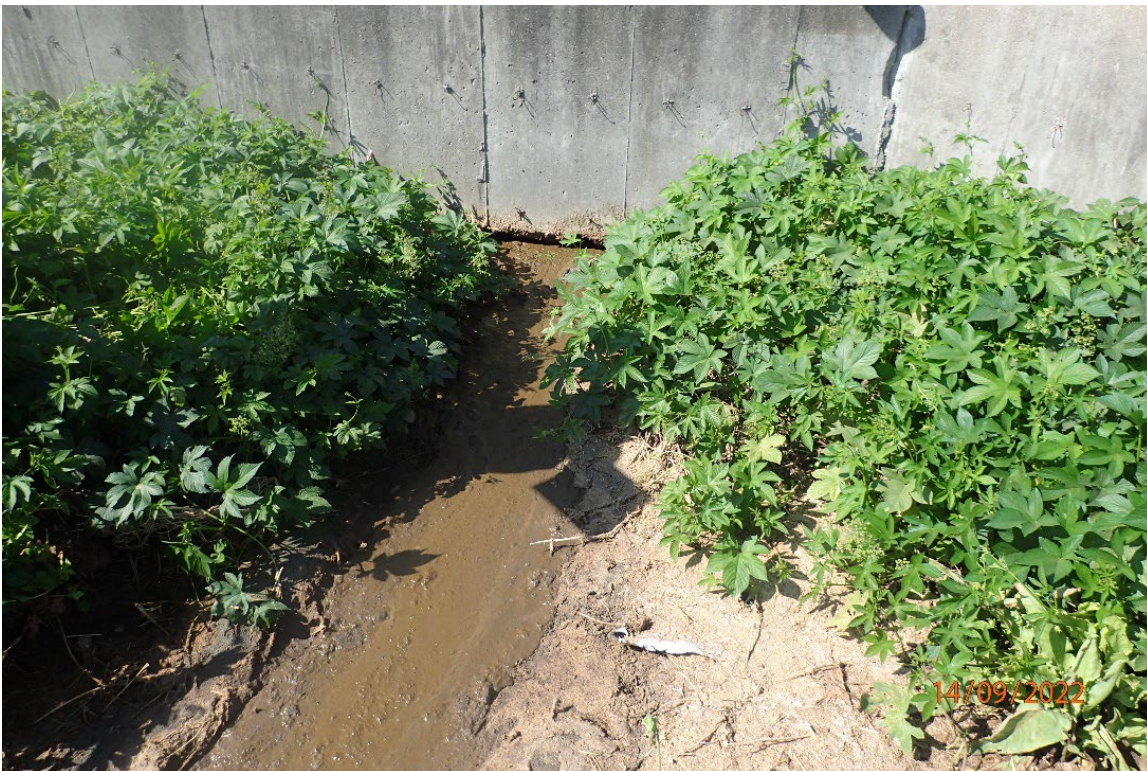
119: P9140210

Description: Cracked concrete wall allowing manure to flow into channelized path to Bull Branch.

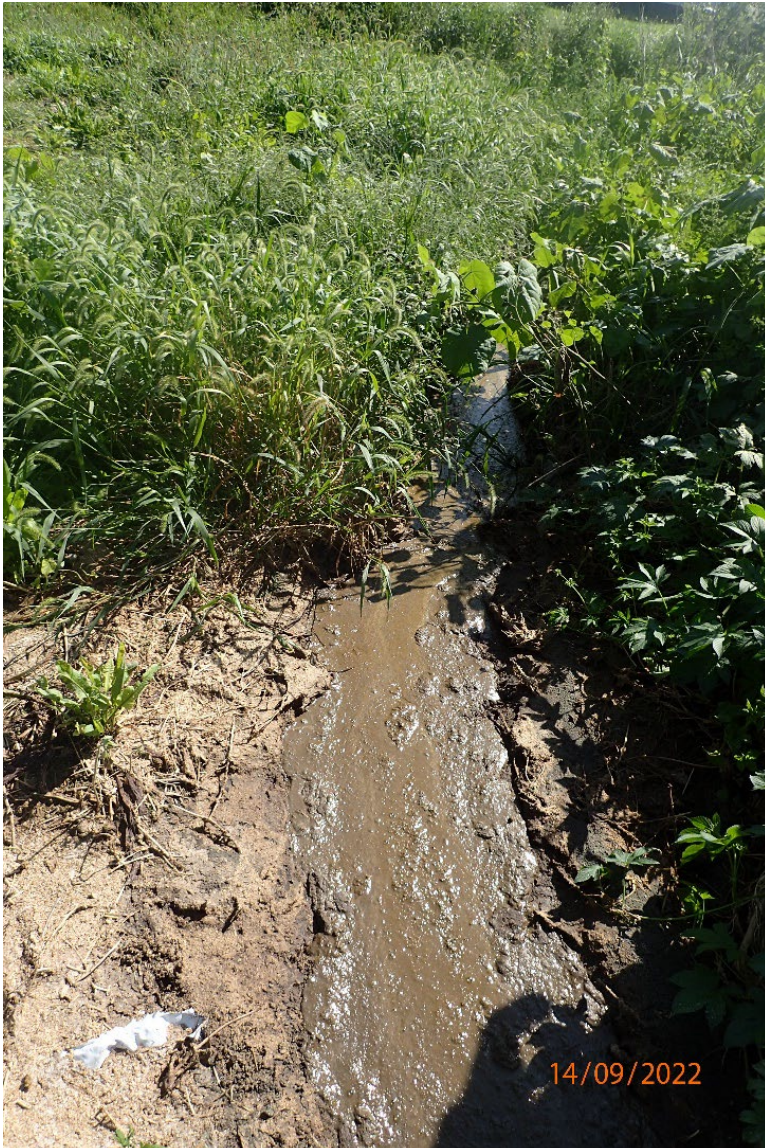
120: P9140211

Description: Channelized flow path conveying liquid manure to Bull Branch.

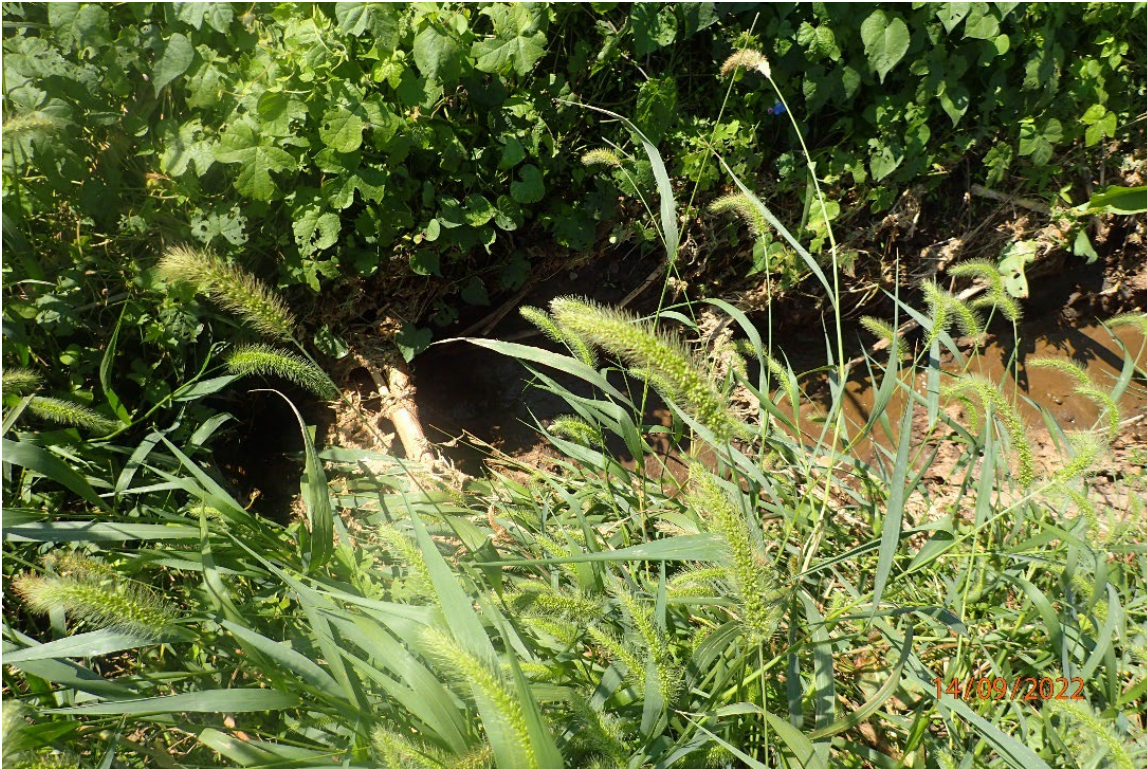
121: P9140212

Description: Manure flowing in the channelized flow path to Bull Branch.

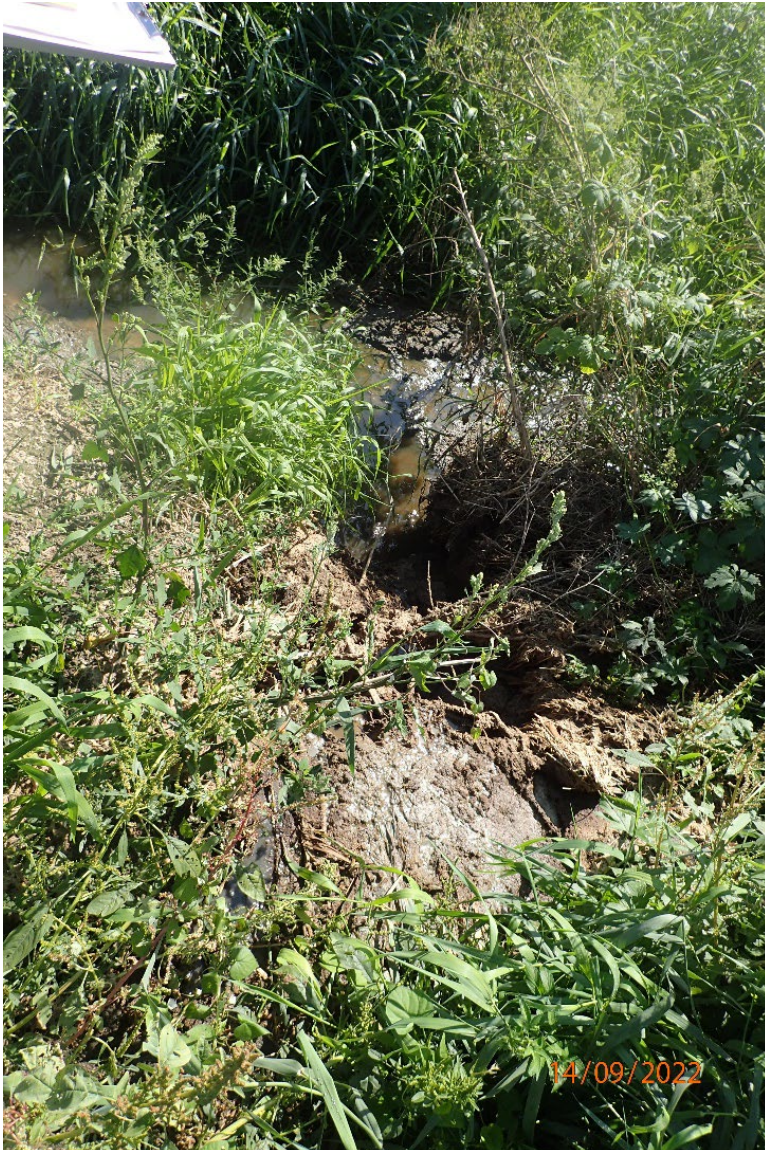
122: P9140213

Description: Confluence of the channelized flow path conveying manure to Bull Branch.

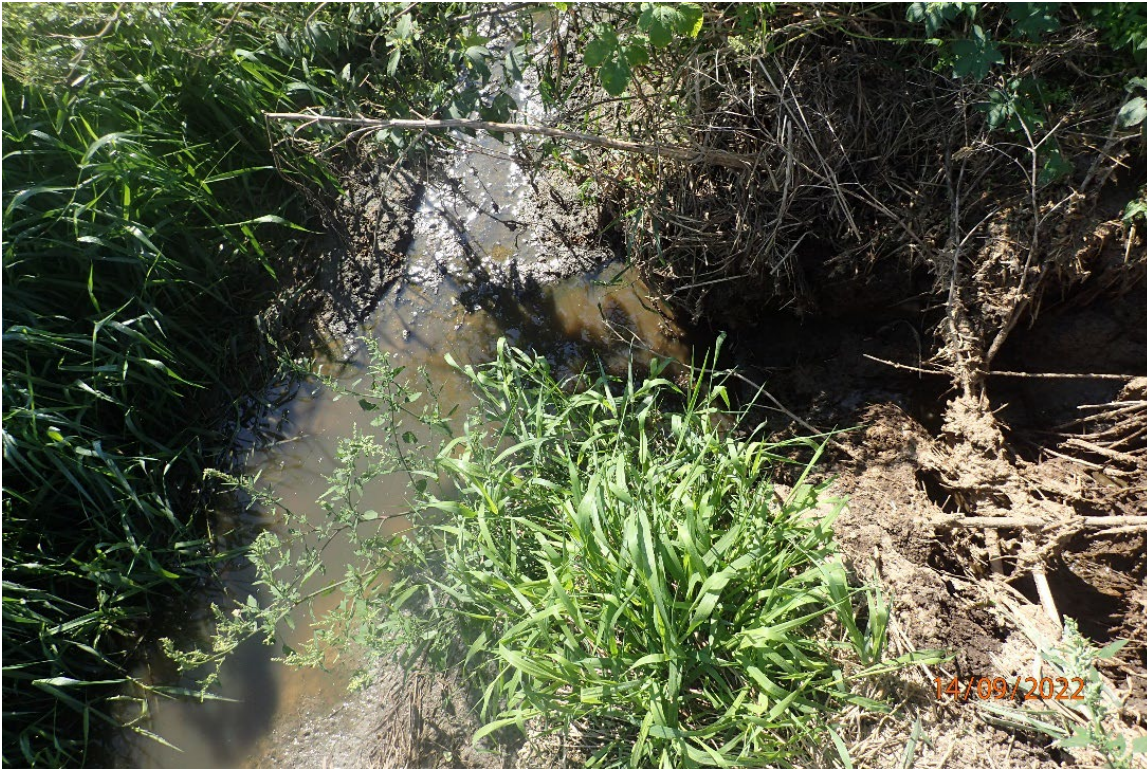
123: P9140214

Description: Confluence of the channelized flow path conveying manure to Bull Branch.

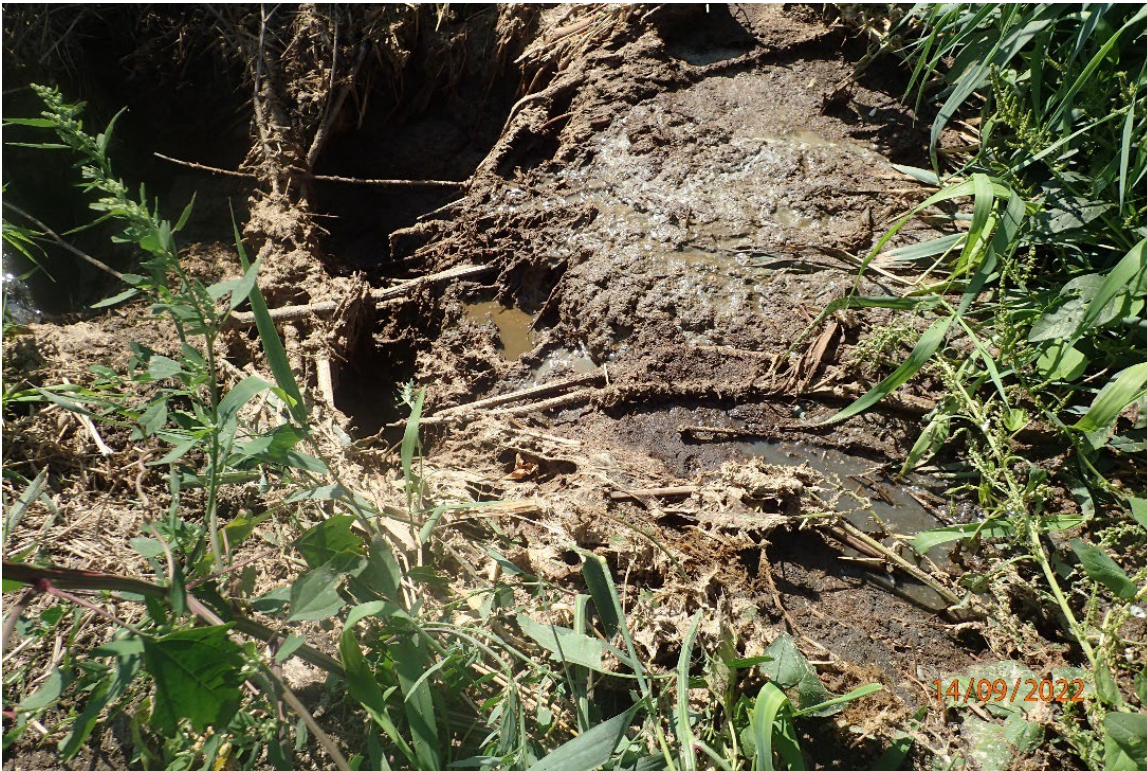
127: P9140218

Description: Closeup of manure flowing into Bull Branch from the channelized flow path.

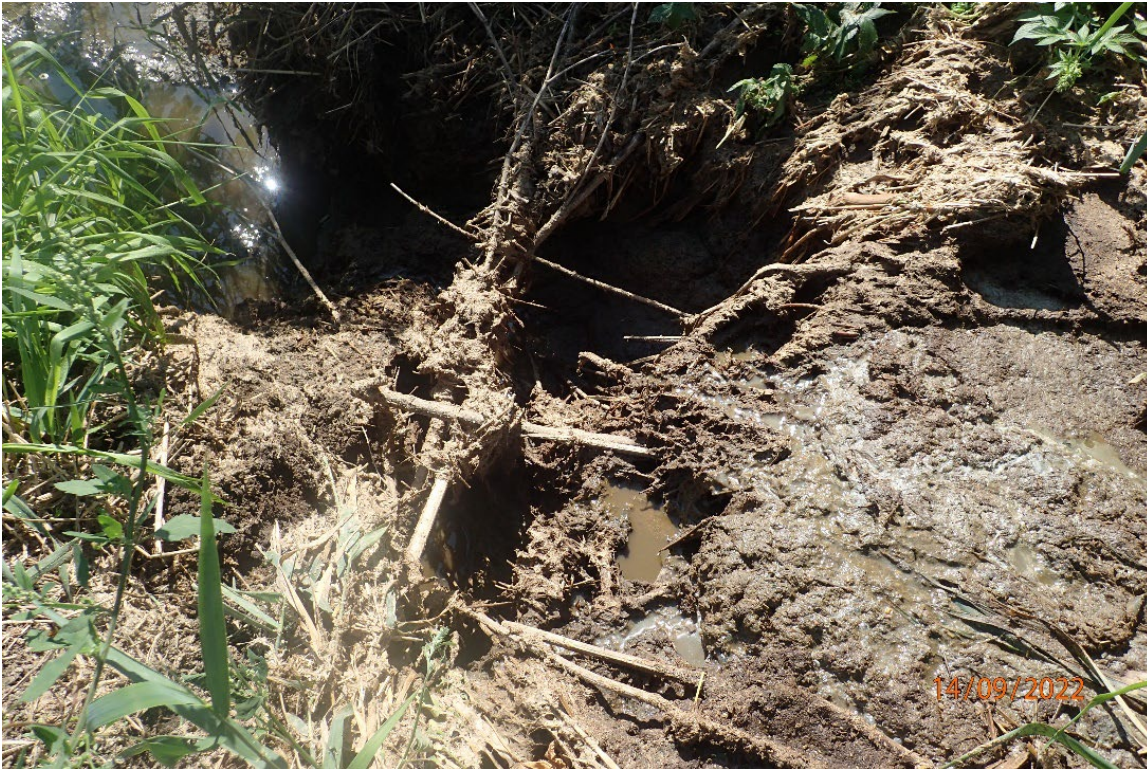
128: P9140219

Description: Closeup of manure flowing into Bull Branch from the channelized flow path.

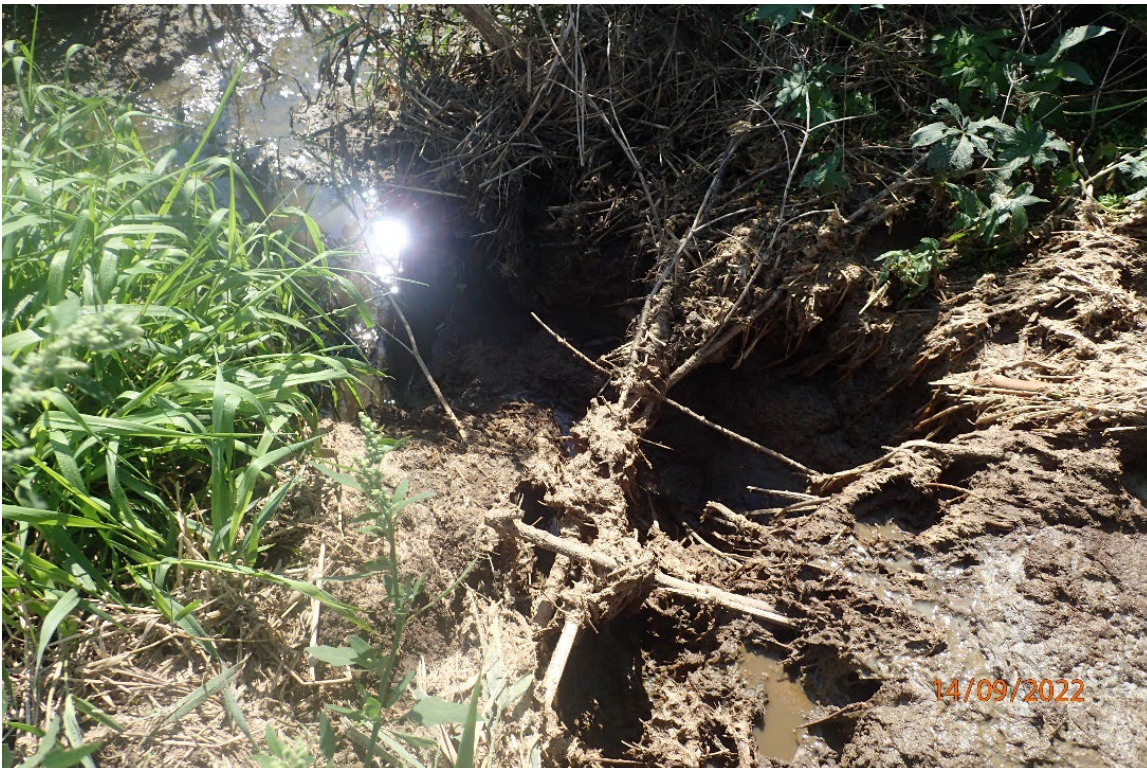
129: P9140220

Description: Closeup of manure flowing into Bull Branch from the channelized flow path.

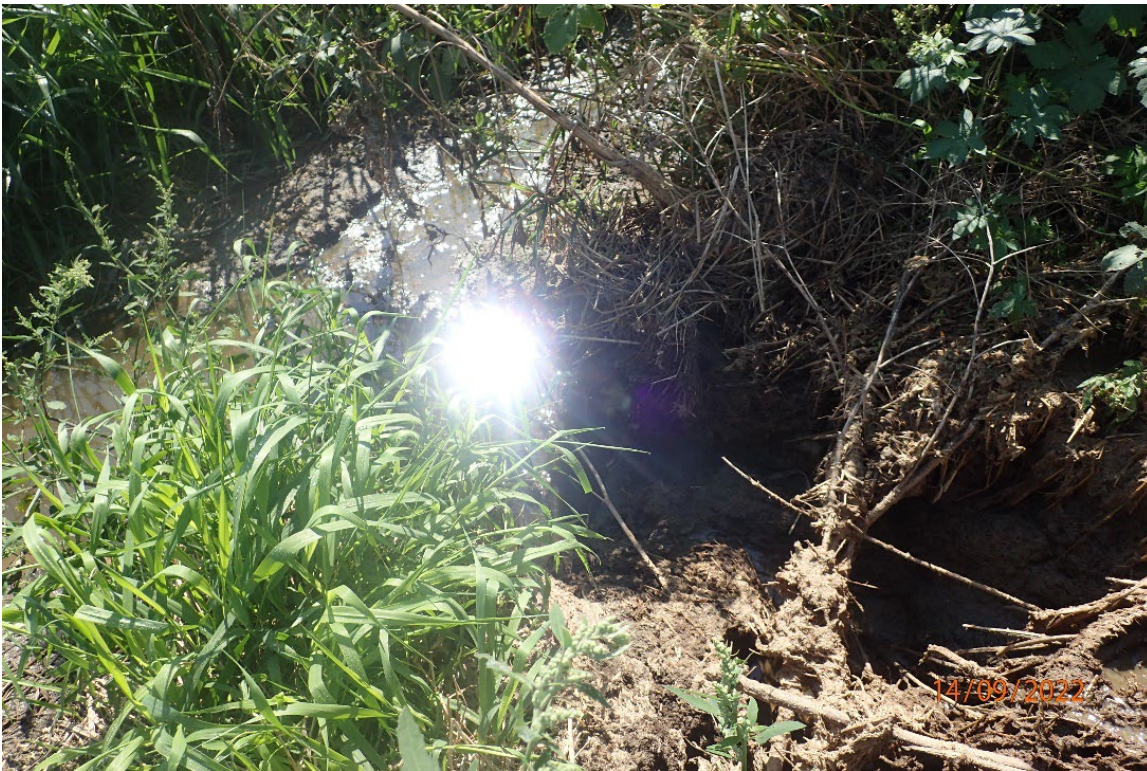
130: P9140221

Description: Closeup of manure flowing into Bull Branch from the channelized flow path.

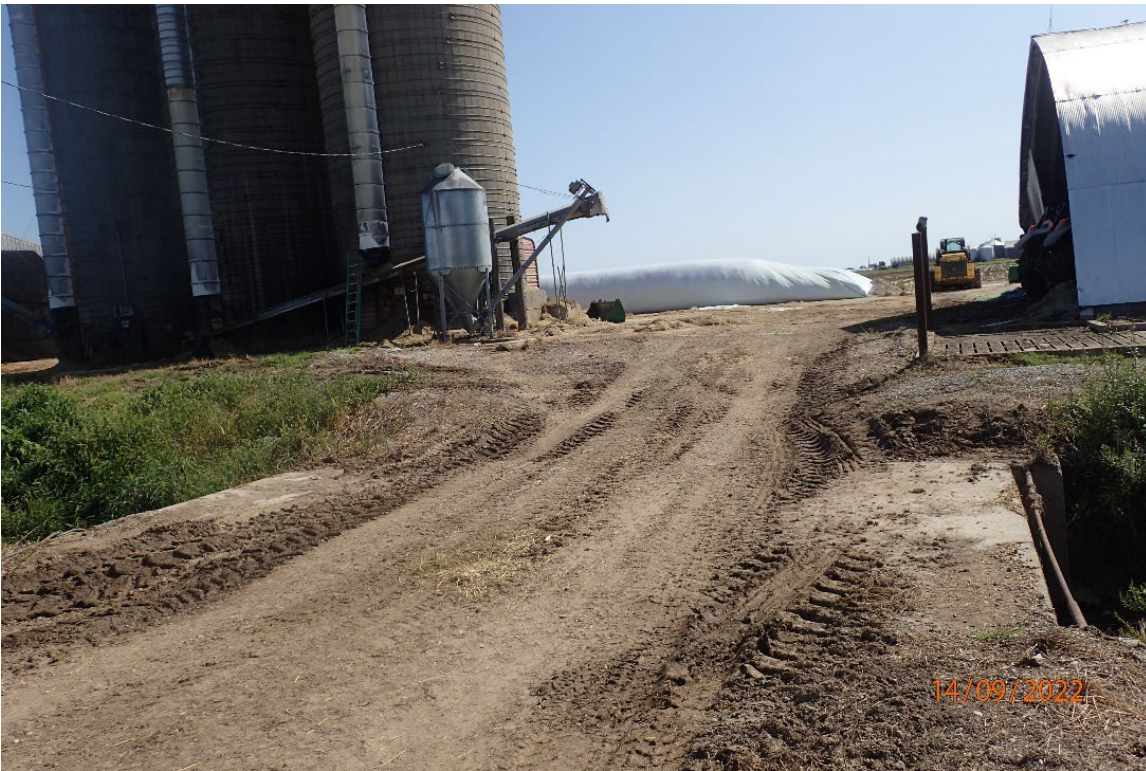
132: P9140223

Description: Looking east across the culvert for the access road on the north side of the facility.
