**CWA COMPLIANCE EVALUATION INSPECTION REPORT
U.S. ENVIRONMENTAL PROTECTION AGENCY, REGION 5**

Compliance Evaluation Sampling Inspection

Richter Dairy Farm
14113 St. Rose Road
Breese, Illinois 62230
Clinton County, Illinois
38.62797657159176, -89.55355561706052

Date of Inspection: Site Inspection - September 14th, 2022
Operator Interview – September 27th, 2022

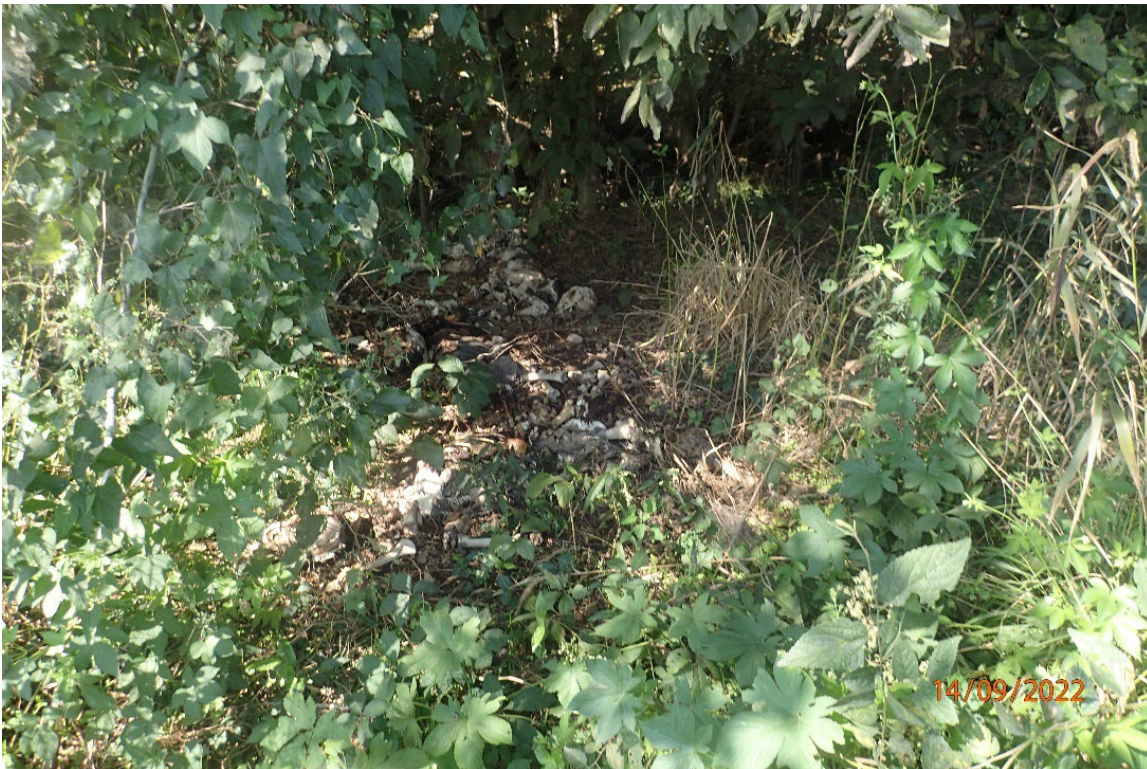
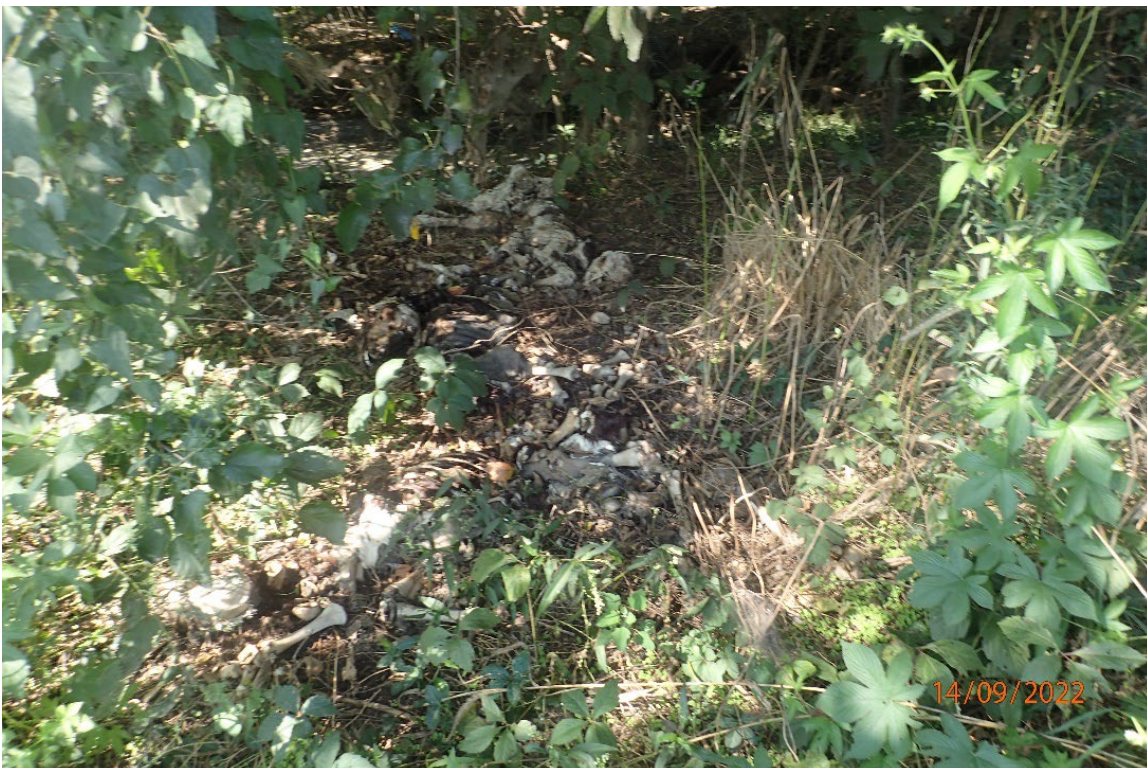
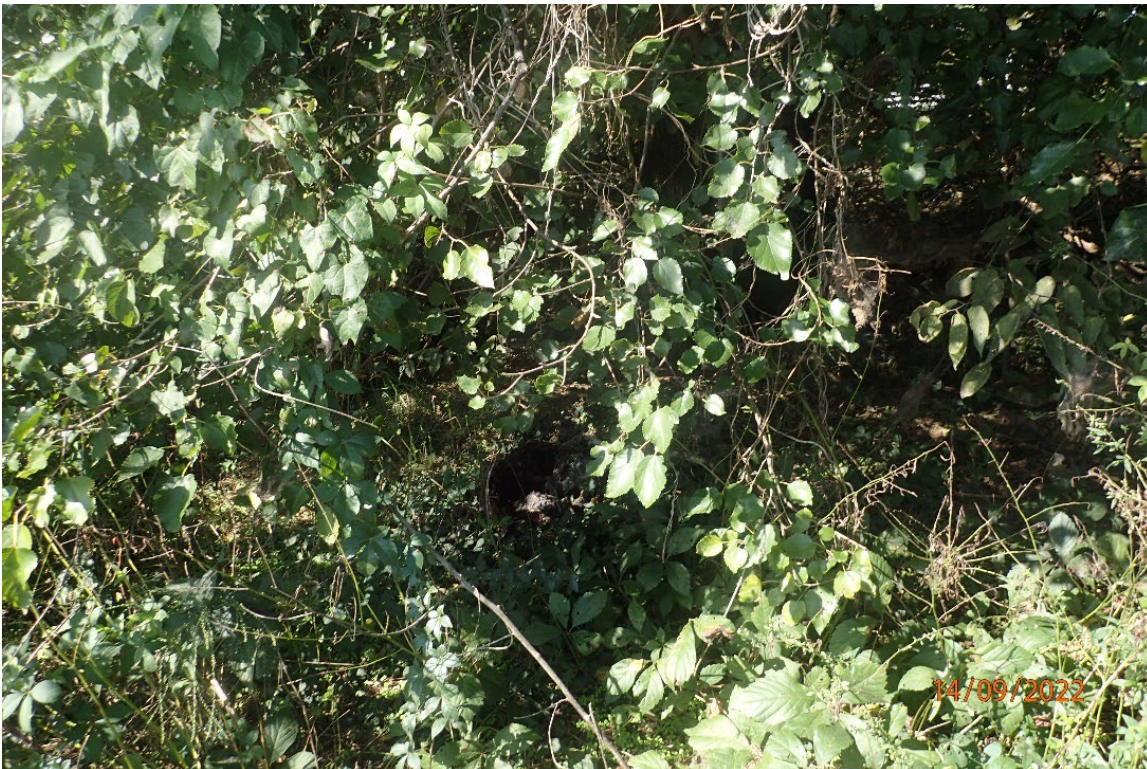
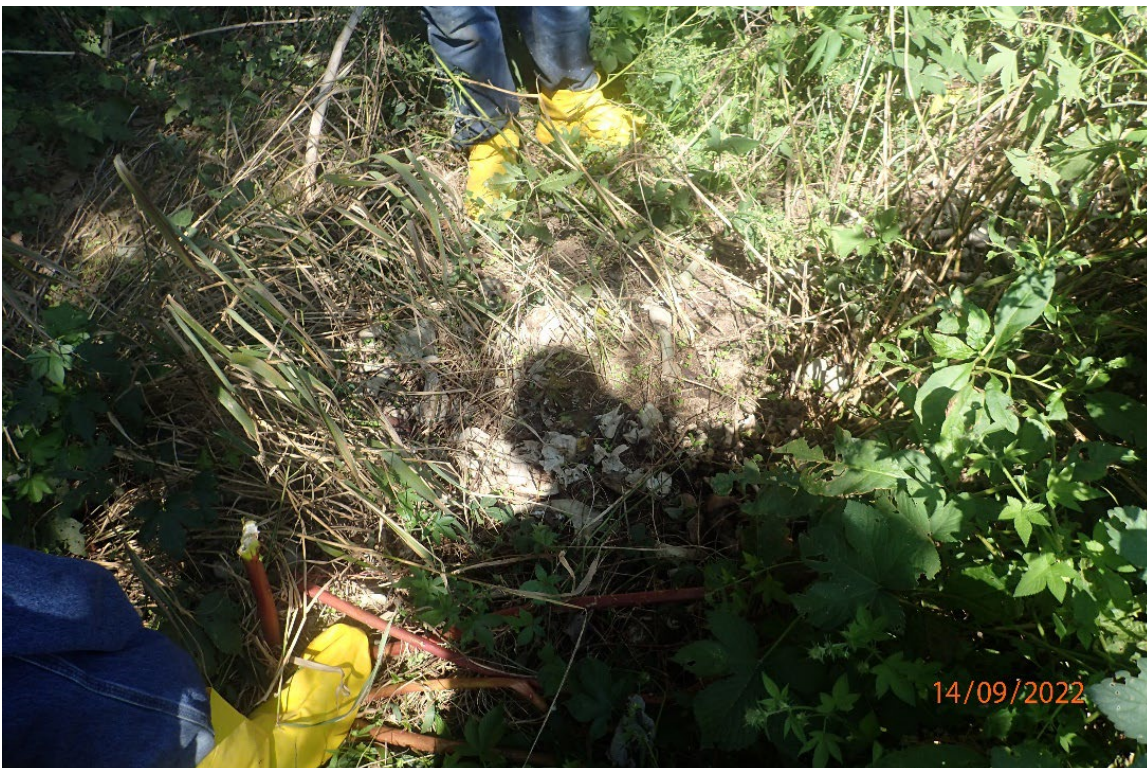
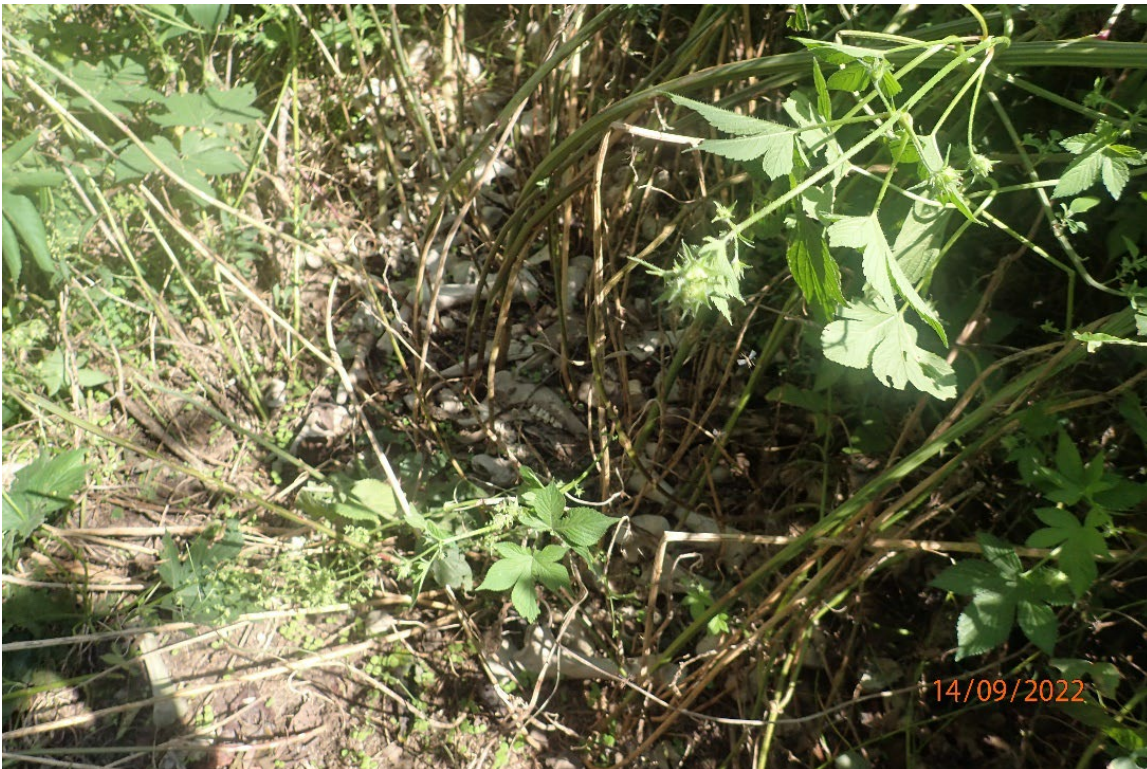
The Inspectors observed an area west between Pit 5 and Bull Branch where there were multiple animal bones and decomposing animal carcasses (photos 134 -139). The Inspectors walked around Pit 5 and returned north to the EPA Vehicle. The Inspectors met the Operator and informed him that they would be taking samples and offered split samples. The Operator declined the split samples. The Operator notified the Inspectors that he had filled the area around the concrete hole with soil to stop the flow of manure. The Inspectors provided the Operator with a summary of the areas of concern they had observed which included the lack of containment for manure and runoff from the

Description: Bones and decomposing animal carcasses on east side of Bull Branch.

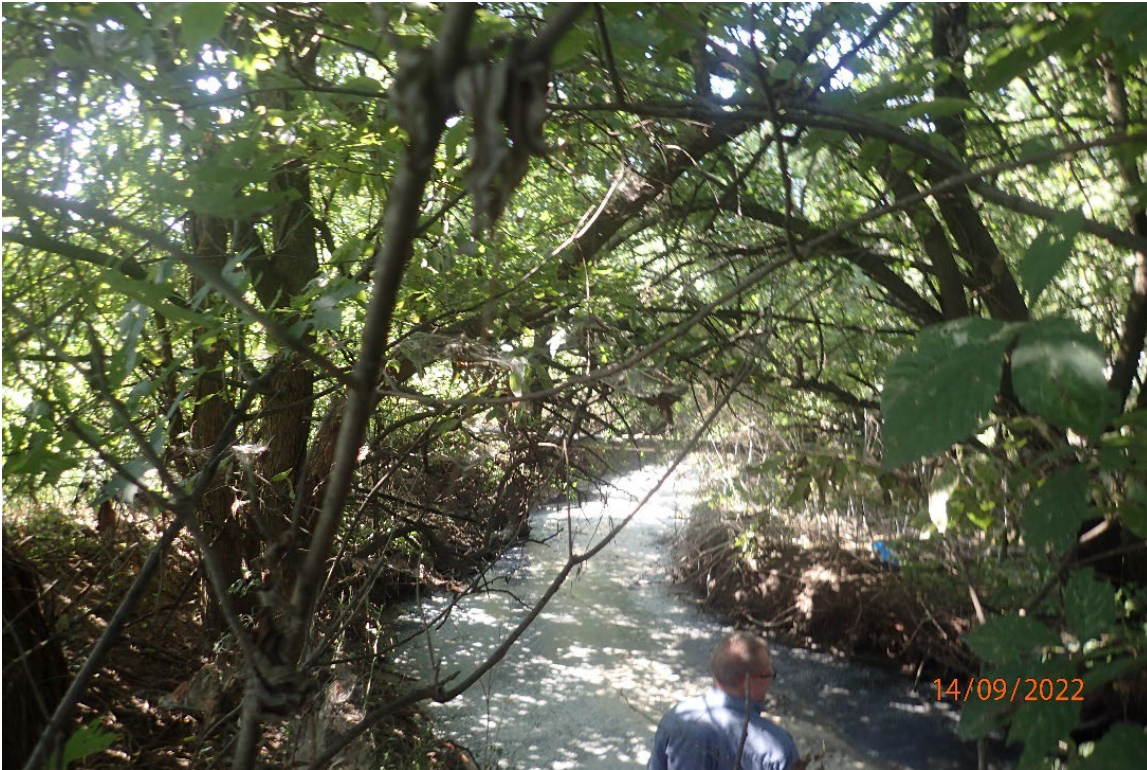
140: P9140231

Description: Looking downstream along Bull Branch. Note the foam on the surface of the water.

The Inspectors walked north along the east side of Pit 4 and observed manure solids deposited on the fence along Pit 4 (Photos 88 and 89). The Inspectors also observed Bull Branch was covered in foam (photos 92-97). The Inspectors continued north and observed manure deposited on top and exterior side of the east concrete wall of Pit 4 (photos 99-102).

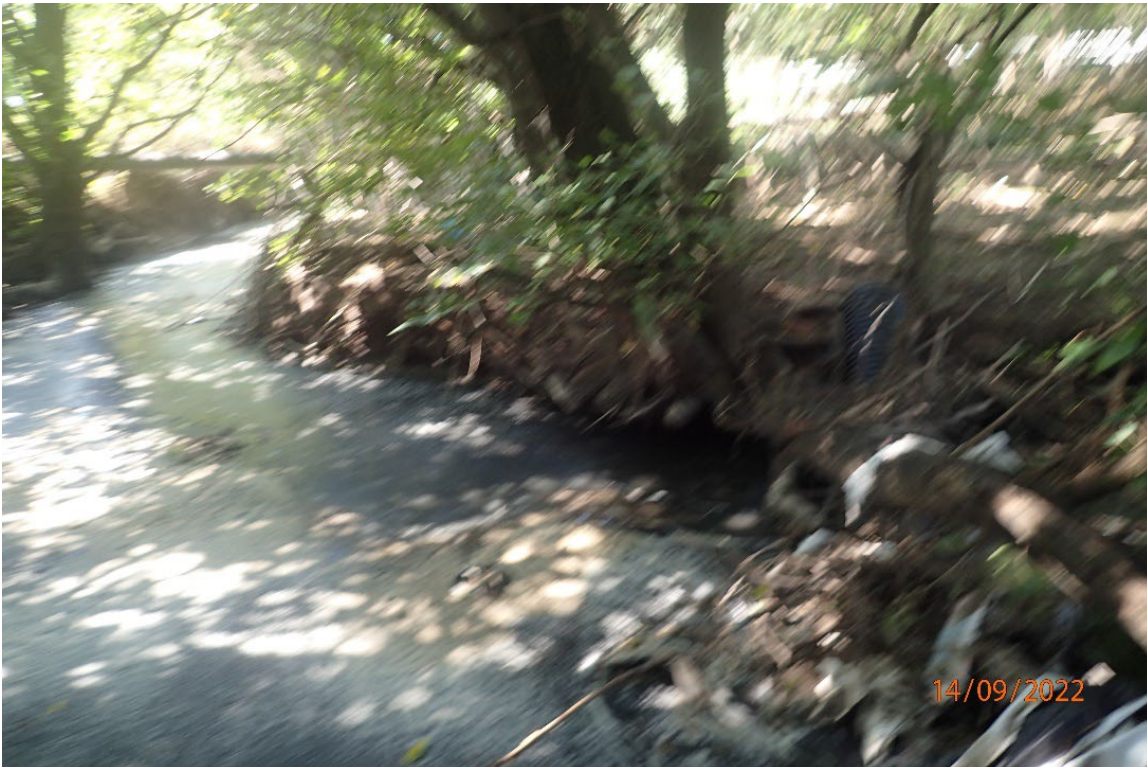
141: P9140232

Description: Looking downstream along Bull Branch. Note the foam on the surface of the water.

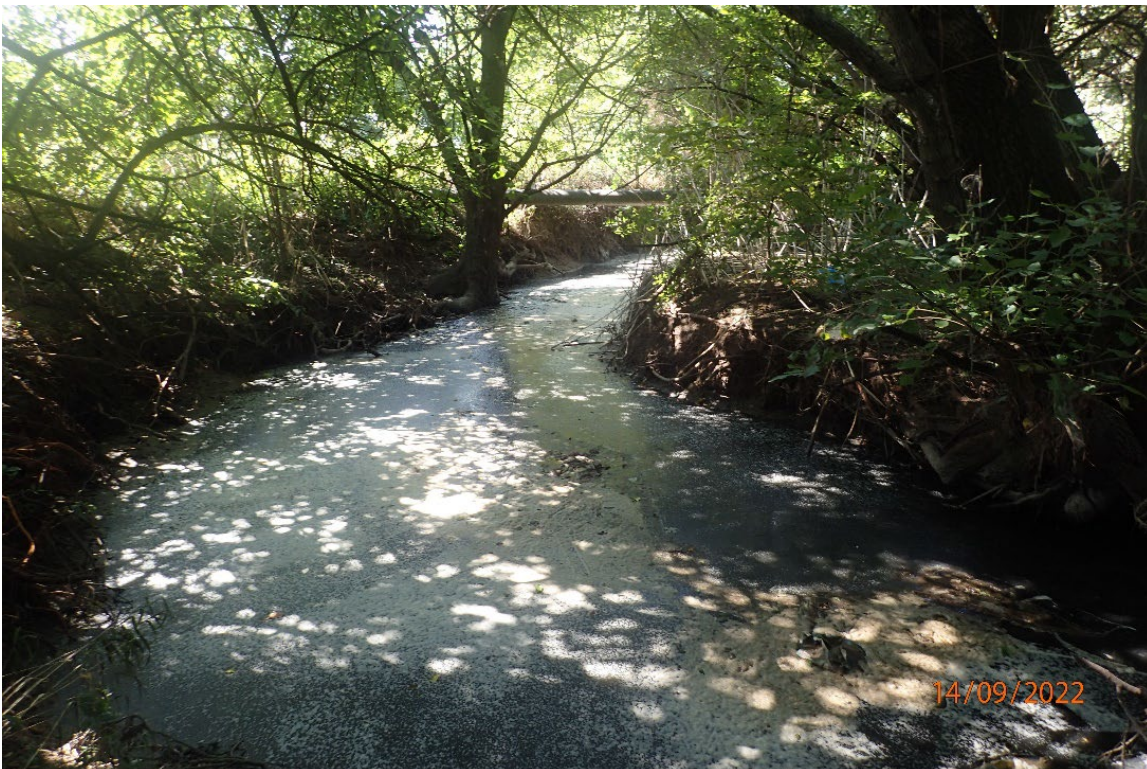
143: P9140234

Description: Looking downstream along Bull Branch. Note the foam on the surface of the water.

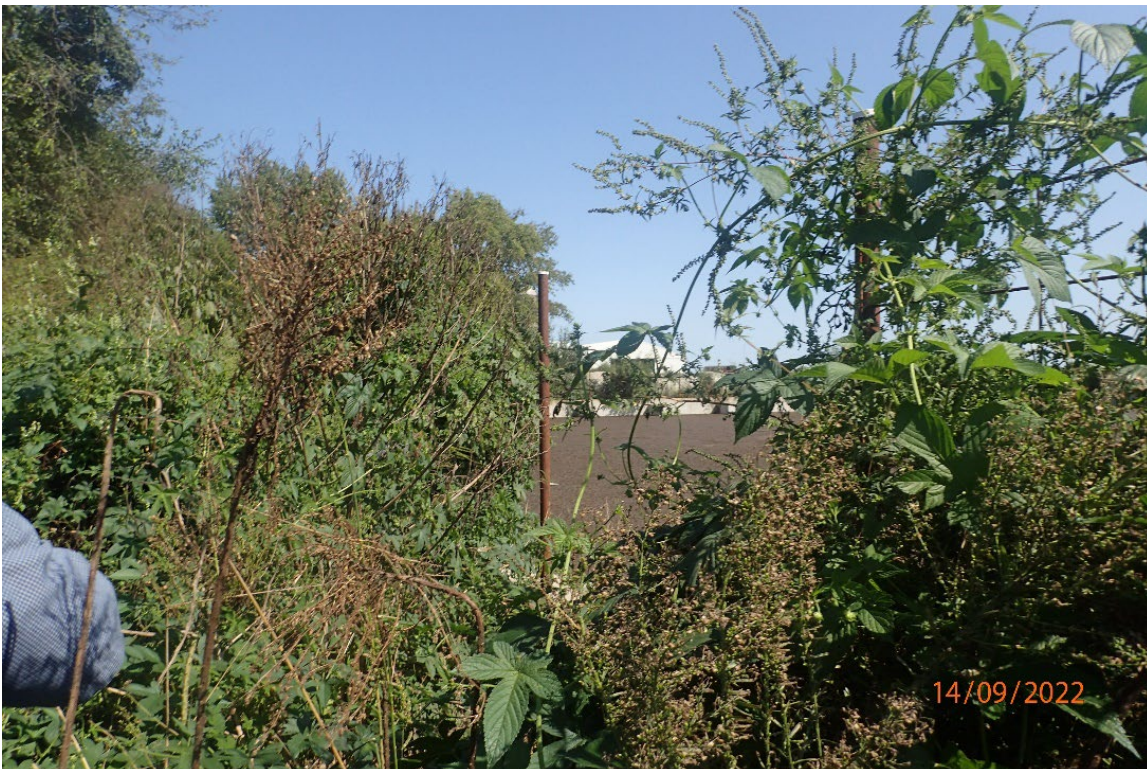
151: P9140242

Description: Looking northeast across Pit 5 from the southwest side.

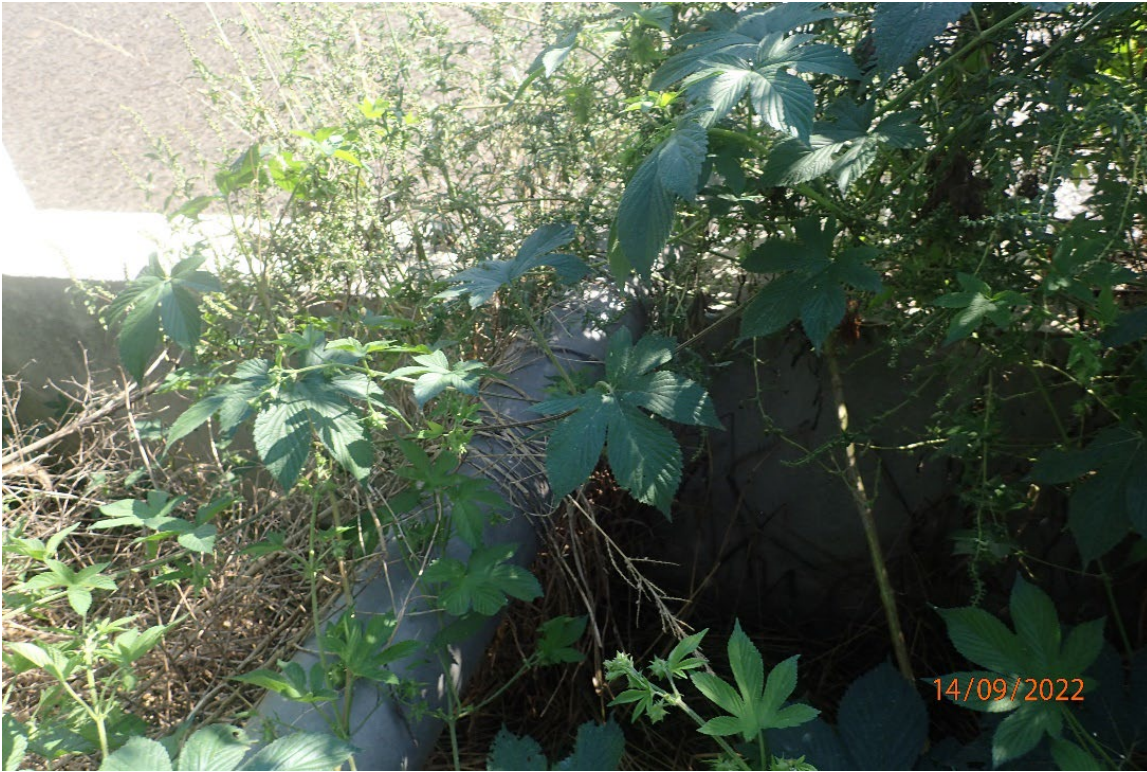
152: P9140243

Description: Hose used to transfer manure from Pit 4 to Pit 5.

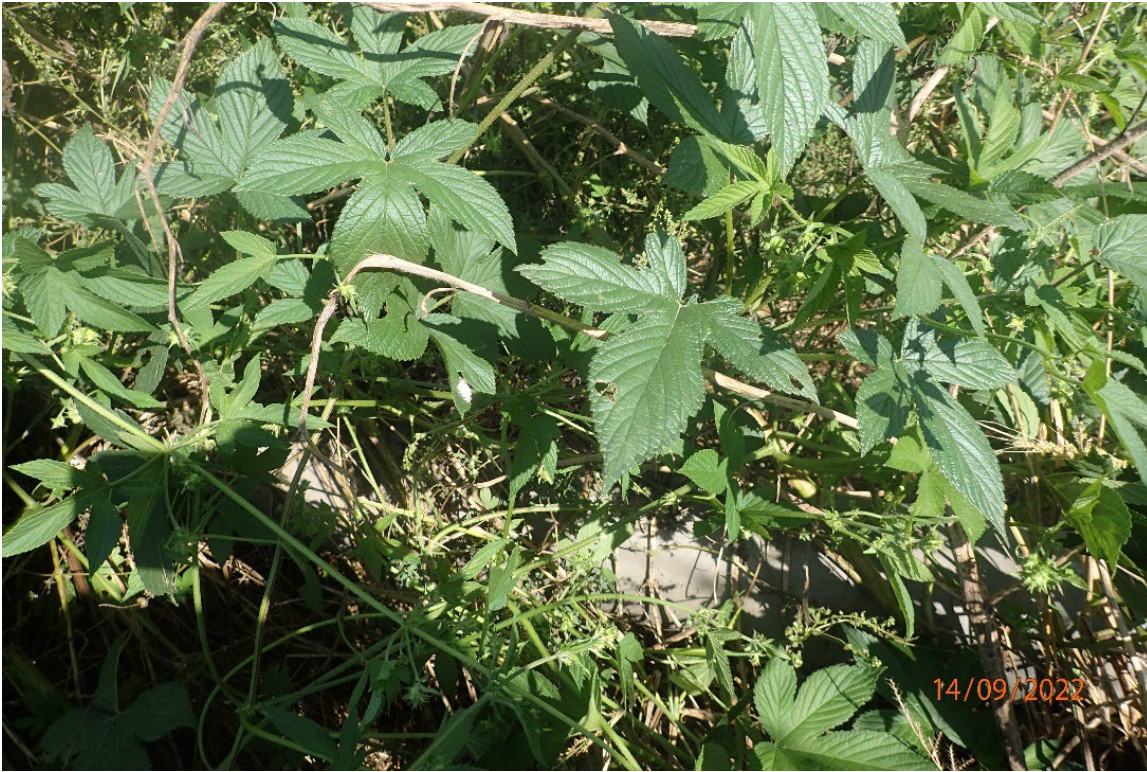
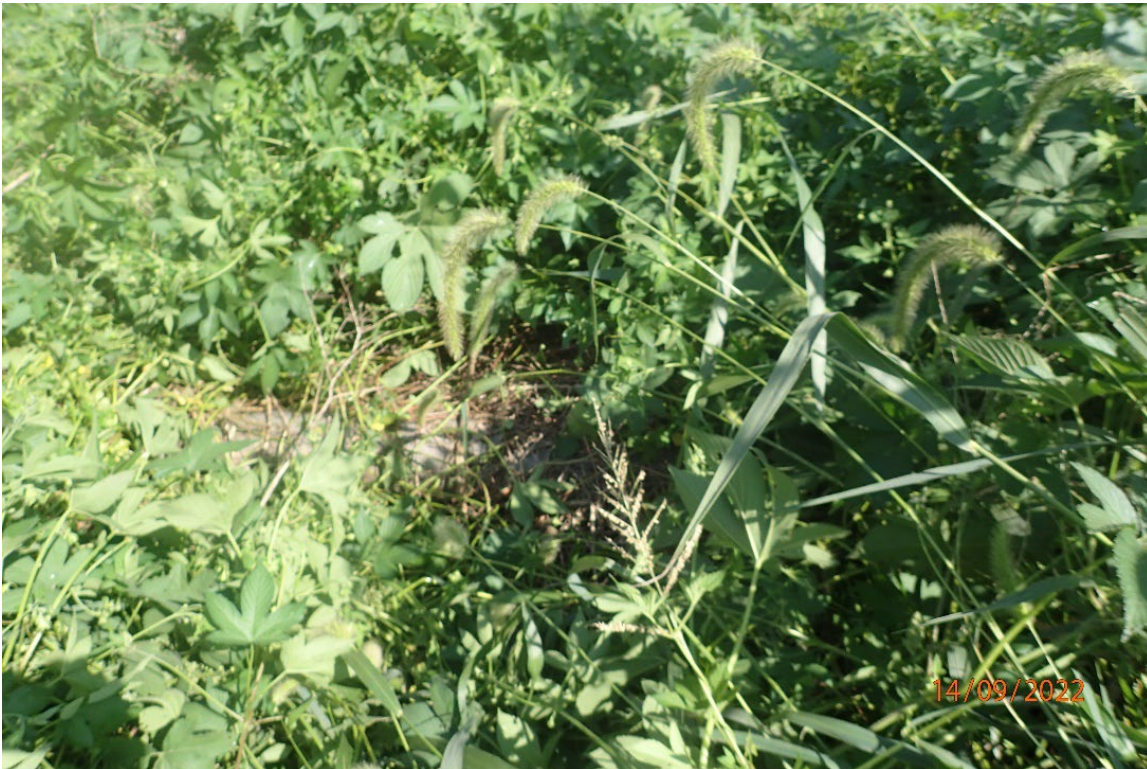
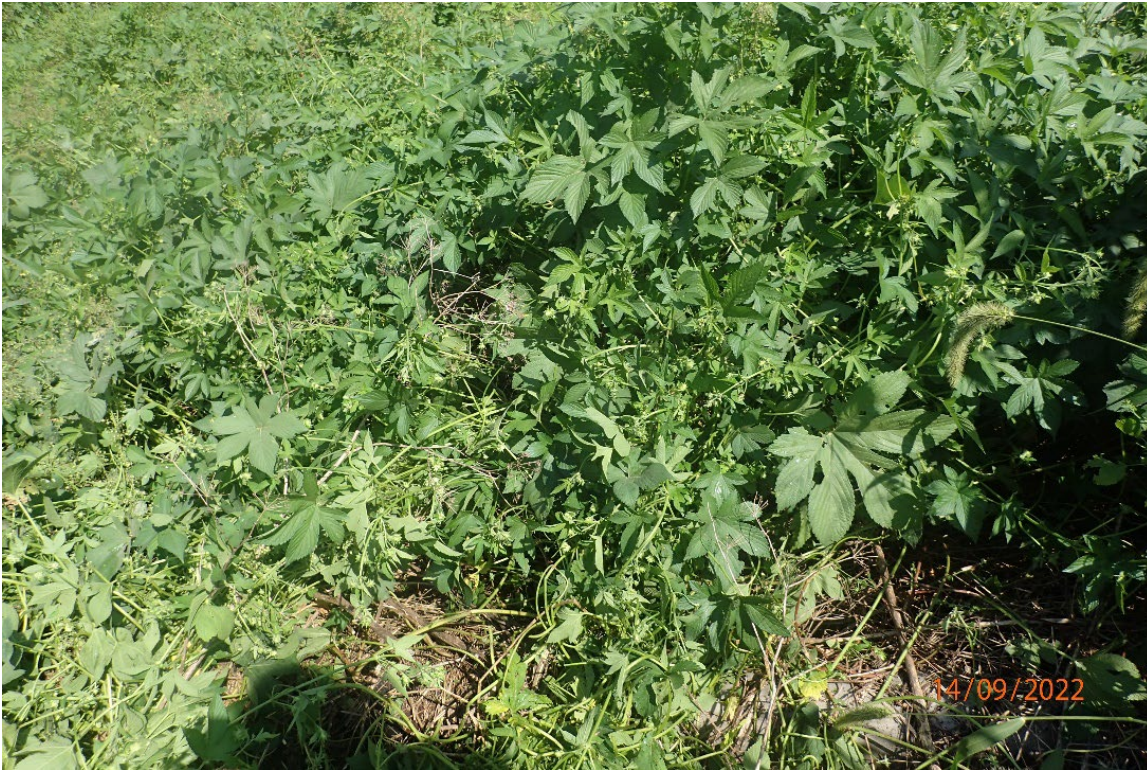
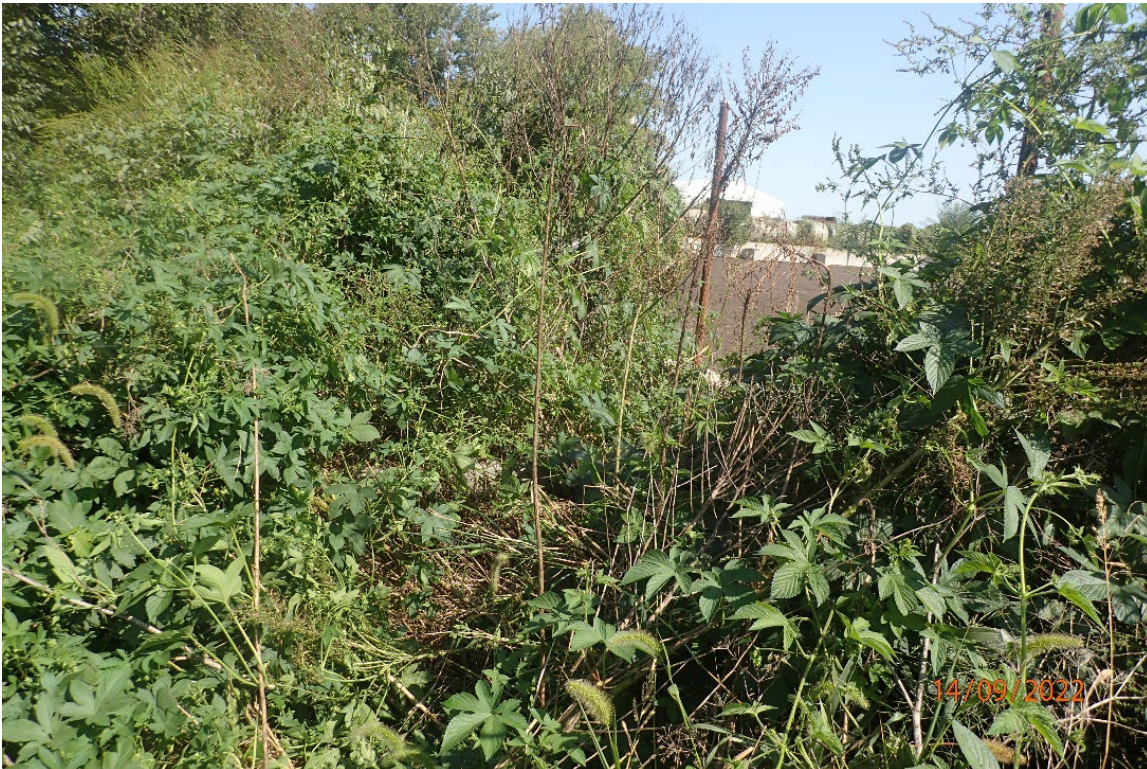
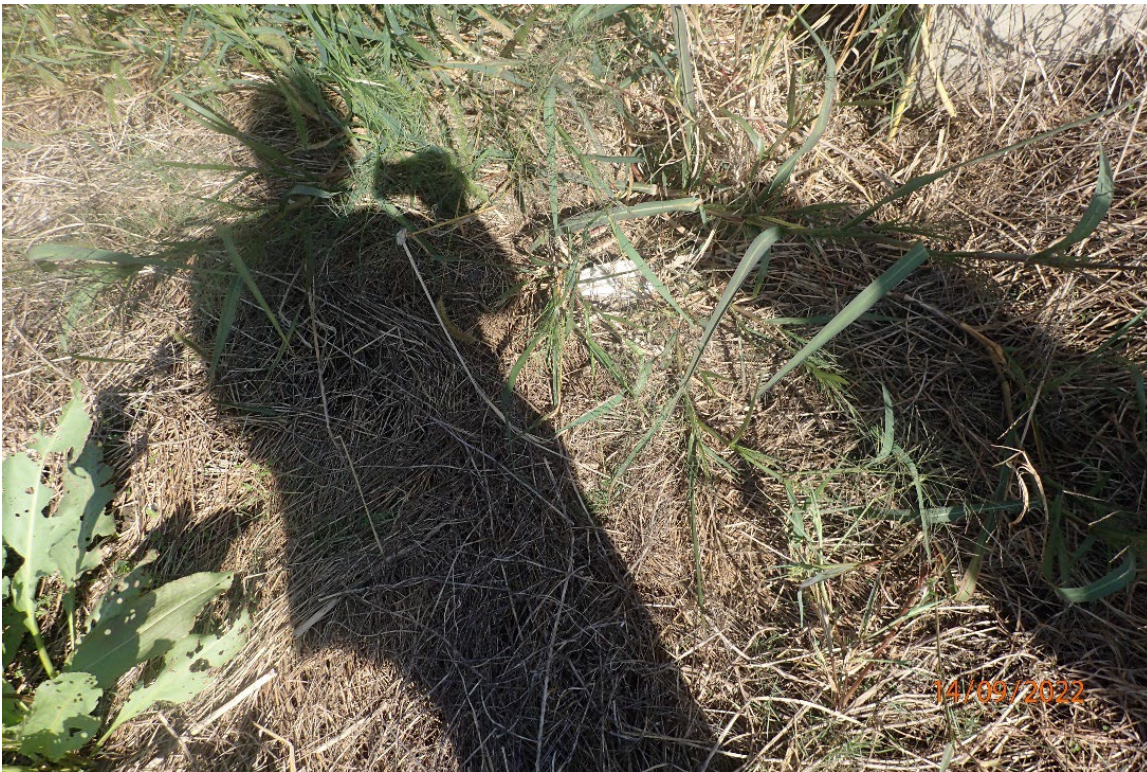
Description: Hose used to transfer manure from Pit 4 to Pit 5.

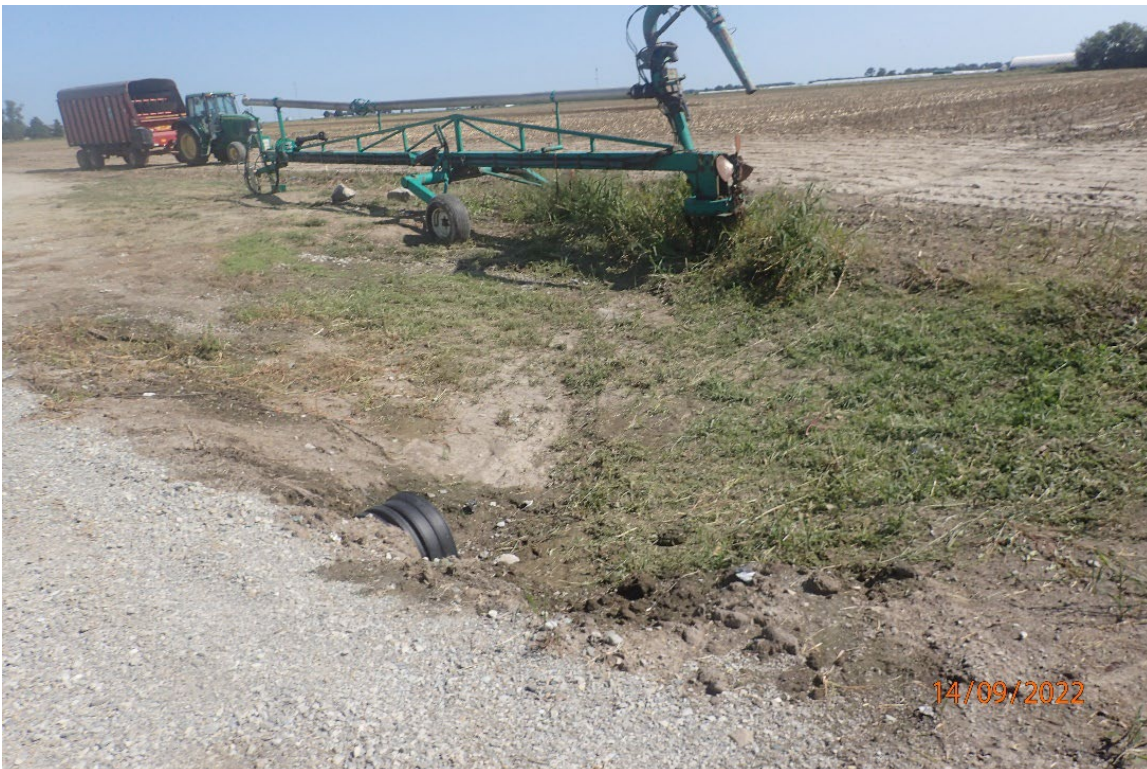
167: P9140258

Description: Manure application gun sitting east of Pit 5.

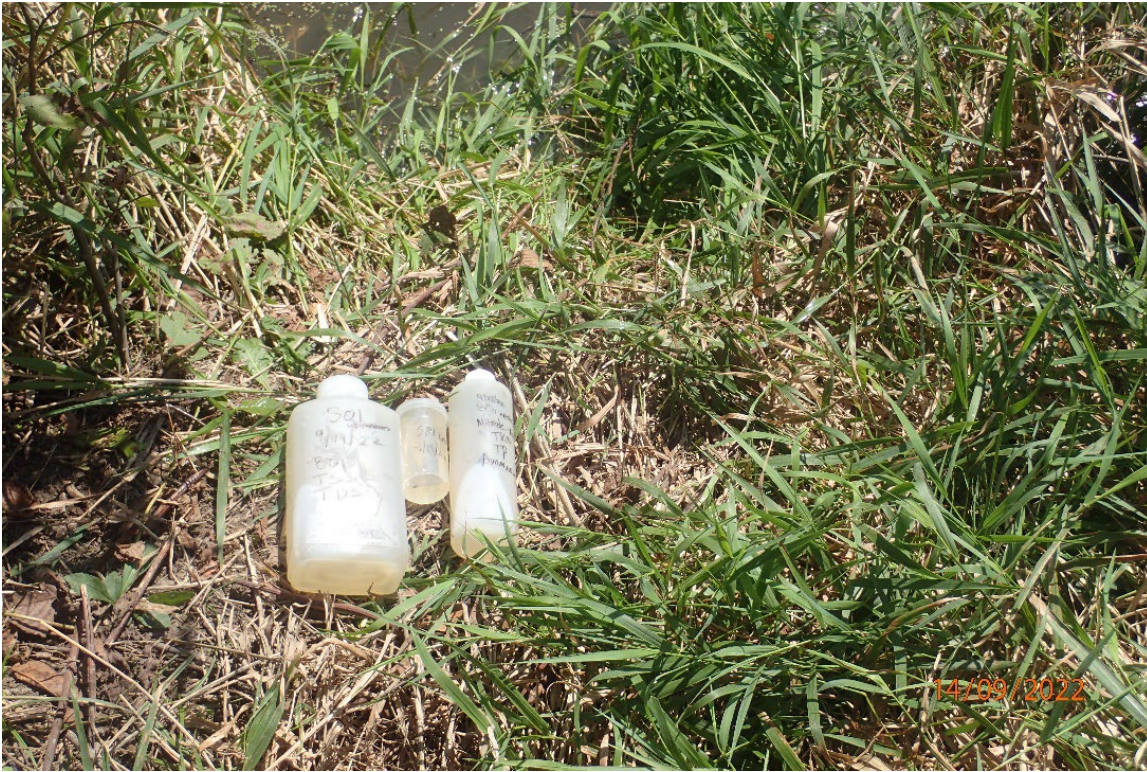
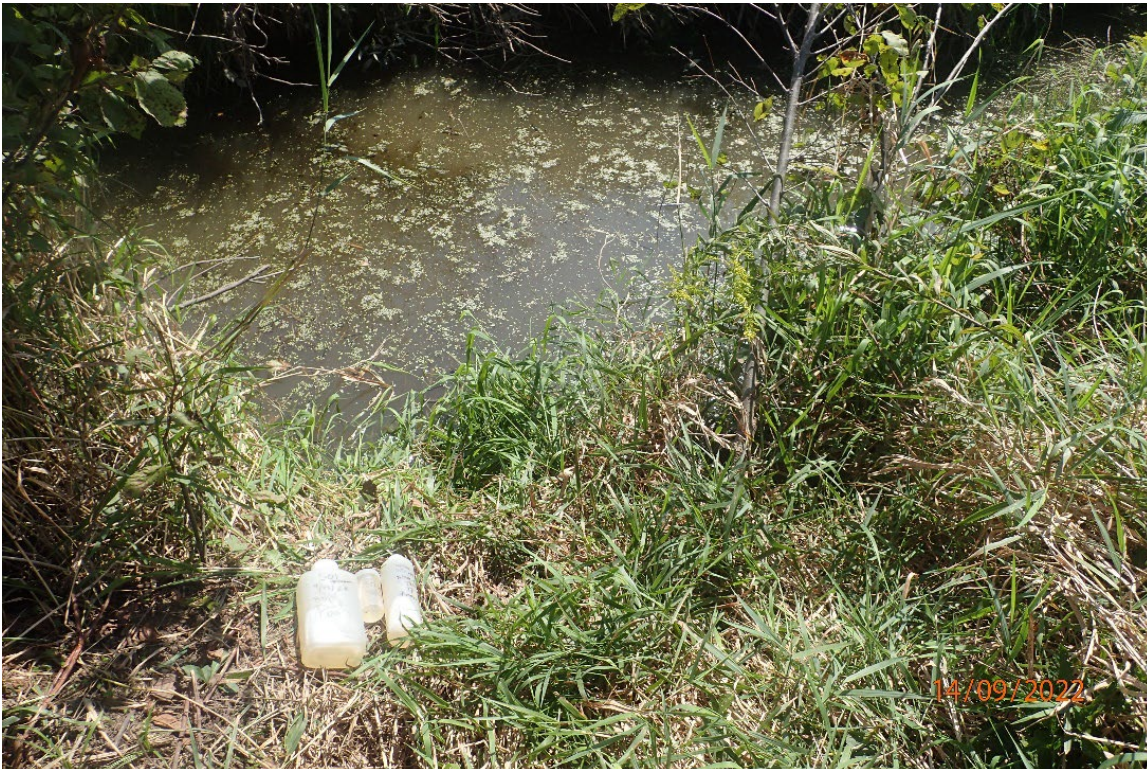
170: P9140261

Description: Sample S01 taken at the north end of the facility

Location: Bull Branch at the north end of the facility.

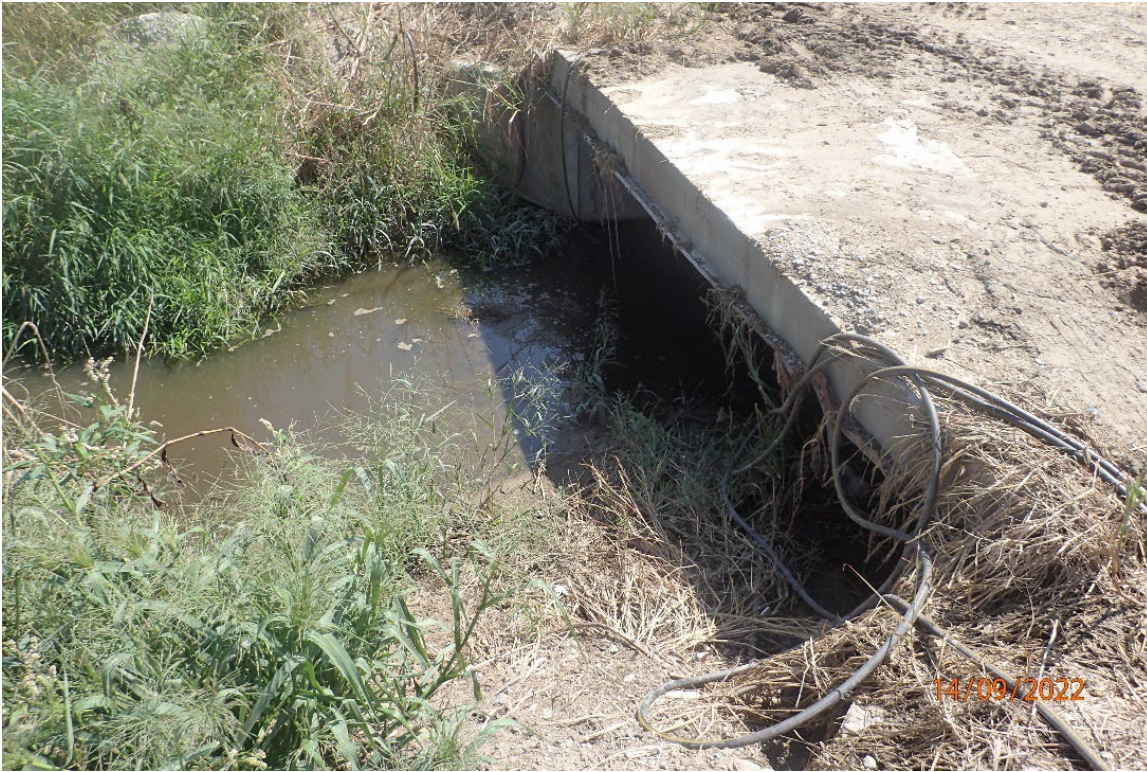
172: P9140263

Description: Water flowing south into the access road culvert over Bull Branch.

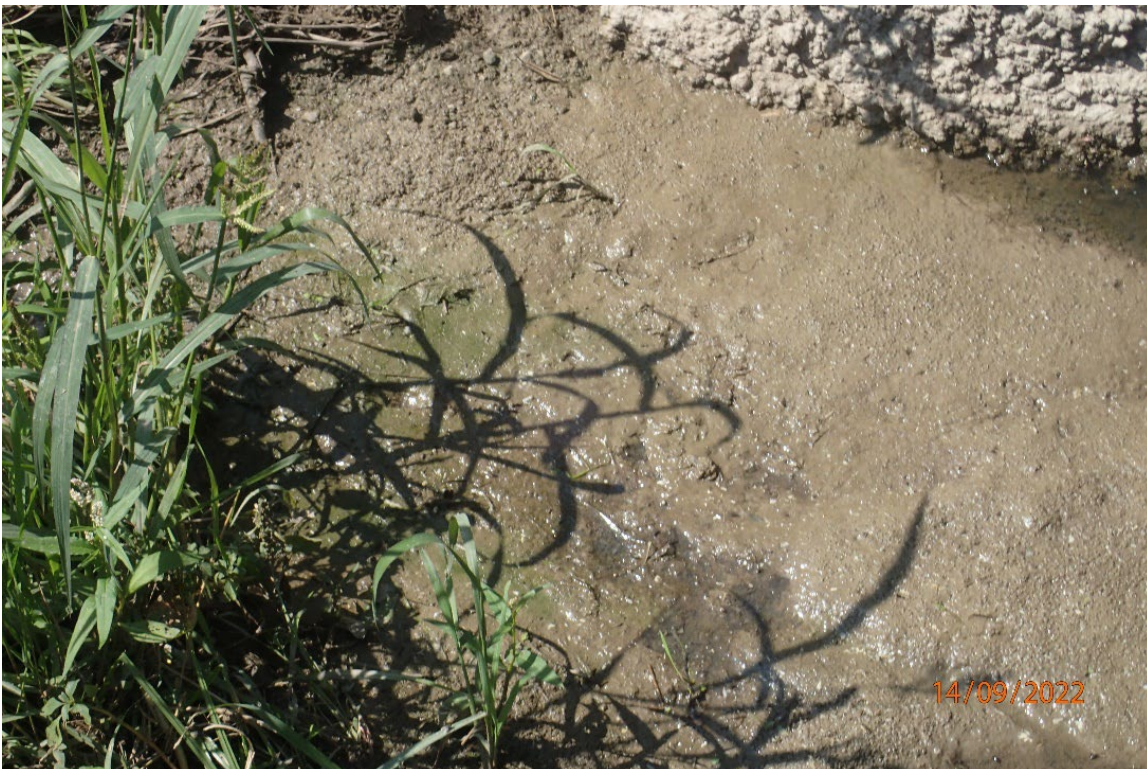
175: P9140266

8. Manure and feed solids were observed uncontained on and around the culvert over Bull Branch.
9. A pump with a hose from manure Pit 3 was observed directed toward Bull Branch.

Description: Solids near Bull Branch near the outlet of the the acces road culvert over Bull Branch.

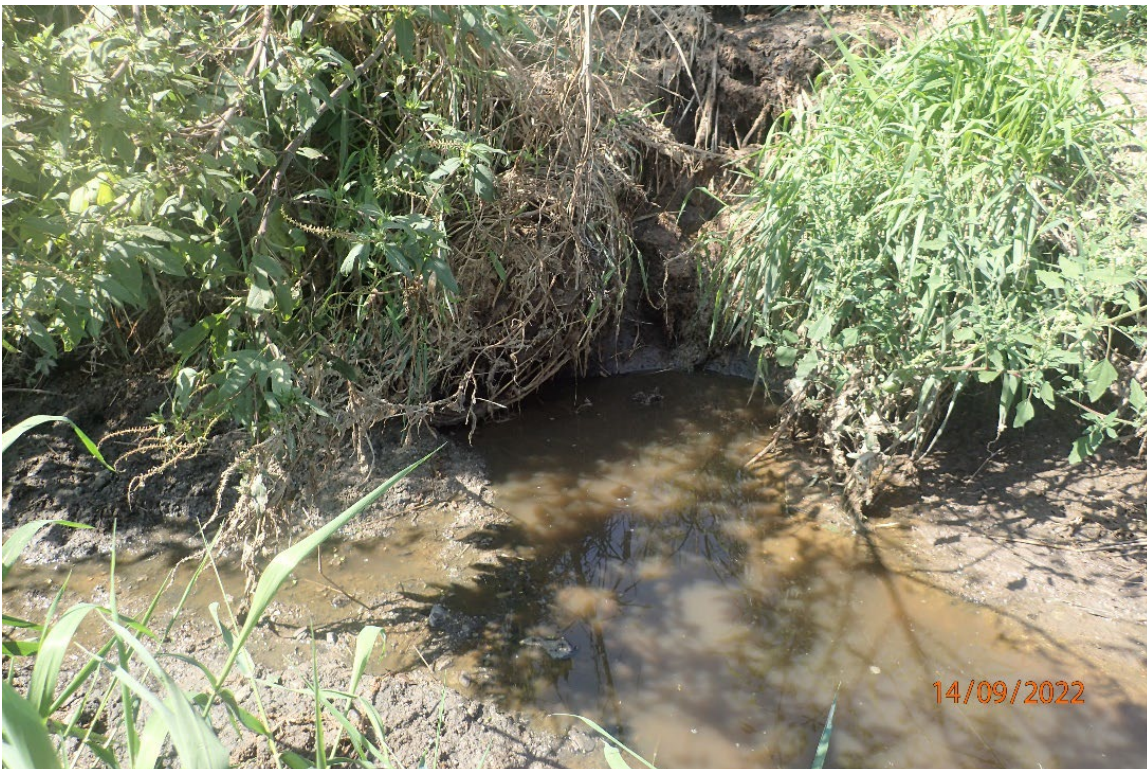
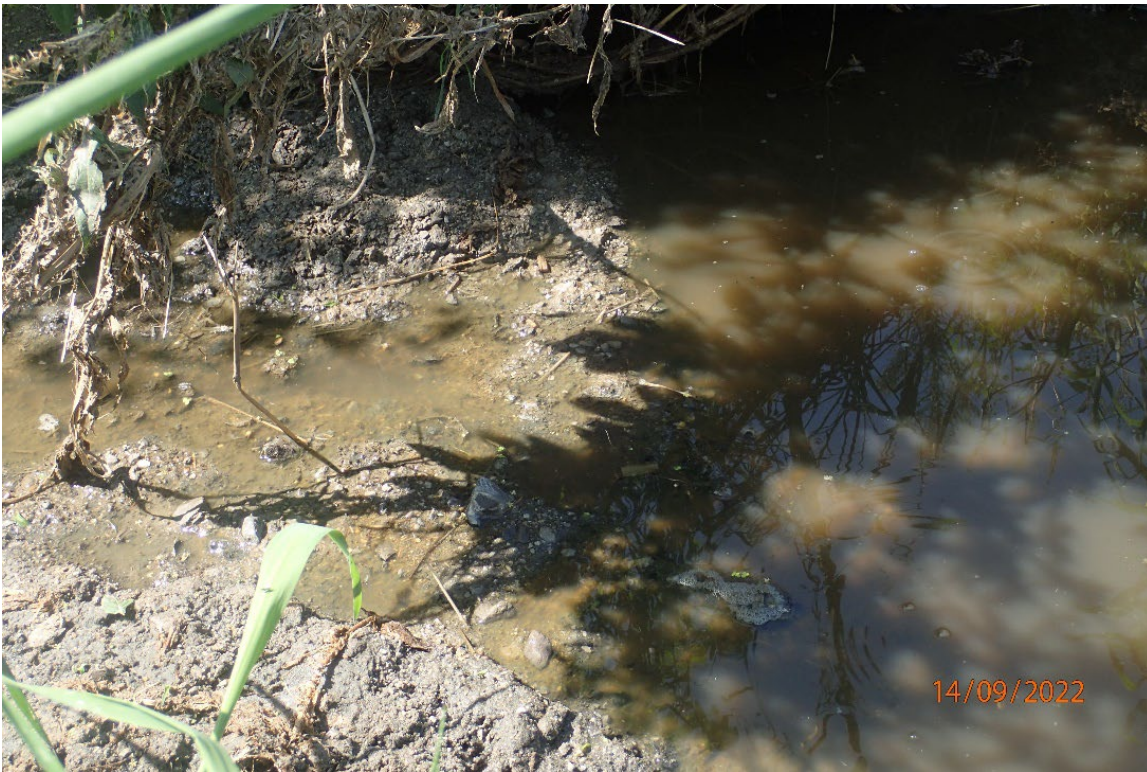
177: P9140268

The Inspectors then collected their sampling equipment and went to the north end of the facility to collect an upstream sample from Bull Branch (photos 170 – 171). The Inspectors then returned to confluence of the channel conveying manure from the cracked wall to Bull Branch and collected a sample from Bull Branch at the confluence with the channel (photos 177 – 181).

1. Manure was observed flowing out of a hole in the concrete wall along the east side of Pit 4 in a channel approximately 50 feet into Bull Branch.
2. Manure solids were observed in the channel of Bull Branch.

Description: Sampling point S02. The confluence of the channelized manure flow path and Bull Branch.

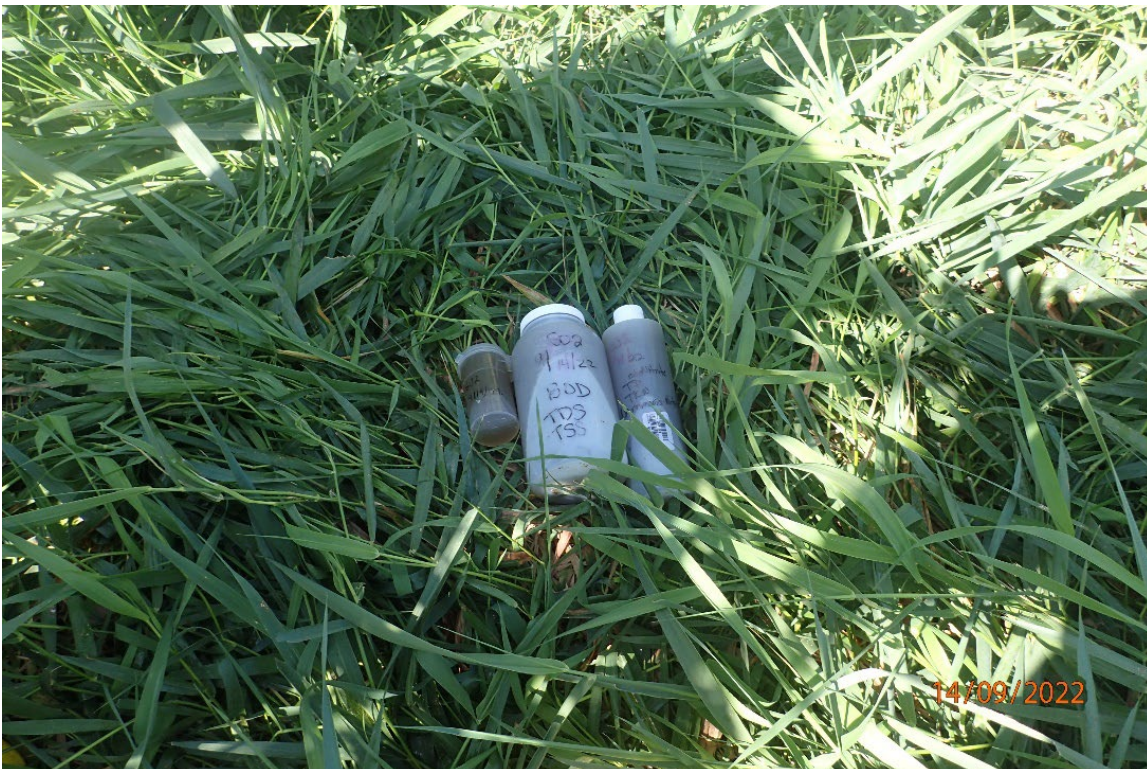
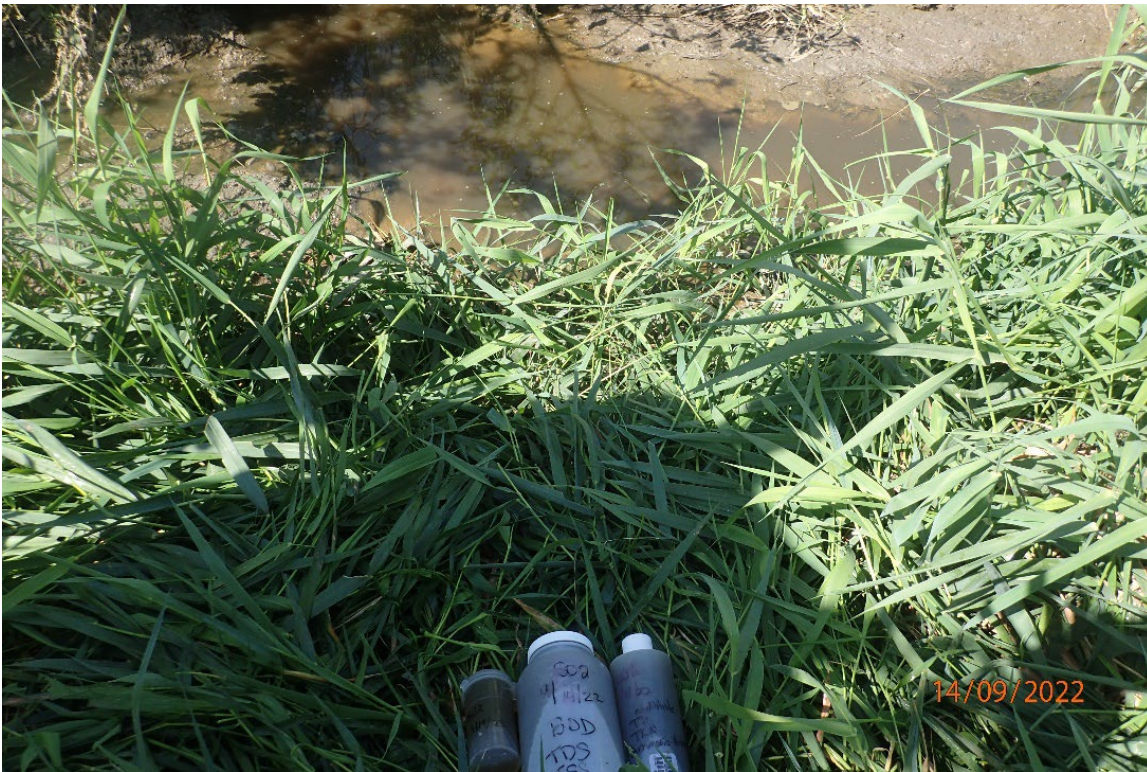
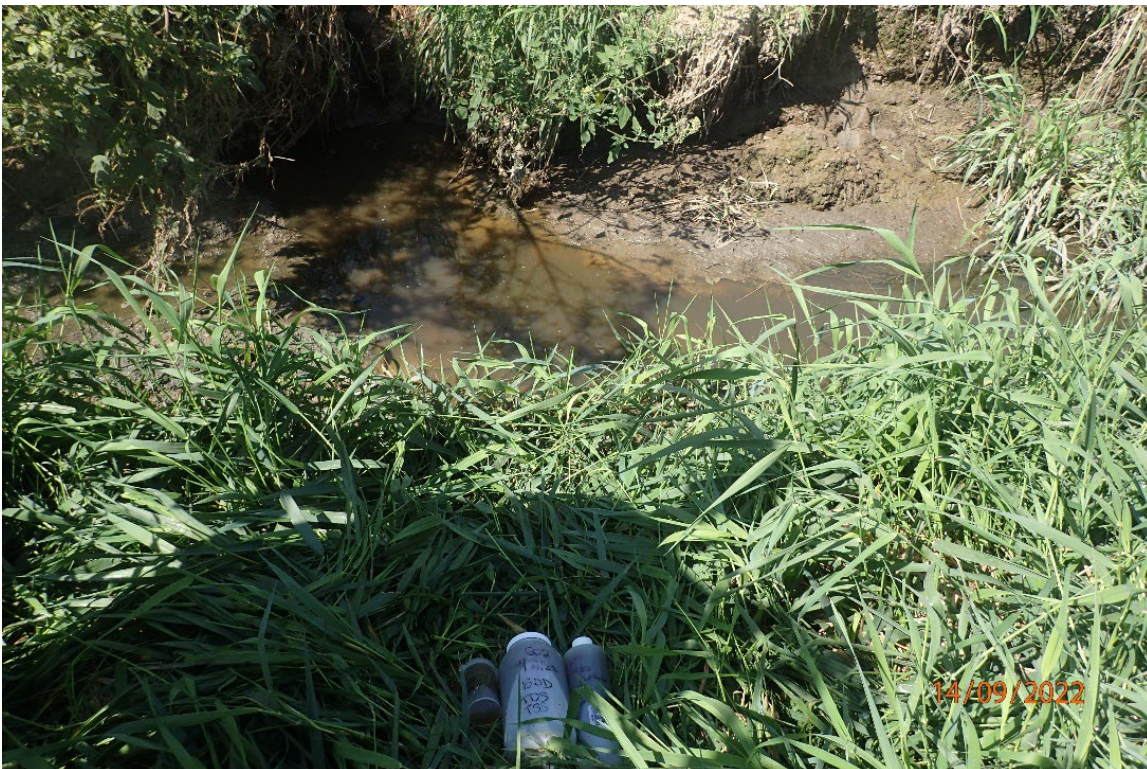
179: P9140270

Description: Sample S02.
