**CWA COMPLIANCE EVALUATION INSPECTION REPORT
U.S. ENVIRONMENTAL PROTECTION AGENCY, REGION 5**

Compliance Evaluation Sampling Inspection

Richter Dairy Farm
14113 St. Rose Road
Breese, Illinois 62230
Clinton County, Illinois
38.62797657159176, -89.55355561706052

Date of Inspection: Site Inspection - September 14th, 2022
Operator Interview – September 27th, 2022

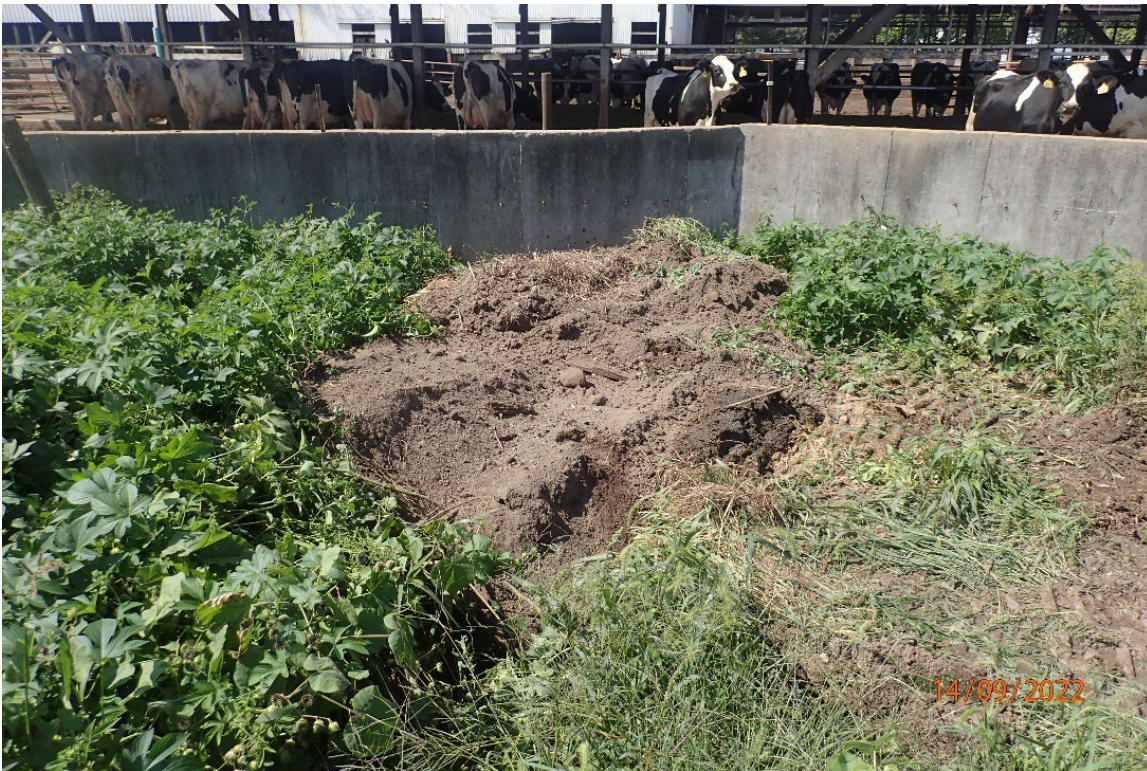
182: P9140273

The Inspectors observed that fill had been placed over the hole in the concrete wall (photos 182 and 183).

Location: Cracked concrete wall east of the East Milk Cow Barn.
