## **RCRA Compliance Evaluation Inspection Report**

Fort Walton Machining Inc.  
635 Anchors St NW  
Fort Walton Beach, Florida 32548  
Okaloosa County

July 13, 2023, 10:30 a.m.

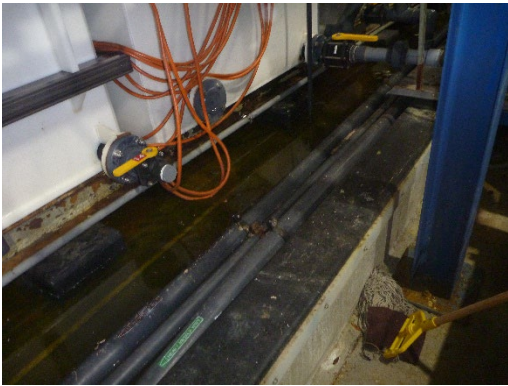
The inspectors proceeded to the plating lines. The plating line is equipped with a series of tanks. Beneath each plating tank is a concrete secondary containment structure which was observed to contain several inches of rinse water (Photos #1-2). The facility indicated that excess rinse water will be processed through the WWTS. It appears that MFD has been using the plating tanks containment system as a hazardous waste storage tank. This area is being used for primary containment of hazardous waste. Primary containment structures are subject to tank/secondary containment requirements in 40 C.F.R. Part 265, Subpart J. During the inspection, the inspectors informed the MFD representative that the containment area cannot be used to store plating waste rinsewater from the plating process. On July 20, 2023, MFD submitted pictures showing that secondary containment system has been cleaned and emptied of plating rinse

Photo #1 – Several inches of plating rinse water stored in the secondary containment.

**Pursuant to F.A.C. Chapter 62-730.160(1), [40 C.F.R. § 262.17(a)(5)(ii)], which is a condition of the LQG Permit Exemption, a large quantity generator accumulating hazardous waste in tanks must do the following: (A) Mark or label its tanks with the words “Hazardous Waste”; (B) Mark or label its tanks with an indication of the hazards of the contents (examples include, but are not limited to, the applicable hazardous waste characteristic(s) (*i.e.*, ignitable, corrosive, reactive, toxic); hazard communication consistent with the Department of Transportation requirements at 49 CFR part 172 subpart E (labeling) or subpart F (placarding); a hazard statement or pictogram consistent with the Occupational Safety and Health Administration Hazard Communication Standard at 29 CFR 1910.1200; or a chemical hazard label consistent with the National Fire Protection Association code 704); (C) Use inventory logs, monitoring equipment or other records to demonstrate that hazardous waste has been emptied within 90 days of first entering the tank if using a batch process, or in the case of a tank with a continuous flow process, demonstrate that estimated volumes of hazardous waste entering the tank daily exit the tank within 90 days of first entering; and (D) Keep inventory logs or records with the above information on site and readily available for inspection.**

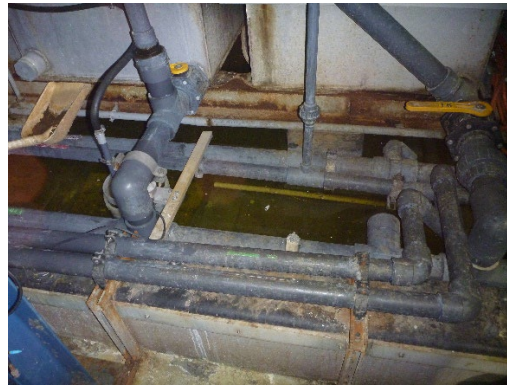
Photo #2 – Several inches of plating rinse water stored in the secondary containment.

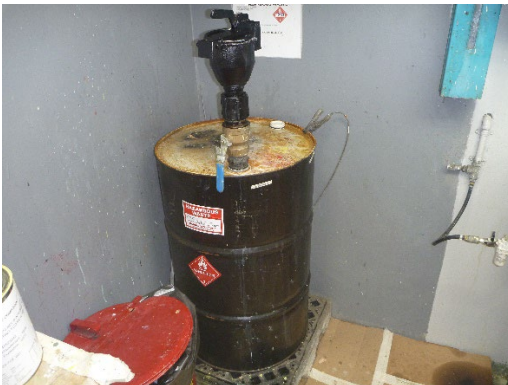
- Three paint booths each had one closed 5-gallon container of waste solvent paint debris marked “Hazardous Materials” and with no indication of the hazards of the contents;
- One open 15-gallon container of waste liquid from the paint gun washer marked “Hazardous Waste” with an indication of the hazards of the contents;
- One open 55-gallon container of waste paint/thinners marked “Hazardous Waste” with an indication of the hazards of the contents (Photo #3); and
- One open 15-gallon container of solvent wipes/paint debris illegible markings of “Hazardous Waste” with no indication of the hazards of the contents.

Photo #3 – Open 55-gallon container of Paint waste in the paint mix room.

**Pursuant to F.A.C. Chapter 62-730.160(1) [40 C.F.R. § 262.15(a)(4)], which is a condition of the SAA Permit Exemption, a container holding hazardous waste must be closed at all times during accumulation, except: (i) when adding, removing, or consolidating waste; or (ii) when temporary venting of a container is necessary (A) for the proper operation of equipment, or (B) to prevent dangerous situations, such as build-up of extreme pressure.**
