## LEAD INDUSTRIES ASSOCIATION, INC.

L. N. Miller

Rolt, Boranek and Newman, Inc.

### SOME OBSERVATIONS OF THE VIBRATION ISOLATION EFFECTIVENESS OF LEAD-ASBESTOS PADS\*

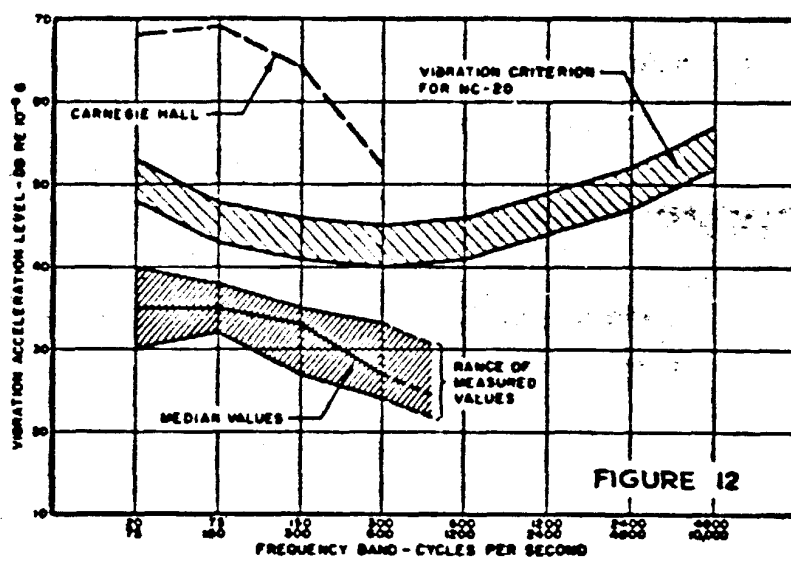
The measured subway vibration levels at Position 19 in the seating area nearest the subway are plotted as a function of frequency in the lower shaded area of Figure 12. These levels are seen to be about 10 db below the "vibration criterion" levels that were set for the hall. This means that subway passages cannot be heard inside the main hall even during the quietest background when the orchestra may be preparing for recording sessions. Even though these measurements were made nearly a year before Philharmonic Hall was opened, the data gave the assurance that the vibration levels were satisfactorily low. We believe no one has heard a subway passage inside the auditorium area since its completion.

Also shown on Figure 12 is a plot of some earlier vibration levels obtained in Carnegie Hall for nearby Seventh Avenue subway passages. These were definitely audible inside the hall.

11. Measurement Positions 17, 18 and 19 inside and nearby Positions 14 and 16 just outside the main hall.
12. Comparison of measured vibration levels at orchestra seating Position 19 with criterion levels and Carnegie Hall levels.

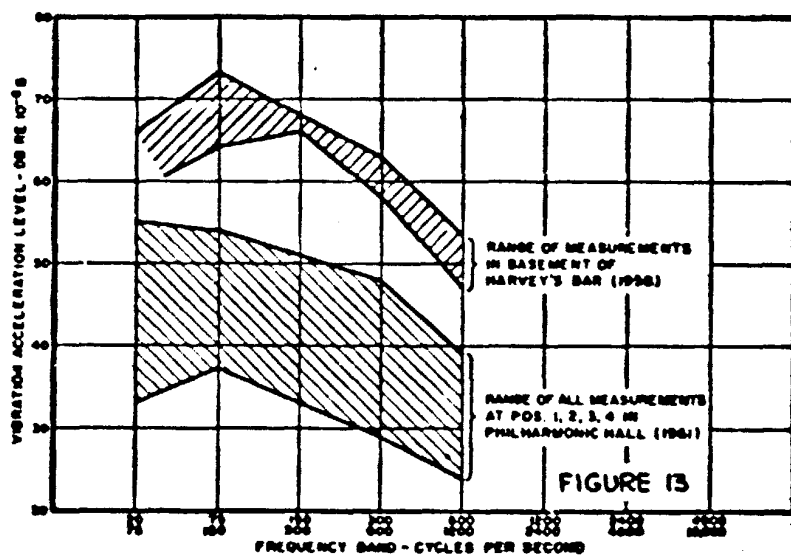
One other significant comparison is shown in Figure 13. In 1958 an establishment known as Harvey's Bar occupied the corner of the present site of Philharmonic Hall, near the subways. In Figure 13 the upper shaded area gives the vibration levels measured at a wall and a floor position in the basement of Harvey's Bar about 53 ft. from the nearest subway tracks. The lower shaded area gives the range of vibration levels measured at four positions in the basement of Philharmonic Hall not more than about 6 to 10 ft. from the original measurements in Harvey's Bar. On the average, the vibration levels in the basement positions of Philharmonic Hall range about 15 to 30 db lower than those for the similar location in Harvey's Bar. The distance to the subway tracks is essentially the same for both groups of readings, so we believe the large improvement can be attributed to the new construction. We do not know how much of this difference might be due to the more massive construction of Philharmonic Hall, but we believe that the column isolation joints, the wall isolation joints, and the "resilient" lining of the exterior underground walls all share a large part in achieving the lower vibration levels.

13. Comparison of measured vibration levels at approximately the same location in 1958 and 1961.
