### INSPECTION REPORT

| Company Name: | Nevada Oil, LLC | |
| Facility Name: | Irma Nacatoch (Sand) Unit 28 Tank Battery | |

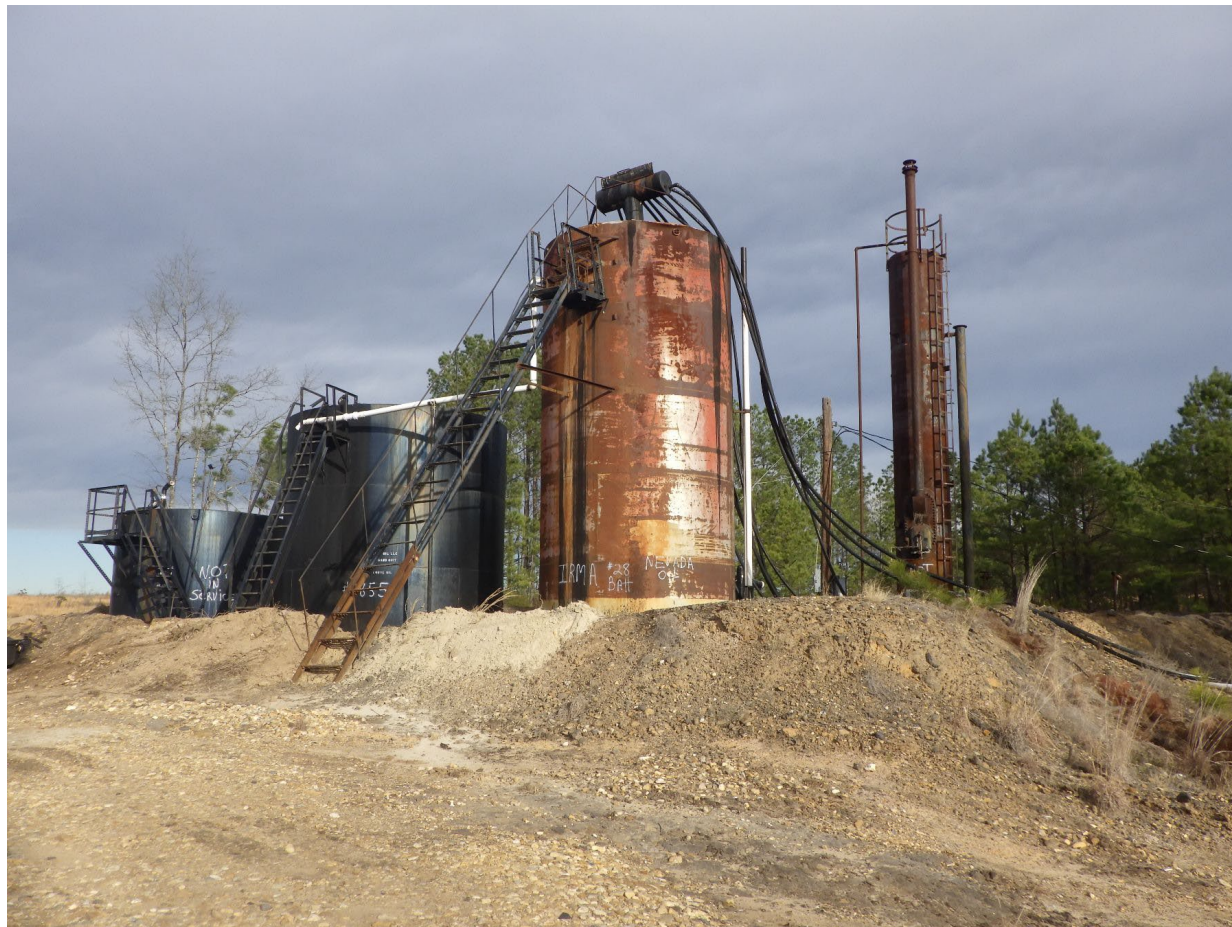
Photo No. 2

I observed the facility signage, tank battery, pipes and valves, storage tanks, and separators/treaters; see Appendix 1 (Photographs Log), see Photos No. 1 and No. 2. For additional GPS location and photo metadata, see Appendix 1.

| Description: | Looking SW, this photo shows an overview of the facility. | | |

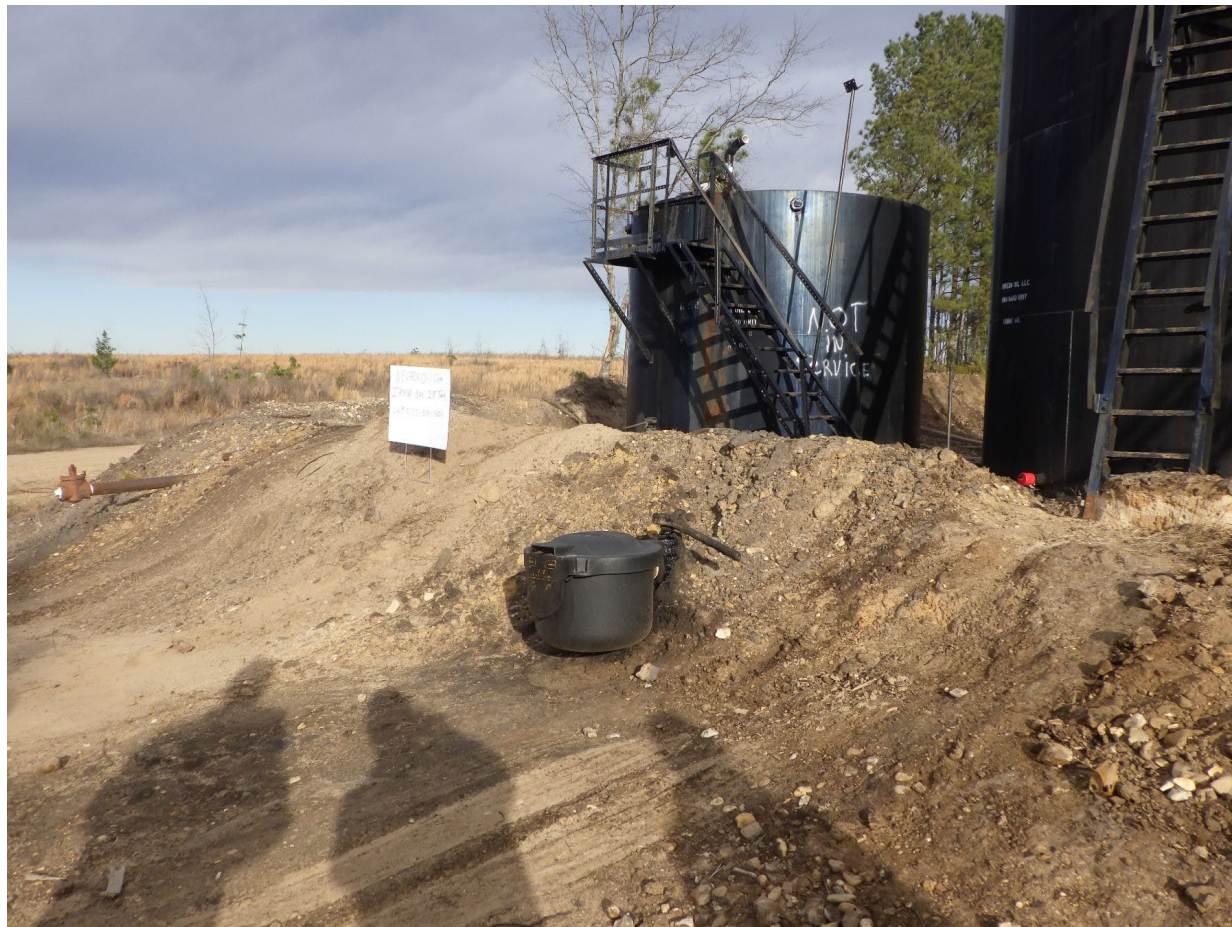
Photo No. 3

I observed the load line with a catchment bucket for secondary containment, see Photo No. 3.

| Description: | Looking SW, this photo shows the transfer line for the tank battery with a catchment bucket in place. | | |

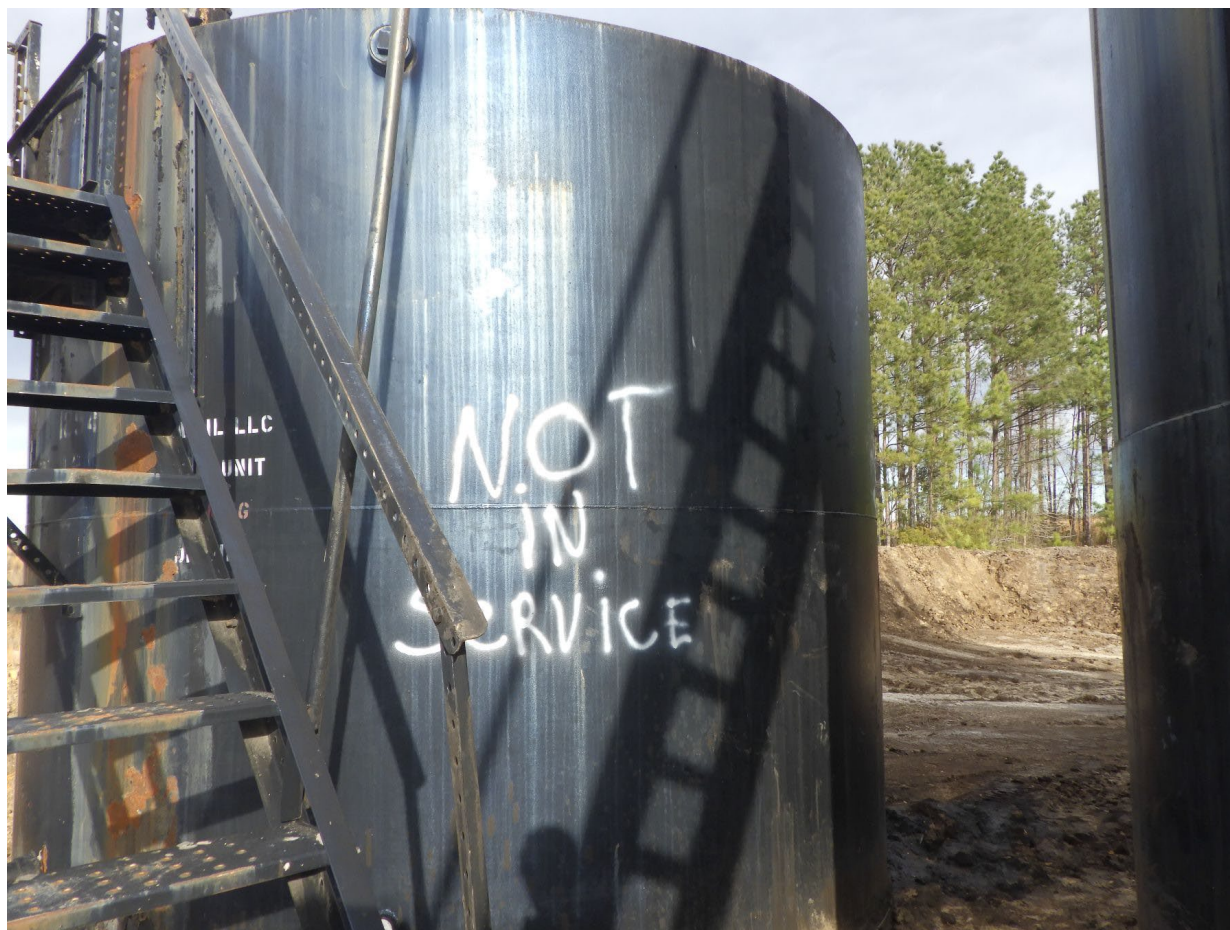
Photo No. 4

I observed a tank plated (i.e., with the manway removed) in preparation for permanent closure with “out of service” tagging, see Photos No. 4 and No. 5.

| Description: | Looking SW, this photo shows a tank that has been labeled "not in service" in preparation for permanent closure. | | |

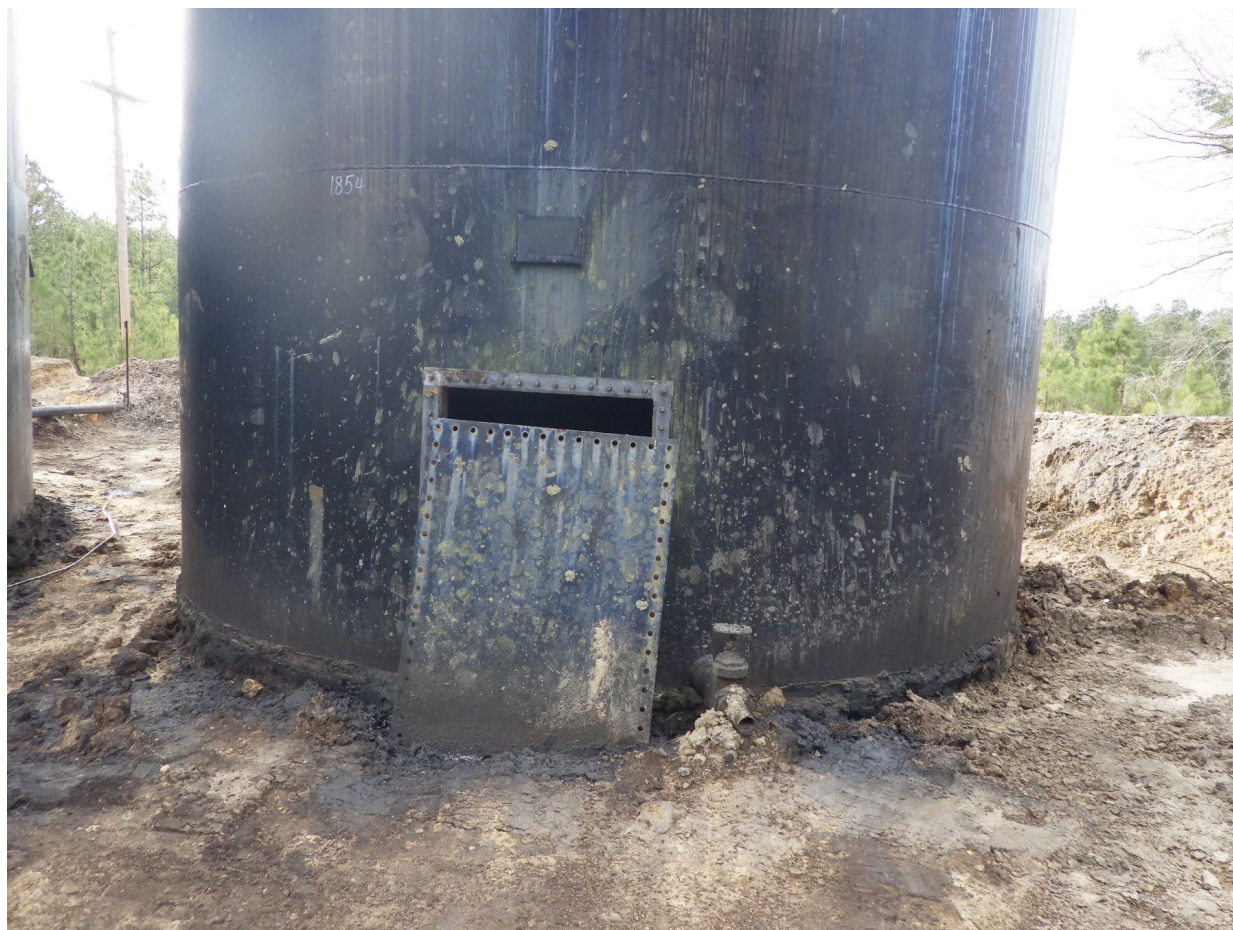
Photo No. 5

| Description: | Looking SSW, this photo shows the same tank from Photo No. 4 that Nevada Oil, LLC plated (i.e., removed the manway) in preparation for permanent closure. | | |

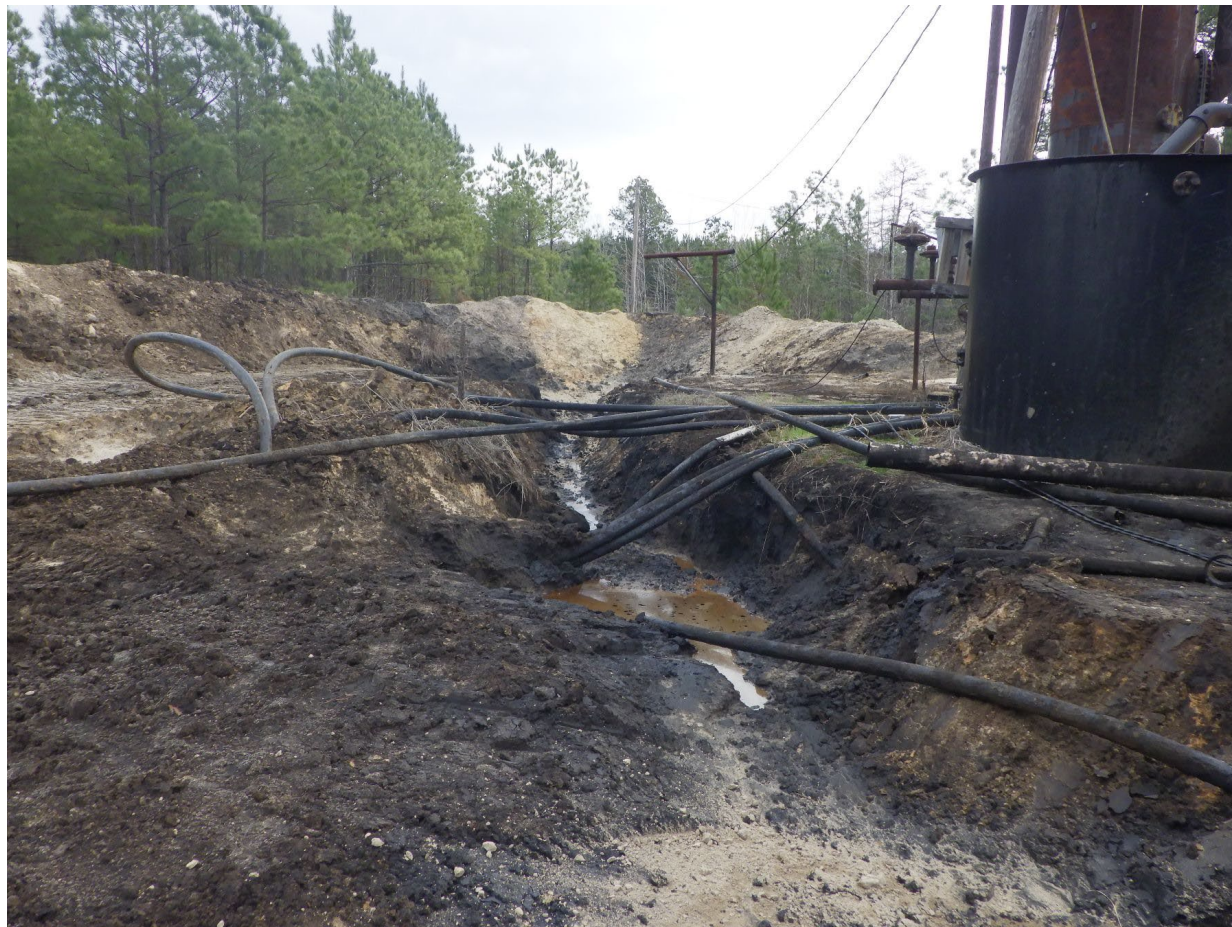
Photo No. 6

I observed the sump channel and pit with loose oil inside secondary containment, see Photos No. 6 and No. 7.

- Loose oil and saltwater inside secondary containment, 40 CFR 112.9(b)(1) (Photos No. 6 and No. 7), and
- Active leaks of oil from valves/couplings inside secondary containment, 40 CFR 122.9(d)(1) (Photos No. 8 through No. 10 and No. 13).

| Description: | Looking S, this photo shows the sump system for the facility and loose oil inside the tank battery. | | |

Inspector will conduct follow-up phone calls with the company representative(s) over the coming weeks and months to ensure areas of concern are properly addressed. SEE Inspector Tom McKay will address SPCC rule concerns.

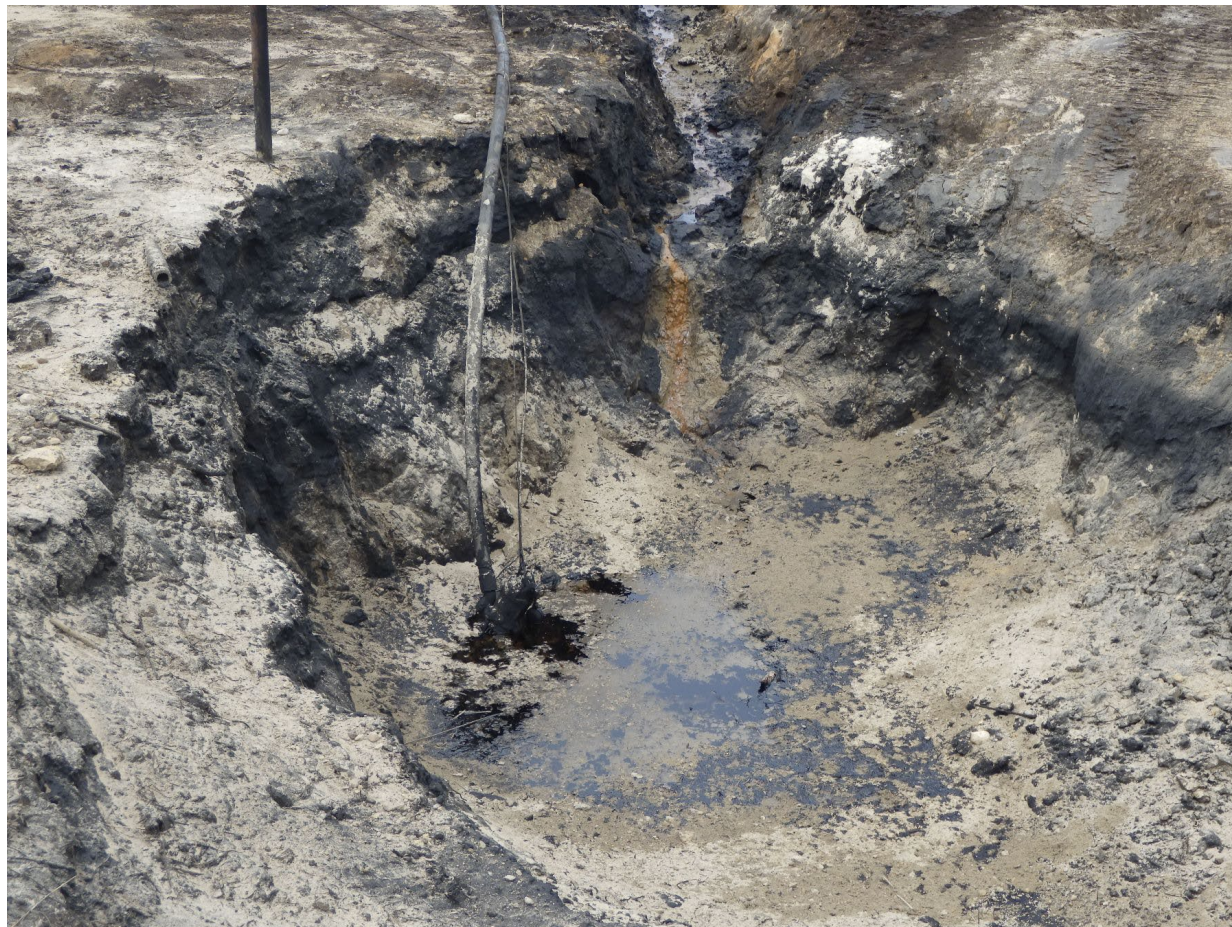
Photo No. 7

| Description: | Looking SW, this photo shows a close-up view of the sump area with sump pump and loose oil. | | |

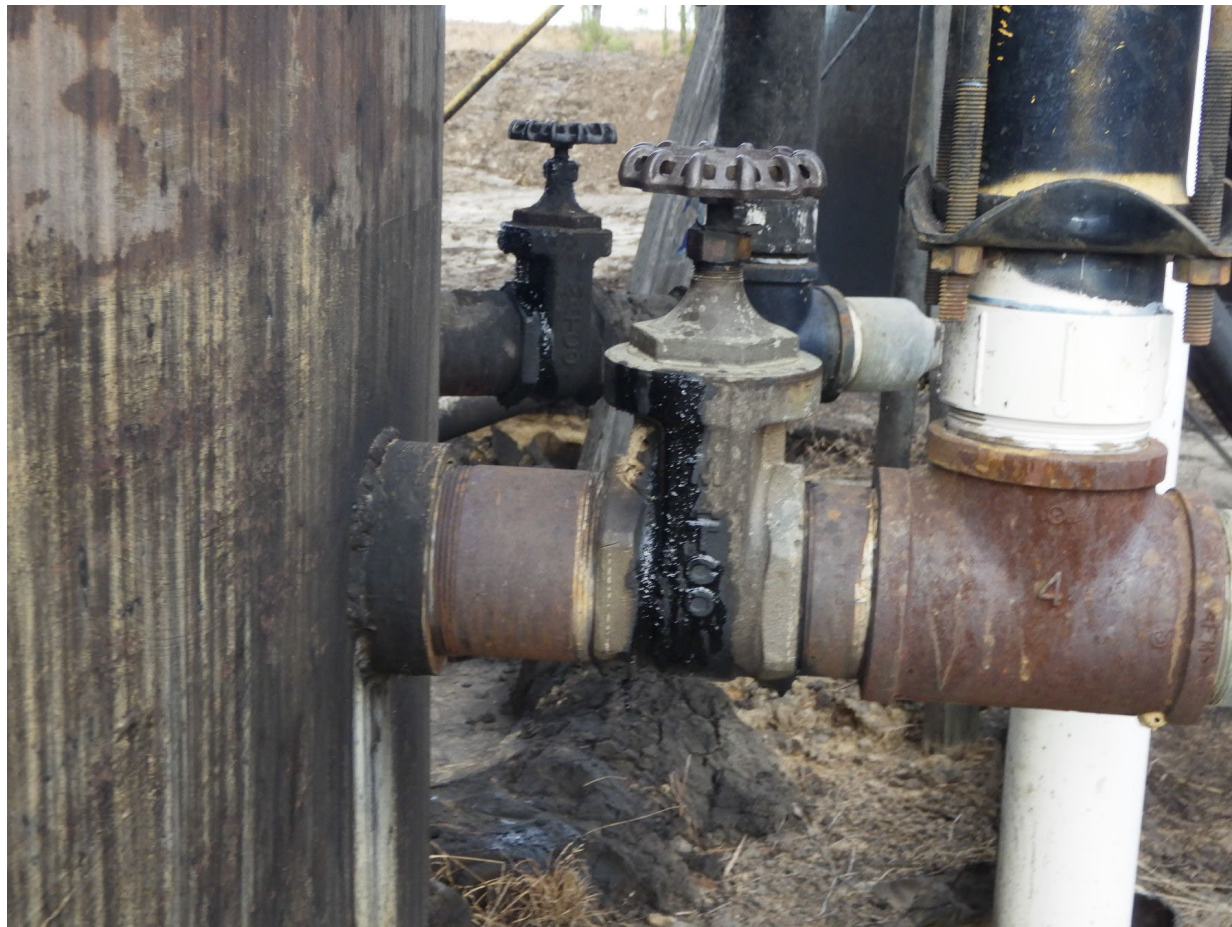
Photo No. 8

I observed active oil leaks from valves/couplings inside secondary containment, see Photos No. 8 through No. 10 and No. 13.

| Description: | Looking SW, this photo shows active leaks from valves at an oil storage tank. | | |

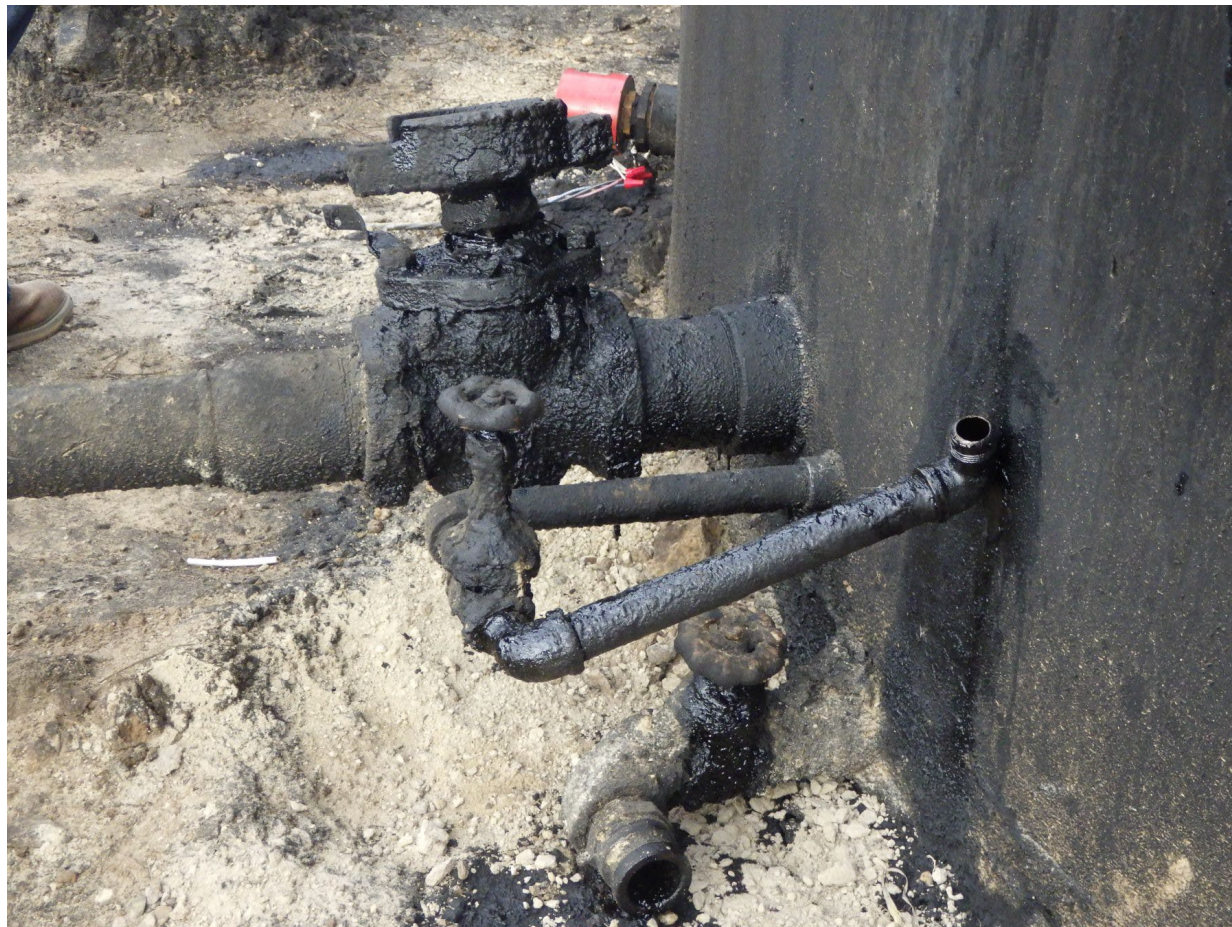
Photo No. 9

| Description: | Looking SW, this photo shows an additional active leak from a valve for one of the oil storage tanks. | | |

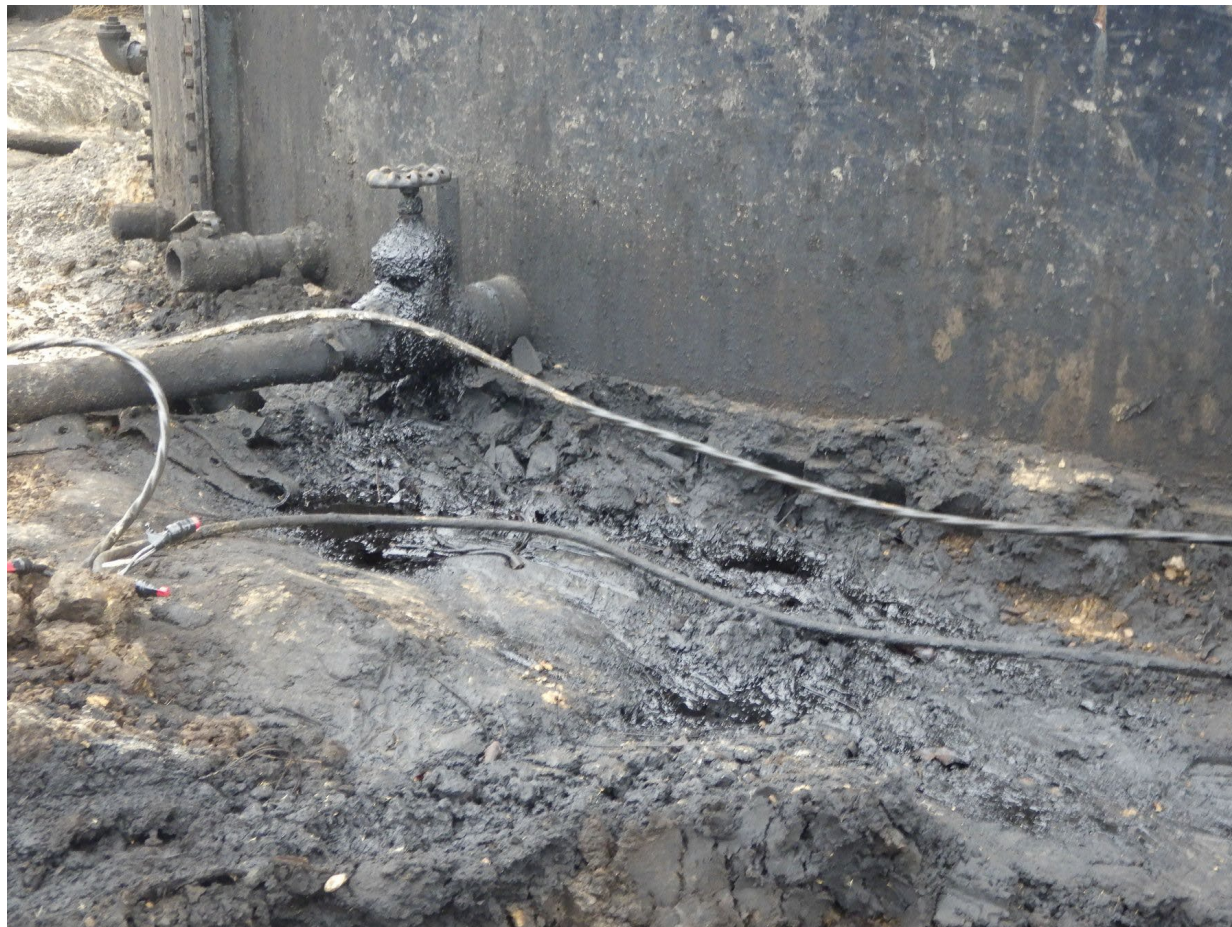
Photo No. 10

| Description: | Looking S, this photo shows an active leak from a valve for one of the oil storage tanks. | | |

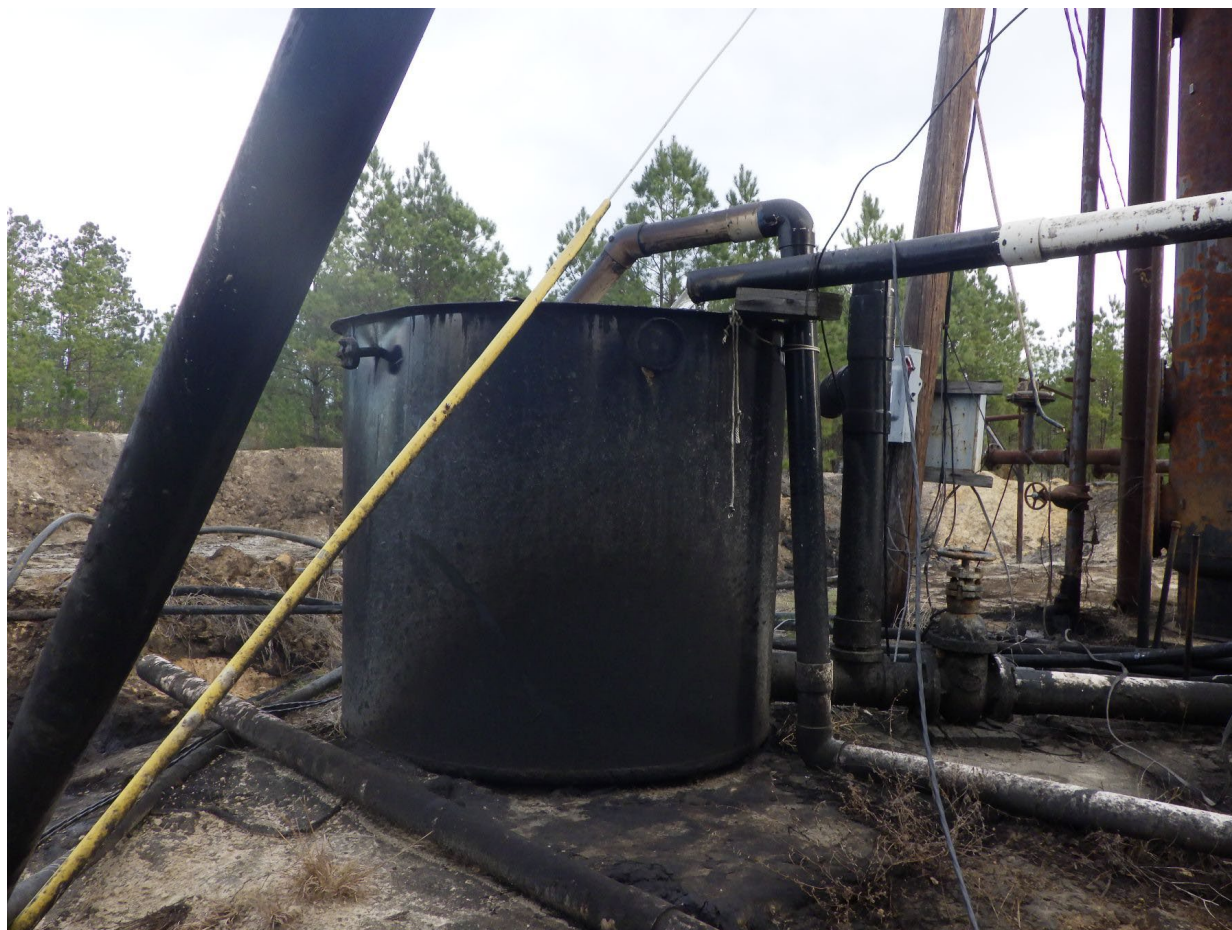
Photo No. 11

I observed an open-top skimming tank with gapping between the tank and battery surface, see Photos No. 11 and No. 12.

| Description: | Looking SSW, this photo shows an open-topped skimming tank for additional oil/water separation. | | |

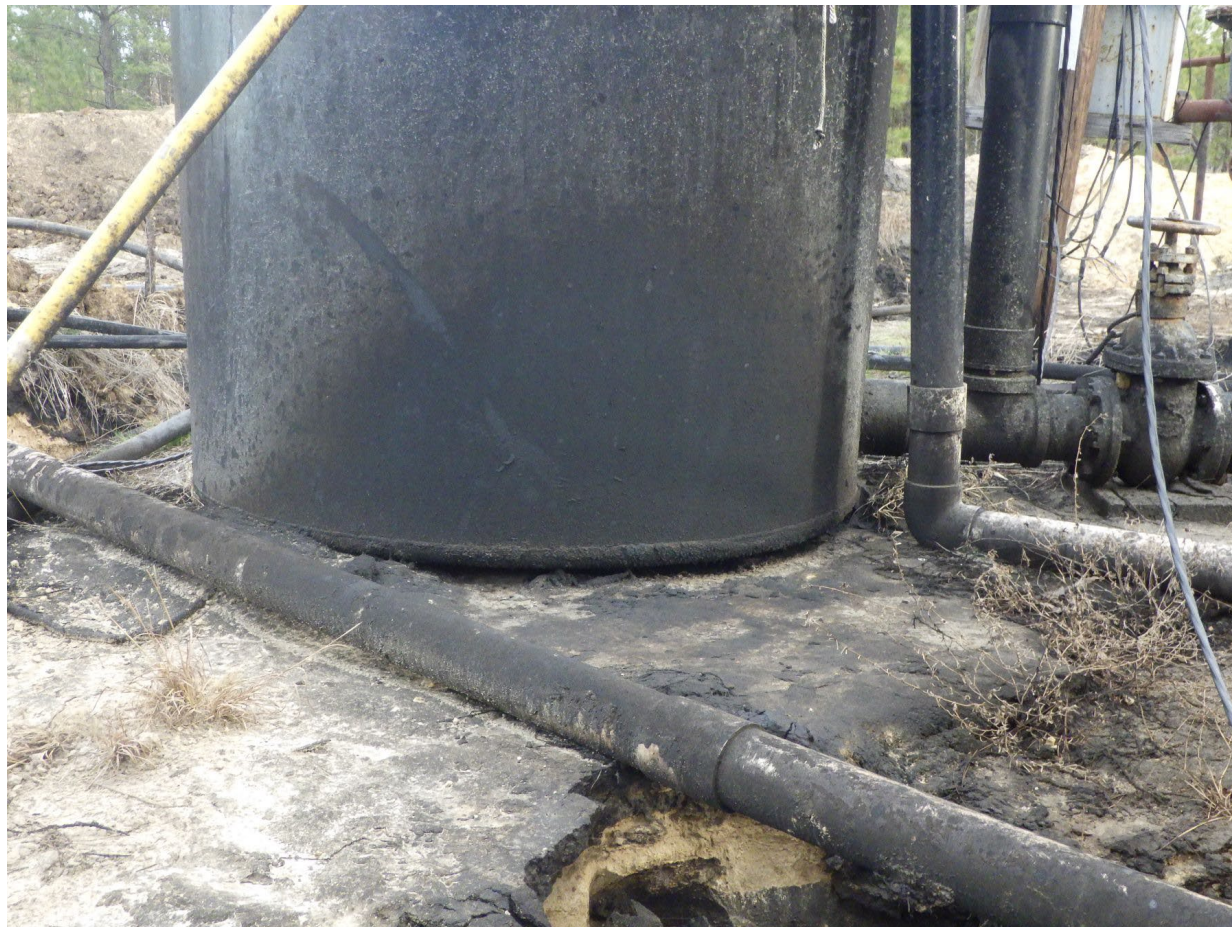
Photo No. 12

| Description: | Looking SSW, this photo shows a gap between a tank and the ground. | | |

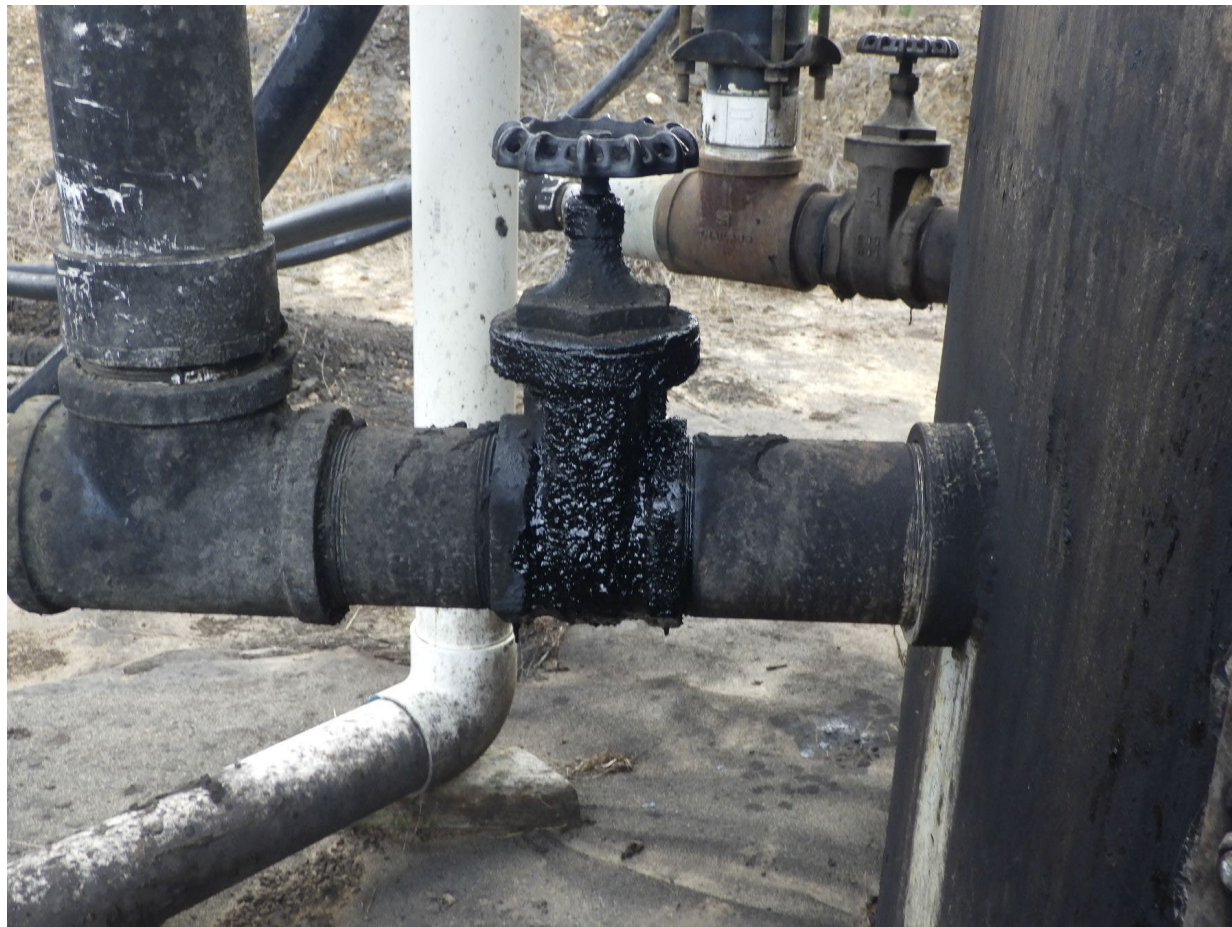
Photo No. 13

| Description: | Looking S, this photo shows an active leak from a valve for one of the oil storage tanks. | | |
