## **RCRA Inspection Report**

Austal USA–Austal West Campus  
100 Elmira Street  
Mobile, Alabama 36603

EPA ID# ALR000065755

August 17, 2022

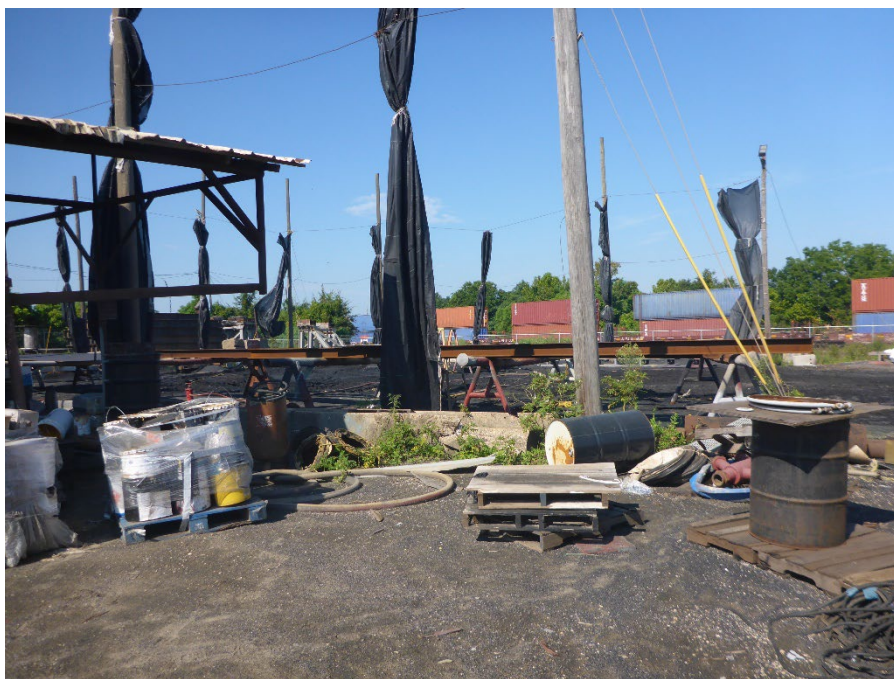
Outdoor Painting and Blasting Area: The inspection tour began at the Outdoor Painting and Blasting Area (Photo 1). This area consists of a covered area where new and used paints and painting equipment are used and stored next to an open-air area where blasting and painting operations are performed.

**Photo 1:** Outdoor Painting and Blasting Area.

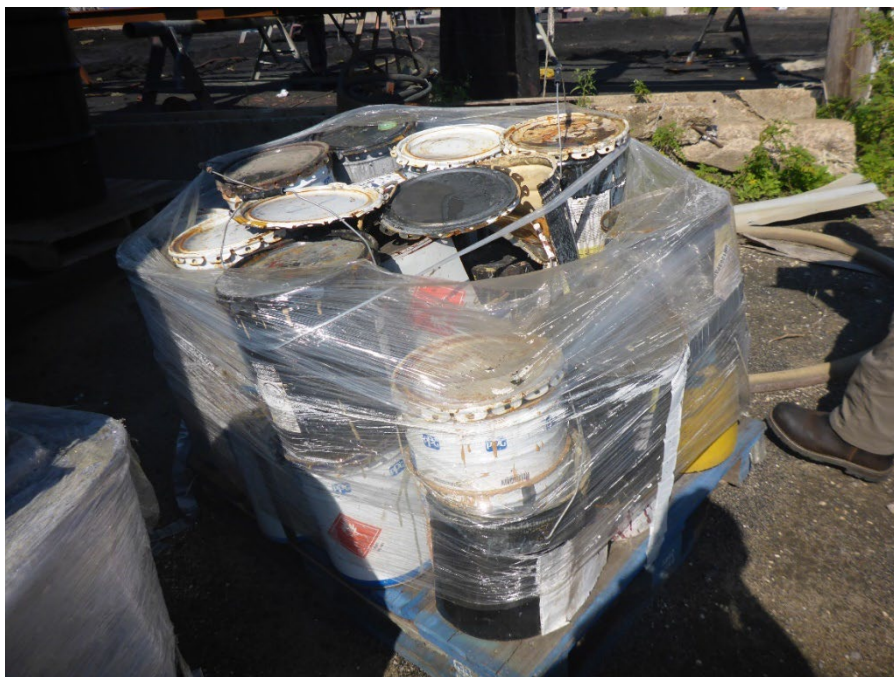
Mr. Hunt stated that RCRA-empty 1-gallon and 5-gallon paint cans are placed into a supersack and shipped off-site as solid waste (Photo 2). The inspectors noted that in order to qualify as RCRA-empty, personnel must first employ common practices to remove all waste paint from the container that can be removed. Furthermore, if any waste paint remains in the container because it cannot be removed, the remaining paint residual must weigh no more than 3% of the total capacity by weight of that container.

**Photo 2:** One shrink-wrapped pallet of emptied paint buckets in the Painting and Blasting Area.

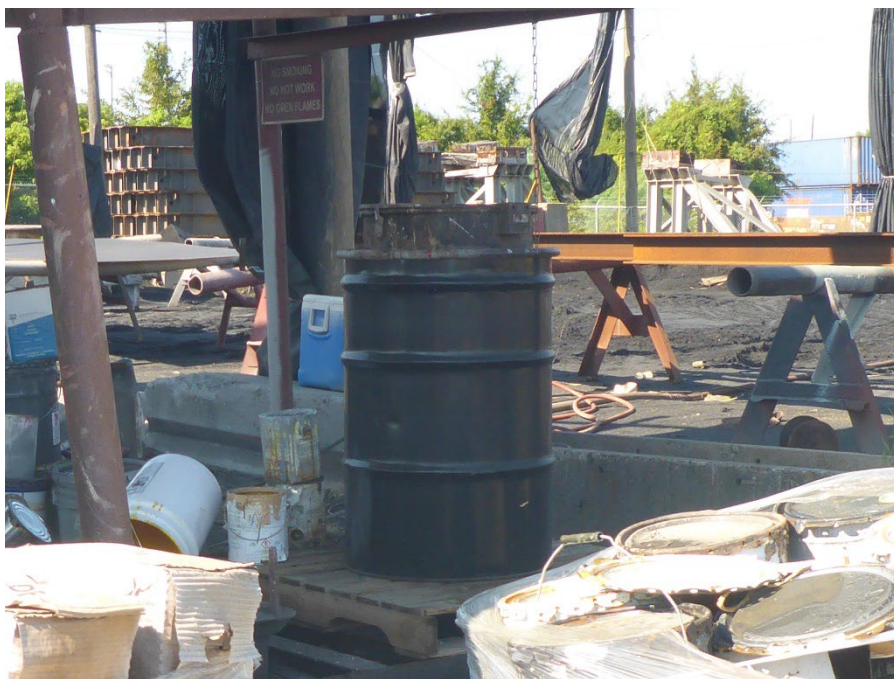
The inspectors observed one SAA in the covered area for accumulating hazardous waste paint and hazardous waste paint related material. One 55-gallon drum of hazardous waste paint (Photo 3), approximately thirty 1-gallon or 5-gallon containers of hazardous waste paint (Photo 4), and one transport pallet with hazardous waste paint (Photo 4) were observed in this SAA. The 55-gallon drum was not labeled as hazardous waste, and it was not marked with an indication of the hazards of its contents. The 1-gallon and 5-gallon containers were open and not labeled as hazardous waste. The transport pallet, which was approximately 5'x5' square and 8-10" deep, was open and not labeled as hazardous waste. Mr. Hunt explained that this pallet was present at the facility when it was purchased from MARRS, and that Austal USA has never emptied the pallet or moved it from this position. The inspectors observed an excess of 55-gallons of hazardous waste in this SAA, and none of the containers were marked with an accumulation start date. It appears that hazardous waste has been stored in this area since the facility was purchased in October 2020.

**Pursuant to ADEM Admin. Code r.335-14-3-.01(5)(a)4. [40 C.F.R. § 262.15(a)(4)], which is a condition of the SAA Permit Exemption, a generator is required to keep containers of hazardous waste closed at all times during accumulation, except when adding, removing, or consolidating waste; or when temporary venting of a container is necessary for the proper operation of equipment, or to prevent dangerous situations, such as build-up of extreme pressure.**

**Pursuant to ADEM Admin. Code r.335-14-3-.01(5)(a)5. [40 C.F.R. § 262.15(a)(5)], which is a condition of the SAA Permit Exemption, a generator is required to mark**

or label its containers with the words “Hazardous Waste” and with an indication of the hazards of the contents.

**Photo 3:** One 55-gallon drum in the SAA at the Outdoor Painting and Blasting Area.

When the inspectors voiced concerns over the general housekeeping of this SAA and the number of 1-gallon and 5-gallon buckets of waste paint that were being improperly managed in this area, Mr. Hunt stated that he intended to create a standard operating procedure (SOP) for managing buckets of paint in this area when that paint becomes a waste. Under the new SOP, Mr. Hunt intends to have paint emptied from buckets no later than the end of the workday in which the bucket of paint becomes a waste. This SOP should improve the general housekeeping in this area and minimize the presence of 1-gallon and 5-gallon buckets containing waste paint.

In an email dated August 19, 2022, Mr. Hunt indicated that the contents of the 1-gallon and 5-gallon paint containers were removed, and the RCRA-empty containers were taken to the warehouse CAA for packaging and disposal. He also indicated that the transport pallet was cleaned out to be used as secondary containment, and the volume of hazardous waste has been reduced to less than 55-gallons per SAA. Mr. Hunt also provided photographs which document the condition of the Blasting and Painting Area before and after the inspection. No 1-gallon or 5-gallon paint containers were observed in the photographs of the area taken following the inspection.

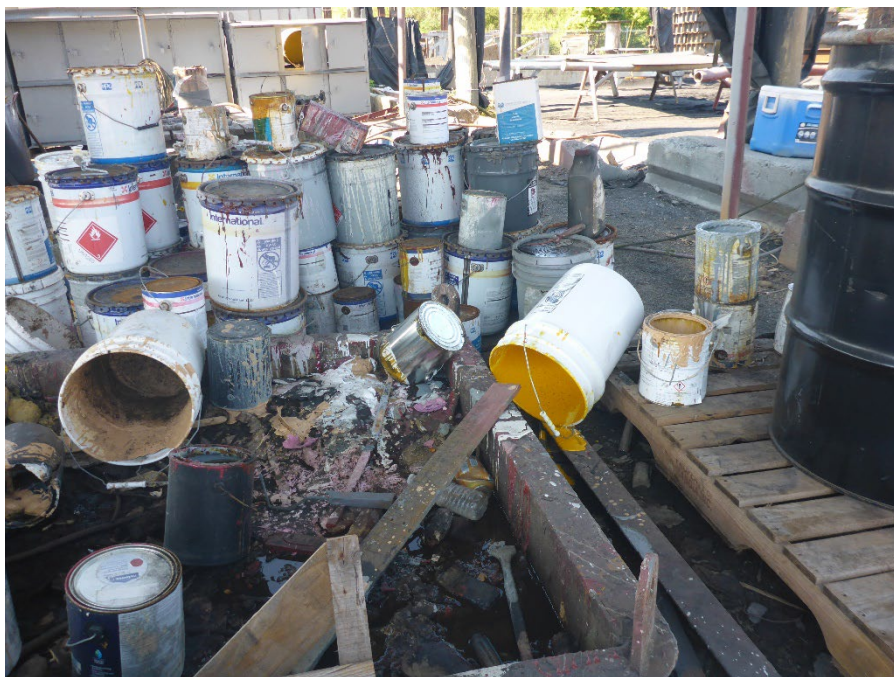
**Pursuant to ADEM Admin. Code r.335-14-3-.01(5)(a)6. [40 C.F.R. § 262.15(a)(6)], which is a condition of the SAA Permit Exemption, a generator who accumulates hazardous waste in excess of 55-gallons at or near any point of generation must do the following: (i) comply within three consecutive calendar days with the applicable CAA regulations in 335-14-3-.01(6)(b) or (7)(a), or (ii) remove the excess from the SAA within three consecutive calendar days to either a CAA operated in accordance with the applicable requirements in 335-14-3-.01(6)(b) or (7)(a), an on-site interim status or permitted treatment, storage, or disposal facility, or an off-site designated facility; and (iii) during the three consecutive-calendar-day period the generator must continue to comply with 335-14-3-.01(5)(a)1. Through 5. The generator must mark or label the container(s) holding excess accumulation of hazardous waste with the date the excess amount began accumulating.**

**Pursuant to ADEM Admin. Code r.335-14-3-.01(7)(b) [40 C.F.R. § 262.17(b)], a LQG who accumulates hazardous waste for more than 90 days is subject to the requirements of 335-14-5 through 9, unless it has been granted an extension to the 90-day period.**

**Photo 4:** Approximately thirty 1-gallon and 5-gallon containers of waste paint and one transport pallet with hazardous waste paint in the Painting and Blasting Area SAA.

In an email dated August 23, 2022, Mr. Hunt provided a photograph of the transport pallet showing that all waste paint and debris had been removed from the pallet.

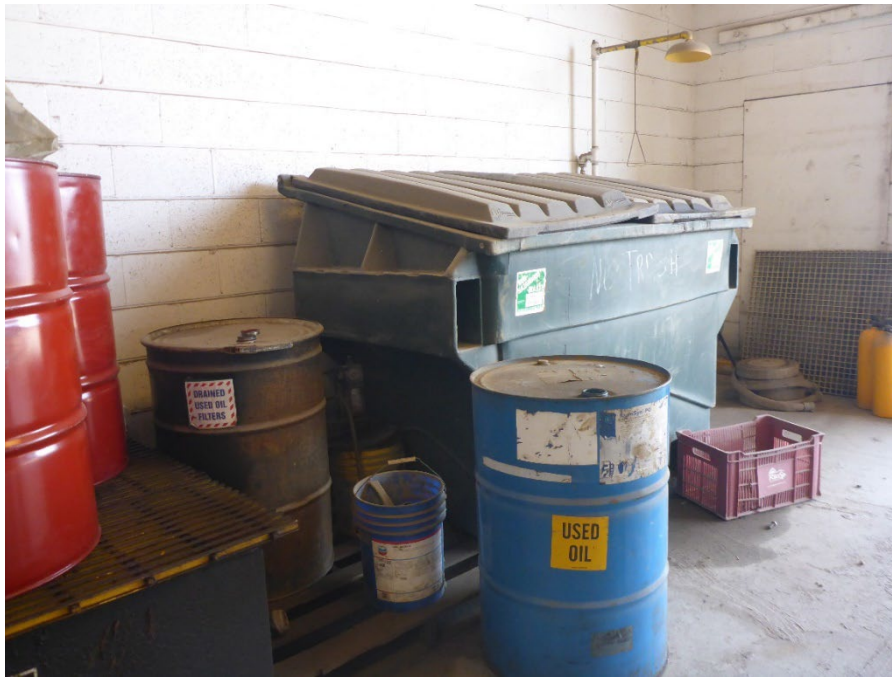
The inspectors observed two secondary containment units that were each labeled “used oil”, one 55-gallon drum labeled “drained used oil filters”, one 55-gallon drum labeled “used oil”, and one 3-yard trash dumpster labeled “oily debris” along the wall to the right just inside the warehouse door (Photo 5). Each of the secondary containment units was covered by an open grate, and the inspectors explained that this grate is not sufficient to close the secondary containment container as required by ADEM Admin. Code r. 335-14-17-.03(4)(a)1. [40 C.F.R. § 279.22]. At the time of the inspection, one of the secondary containment units observed in this area was not required to be closed because it was empty. The other secondary containment unit was not required to be closed because it was accumulating used oil from three 55-gallon drums that were placed upside-down on top of the open grate (Photo 6).

**Photo 5:** One 55-gallon drum labeled drained used oil filters, one 55-gallon drum labeled used oil, and one 3-yard trash dumpster labeled oily debris located along the wall to the right just inside the CAA.

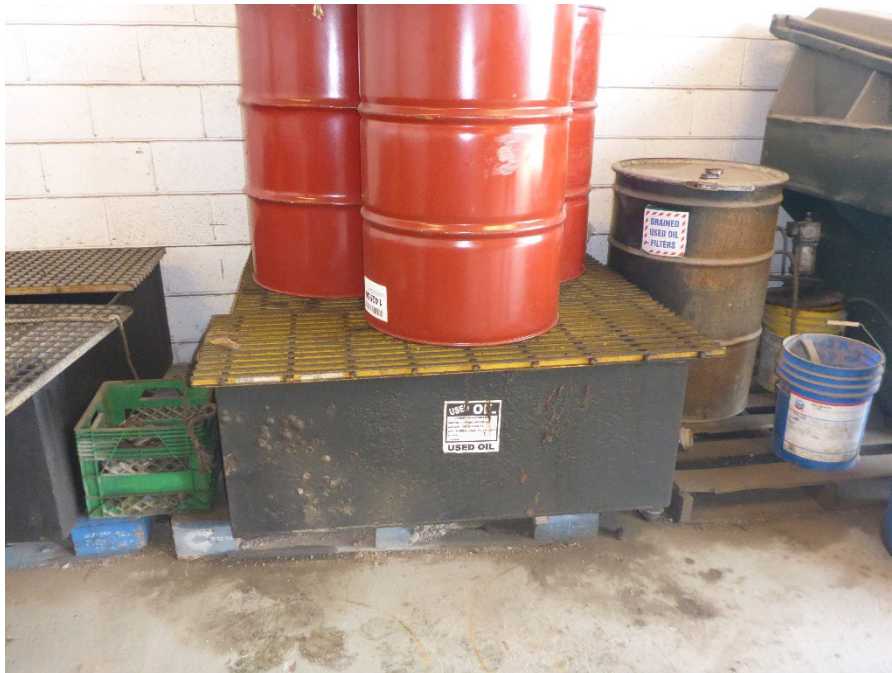
**Photo 6:** Secondary containment pallet accumulating used oil from 55-gallon drums in the CAA warehouse.

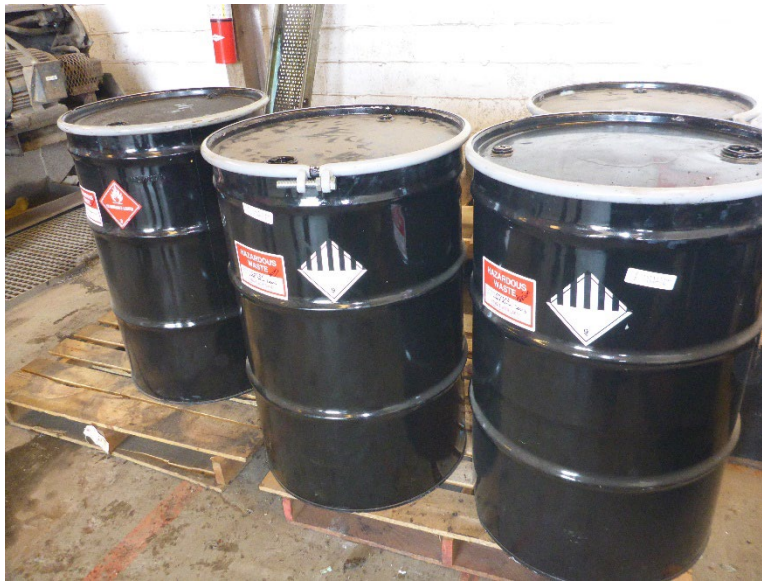
- Six were labeled as “oily debris”.
- One was labeled as “loose pack liquids”.
- Two were labeled hazardous waste barium debris, identified with a class 9 DOT hazard placard, and dated August 17, 2022 (Photo 7). Neither of these drums were marked with the EPA hazardous waste codes or with an indication that the contents are hazardous due to toxicity.
- One was labeled hazardous waste flammable liquid, identified with a flammable liquid DOT hazard placard, and dated August 17, 2022 (Photo 7). The drum was not marked with the EPA hazardous waste codes.
- One was empty.

**Pursuant to ADEM Admin. Code r. 335-14-3-.01(7)(a)5.(i)b. and d. [40 C.F.R. § 262.17(a)(5)(i)], which is a condition of the LQG Permit Exemption, a generator is required to mark or label containers with an indication of the hazards of the contents clearly visible for inspection on each container; and all appropriate EPA hazardous waste numbers associated with the hazardous waste as specified in 335-14-2-.03 and 335-14-2-.04.**

**Photo 7:** One 55-gallon drum labeled hazardous waste flammable liquid, and two 55-gallon drums labeled hazardous waste barium debris on wooden pallets in the CAA warehouse. The containers of hazardous waste barium debris were not marked to indicate that the contents are hazardous due to toxicity, and none of the drums were marked with the EPA hazardous waste codes.

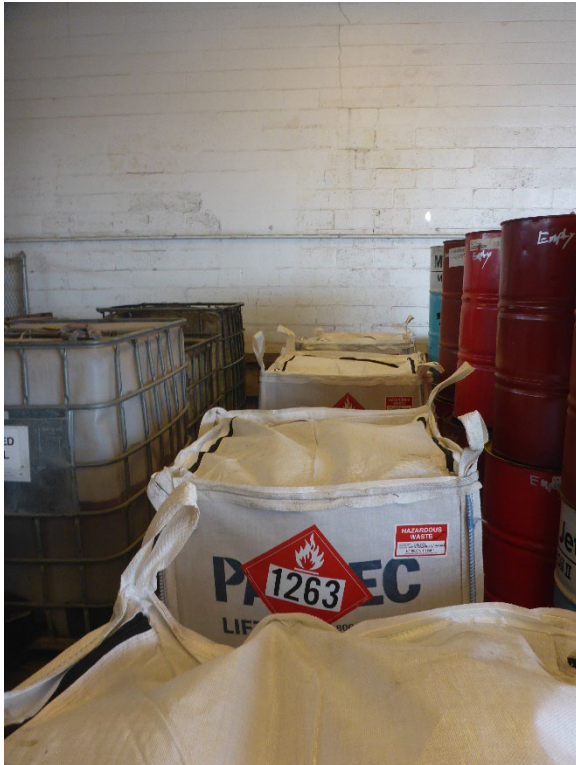
To the left of the 55-gallon drums listed above, the inspectors observed one row of empty drums and one supersack of oily debris and a second row of three supersacks of hazardous waste (Photo 8). Each supersack was labeled hazardous waste paint related material, identified with a flammable DOT hazard placard, and dated August 17, 2022. According to the facility’s hazardous waste manifest records, waste paint related materials generated on-site exhibit the hazardous waste characteristic of ignitability and toxicity. None of the containers of hazardous waste paint related material were marked with the EPA hazardous waste codes or with an indication that their contents are hazardous due to toxicity.

**Pursuant to ADEM Admin. Code r. 335-14-3-.01(7)(a)5.(i)b. and d. [40 C.F.R. § 262.17(a)(5)(i)], which is a condition of the LQG Permit Exemption, a generator is required to mark or label containers with an indication of the hazards of the contents clearly visible for inspection on each container; and all appropriate EPA hazardous waste numbers associated with the hazardous waste as specified in 335-14-2-.03 and 335-14-2-.04.**

Although facility personnel initially identify solid and liquid paints and other solid wastes contaminated with paint as hazardous waste paint and/or hazardous waste paint related material at the Blasting and Painting Area SAA, Mr. Hunt explained that the facility's vendor completes the hazardous waste determination when the drum is being prepared for shipment in the CAA. Mr. Hunt explained that the vendor reviews Safety Data Sheets (SDSs) for paints to determine the EPA Hazardous Waste Numbers associated with each drum of hazardous waste and identifies drums that may require sampling and analysis to complete the hazardous waste determination. Because ADEM Admin. Code r. 335-14-3-.01(2) [40 C.F.R. § 262.11], requires a person who generates a solid waste to make an accurate hazardous waste determination in order to ensure wastes are properly managed, the inspectors recommended that the hazardous waste determination be completed at or before the time that the waste is generated.

**Photo 8:** Row of three supersacks of hazardous waste paint related material in the CAA warehouse. Each supersack was labeled hazardous waste paint related material, identified with a flammable DOT hazard placard, and dated August 17, 2022. The containers were not marked with EPA hazardous waste codes or with an indication that their contents are hazardous due to toxicity.

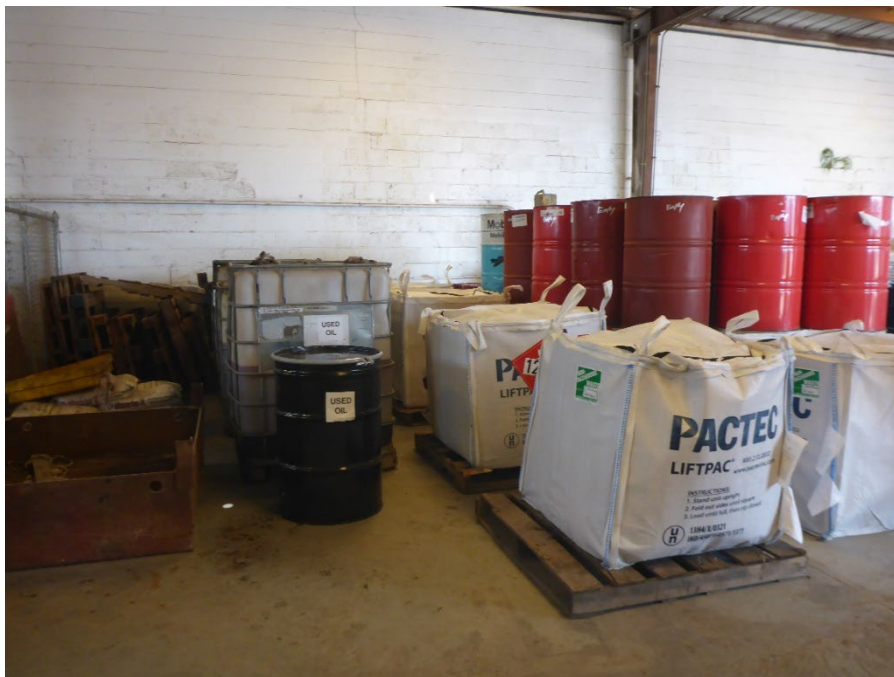
The inspectors observed that the available aisle spacing between rows of used oil tote, hazardous waste supersacks, and empty drums was not sufficient to allow for the unobstructed movement of personnel, fire protection equipment, spill control equipment, and decontamination equipment in an emergency (Photo 9). In an email dated August 19, 2022, Mr. Hunt provided a photograph demonstrating adequate aisle spacing that was provided between these rows following the inspection.

**Pursuant to ADEM Admin. Code r. 335-14-3-.01(7)(a)6. [40 C.F.R. § 262.17(a)(6)], which incorporates 335-14-3-.14(6) [40 C.F.R. § 262.255] and is a condition of the LQG Permit Exemption, a LQG must maintain aisle space to allow the unobstructed movement of personnel, fire protection equipment, spill control equipment, and decontamination equipment to any area of facility operation in an emergency, unless aisle space is not needed for any of these purposes.**

**Photo 9:** Rows of used oil totes, hazardous waste supersacks and empty drums without sufficient aisle spacing in the CAA warehouse.

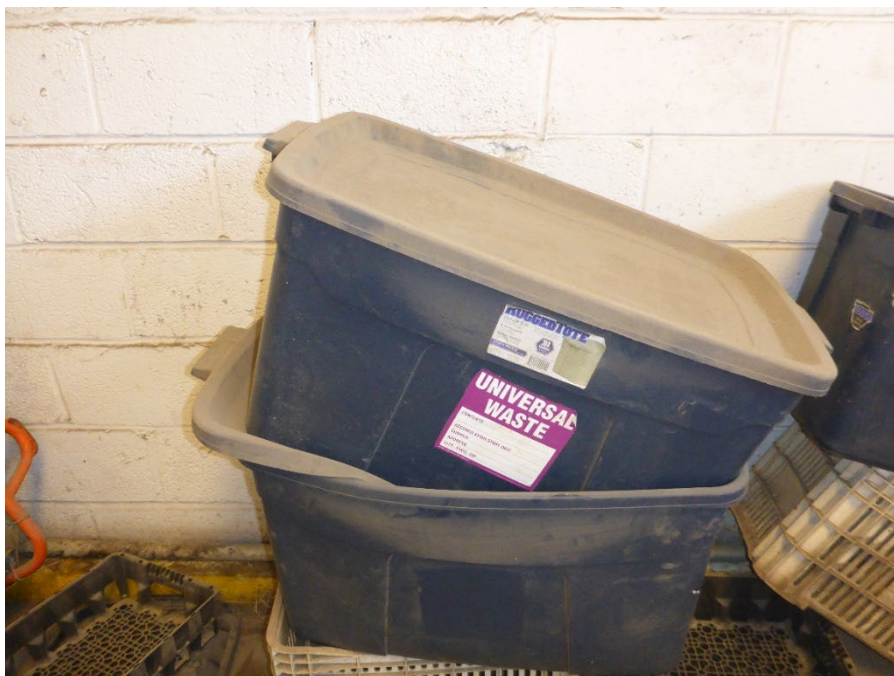
Austal USA also accumulates and manages universal waste inside the warehouse CAA. Manifest records indicate that the facility shipped universal waste mercury contained in manufactured

articles to Complete Environmental (MSR000101121) on August 23, 2021, and to Lighting Resources (FLR000070565) on December 1, 2021. However, all containers labeled universal waste were empty (Photo 10), and no universal waste was observed during the inspection.

**Photo 10:** Empty container labeled universal waste in the near left corner of the CAA warehouse.

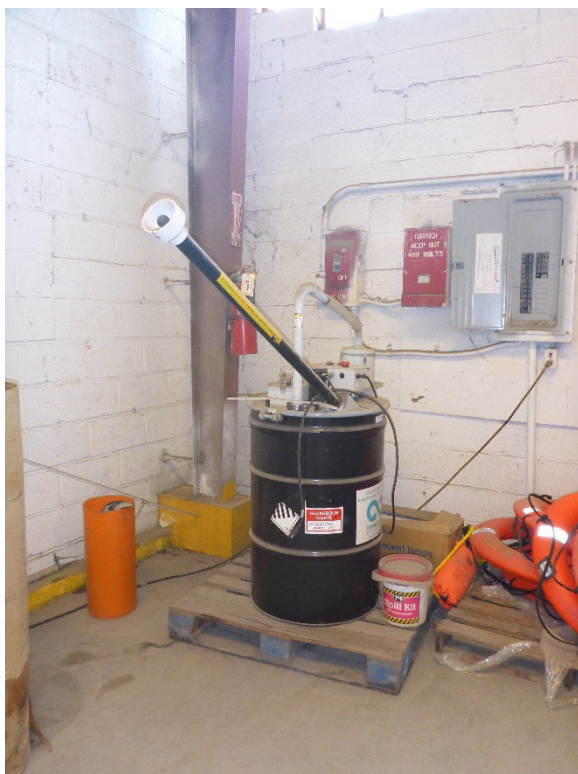
Bulb Crusher SAA: Austal USA manages a SAA for accumulating hazardous waste generated from crushing fluorescent bulbs in the near left corner of the CAA warehouse. The inspectors observed one 55-gallon drum, which was equipped with a bulb-crusher unit, in this SAA (Photo 11). The drum was labeled hazardous waste crushed bulbs (mercury) and identified with a Class 9 DOT hazard placard. It was not identified with an indication that its contents are toxic.

**Pursuant to ADEM Admin. Code r.335-14-3-.01(5)(a)5.(ii) [40 C.F.R. § 262.15(a)(5)(ii)], which is a condition of the SAA Permit Exemption, a generator is required to mark or label its containers with an indication of the hazards of the contents.**

**Photo 11:** One 55-gallon drum equipped with a bulb-crusher unit in the SAA in the near left corner of the CAA warehouse. The drum was not identified with an indication that its contents are toxic.

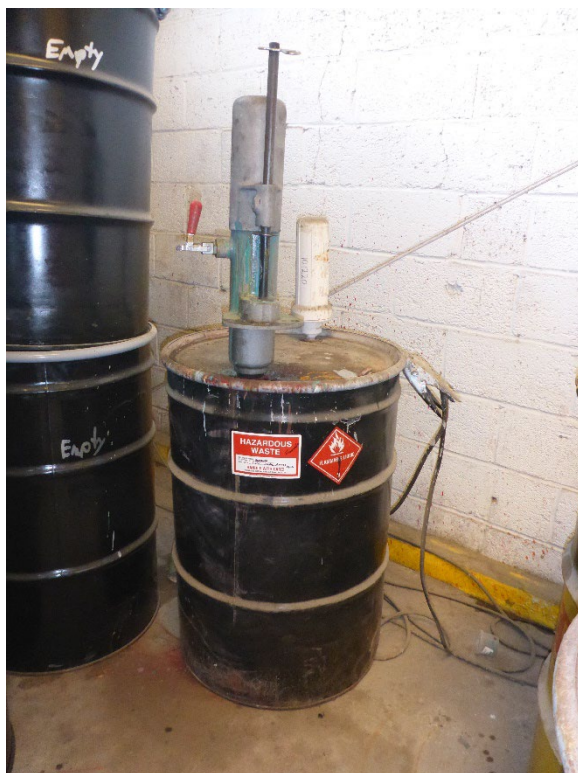
Aerosol Can SAA: Austal USA manages a SAA for accumulating hazardous waste generated from puncturing aerosol cans in the far-left corner of the CAA warehouse. The inspectors observed one 55-gallon drum, which was equipped with a can puncturing device, in this SAA (Photo 12). The drum was labeled hazardous waste aerosols and identified with a flammable liquid DOT hazard placard. The inspectors also observed a salvage drum labeled hazardous waste aerosols located next to the 55-gallon drum (Photo 13), but this salvage drum was empty.

**Photo 12:** One 55-gallon drum equipped with a can puncturing device in the SAA located at the far-left corner inside the CAA warehouse.

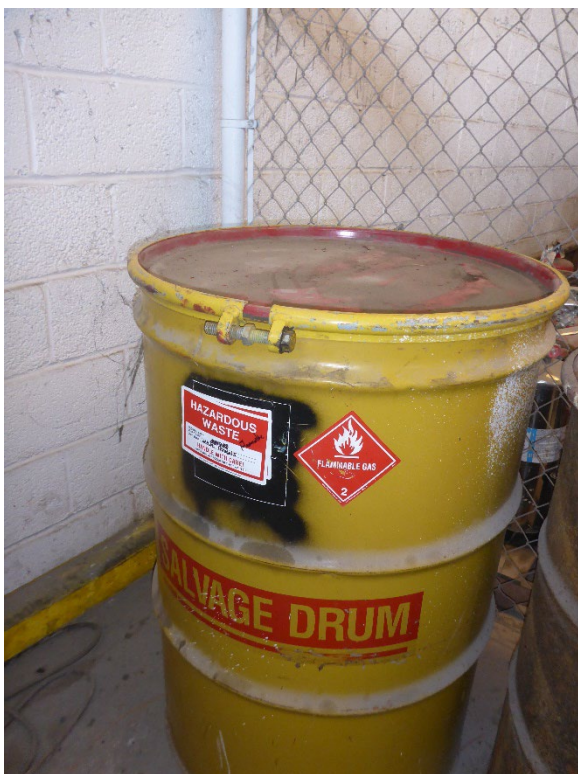
**Photo 13:** Empty salvage drum labeled hazardous waste aerosols located in the SAA at the far-left corner inside the CAA warehouse.
