INSPECTION REPORT

| Type of Inspection | Focused Compliance Inspection (FCI) | | | |
| Facility or Site Name | Cooper/Ports America | | | |
| Type of Operation | Cooper/Ports America is a facility that loads and unloads cargo from vessels. | | | |

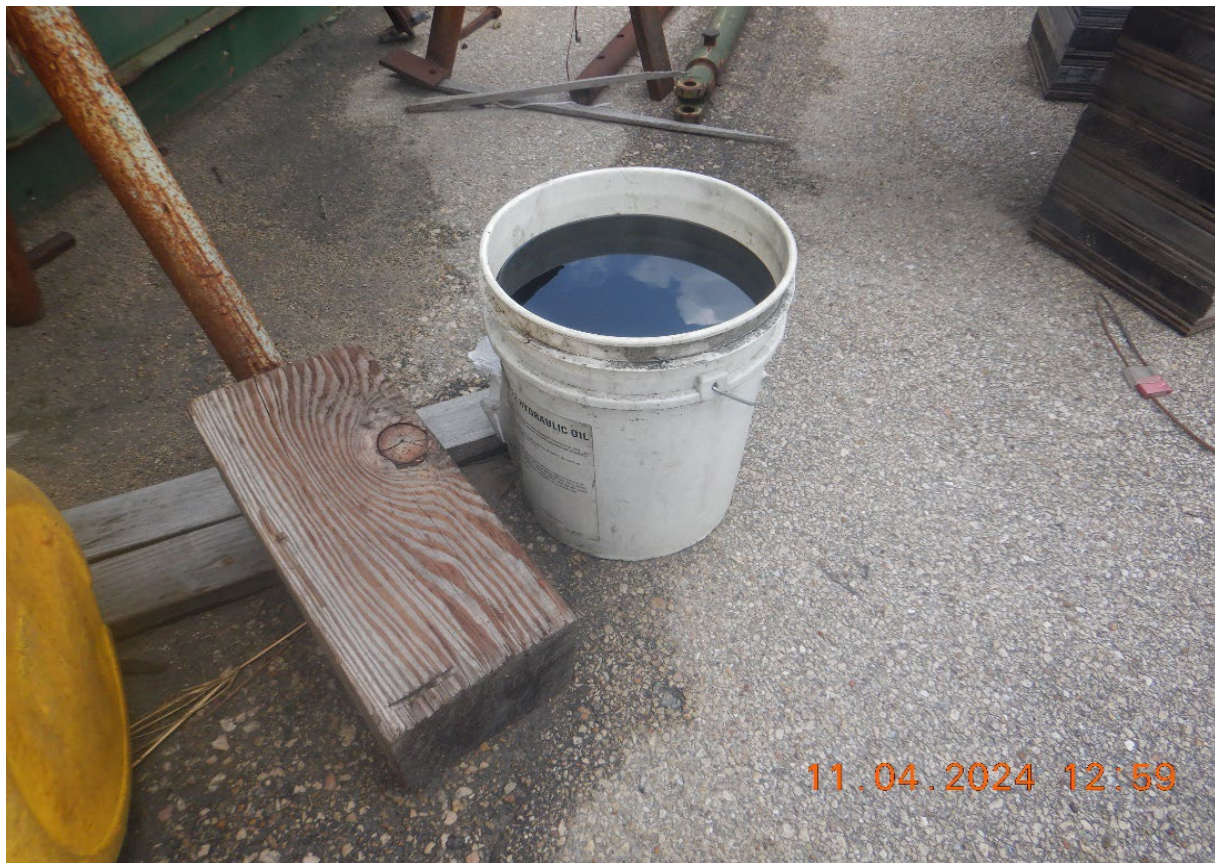
**Photo No. 1**

Description: View of a 5-gal container storing oil found next to the fuel tank shed. CPA did not verify with the inspection team if the contents of the container were product or waste at the time of the inspection.

| <b>Tenant:</b> Cooper/Ports America | | |
|---|---|---|
| <b>AOC #1</b> – CPA did not make a waste determination on the contents of a bucket. | <b>Citation:</b> 40 CFR 262.11 | Section: 2.1 |

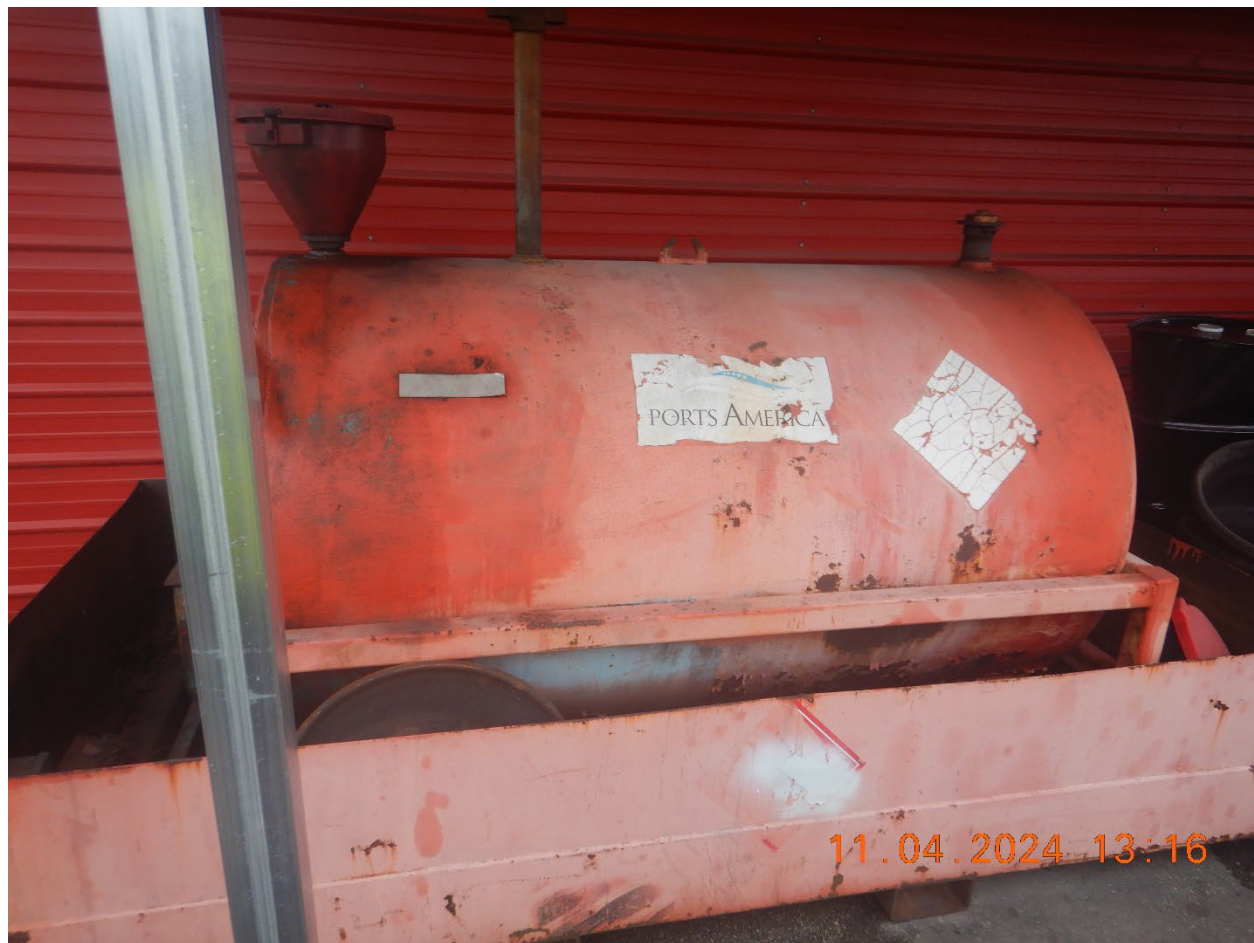
**Photo No. 2**

Description: View a 500-gal used oil recovery tank in the used oil storage area that was not labeled "Used Oil". The tank was closed and in good condition.

| <b>Tenant:</b> Cooper/Ports America | | |
|---|---|---|
| <b>AOC #2</b> – CPA did not clearly label containers used to store used oil with the words “Used Oil.” | <b>Citation:</b> 40 CFR 279.22 (c)(1) | Section: 2.1 |

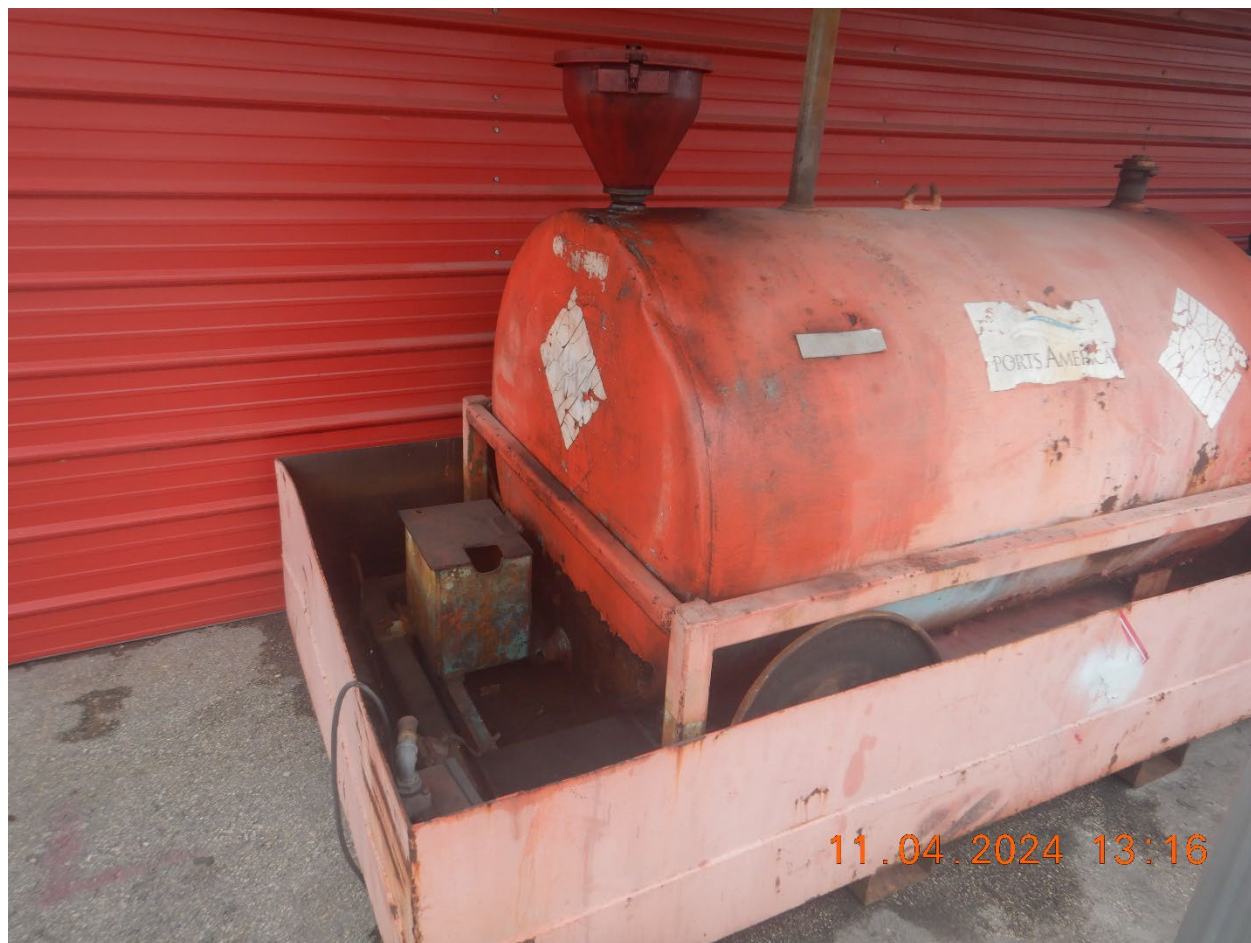
**Photo No. 3**

Description: View a 500-gal used oil recovery tank in the used oil storage area that was not labeled "Used Oil."  
The tank was closed and in good condition

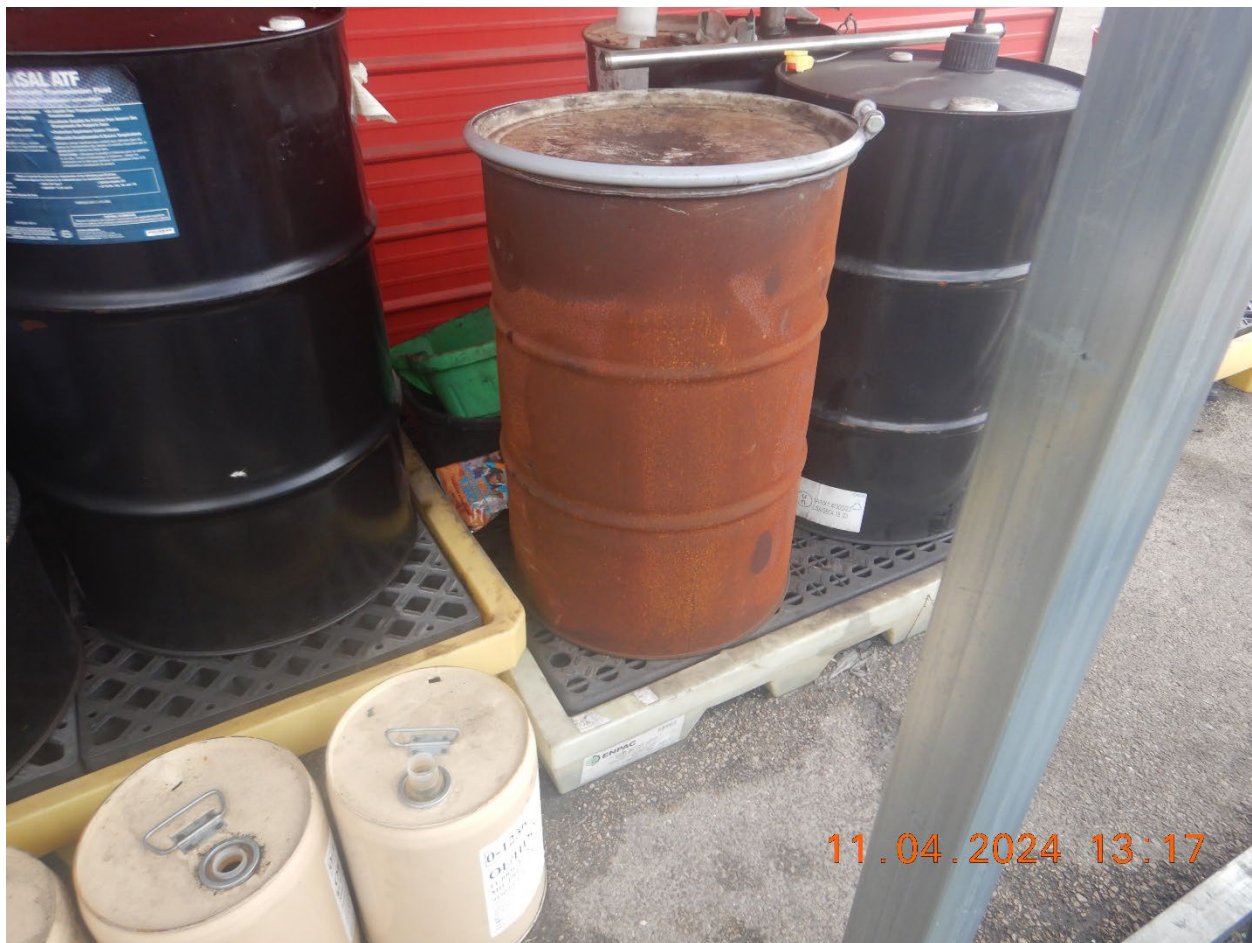
**Photo No. 4**

Description: View of two 55-gal drums that contained used oil and were not labeled "Used Oil" in the used oil storage area. The containers were closed and in good condition.

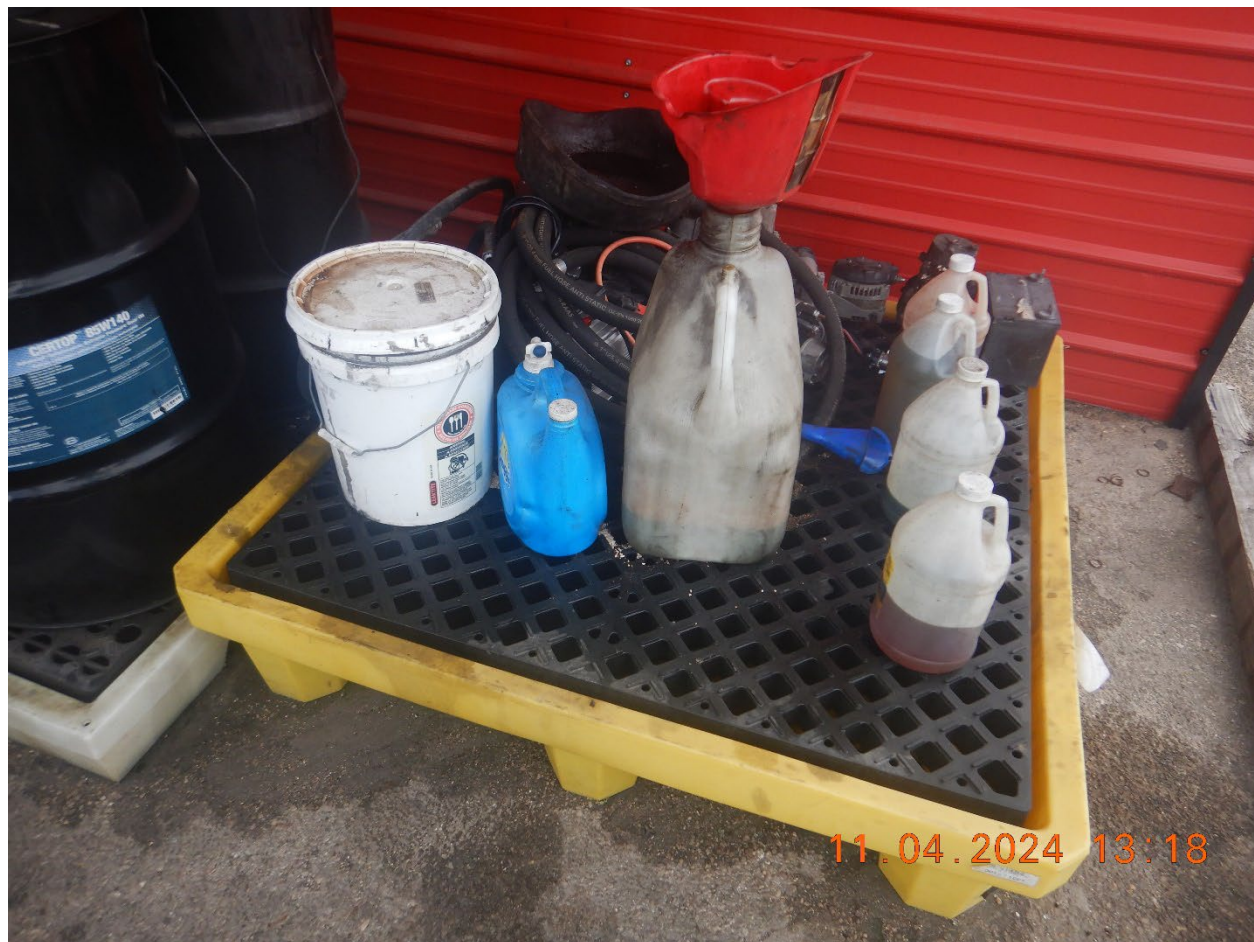
Photo No. 5

Description: View of one 5-gal container (middle of picture with red funnel) that contained used oil and was not labeled "Used Oil" in the used oil storage area.
