**UNITED STATES ENVIRONMENTAL PROTECTION AGENCY**

**Subject:** Sampling Inspection Report  
Clean Water Act – National Pollutant Discharge Elimination System  
City of Lawrence, MA

### **VI. 05/24/22 Sampling Inspection Summary**

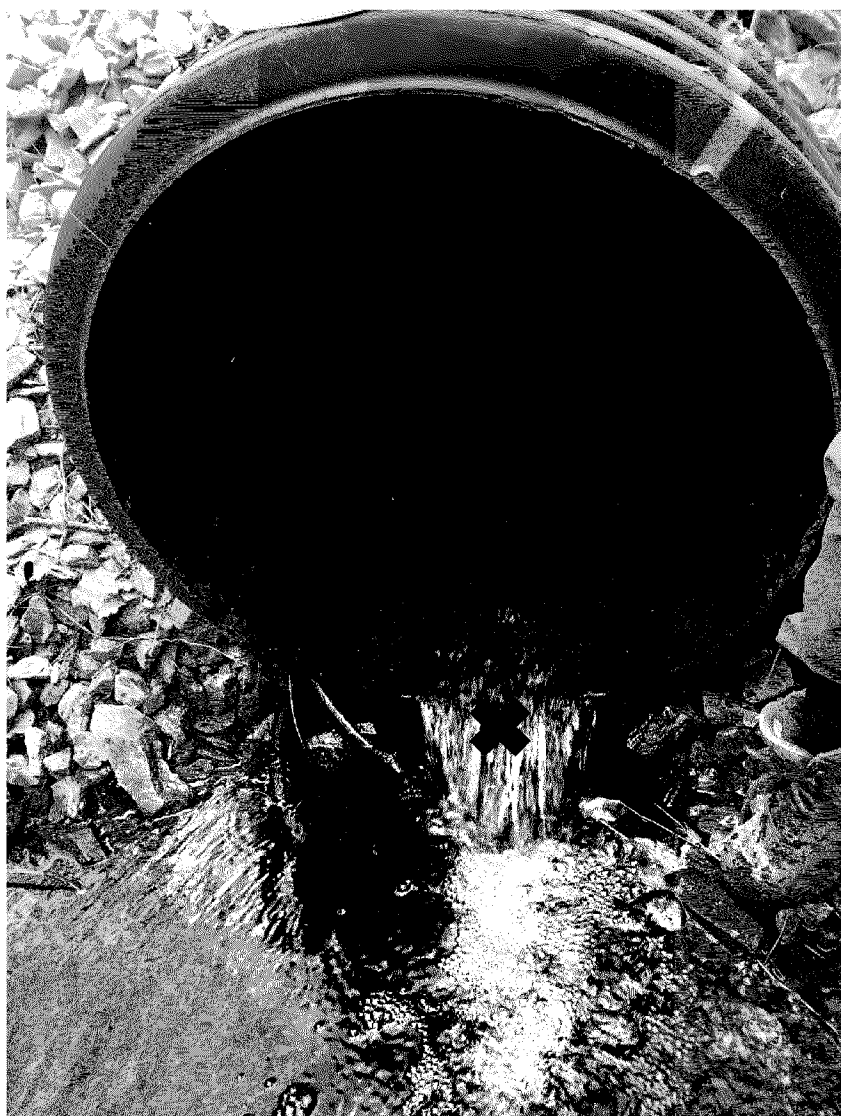
- **Market01**: a single, plastic, circular outfall, approximately 36 inches in diameter, located near the eastern side of the parking lot at 1 Essex Dr. Discharge flow was approximately 5-7 gallons per minute (gpm) into Shawsheen River. Sample was collected at the mouth of the outfall. Dark green/brown algae growth was observed on rocks and a brown film was observed on the pipe. Trash was observed downstream of the outfall. A sewage odor was observed upstream of the outfall. The upstream infrastructure, a manhole and a secondary unseen source, was observed to be leaking onto the ground. Sample preserved with ammonium acetate due to the presence of elevated levels of total chlorine.

**Market01 (photo taken 05/24/22 at 09:05 AM)** Outfall located near the eastern side of the parking lot at 1 Essex Dr into an unnamed stream into the Shawsheen River. Sample point is indicated by a red x.

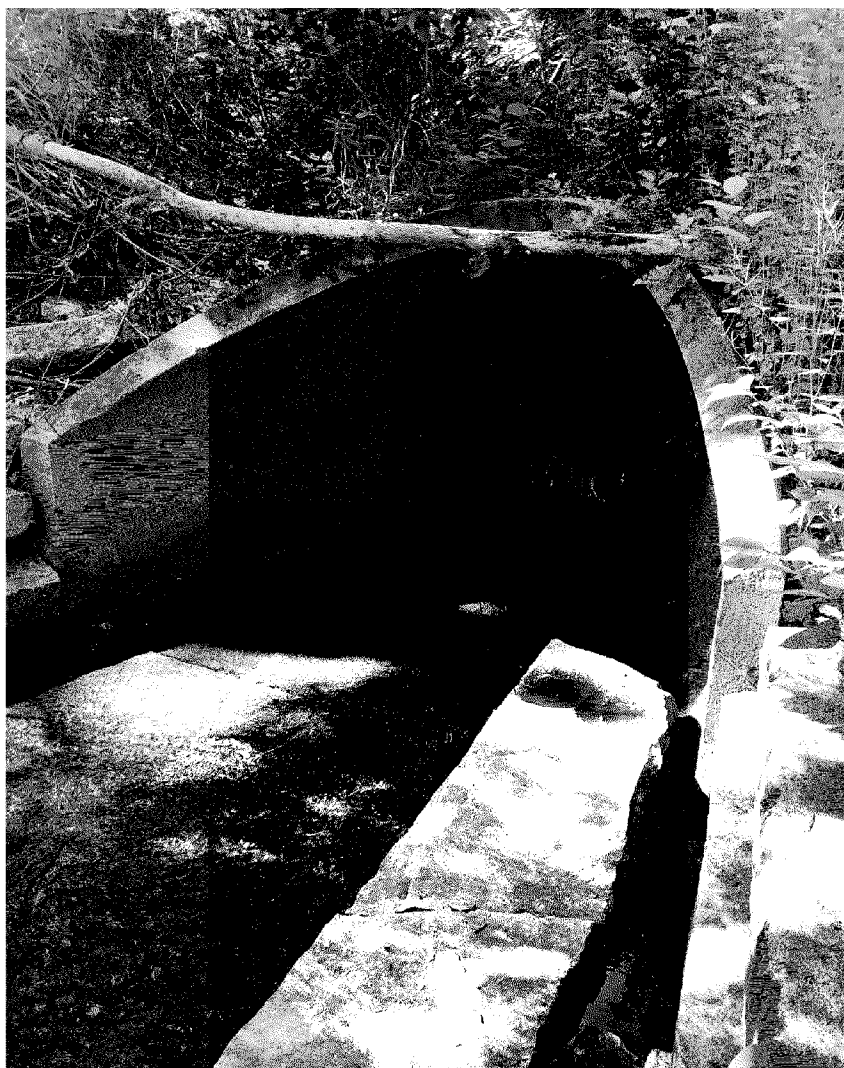
- **Law02**: a single concrete, circular outfall, approximately 48 inches in diameter, located at the north-west corner of sports field behind 165 Crawford St. Discharge flow was approximately 8-10 gallons per minute (gpm) into Shawsheen River. Sample was collected at the mouth of the elliptical structure surrounding the outfall. A musty odor was detected. Brown algae growth was observed inside outfall. Trash and rags were caught on the grate at the mouth of the outfall.

**Law02 (photo taken 05/24/22 at 09:35 AM)** located at the north-west corner of sports field behind 165 Crawford St into the Shawsheen River. Sample point is indicated by a red x.

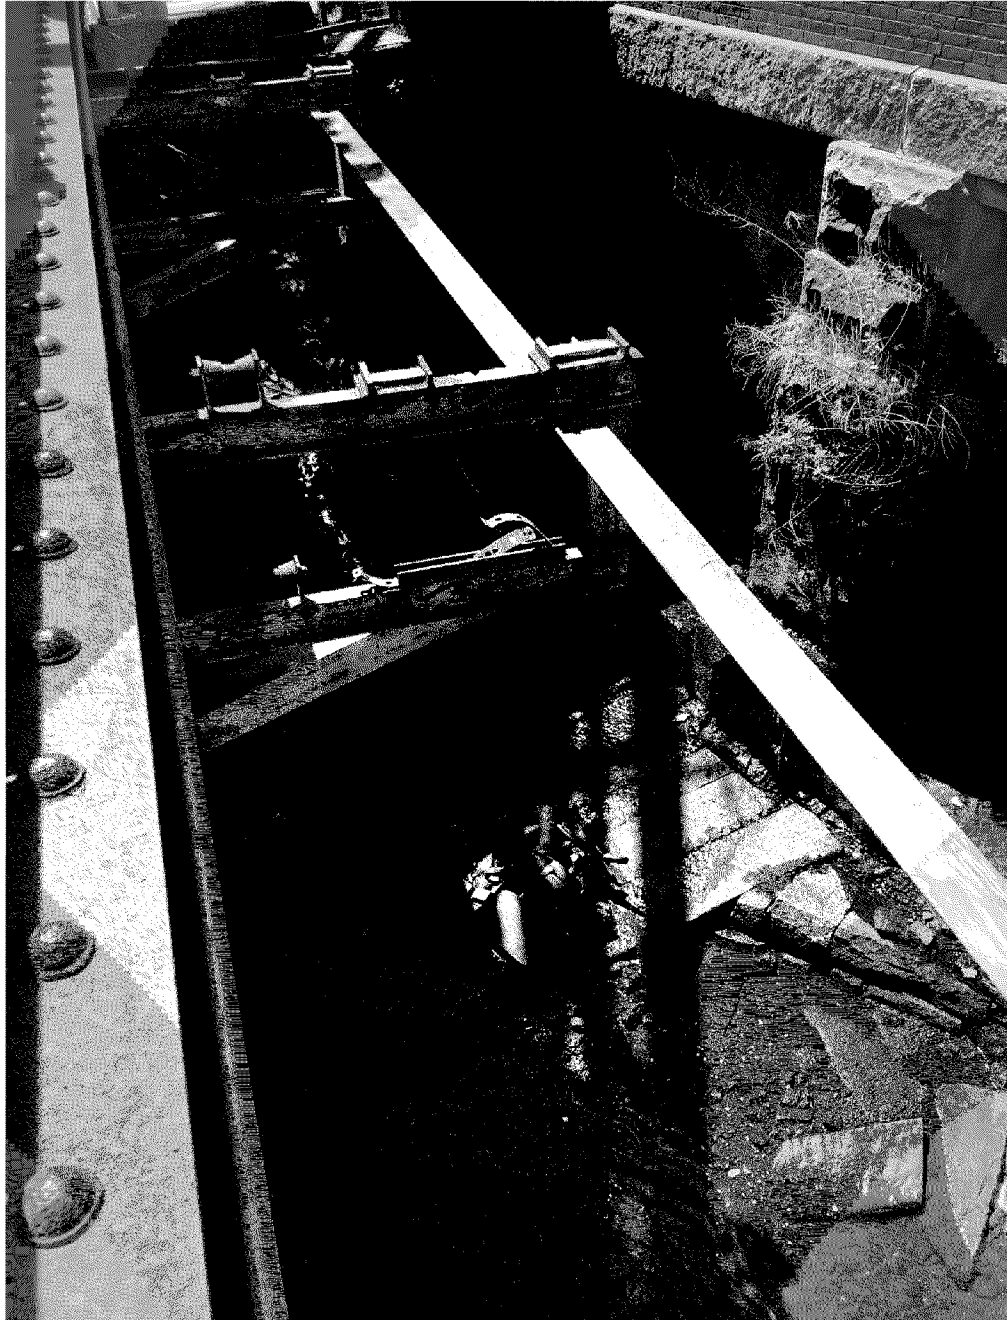
- **MM01**: a single, concrete, circular outfall, approximately 26 inches in diameter, located at southern western corner of the bridge located in the parking lot of 550 Broadway St. Discharge flow was approximately 8-10 gallons per minute (gpm) into Spicket River. Sample was collected at the mouth of the outfall using sampling pole. Suds and trash observed downstream of outfall. Orange staining observed on pipe.

**MM01 (photo taken 05/24/22 at 11:45 AM)** located at southern western corner of the bridge located in the parking lot of 550 Broadway St into the Spicket River. Sample point is indicated by a red x.

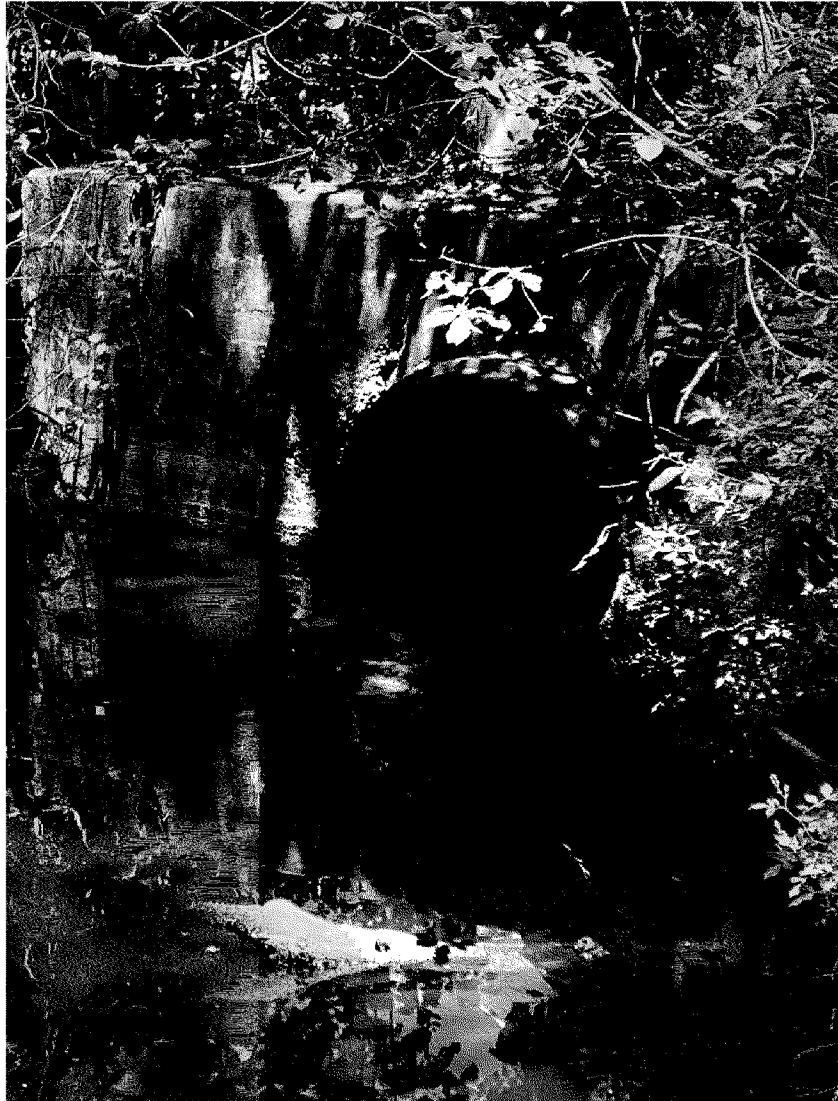
- **Law05**: a single, circular outfall, approximately 48 inches in diameter, located at the left-hand side of the parking lot entrance to 1 Eaton St. Discharge flow was approximately <1 gallon per minute (gpm) into an unknown tributary adjacent to the Merrimack river. Sample was collected at the mouth of the outfall. A milky color and consistency was observed in pool downstream

**Law05 (photo taken 05/24/22 at 12:55 PM)** located at the left-hand side of the parking lot entrance to 1 Eaton St. into an unknown tributary. Sample point is indicated by a red x.
