## **RCRA Inspection Report**

| Schaeffler Group USA Inc. | Physical Address: |

August 19, 2020

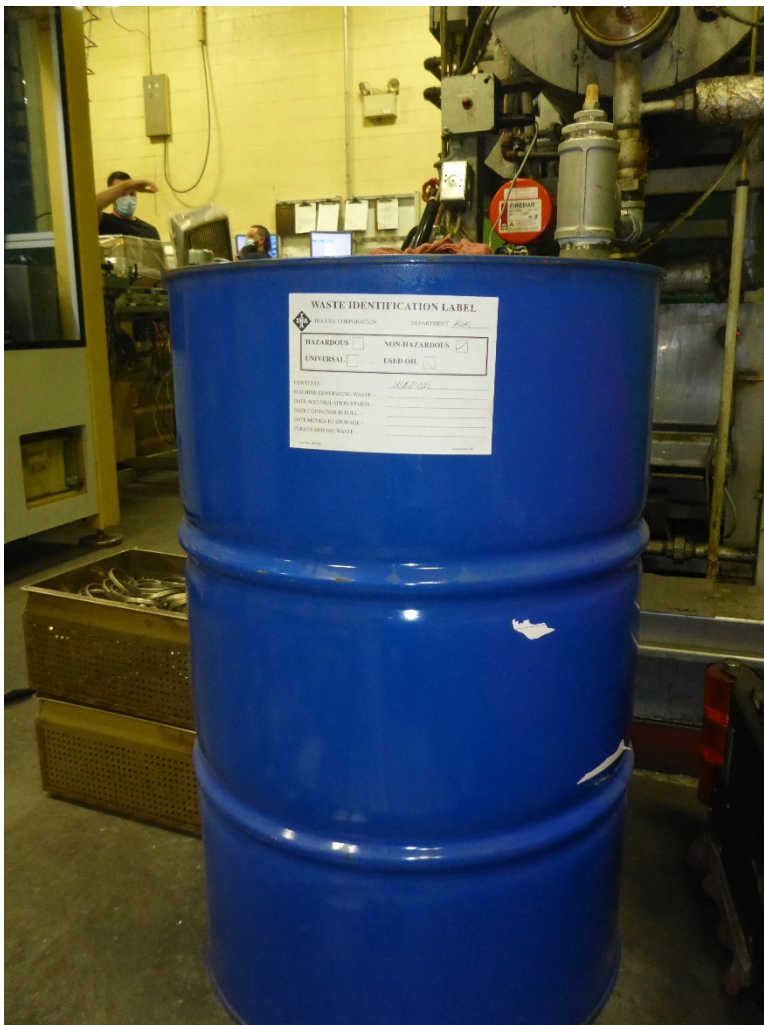
Assembly Roll Washer Units: The inspectors observed one 55-gallon drum attached to the old washer unit (Photo #1) and another attached to the new washer unit in the K2K department. Mr. Ratliff noted that the waste generated by the old washer unit was managed as D001 spent Isopar-K solvent (oil) from removing spent liquid until the recent analytical testing confirmed that the flashpoint of the liquid waste is above 140° F for the characteristic of ignitability. The liquid waste accumulation drums were closed and labeled as non-hazardous used oil. Mr. Ratliff explained that the contents of these drums will be pumped to the on-site oil water separator. The separated water will be treated in the on-site wastewater treatment system and the used oil will be picked up by Nobel Oil. Mr. Ratliff also noted that the old washer unit is scheduled to be phased out and replaced within the next 2-3 weeks.

**Photo 1:** 55-gallon drum attached to the old assembly roll washer unit. The drum is labeled as non-hazardous used oil.

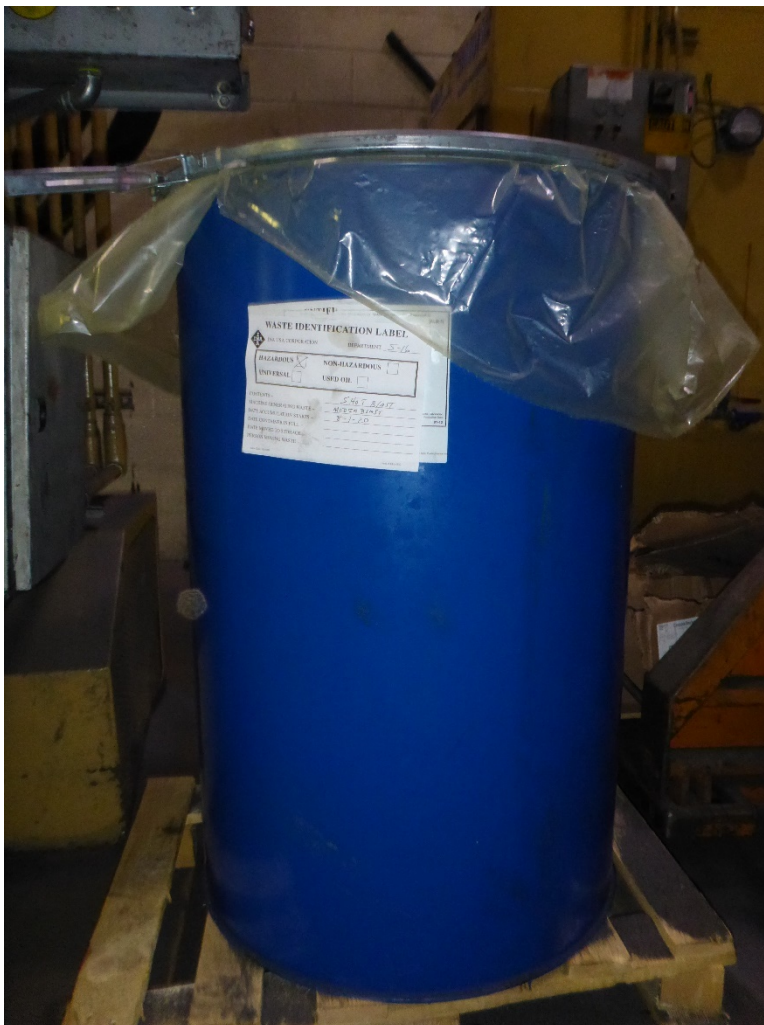
Finger Follower Heat Treat Area: The inspection participants observed the shot blast unit in the Finger Follower Heat Treat Area. Mr. Ratliff explained that employees use a bucket to scoop spent shot blast media from the unit and accumulate it in the designated SAA next to the unit. The inspectors observed one 55-gallon blue poly drum in the SAA (Photo #2). The drum was covered with an unlatched lid sitting on top of the drum. The waste identification label on the drum identified the contents as hazardous shot blast media blast generated by Department S-16 (Photo #3). The drum was not labeled with an indication of the hazards of this material.

**Photo 2:** 55-gallon blue poly drum in the spent shot blast media SAA. The ring is not latched to secure the lid on top of the drum.

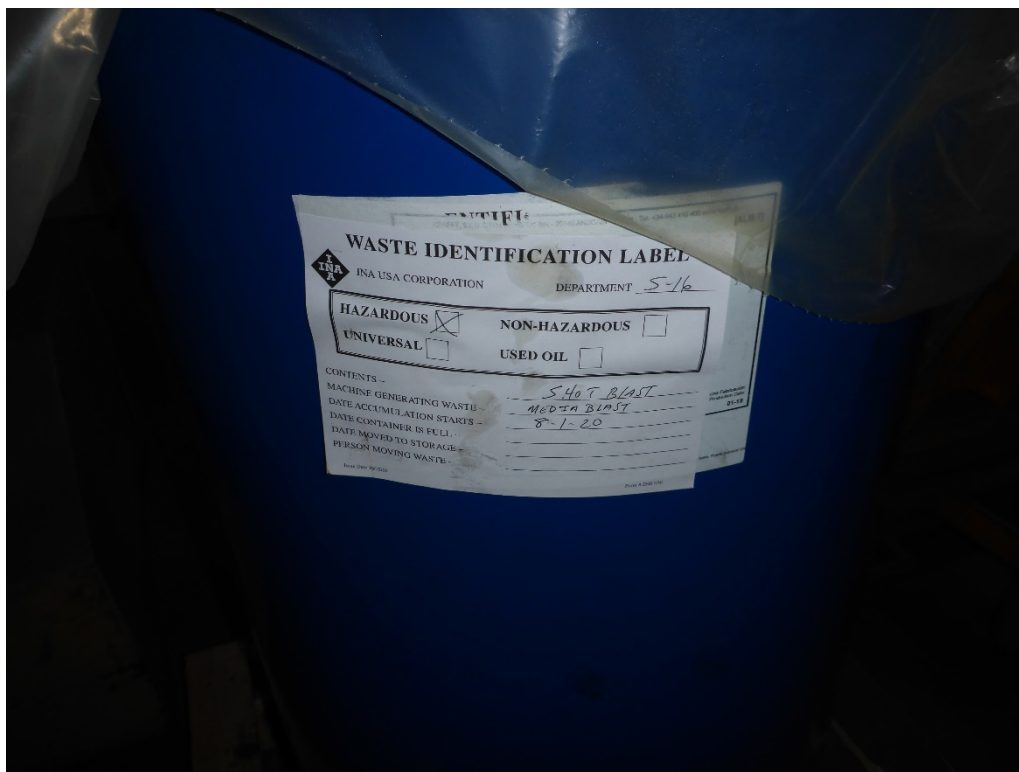
**Photo 3:** 55-gallon blue poly drum in the spent shot blast media SAA. The waste identification label identifies the material as hazardous shot blast media blast.

**Pursuant to 25 S.C. Code Ann. Regs. 61-79.262.15(a)(5) [40 C.F.R. § 262.15(a)(5)], which is a condition of the SAA Permit Exemption, a generator is required to mark or label its containers (i) with the words “Hazardous Waste” and (ii) with an indication of the hazards of the contents.**

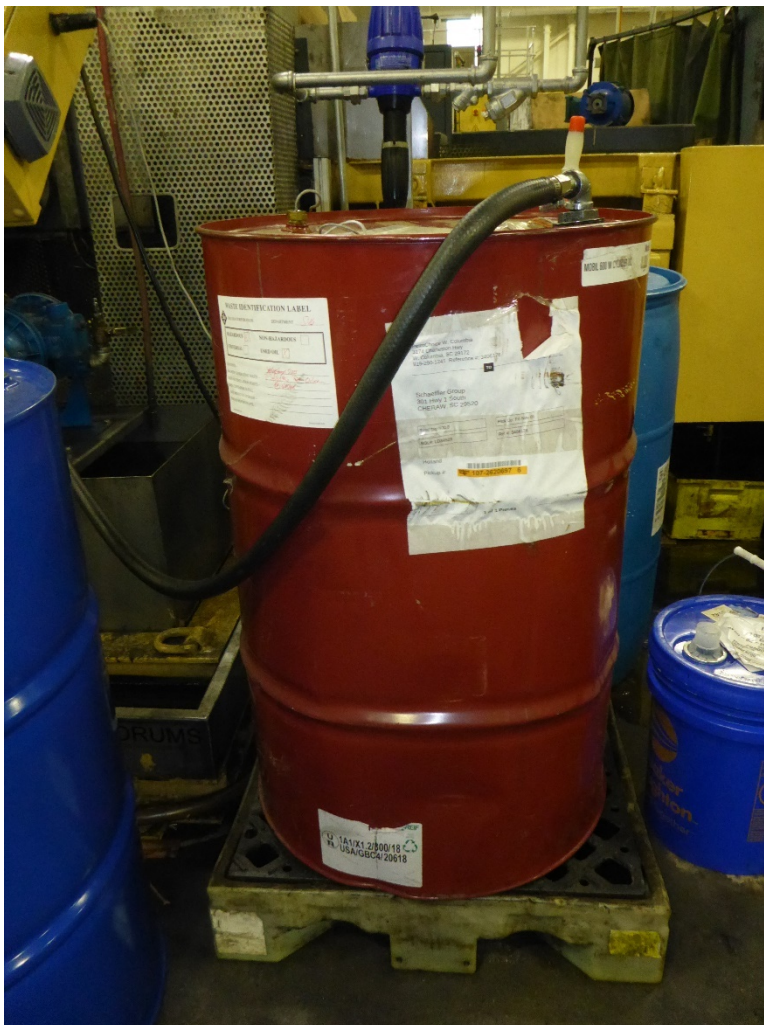
The inspectors observed one 55-gallon red metal drum on a portable secondary containment unit in the Finger Follower Heat Treat Process Area (Photo #4). This drum is used to accumulate used oil pumped from the bottom of the process unit. The waste identification label on the drum identified the contents as hazardous used oil generated by the Safed #6 De-Oiler machine in Department S-16 (Photo #5). According to Mr. Ratliff, this drum contains non-hazardous used oil, and it was mis-labeled as hazardous.

**Photo 4:** 55-gallon red metal drum in the Finger Follower Heat Treat Process Area. The drum is used to accumulate used oil pumped from the bottom of the Safed #6 De-Oiler machine.

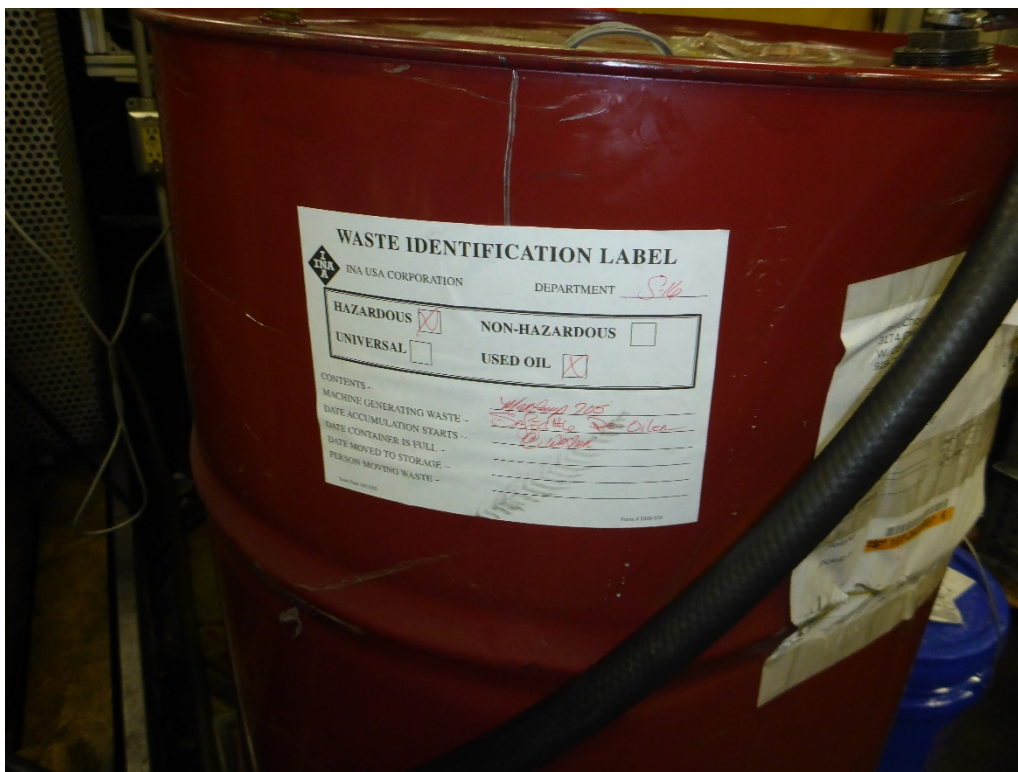
**Photo 5:** 55-gallon red metal drum in the Finger Follower Heat Treat Process Area. The waste identification label identifies the material as hazardous used oil, but Mr. Ratliff explained that the container of non-hazardous waste oil was mis-labeled.

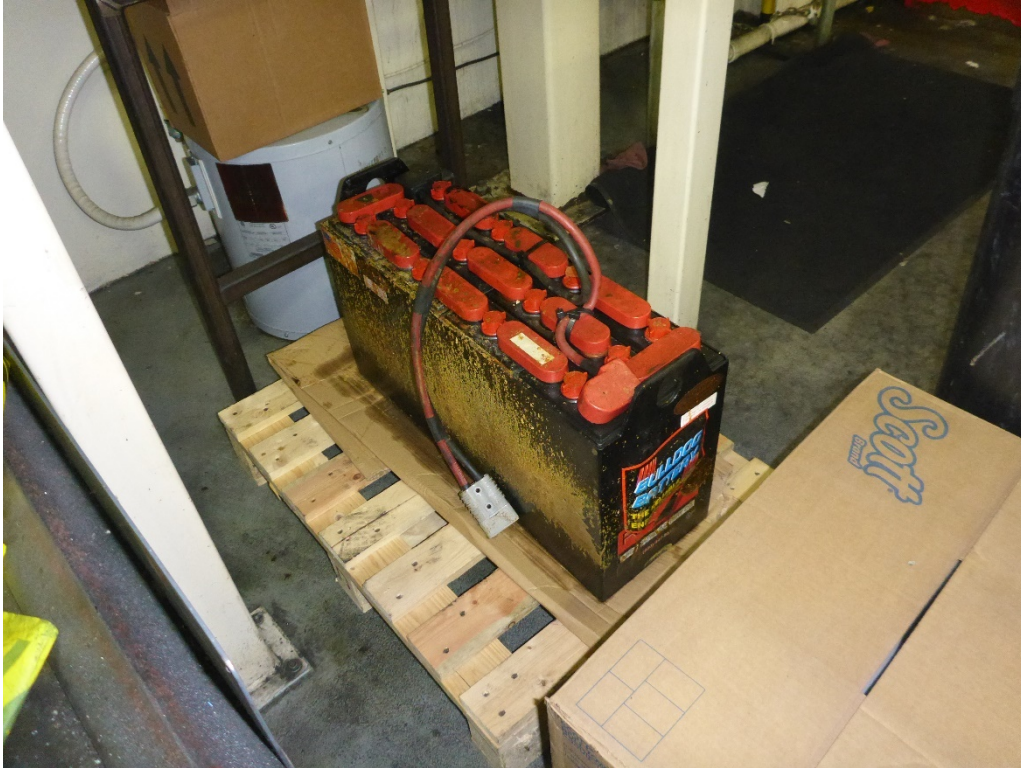
The inspectors observed one large battery on a wooden pallet near the parts washer units (Photo #6). The battery appeared to have leaked onto a piece of cardboard. Personnel stated that the battery came out of a tool cart in the Press Department last week, and it was staged here to be picked up when the new battery is delivered. The battery was not labeled as universal waste.

**Photo 6:** Large battery taken from a tool cart in the Press Department. Staged in the Maintenance Area. The battery appeared to be leaking, and it was not labeled as universal waste.

**Pursuant to 25 S.C. Code Ann. Regs. 61-79.273.13(a)(1) [40 C.F.R. § 273.13(a)(1)], a SQHUW must contain any universal waste battery that shows evidence of leakage, spillage, or damage that could cause leakage under reasonably foreseeable conditions in a container. The container must be closed, structurally sound, compatible with the contents of the battery, and must lack evidence of leakage, spillage, or damage that could cause leakage under reasonably foreseeable conditions.**

**Pursuant to 25 S.C. Code Ann. Regs. 61-79.273.14(a) [40 C.F.R. § 273.14(a)], a SQHUW must label or mark each universal waste battery or container or tank in which the batteries are contained clearly with one of the following phrases: “Universal Waste - Battery(ies),” or “Waste Battery(ies),” or “Used Battery(ies).”**

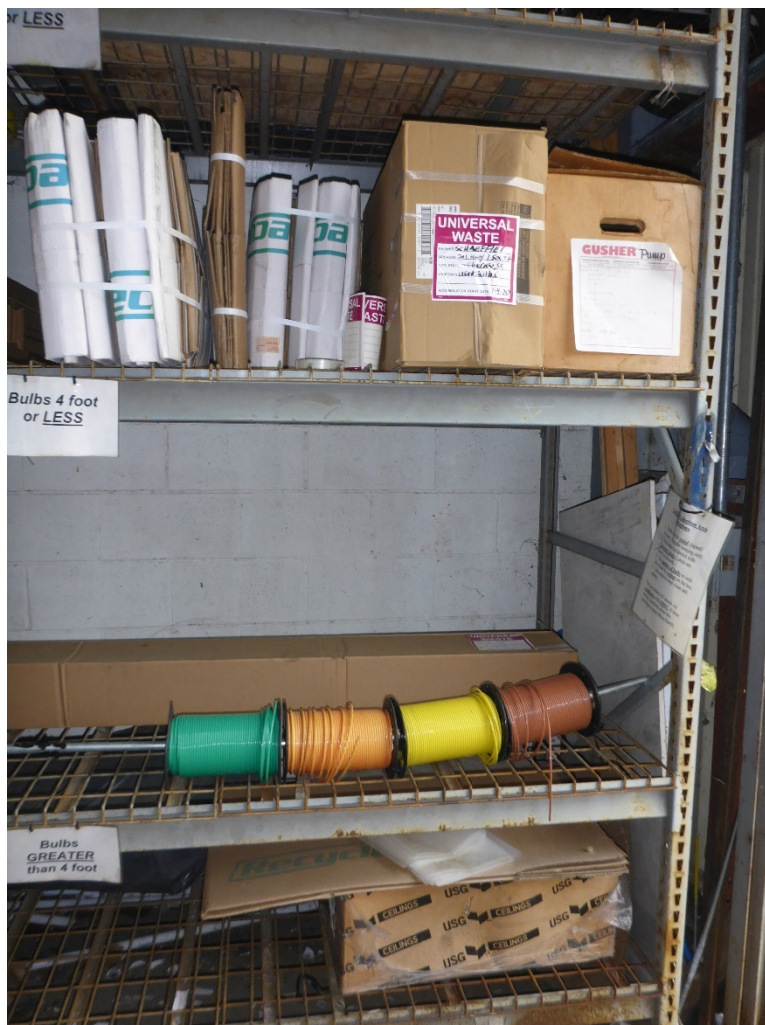
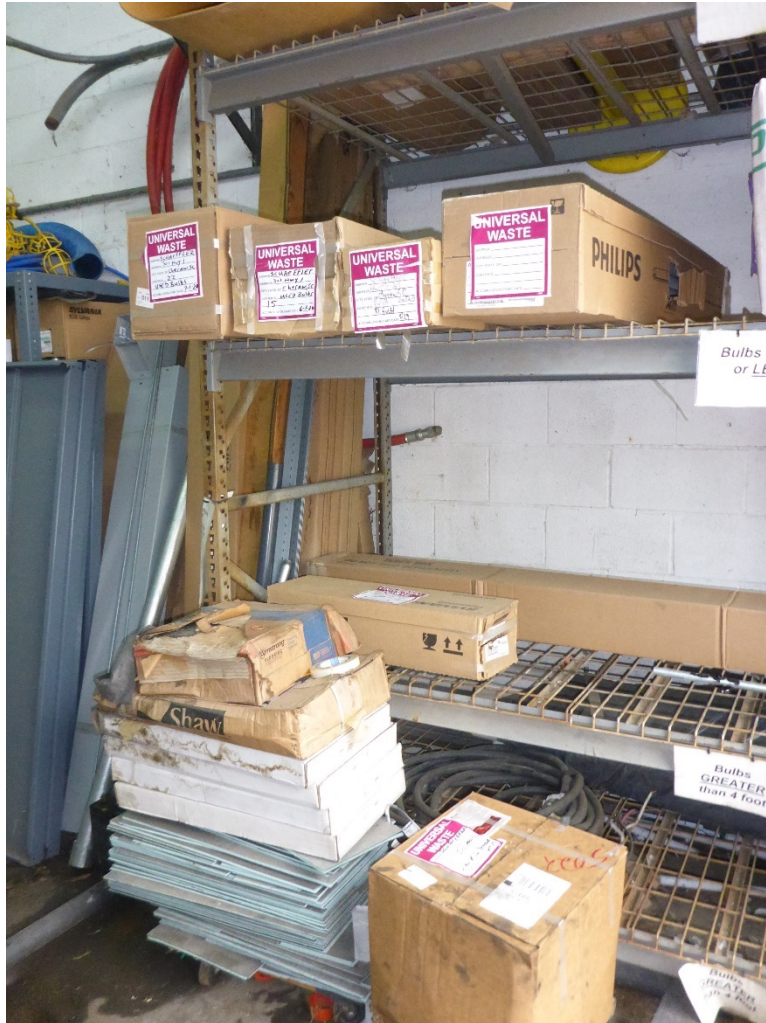
Contractor Storage Room: Schaeffler accumulates and stores universal waste in an outbuilding known as the Contractor Storage Room. The inspectors observed one box labeled used miscellaneous batteries dated 06/04/2020. The inspectors also observed two boxes of used 2-foot fluorescent lamps dated 08/01, and 01/04/2020; one box of used 8-foot lamps dated 03/08/2020; and four boxes of used 4-foot lamps dated 02/01/2020, 03/29/2020, 06/01/2020, and 07/01/2020 (Photo #s 7 and 8). The boxes were each labeled “used bulbs.” On the floor beneath the shelving, the inspectors observed loose and broken used fluorescent lamps (Photo #s 9 and 10).

**Photo 7:** Boxes of universal waste observed in the Contractor Storage Room.

**Photo 8:** Boxes of universal waste observed in the Contractor Storage Room.

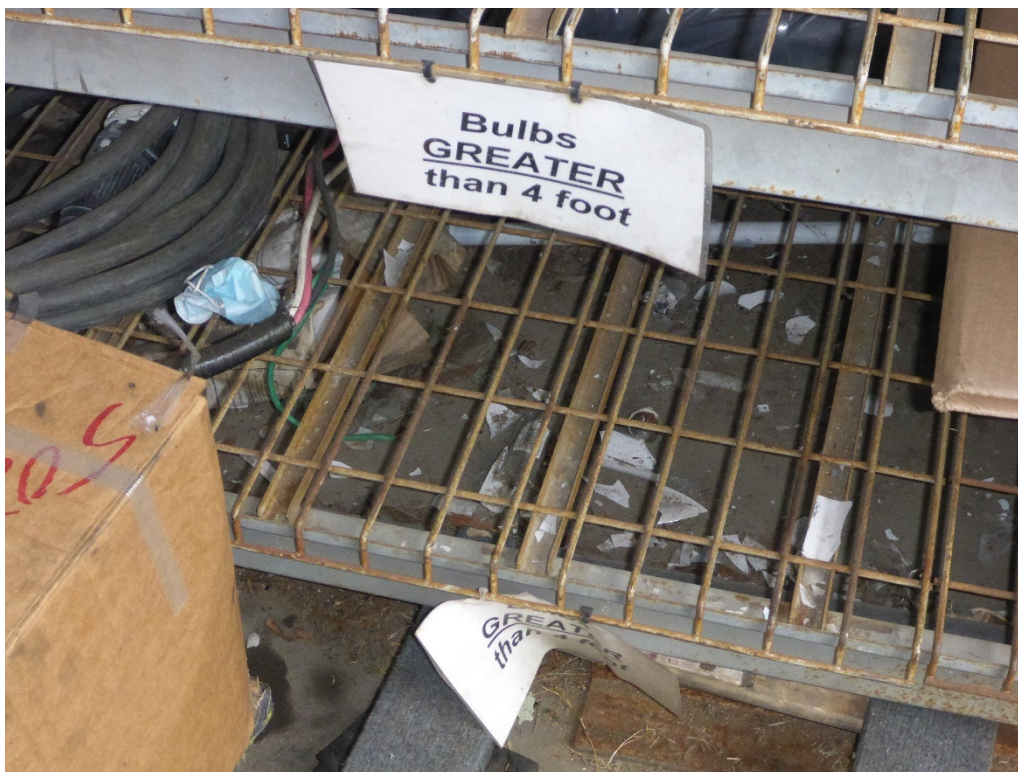
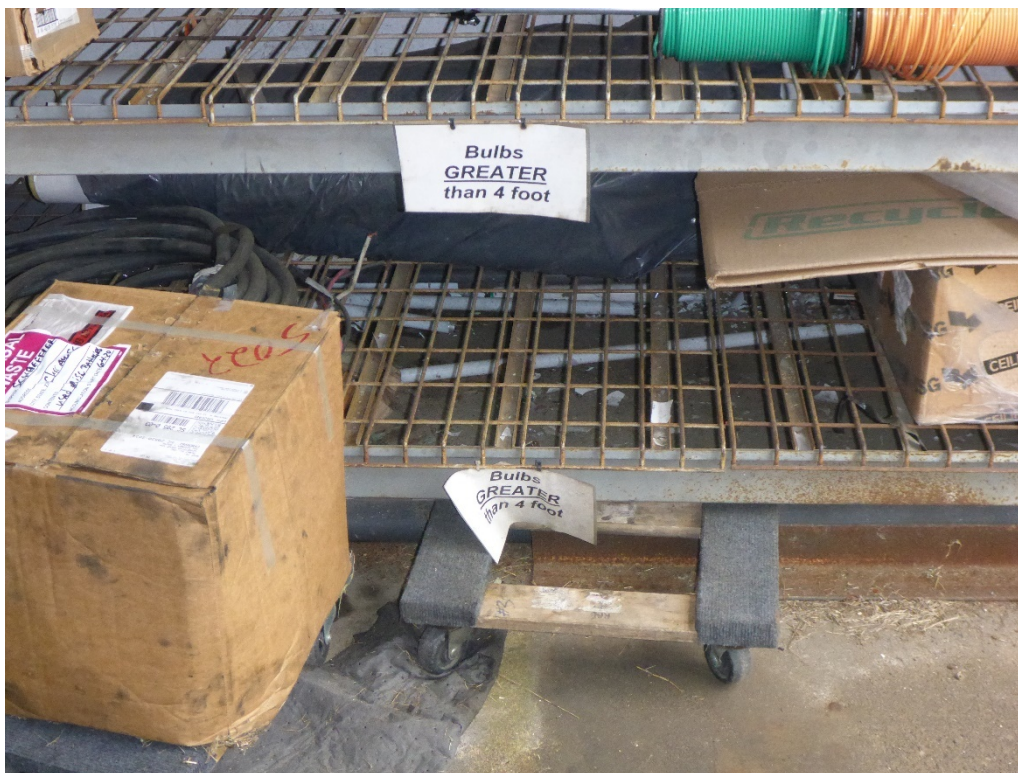
**Photo 9:** Broken glass from fluorescent bulbs located on the floor beneath the shelving unit holding universal waste in the Contractor Storage Room.

**Photo 10:** Broken glass from fluorescent bulbs located on the floor beneath the shelving unit holding universal waste in the Contractor Storage Room.

**Pursuant to 25 S.C. Code Ann. Regs. 61-79.273.13(d)(1) [40 C.F.R. § 273.13(d)(1)], a SQHUW must contain any lamp in containers or packages that are structurally sound, adequate to prevent breakage, and compatible with the contents of the lamps. Such containers and packages must remain closed and must lack evidence of leakage, spillage or damage that could cause leakage under reasonably foreseeable conditions.**

**Pursuant to 25 S.C. Code Ann. Regs. 61-79.273.13(d)(2) [40 C.F.R. § 273.13(d)(2)], a SQHUW must immediately clean up and place in a container any lamp that is broken and must place in a container any lamp that shows evidence of breakage, leakage, or damage that could cause the release of mercury or other hazardous constituents to the environment. Containers must be closed, structurally sound, compatible with the contents of the lamps and must lack evidence of leakage, spillage or damage that could cause leakage or releases of mercury or other hazardous constituents to the environment under reasonably foreseeable conditions.**

**Pursuant to 25 S.C. Code Ann. Regs. 61-79.273.14(e) [40 C.F.R. § 273.14(e)], a SQHUW must label or mark each lamp or container or package in which such lamps are contained clearly with one of the following phrases: “Universal Waste - Lamp(s),” or “Waste Lamp(s),” or “Used Lamp(s).”**

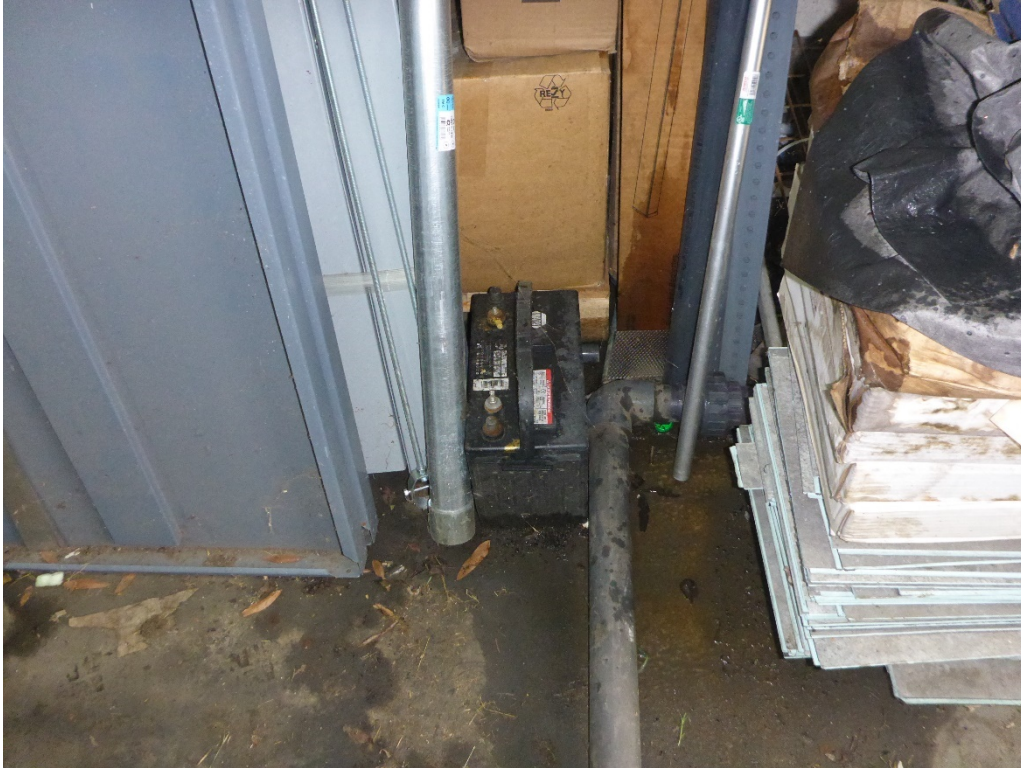
The inspectors also observed one used battery on the floor next to the shelving unit (Photo #11). The battery was not labeled as universal waste.

**Photo 11:** One used battery located on the floor next to the shelving unit in the Contractor Storage Room.

**Pursuant to 25 S.C. Code Ann. Regs. 61-79.273.14(a) [40 C.F.R. § 273.14(a)], a SQHUW must label or mark each universal waste battery or container or tank in which the batteries are contained clearly with one of the following phrases: “Universal Waste - Battery(ies),” or “Waste Battery(ies),” or “Used Battery(ies).”**
