**CHEMOURS FIRST CHEMICAL CORPORATION  
CLEAN WATER ACT (CWA)  
INSPECTION AND SAMPLING**

**Pascagoula,  
Mississippi**

**Report Date: January 9, 2020 (Revised 1/5/2023)**

**Inspection and Sampling Activities: November 19 – 21, 2019**

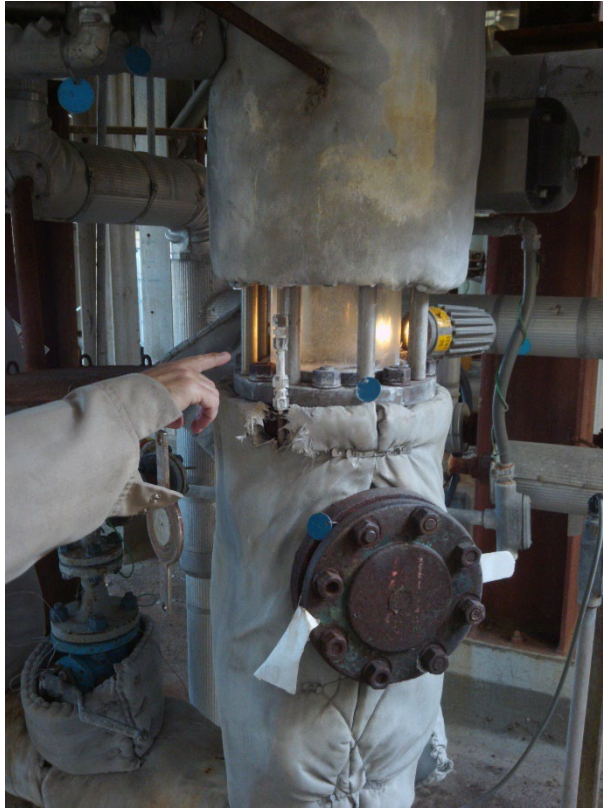
**Photograph 1.** Bottom pipe through which material is transferred from vessel RG-6500 to RG-5000 in the Capstone (Unit 6) operations. Operators visually inspect the material transfer through the backlit glass pipe segment.

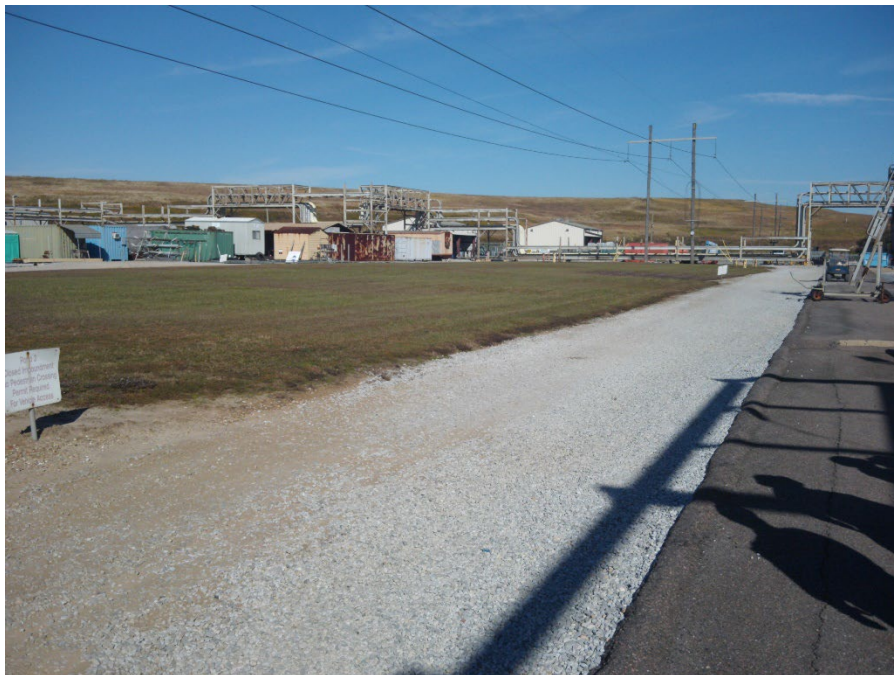
**Photograph 2.** Former lagoon that discharged through an old (closed) outfall.

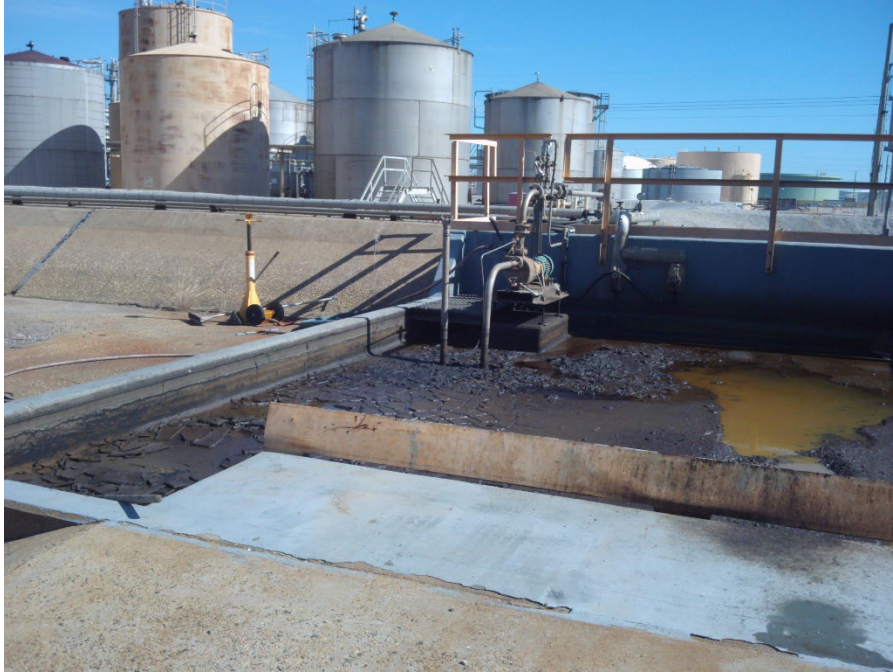
The Inspection and Sampling Team observed an outdoor concrete pad that facility representatives indicated was used for dewatering solid hazardous waste (refer to Photograph 3). Facility representatives explained that solid hazardous waste generated at the facility is collected in trucks and placed in the drying pad to allow for dewatering. After settling occurs, the water is pumped from the drying pad to the Rain Water Storage Tank, from which it is sent to the Effluent Pretreatment System. The dewatered solids are removed from the pad and disposed of off-site as hazardous waste.

**Photograph 3.** Hazardous waste drying pad with solids from Sumps 21, 22, and 24 (truck and rail loading/unloading area).

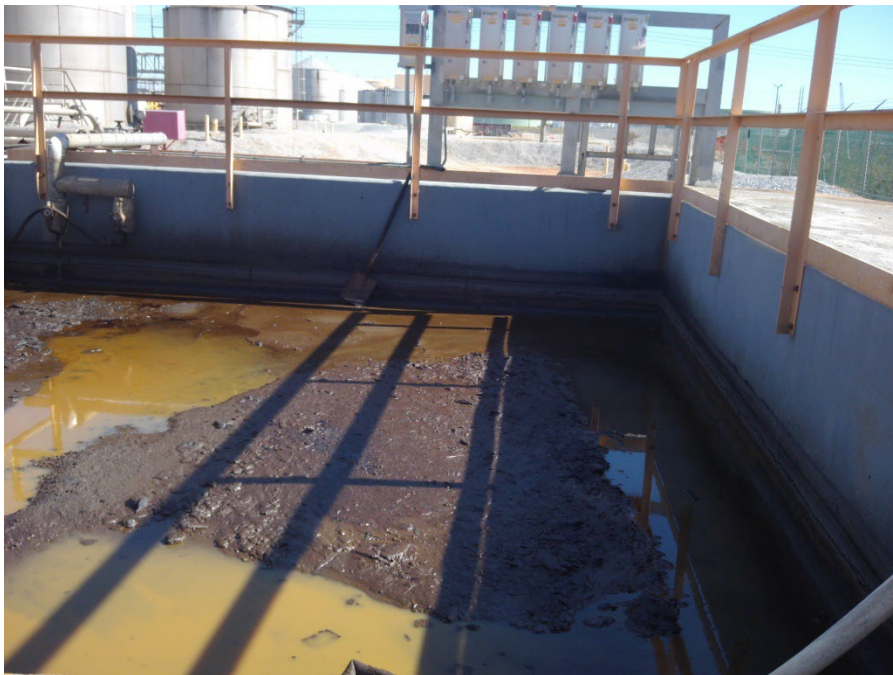
At the time of the inspection, the Inspection and Sampling Team observed solids with some pooling of liquid (refer to Photograph 4). Facility representatives explained that the solids were generated from cleaning of three stormwater sumps, specifically Sumps 21, 22, and 24, which are located at the facility's truck and rail loading/unloading area (discussed above). The facility provided records of the sump cleaning activities. The records indicated the sump cleaning for all three sumps occurred on October 25 – November 1, 2019 as a result of a five-year sump integrity inspection. The facility also provided the waste characterization form for this waste (refer to Appendix C: Rain Water Storage Tank Solids Waste Characterization Form). The waste characterization form was dated March 2016 and for "Rain Water Storage Tank Solids"; facility representatives indicated that the solids from the process area stormwater sumps is treated as the same waste as the "Rain Water Storage Tank Solids". The waste characterization form lists the waste as hazardous, based on analytical testing showing that the waste contains aniline, benzene, toluene, phenol, and other chemicals.

waste drying pad is exempt under RCRA, per 40 CFR 264.1(g)(6), 265.1(c)(10), and 270.1(c)(2)(v). However, the waste characterization form indicates that the waste is subject to the Benzene Waste Operations National Emission Standards for Hazardous Air Pollutants (NESHAP). The Inspection and Sampling Team did not review the requirement of the Benzene Waste Operations NESHAP.

At the time of the inspection, the Inspection and Sampling Team observed solids with some pooling of liquid (refer to Photograph 4). Facility representatives explained that the solids were generated from cleaning of three stormwater sumps, specifically Sumps 21, 22, and 24, which are located at the facility's truck and rail loading/unloading area. The facility provided records of the sump cleaning activities. The records indicated the sump cleaning for all three sumps occurred on October 25 – November 1, 2019 as a result of a five-year sump integrity inspection. The facility also provided the waste characterization form for this waste (refer to Appendix C: Rain Water Storage Tank Solids Waste Characterization Form). The waste characterization form was dated March 2016 and was for "Rain Water Storage Tank Solids"; facility representatives indicated that the solids from the process area stormwater sumps are treated the same as the "Rain Water Storage Tank Solids". The waste characterization form lists the waste as hazardous, based on analytical testing showing that the waste contains aniline, benzene, toluene, phenol, and other chemicals.

The Inspection and Sampling Team conferred with the EPA Region 4 RCRA representative who was present at the inspection. The EPA Region 4 representative indicated the hazardous waste drying pad is exempt under RCRA, per 40 CFR §§ 264.1(g)(6), 265.1(c)(10), and 270.1(c)(2)(v). However, the waste characterization form indicates that the waste is subject to the Benzene Waste Operations National Emission Standards for Hazardous Air Pollutants (NESHAP). The Inspection and Sampling Team did not review the requirement of the Benzene Waste Operations NESHAP.

**Photograph 4.** Closer view of the solids being dried on the hazardous waste drying pad at the time of the inspection.

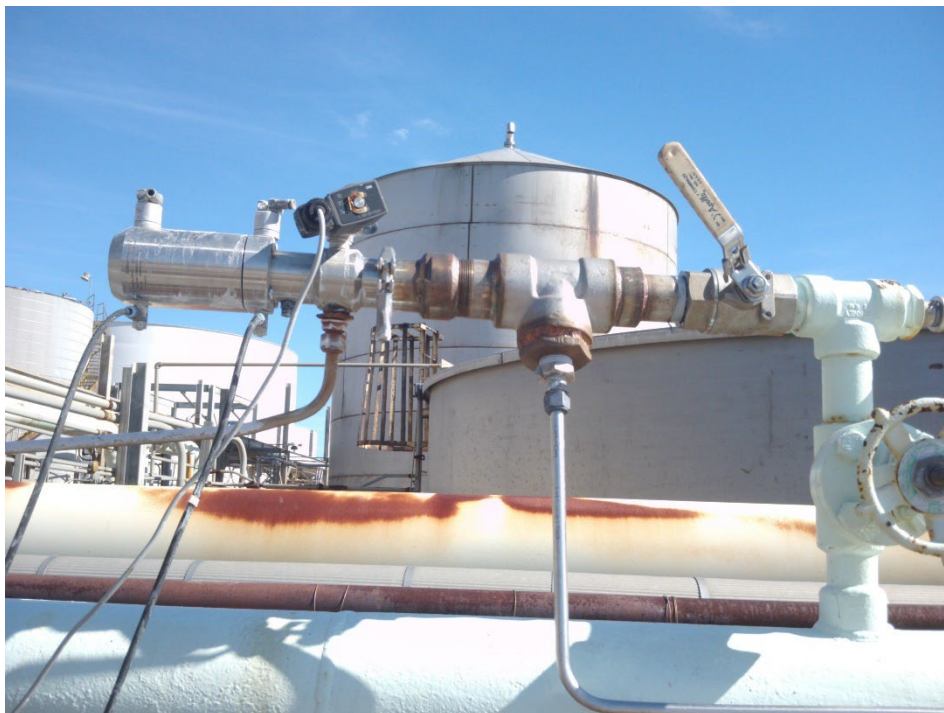
The location where the Inspection and Sampling Team observed that the facility conducts compliance monitoring for all of the pretreatment permit standards, including the 40 CFR Part 414 categorical standards, is located along the pipe that conveys effluent to the POTW, at a point after the pretreated process discharge commingles with the dilution sources from sanitary wastewater, non-contact cooling water, stormwater, and boiler blow down (refer to Photograph 5 and Photograph 6). The pretreated process wastewater effluent that is subject to the categorical standards is therefore diluted at this location, precluding a direct comparison against both the pretreatment permit per condition L-2 and the applicable 40 CFR Part 414 standards.

**Photograph 6.** Closer view of the monitoring point in Photograph 5.
