## **RCRA Inspection Report**

SABIC Innovative Plastics US LLC  
3531 Port and Harbor Drive  
Port Bienville Industrial Park  
Bay St. Louis, Mississippi 39520-9669

EPA ID# MSD000742668

January 9, 2023

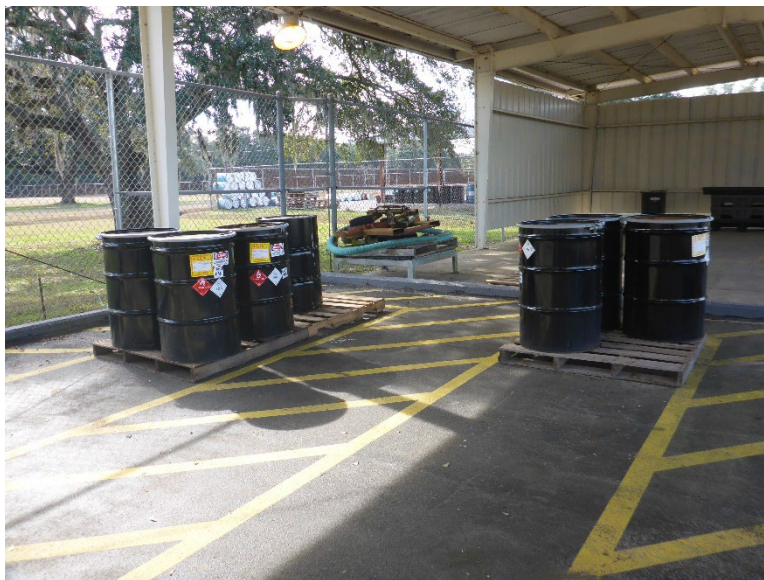
The facility tour began at the hazardous waste CAA (Photo 1), which is on a covered, concrete pad and surrounded by a chain link fence. The area was identified with signs which read "danger, hazardous waste accumulation area," "unauthorized persons keep out," "danger, flammable materials," and "no smoking." Facility personnel working in this area carry hand-held two-way radios to summon emergency assistance. The CAA is also equipped with a portable fire extinguisher, spill control equipment, and an emergency shower and eyewash station.

The inspectors observed lines painted on the concrete pad which divided the area into three distinct storage rows separated by aisle spacing. Two wooden pallets were present in the first row:

- One pallet held one 55-gallon drum of hazardous waste. This drum was labeled D001, F005 hazardous waste solid (MEK), identified with a flammable liquid DOT hazard placard, and marked with an accumulation start date of December 14, 2022. The drum was not marked to indicate that its contents exhibit the characteristic of toxicity.

**Photo 1:** Central Accumulation Area

**Pursuant to 11 Miss. Admin. Code Pt. 3, R. 1.3 [40 C.F.R. § 262.17(a)(5)(i)], which is a condition of the LQG Permit Exemption, a generator must mark or label its containers with an indication of the hazards of the contents clearly visible for inspection on each container.**

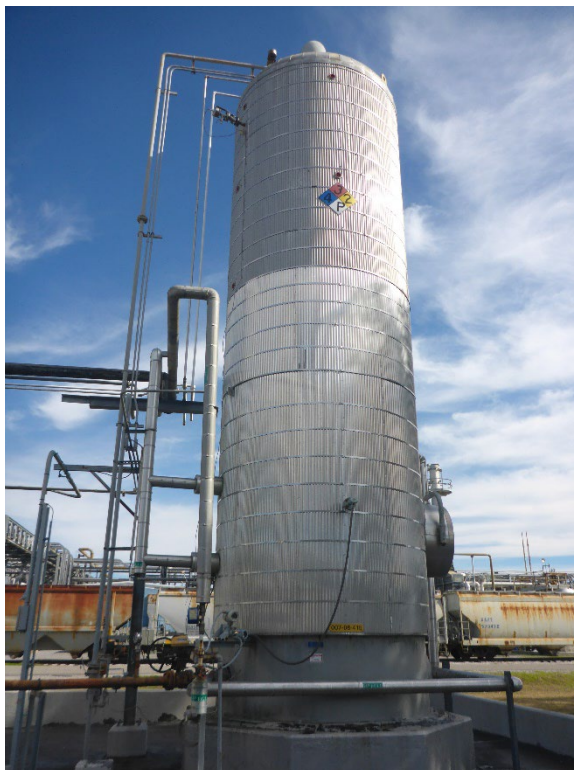
The inspectors observed two hazardous waste storage tanks near the CAA (Photos 2 and 3). The tanks were located within a curbed, concrete secondary containment area and each tank was labeled with the words “hazardous waste.” The inspectors also observed the piping line used to transfer hazardous waste from the production area to the tank farm. At the tank farm, a valve is used to direct this combined influent line into one of two lines. Each of these two lines is used to feed one of the two hazardous waste storage tanks. The combined influent line between the production area and the tank farm is labeled as “hazardous waste,” and each of the two lines between the combined influent line and the associated storage tank is painted orange and labeled “AN wastewater” (Photos 4 and 5).

At the time of the inspection, one tank was identified as tank 007-25-027 hazardous waste mixed monomers and water and it was marked with an accumulation start date of December 1, 2022. The second tank was identified as tank 007-08-415, but it was not marked with an accumulation start date. The inspectors observed the liquid level indicator on the second tank and verified that it was empty.

**Photo 2:** Hazardous Waste Storage Tank 007-08-415.

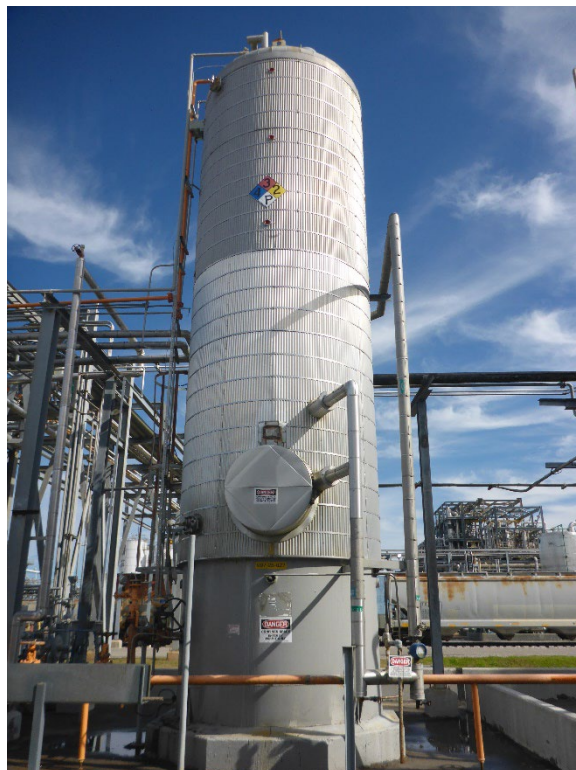
**Photo 3:** Hazardous Waste Storage Tank 007-25-027.

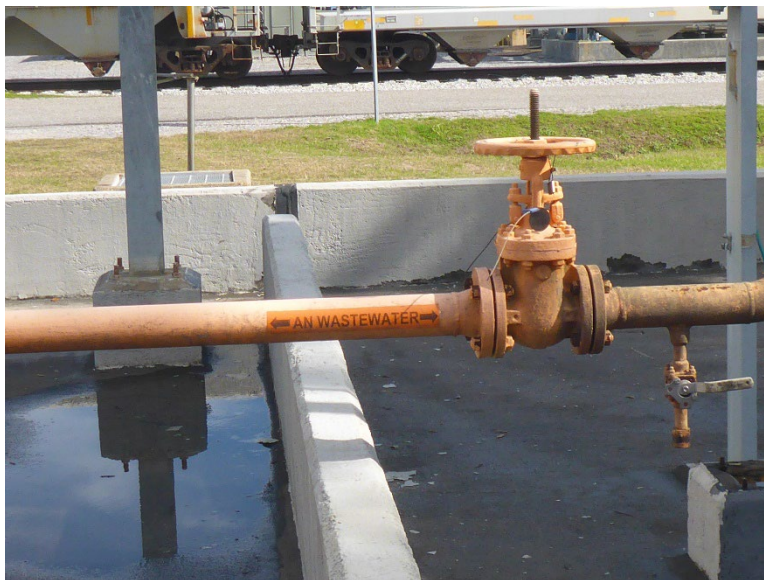
Facility personnel explained that SABIC accumulates hazardous waste in one tank until the volume approaches the maximum level that can be loaded onto a tanker truck. At that time, personnel turn the valve to direct the flow from the combined influent line to the other storage tank. When a tanker truck arrives to remove the waste load, the full tank is emptied into the tanker truck and, if the truck has additional storage capacity, waste from the second tank is pumped into the truck until the load is full. An accumulation start date is added to each tank on the date that hazardous waste is first directed into that tank, and the accumulation start date is removed from the tank when its contents are emptied into the tanker truck.

**Photo 4:** Piping to transfer combined influent line to the hazardous waste storage tanks.

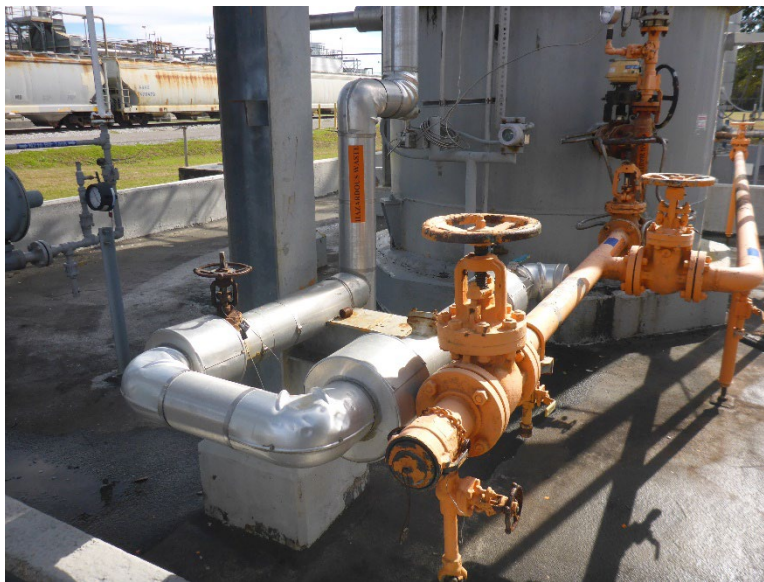
**Photo 5:** Piping to transfer combined influent line to the hazardous waste storage tanks.

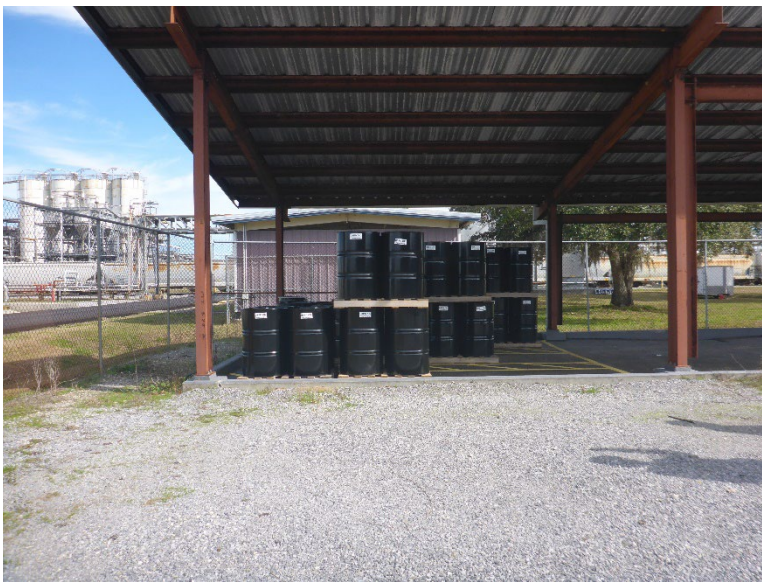
Next, the inspection participants visited the facility’s nonhazardous waste storage area (Photo 6). This area is divided into two sections on a covered, concrete pad and surrounded by a chain link fence. The inspectors observed lines painted on the concrete pad which divided each section into three distinct storage rows separated by aisle spacing. The inspectors observed fifty-two 55-gallon drums of used oil on one side of this area. The drums were placed on wooden pallets, which were stacked one or two pallets high. Each pallet held four 55-gallon drums, and each drum was labeled used oil therminol. The inspectors observed sixteen additional 55-gallon drums of nonhazardous waste on the other side of this area. These drums were also placed on wooden pallets, but the pallets were not stacked.

**Photo 6:** Nonhazardous waste storage area.

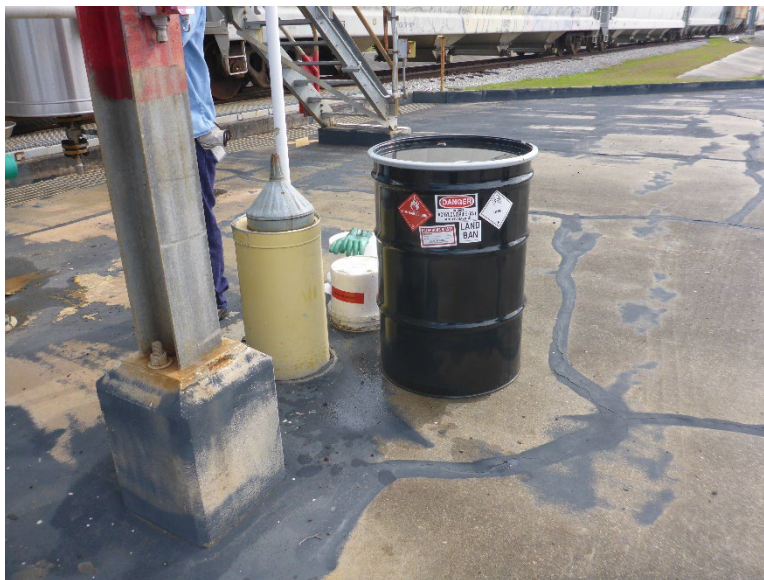
- Truck Unloading - After unloading raw materials, SABIC accumulates material that remains in transfer lines as hazardous waste in a SAA at the truck unloading area (Photo 7). The inspectors observed one 55-gallon drum, which was labeled hazardous waste acrylonitrile and marked to indicate that the contents were a flammable liquid and toxic, in this SAA.

**Photo 7:** One 55-gallon drum, which was labeled hazardous waste acrylonitrile (AN) and marked to indicate that the contents are flammable and toxic, in the Truck Unloading SAA.

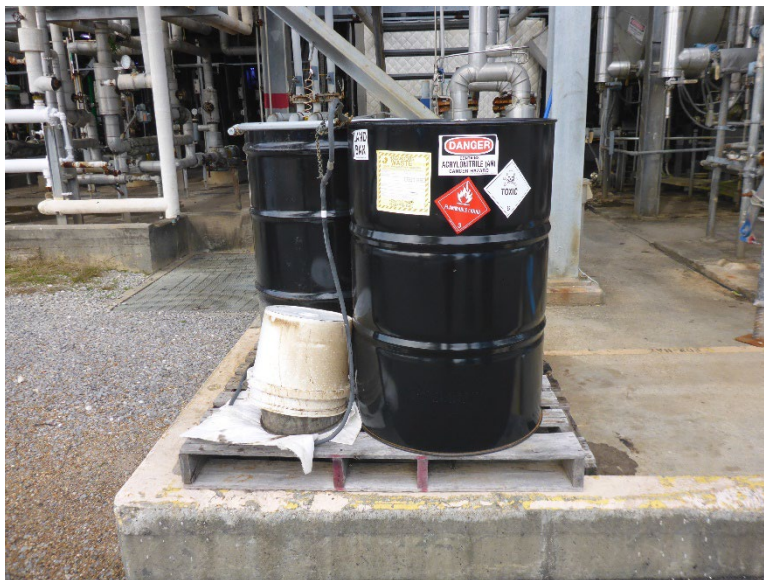
- Line 4/5 Decanter - At some point in the production process, a mixture of unreacted raw materials and water exit the reactor vessel and enter into the collection and separation tanks where the raw materials and water separate into distinct layers. Operation personnel in the control room monitor the water level in these tanks, and they periodically come out to the tanks where they manually engage a pump and transfer the water layer to one of the two hazardous waste storage tanks. SABIC manages a SAA for accumulating hazardous waste generated during sampling events at the collection and separation tanks (Photo 8). The inspectors observed one 55-gallon drum in this SAA. The drum was labeled hazardous waste (acrylonitrile, styrene) and it was identified with flammable liquid and toxic DOT hazard placards. Facility personnel estimated that it takes about one or two months to fill a 55-gallon drum in this SAA but stated that they may ship the container offsite before it is full if they observe surface rust on the container.

**Photo 8:** One 55-gallon drum, which was labeled hazardous waste (acrylonitrile, styrene) and identified as flammable and toxic, in the Line 4/5 Decanter SAA.

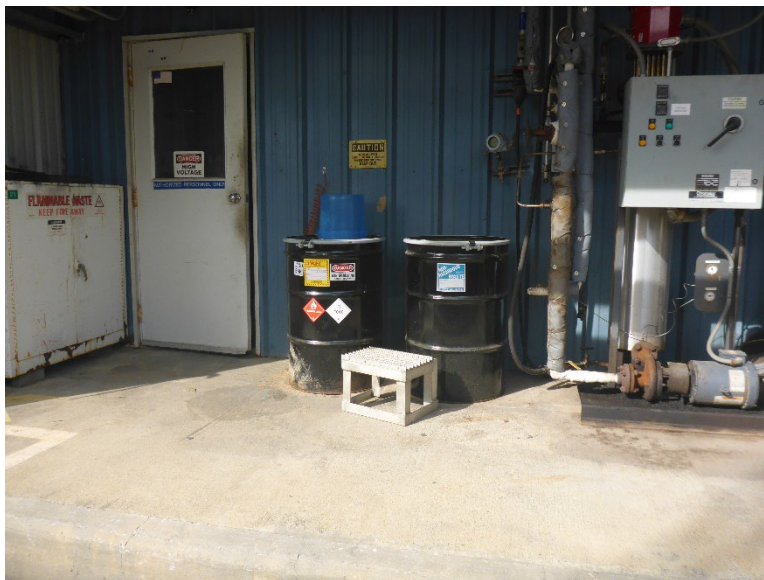
- Pilot Plant SW End – SABIC manages two SAAs in a curbed concrete area adjacent to the Pilot Plant Building. The area is covered with a roof and enclosed on three sides. The first SAA is used to accumulate hazardous waste generated in the Pilot Plant (Photo 9). The inspectors observed one 55-gallon drum in this SAA. The drum was labeled hazardous waste (acrylonitrile, styrene) and it was identified with flammable liquid and toxic DOT hazard placards. The second SAA is used to accumulate hazardous waste generated in the laboratory (Photo 10). The inspectors observed one 20-gallon container in this SAA. The container was labeled D001, F005 hazardous waste solid (MEK) and it was identified with a Class 9 DOT hazard placard. This SAA is not located at or near the point where the hazardous waste solid MEK is generated, and the Class 9 DOT hazard placard does not indicate the specific hazards of the contents of this container.

**Photo 9:** One 55-gallon drum, which was labeled hazardous waste (acrylonitrile, styrene) and identified as flammable and toxic, in the first Pilot Plant SW End SAA.

**Pursuant to 11 Miss. Admin. Code Pt. 3, R. 1.3 [40 C.F.R. § 262.15(a)], a generator may accumulate as much as 55 gallons of non-acute hazardous waste in containers at or near the point of generation where wastes initially accumulate, which is under the control of the operator of the process generating the waste, without a permit or without having interim status, as required by Section 17-17-27(4) of the Mississippi Code of 1972, Miss. Code Ann. § 17-17-27(4) [Section 3005 of RCRA, 42 U.S.C. § 6925], and without complying with 11 Miss. Admin. Code Pt. 3, R. 1.3 [40 C.F.R. § 262.16(b) or §**

**262.17(a)], except as required in 11 Miss. Admin. Code Pt. 3, R. 1.3 [40 C.F.R. § 262.15(a)(7) and (8)], provided that the generator complies with the SAA Permit Exemption.**

**Pursuant to 11 Miss. Admin. Code Pt. 3, R. 1.3 [40 C.F.R. § 262.15(a)(5)(ii)], which is a condition of the SAA Permit Exemption, a generator is required to mark or label its containers with an indication of the hazards of the contents.**

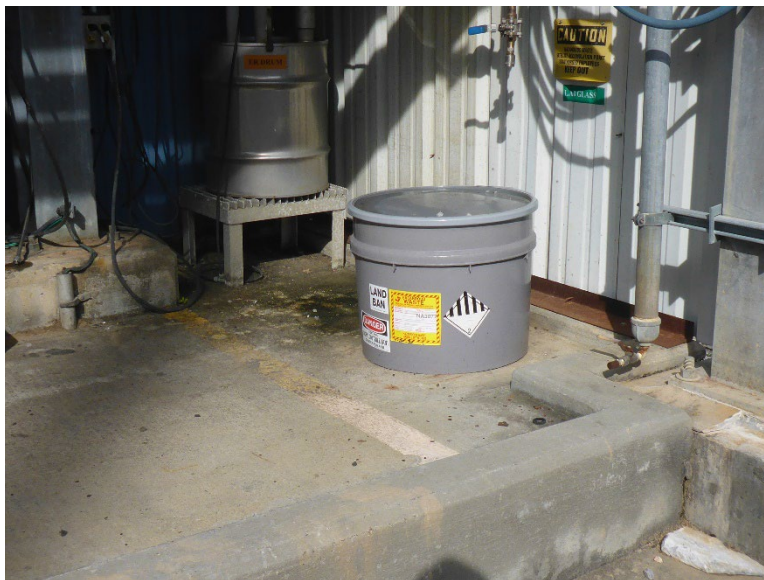
**Photo 10:** One 20-gallon container, which was labeled D001, F005 hazardous waste solid (MEK), in the second Pilot Plant SW End SAA.

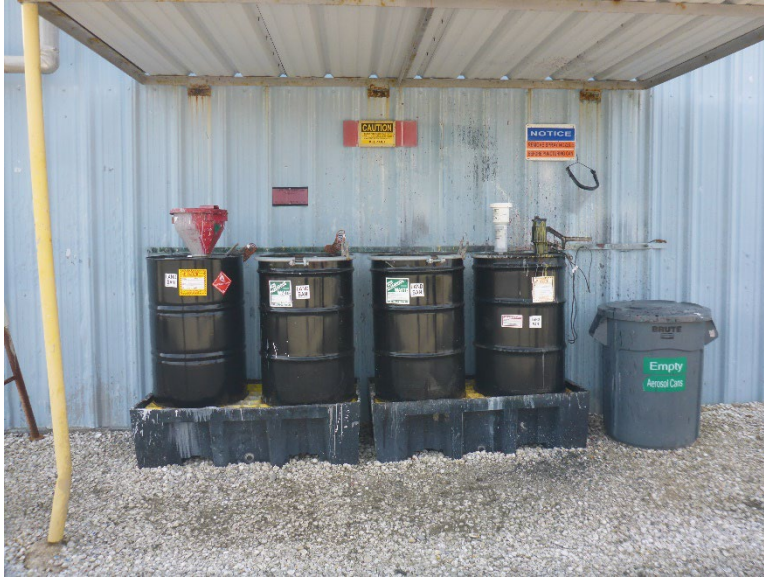
- Maintenance Paint Shop – SABIC manages two SAAs for accumulating hazardous wastes generated in the Maintenance Shop (Photo 11). The first SAA is used to accumulate hazardous waste used paint. The inspectors observed one 55-gallon drum with a latched funnel lid on a portable secondary containment pallet in this SAA. The drum was labeled D001, F005 hazardous waste used paint (MEK) and it was identified with a flammable liquid DOT hazard placard. However, it was not marked with an indication that its contents are also toxic. The second SAA is used to puncture used aerosol cans and accumulate their contents. The inspectors observed one 55-gallon drum in this SAA. The drum was labeled D001, F005 hazardous waste flammable liquids (toluene, MEK) and it was identified with a flammable liquid DOT hazard placard. However, it was not marked with an indication that its contents are also toxic.

**Photo 11:** One 55-gallon drum, which was labeled D001, F005 hazardous waste used paint (MEK) and identified as flammable, in the first Maintenance Paint Shop SAA on the left pallet; and one 55-gallon drum, which was labeled D001, F005 hazardous waste flammable liquids (toluene, MEK) and identified as flammable, in the second Maintenance Paint Shop SAA on the right pallet.

**Pursuant to 11 Miss. Admin. Code Pt. 3, R. 1.3 [40 C.F.R. § 262.15(a)(5)(ii)], which is a condition of the SAA Permit Exemption, a generator is required to mark or label its containers with an indication of the hazards of the contents.**

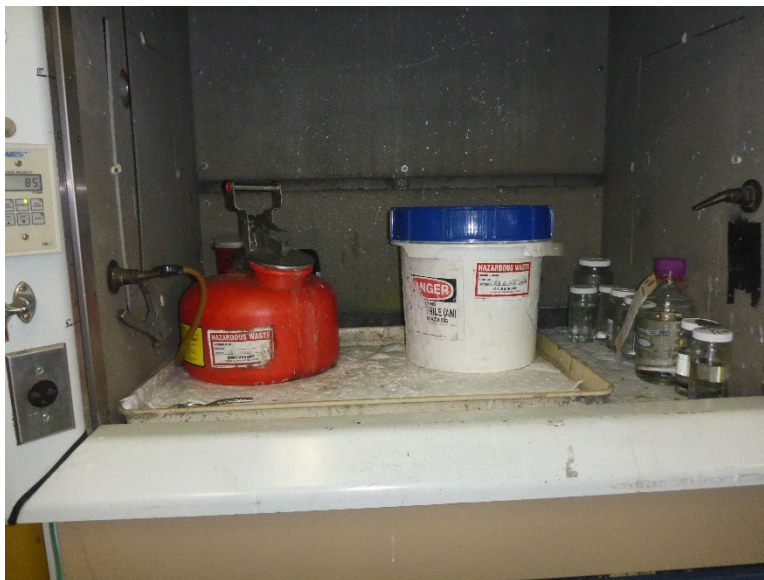
- Laboratory – SABIC manages a SAA for accumulating hazardous waste generated in the laboratory (Photo 12). The inspectors observed one flammable can and one 5-gallon bucket in this SAA. Each container was labeled with the words “hazardous waste,” but neither was marked with an indication of the hazards of its contents. Personnel explained that used samples are accumulated in the flammable can as a hazardous waste flammable liquid and that the contents of the can are transferred to a 55-gallon drum in one of the other SAAs as often as once each week or once each month. Personnel also explained that empty glass sample jars are accumulated in the 5-gallon bucket and that the contents of the bucket are transferred to the 20-gallon container at the Pilot Plant SAA every Friday. Containers in other SAAs are not at or near the laboratory where these hazardous wastes are generated, and they are not under the control of laboratory personnel who generate these hazardous wastes.

**Photo 12:** One flammable can and one 5-gallon bucket in the Laboratory SAA. Each container was labeled with the words “hazardous waste,” but neither was marked with an indication of the hazards of its contents.

**Pursuant to 11 Miss. Admin. Code Pt. 3, R. 1.3 [40 C.F.R. § 262.15(a)(5)(ii)], which is a condition of the SAA Permit Exemption, a generator is required to mark or label its containers with an indication of the hazards of the contents.**

**Pursuant to 11 Miss. Admin. Code Pt. 3, R. 1.3 [40 C.F.R. § 262.15(a)], a generator may accumulate as much as 55 gallons of non-acute hazardous waste in containers at or near the point of generation where wastes initially accumulate, which is under the control of the operator of the process generating the waste, without a permit or without having interim status, as**

**required by Section 17-17-27(4) of the Mississippi Code of 1972, Miss. Code Ann. § 17-17-27(4) [Section 3005 of RCRA, 42 U.S.C. § 6925], and without complying with 11 Miss. Admin. Code Pt. 3, R. 1.3 [40 C.F.R. § 262.16(b) or § 262.17(a)], except as required in 11 Miss. Admin. Code Pt. 3, R. 1.3 [40 C.F.R. § 262.15(a)(7) and (8)], provided that the generator complies with the SAA Permit Exemption.**
