## **RCRA Inspection Report**

Ascend Elements, Inc.  
9176 Industrial Drive, NE  
Covington, GA 30014  
Newton County

EPA ID#: GAR000094110  
NAICS #: 335910 – Battery Manufacturer

January 17, 2024, at 8:50 a.m.

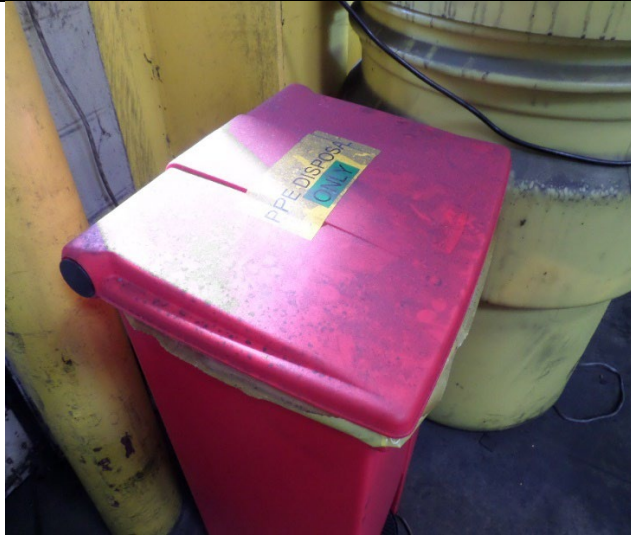
Ascend Elements, Inc. (AEI). Battery Receiving and Storage Area. The inspectors observed a 10-gallon container of waste PPE next to an emergency spill kit. AEI determined the solid waste is nonhazardous waste. The inspectors requested the record of the waste determination. Photograph 1 taken at 10:54 a.m.

AEI representatives indicated their response to a spill or a broken battery depends on the type of battery and if electrolyte has been released. The response is to segregate the battery, contain the spill or release of the battery or electrolyte using emergency kits, and to follow emergency procedures. Broken battery material is stored in a container. AEI representatives indicated there are four spill kits in the BRSA. The inspectors observed a red container storing waste personal protective equipment (PPE) in the BRSA. The inspectors observed the container was closed and labeled with the words, "PPE Disposal Only" (Attachment 1 Photographs 1 and 2). The inspectors requested the waste determination record.

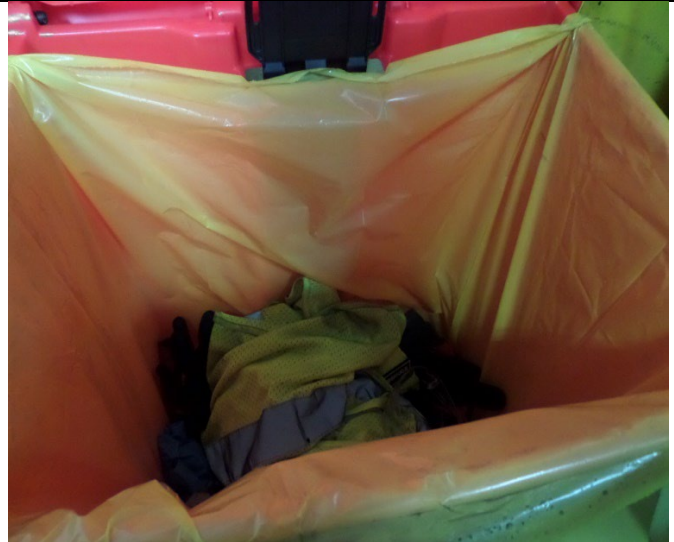
AEI. Battery Receiving and Storage Area. The inspectors observed a 10-gallon container of waste PPE next to an emergency spill kit. AEI determined the solid waste is nonhazardous waste. The inspectors requested the record of the waste determination. Photograph 2 taken at 11:00 a.m.

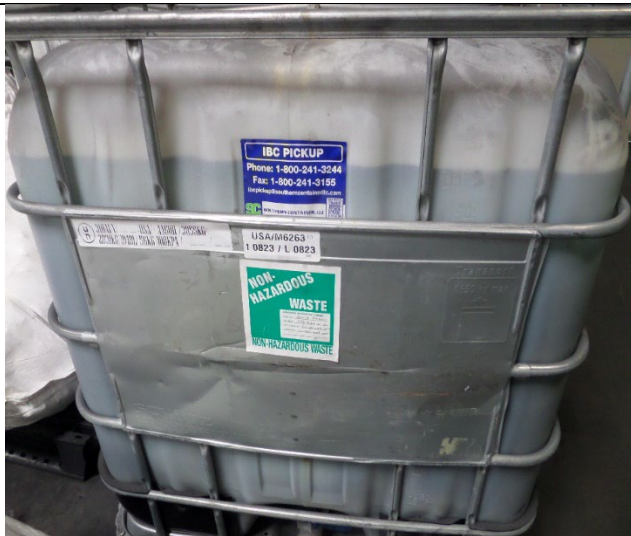
AEI. Outside the Control Room. The inspectors observed a 250-gallon tote outside the control room area accumulating scrubber water labeled with the words nonhazardous waste. Photograph 3 taken at 11:01 a.m.

The inspectors observed a 250-gallon tote labeled with the words nonhazardous waste in a hallway outside the control room accumulating scrubber water (Attachment 1 Photograph 3).

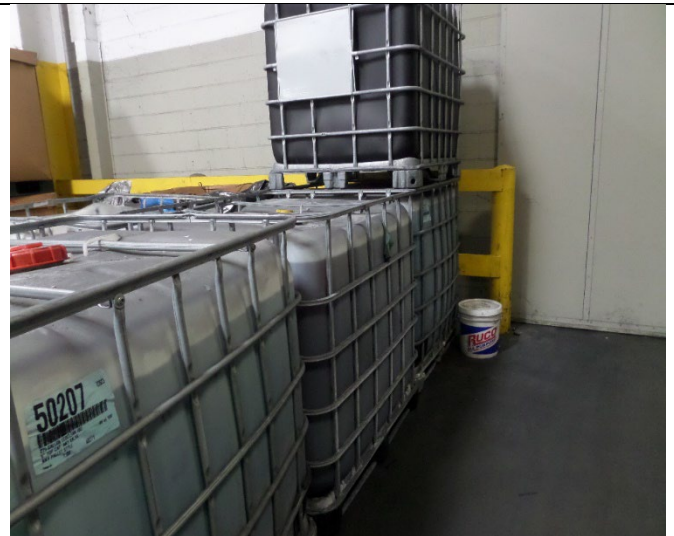
AEI. Outside of Control Room. The inspectors observed four 250-gallon totes accumulating floor scrubber water generated from mechanically scrubbing the floor. Photograph 4 taken at 11:01 a.m.

The inspectors observed four 250-gallon totes storing floor scrubber water generated from mechanically scrubbing the floor (Attachment 1 Photograph 4).

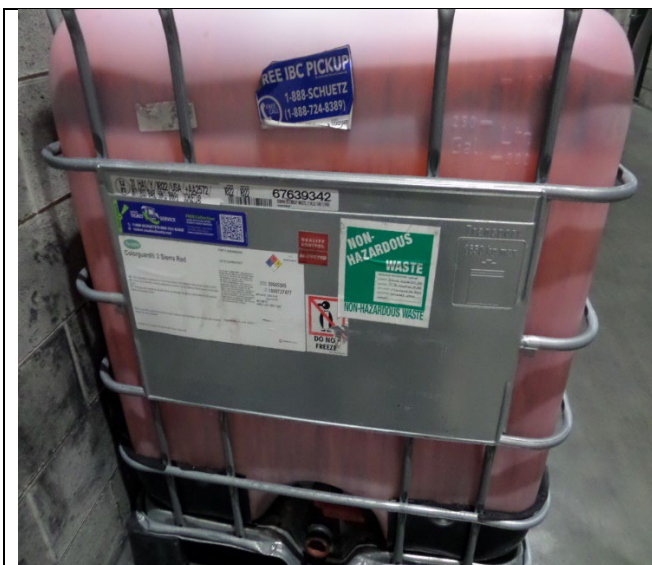
AEI. Outside the Scrubber Room. The inspectors observed a 250-gallon tote outside the scrubber room area accumulating scrubber water labeled with the words nonhazardous waste. Photograph 5 taken at 11:47 a.m.

The inspectors observed a 250-gallon tote in the hallway outside the scrubber room accumulating scrubber water. The 250-gallon tote was labeled with the words nonhazardous waste (Attachment 1 Photograph 5).

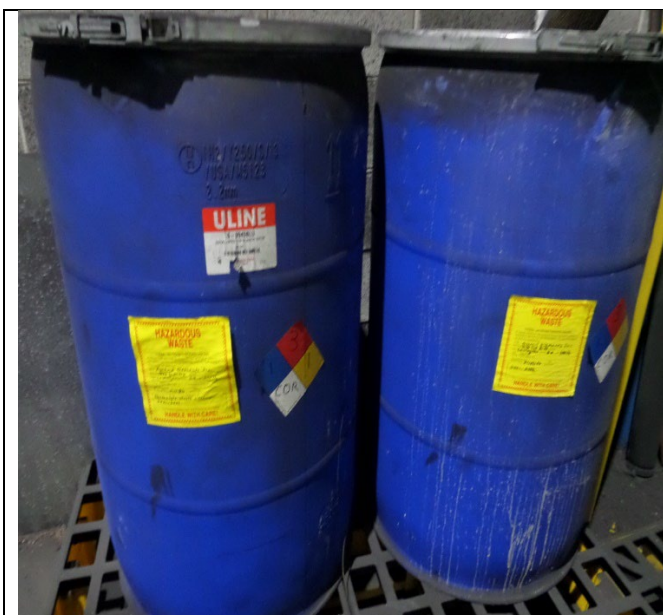
This area accumulates hazardous waste for 90-days or less and is located against a wall in the Hallway adjacent to the Condenser Room. The inspectors observed two 30-gallon containers of waste electrolyte cleanup solids, one 5-gallon container of nonhazardous waste gear oil, and one empty 15-gallon container (Attachment 1 Photograph 7). The inspectors observed the two

AEI. Central Accumulation Area (CAA). The inspectors observed the CAA was storing ignitable hazardous waste and not identified with the words "no smoking" Photograph 7 taken at 12:13 p.m.

On January 29, 2024, AEI emailed the EPA a photograph of the Condenser Room’s door, adjacent to the CAA, that showed a no smoking sign posted on the door and a photograph of the CAA with a sign on the wall marked as a “Hazardous Waste Central Accumulation Area”.

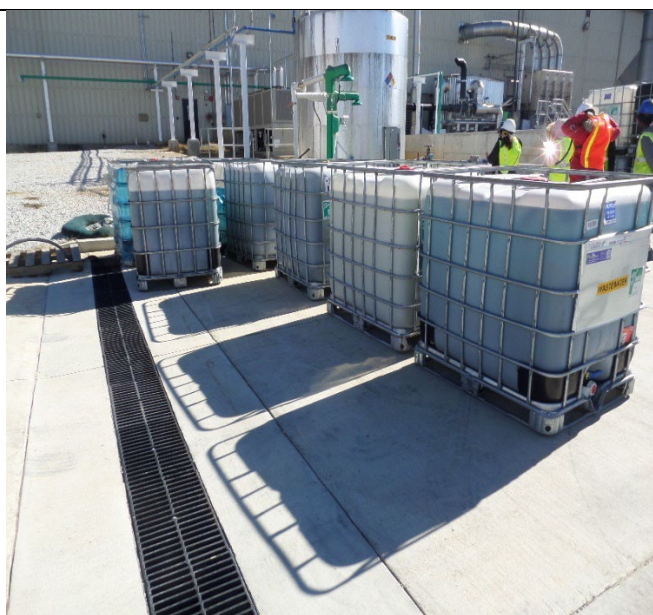
AEI. Tank T-3030. The inspectors observed five 250-gallon totes accumulating scrubber water. Tank T-3030 is in the background. Photograph 8 taken at 12:17 p.m.

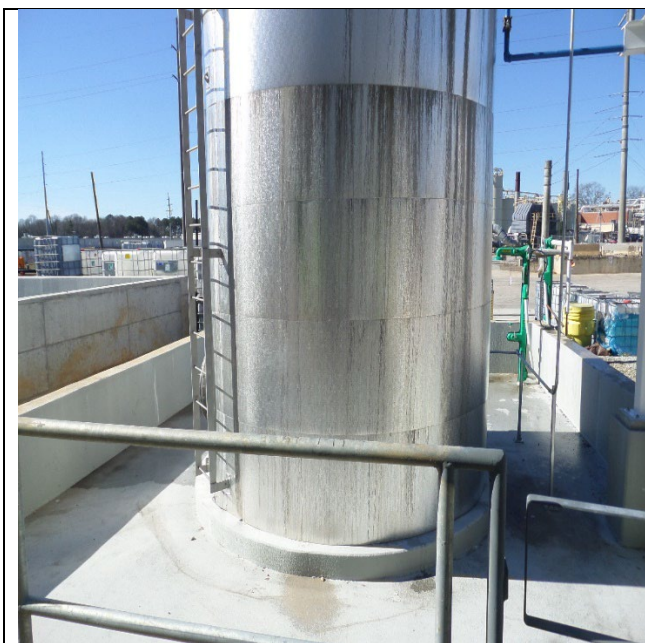
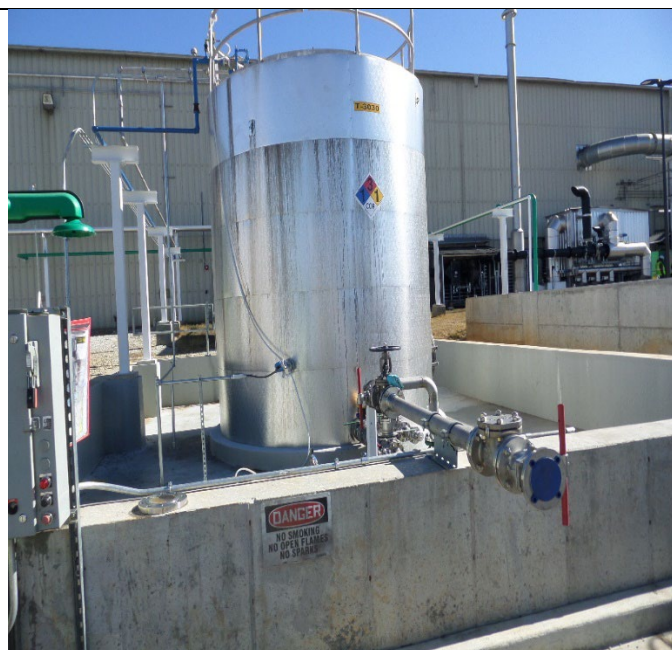
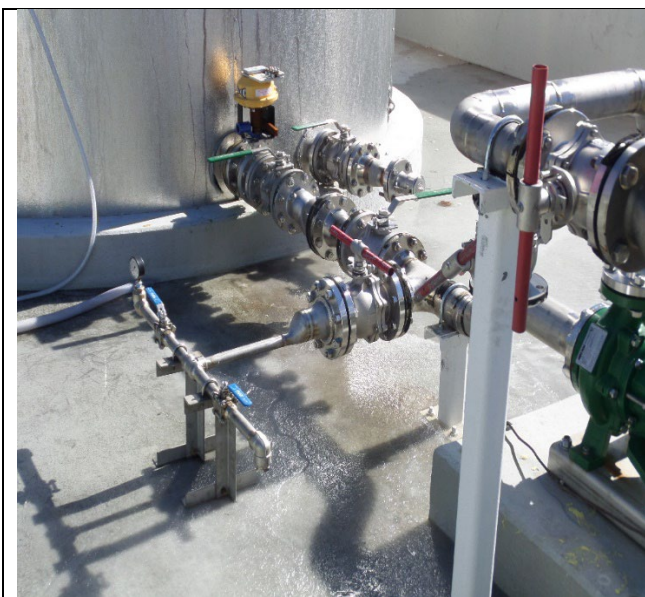
The inspectors observed the condensers, pumps, valves, flanges, connections, and pipe connections (components) were not marked to identify each piece of equipment. The inspectors requested to review the records for the determination made for each piece of equipment that contains or contacts a hazardous waste with organic concentration that equals or exceeds 10 percent by weight. The liquid electrolyte is stored in an outdoor aboveground tank.

AEI. Tank T-3030. The inspectors observed the tank pumps, valves, and flanges and other pipe connections were not marked to identify each piece of equipment. The inspectors observed the tank was not labeled or marked with the words hazardous waste and not marked with a date. Photograph 9 taken at 12:19 p.m.

AEI. Tank T-3030. The inspectors observed the tank pumps, valves, and flanges and other pipe connections were not marked to identify each piece of equipment. The inspectors observed the tank was not labeled or marked with the words hazardous waste and not marked with a date. Photograph 10 taken at 12:19 p.m.

AEI. Tank T-3030. The inspectors observed the tank pumps, valves, and flanges and other pipe connections were not marked to identify each piece of equipment. The inspectors observed the tank was not labeled or marked with the words hazardous waste and not marked with a date. Photograph 11 taken at 12:19 p.m.

**Pursuant to Ga. Comp. R. and Regs. 391-3-11-.08(1) [40 C.F.R. § 262.17(a)(6)], which incorporates Ga. Comp. R. and Regs. 391-3-11-.10(1) [40 C.F.R. § 265.1050(c)], a condition of the LQG Permit Exemption requires that each piece of equipment to which 40 C.F.R. § 265 - Subpart BB applies shall be marked in such a manner that it can be distinguished readily from other pieces of equipment.**

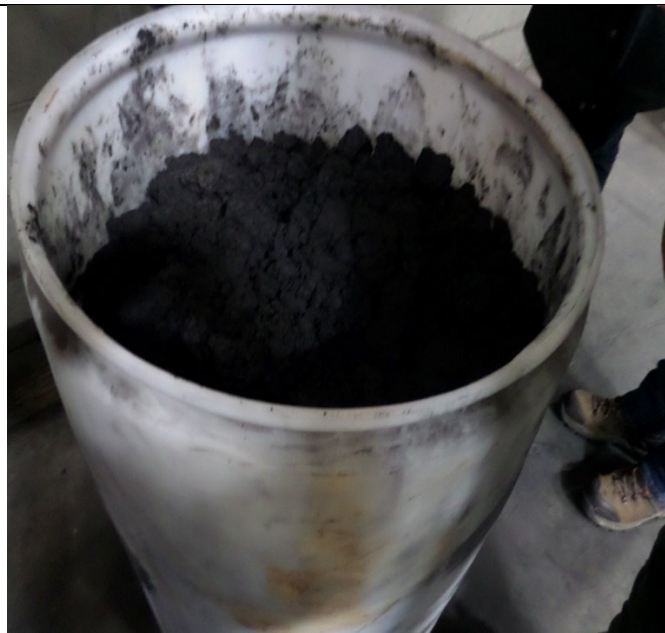
AEI. Container of Black Mass Near Wastewater Treatment System. The inspectors observed a 55-gallon container with a small hole in the container's top near the wastewater treatment system. AEI representatives opened it and indicated the contents was black mass was sent from AEI's Westboro, Massachusetts research and development program. Photograph 12 taken at 12:32 p.m.

AEI. AEI. Container of Black Mass Near Wastewater Treatment System. The inspectors observed a 55-gallon container with a small hole in the container's top near the wastewater treatment system. AEI representatives opened it and indicated the contents was black mass was sent from AEI's Westboro, Massachusetts research and development program. Photograph 13 taken at 12:32 p.m.

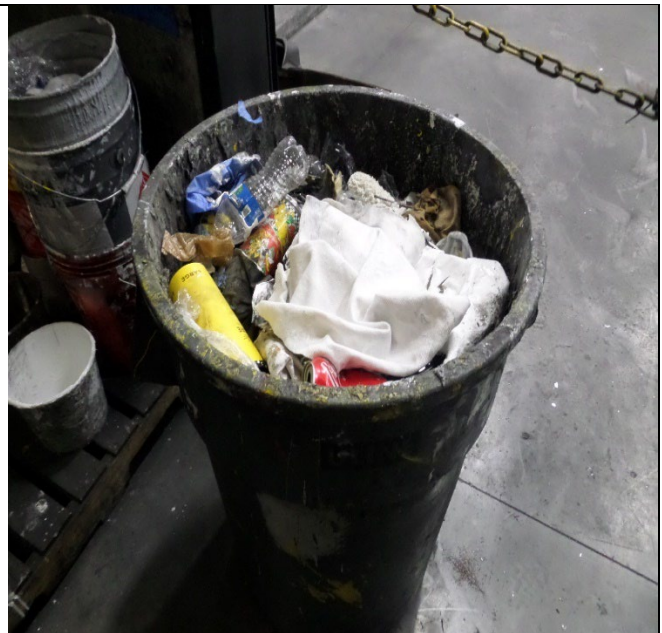
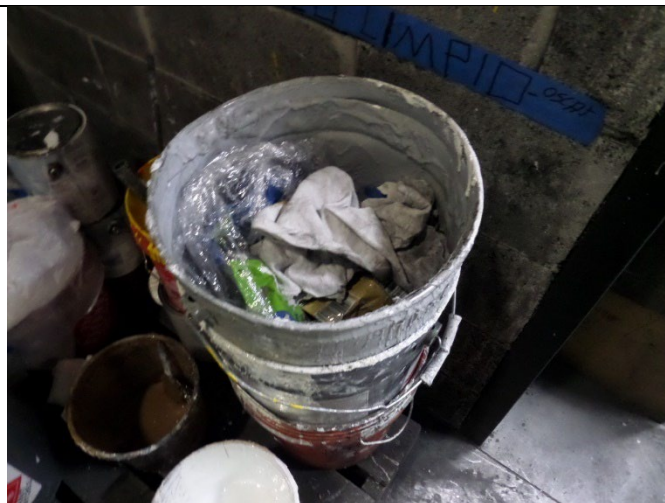
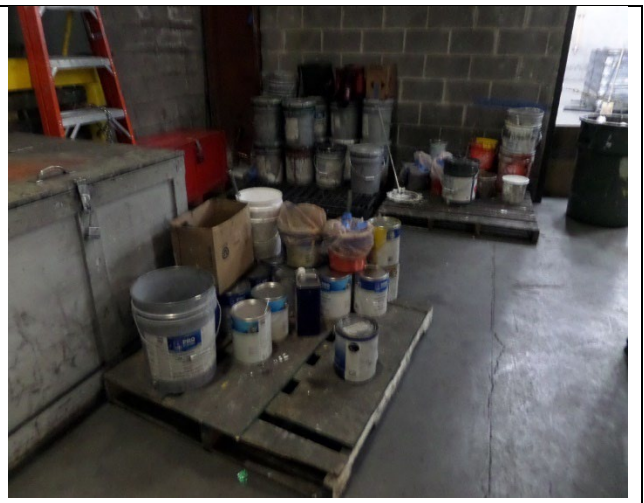
AEI. Paint Contractor. The inspectors observed several one-gallon to 5-gallon containers of paint related material generated by a paint contractor near the Metal Recovery Line. The inspectors observed full and partially full containers of wet paint. Several containers were open. The inspectors observed a trash container accumulating waste paint related debris. Photograph 14 taken at 12:39 p.m.

AEI. Paint Contractor. The inspectors observed several one-gallon to 5-gallon containers of paint related material generated by a paint contractor near the Metal Recovery Line. Several containers were open. Photograph 15 taken at 12:39 p.m.

AEI. Paint Contractor. The inspectors observed a trash container accumulating waste paint related debris. Photograph 16 taken at 12:39 p.m.

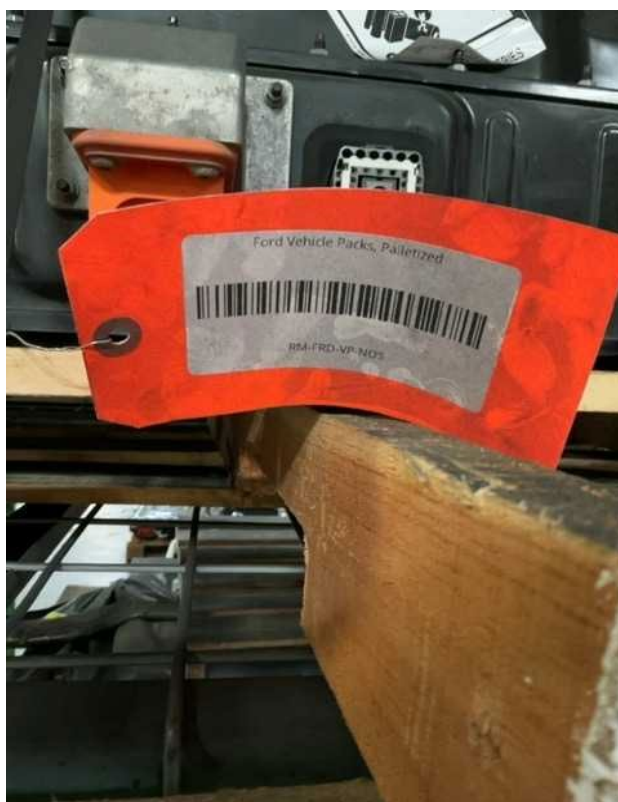
The inspectors randomly inspected the dry, wet non-charged, and wet charged BRSA. The inspectors observed the batteries are received in a variety of quality and some of the dry and wet non-charged batteries did not appear in good condition (Attachment 2 Photograph 1 through 5).

| The inspectors observed dry and wet (charged and noncharged) batteries in storage. Back of tag has lot number with date of shipment, marked with identification number for shipping records, bill of lading, and stamped with date received. Attached list of material that came in shipment and the number of pieces shipped. | | | |

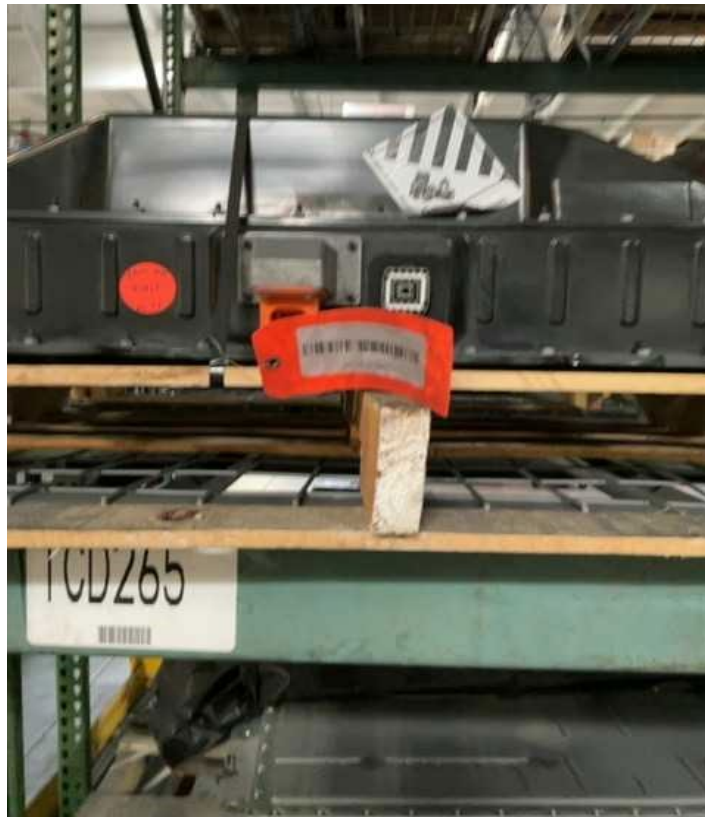
| <p>The inspectors observed dry and wet (charged and noncharged) batteries in storage. Back of tag has lot number with date of shipment, marked with identification number for shipping records, bill of lading, and stamped with date received. Attached list of material that came in shipment and the number of pieces shipped. Rack identification number and bar code.</p> | | | |

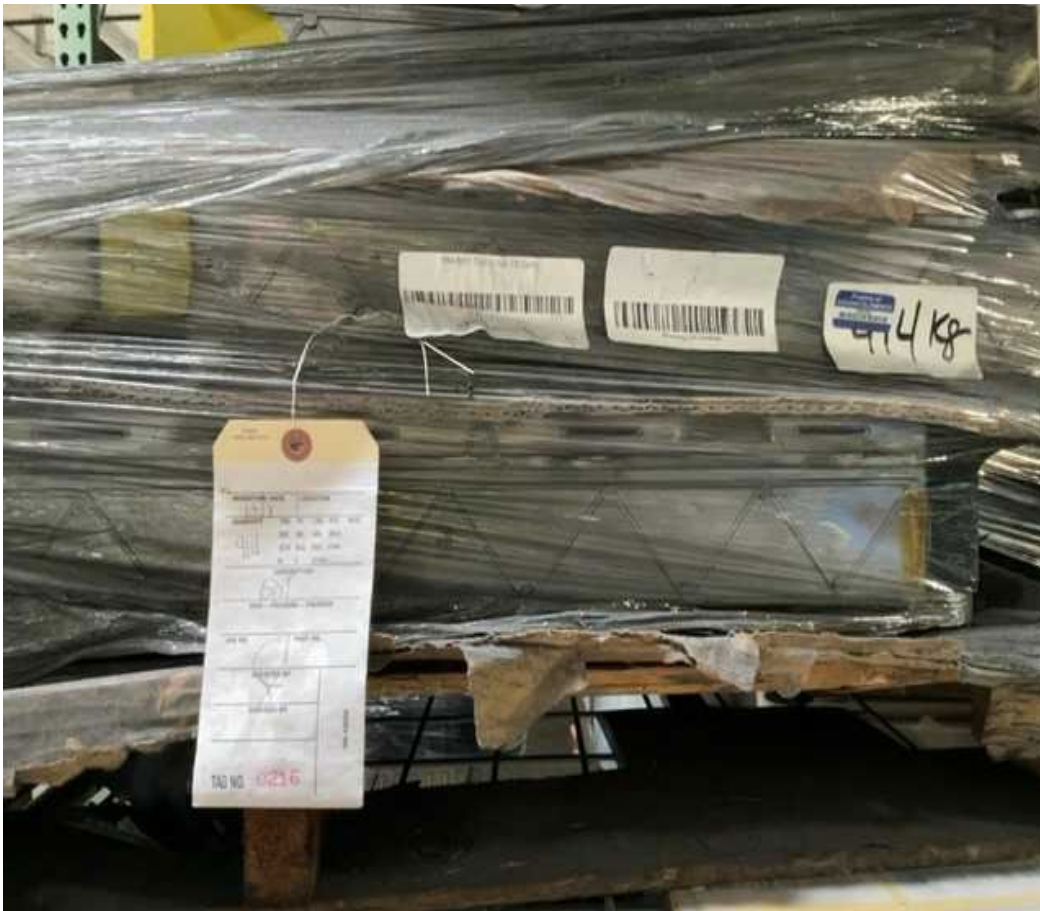
| The inspectors observed dry and wet (charged and noncharged) batteries in storage. AEI internal tag attached to battery identifies the date received, storage location, quantity, marked with the type of battery, marked as raw, processed, or finished, and marked with the persons initials. | | | |

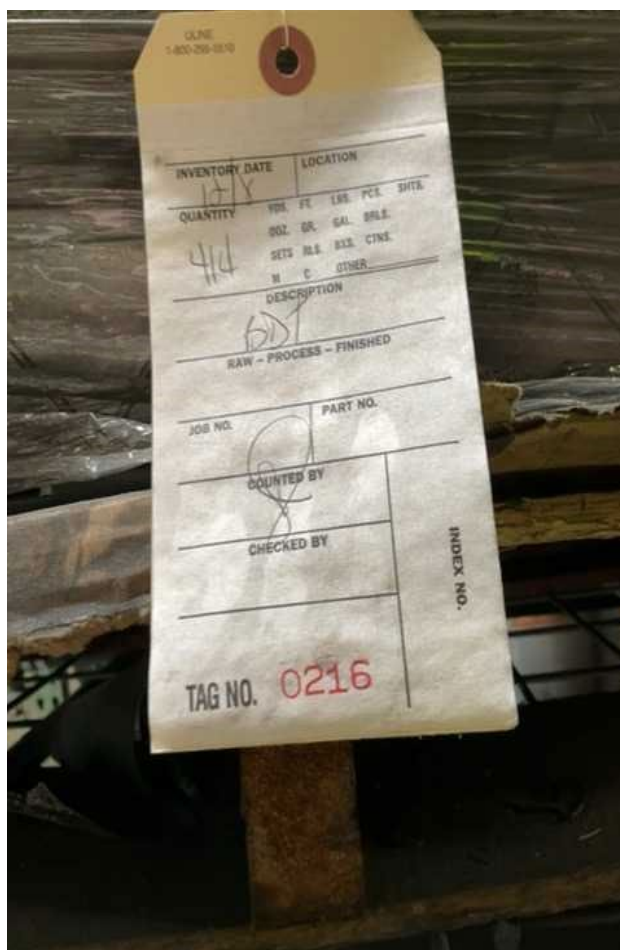
| The inspectors observed dry and wet (charged and noncharged) batteries in storage. AEI internal tag attached to battery identifies the date received, storage location, quantity, marked with the type of battery, marked as raw, processed, or finished, and marked with the persons initials. | | | |

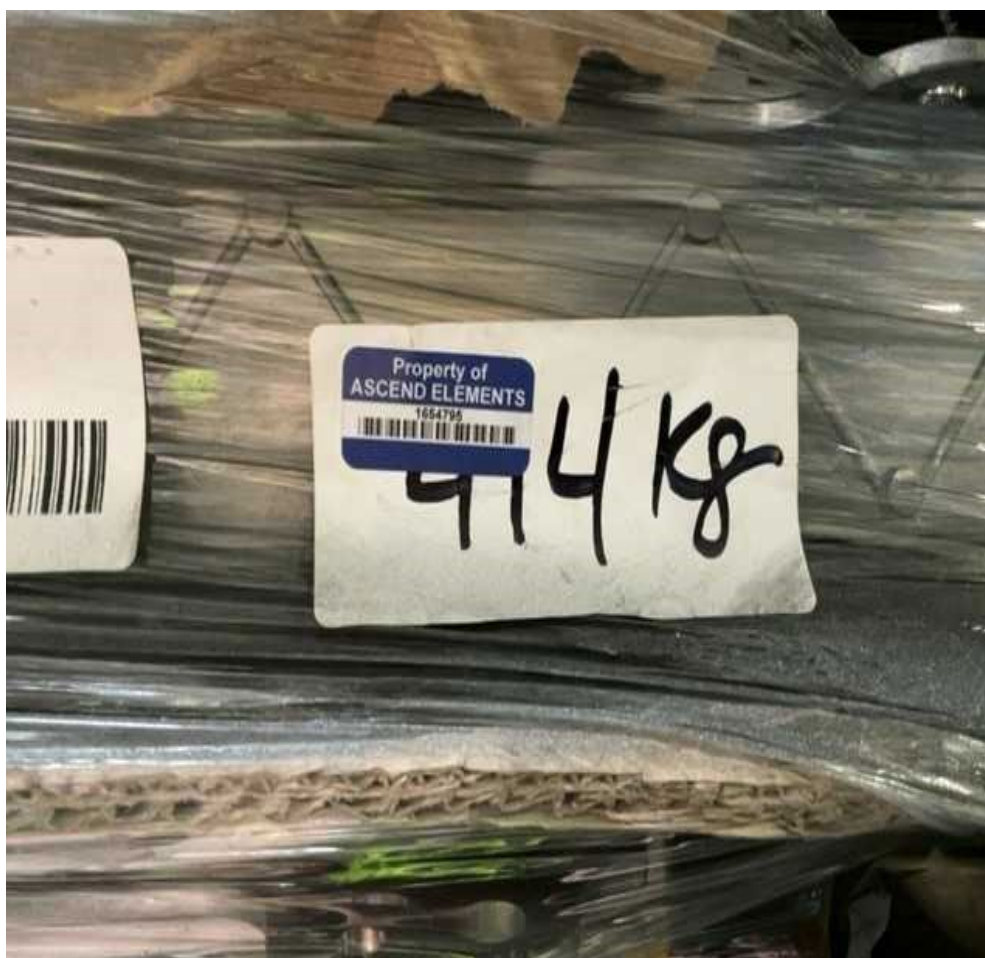
| Photograph 5 Battery Receiving and Storage Area | | | 33.61238548, -83.84238511 |

| AEI Internal label and bar code. | | | |

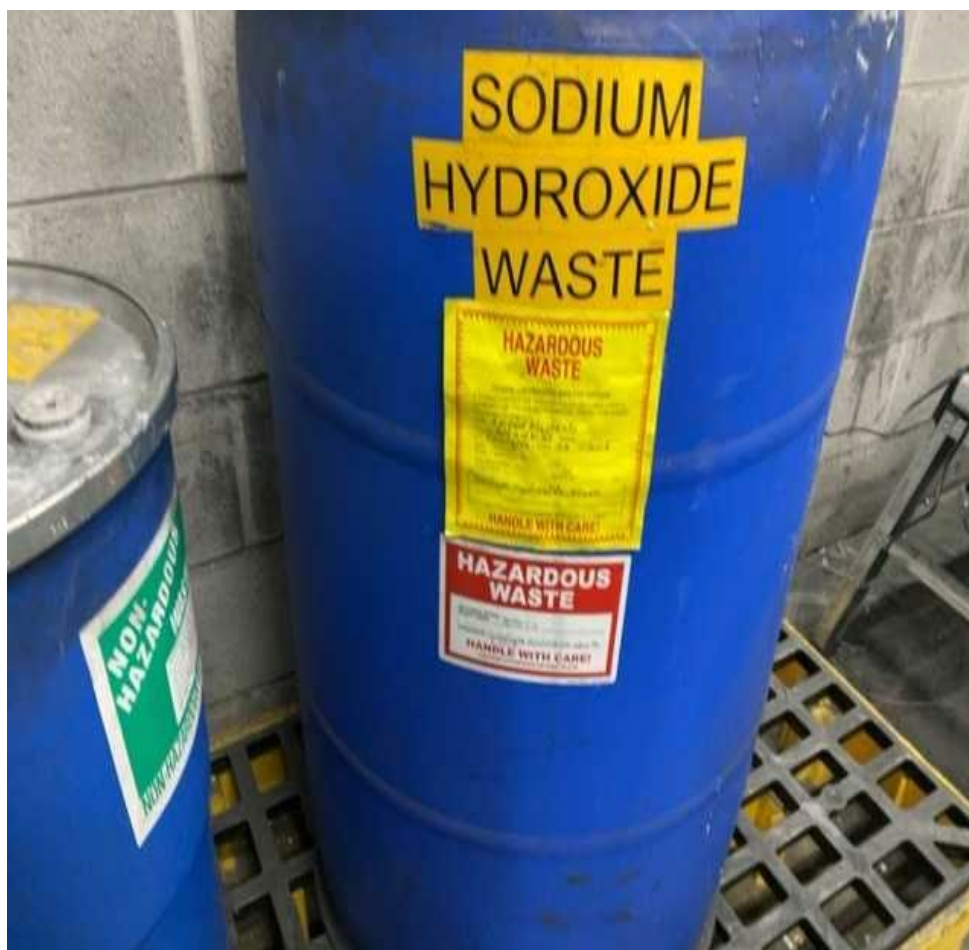
| Photograph 6 Scrubber Room | | | 33.61272665, -83.84245484 |

hazards (Attachment 1 Photograph 6 and Attachment 2 Photographs 6 and 7). AEI representatives indicated the date was marked on the container to track the amount of time and waste needed to fill the container, and that the container was not full and was continuing to accumulate waste.

| The inspectors observed one 55-gallon SAA container. The container was not marked or labeled with an indication of the hazards. | | | |

**Pursuant to Ga. Comp. R. and Regs. 391-3-11-.08(1) [40 C.F.R. § 262.15(a)(5)(ii)], which is a condition of the SAA Permit Exemption, a generator is required to mark or label its containers with an indication of the hazards of the contents.**

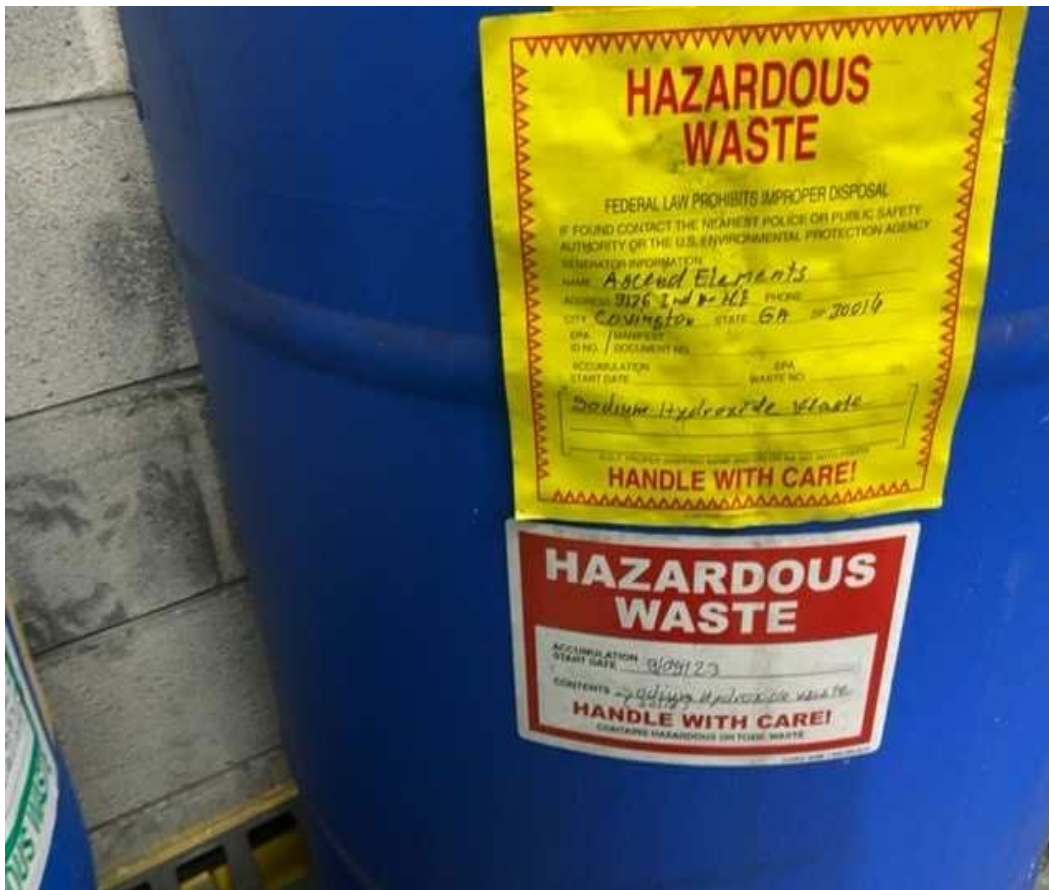
| Photograph 7 Scrubber Room | | | 33.61274063, -83.84245221 |

| The inspectors observed one 55-gallon SAA container. The container was not marked or labeled with an indication of the hazards. | | | |

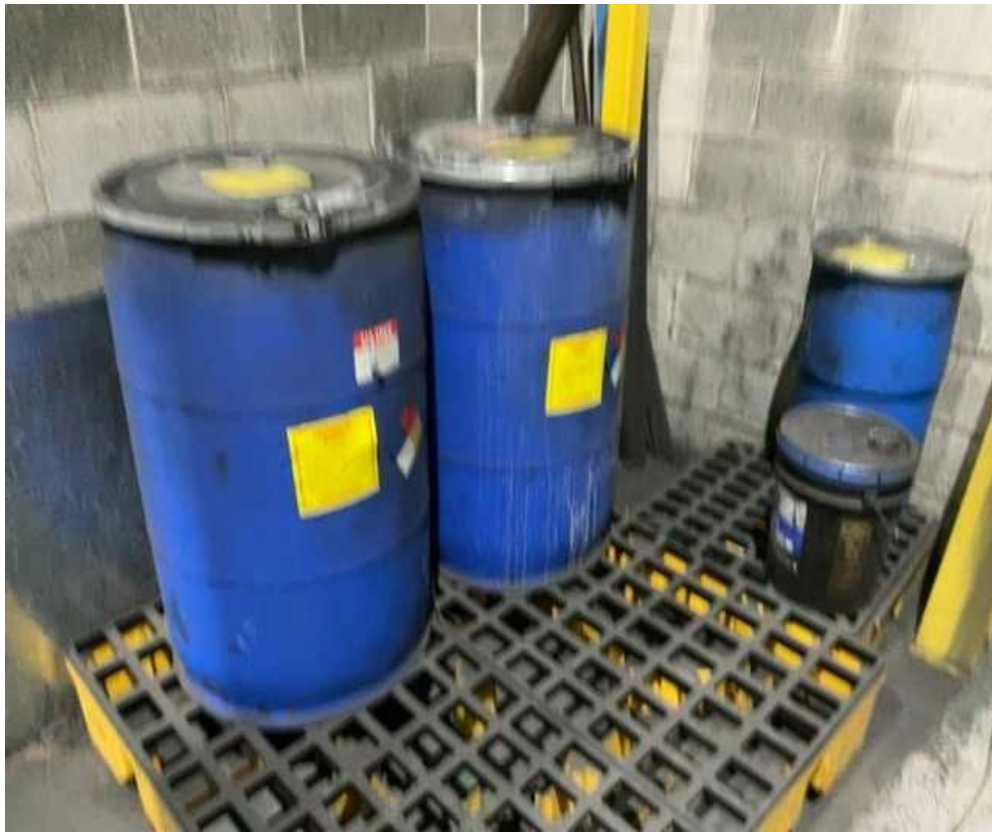
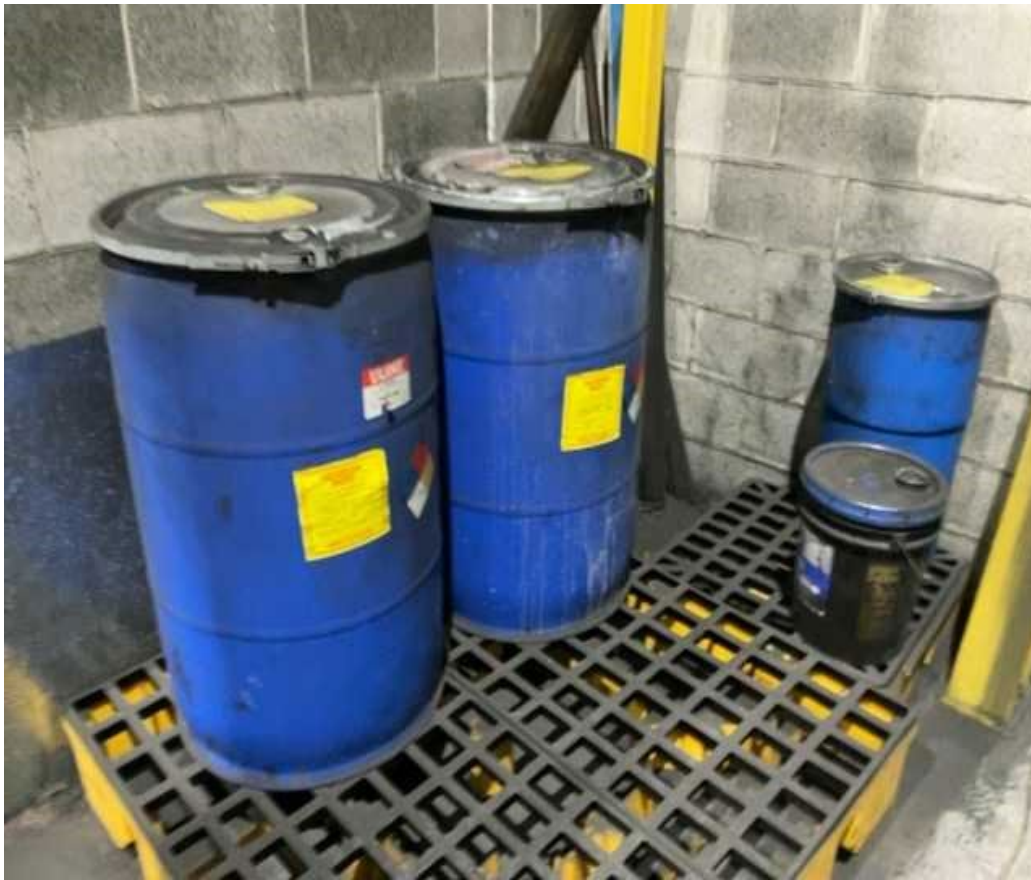
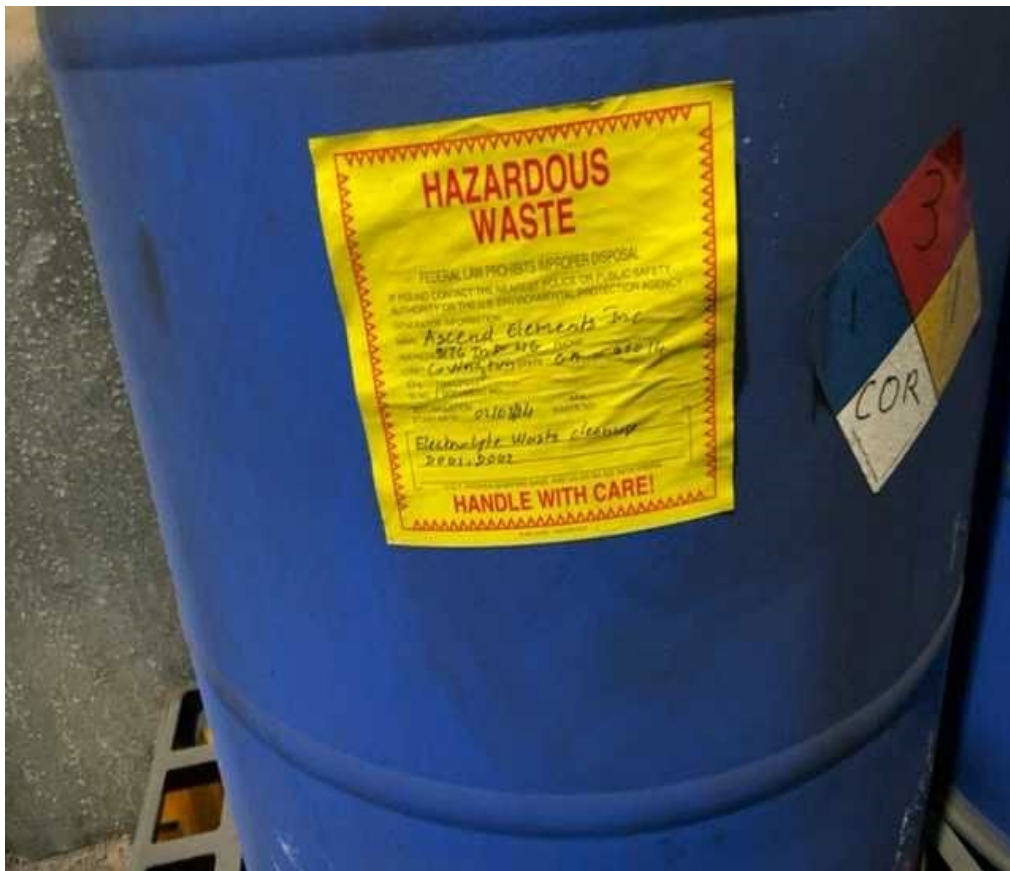
| The inspectors observed two 30-gallon containers of hazardous waste electrolyte cleanup solids, one 5-gallon container of nonhazardous waste gear oil, and one empty 15-gallon drum. The inspectors observed the CAA is storing ignitable hazardous waste and not identified with the words “no smoking”. | | | |

| The inspectors observed two 30-gallon containers of hazardous waste electrolyte cleanup solids, one 5-gallon container of nonhazardous waste gear oil, and one empty 15-gallon drum. The inspectors observed the CAA is storing ignitable hazardous waste and not identified with the words "no smoking". | | | |

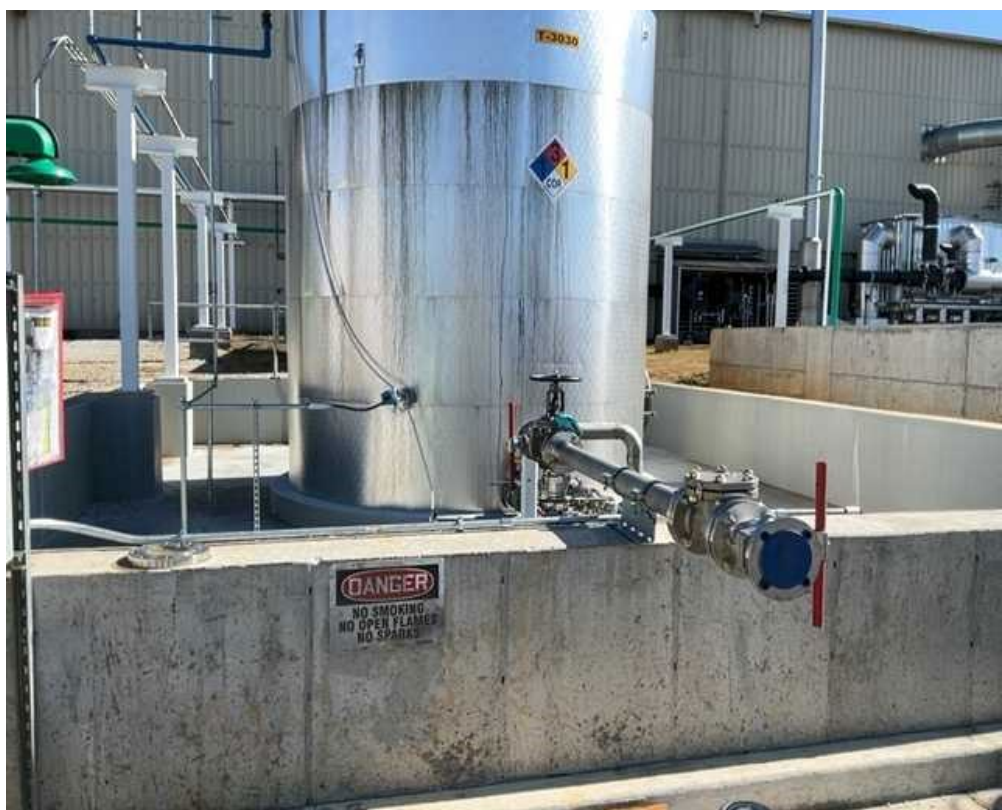
| The inspectors observed the tank pumps, valves, and flanges and other pipe connections were not marked to identify each piece of equipment. The inspectors observed the tank was not labeled or marked with the words hazardous waste and not marked with a date. | | | |

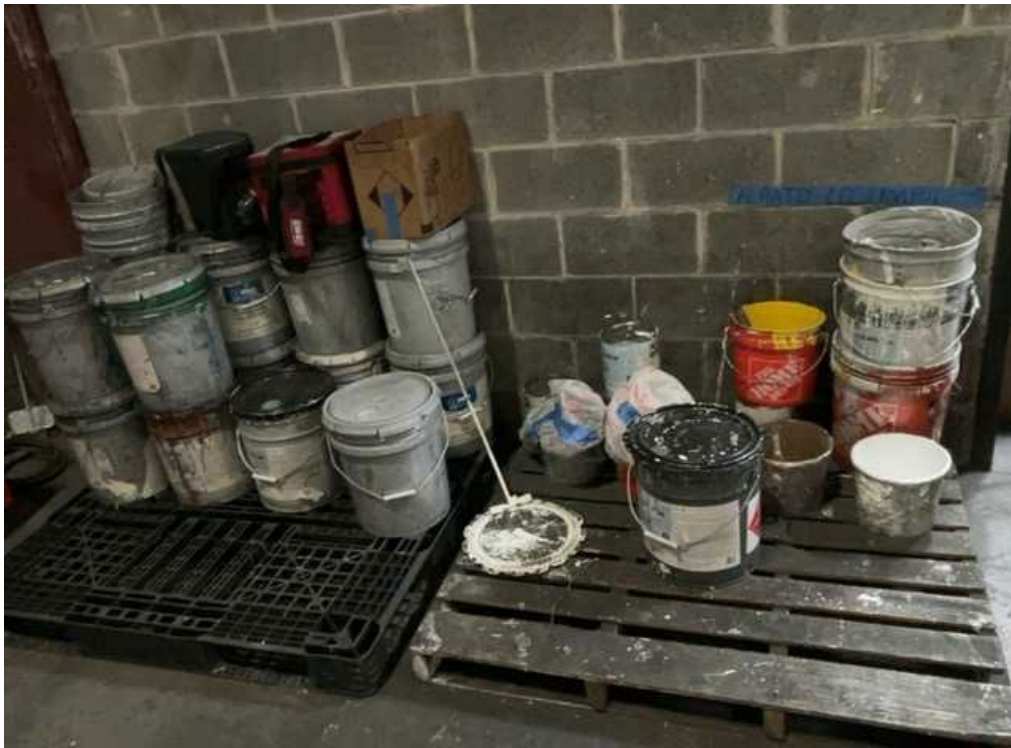
| Photograph 14 Paint Contractor Area | | | 33.61295318, -83.84229153 |

| The inspectors observed several one-gallon to 5-gallon containers of paint related material. Several containers were open accumulating wet paint. The inspectors observed a trash container accumulating waste paint related debris. | | | |
