## Clean Water Act Section 404: Site Visit/Case Development

| Site Name | Washington County Road Department, Jeff Crowder | | | | |

| Inspection Purpose | Initial site visit | | |

### Photograph Log

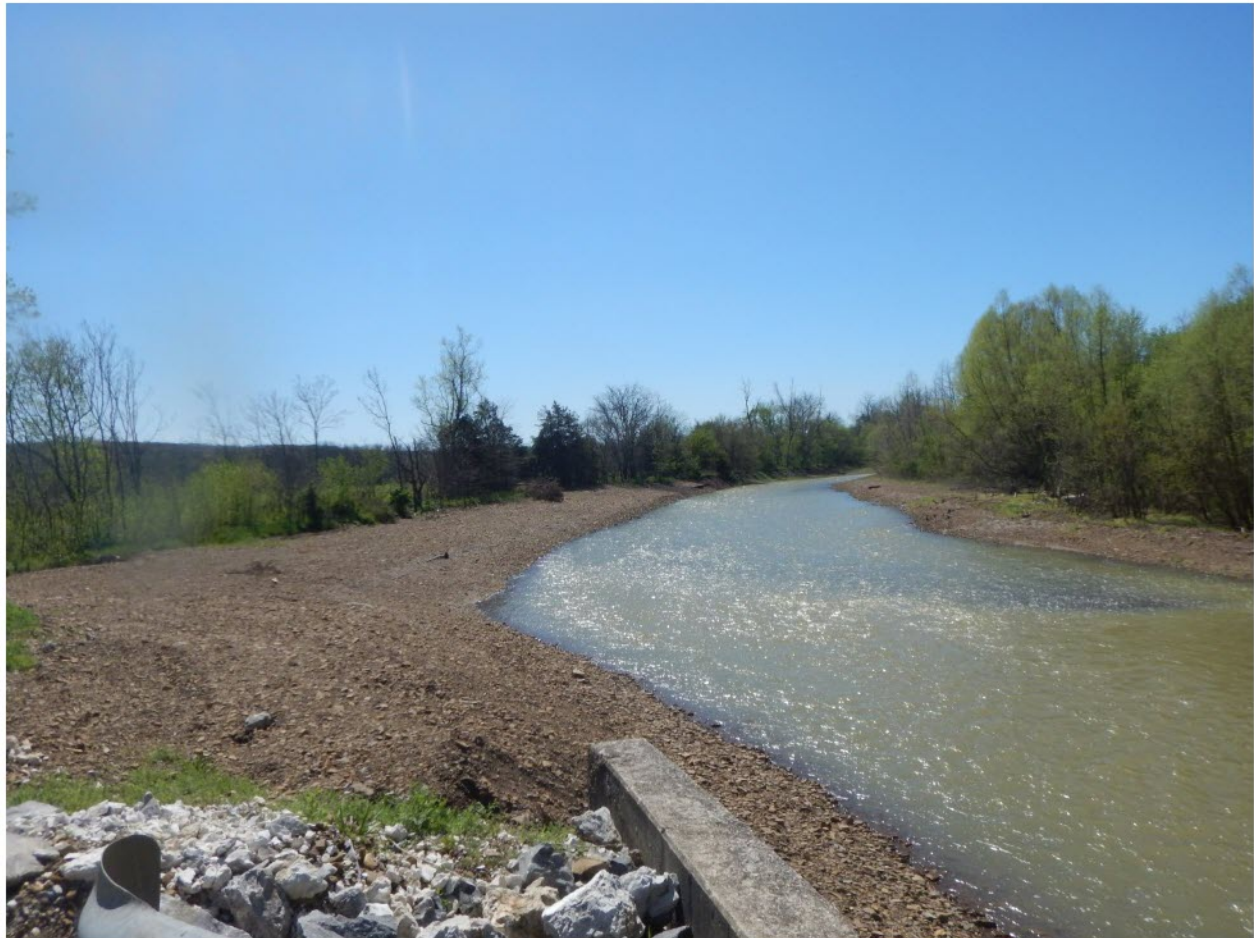
Photo No. 1

| Photo File Name | Date and Time of Photo | Photographer | Description |
|---|---|---|---|
| DSCN6405 | 04/11/2024, 10:46 AM | Chelsey Sherwood | Showing stream channelization and fill material consisting of stream bed substrate placed on river right and left. Note: riparian corridor removed and replaced with stream bed material. Picture taken facing upstream, south. |

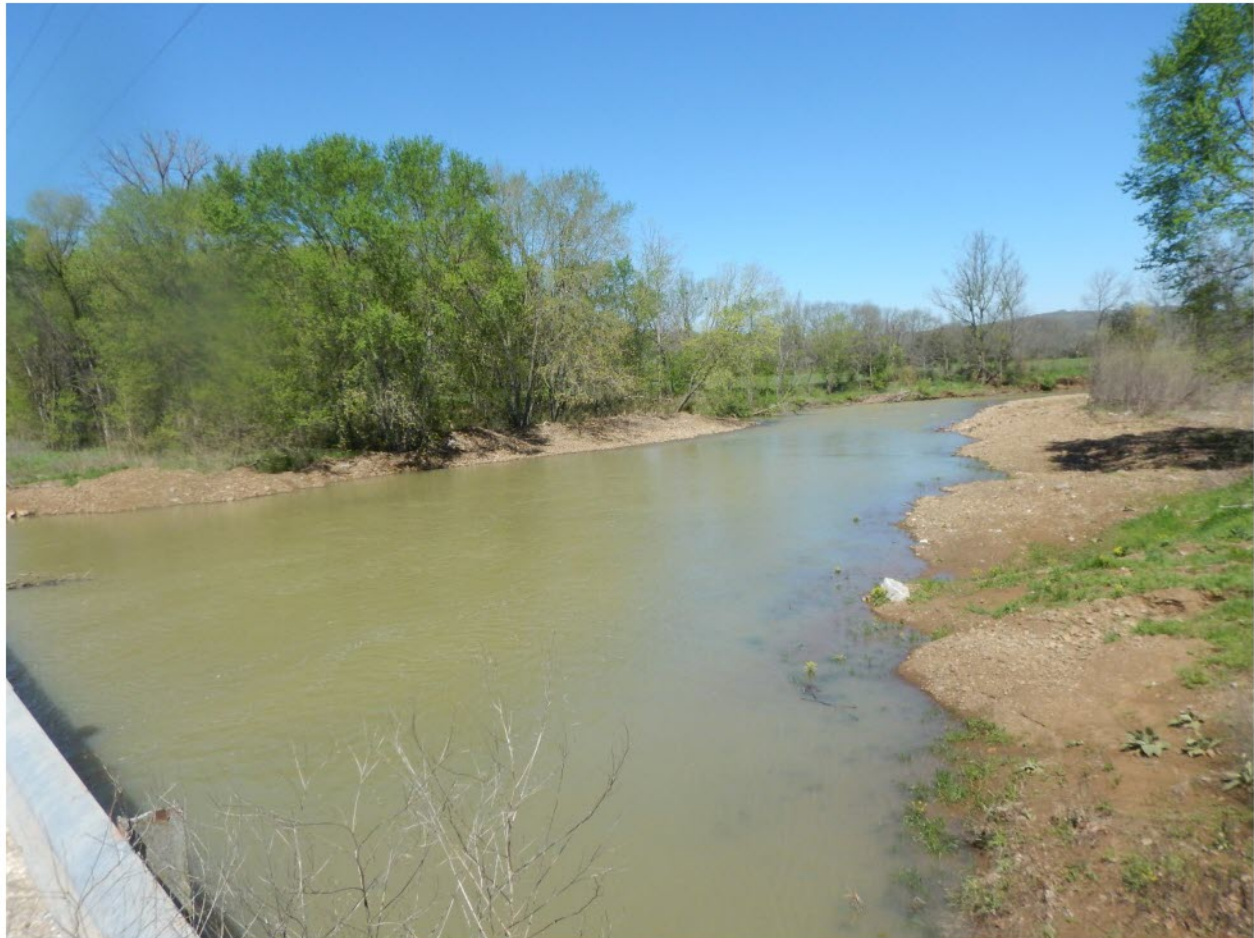
Photo No. 2

| Photo File Name | Date and Time of Photo | Photographer | Description |
|---|---|---|---|
| DSCN6406 | 04/11/2024, 10:47 AM | Chelsey Sherwood | Showing stream channelization and fill material consisting of stream bed substrate placed on river right and left. Picture taken facing downstream, north. |

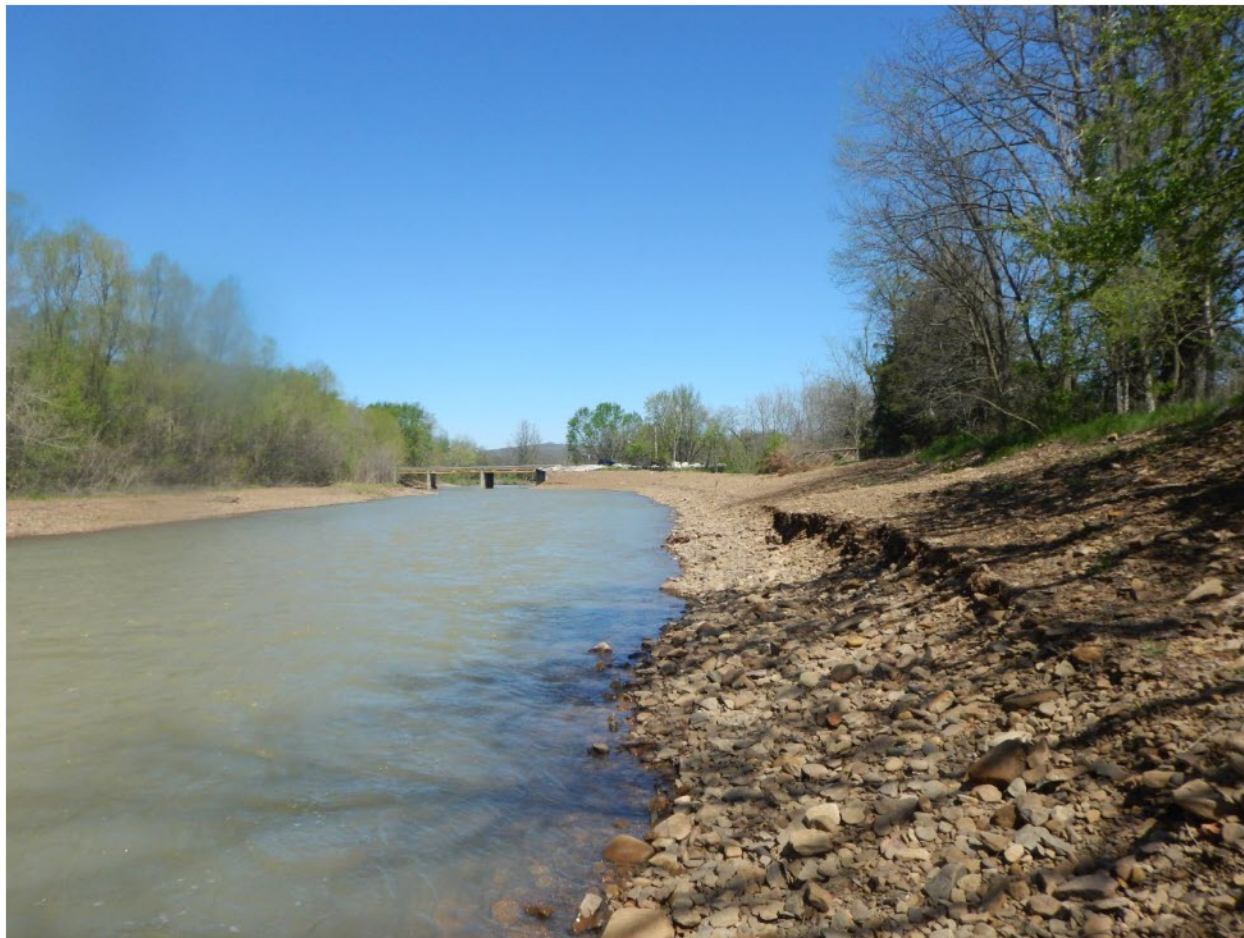
Photo No. 3

| Photo File Name | Date and Time of Photo | Photographer | Description |
|---|---|---|---|
| DSCN6407 | 04/11/2024, 10:53 AM | Chelsey Sherwood | Showing stream channelization and fill material consisting of stream bed substrate placed on river right and left. Picture taken facing downstream, north. |

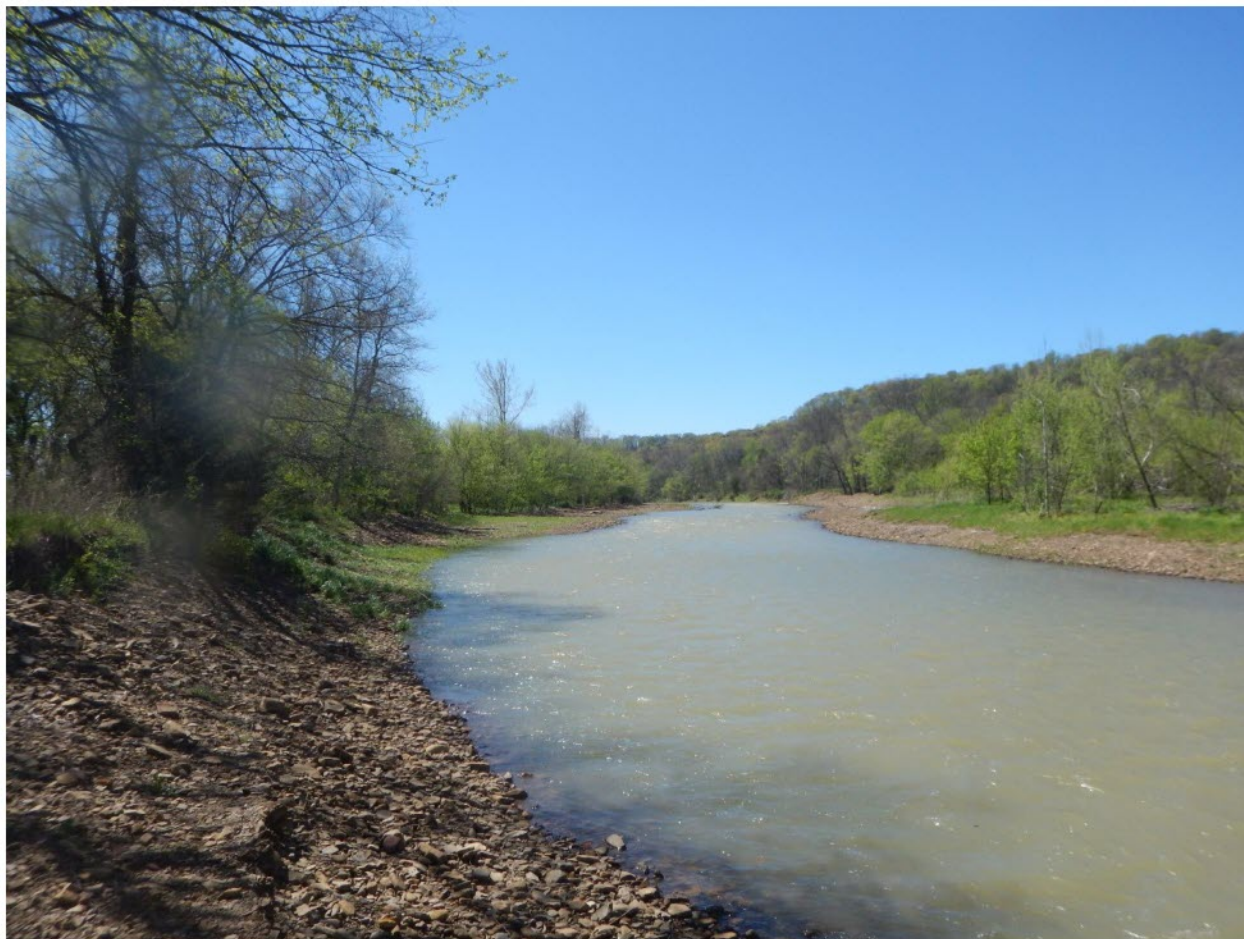
Photo No. 4

| Photo File Name | Date and Time of Photo | Photographer | Description |
|---|---|---|---|
| DSCN6408 | 04/11/2024, 10:59 AM | Chelsey Sherwood | Showing stream channelization and fill material consisting of stream bed substrate placed on river right and left. Picture taken facing upstream, south. |

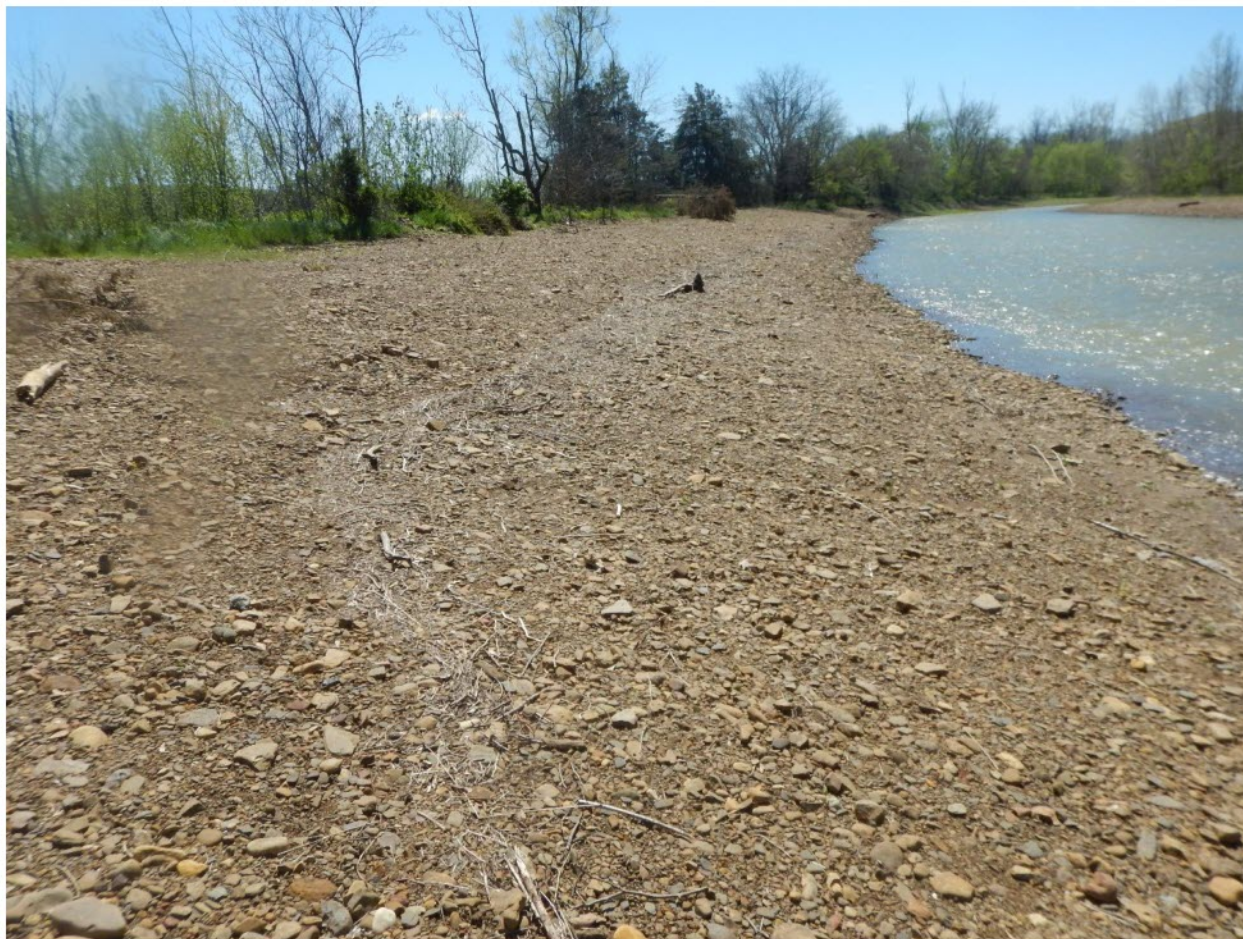
Photo No. 5

| Photo File Name | Date and Time of Photo | Photographer | Description |
|---|---|---|---|
| DSCN6409 | 04/11/2024, 11:06 AM | Chelsey Sherwood | Showing wrack lines of debris along stream bank. Picture taken facing upstream, south. |

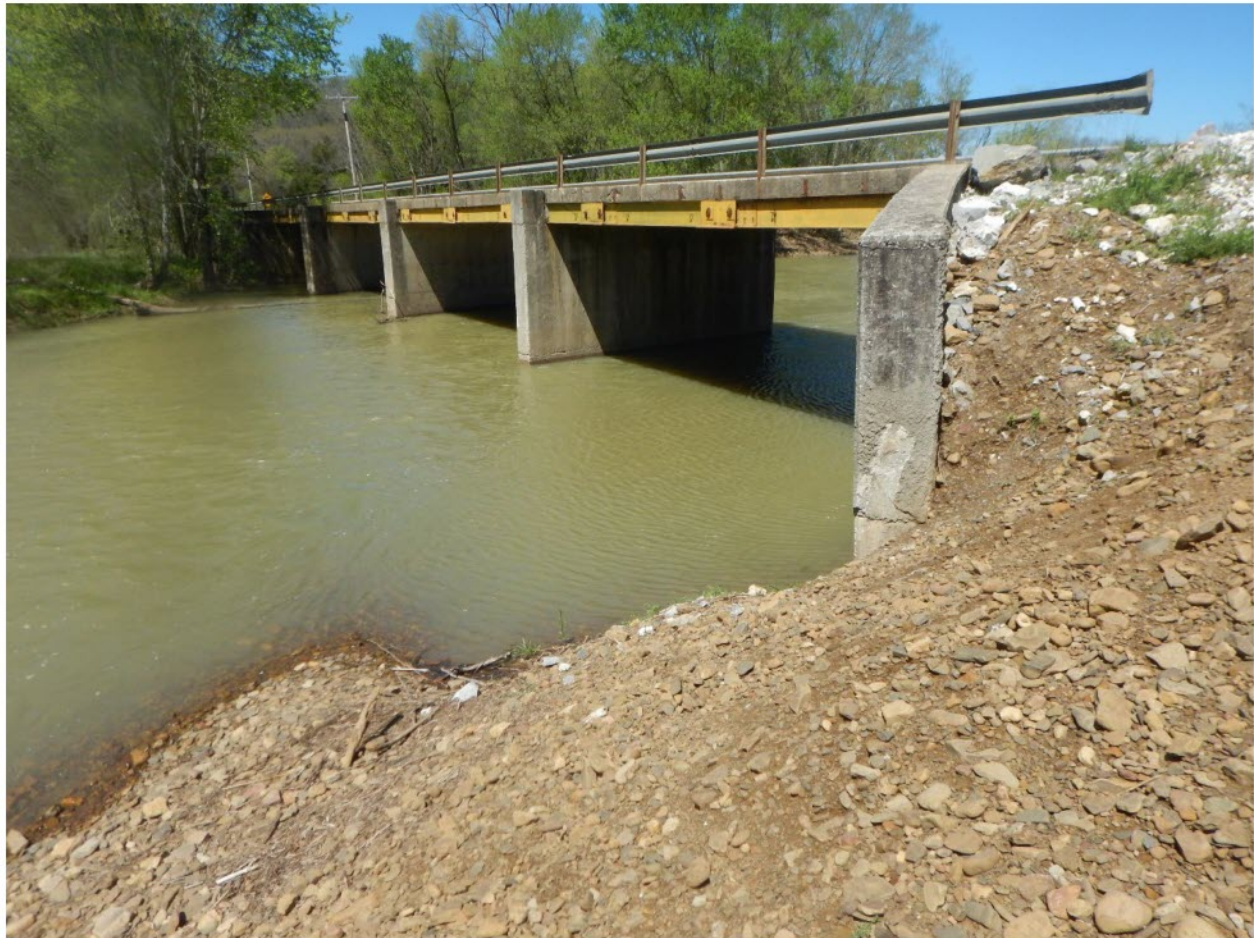
Photo No. 6

| Photo File Name | Date and Time of Photo | Photographer | Description |
|---|---|---|---|
| DSCN6410 | 04/11/2024, 11:08 AM | Chelsey Sherwood | Showing where stream bed substrate piled around bridge. Note: erosion and sloughing of materials around bridge. Picture taken facing northwest. |

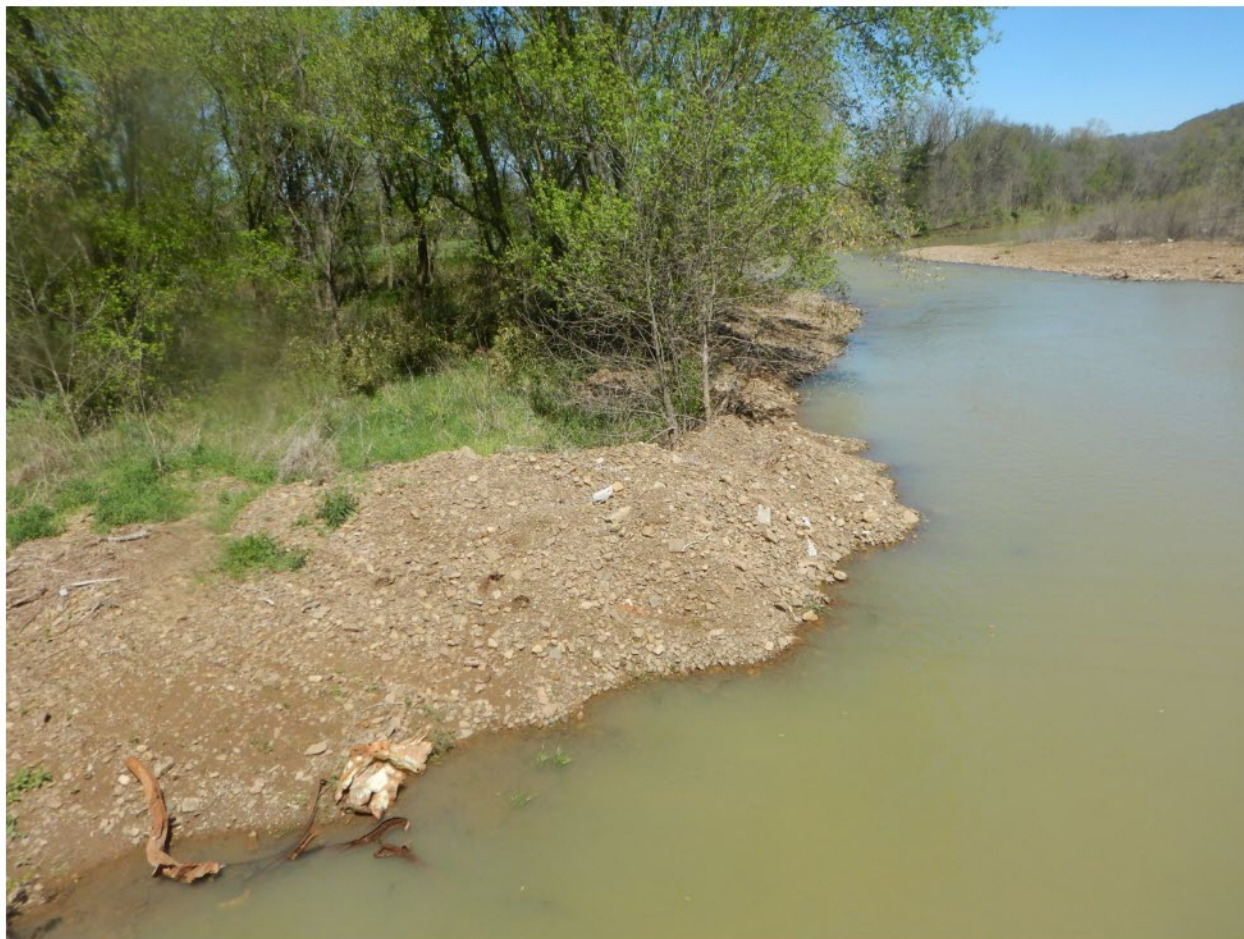
Photo No. 7

| Photo File Name | Date and Time of Photo | Photographer | Description |
|---|---|---|---|
| DSCN6411 | 04/11/2024, 11:12 AM | Chelsey Sherwood | Showing approximately 6 feet in height of fill material consisting of stream bed substrate piled in river. Picture taken facing downstream, northwest. |

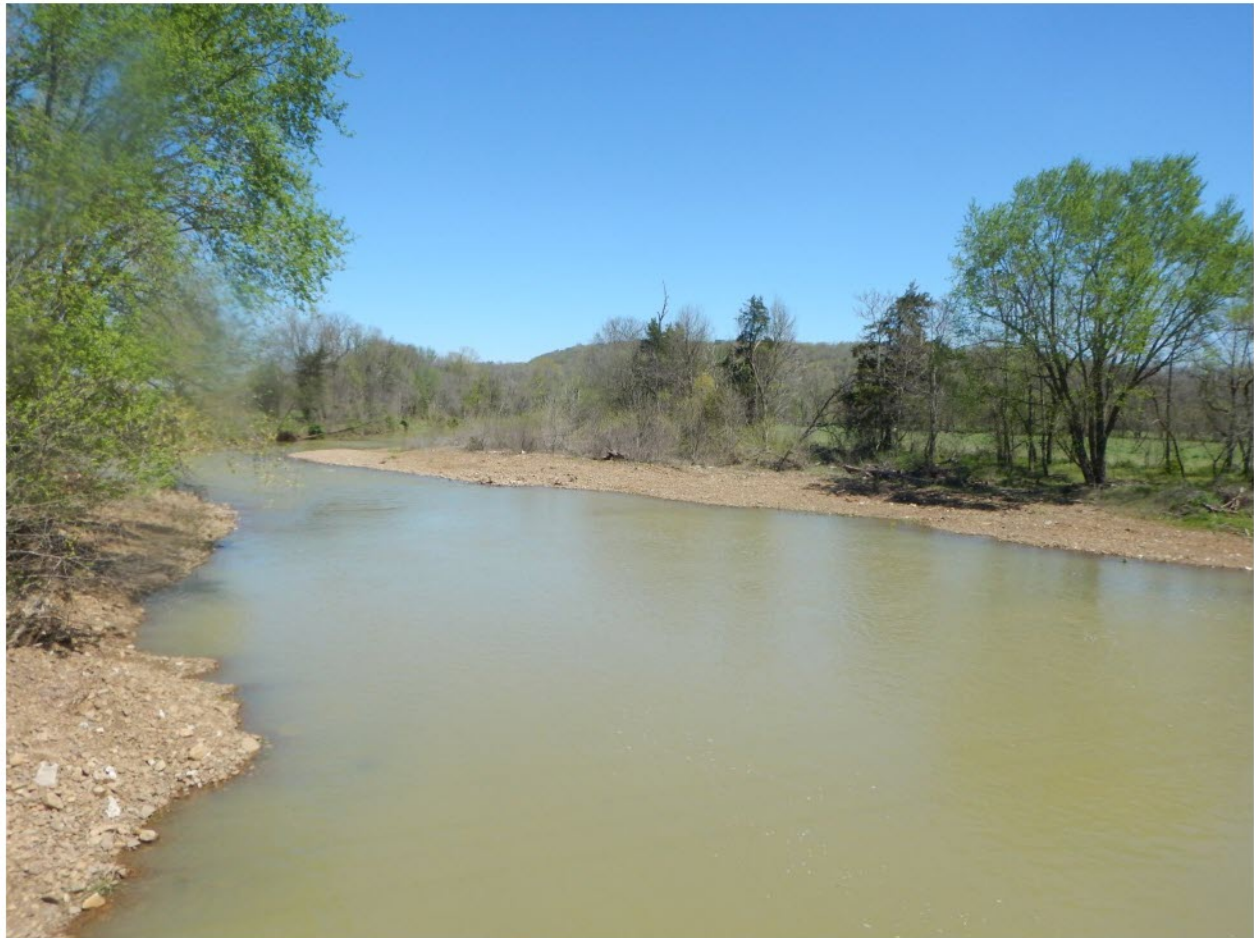
Photo No. 8

| Photo File Name | Date and Time of Photo | Photographer | Description |
|---|---|---|---|
| DSCN6412 | 04/11/2024, 11:13 AM | Chelsey Sherwood | Showing stream channelization and fill material consisting of stream bed substrate on river right and left. Picture taken facing downstream, north. |

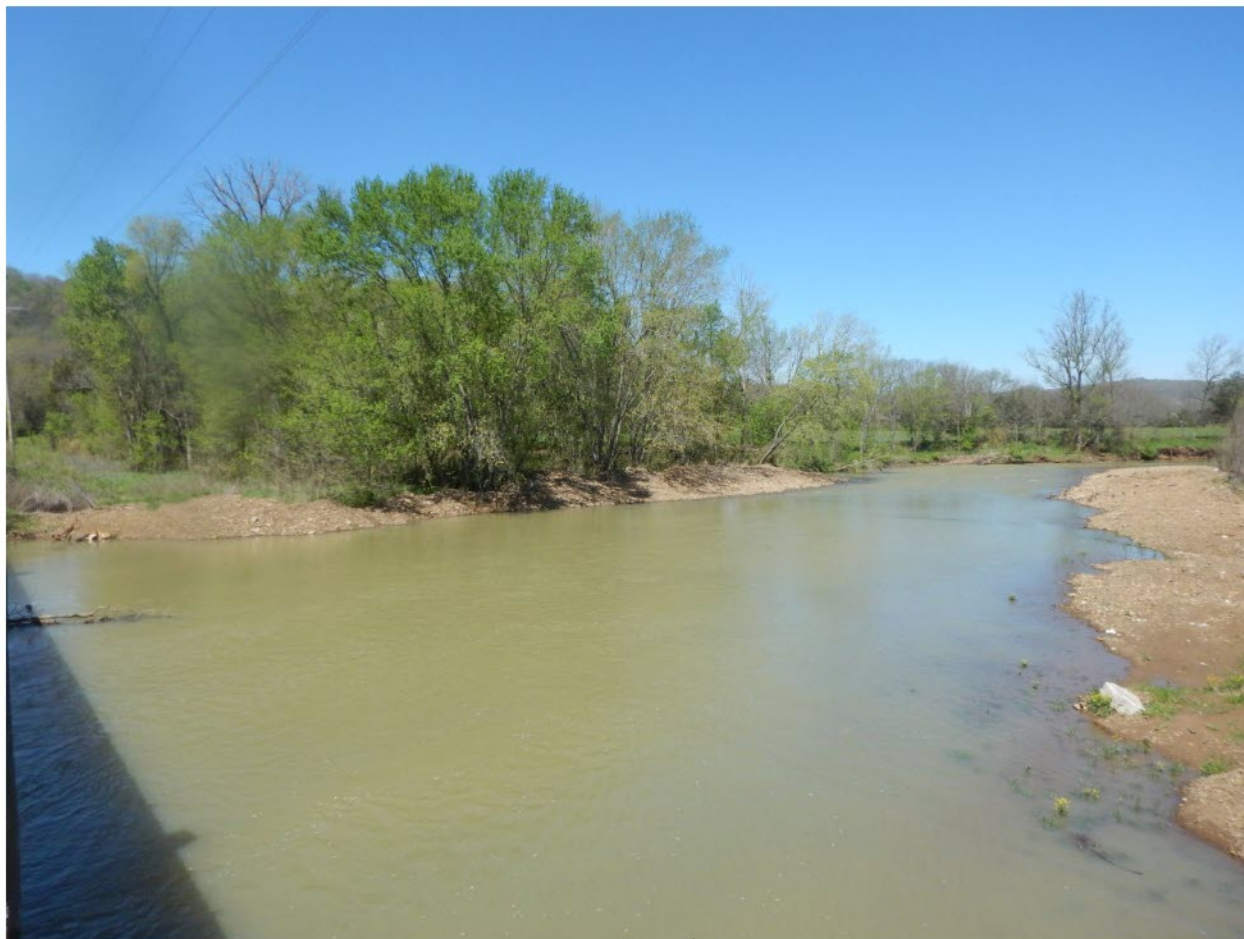
Photo No. 9

| Photo File Name | Date and Time of Photo | Photographer | Description |
|---|---|---|---|
| DSCN6413 | 04/11/2024, 11:15 AM | Chelsey Sherwood | Showing stream channelization and fill material consisting of stream bed substrate on river right and left. Picture taken facing downstream, northwest. |
