## **RCRA Inspection Report**

Columbus Air Force Base (CAFB)  
(b) (6)  
(b) (6)  
Columbus, Mississippi 39710

EPA ID#: MS7570024060  
NAICS #: 928110 – National Security

April 26, 2023

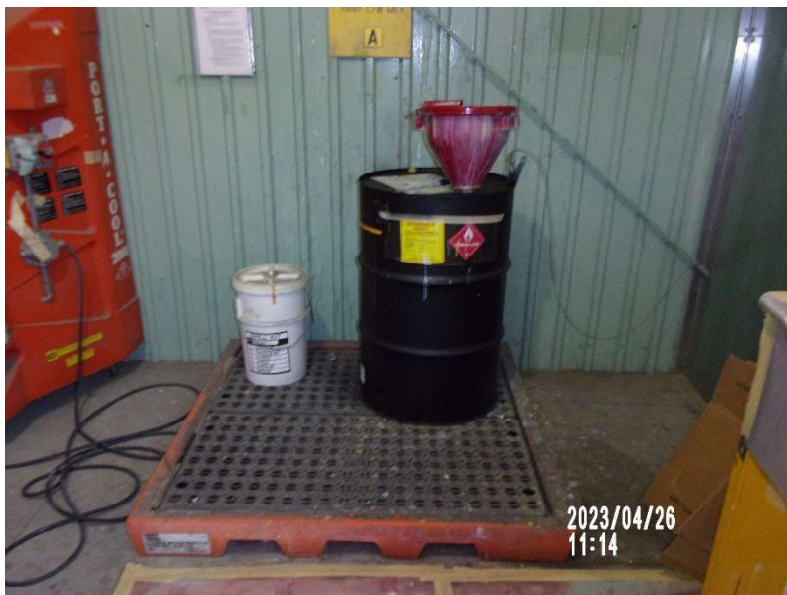
Photograph 1: Liquid Hazardous Waste in Building 220, SAA A

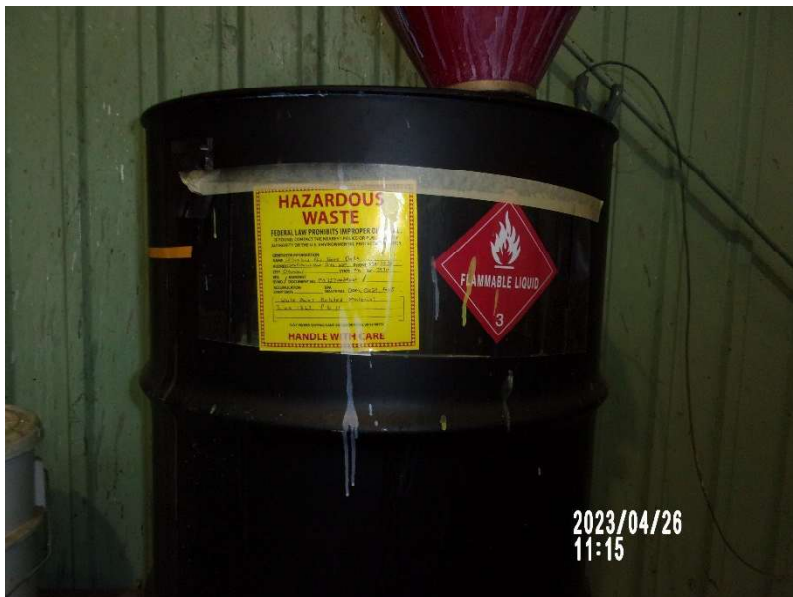
Photograph 2: Labels on 55-gallon Container in Building 220, SAA A

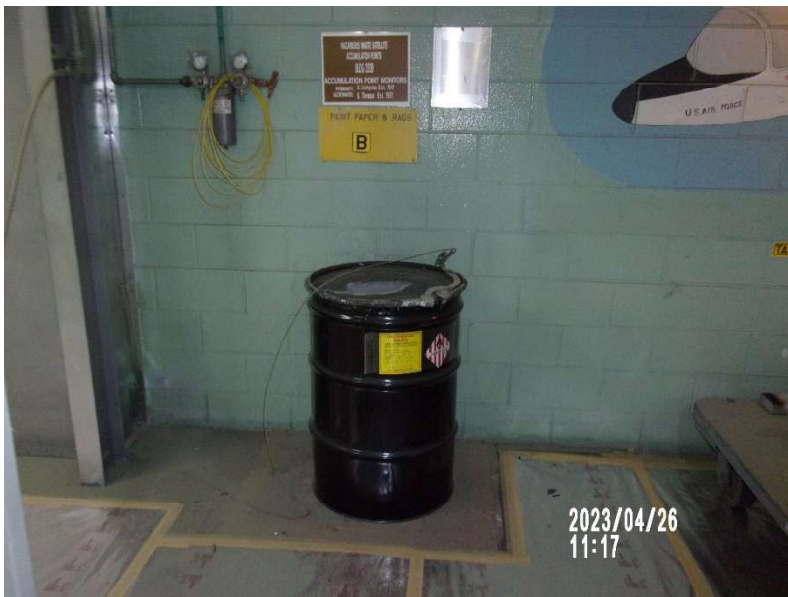
Photograph 3: 55-Gallon Container of Hazardous Waste Solids in Building 220, SAA B

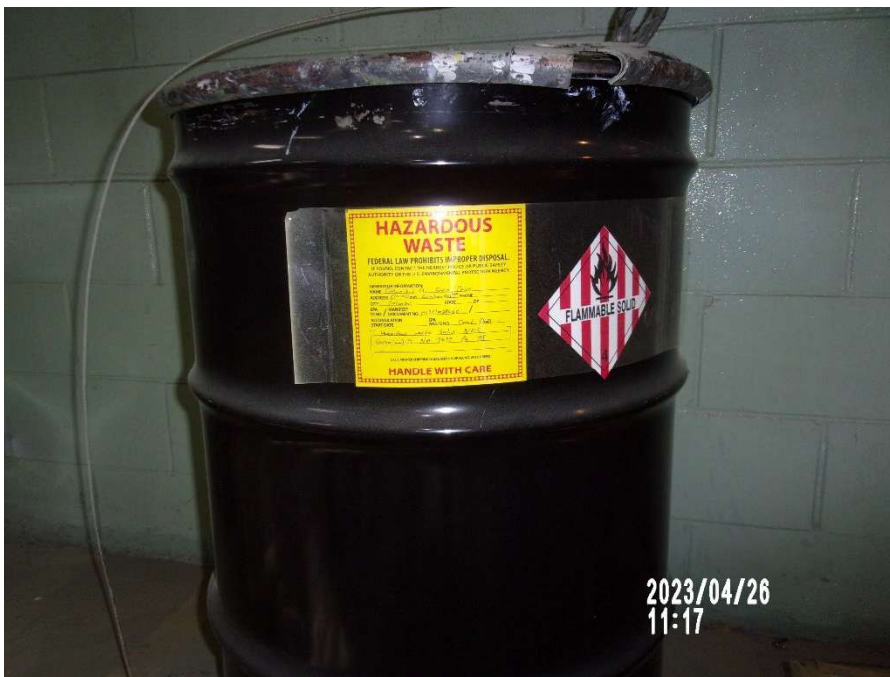
Photograph 4: Labels on Hazardous Waste Solids Container in Building 220, SAA B

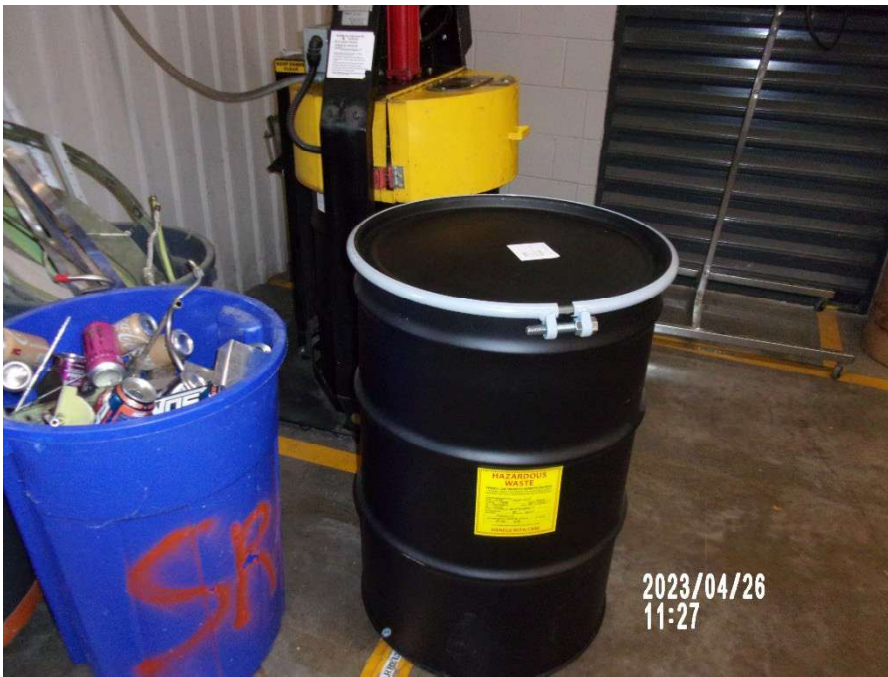
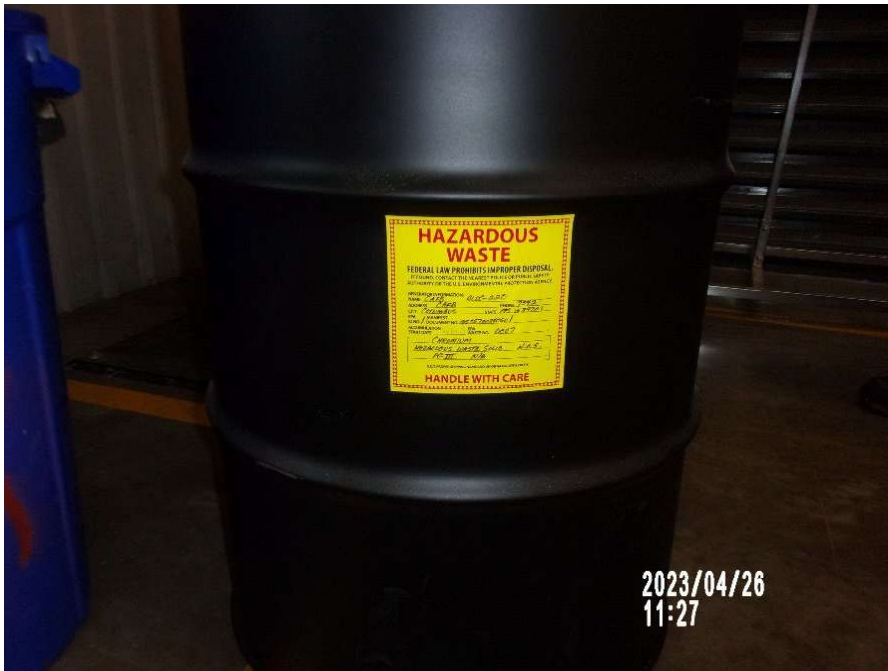
Building 220 also included a SAA for hazardous waste (D007) generated from maintenance operations within the building. SAA C had a waste compactor. One (1) full 55-gallon drum was also in this area and was dated April 26, 2023. Both 55-gallon drums included the words

“Hazardous Waste” however, it was observed that neither the drum in the compactor nor the full drum were labeled with an appropriate hazard indicator label or marking (Photographs 5 and 6).

**Pursuant to 11 Miss. Admin. Code Pt. 3, R. 1.3 [40 C.F.R. § 262.15(a)(5)], A generator must mark or label its container with the following: (ii) An indication of the hazards of the contents (examples include, but are not limited to, the applicable hazardous waste characteristic(s) (i.e., ignitable, corrosive, reactive, toxic); hazard communication consistent with the Department of Transportation requirements at 49 CFR part 172 subpart E (labeling) or subpart F (placarding); a hazard statement or pictogram consistent with the Occupational Safety and Health Administration Hazard Communication Standard at 29 CFR 1910.1200; or a chemical hazard label consistent with the National Fire Protection Association code 704).**

Photograph 5: 55-Gallon Container Missing the Hazard Indicator

Photograph 6: 55-Gallon Container Missing the Hazard Indicator

MDEQ briefed CAFB on recent guidance from the EPA (February 2023), which states that the Class 9 DOT label, by itself, does not adequately indicate the hazard associated with the container’s content. CAFB addressed this observation at the time of the inspection. CAFB addressed this observation by adding a Class 9 label to the containers and also adding the words “Toxic” and “Chromium D007” to the containers (Photographs 7 and 8). It is recommended that no writing be written on the DOT Class 9 label itself.

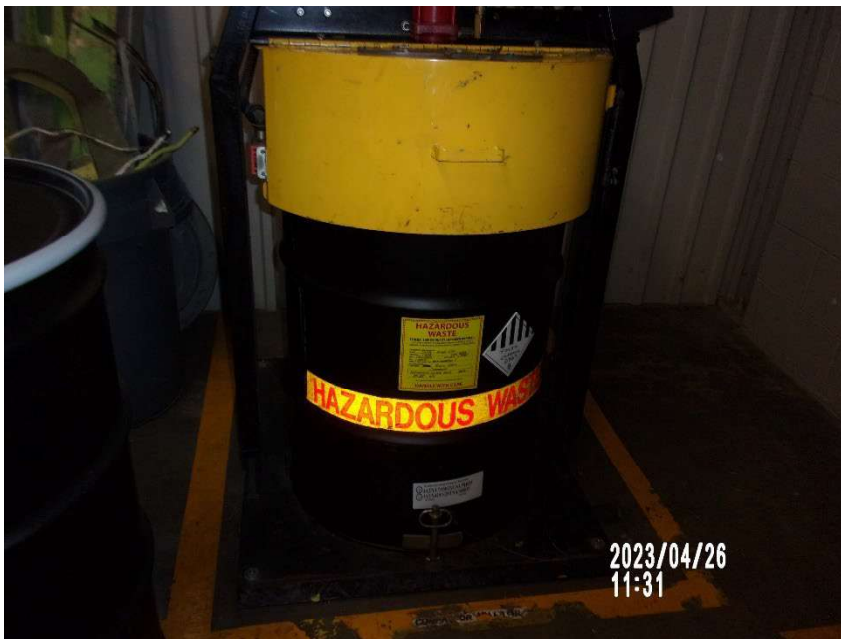
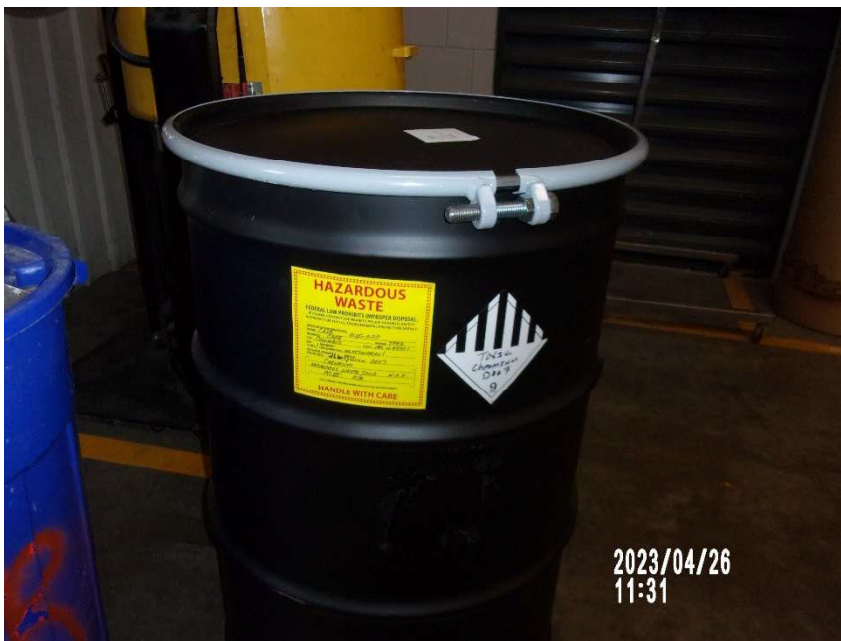
Photograph 7: Hazard indicator information added to container.

Photograph 8: Hazard indicator information added to container.

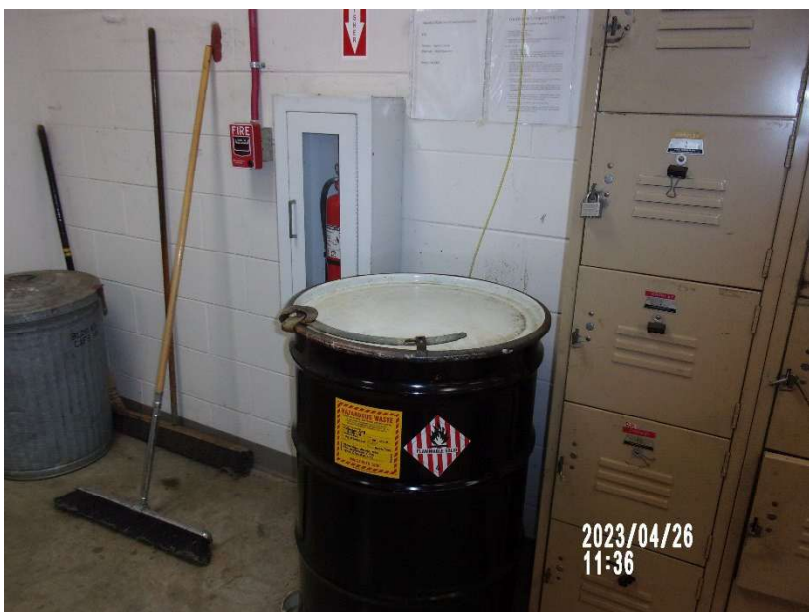
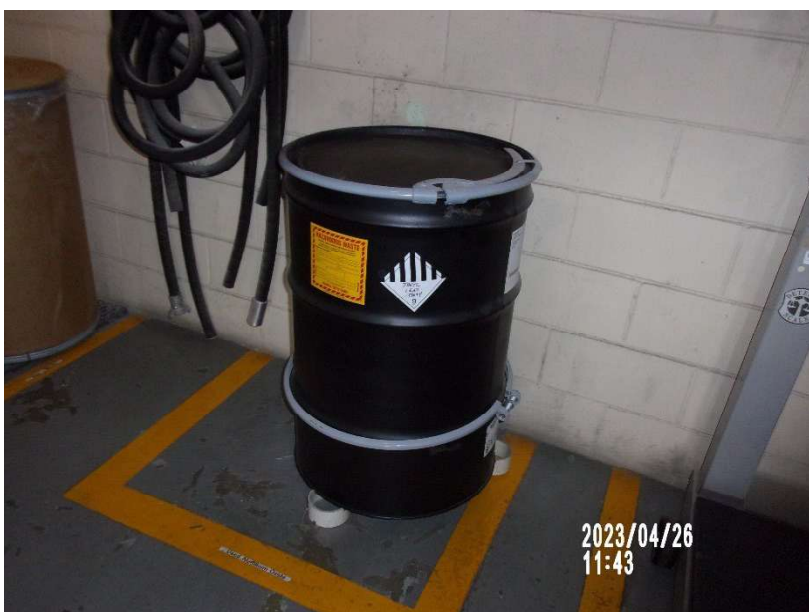
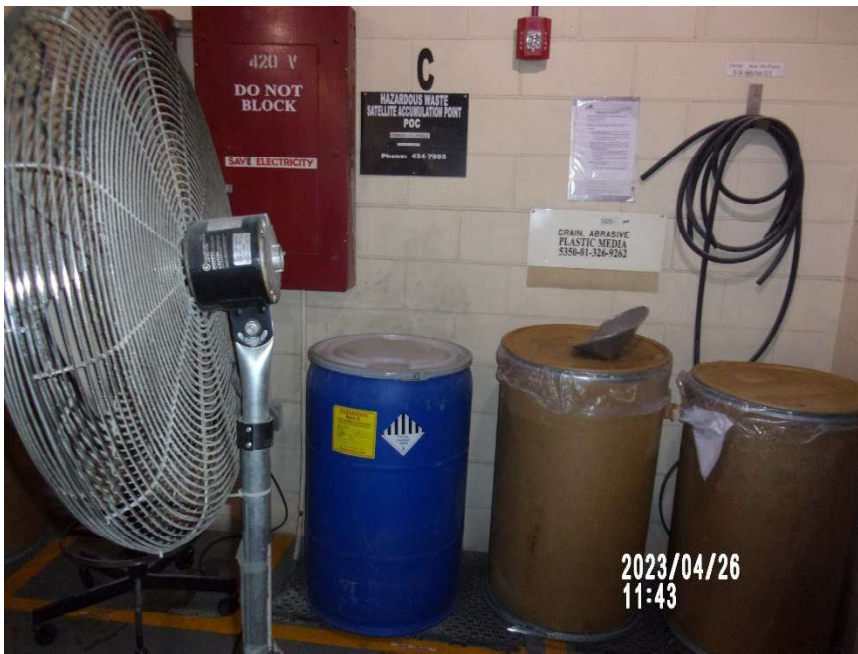
Building 218 – The inspectors then went to Building 218. The containers in Building 218 SAAs A, C, and D were properly labeled with the words “hazardous waste” and with the hazard indicator label (Photographs 9, 10, and 11). SAA B for the ultrasonic cleaner hazardous waste for this building is not operational but can be added, if needed. Universal waste was also being stored in this building in a closed and dated 5-gallon container (Photograph 12). CAFB also operates a parts washer in Building 218. This unit is serviced by contract. The sodium hydroxide tanks are cleaned out every two to three years. The spent solution is manifested as hazardous waste and is pumped into and transported by a disposal tanker truck. Building 218 also has a nonhazardous parts washer that is serviced by a contractor (Photographs 13 and 14).

Photograph 9: Building 218 SAA D

Photograph 10: Building 218 – SAA A

Photograph 11: Building 218 SAA C

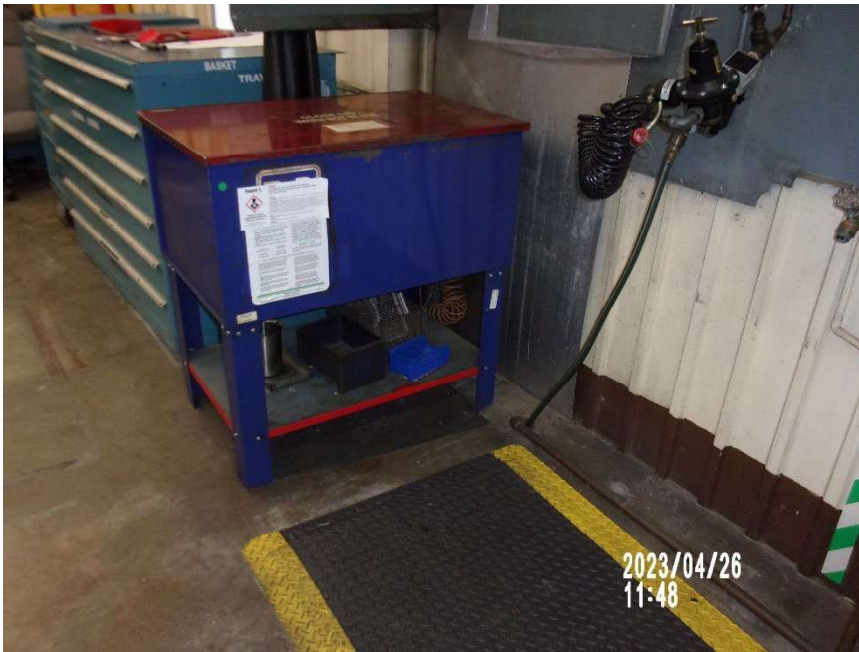
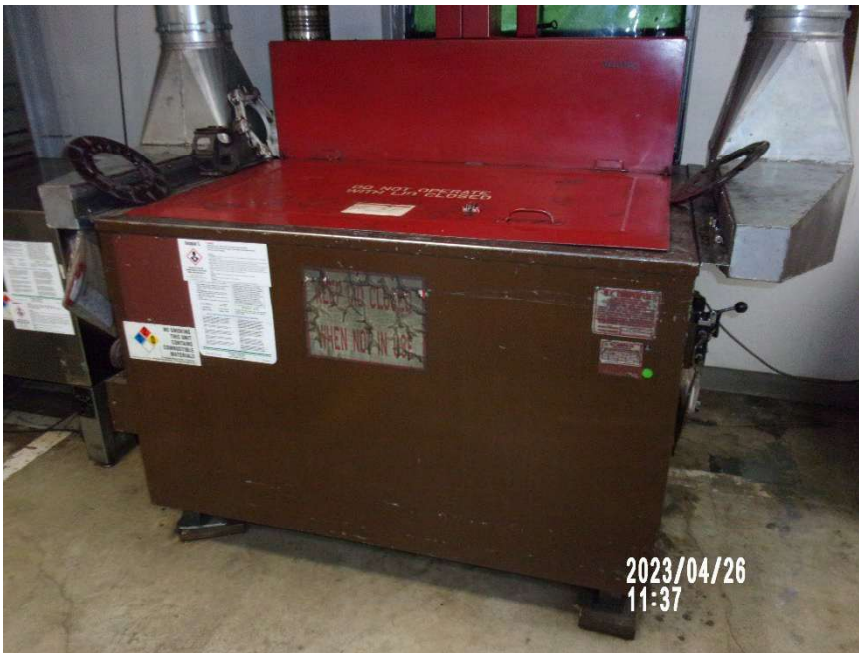
Photograph 13: Parts Washer Unit.

Photograph 14: Parts Washer Unit.

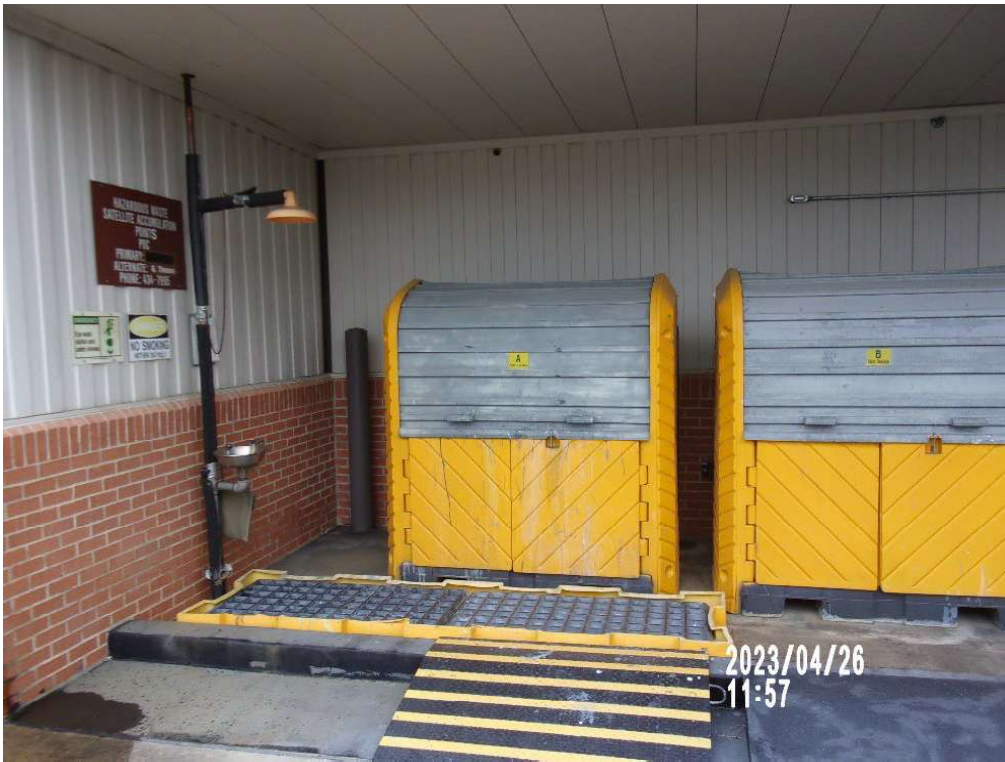
Building 406 – SAA A and SAA B are for the operation of the large paint booth in Building 406 (Photograph 15). SAA A is for hazardous waste liquid paint waste generated specifically from painting operations (Photograph 16). The paint booths have three stages of air pollution control filters. The first stage is changed monthly, the second stage is changed every six months, and the third stage is changed annually. SAA B is for hazardous waste solid residues and PPE that are generated throughout the building and these wastes are placed in SAA B (Photograph 17). The containers in these areas were properly labeled and marked and were observed to be in good condition and closed.

Photograph 15: Building 406 SAAs A and B

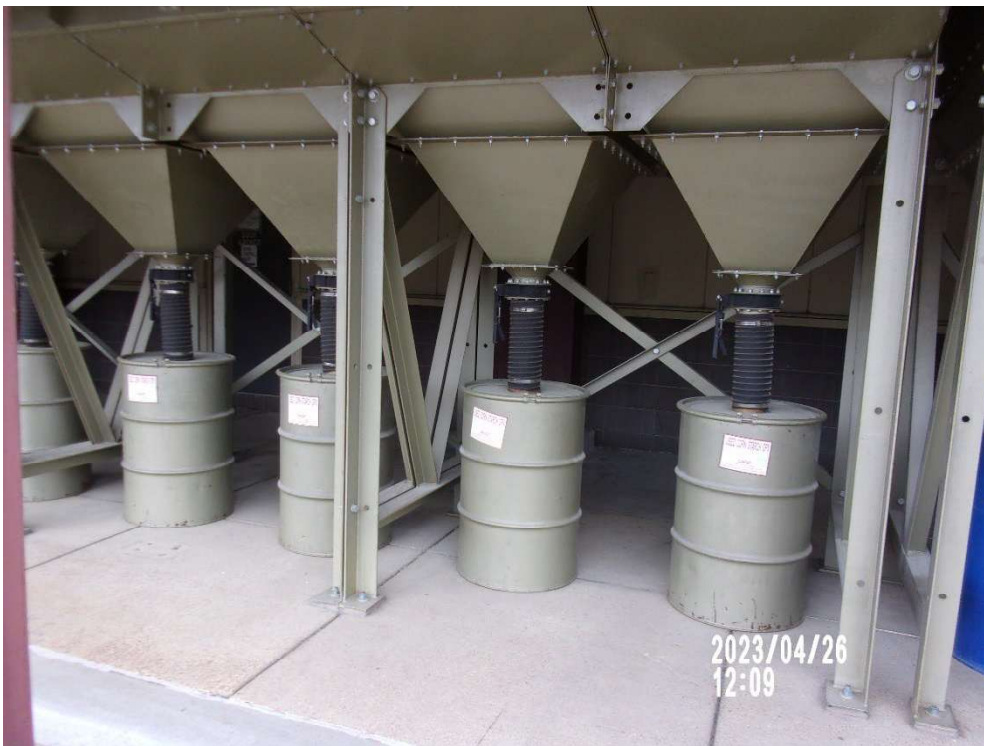
way down to the metal surface. Hazardous waste blast media is collected in the bag house collection system that feeds into 55-gallon drums (Photograph 18). The media is filtered through the system until it is finally collected in the blue drum for disposal. This hazardous waste blast media is hazardous due to its metal content. The metal related hazardous waste codes for this waste are D006, D007, and D008. Once full, the hazardous waste drum is removed, labeled as hazardous waste and dated. Approximately one drum of hazardous waste blast media is generated per hour during blasting shifts. The waste is subsequently moved to the 90-day area in Building 265.

Photograph 18: Building 414 – Blast media collection

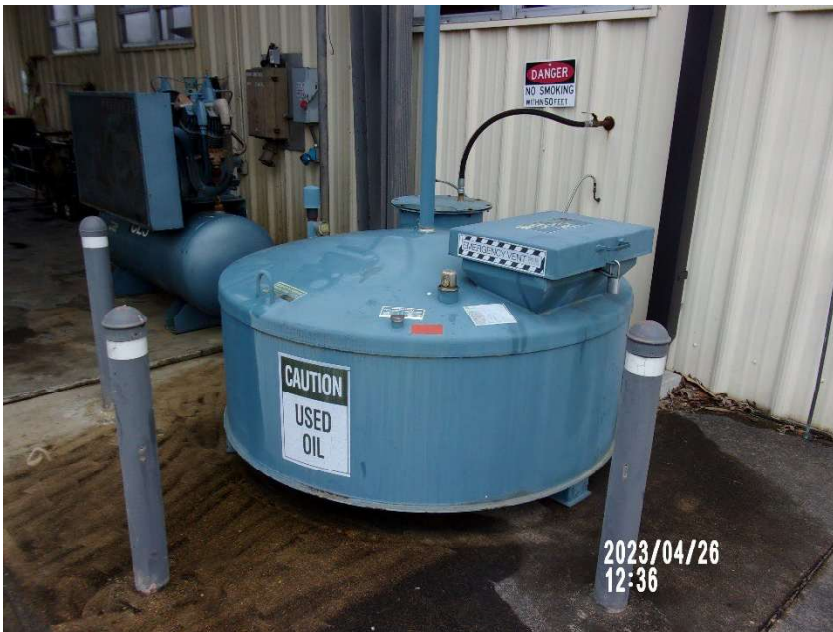
Building 410 – The inspectors next went to Building 410 which had used oil storage. Used oil was being accumulated in a 500-gallon double-walled tank. The tank was closed and labeled as “Used Oil” (Photograph 26).

Photograph 26: Building 410 Used Oil Container

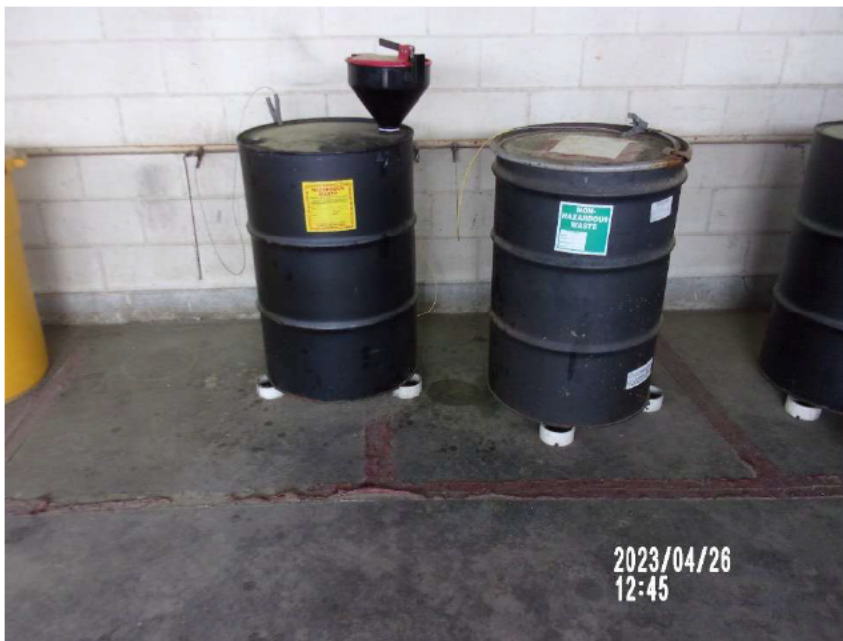
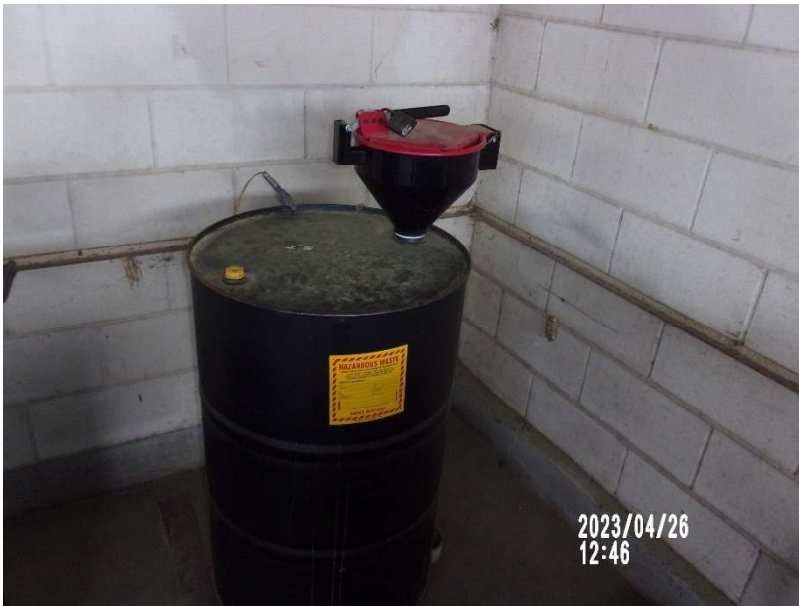
Building 449 – The inspectors then went to Building 449 (Photograph 27). The hazardous waste in Building 449 is generated from aircraft maintenance repairs. Two SAAs were in Building 449, SAA A and SAA B. One 55-gallon container was observed to be in each SAA. It was observed that each of the two hazardous waste 55-gallon accumulation drums was missing the flammable hazard indicator label (Photographs 28 and 29). The building is equipped with a spill kit and fire extinguisher. It was recommended that a portable eye wash be included where applicable (**11 Miss. Admin. Code Pt. 3, R. 1.3 [40 C.F.R. § 262.15(a)(5)]**).

Photograph 28: Building 449, SAA A, Container Missing Hazard Indicator

Photograph 29: Building 449, SAA B, Container Missing Hazard Indicator

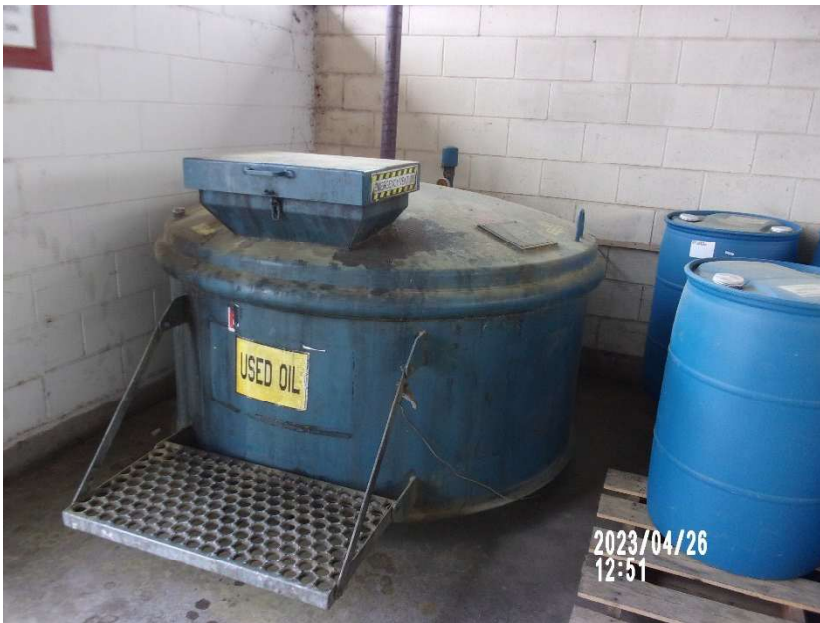
Building 449 also contained a used oil accumulation container that was closed and labeled as “Used Oil” (Photograph 30). The remaining accumulation is for nonhazardous or nonregulated waste, such as used jet fuel.

Photograph 30: Building 449, Used Oil Container

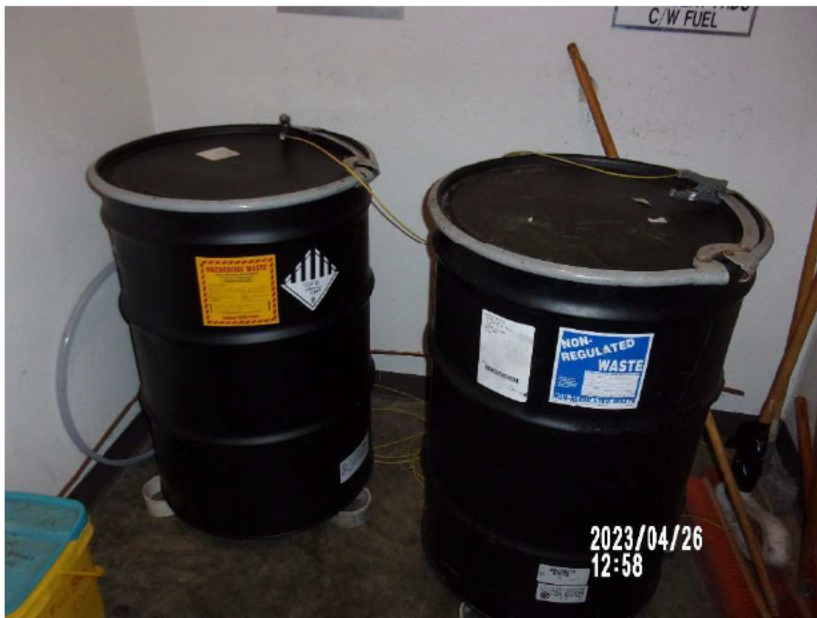
Building 460 – The inspectors next went to tour Building 460. This building had a SAA, SAA B for accumulating sealant hazardous waste. The container in SAA B was labeled and had a Class 9 DOT hazard label but was missing other hazard indicator information. This observation was immediately addressed as the container was supplemented with the words “Toxic Chromium D007” while the inspectors observed (Photograph 31) **(11 Miss. Admin. Code Pt. 3, R. 1.3 [40 C.F.R. § 262.15(a)(5)])**.

Photograph 31: Building 460, SAA B

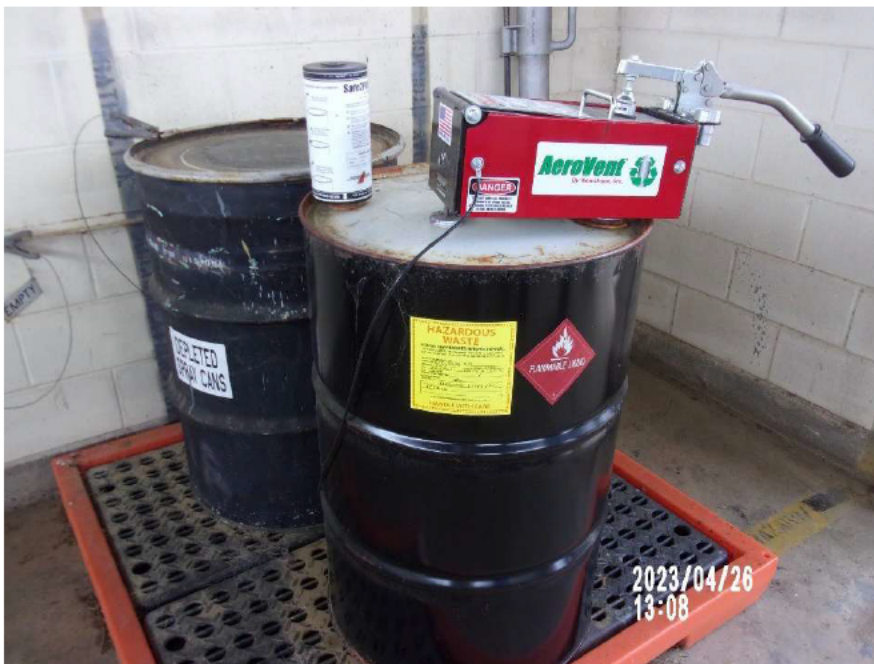
Building 212 – CAFB manages a SAA in Building 212 for accumulating the contents of aerosol cans. The inspectors observed an AeroVent puncture unit on top of a 55-gallon hazardous waste accumulation container in this SAA. The AeroVent puncture unit is used to puncture aerosol cans and drain their contents into the 55-gallon container, which was labeled as hazardous waste and marked with a Class 3 DOT label. There was also a 55-gallon drum for scrap metal labeled as “Depleted Spray Cans” (Photograph 33).

Photograph 33: Building 212, Aerosol Can Puncture Unit Over SAA Container

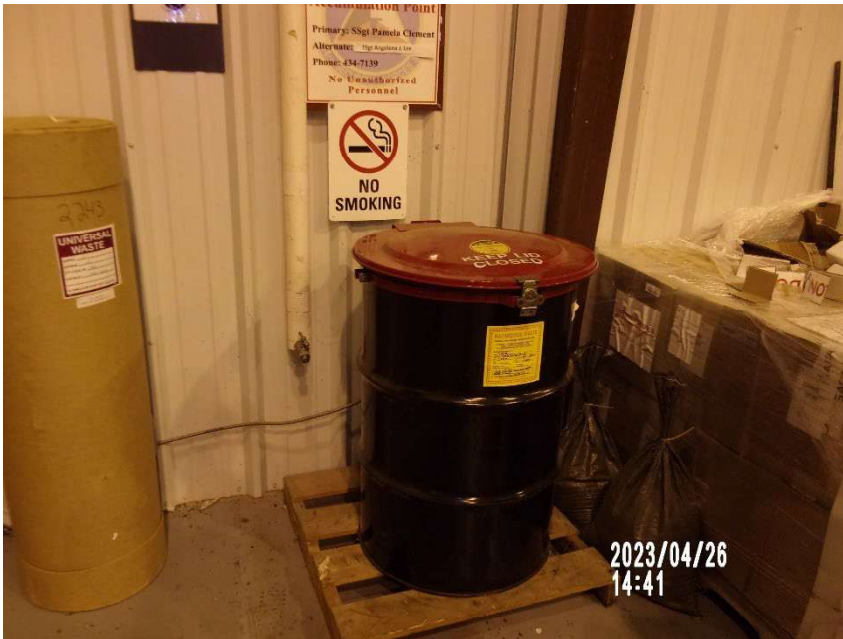
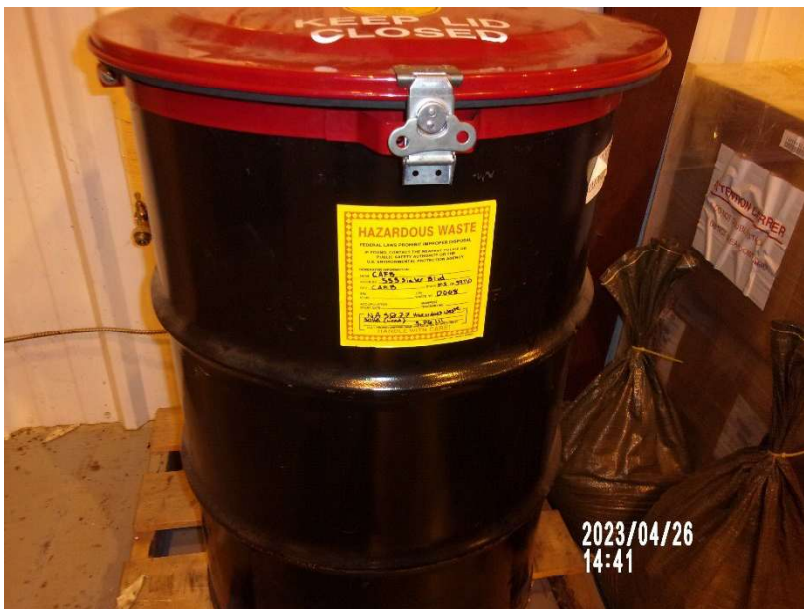
Building 205 – The inspectors then went to the Security Forces Warehouse, Building 205. The waste collection area had a universal waste container of universal waste lamps dated January 6, 2023 (Photograph 36). Hazardous waste generated from security operations in the Building 205 area was being accumulated in a SAA. The 55-gallon hazardous waste accumulation drum at the SAA was labeled as hazardous waste but it was observed the hazard indicator label was missing (Photographs 37 and 38). It was noted that the hazard marking would include a DOT Class 9 label and also include the words “Toxic” added to the container **(11 Miss. Admin. Code Pt. 3, R. 1.3 [40 C.F.R. § 262.15(a)(5)])**.

Photograph 37: SAA Container Missing Hazard Indicator

Photograph 38: SAA Container Missing Hazard Indicator

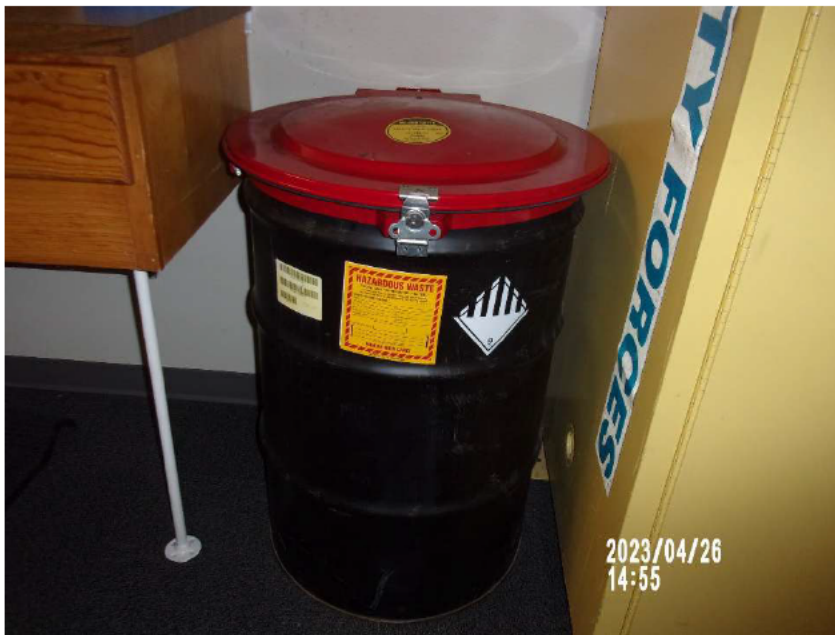
Building 926 – The inspectors then went to a second Security Forces Building. Hazardous waste generated from security operations in the Building 926 area were being accumulated in a SAA. The 55-gallon container in the SAA included the hazardous waste label but it was observed that the container was missing the hazard indicator marking **(11 Miss. Admin. Code Pt. 3, R. 1.3 [40 C.F.R. § 262.15(a)(5)])**.

Photograph 39: Building 926 SAA Container, Missing Full Hazard Indicator Information

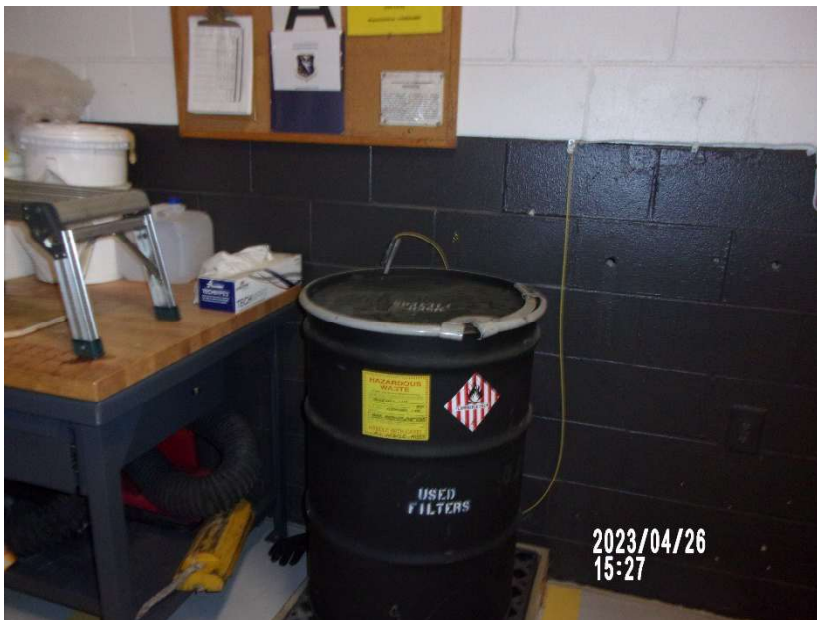
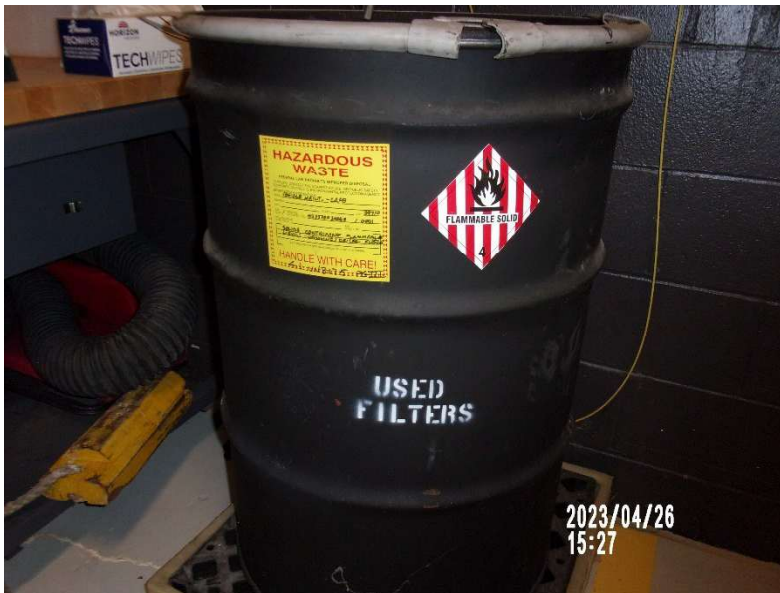
Building 304 – Two SAAs for hazardous waste were located in this building. SAA A had a 55-gallon container being used to accumulate used gasoline and diesel fuel filters (Photographs 45 and 46) and SAA B had a 55-gallon container containing the contents from aerosol can

Photograph 45: Building 304 SAA A

Photograph 46: Building 304 SAA A Container Labeling

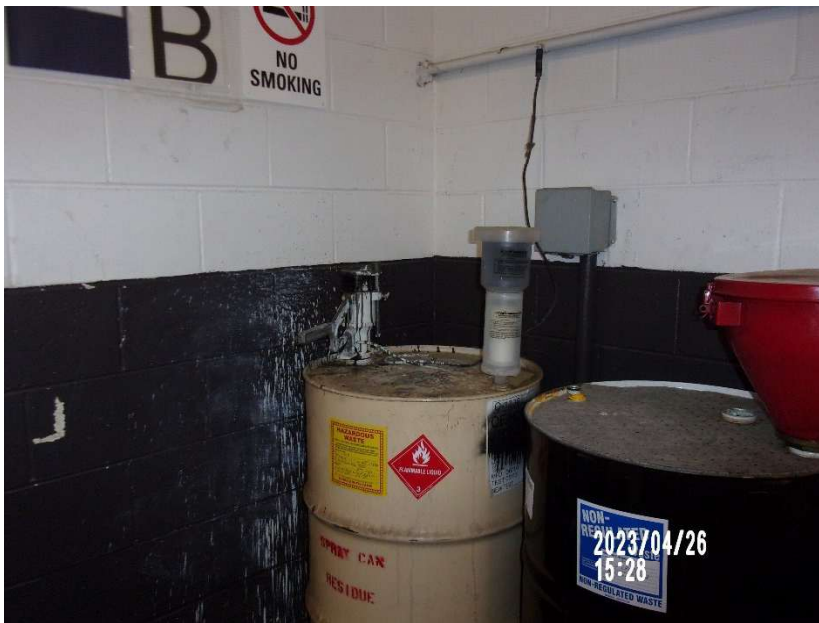
puncturing (Photographs 47 and 48). Used Oil (Photograph 49) and universal wastes are also accumulated in Building 304 (Photograph 50).

Photograph 47: Building 304 Aerosol Puncture Station SAA B

Photograph 48: Building 304 Aerosol Puncture Station SAA B

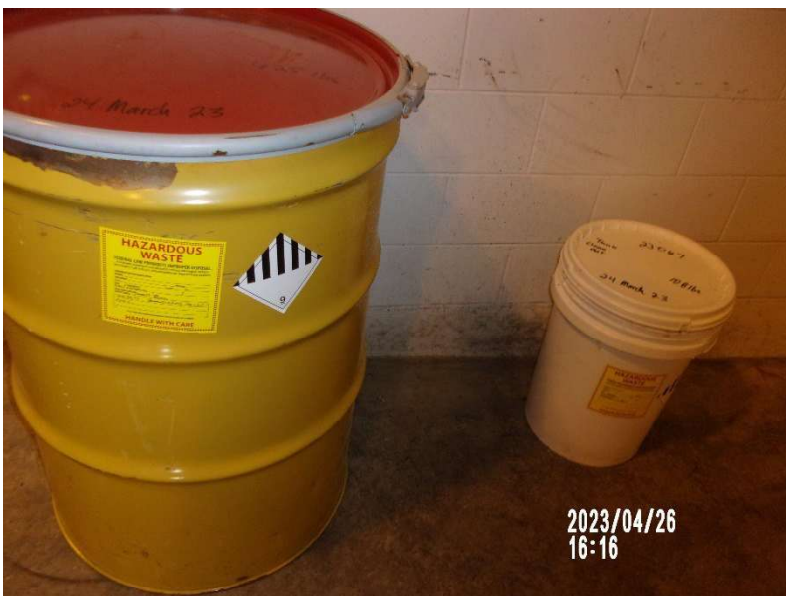
Building 267 – The inspectors final stop on the walk-through portion of the inspection was at the 90-day CAA located in Building 267 (Photograph 57 and 58). Most of the hazardous waste in 90-day CAA had been removed during CAFB’s scheduled pick up earlier in the day. One 55-gallon drum observed in this area had a Class 9 DOT miscellaneous label (Photograph 59) but did not have any additional hazard marking or labeling.

**Pursuant to 11 Miss. Admin. Code Pt. 3, R. 1.3 [40 C.F.R. § 262.17(a)(5)(i)], which is a condition of the LQG Permit Exemption, a large quantity generator must mark or label its container with the following: (B) An indication of the hazards of the contents (examples include, but are not limited to, the applicable hazardous waste characteristic(s) (i.e., ignitable, corrosive, reactive, toxic); hazard communication consistent with the Department of Transportation requirements at 49 CFR part 172 subpart E (labeling) or subpart F (placarding); a hazard statement or pictogram consistent with the Occupational Safety and Health Administration Hazard Communication Standard at 29 CFR 1910.1200; or a chemical hazard label consistent with the National Fire Protection Association code 704).**

The inspectors observed four containers of hazardous waste in the building. One 55-gallon container of hazardous waste contained hazardous waste solids (D006) and was dated March 10, 2023. A 5-gallon container of hazardous waste solids (D006) was dated March 24, 2023. One drum contained a toxic and flammable hazardous waste solid (D006 and D001) and was dated April 13, 2023, and included the hazard indicator label. The remaining hazardous waste drum contained an ignitable liquid hazardous waste (D001) and was dated April 5, 2023, and had the hazard indicator. Two containers of universal waste were also in Building 267 and those containers were dated January 6, 2023, and January 10, 2023.

Photograph 58: Building 267, Hazardous Waste Container With Incomplete Hazard Indicator

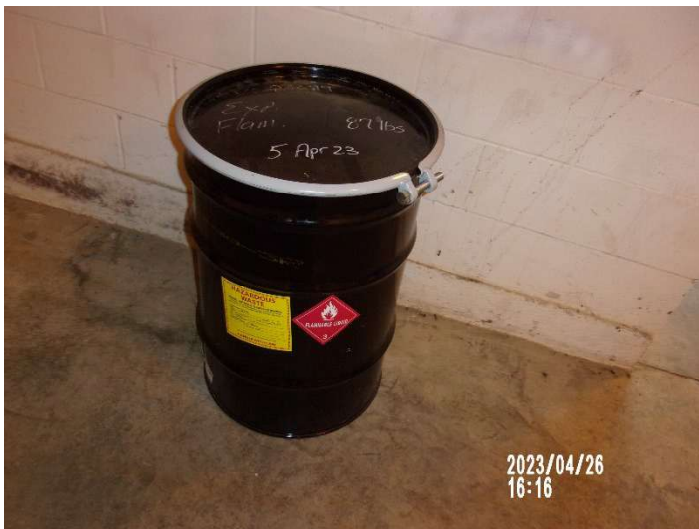
Photograph 59: Building 267, Hazardous Waste Container
