# Clean Water Act Section 404: Site Visit/Case Development

Site Name	Battaglia Property and eastern corner of Dikeman Firehouse Property	Start Date	January 17, 2023
		End Date	January 17, 2023
Inspection Purpose	Initial site visit		
<b>Opening Conference</b>			
<input checked="" type="checkbox"/> Presentation of Inspector Credentials			
Name and Title (Use N/A if owner/operator not available to join the inspection)			
Credentials were presented to Mr. Giuseppe (Joe) Battaglia, the owner/president of Orange Builders, LLC			
<input checked="" type="checkbox"/> Opening Conference			
Name of person authorizing access if applicable			
Mr. Battaglia authorized access via phone and e-mail prior to the inspection. Access was initially requested to be limited to a wetland area depicted on a survey provided by Mr. Battaglia located on 6 Dikeman Drive.			
Notes from Opening Conference			
I asked Mr. Battaglia about the delineation process for the wetland delineation figure he provided for the 6 Dikeman Drive property, which shows one wetland area located in the northern corner of the parcel. He stated that his wetland delineator was at the site for two full days. When I asked about any surve

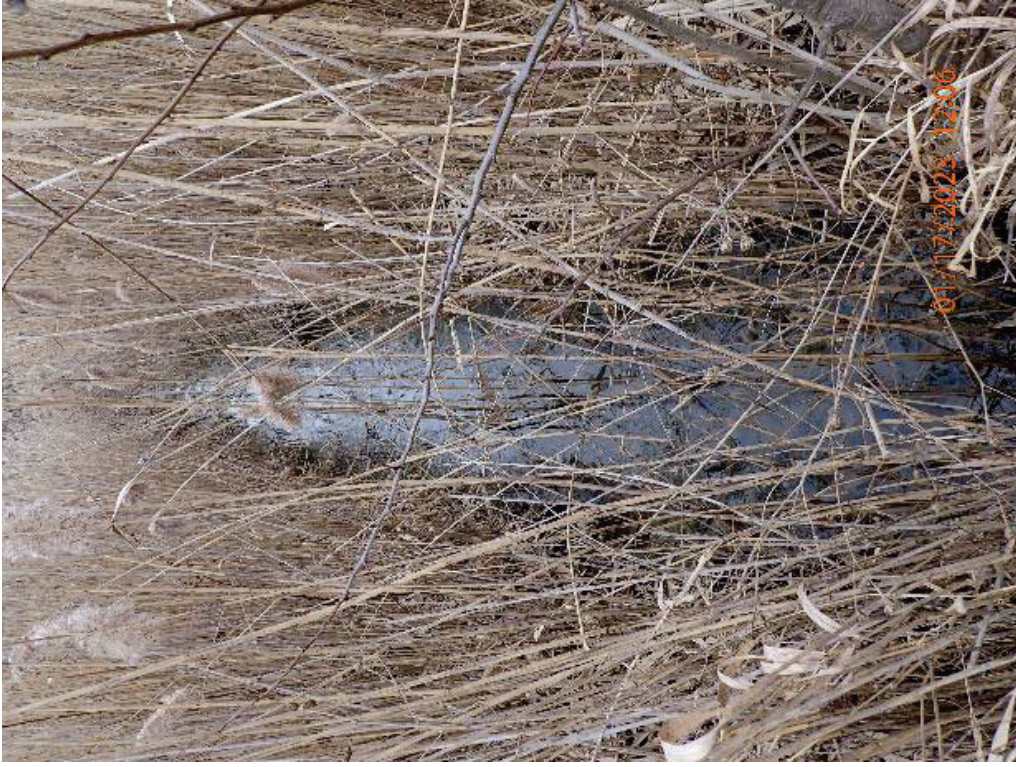
**Date:** 1/17/2023  
**Time:** 11:06 AM  
**Photographer:** S. Andreescu  
**Photo ID:** 1 – P1170542

Ditch on Goshen Fire District property.  
Photograph taken from culvert location

EPA started field work by observing a ditch located on Goshen Fire District property. An 18" culvert located under the access roads/driveways to the firehouse hydrologically connects wetlands located on the eastern corner of Dikeman Firehouse Property and 6 Dikeman Drive to presumed wetlands on the northern side of the access roads. The culvert was nearly fully submerged at the time of the inspection. The ditch was approximately 3'6" wide and water depth was approximately 18" near the culvert. The ditch measured approximately 115 feet from the culvert along Dikeman Drive to a 90 degree turn, then measures an additional 70 feet perpendicular to Dikeman Drive (southwest direction). Near the 90 degree turn, the ditch measured approximately 6'8" wide.

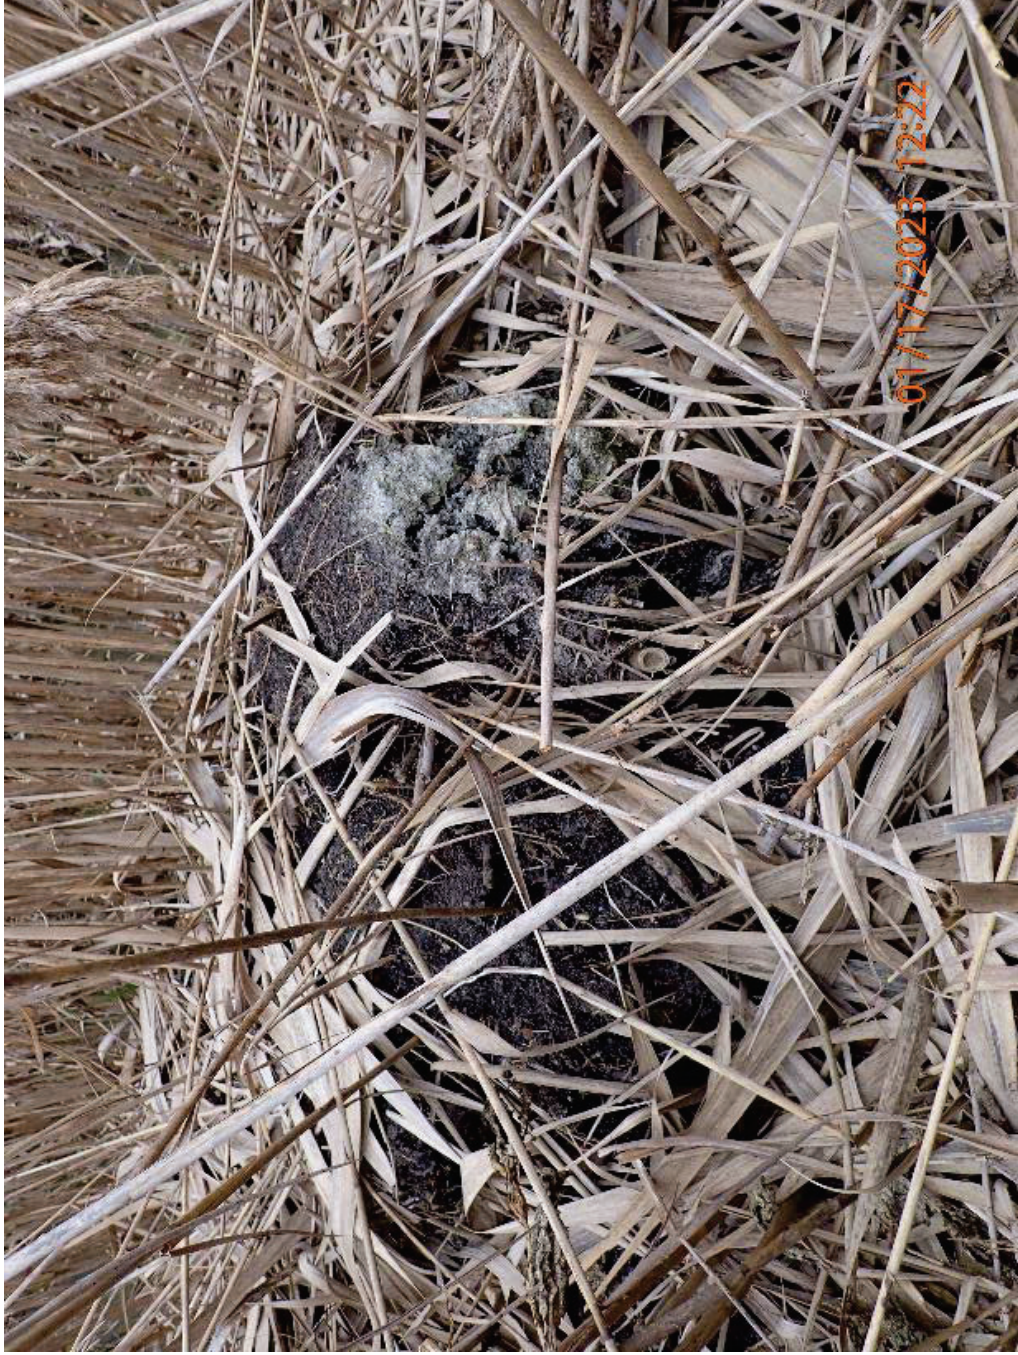
**Date:** 1/17/2023  
**Time:** 11:22 AM  
**Photographer:** S. Andreescu  
**Photo ID:** 2 – P1170543

**Description:**  
Sidecasted soil displaying a depleted matrix.

EPA observed sidecasted material in areas surrounding the ditch and noted indicators of hydric soil in the piles of material. Common reed, a hydrophytic plant, was observed to be the dominant vegetation near the ditch. Soft rush, cattail, and reed canary grass were also observed in surrounding areas.

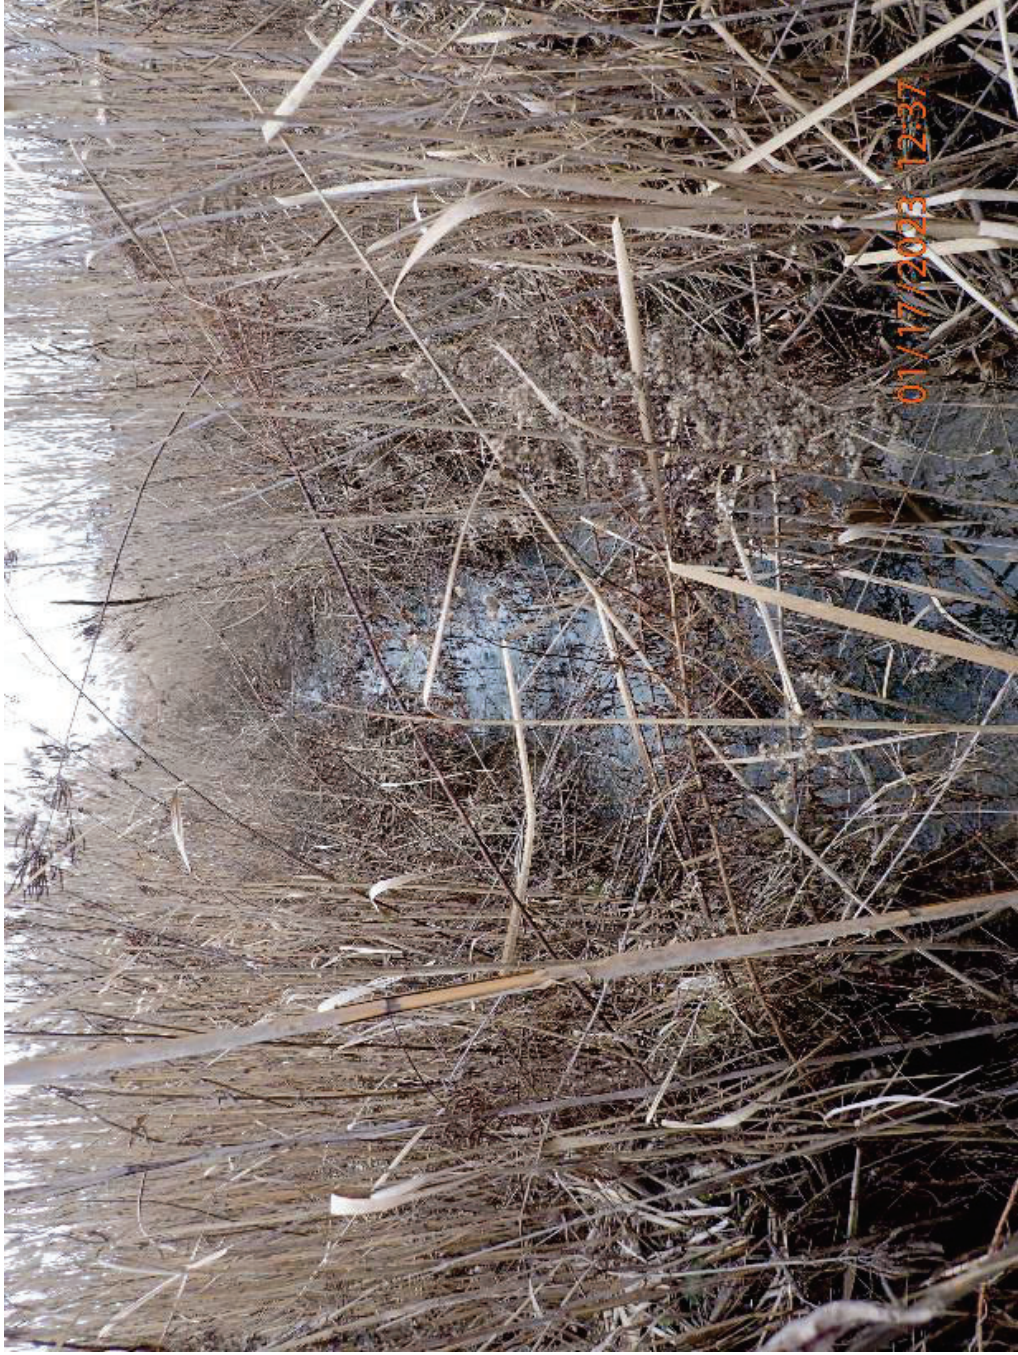
**Date:** 1/17/2023  
**Time:** 11:37 AM  
**Photographer:** S. Andreescu  
**Photo ID:** 3 – P1170544

Ditch

Photo taken from 90 degree turn

Photo facing Goshen Fire District property

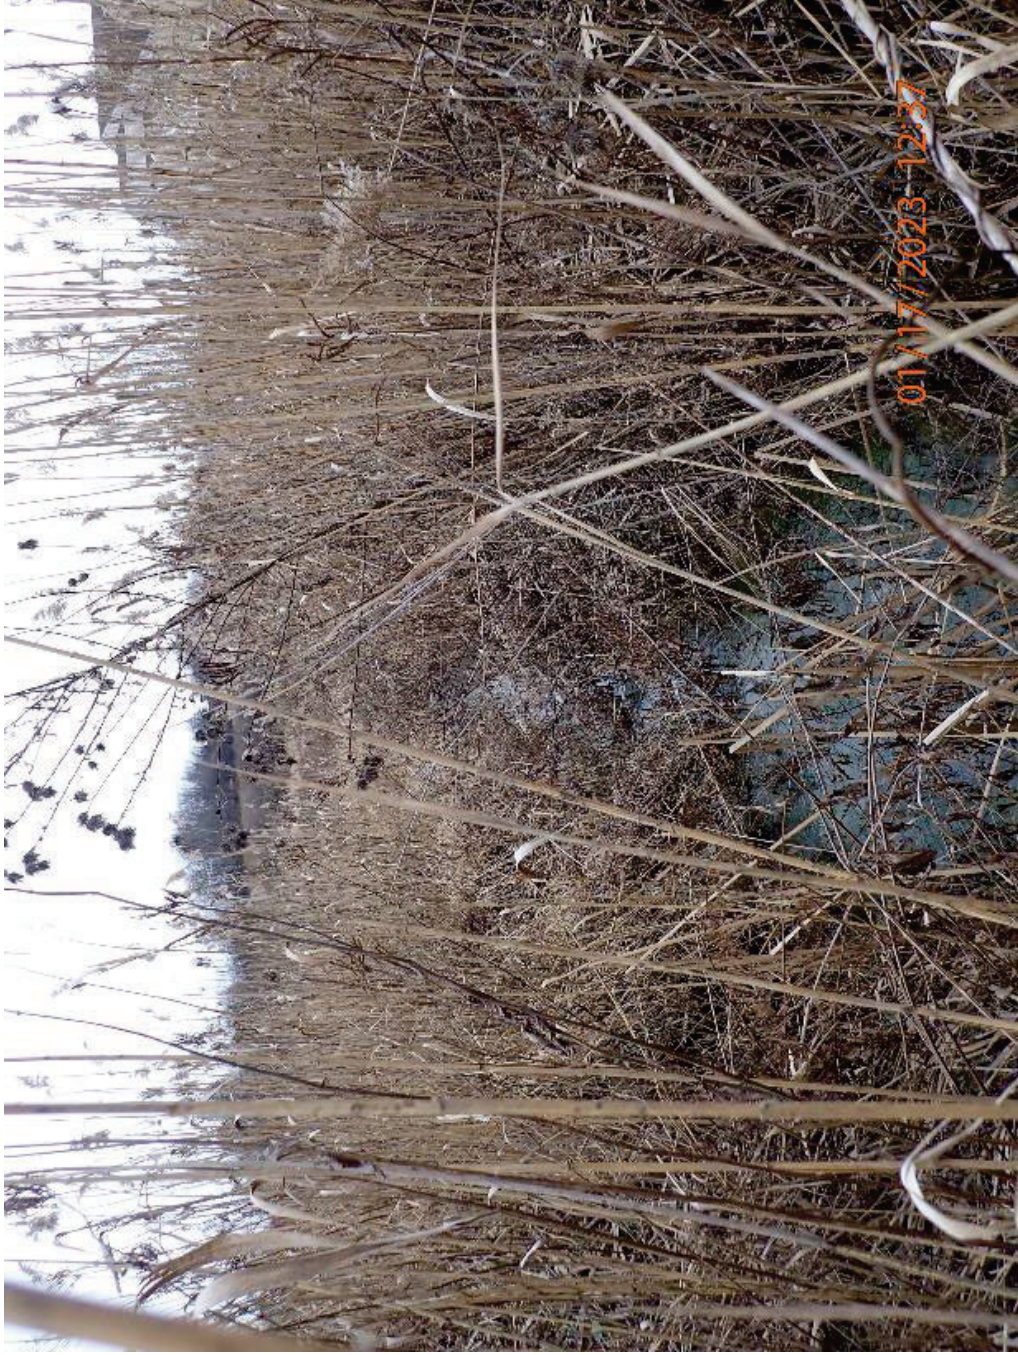
**Date:** 1/17/2023  
**Time:** 11:37 AM  
**Photographer:** S. Andreescu  
**Photo ID:** 4 – P1170545

Ditch

Photo taken from 90 degree turn

Photo facing back of 6 Dikeman Drive property

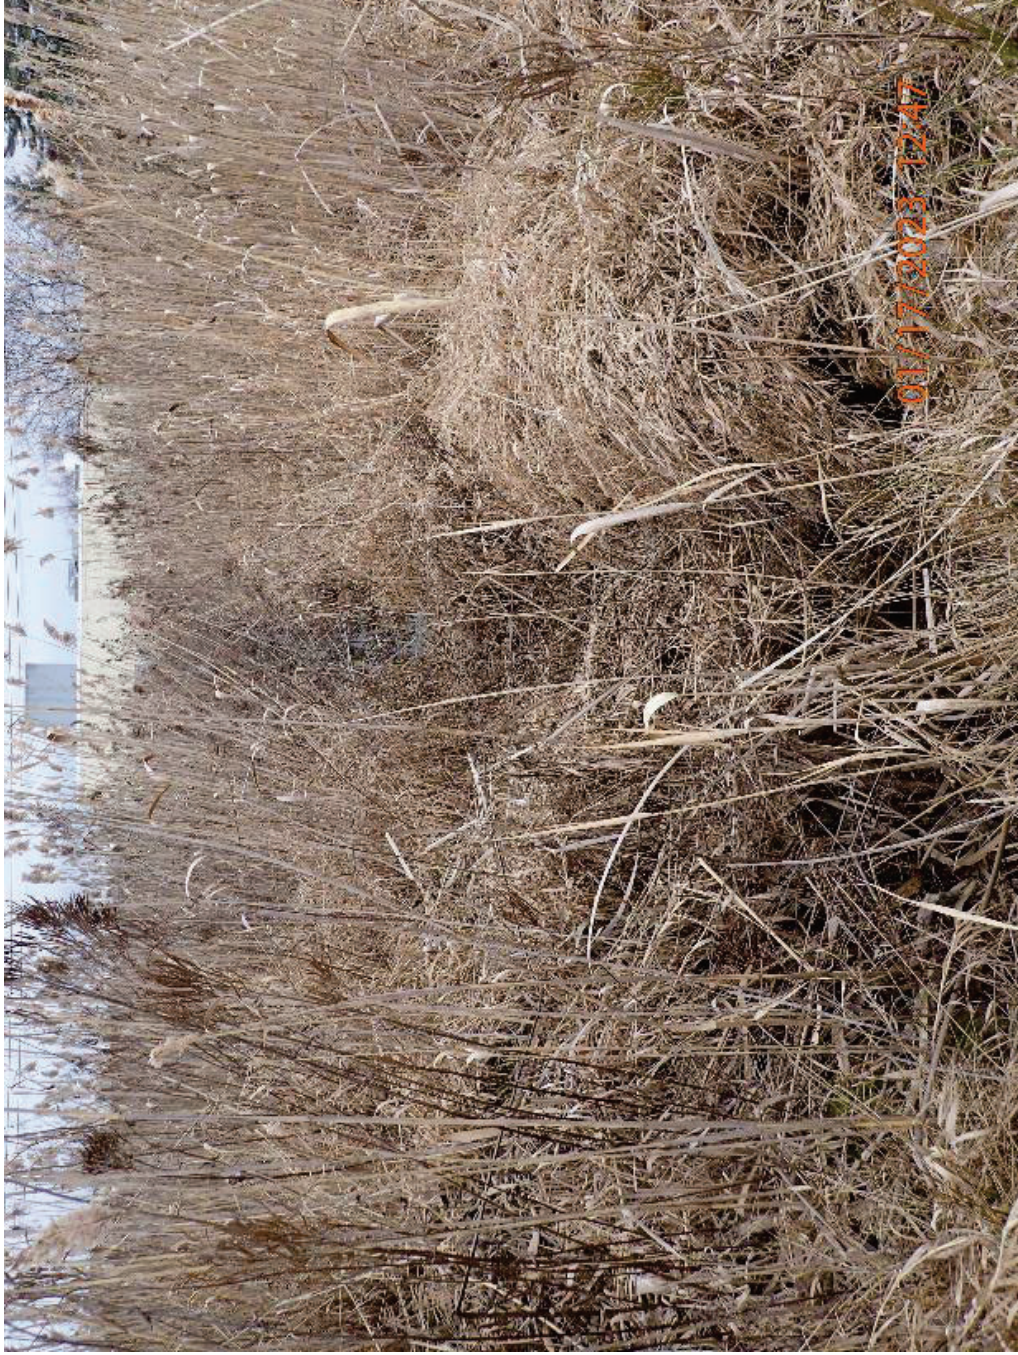
**Date:** 1/17/2023  
**Time:** 11:47 AM  
**Photographer:** S. Andreescu  
**Photo ID:** 5 – P1170546

Ditch

Photo taken from end of ditch

Photo facing Dikeman Drive

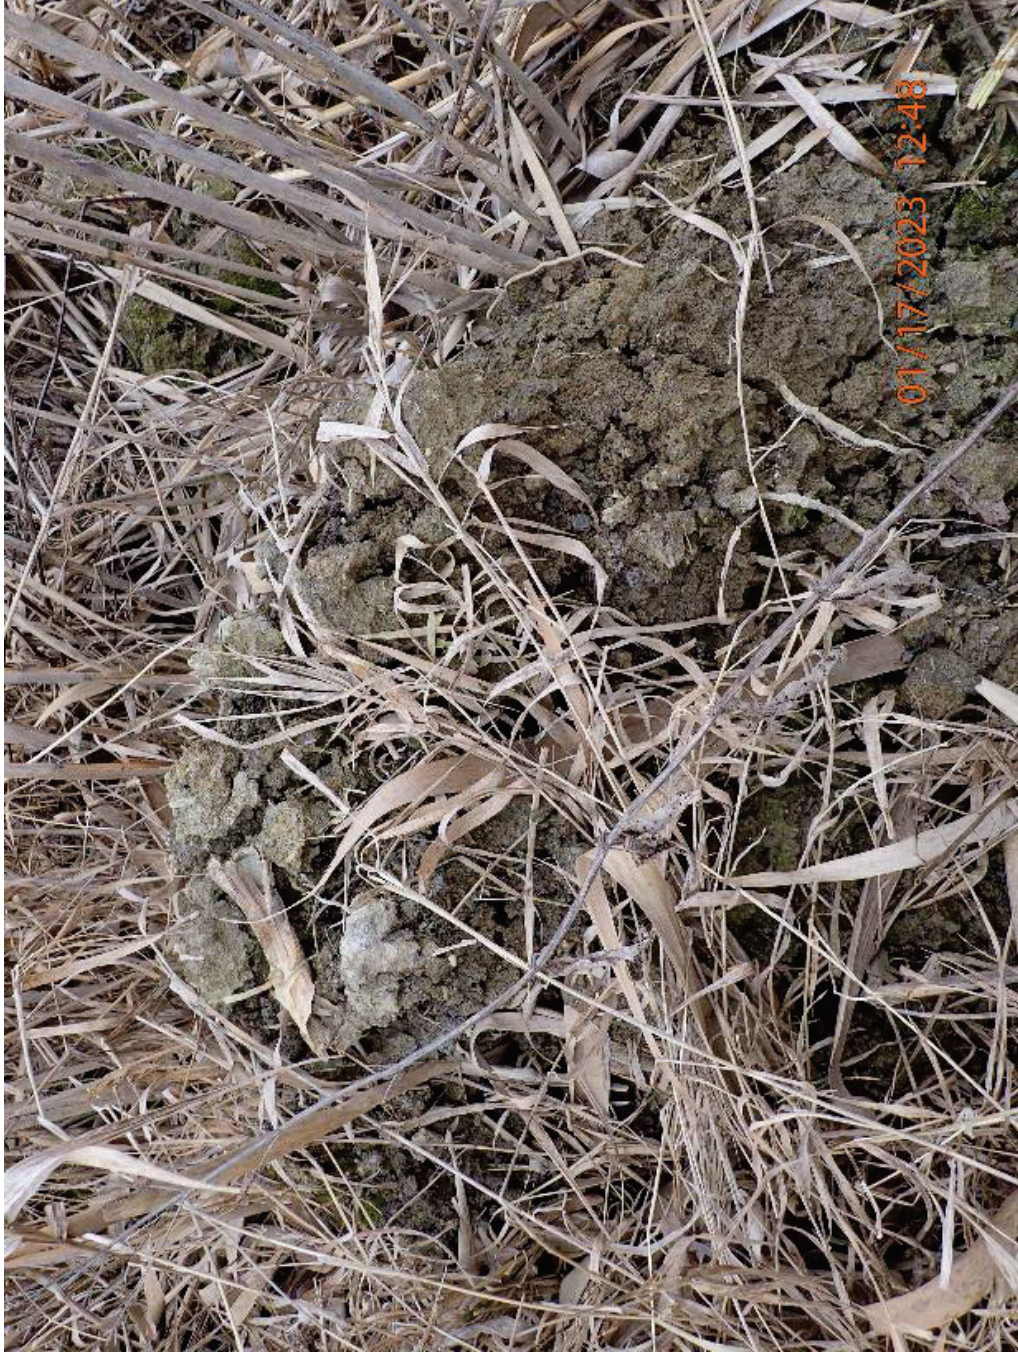
**Date:** 1/17/2023  
**Time:** 11:48 AM  
**Photographer:** S. Andreescu  
**Photo ID:** 6 – P1170547

**Description:**  
Sidecasted material from ditch

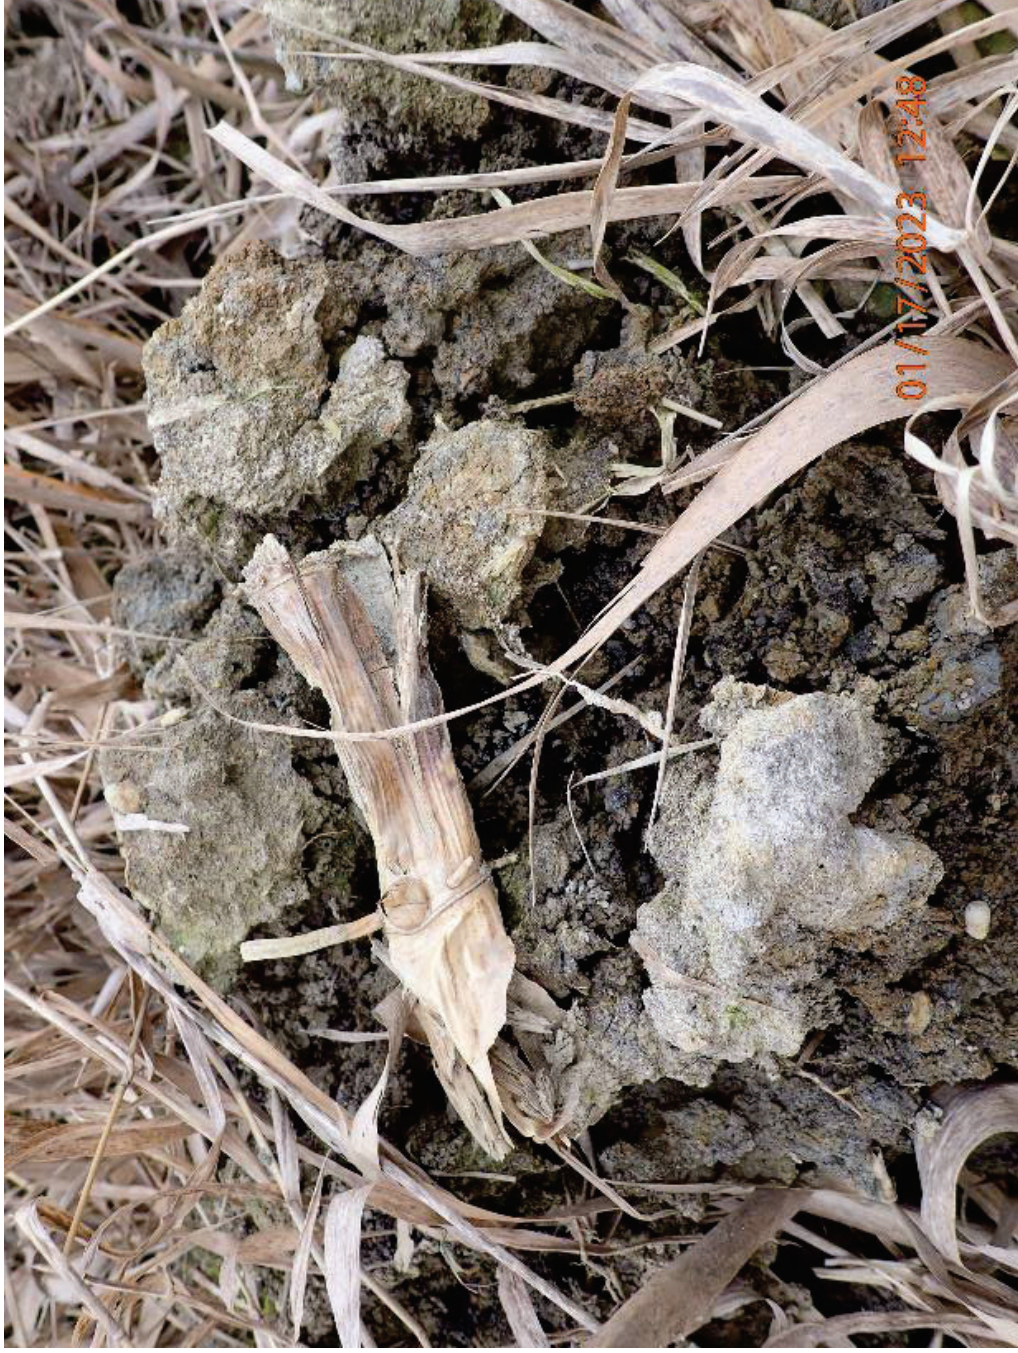
**Date:** 1/17/2023  
**Time:** 11:48 AM  
**Photographer:** S. Andreescu  
**Photo ID:** 7 – P1170548

**Description:**  
Sidecasted material from ditch  
displaying redoximorphic  
features

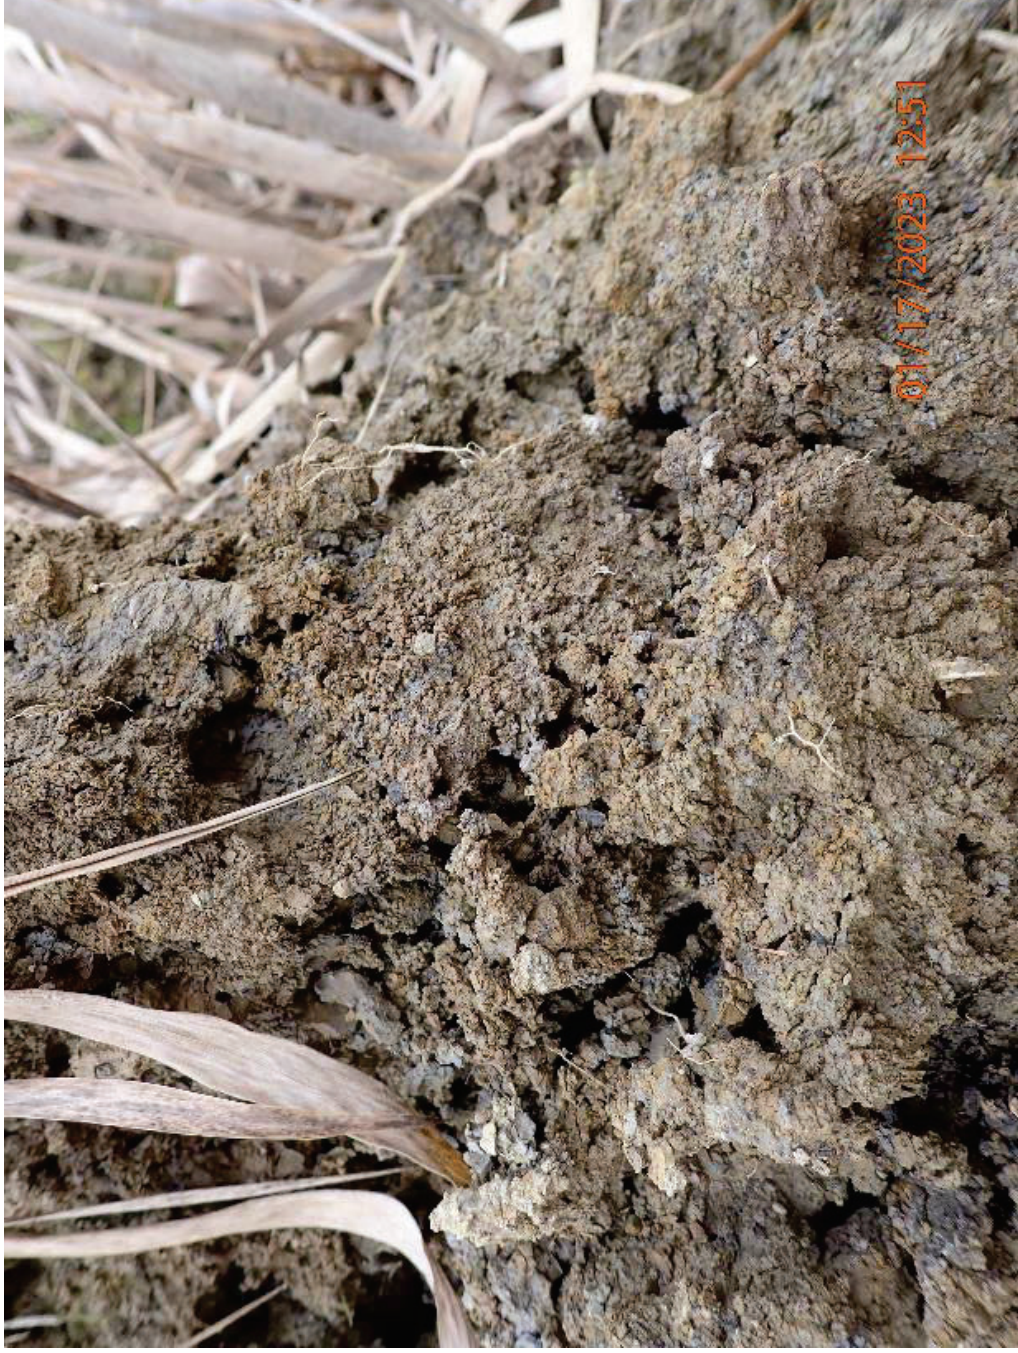
**Date:** 1/17/2023  
**Time:** 11:51 AM  
**Photographer:** S. Andreescu  
**Photo ID:** 8 – P1170549

Sidcasted material from ditch displaying redoximorphic features

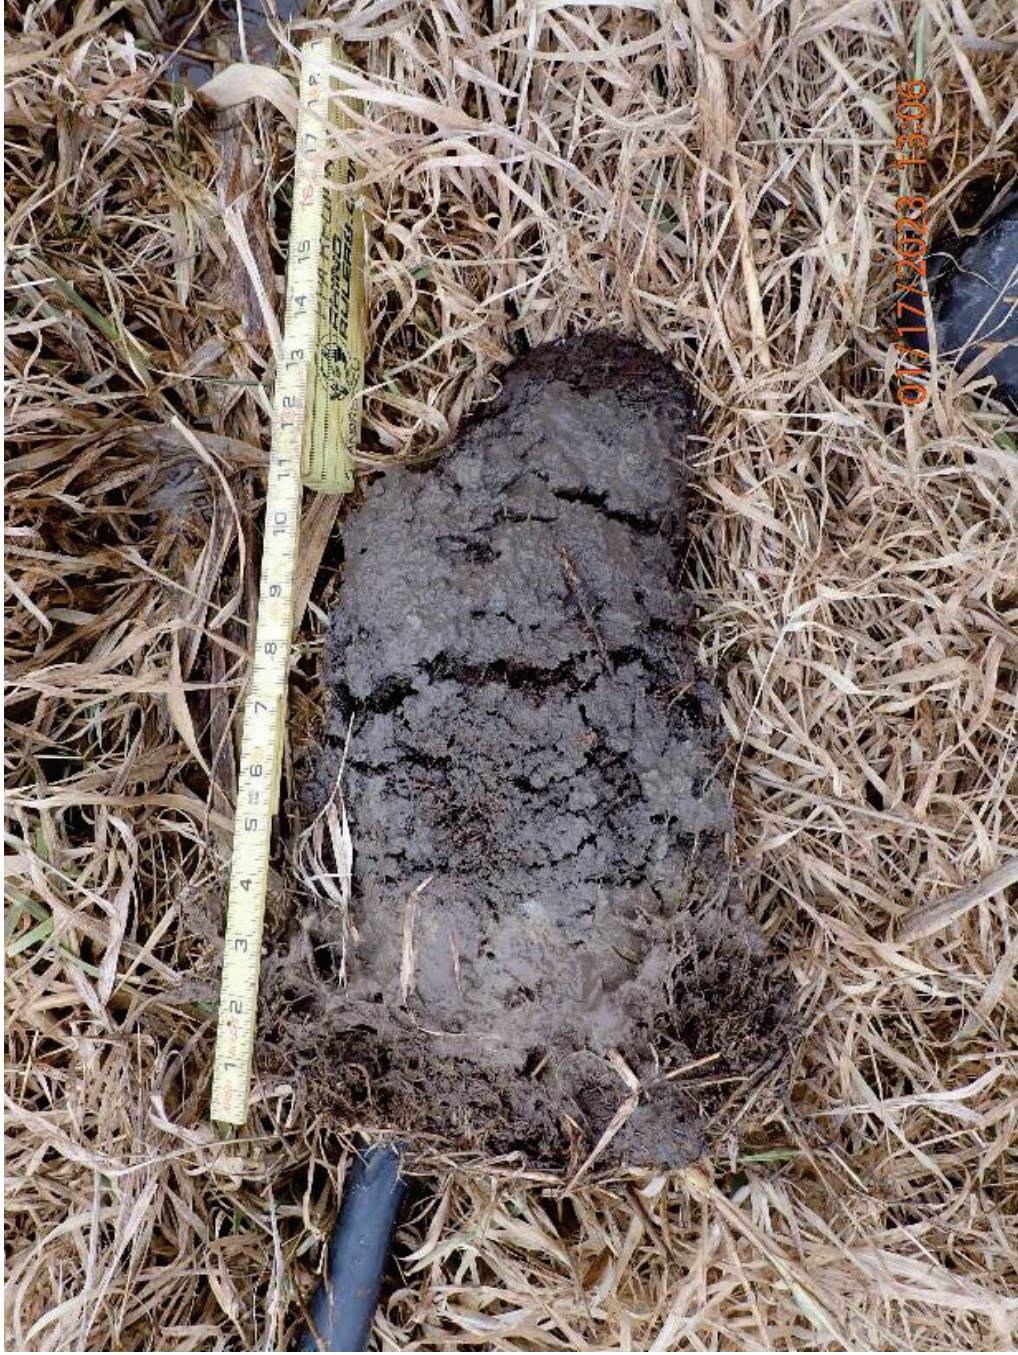
**Date:** 1/17/2023  
**Time:** 12:06 PM  
**Photographer:** S. Andreescu  
**Photo ID:** 9 – P1170550

**Description:**  
SS1 soil profile

EPA took a soil sample, SS#1, near the ditch and sidecasted material (see attached map). At this location, EPA observed indicators of wetland hydrology, hydrophytic vegetation, and hydric soils. Vegetation consisted of 100% coverage of reed canary grass. The water table was measured at 8" below the ground surface. Ponding surface water was observed in other locations on the property. EPA determined that this location was in a wetland.

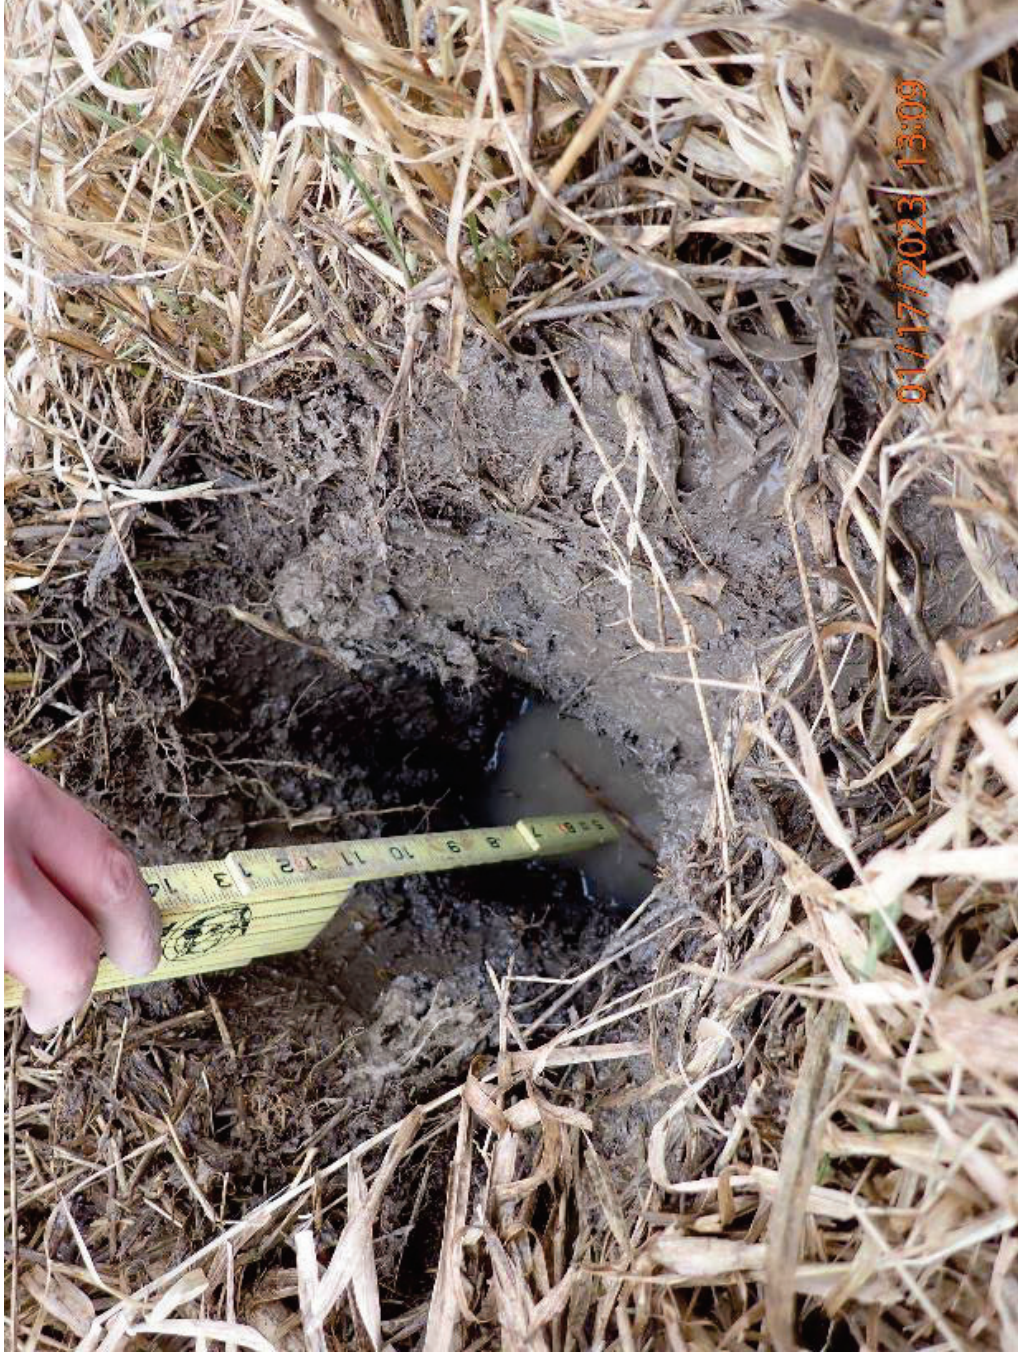
**Date:** 1/17/2023  
**Time:** 12:09 PM  
**Photographer:** S. Andreescu  
**Photo ID:** 10 – P1170551

**Description:**  
SS1 soil pit

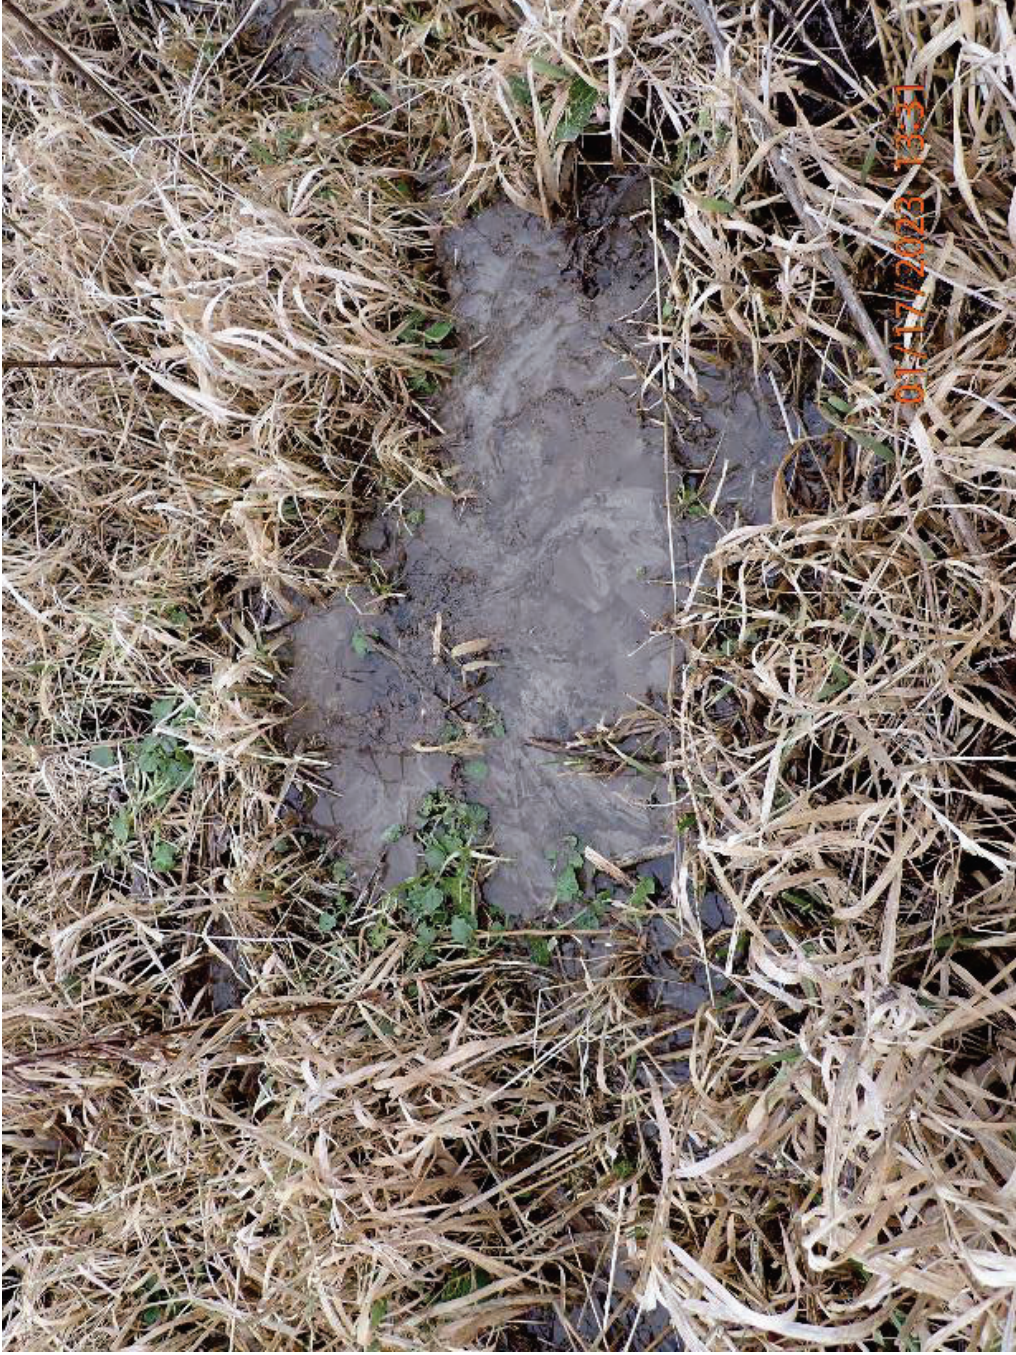
**Date:** 1/17/2023  
**Time:** 12:31 PM  
**Photographer:** S. Andreescu  
**Photo ID:** 11 – P1170552

**Description:**  
Hillside seep

EPA walked with Mr. Battaglia towards the back of the property where EPA observed a hillside seep. Near this location, EPA dug two exploratory holes, SS#2 and SS#3 (see attached map). Vegetation around SS#2 consisted of nearly 100% coverage of reed canary grass, a hydrophytic plant. While there was standing water in the vicinity, soils at SS#2 did not appear to be hydric. At SS#3, the water table was approximately 7" below the ground surface and soils were observed to be hydric. Due to seasonal conditions, vegetation was generally not able to be identified.

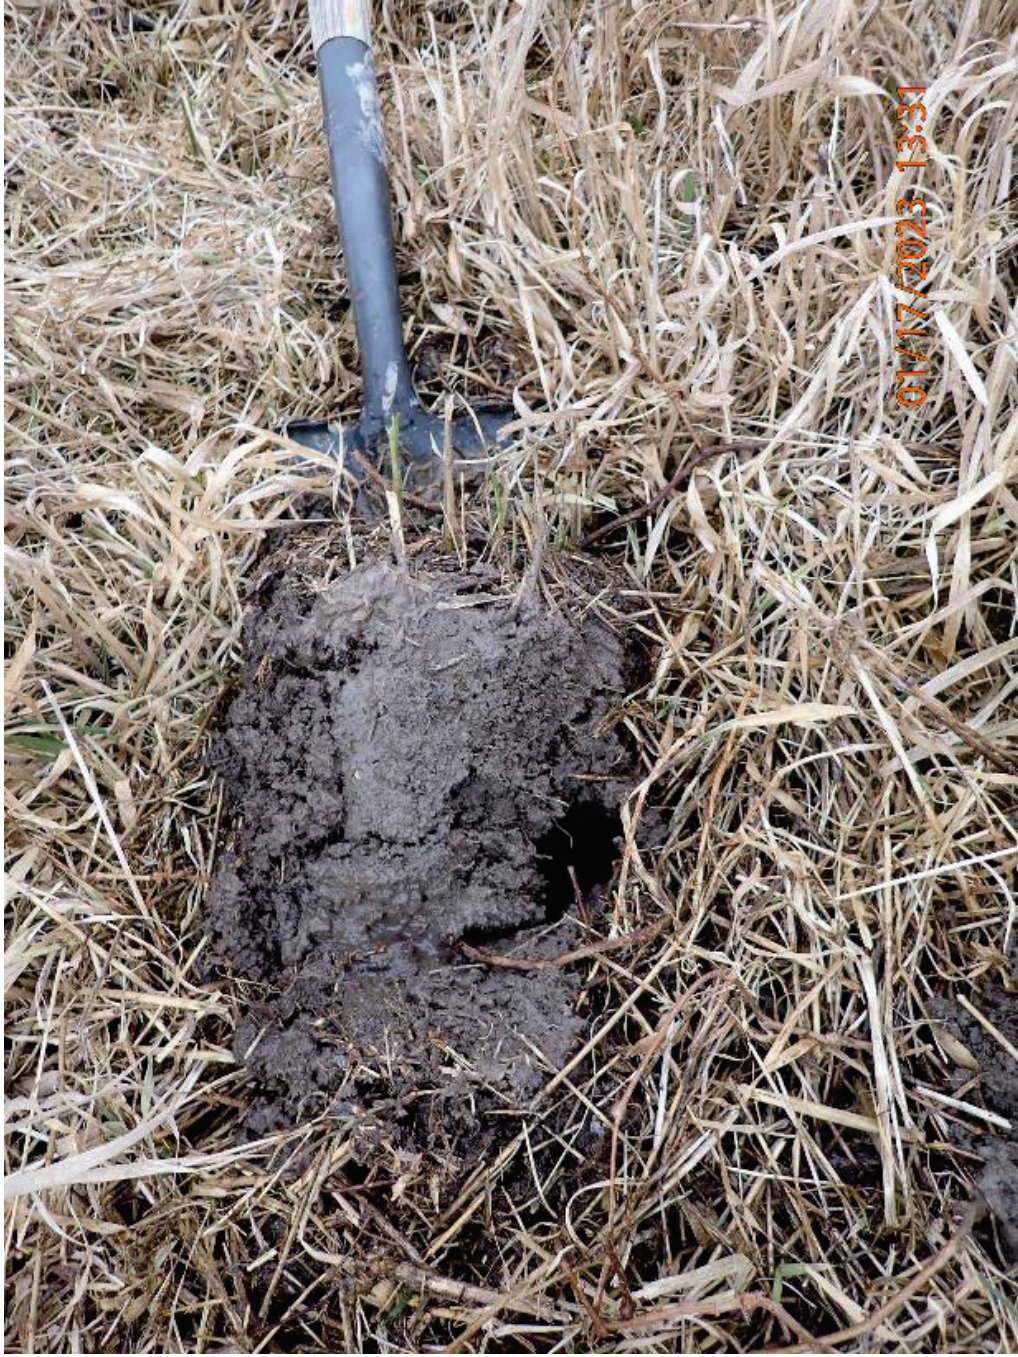
**Date:** 1/17/2023  
**Time:** 12:31 PM  
**Photographer:** S. Andreescu  
**Photo ID:** 12 – P1170553

**Description:**  
SS3 Soil Profile

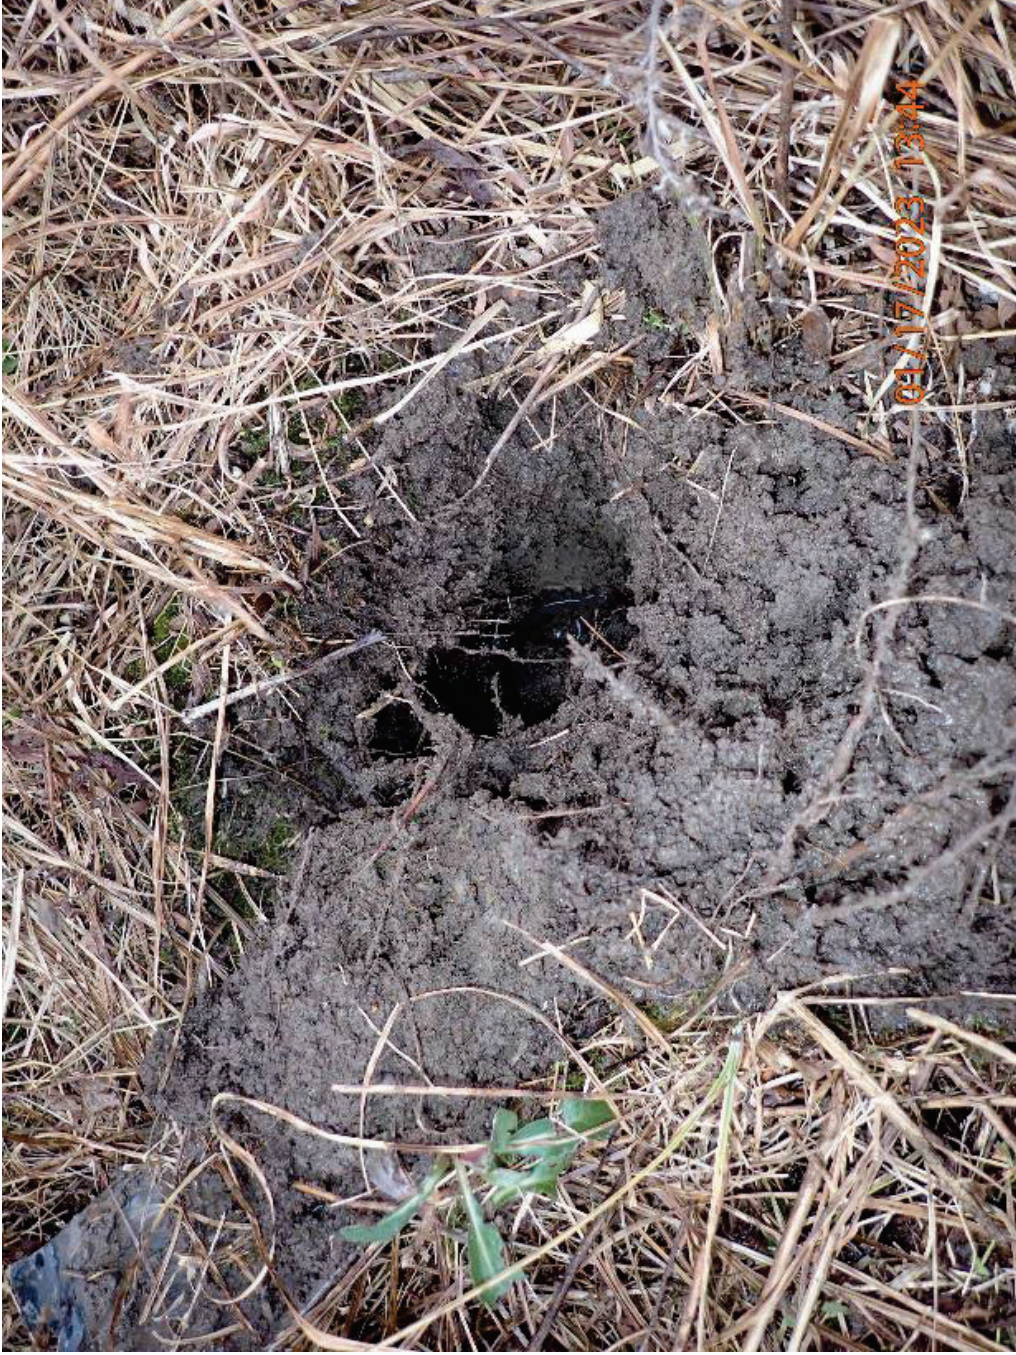
**Date:** 1/17/2023  
**Time:** 12:44 PM  
**Photographer:** S. Andreescu  
**Photo ID:** 13 – P1170554

**Description:**  
SS3 Soil Pit

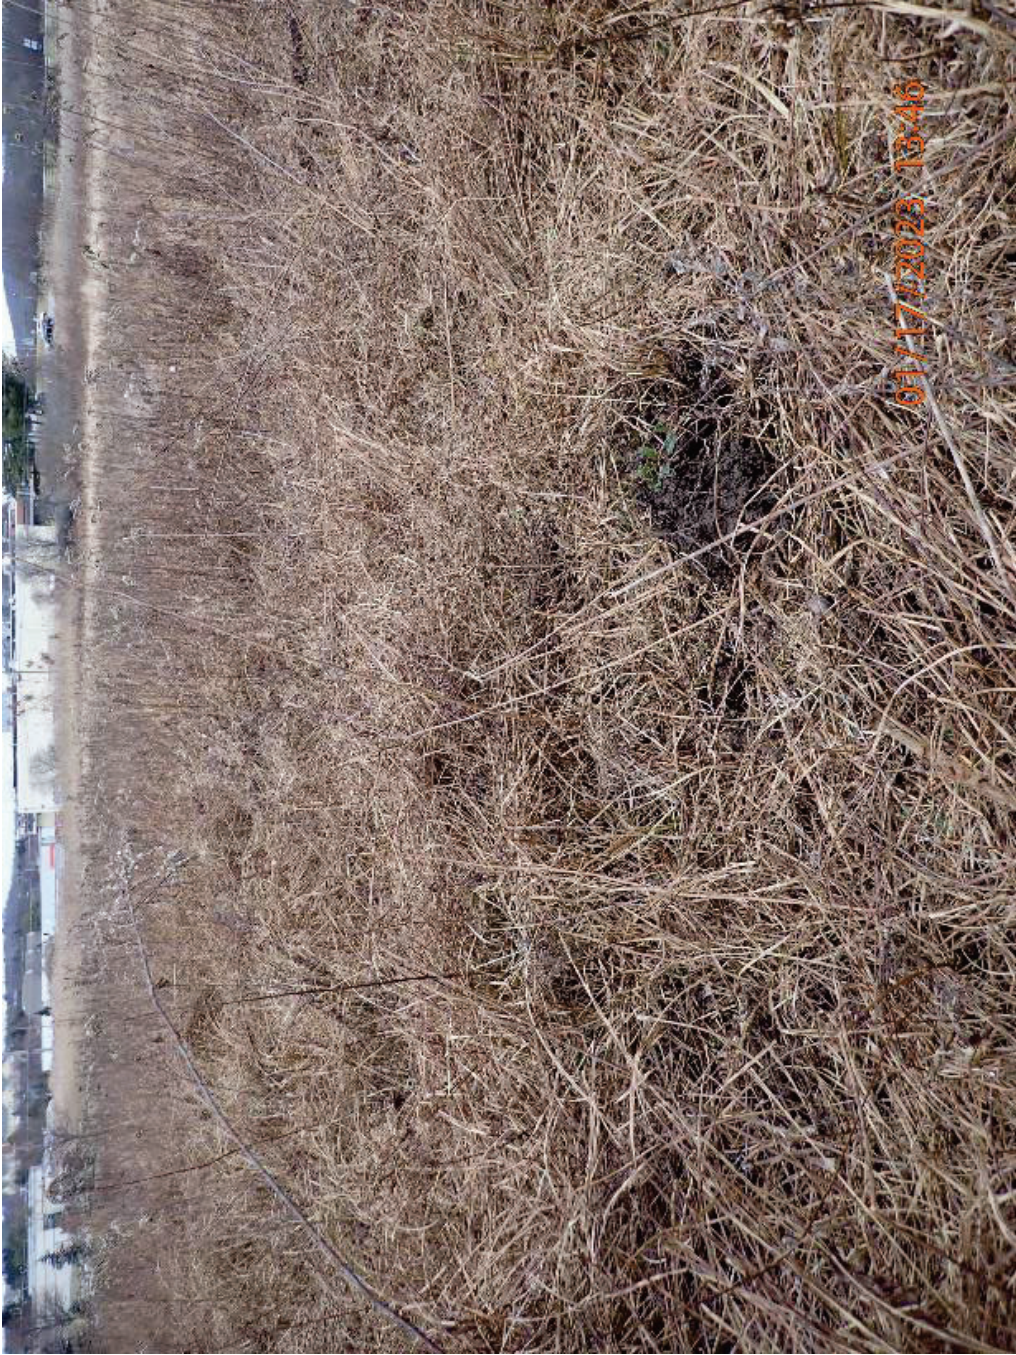
**Date:** 1/17/2023  
**Time:** 12:46 PM  
**Photographer:** S. Andreescu  
**Photo ID:** 14 – P1170555

Area surrounding SS3 Soil Pit

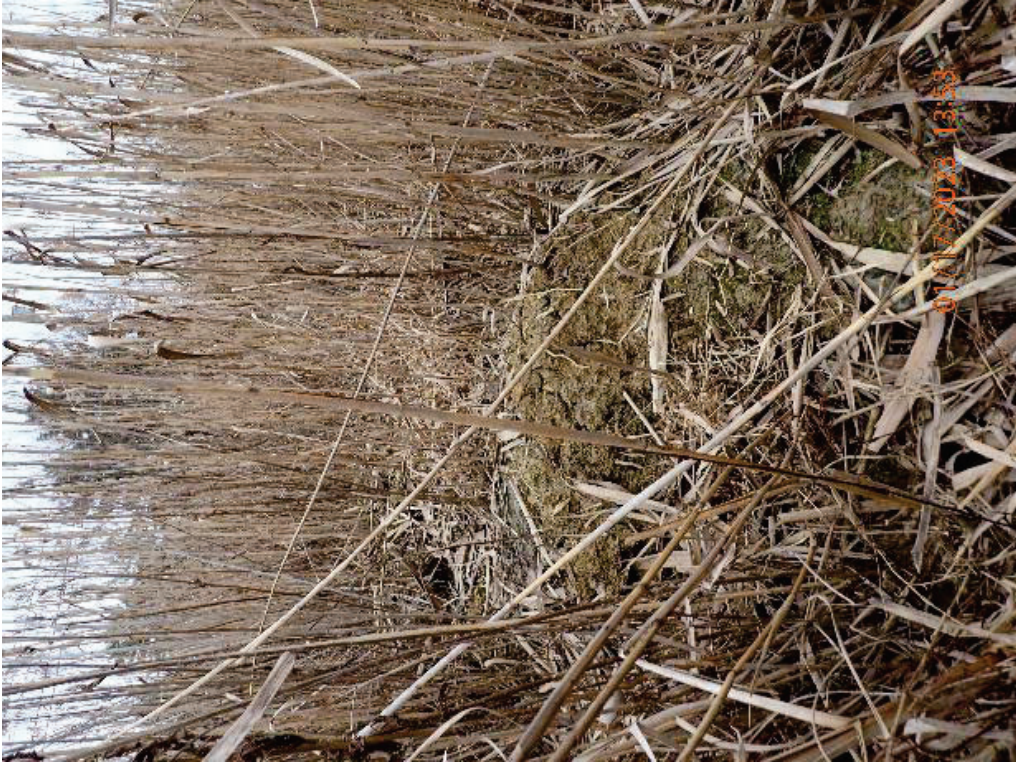
**Date:** 1/17/2023  
**Time:** 12:53 PM  
**Photographer:** S. Andreescu  
**Photo ID:** 15 – P1170556

Pile of sidecasted material  
located approximately 15' from  
ditch
