# Clean Water Act Section 404: Site Visit/Case Development

Site Name	Battaglia Property and eastern corner of Dikeman Firehouse Property	Start Date	January 17, 2023
		End Date	January 17, 2023
Inspection Purpose	Initial site visit		
<b>Opening Conference</b>			
<input checked="" type="checkbox"/> Presentation of Inspector Credentials			
Name and Title (Use N/A if owner/operator not available to join the inspection)			
Credentials were presented to Mr. Giuseppe (Joe) Battaglia, the owner/president of Orange Builders, LLC			
<input checked="" type="checkbox"/> Opening Conference			
Name of person authorizing access if applicable			
Mr. Battaglia authorized access via phone and e-mail prior to the inspection. Access was initially requested to be limited to a wetland area depicted on a survey provided by Mr. Battaglia located on 6 Dikeman Drive.			
Notes from Opening Conference			
I asked Mr. Battaglia about the delineation process for the wetland delineation figure he provided for the 6 Dikeman Drive property, which shows one wetland area located in the northern corner of the parcel. He stated that his wetland delineator was at the site for two full days. When I asked about any surve

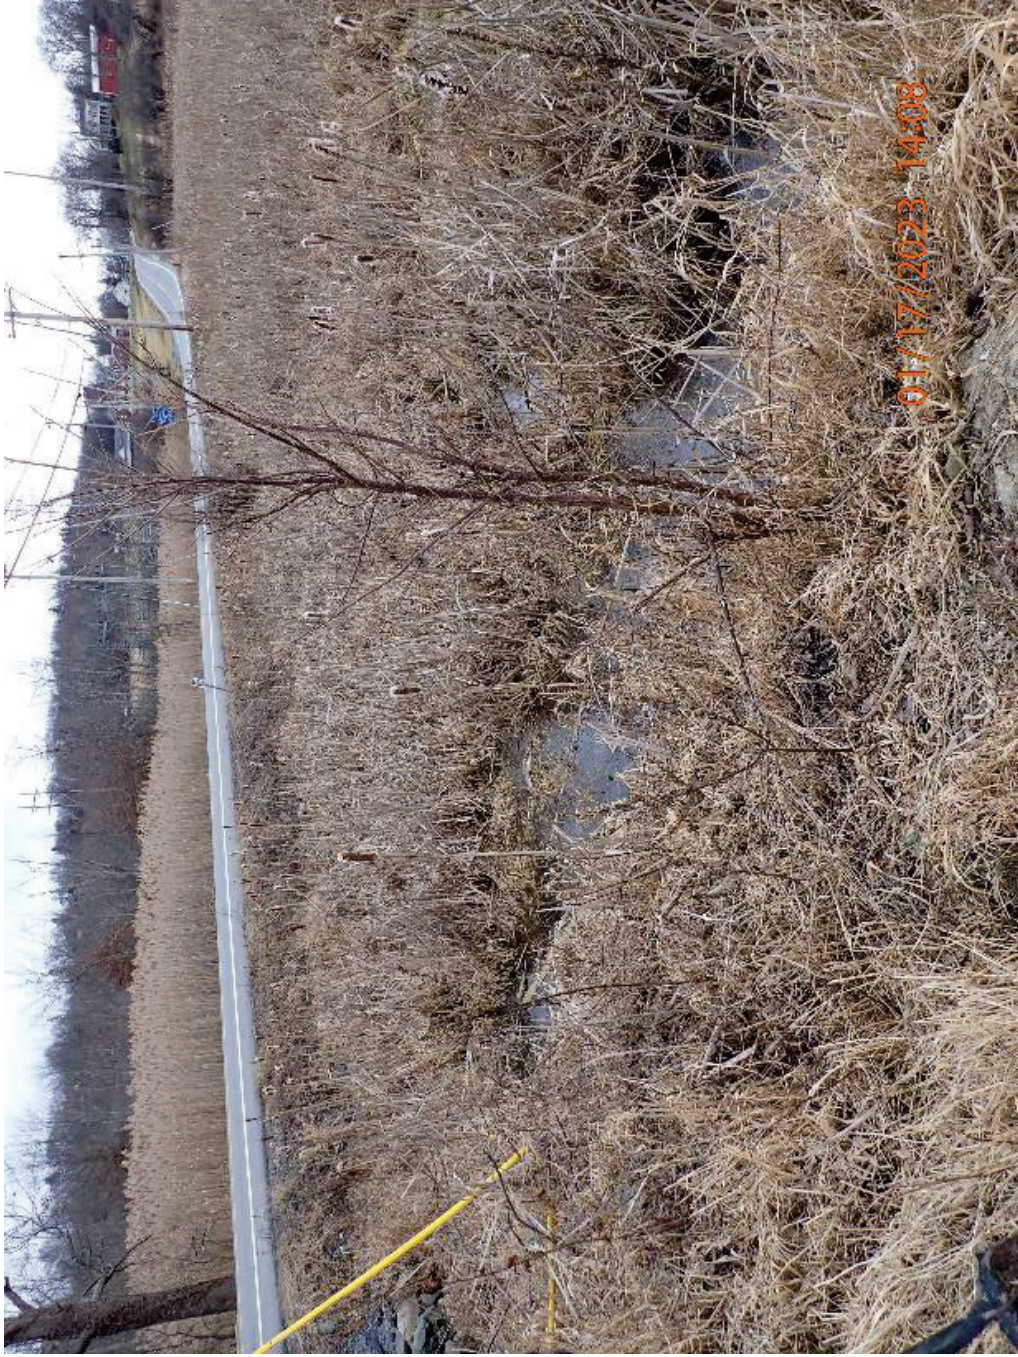
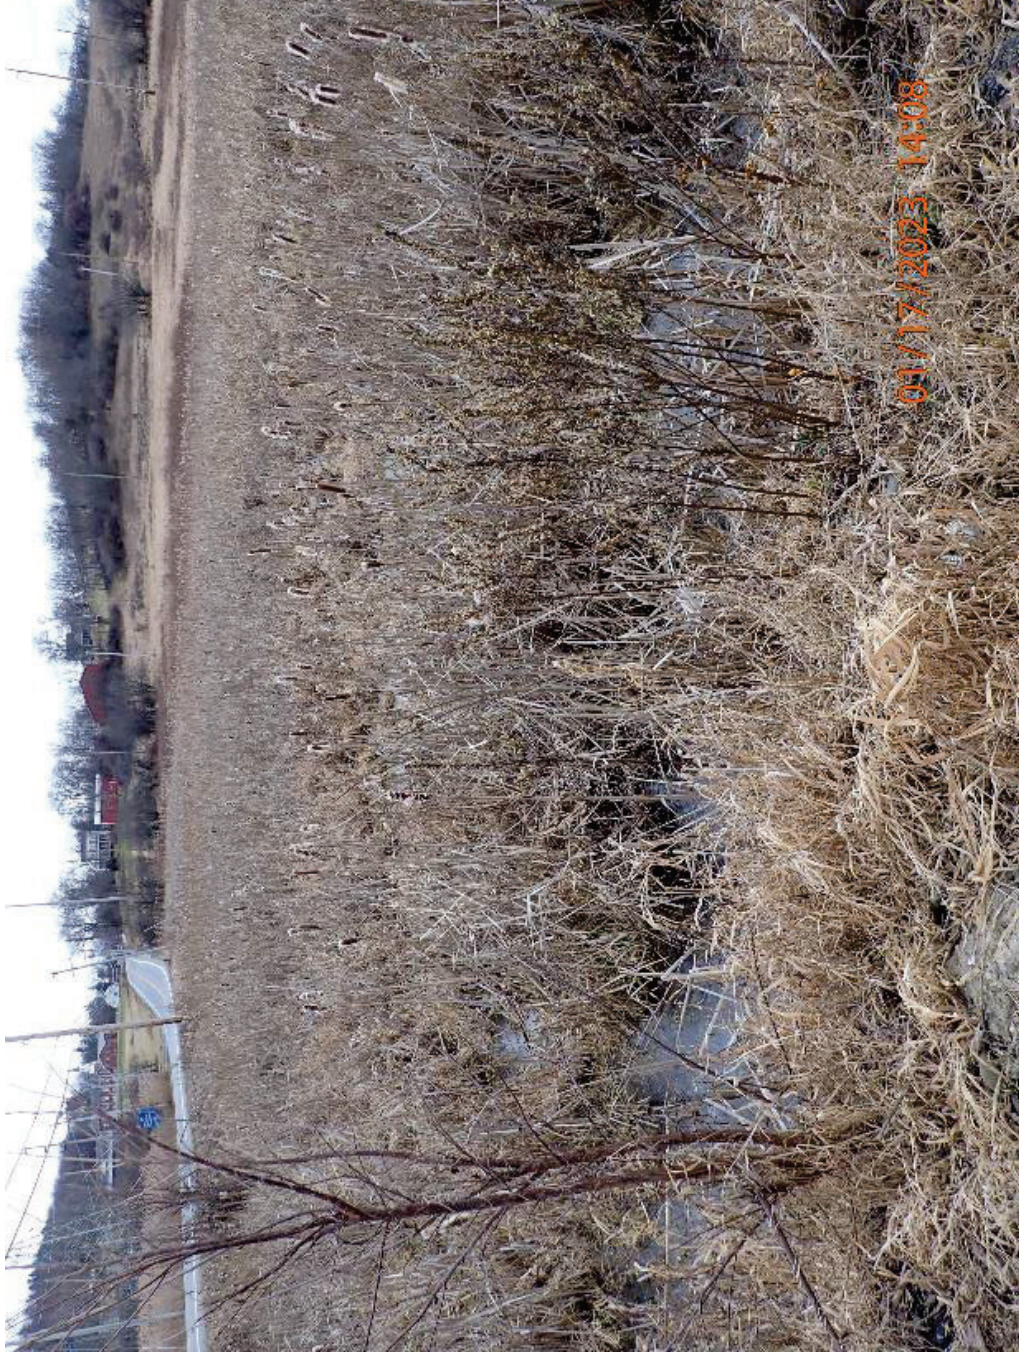
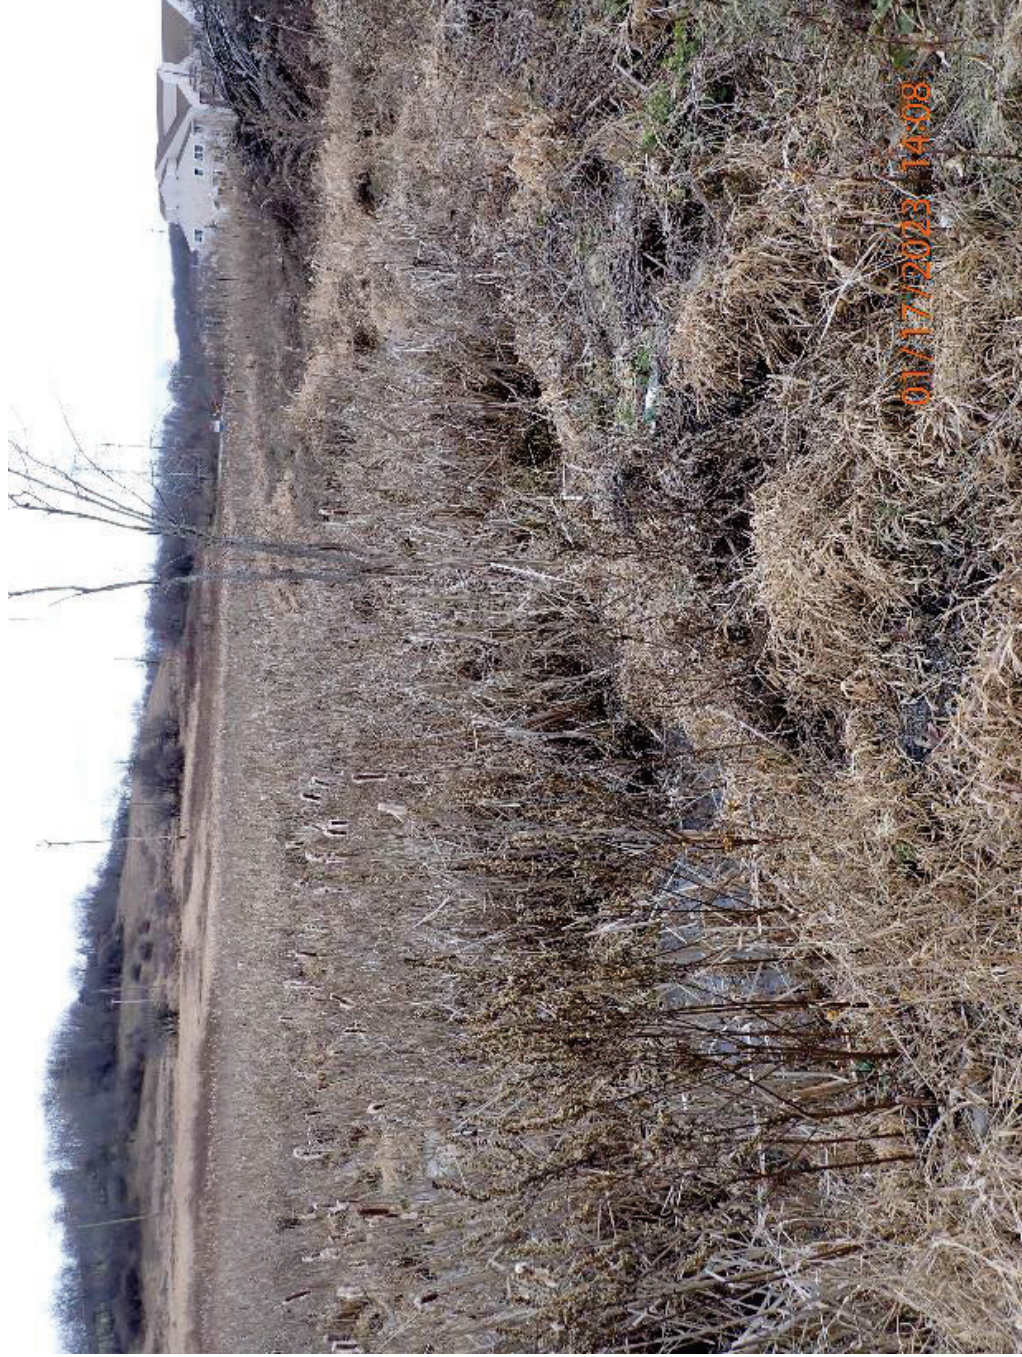
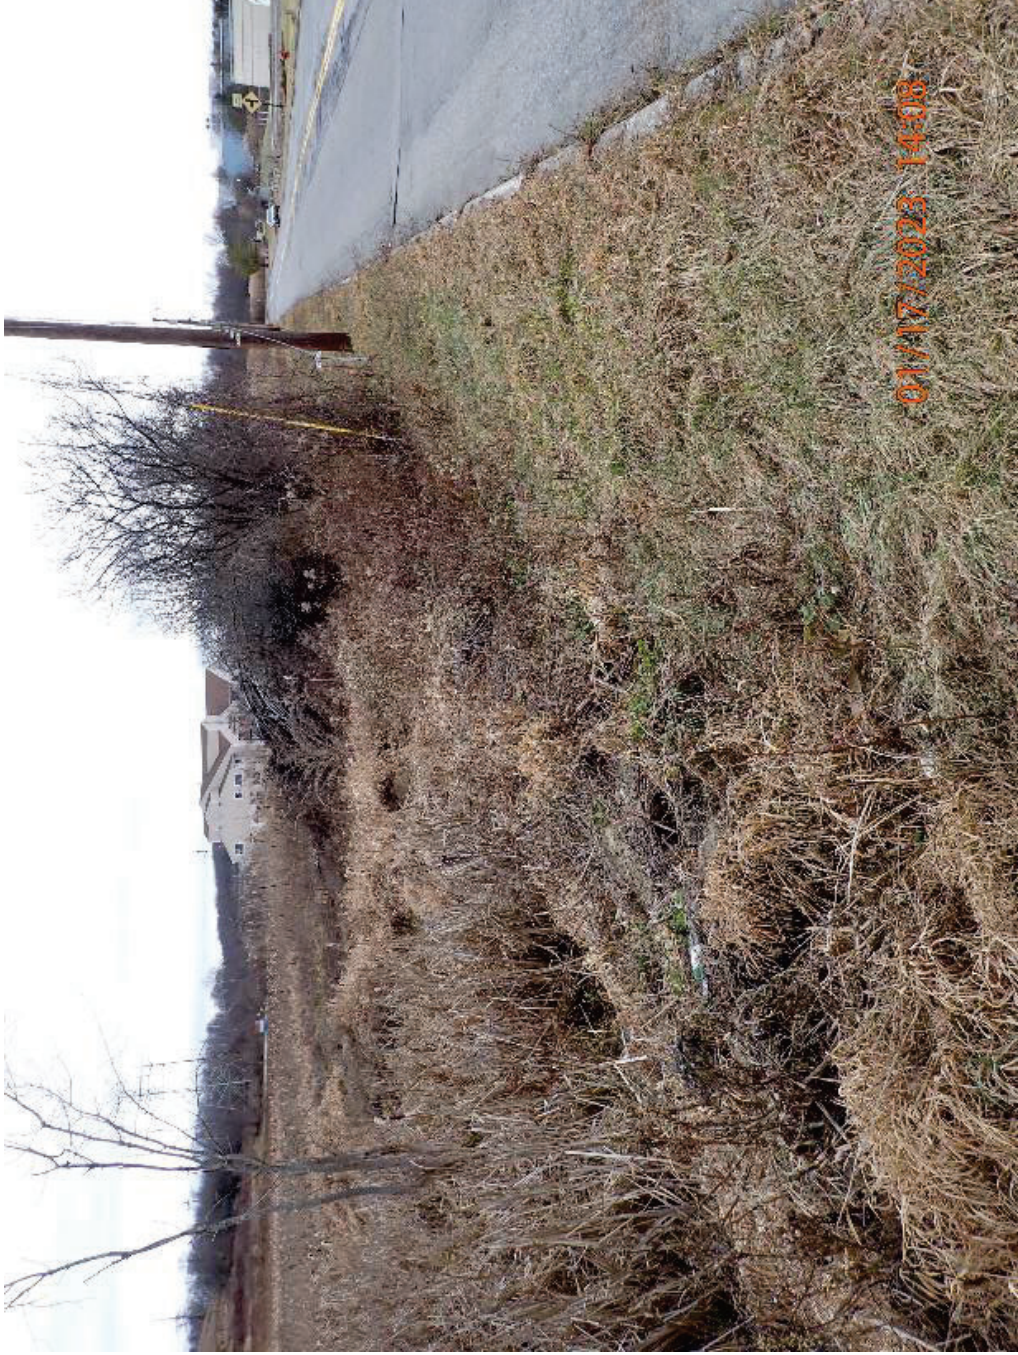
(1/4) Panorama from road, 2  
Dikeman Drive

(2/4) Panorama from road, 2  
Dikeman Drive

**Description:**  
(3/4) Panorama from road, 2  
Dikeman Drive, 6 Dikeman Drive

(4/4) Panorama from road, 2  
Dikeman Drive, 6 Dikeman Drive

From the road, EPA was able to observe that a second ditch had been dug on the 2 Dikeman Drive property and that sidecasted material lay nearby. EPA did not access this property. Areas surrounding the ditch was dominated by cattail, a hydrophytic plant.

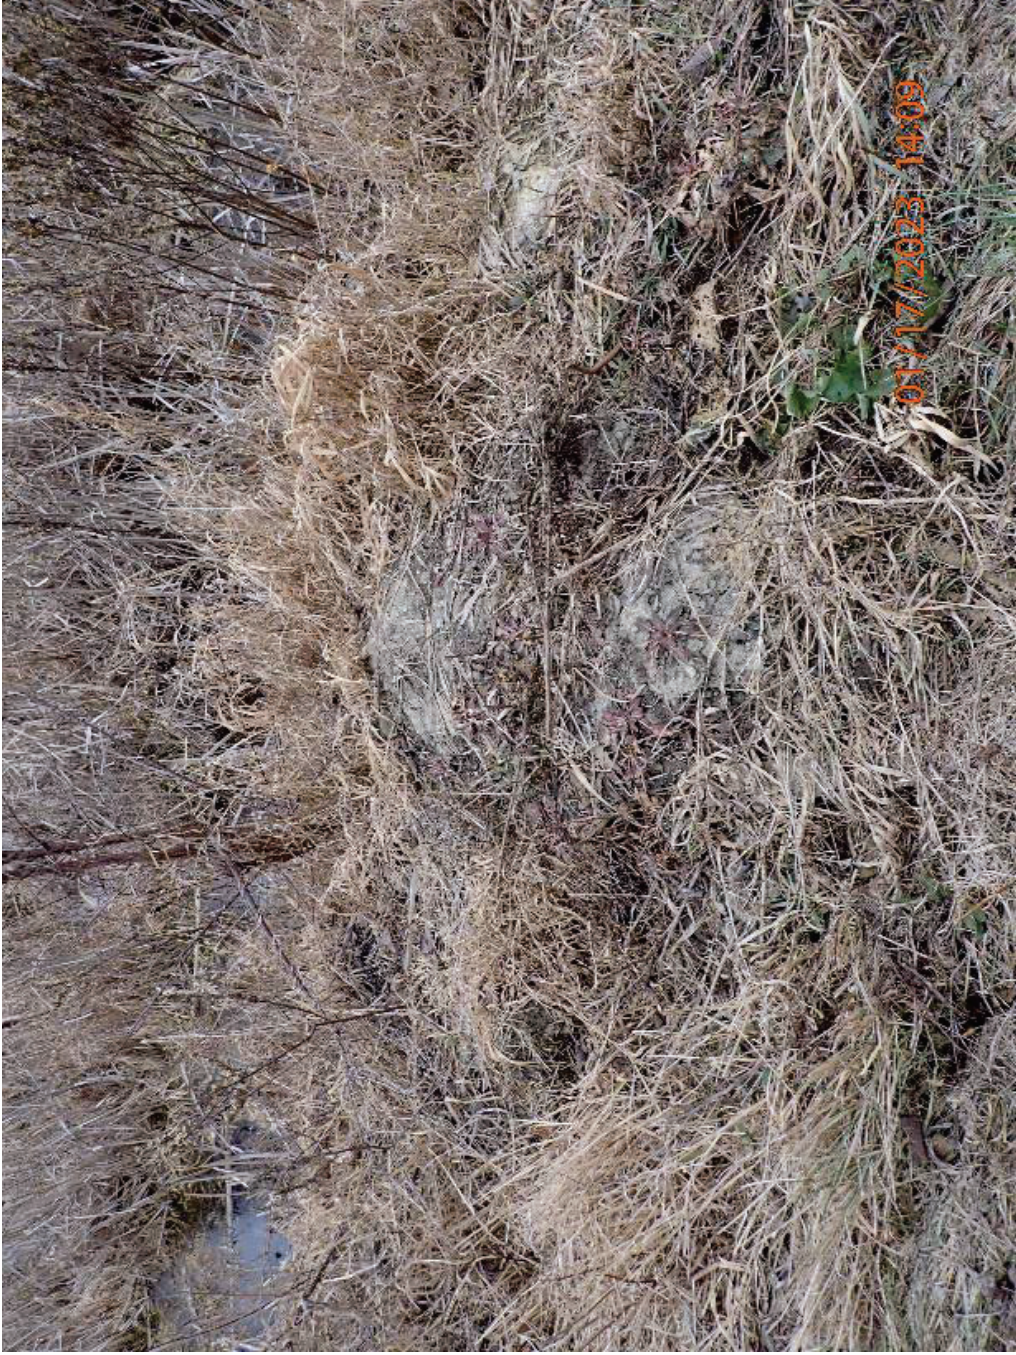
**Date:** 1/17/2023  
**Time:** 1:09 PM  
**Photographer:** S. Andreescu  
**Photo ID:** 20 – P1170561

Sidecasted material on 2  
Dikeman Drive, viewed from the  
road
