INSPECTION REPORT

| Type of Inspection | Compliance Evaluation Inspection (CEI) | |
| Facility or Site Name | Bludworth Marine LLC | |

APPENDIX 1.  
PHOTOGRAPH LOG

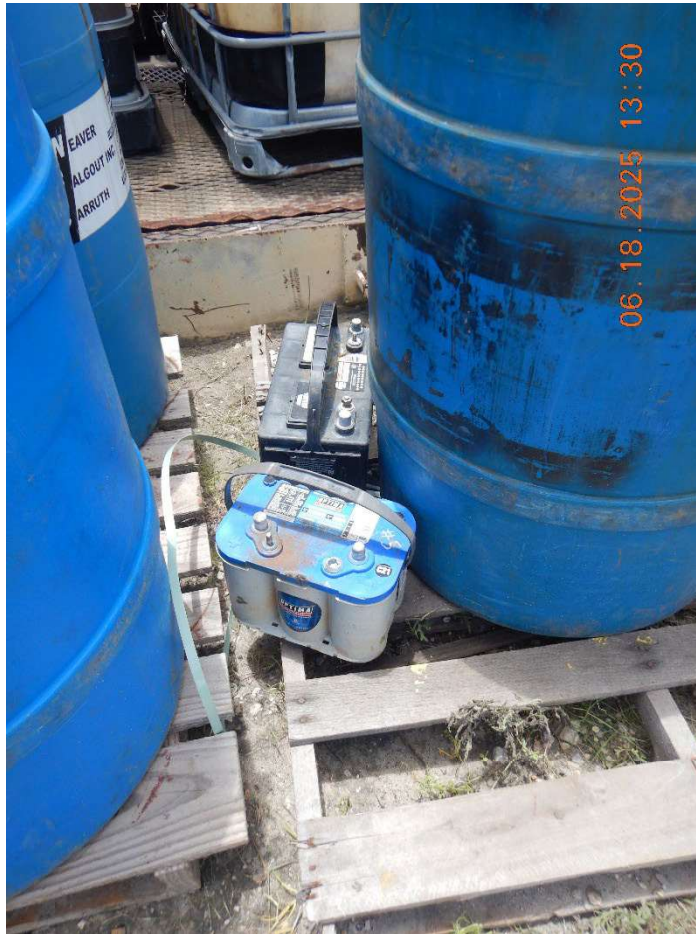
**Photo No. 1**

Description: View of the universal waste collected on site in the waste storage area. The batteries were not labeled and did not have an accumulation start date.

| <b>Facility:</b> Bludworth Marine LLC | | |
|---|---|---|
| <b>AOC #1</b> – BM did not label individual batteries or their containers “Universal Waste-Battery(ies),” or “Waste Battery(ies),” or “Used Battery(ies).” | <b>Citation:</b> 40 CFR 273.14(a) | Section: 2.1 |
| <b>AOC #2</b> – BM did not demonstrate the length of time that the universal waste has been accumulated from the date it becomes waste – 40 CFR 273.15(c). | <b>Citation:</b> 40 CFR 273.15(c) | Section: 2.1 |

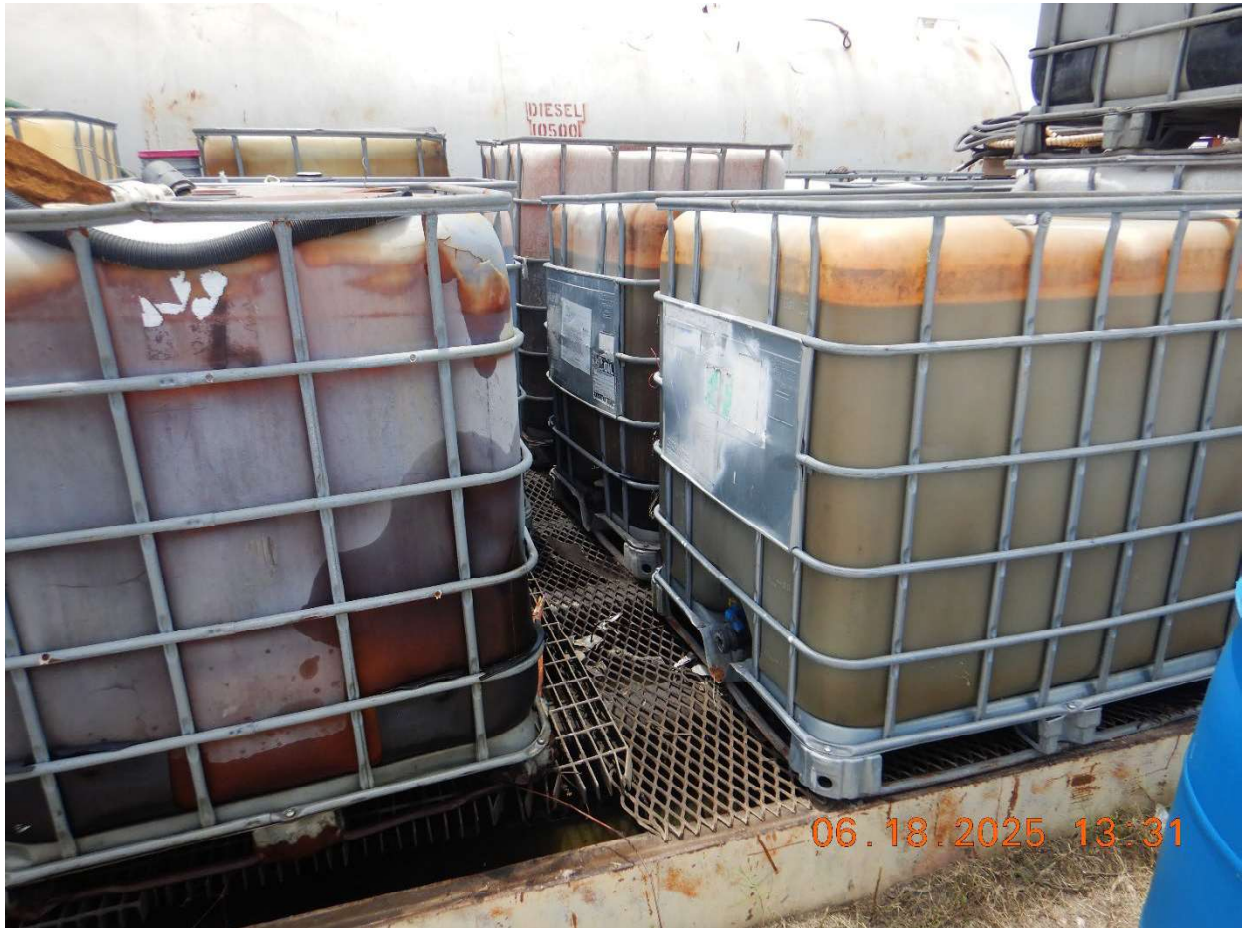
**Photo No. 2**

Description: Overview of waste storage area. Mr. Boudreaux stated all totes are accumulating wash water from washing vessels.
