**COMPLIANCE EVALUATION INSPECTION REPORT**  
EBCI Trout Hatchery, Project No. CV-NC0052451-06162021

**EBCI Trout Hatchery  
Eastern Band of Cherokee Indians  
1840 Paint Town Road (PO Box 455)  
Cherokee, North Carolina, 28719  
NPDES Permit Number: NC0052451**

**Inspection Date:**  
June 16, 2021

**Project ID:**  
CV-NC0052451-06162021

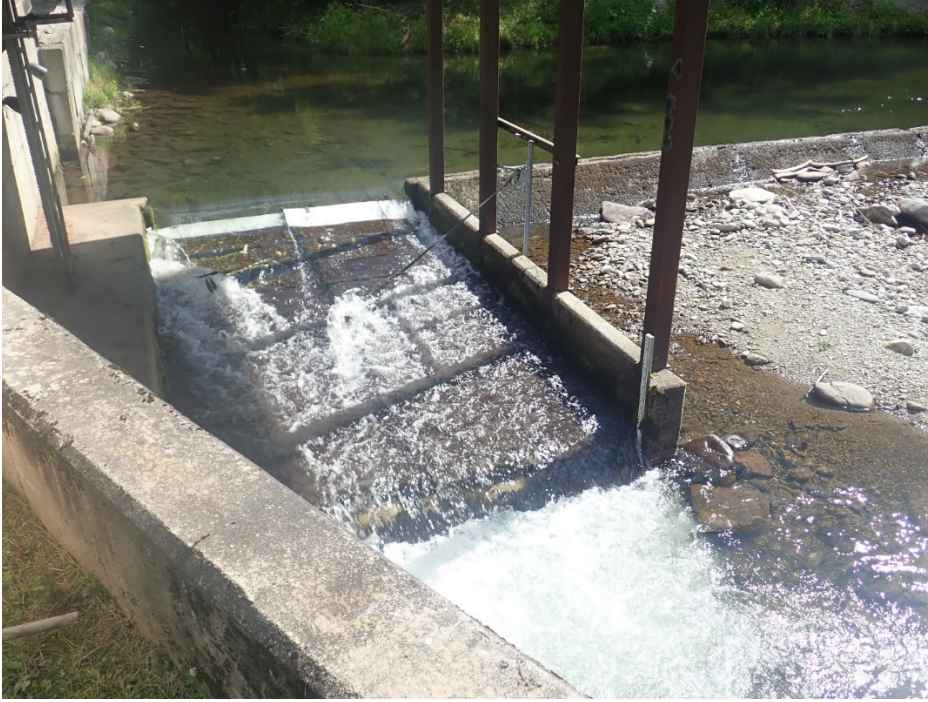
*Photo 1. Inlet structure. Water passes through a grate into the system. A rough flow measurement staff is visible at the end of the inlet. Wear is visible on the retaining wall structure. Heavy sedimentation near the wall is the result of high flow conditions.*

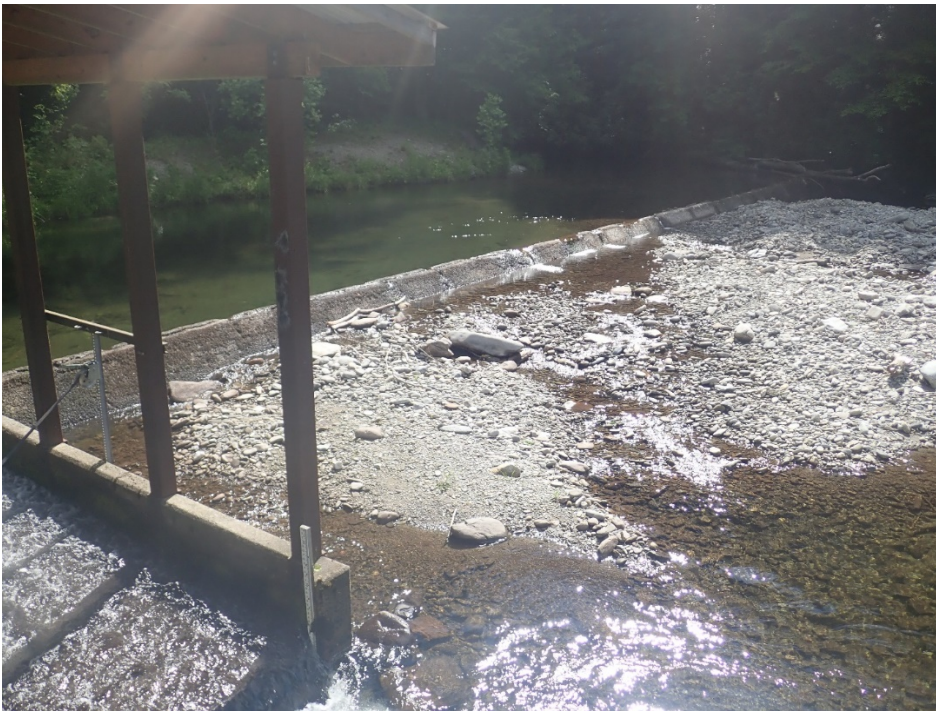
*Photo 2. Retaining wall showing wear and damage. Clearer view of sedimentation.*

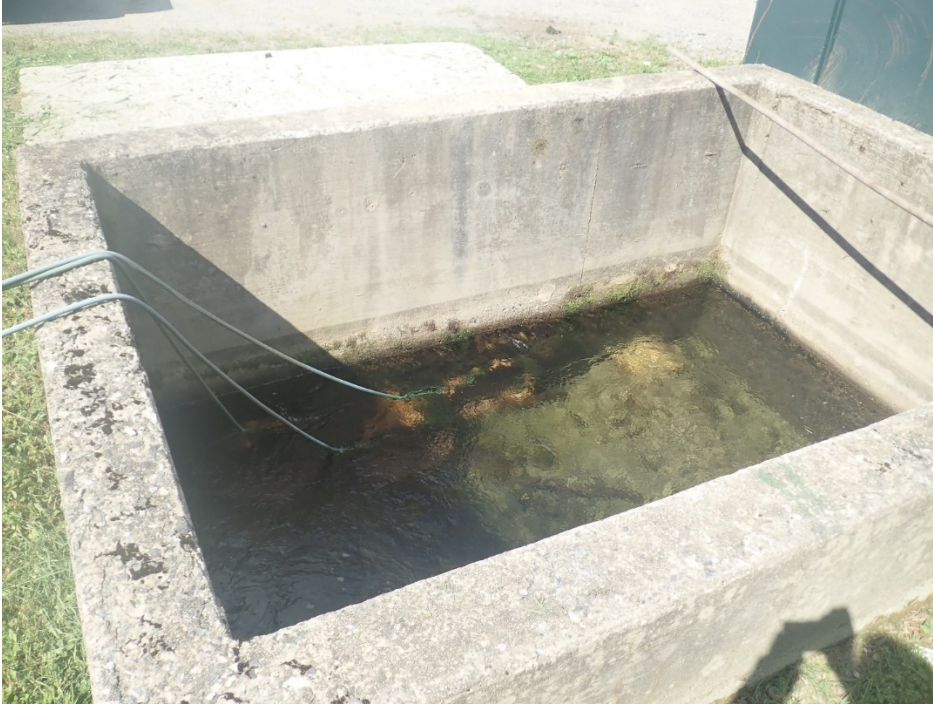
Water is supplied from the Straight Fork of the Raven Fork river (Photos 1 & 2) with an estimated flow of 3,000-5,000gpm. The water enters a splitter box (Photo 3) diverting water into three parallel trains (A, B, C). Liquid oxygen is supplied to the system from a liquid oxygen tank via the splitter box to achieve a desired dissolved oxygen concentration of 8-10 ppm.

*Photo 3. Splitter box distributing water incoming from inlet to three parallel raceway systems. Grey lines are liquid oxygen supplied from a nearby tank.*

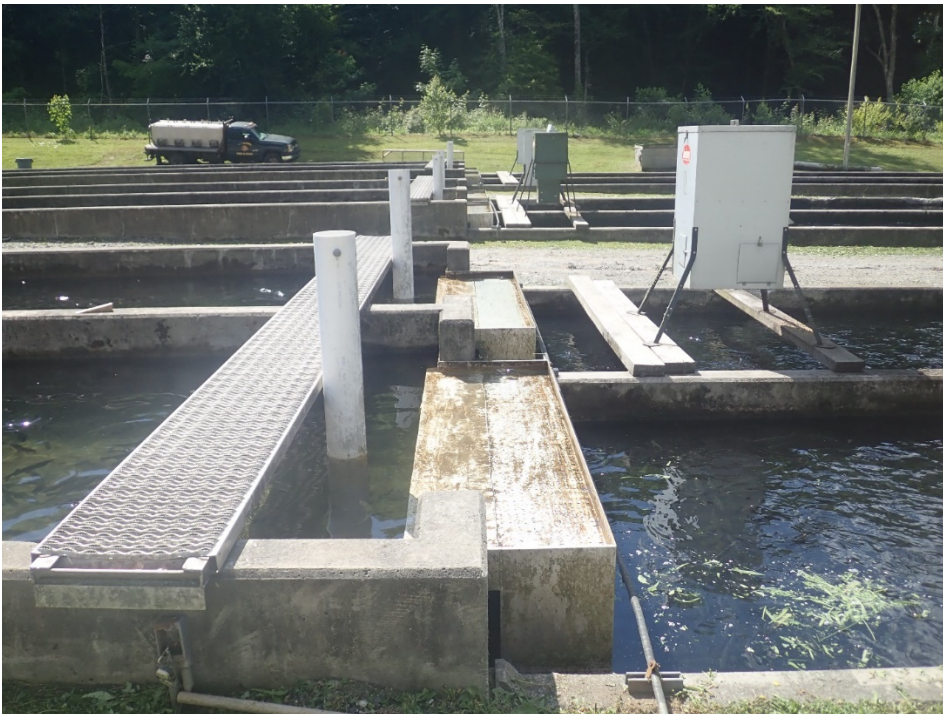
Fish are regularly sorted into size category so that each raceway contains approximately 8,000 – 10,000 lbs of fish. Feed is supplied to fish by automatic feeders (Photo 4) five times per day. At the time of inspection, the operations were about to switch to nighttime feeding as the days were becoming too warm for the fish.

*Photo 4. Time automated feeder boxes beside raceways.*

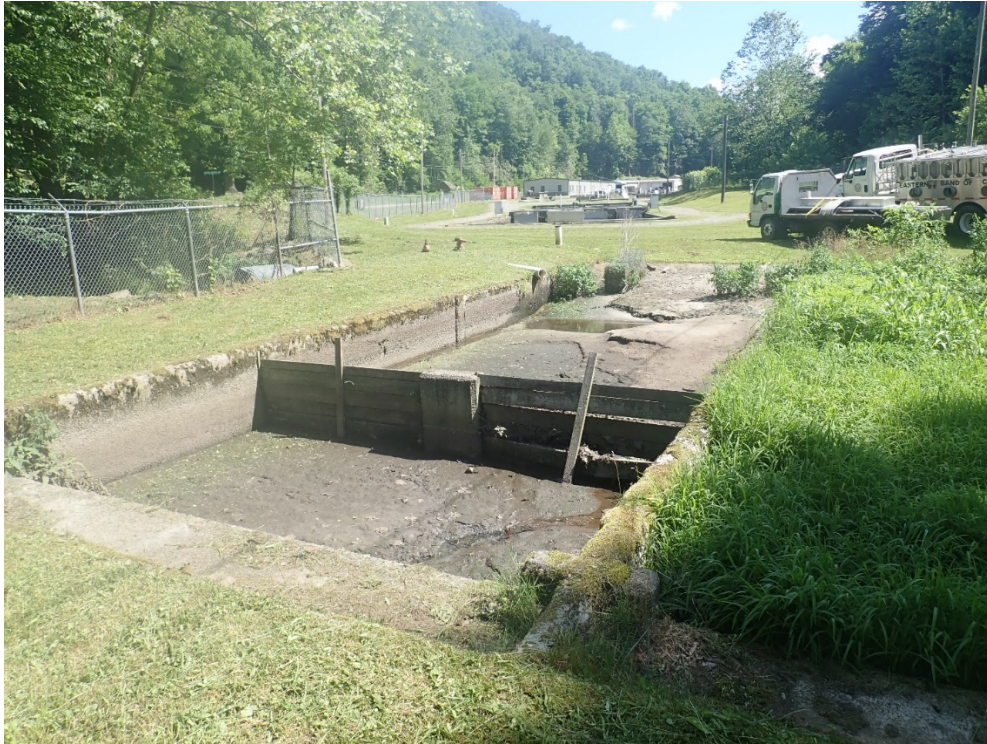
Water exits the final raceway directly into the Straight fork of the Raven Fork River. During high activity (e.g., cleaning, fish moving) effluent is routed to the settling pond (Photo 5). The settling pond is a 62'x19'8" concrete basin with a wooden baffle at one end to slow flow and retain solids. The original design of the system has two sedimentation chambers, but only one is active with the other used to store excess sediment emptied annually for the active pond. Wastes are

The removal of solids in the raceways appeared to be ongoing, with no buildup observed in quiescent zones. However, EPA observed a significant accumulation of solids in the settling pond. According to the operator, while the BMP Plan specifies that solids shall be removed from settling ponds annually, the pond had not been emptied since 2019 due to restrictions from COVID-19. Furthermore, wooden baffle structures in the pond had severe damage with one board broken in half (Photo 5). The EPA recommends that the facility promptly fix this board and empty the pond according to facility BMP Plan.

*Photo 5. Settling pond with raceways in background. Pond is shown with high sediment buildup. Wooden wall is broken on the right.*
