## **RCRA Inspection Report**

Nucor Steel Jackson, Inc.  
3630 Fourth Street  
Flowood, Mississippi 39232  
Rankin County

**COMPLIANCE EVALUATION INSPECTION PHOTOGRAPHS**

**February 14, 2024**

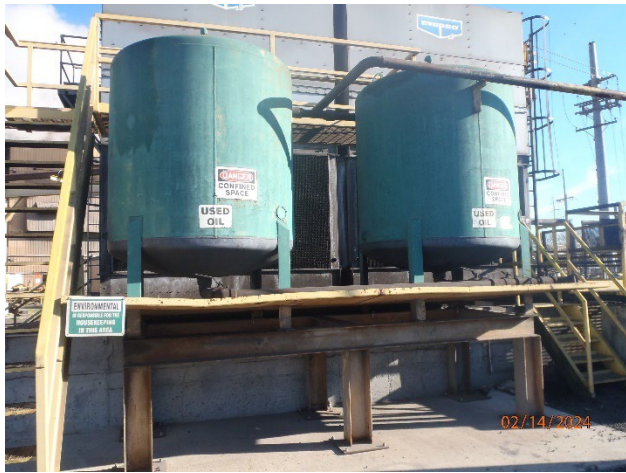
The tour began at the Roll Mill used oil tanks. The area contained two 1,000-gallon tanks sitting on a drain structure that feeds the water back into the pond with an oil skimmer (Pictures 1-2). Mr. Burton explained that process water from the mill enters the pond, is skimmed of oil, and the skimmed oil is pumped to the tanks. The oily water feeds into an oil water separator and then a water treatment system before being placed back as process water in the plant. The tanks separate any excess water from the oil and drains it back into the pond via the attached tray. The tanks were observed labeled. No issues were noted in this area.

Picture 1 – Roll Mill Used Oil Tanks

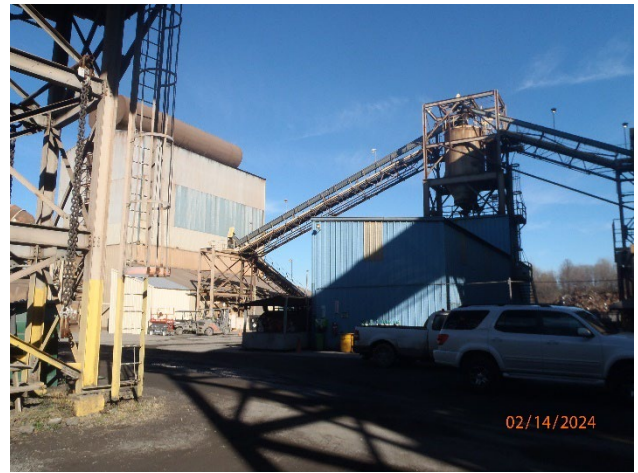
The inspectors then walked to the baghouses where the EAF dust is collected and stored until shipped off site for recycling or disposal. The Caster Baghouse and the Furnace Baghouse are separate buildings that share a silo (Pictures 4-10). The EAF dust is sent to either baghouse then

Picture 4 – Furnace Baghouse and Silo

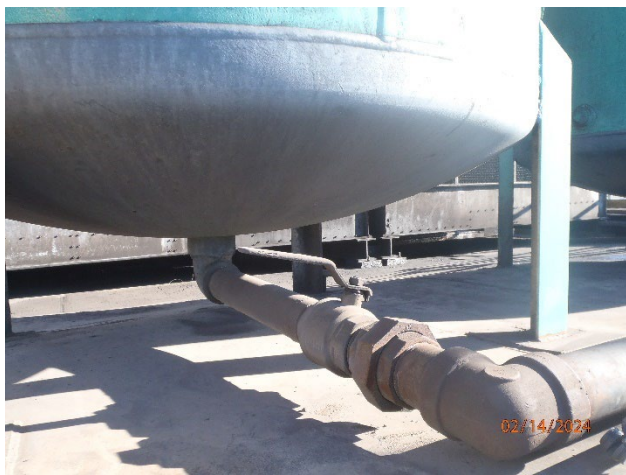
Picture 2 – Roll Mill Used Oil Tank drain structure to skimmer

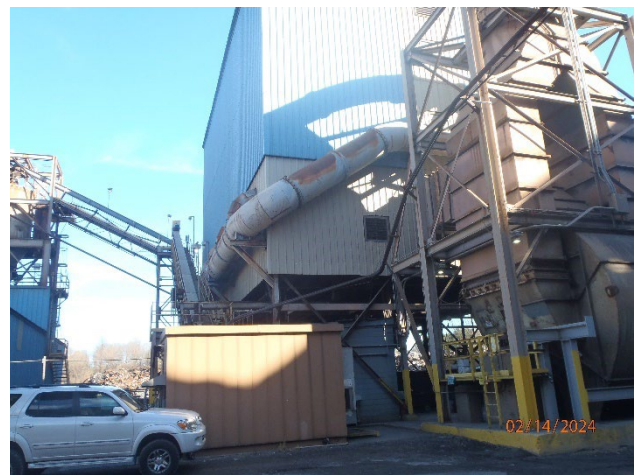
The Caster Baghouse has twelve hoppers that receive the EAF dust. The hoppers contain polyester filter bags that capture the EAF dust. The Furnace Baghouse has eight hoppers that contain fiberglass membrane filter bags. These bags allow for low drag which uses less energy to get the air through the filter bags. This baghouse is connected directly to the furnace and runs hotter, which requires a filter bag that can take the intense heat. Both baghouses were observed having good housekeeping, were regularly vacuumed and no spills were noted on the floor.

Picture 5 – Caster Baghouse

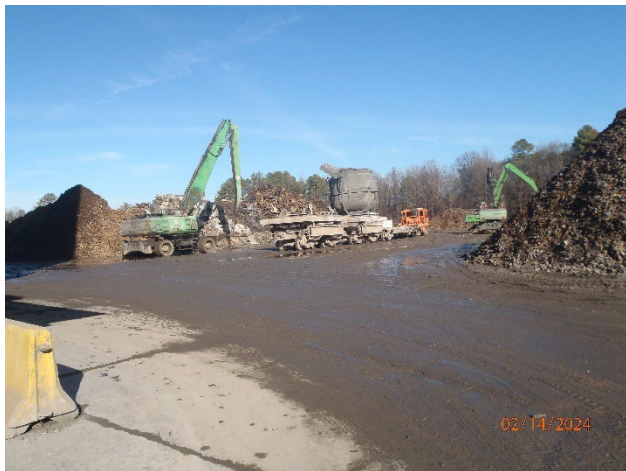
Mr. Burton explained the metal is separated into different grades and sizes. The inspectors observed piles of shredded, cut grade and turning steel (Picture 3). No issues were observed in this area.

Picture 3 – Scrap Yard

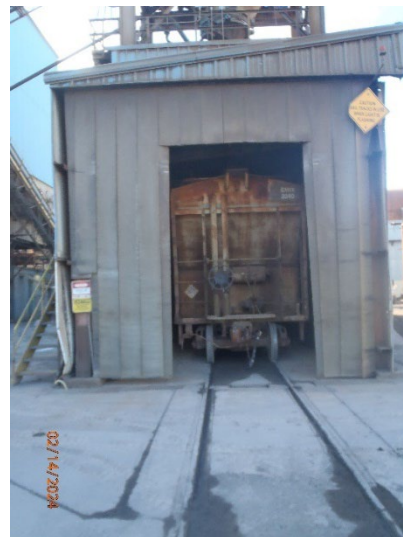
sent by auger into the silo. Inside the silo is a railcar with a magnetic hazardous waste label on the side that receives the EAF dust. The label was dated February 1, 2024, with the EPA hazardous waste code K061, and had a toxic placard. The railcar is shipped to Steel Dust Recycling in Millport, Alabama to reclaim the zinc. An eyewash and a spill kit were also observed in the Silo building.

Picture 6 – Silo Railcar CAA

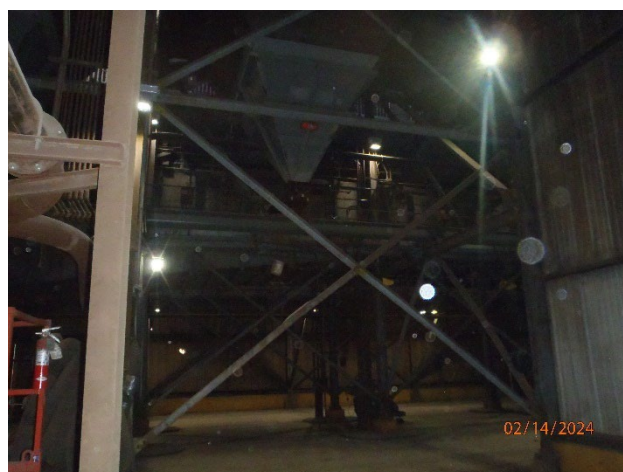
Picture 10 – Furnace Baghouse interior and hoppers

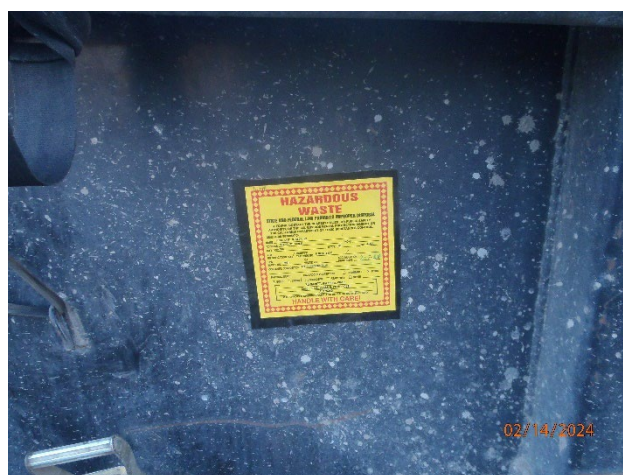
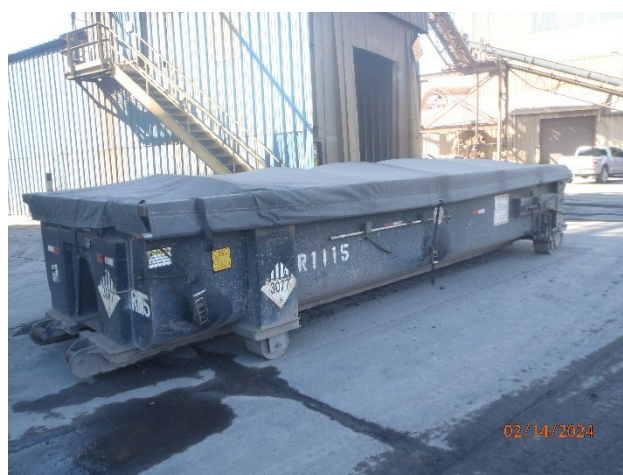
Between the Silo building and the Furnace Baghouse is a 20-cubic yard roll-off used to collect miscellaneous K061 clean up material and debris (Pictures 11-12). The roll-off was observed closed, labeled, and dated February 7, 2024. This roll-off will be shipped to Chemical Waste Management in Emelle, Alabama.

Picture 11 – Silo CAA Roll-off

Picture 12 – Silo CAA Roll-off

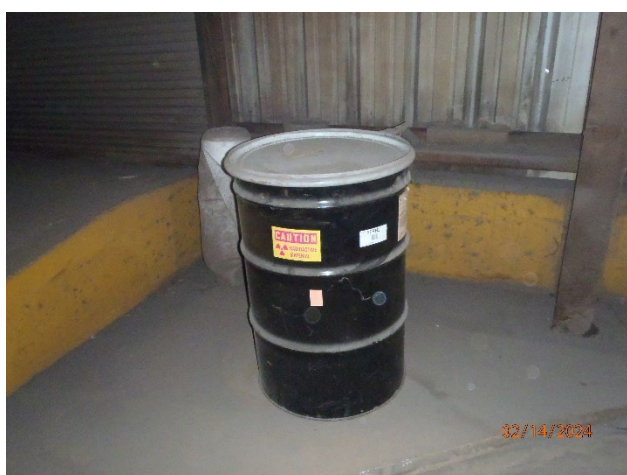
The Furnace Baghouse was also used as central accumulation area for storage of hazardous waste. However, at the time of the inspection no hazardous waste containers were observed in the area. The inspectors did observe a black 55-gallon container used to collect radioactive debris waste. The container was noted to be mostly empty.

Picture 9 – Furnace Baghouse CAA and radioactive container

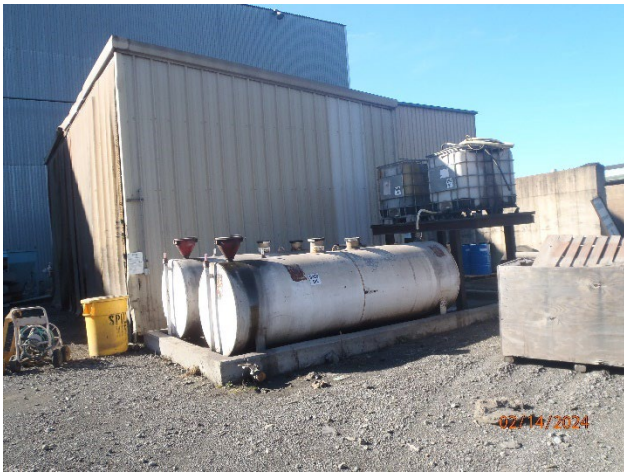
Outside of the Melt Shop was a used oil storage area with two 1,000-gallon double walled used oil storage tanks (Picture 13). The tanks sit inside a secondary containment area. The tanks have red funnels to add used oil and a gravity feed via piping connected to two 275-gallon totes. The tanks and totes were closed and labeled. No releases were noted in the secondary containment.

Picture 13 – Melt Shop Used Oil Storage

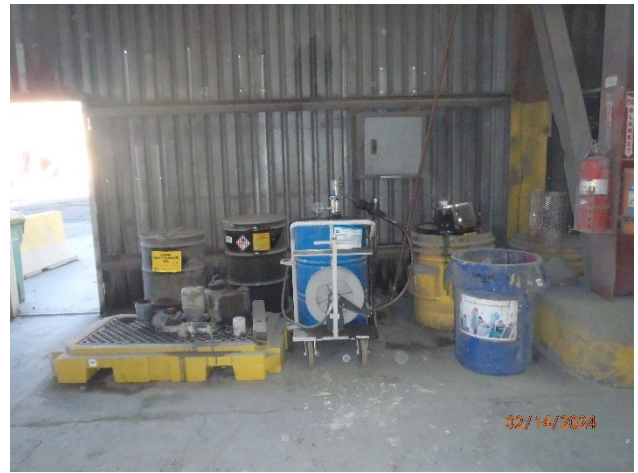
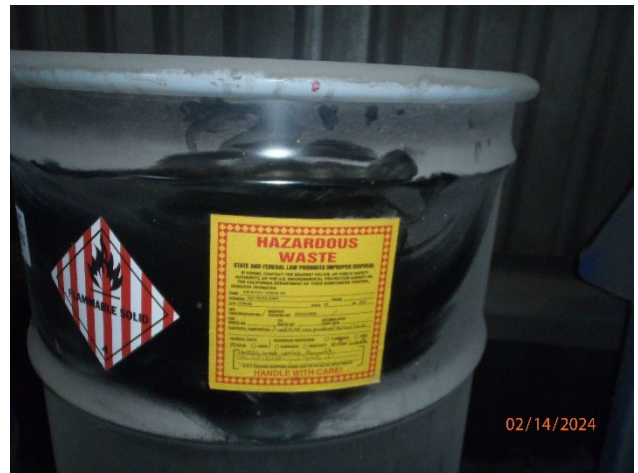
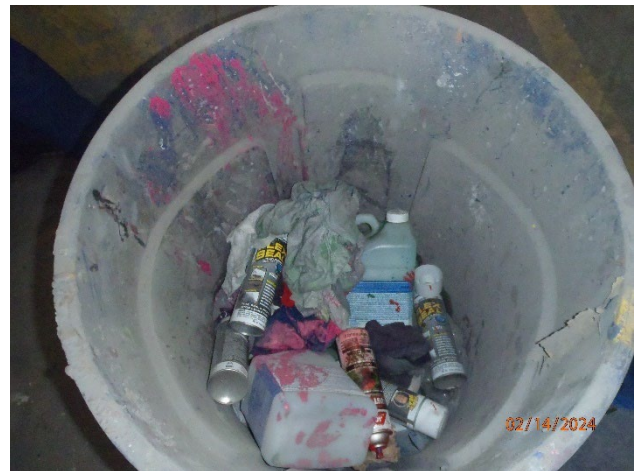
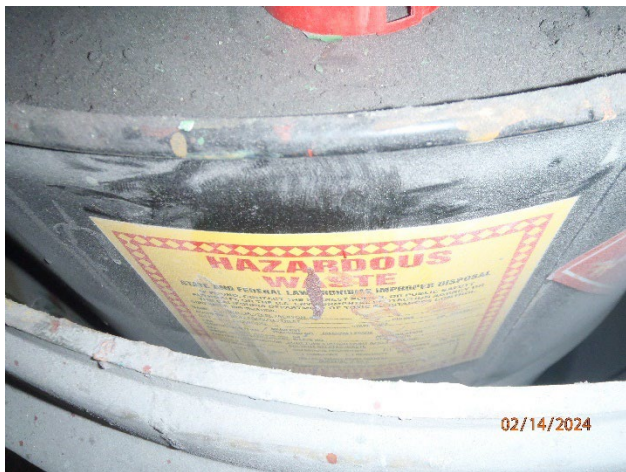
The maintenance area had a satellite accumulation area (SAA) with the following (Pictures 16-19):

- a spent aerosol can puncture station connected to a blue 55-gallon container;
- a 55-gallon container of punctured aerosol cans;
- a 55-gallon container of discarded Great Stuff aerosol cans;
- a 55-gallon container of excluded solvent contaminated wipes; and
- discarded used oil filters being drained on a secondary containment system grate.

The containers were observed closed and labeled. At the time of the inspection, the secondary containment grate for draining used oil filters was not labeled 'Used Oil'. Mr. Wynn immediately applied a label to the secondary containment and took a picture.

Picture 16 – Melt Shop Maintenance SAA

Picture 17 – Melt Shop Maintenance SAA spent aerosol cans.

Picture 18 – Melt Shop Maintenance SAA punctured aerosol cans

Picture 19 – Melt Shop Maintenance SAA aerosol puncture system label

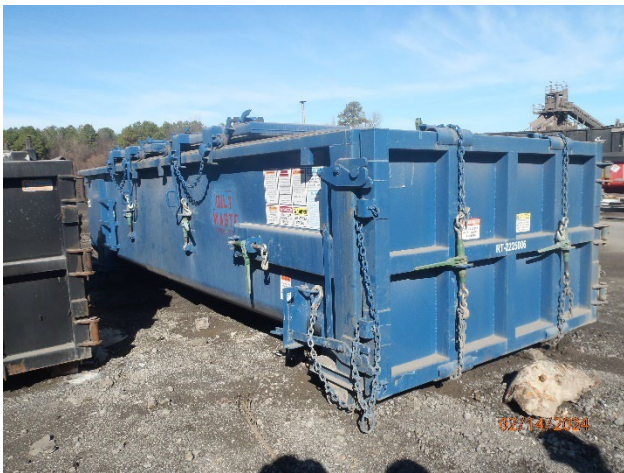
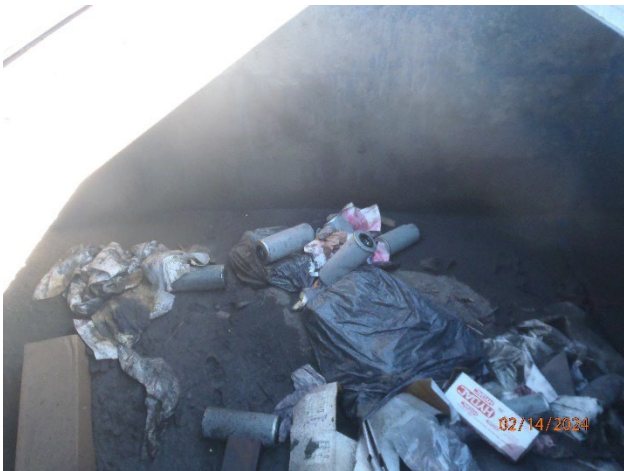
Near the used oil storage area was an oily waste dumpster that is used to collect oily debris, spent filters, and used personal protective equipment (Pictures 14-15). No free liquids are allowed in this 20-cubic yard roll-off. The inspectors observed that the roll-off was labeled and closed. No releases were noted around the roll-off.

Picture 14 – Melt Shop Oily Waste Roll-off

Picture 15 – Melt Shop Oily Waste Roll-off interior

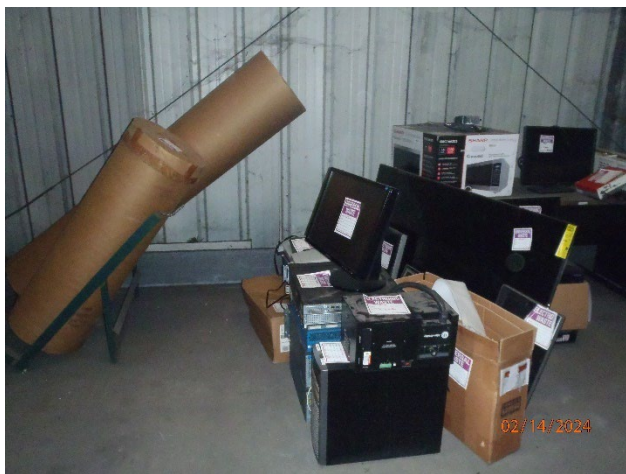
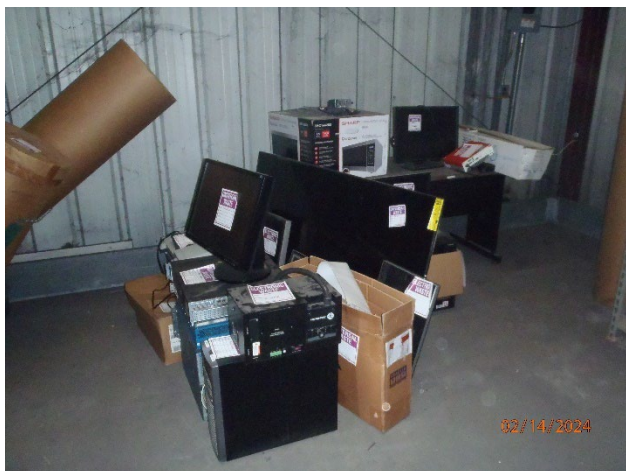
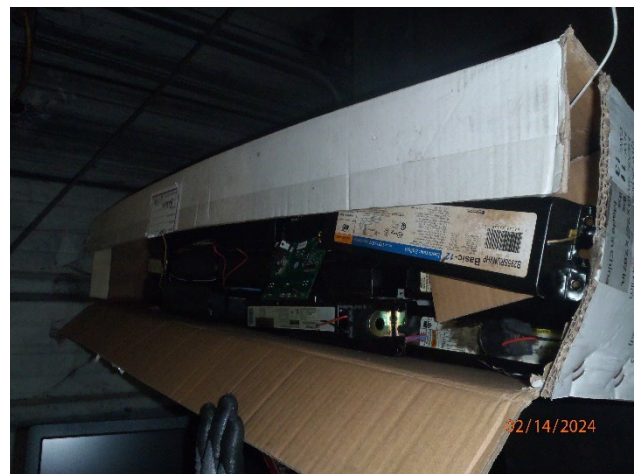
The inspectors toured the production areas in the Melt Shop, the Caster Mill, and the Rolling Mill where the billets are cut to order (Pictures 20-23). The inspectors were then taken to the universal waste storage area, a separate building outside of the Caster Mill. The inspectors observed two fiberboard boxes of spent lamps, the oldest container dated December 11, 2023; electronic waste consisting of monitors, computer equipment, etc. with the oldest date of December 9, 2023; and a box of spent ballasts with the date of December 7, 2023. All containers and discarded equipment were observed closed if applicable, labeled, and dated.

Picture 22 – Universal Waste Storage lamps label

Picture 20 – Universal Waste Storage

Picture 23 – Universal Waste Storage spent ballasts

Picture 21 – Universal Waste Storage electronic waste

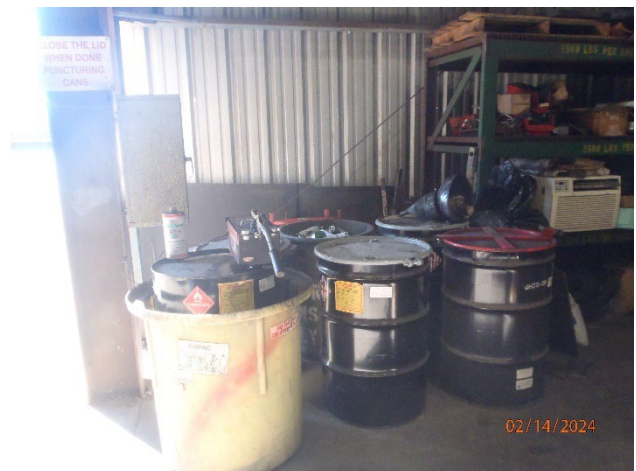
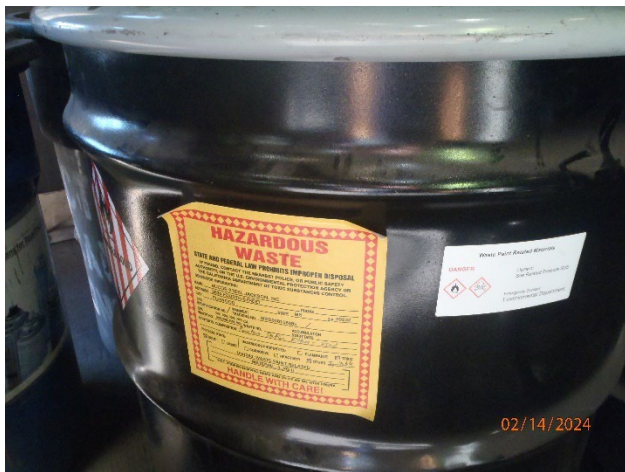
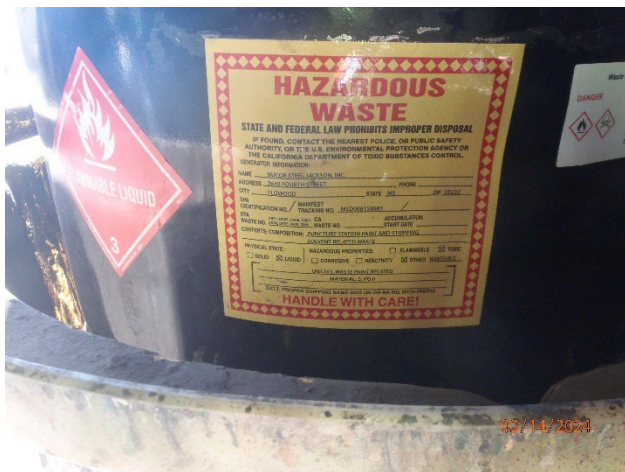
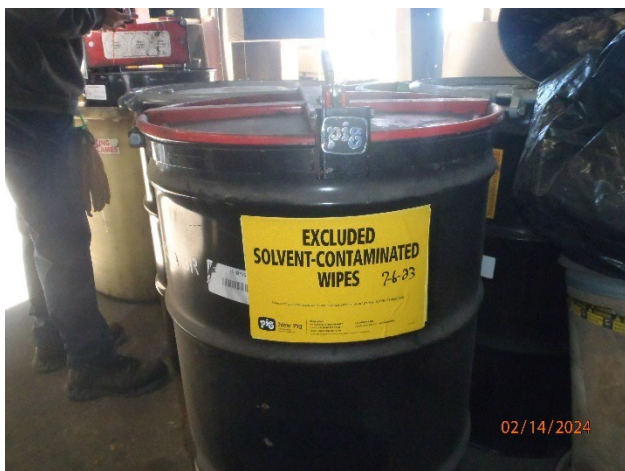
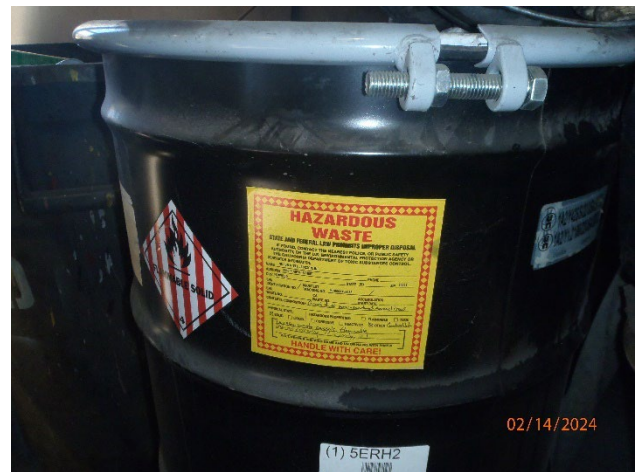
The maintenance area had a SAA with the following (Pictures 24-28):

- a spent aerosol can puncture station connected to a black 55-gallon container inside a secondary containment;
- a 55-gallon container of punctured aerosol cans;
- a 55-gallon container of discarded Great Stuff aerosol cans;
- a 55-gallon container of excluded solvent contaminated wipes; and
- a 55-gallon container of spent paint filters.

The containers were observed closed and labeled.

Picture 24 – Roll Mill Maintenance SAA

Picture 25 – Roll Mill Maintenance SAA spent aerosol cans

Picture 28 – Roll Mill Maintenance SAA

Picture 26 – Roll Mill Maintenance SAA aerosol puncture system

Picture 27 – Roll Mill Maintenance SAA solvent contaminated wipes

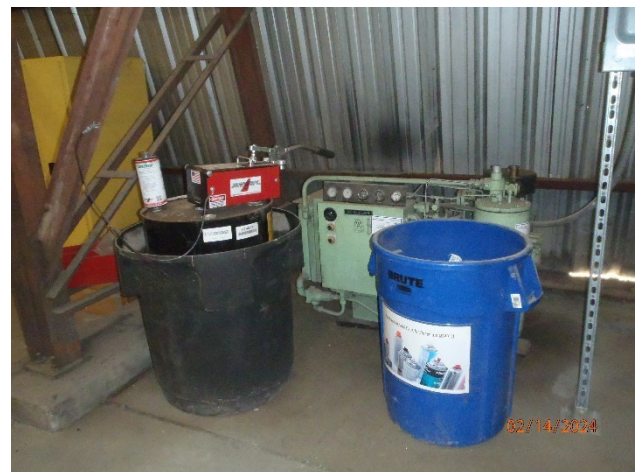
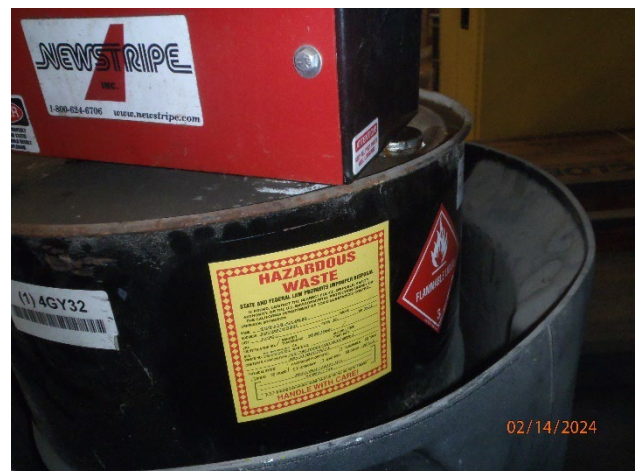
The warehouse is a separate building used for equipment and supply storage for the facility. The inspectors observed a spent aerosol can puncture station connected to a black 55-gallon container inside a secondary containment and a blue trash can have punctured aerosol cans to be recycled (Pictures 29-30). The container was observed labeled and closed.

Picture 29 – Warehouse Aerosol Puncture System SAA

Picture 30 – Warehouse Aerosol Puncture System SAA label
