REPORT OF COMPLIANCE EVALUATION INSPECTION  
(INDUSTRIAL STORMWATER)

**Wichita Iron and Metals**  
**922 W Merton P.O. Box 13021**  
**Wichita, Kansas 67213**

**May 22 and 23, 2024**

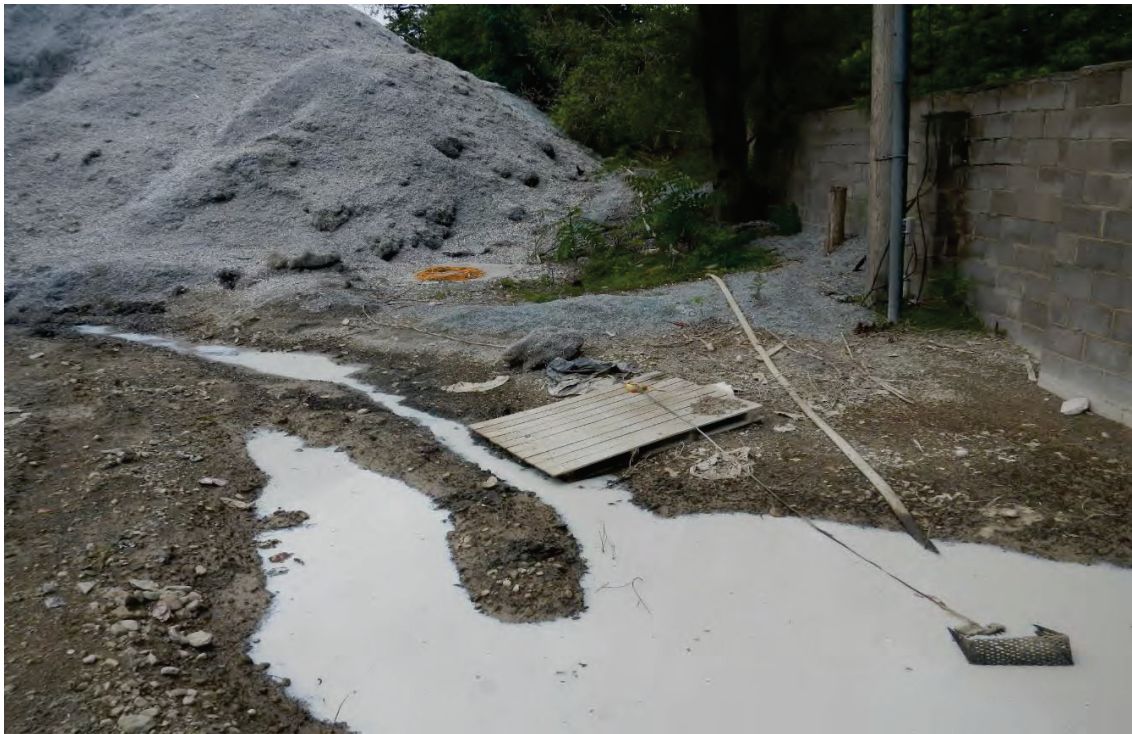
1. At the time of the inspection, I did not observe stormwater discharging from the site.
2. I noticed significant amount of murky water caused by stormwater running off the shredded pile of aluminum (photos 3-7). There was a hose with screen appeared to be used to transfer the murky water to behind the pile. Mr. Gonzalez indicated that they use a pump to remove the murky water to a larger area behind the pile (photo #7) to avoid water budling and for the water to be absorbed by the ground .

**Photo 6 Murky water caused by stormwater runoff off the aluminum pile**

Wichita Iron and Metals should develop and implement stormwater best management practices and should contact KDHE to investigate the applicability of the National Pollutant Discharge Elimination System (NPDES) for Stormwater Runoff from Industrial Activity.

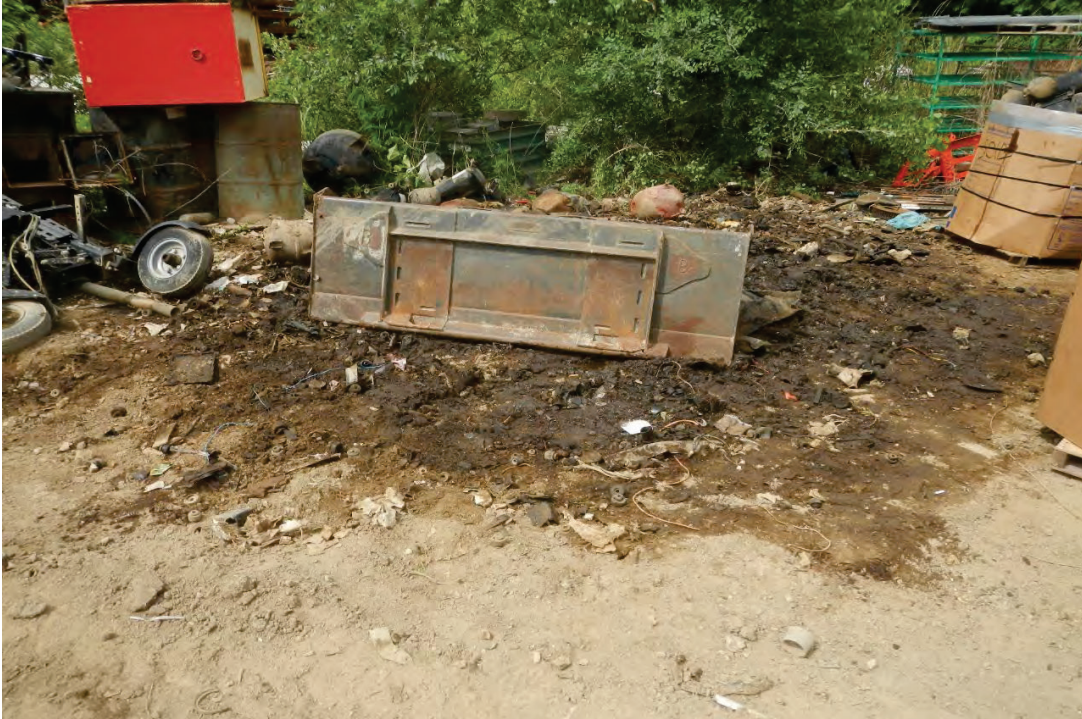
3. I issued Notice of Preliminary Findings number 2 (NOPF #2) because I observed significant ground discolorations throughout the yard, especially in the vicinity of the areas of the salvaged air compressors area (photo #10), salvaged forklifts (photo 13), salvaged drums (photo #17), and salvaged engine blocks (photo #16).

**Photo 10, Significant ground discoloration around the salvaged air compressors**

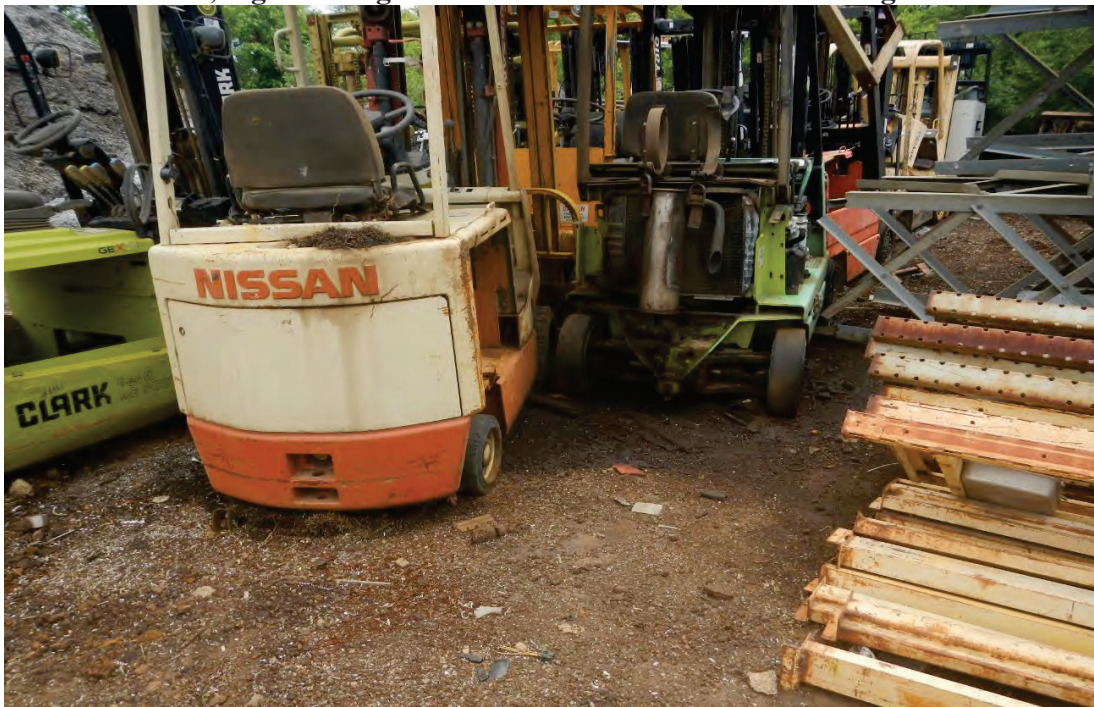
**Photo 1, Significant ground discoloration around the salvaged forklifts**

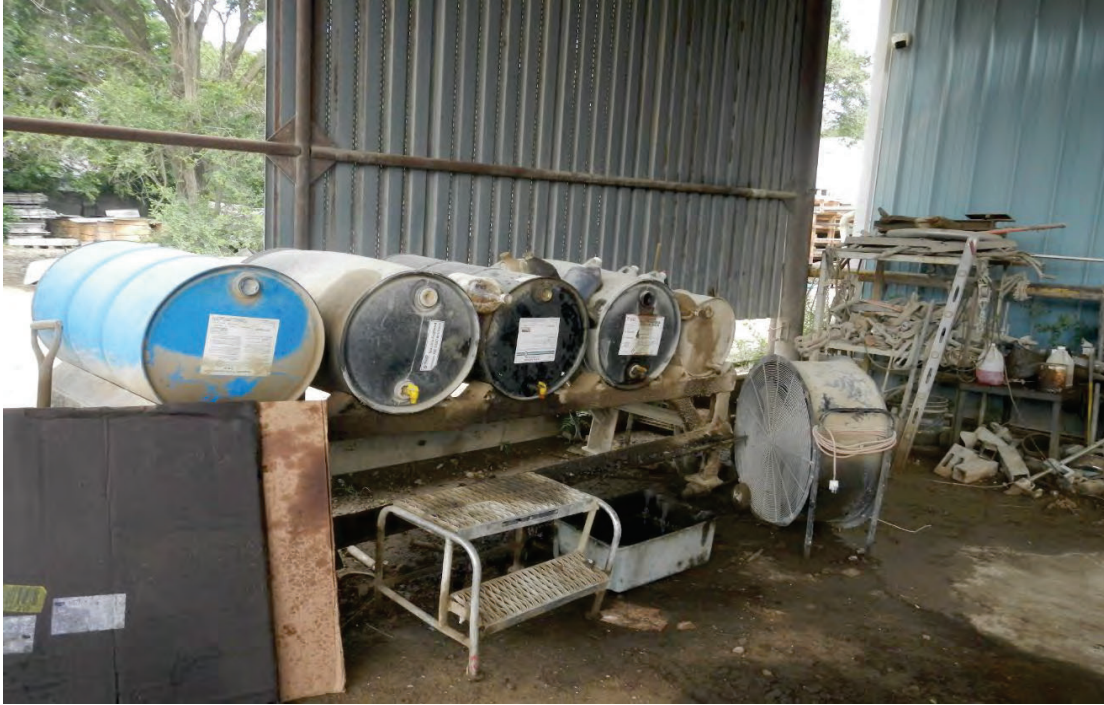
4. The area where the drums of fluids are stored shows improper handling of fluids and significant ground discoloration. The area is under a roofed structure but also can be exposed to stormwater due to the poor enclosure. I noticed there was a sump pump. Mr. Gonzalez was not sure where the sump pump drains to. But he thinks the pump discharges to the sanitary sewer.

**Photo 18, Poor handling of petroleum fluids causing significant ground discoloration**

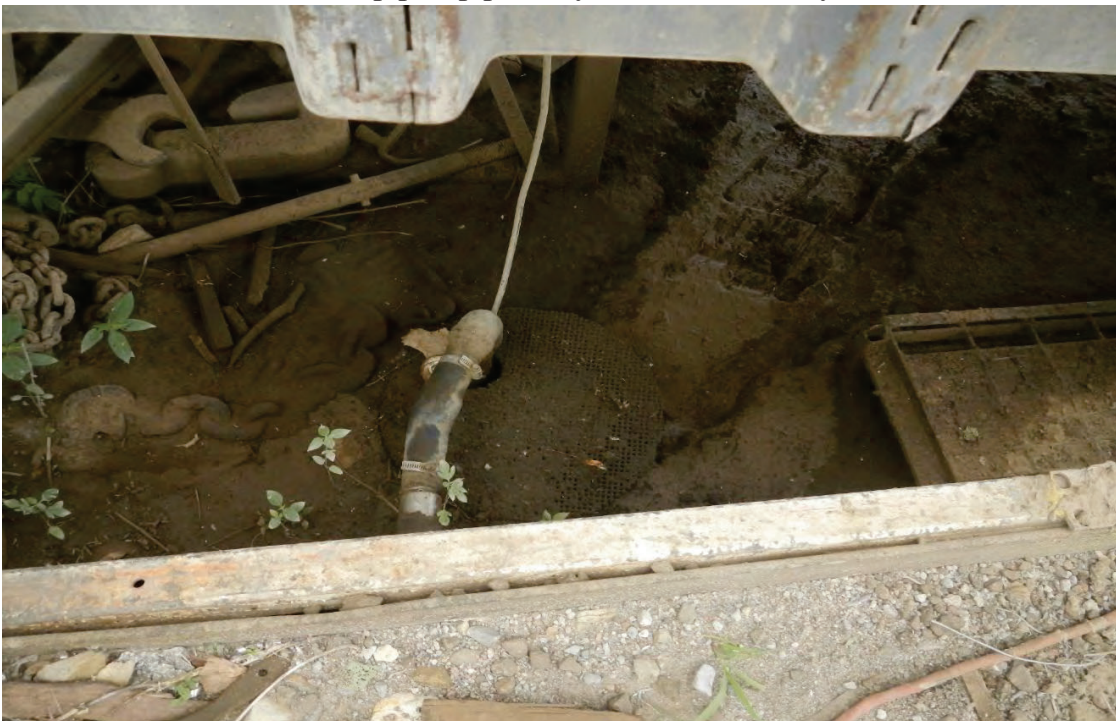
Soon after, Mr. Gonzalez escorted me on a visual inspection of the site. During the site walkthrough I observed the outdoor storage yard, several spots of ground discoloration, and fluid storage tanks area located within roofed structure. We also observed the sump pump that discharge to the city sanitary (photos 20 and 21).

**Photo 21, Sump pump possibly leadn the sanitary sewers**
