**Region 6 - Enforcement & Compliance Assurance Division**  
**INSPECTION REPORT**

| Inspection Date(s): | 3/4/2025 | |
| Company Name: | <b>Lamkin Oil, Inc.</b> | |
| Facility Name: | <b>Linkous A-4 Tank Battery</b> | |

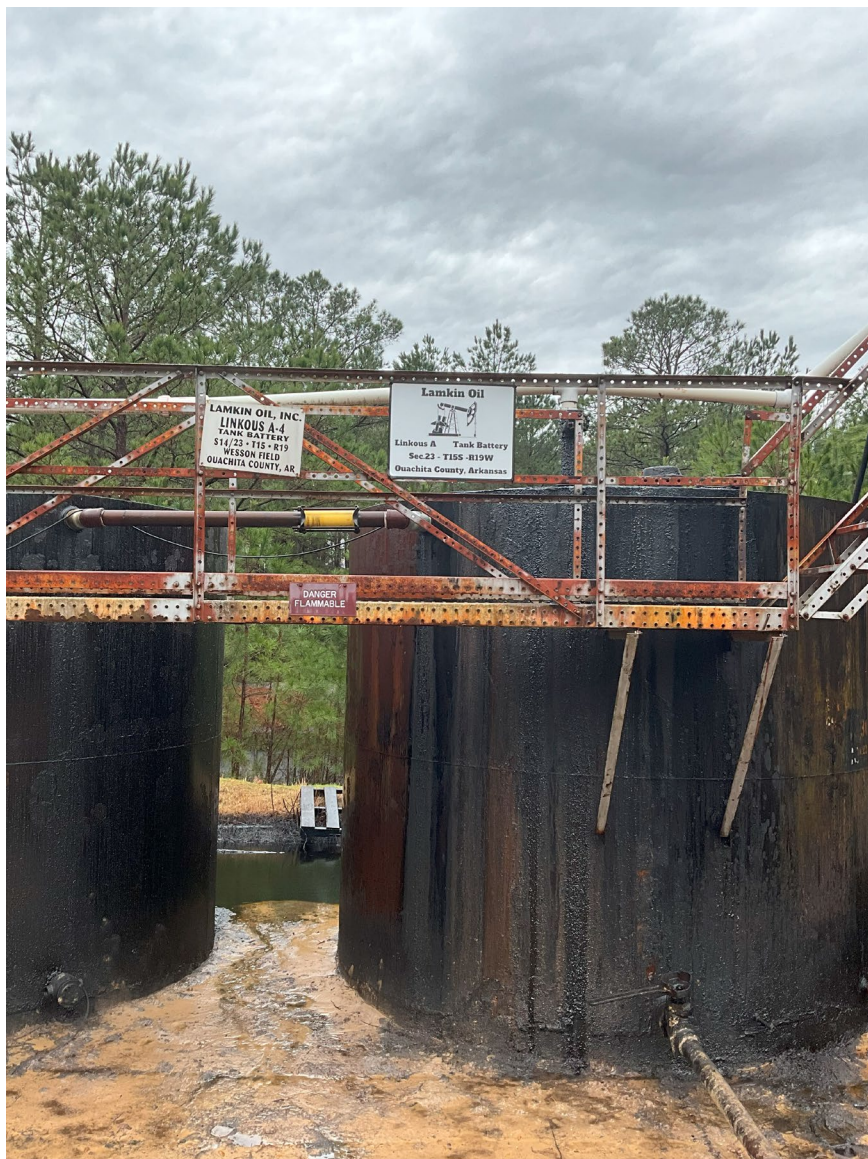
Photo No. 1

**Description:** This photo was taken looking southwest and shows the facility sign.

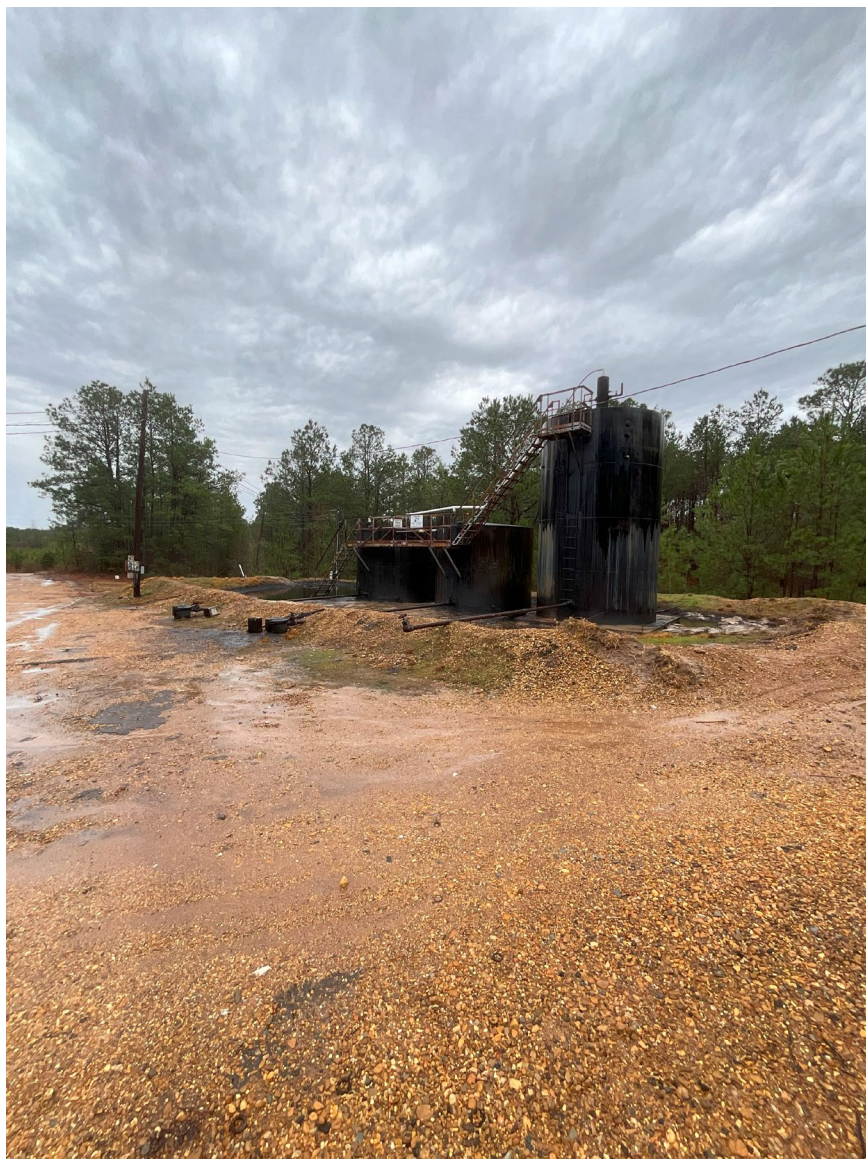
Photo No. 2

I observed missing catchment buckets for load lines outside of secondary containment, see photo No. 2.

**Description:** This photo was taken looking south and shows an overview of the facility.

Inspector will conduct follow-up phone calls with the company representatives over the coming weeks and months to ensure areas of concern are properly addressed.

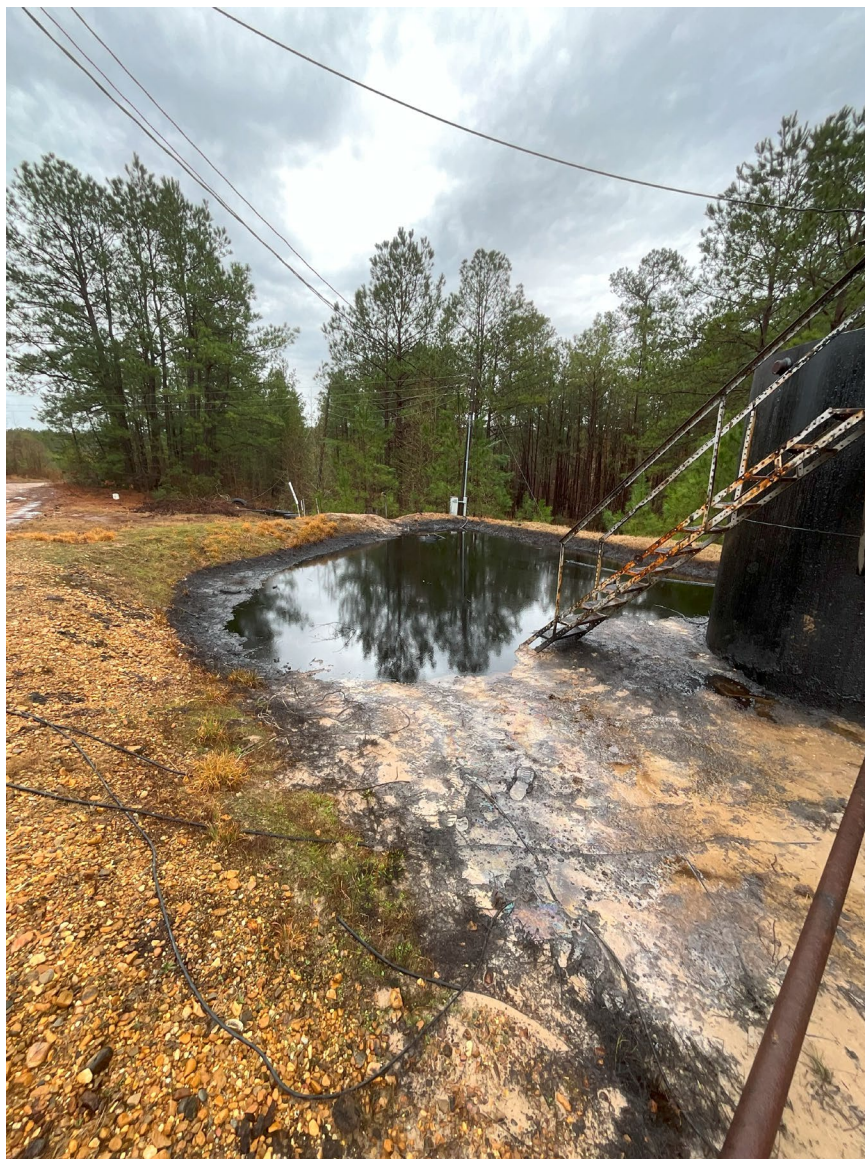
Photo No. 3

I observed loose oil inside secondary containment as well as a low spot in the secondary containment berm, see photo No. 3.

**Description:** This photo was taken looking west and shows loose oil inside secondary containment as well as a low spot in the secondary containment berm.

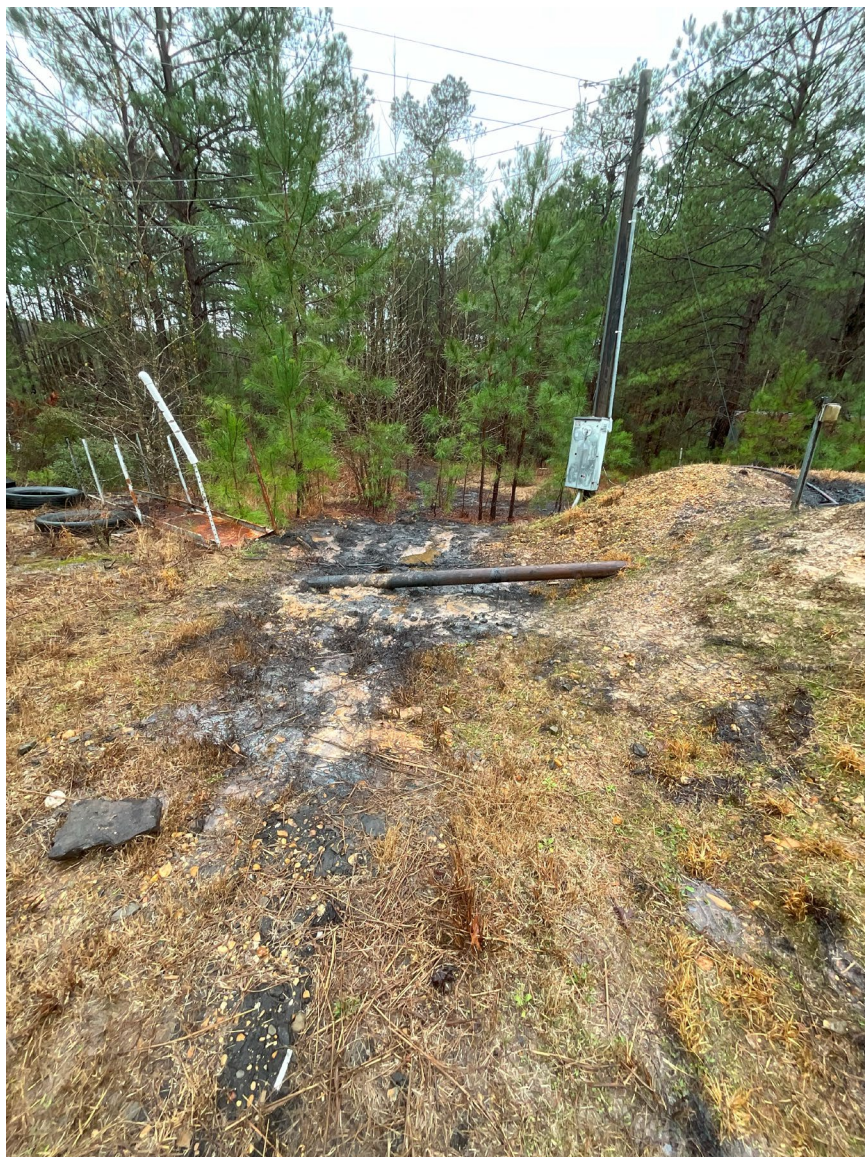
Photo No. 4

I observed loose oil outside of secondary containment near the low spot in the secondary containment berm, see photo No. 4.

No closing conference was held due to no Lamkin Oil, Inc. staff being present during the inspection. Areas of concern at the time of the inspection include no catchment buckets on the load lines outside of secondary containment, low spot in the secondary containment berm, and loose oil outside of secondary containment.

**Description:** This photo was taken looking southeast and shows loose oil outside of secondary containment near the low spot in the berm.
