Battelle Field Sampling Procedures Review. Columbus  
Georgia City Survey regarding Empirical Human  
Exposure Assessment. Multi-City Study

**August 3, 1999**

### Review Objective

The objective of the on-site review was to observe the sampling and handling techniques used by Battelle during the Columbus, Georgia city survey for appropriateness and completeness within the context of the Multi-City Human Exposure Assessment Study (MCHEAS).

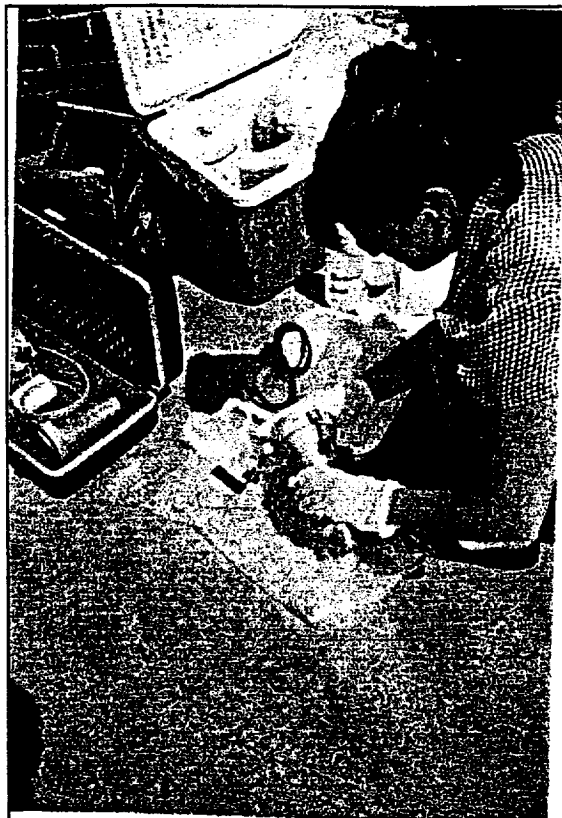
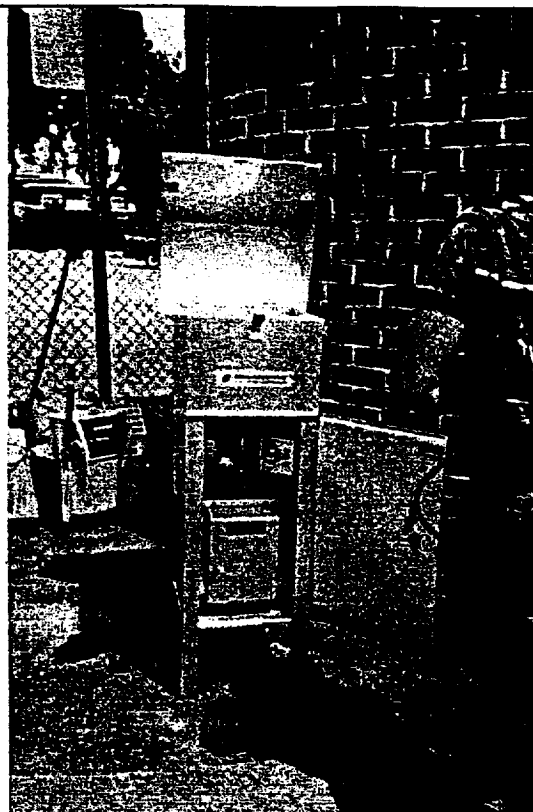
Urban Air Sampler  
Day 1, Set-Up

After traveling to Columbus and meeting Chief Schmidt, the Ambient Urban Air Sampler was set up. The sampler was set up on the ground near a wash area behind Fire Station #1 located at 201 10<sup>th</sup> Street. See the scanned images of the sampling location in the photograph section. Initially there was trouble getting the unit to operate; improper power connection. No timer switch was shipped with the sampler therefore one had to be purchased. After a switch was purchased they went ahead with the set-up. According to the QAPP; the sampler was set up at 15:00 hours  $\pm$  three hours (start time 16:20 hours), an initial totalizer reading was recorded, and the sampler was set to run 12 hours. The coordinates of the sampler location were recorded based on a hand held Global Positioning System (GPS).

**Reviewer Comments:** The initial troubles were resolved quickly and effectively, documentation was thorough, personnel wore disposable gloves while handling critical components of sampling train, and aluminum foil wrapping was in place on pre-cleaned parts.

Several specific sampling set-up requirements were not followed (section 11.3 in TO-13). The sampler was not set-up at least 2 meters from any obstacle (11.3.2). The sampler was placed approximately one foot away from a wall which could cause a flow obstruction. The sampler was not equipped with an exhaust hose to prevent recycling of air into the sample head (11.3.2). A single point flow check was not performed as described in section 11.2.3 of TO-13. Flow rates were varied from 55, 50, 40, 30, and 20 inches of water using the voltage variator during set-up which is incorrect. It appeared that the five point flow variator adjustments were somehow thought to be the calibration procedure described in section 11.2 of TO-13. A thorough review of TO-13 and TO-13A are recommended prior to conducting any further ambient air testing relative to this study.

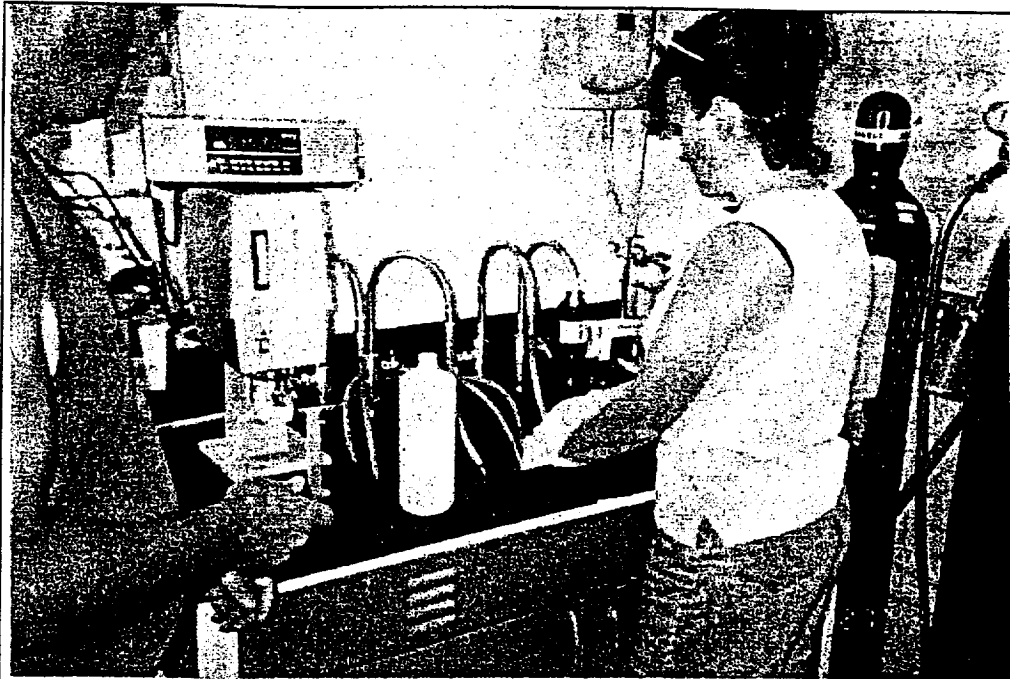
Water Treatment Plant Outlet Day 2 Event #3

**Event #3 - Water Treatment Plant Outlet:** A tap water sample was collected at 09:42 hours from the final treated water. According to the QAPP; replicate samples of the final treated water were collected in pre-cleaned one liter polyethylene bottles, labeled, and sampling information recorded on data sheets. The coordinates of the sampling location were recorded based on a hand held GPS. See the scanned images of the sampling location in the photograph section.

**Reviewer Comments:** Field data documentation was thorough, and personnel wore disposable gloves while handling the samples. There was a short piece of flexible tubing attached to the faucet where the samples were collected. Water runs continually into the sink located in the test lab from several different treatment steps. There is concern about possible residual accumulation of FC's onto the surface of the flexible tubing. Some discussions regarding this concern are warranted. For future reference, it may be advisable to remove any such tubing before sampling.

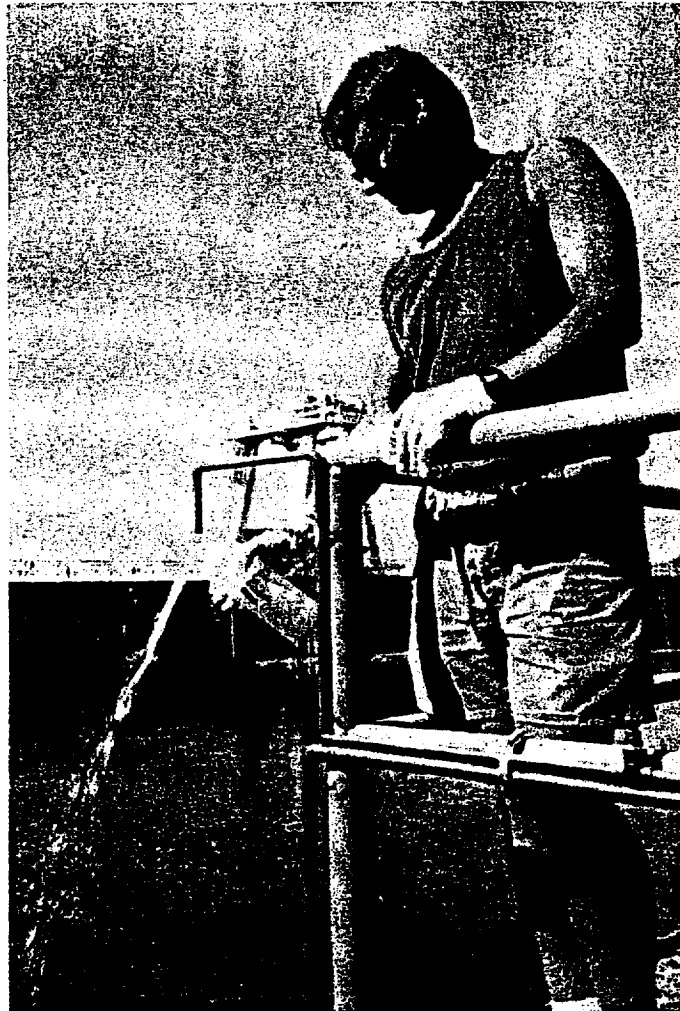
**Water Treatment Plant Inlet Day 2 Event # 4**

**Event #4 - Water Treatment Plant Inlet:** A water sample was collected at 10:16 hours from a slip stream off the pump house main that supplies the water treatment plant. According to the QAPP; replicate samples of the inlet water were collected in pre-cleaned one liter polyethylene bottles, labeled, and sampling

**Reviewer Comments:** Field data documentation was thorough, and personnel wore disposable gloves while handling the samples. The water source is Oliver Lake that has formed behind Oliver Dam located on the Chattahoochee River.

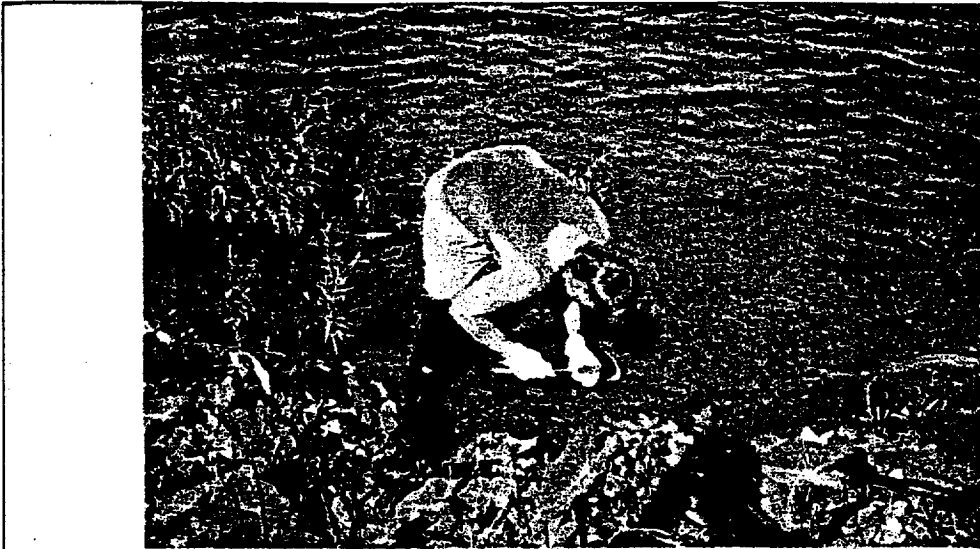
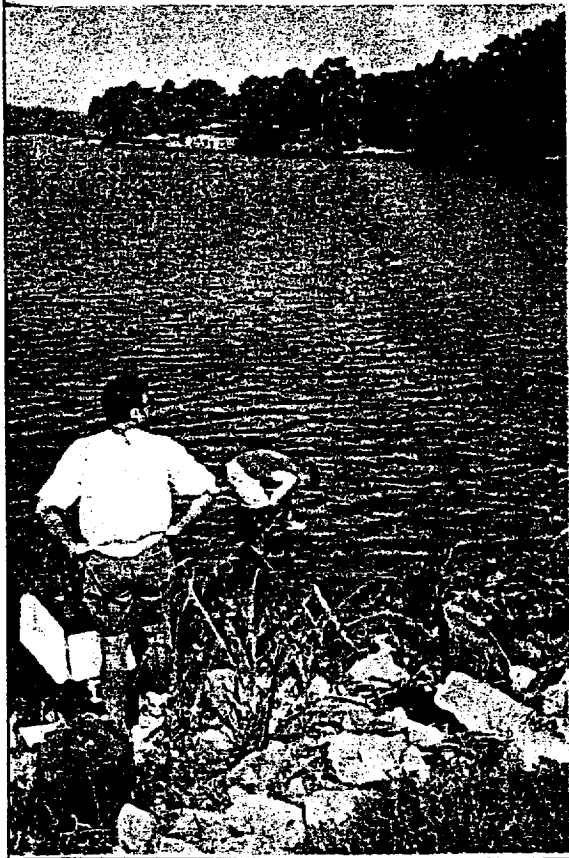
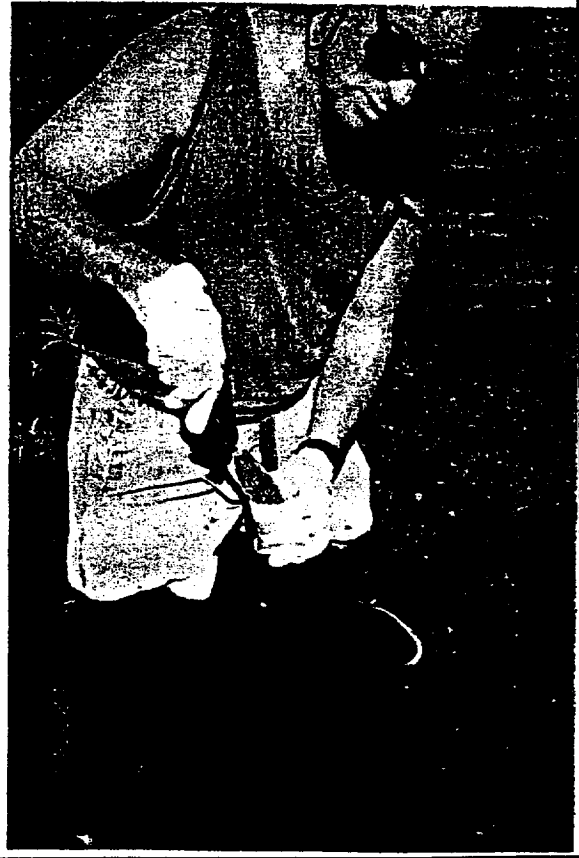
**Drinking Water Source Day 2 Event # 7 and # 8**  
**Oliver Lake, Chattahoochee River**

**Event # 7 and # 8 – Oliver Lake Surface Water:** Surface water and sediment samples were collected at 11:05 and 11:10 hours respectively from a bay area near Roaring Branch River south of the Municipal Marina. Sediment samples were collected near the water/shore boundary using a pre-cleaned stainless steel spoon. According to the QAPP; replicate samples of the surface water and sediment were collected in pre-cleaned polyethylene bottles, labeled, and sampling information recorded on data sheets. The coordinates of the sampling location were recorded based on a hand held GPS. See the scanned images of the sampling location in the photograph section.

**Reviewer Comments:** Field data documentation was thorough, and personnel wore disposable gloves while handling the samples. The water source is from Oliver Lake that has formed behind Oliver Dam located on the Chattahoochee River. The surface water and sediment samples were collected by wading into the shallows near shore. The water samples were collected while remaining still so as not to stir sediment from the bottom.

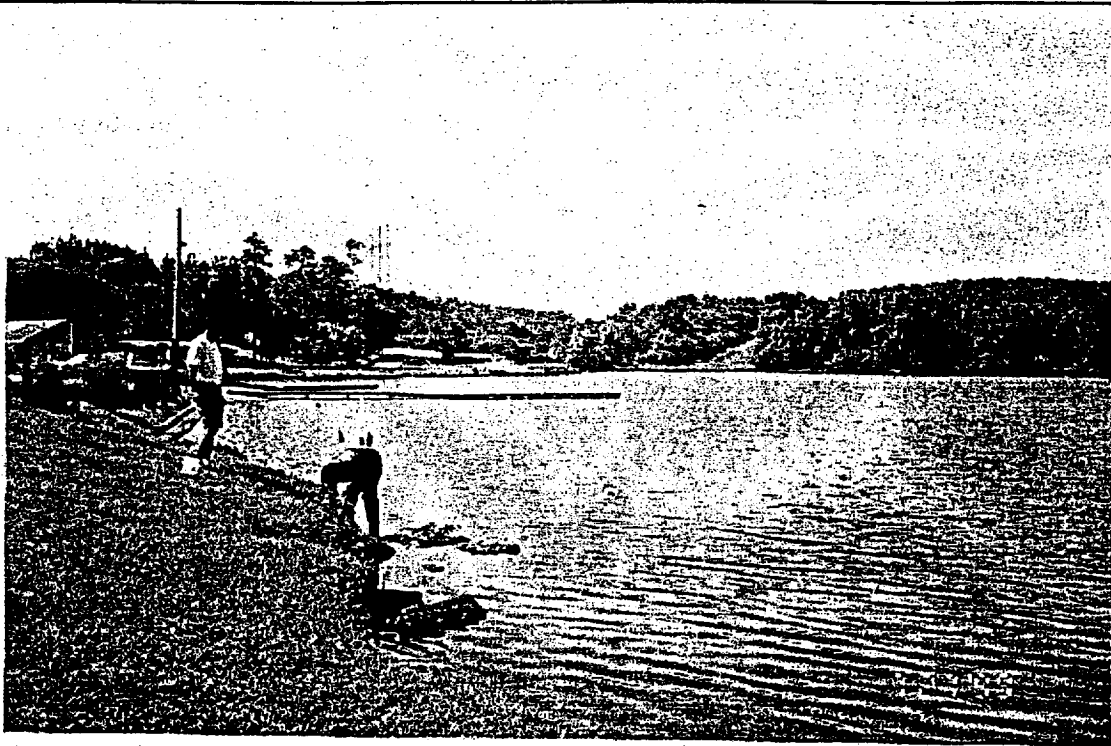
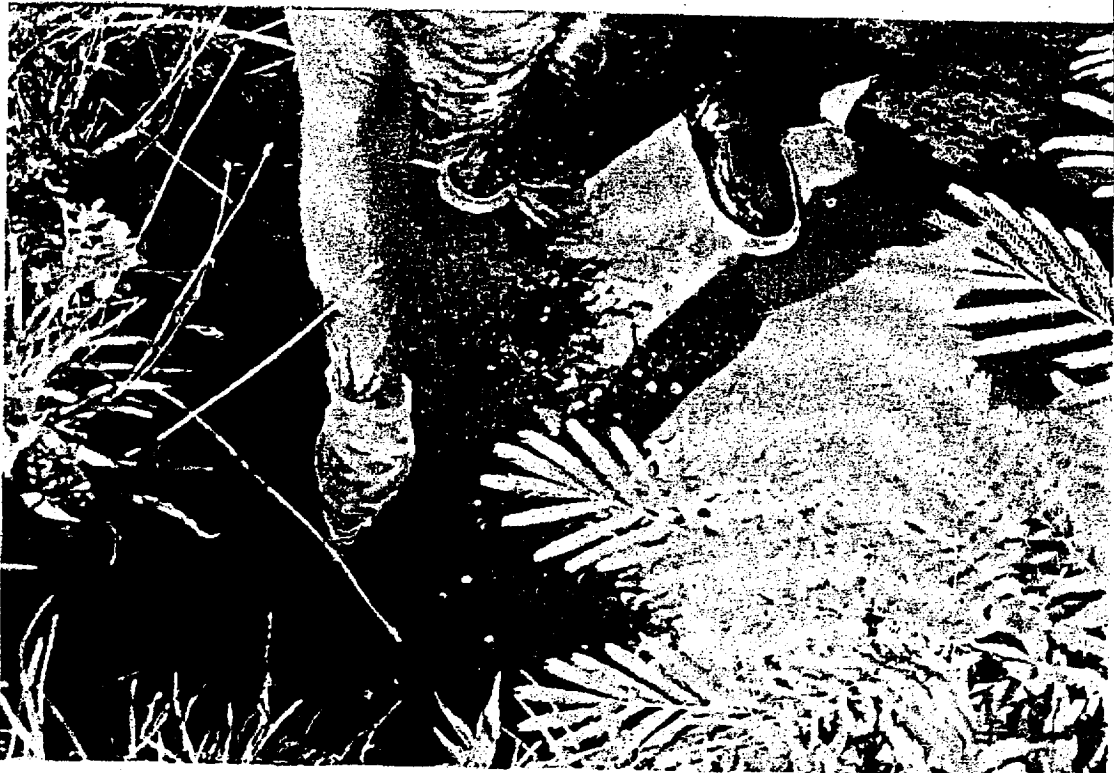
**Drinking Water Source Day 2 Event # 9 and # 10**  
**Oliver Lake, Chattahoochee River**

**Event # 9 and # 10 – Oliver Lake Surface Water:** Surface water and sediment samples were collected at 11:15 and 11:20 hours respectively from a bay area near Roaring Branch River north of the Municipal Marina. Sediment samples were collected near the water/shore boundary using a pre-cleaned stainless steel spoon. According to the QAPP; replicate samples of the surface water and sediment were collected in pre-cleaned polyethylene bottles, labeled, and sampling information recorded on data sheets. The coordinates of the sampling location were recorded based on a hand held GPS. See the scanned images of the sampling location in the photograph section.

**Reviewer Comments:** Field data documentation was thorough, and personnel wore disposable gloves while handling the samples. The water source is Oliver Lake that has formed behind Oliver Dam located on the Chattahoochee River. The surface water and sediment samples were collected by wading into the shallows near shore. The water samples were collected while remaining still so as not to stir sediment from the bottom.

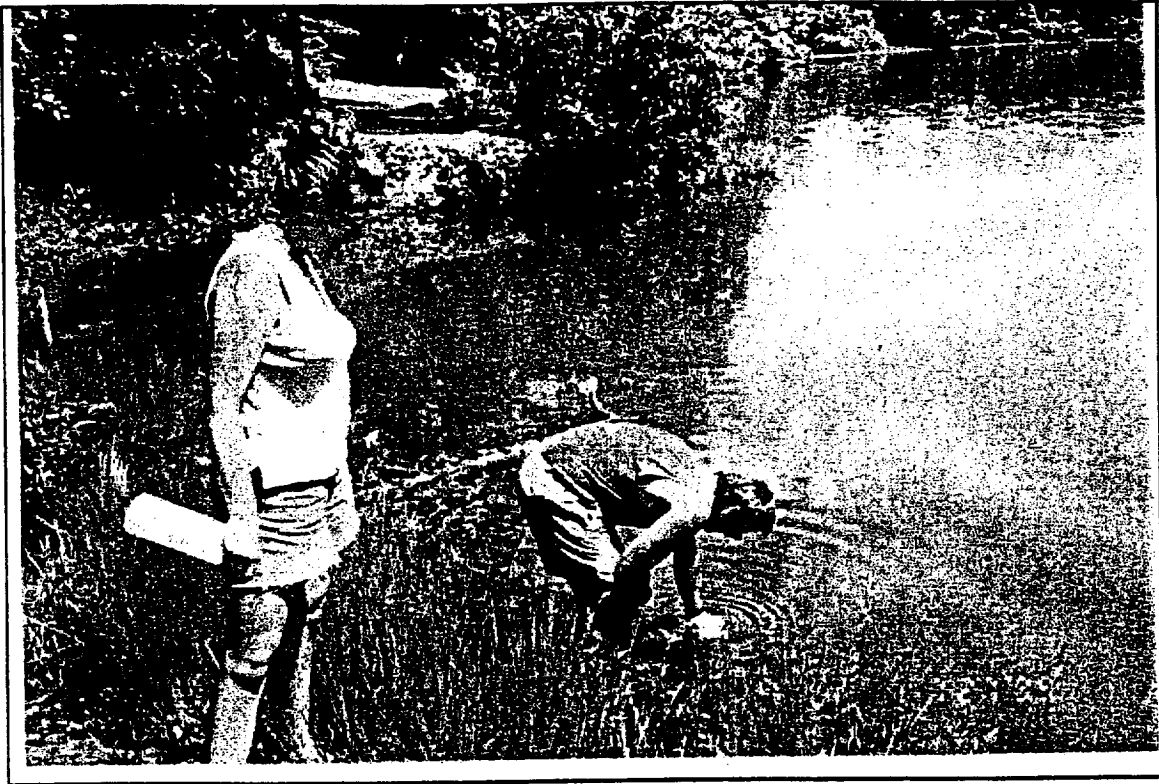
**Quiet Water Day 2 Event # 12**

**Event # 12 – Quiet Water Sample:** A quiet water sample was collected at 12:10 hours from a pond located on private property to the east of Highway 219 near Hieferhorn Creek. Permission was given to sample from the pond. There was a weir structure to allow overflow directly into Hieferhorn Creek if water levels reached the weir elevation. There was a slight trickle of water overflowing the weir at the time of sampling. According to the QAPP; replicate samples were collected in pre-cleaned one liter polyethylene bottles, labeled, and sampling information recorded on data sheets. The coordinates of the sampling location were recorded based on a hand held GPS. See the scanned image of the sampling location in the photograph section.

**Reviewer Comments:** The surface water sample was collected by wading into the shallows near shore. The water sample was collected while remaining still so as not to stir sediment from the bottom. Field data documentation was thorough, and personnel wore disposable gloves while handling the samples.

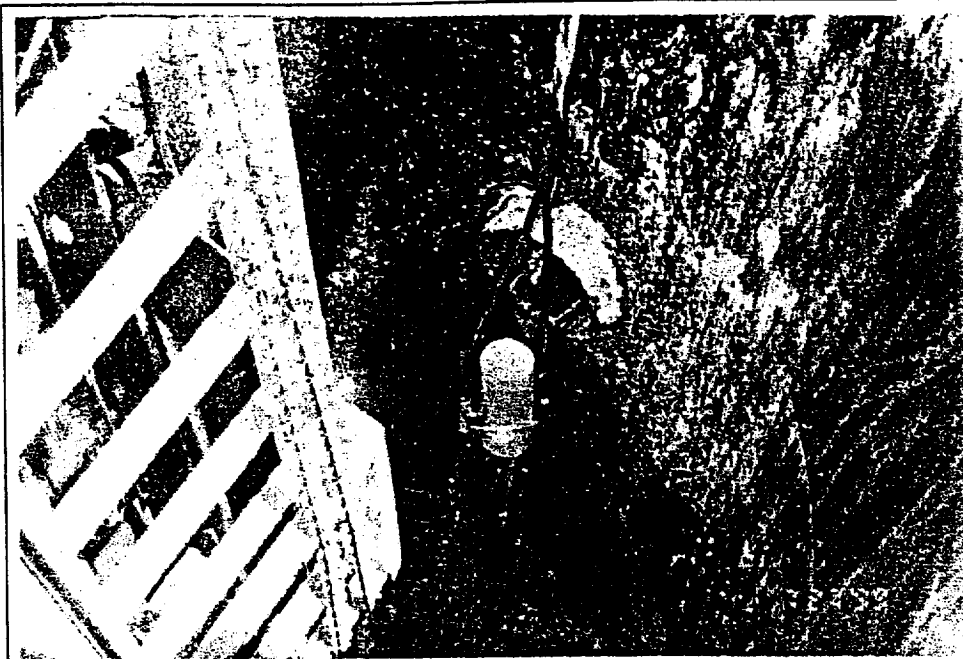
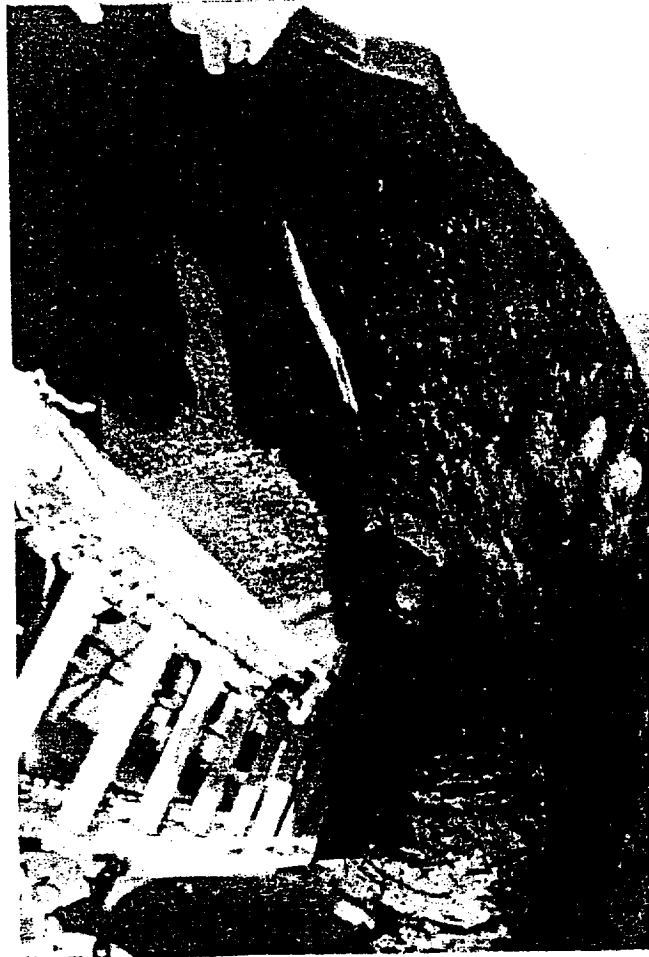
**Landfill Leachate Day 2 Event # 13**

**Event # 13 – Leachate Sample:** A leachate sample was collected 14:15 hours from the Pine Grove Landfill as water poured into the leachate collection sump. According to the QAPP; replicate samples were collected in pre-cleaned one liter polyethylene bottles, labeled, and sampling information recorded on data sheets. The coordinates of the sampling location were recorded based on a hand held GPS. See the scanned images of the sampling location in the photograph section.

**Reviewer Comments:** Access to the sample was through a manhole opening into the collection sump. The pipe connection was about 8 feet below grade so samples needed to be collected remotely utilizing some apparatus. Access into the manhole was considered a confined space entry. Proper safety gear was not available for a confined space entry thus preventing entry. The sampling crew did not have any remote sampling apparatus so one was improvised. The sample bottles were taped to a jumper cable and lowered into position from ground level. A suggestion was made to consider using a 6-8 foot telescoping handle for sample collection in these types of situations. The handles are inexpensive and can be found in any home improvement/hardware store. Field data documentation was thorough, and personnel wore disposable gloves while handling the samples.

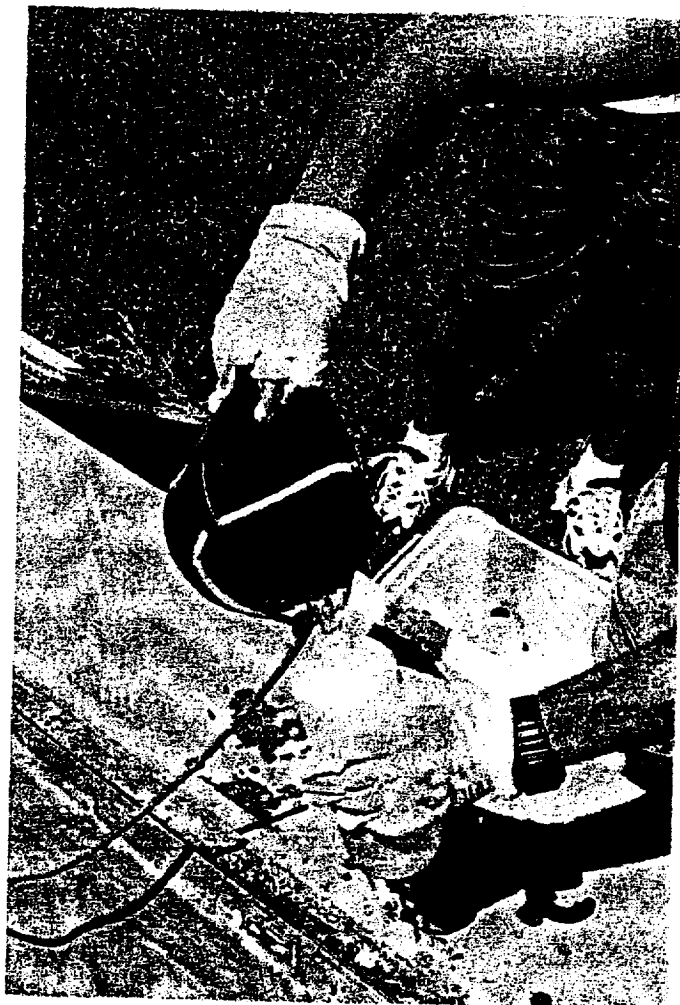
POTW Final Effluent Day 2 Event # 14

**Event # 14 – POTW Final Effluent Sample:** A wastewater sample was collected at 16:00 hours from the final effluent. According to the QAPP; replicate samples were collected in pre-cleaned polyethylene bottles, labeled, and sampling information recorded on data sheets. The coordinates of the sampling location were recorded based on a hand held GPS. See the scanned images of the sampling location in the photograph section.

**Reviewer Comments:** Access to the sample was through a trap door opening into the overflow structure. The pipe connection was about 10 feet below the trap doors so samples needed to be collected remotely utilizing some apparatus. Access into the structure was considered a confined space entry. Proper safety gear was not available for a confined space entry thus preventing entry. The POTW operators have a bucket and rope permanently set up to allow for sample collection. Field data documentation was thorough, and personnel wore disposable gloves while handling the samples. There is concern about possible residual accumulation of FC's onto the surface of the bucket. Some discussions regarding this concern are warranted. For future reference it may be advisable for the sampling crew to provide a remote sampling apparatus such as a telescoping handle.

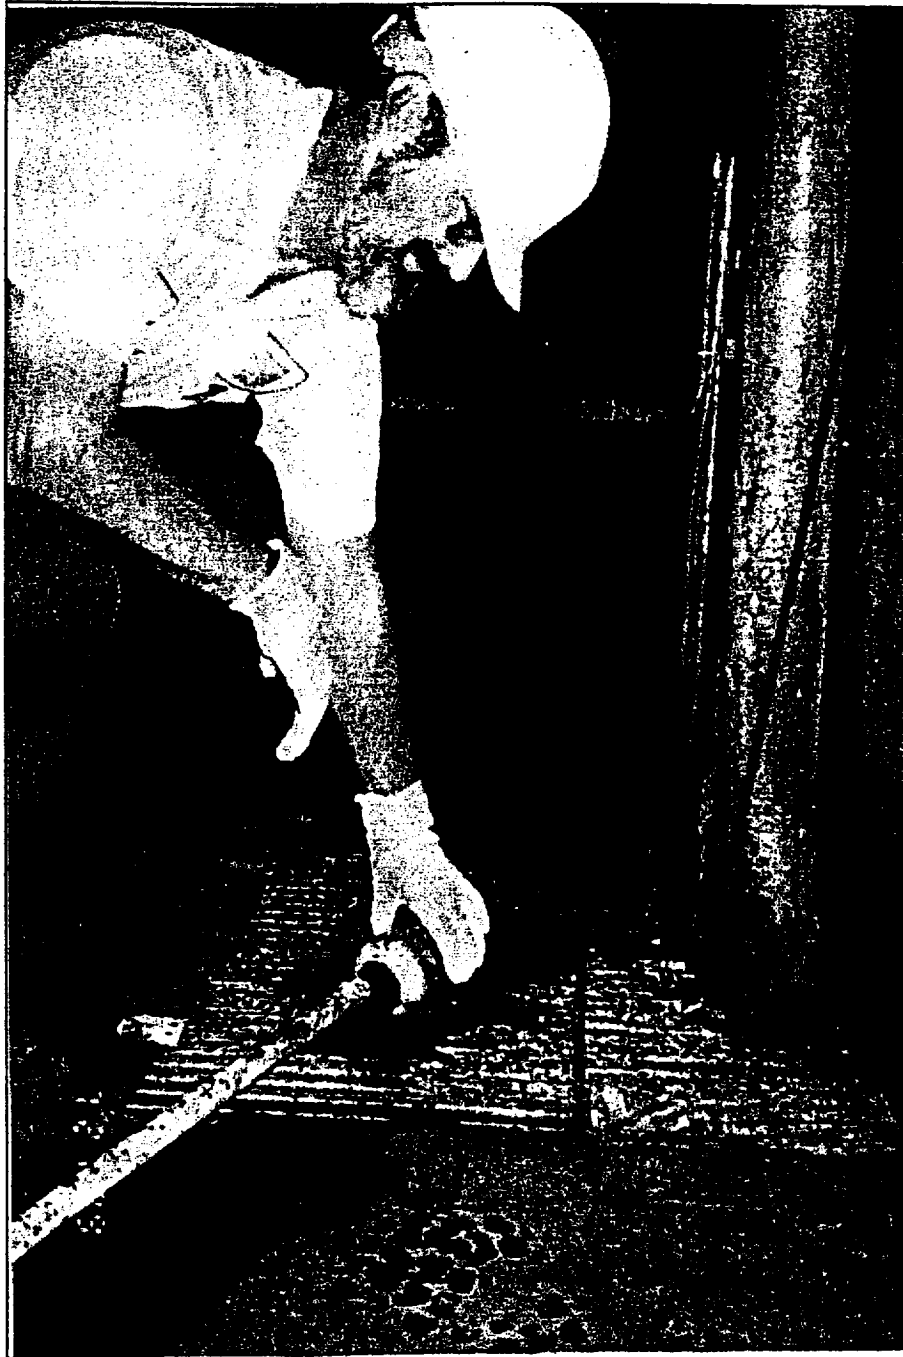
POTW Final Sludge Day 2 Event # 15

**Event # 15 – POTW Final Sludge Sample:** A sludge sample was collected by one of the POTW operators at 16:10 hours from the discharge line from the anaerobic digesters. According to the QAPP; replicate samples were collected in pre-cleaned polyethylene bottles, labeled, and sampling information recorded on the data sheets. The coordinates of the sampling location were recorded based on a hand held GPS. See the scanned image of the sampling location in the photograph section.

**Reviewer Comments:** The sludge sample was collected from the main discharge line by one of the operators and given directly to Chris. Field data documentation was thorough, and personnel wore disposable gloves while handling the samples.

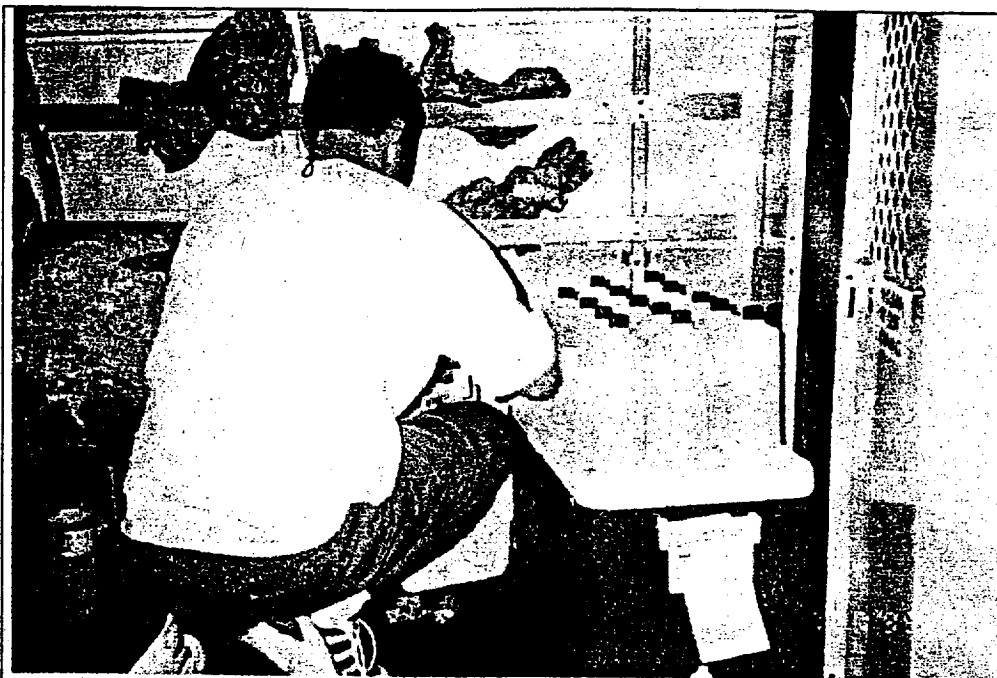
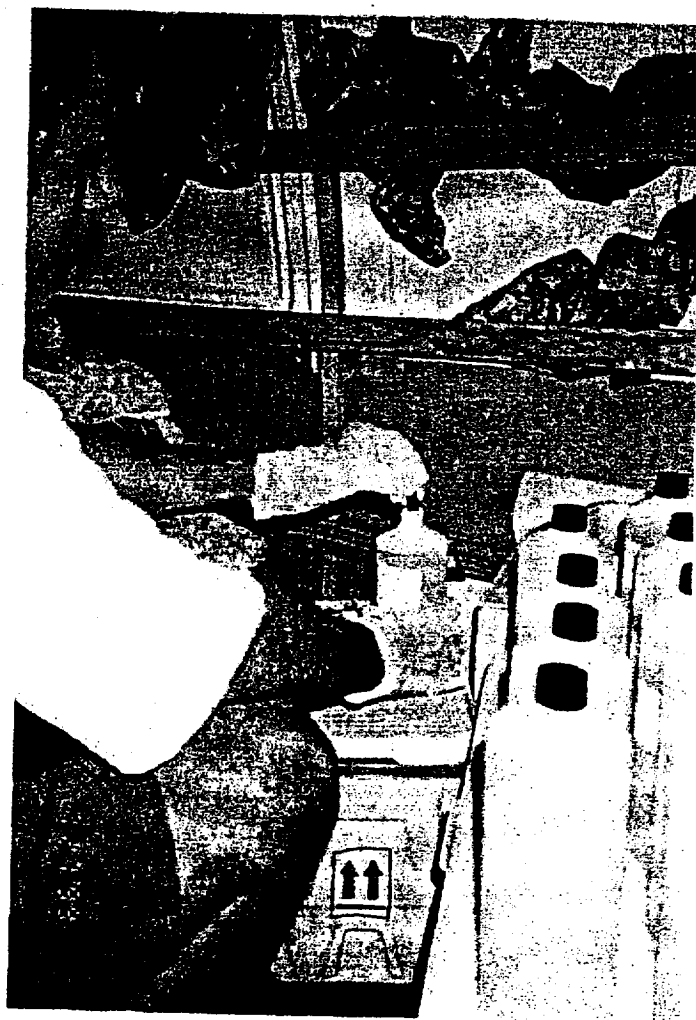
Field Spiking Day 2 Event # 17

**Event # 17 – Field Spiking:** A set of samples collected throughout the day were field spiked. Glass ampules containing the analytes of interest were emptied into the sample bottles. After an ampule was emptied, it was dropped into the sample bottle that was spiked.

**Reviewer Comments:** The addition of the empty vial to the sample raises concern. This procedure follows the QAPP but poses a potential contamination source, that being the outside surfaces of the vial. The QAPP specifies the vial be methanol rinsed and wiped dry with a ChemWipe. What are the precautions that the external surfaces are kept from potential contamination? Field data documentation was thorough, and personnel wore disposable gloves while handling the samples.
