## Region 6 - Enforcement & Compliance Assurance Division

### INSPECTION REPORT

| Company Name: | <b>W M Operating, Inc.</b> | |
| Facility Name: | <b>HGC Lewis-Denman Tank Battery</b> | |

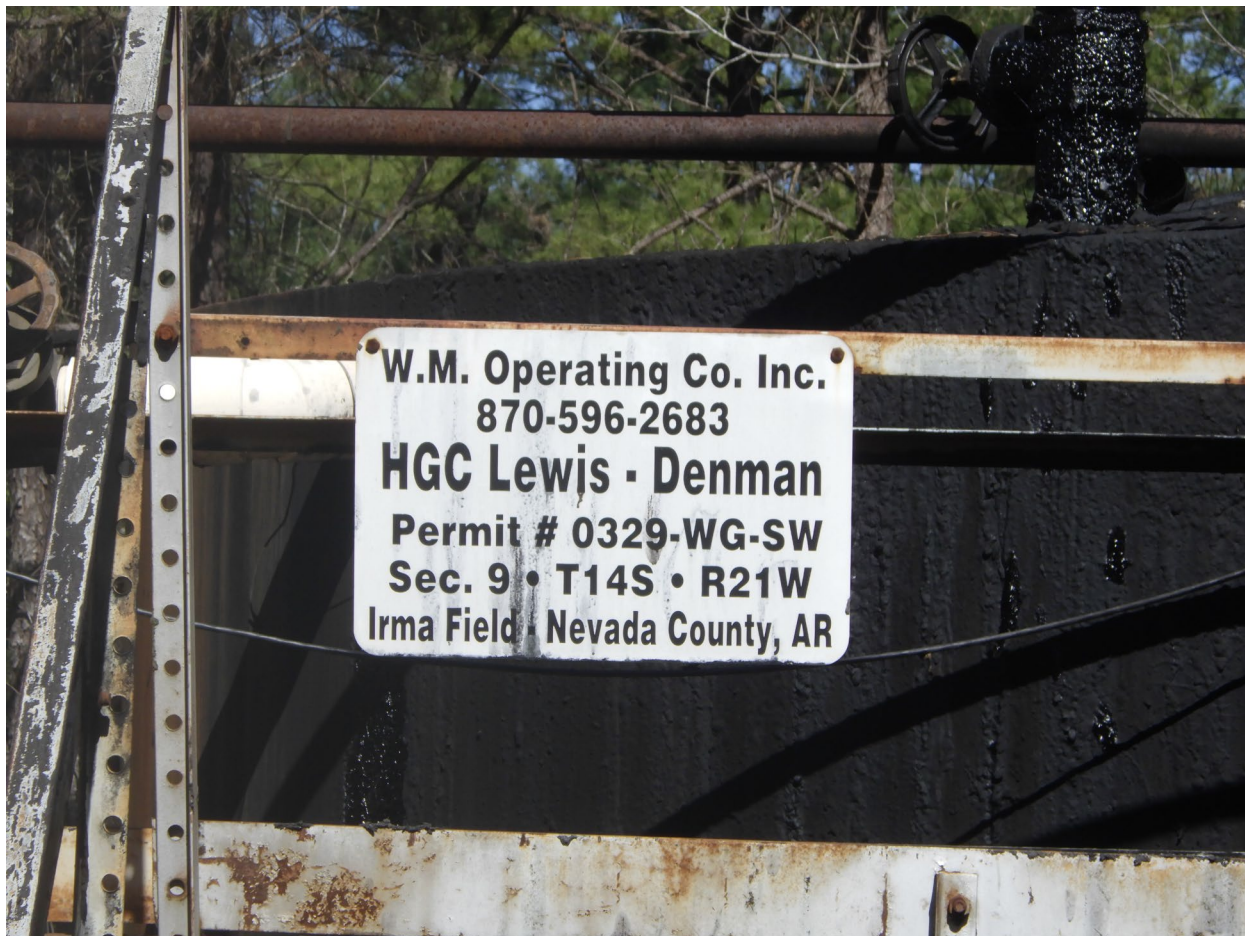
Photo No. 1

**Description:** Looking ENE, this photo shows the signage at the HGC Lewis-Denman Tank Battery ("facility").

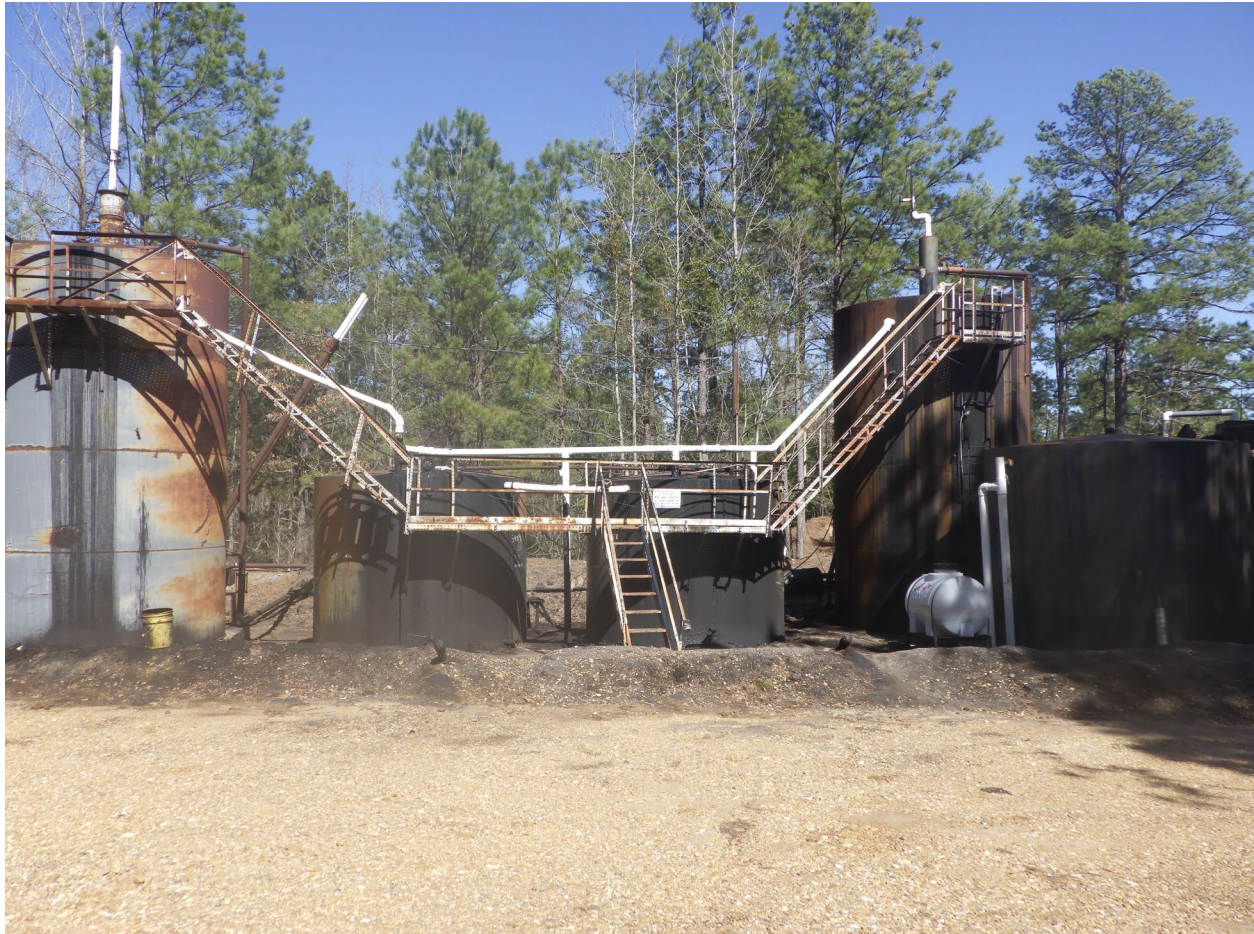
#### Photo No. 2

I observed product transfer lines outside secondary containment without catchment buckets, see Photos No. 2 and No. 3.

I observed a bucket containing crude oil on the berm of the secondary containment, see Photos No. 2 through No. 4.

**Description:** Looking ENE, this photo shows an overview of the facility.

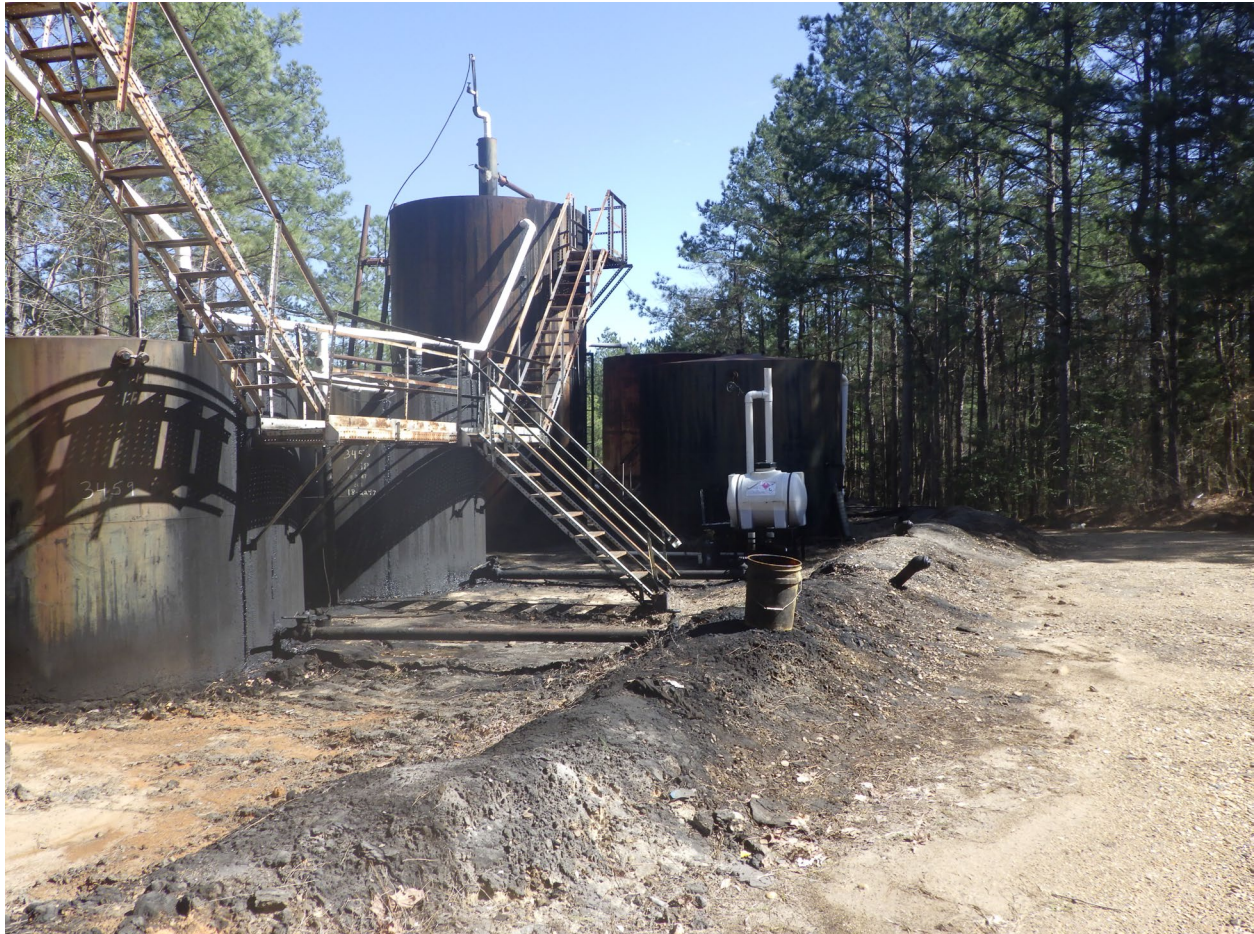
Photo No. 3

**Description:** Looking ESE, this photo shows the front view of the inside and outside of the secondary containment.

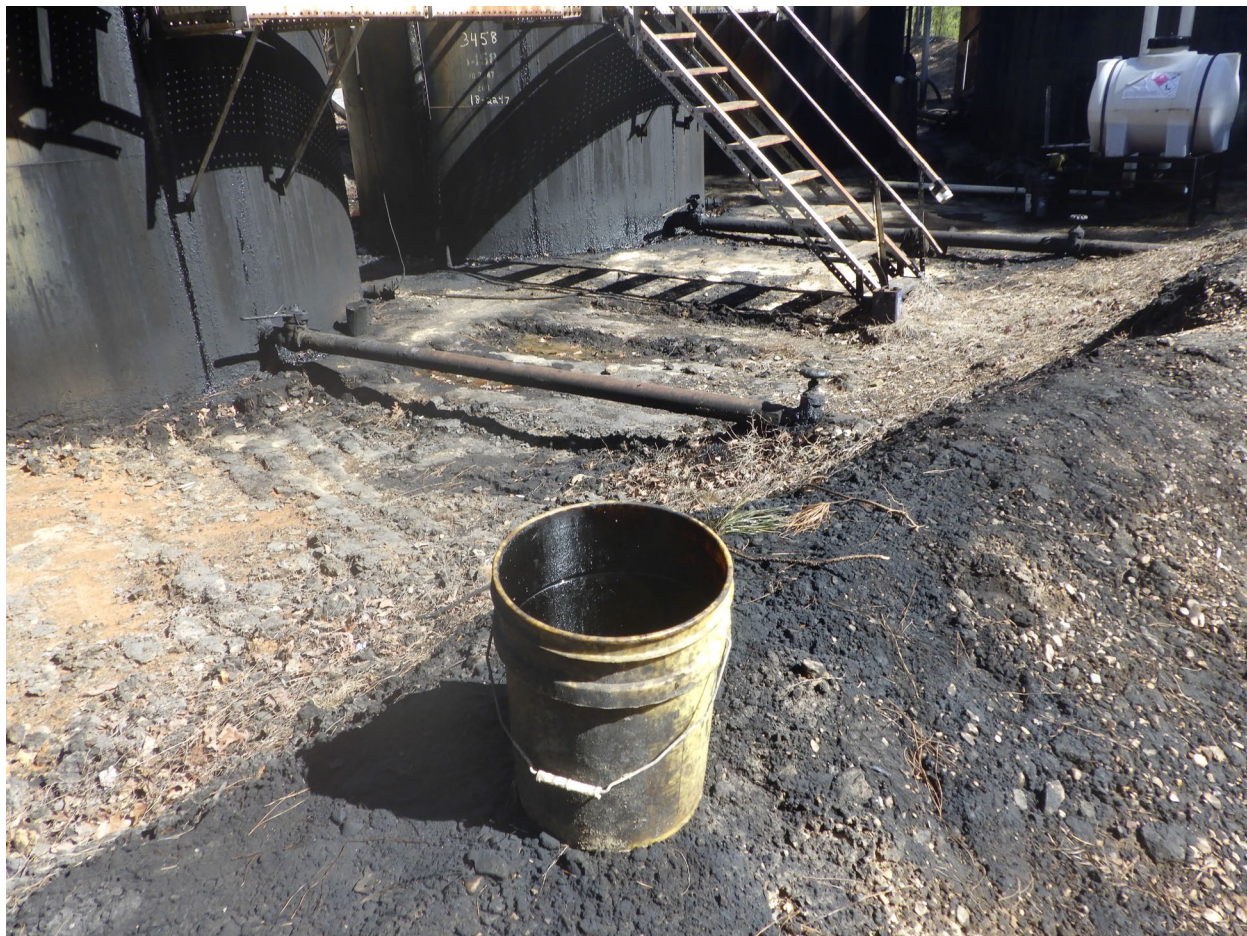
Photo No. 4

**Description:** Looking ENE, this photo shows a bucket full of crude oil on the berm of the secondary containment.

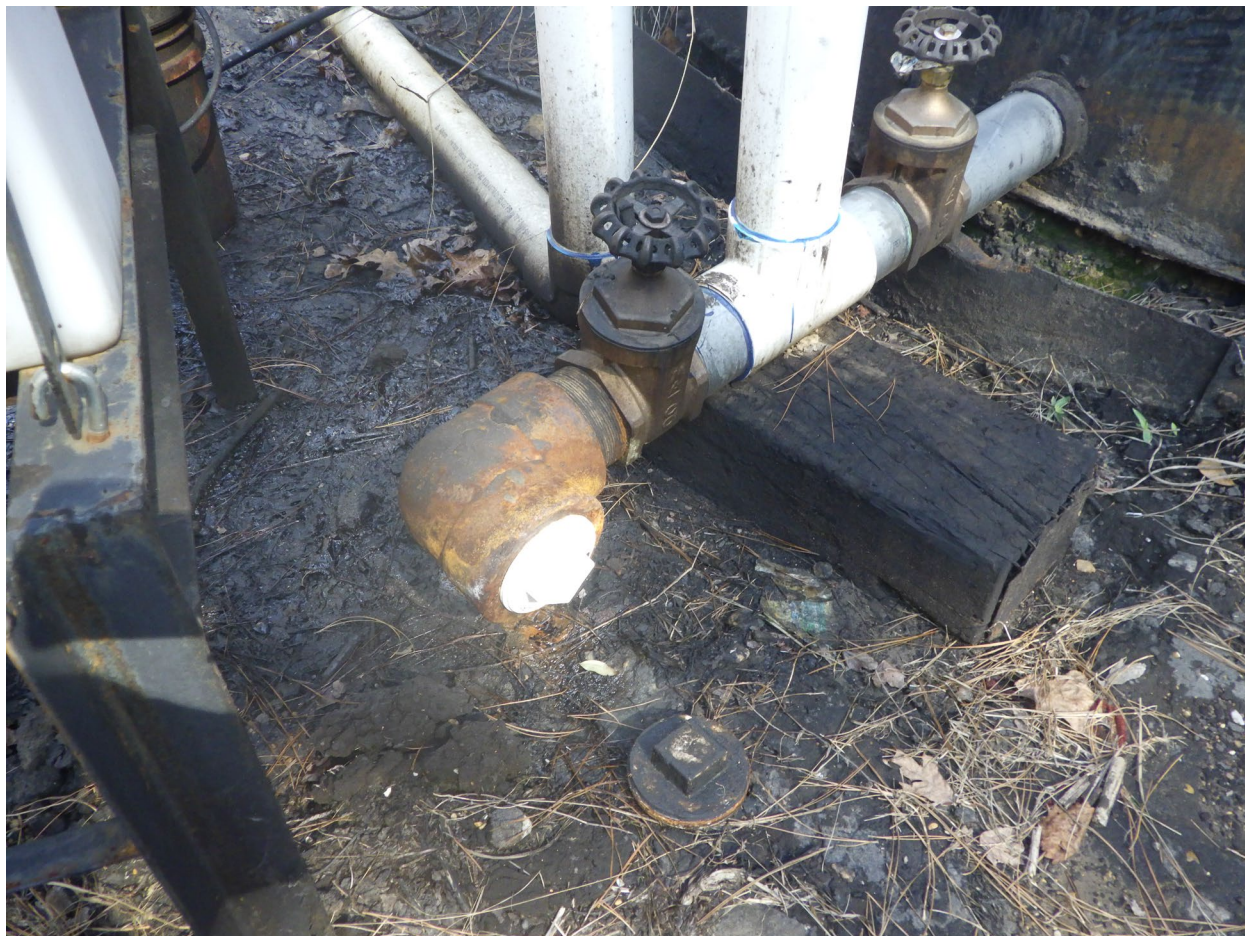
Photo No. 5

I observed a pipe with a replaced cap and a new motor/pump inside secondary containment, see Photos No. 5 and No. 6.

I observed loose crude oil and saltwater inside secondary containment, see Photos No. 5 through No. 7 and Photos No. 9 through No. 11.

**Description:** Looking NE, this photo shows a cap that has been replaced inside the secondary containment.

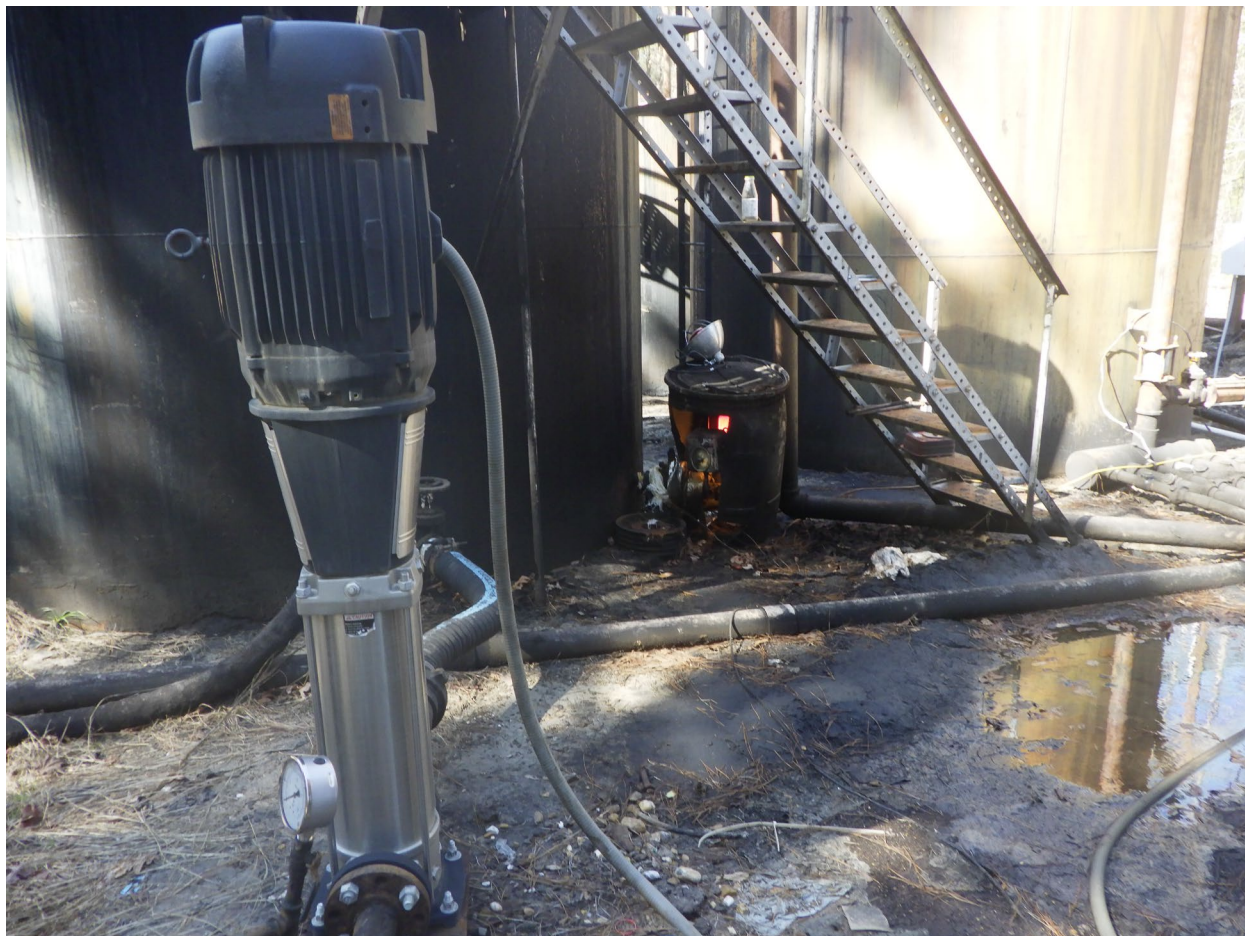
Photo No. 6

**Description:** Looking N, this photo shows a motor inside secondary containment that has been replaced.

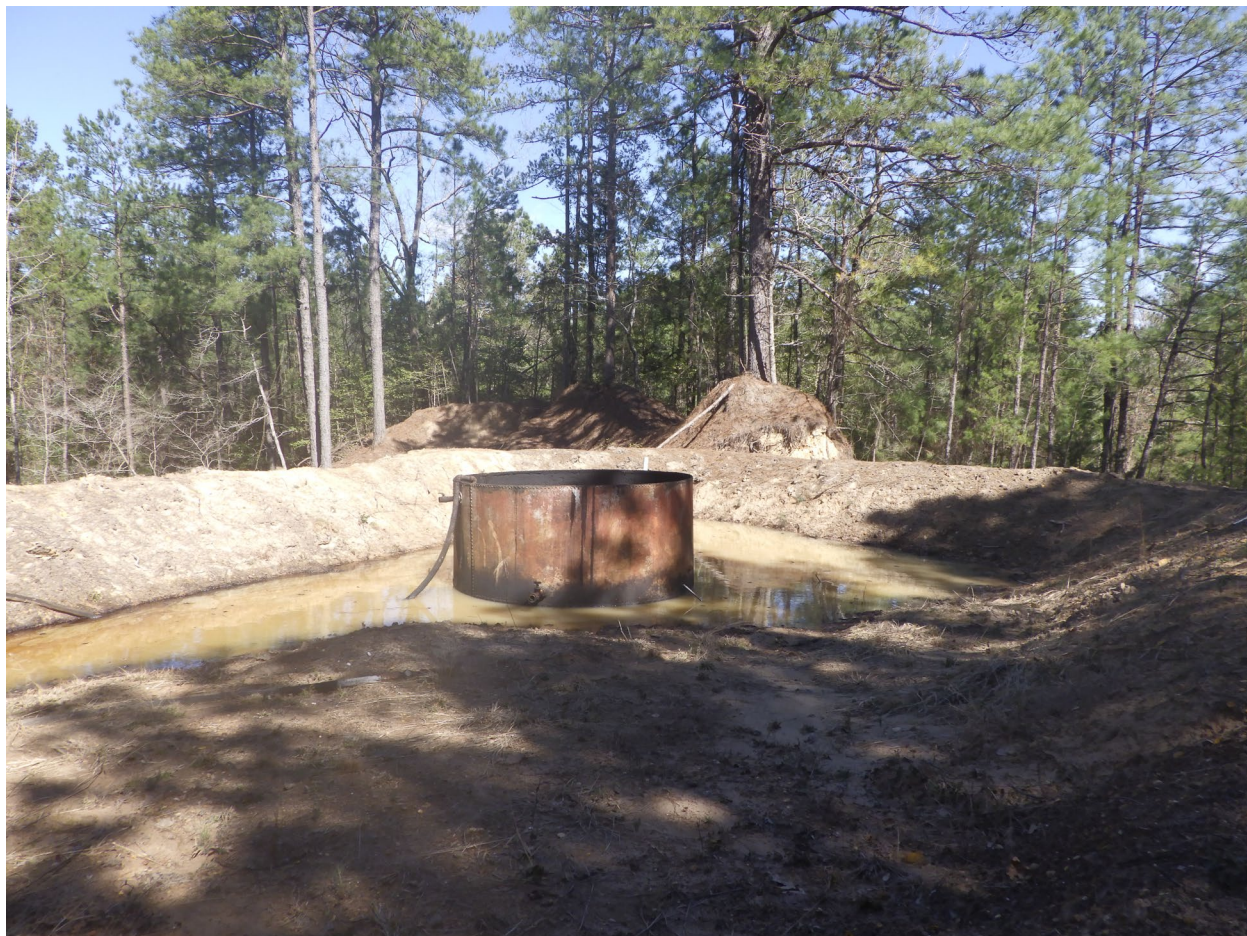
Photo No. 7

I observed an open-top tank in the sump area of the secondary containment, see Photos No. 7 and No. 9.

**Description:** Looking ENE, this photo shows the sump area of the secondary containment.

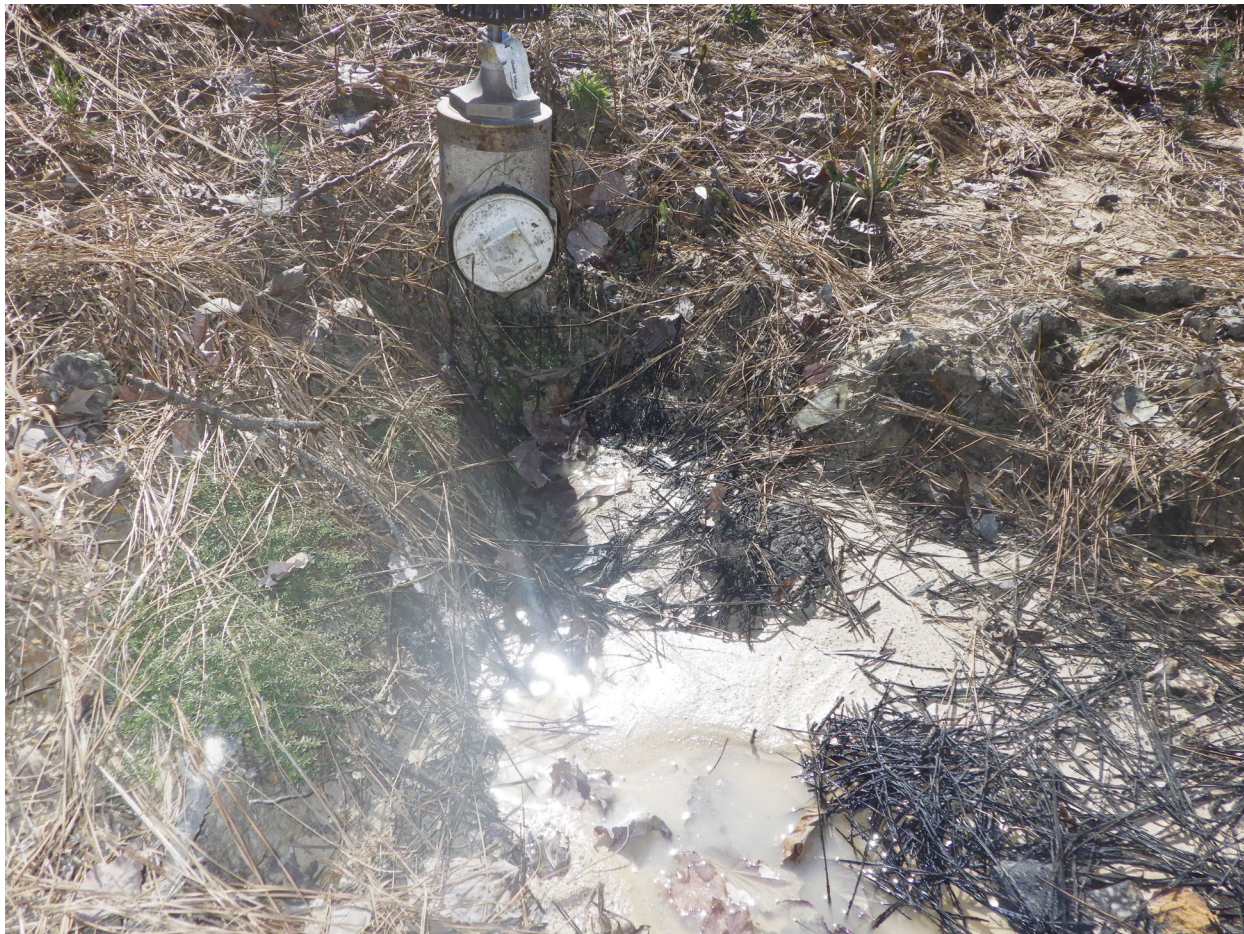
Photo No. 8

I observed the drainpipe for the secondary containment, see Photo No. 8.

**Description:** Looking W, this photo shows the drainpipe for the secondary containment.

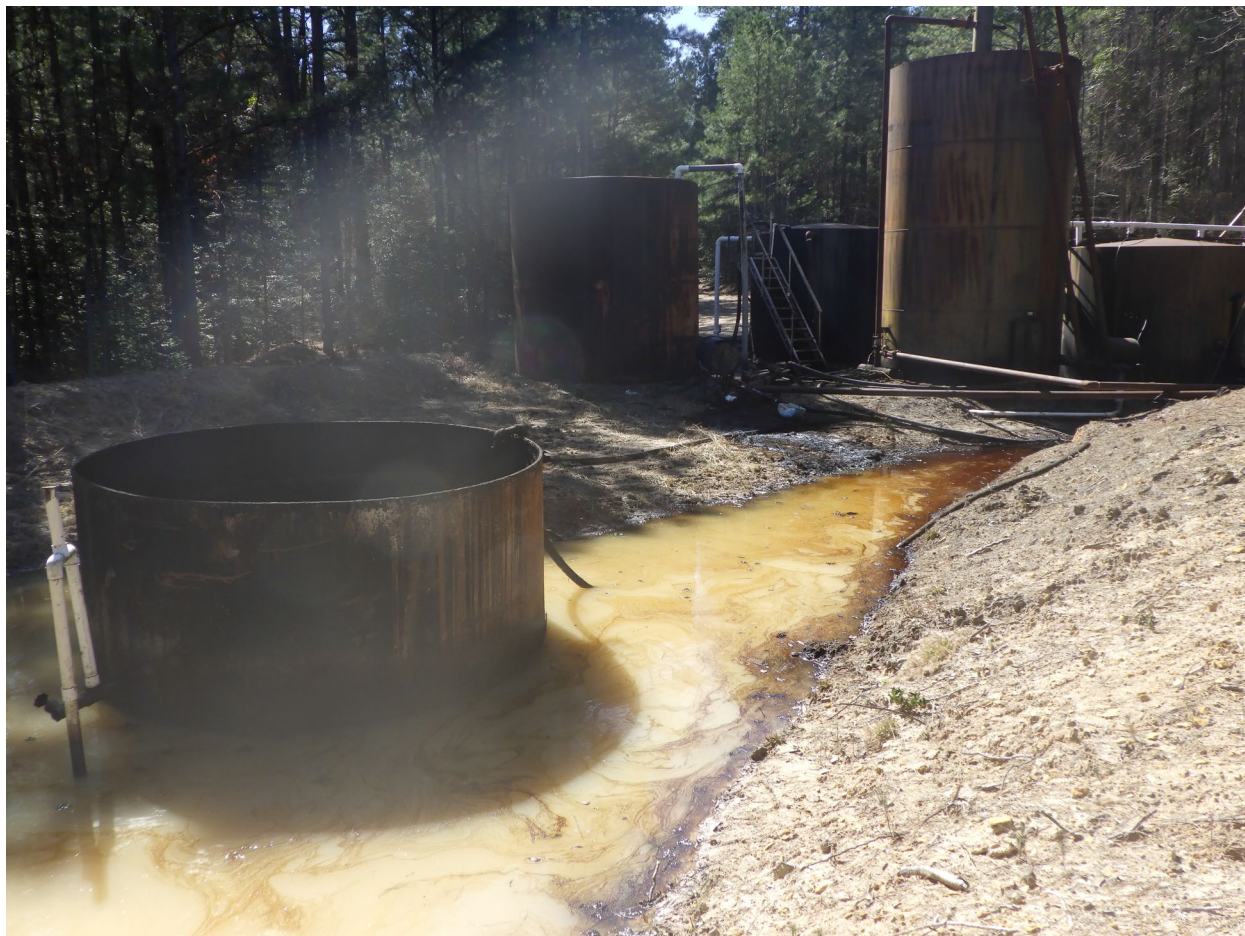
Photo No. 9

**Description:** Looking WSW, this photo shows an open-top tank used as a skimmer for the sump area of the secondary containment.

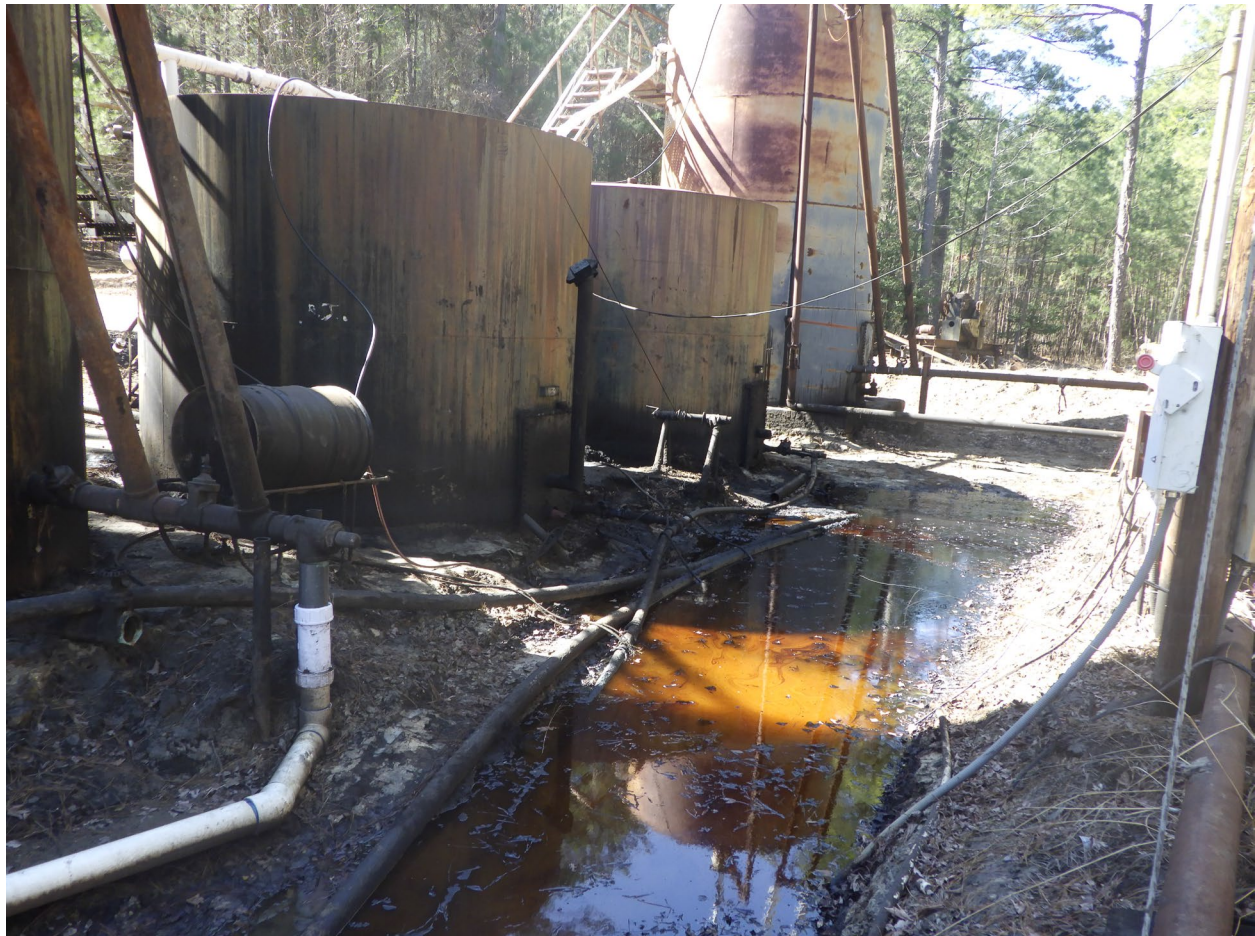
Photo No. 10

**Description:** Looking NW, this photo shows loose crude oil and saltwater inside secondary containment.

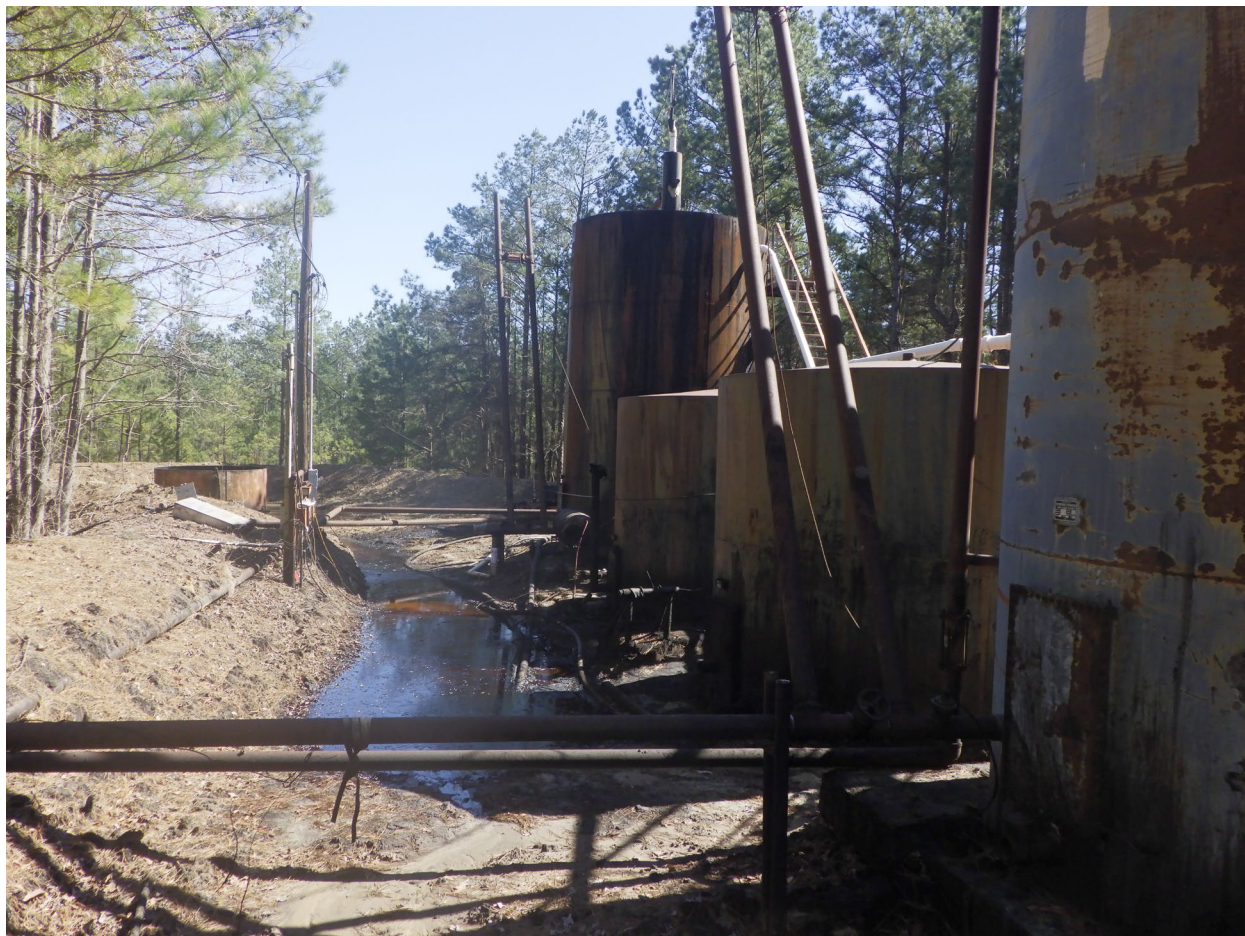
Photo No. 11

**Description:** Looking SE, this photo shows an additional view of the loose crude oil and saltwater inside secondary containment.
