## **RCRA Inspection Report**

Holcim (US) Inc.  
2173 Gardner Boulevard  
Holly Hill, South Carolina 29059

Geocycle, LLC  
2175 Gardner Boulevard  
Holly Hill, South Carolina 29059

February 29 – March 1, 2024

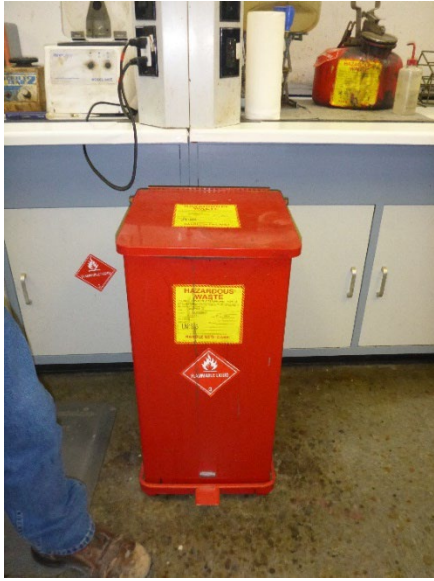
The inspectors observed two 15-gallon containers for accumulating waste solids generated in the laboratory, including used PPE, wipes, containers, and other solids contaminated with solvents and liquid hazardous waste, as hazardous waste solids (Photo 1). Each container was designed with a pedal to open the hinged lid, and an interior bin for accumulating waste. Facility personnel stated that the interior bin is removed from each container and the contents are emptied into a 55-gallon container at the compactor unit in Area 6100. Each container was labeled as hazardous waste and identified with a DOT flammable liquid hazard placard. The inspectors noted that, because the containers held hazardous waste solids rather than liquids, the DOT flammable liquid hazard placard may not be the preferred method to indicate that the contents are ignitable. Although, these hazardous waste solids also exhibit characteristics of toxicity, neither container was marked with an indication that its contents are toxic.

**Photo 1:** One of two 15-gallon containers in the laboratory SAA for accumulating waste solids generated in the laboratory.

**Pursuant to S.C. Code Ann. Regs. 61-79.262.15(a)(5)(ii) [40 C.F.R. § 262.15(a)(5)(ii)], which is a condition of the SAA Permit Exemption, a generator is required to mark or label its containers with an indication of the hazards of the contents.**

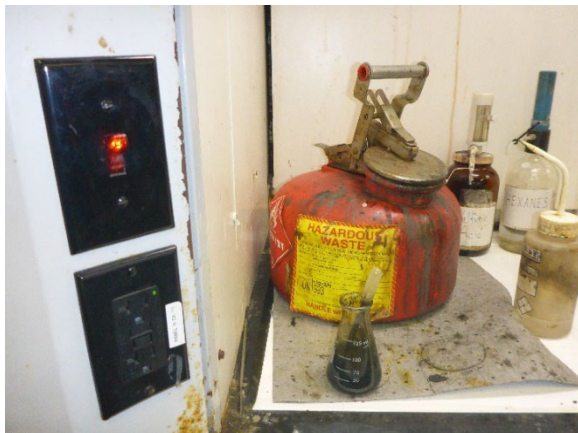
- One 2.5-gallon container of hazardous waste exhibiting the characteristics of ignitability and toxicity in Laboratory Hood #2 (Photo 2). The container was labeled as hazardous waste and identified with a DOT flammable liquid hazard placard, but it was not marked with an indication that its contents are also toxic;

**Photo 2:** One of two 2.5-gallon containers in the laboratory SAA for accumulating waste flammable liquids generated in the laboratory. This container was observed in Laboratory Hood #2.

**Pursuant to S.C. Code Ann. Regs. 61-79.262.15(a)(5)(ii) [40 C.F.R. § 262.15(a)(5)(ii)], which is a condition of the SAA Permit Exemption, a generator is required to mark or label its containers with an indication of the hazards of the contents.**

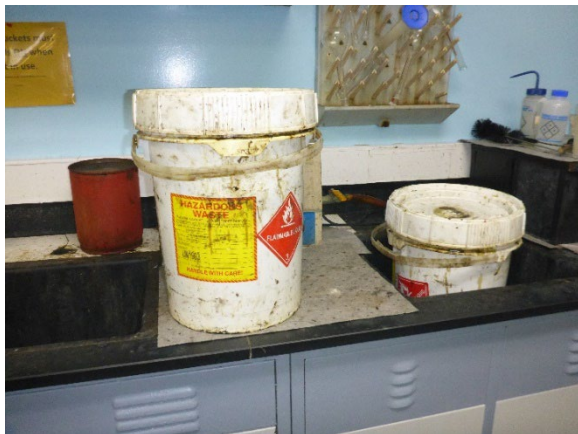
- Two 5-gallon containers of acid waste (acetone and water and acid), which were each labeled as hazardous waste and identified with a DOT flammable liquid hazard placard, in a laboratory sink (Photo 3);

**Photo 3:** Two 5-gallon containers of acid waste (acetone and water and acid) in the laboratory SAA. Each container was observed in a laboratory sink.

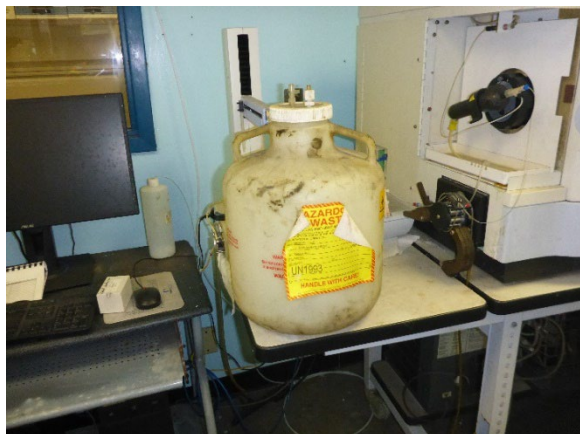
- Two 5-gallon containers of waste nitric acid, which were each labeled as hazardous waste and identified with a DOT corrosive hazard placard, in the ICP testing area (Photo 4); and

**Photo 4:** One of two 5-gallon containers of waste nitric acid in the laboratory SAA. This container was connected to an ICP testing unit.

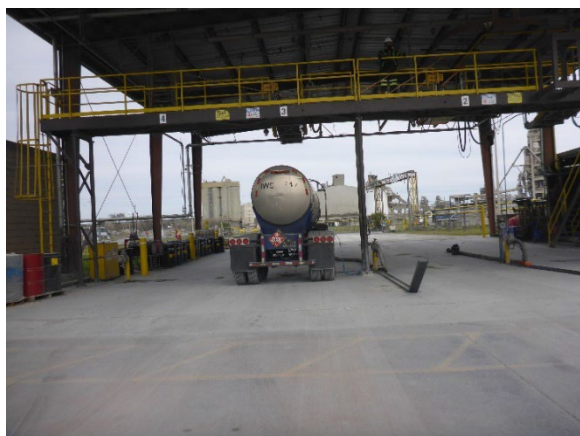
**Photo 5:** Tanker truck unloading bays in Area 6100.

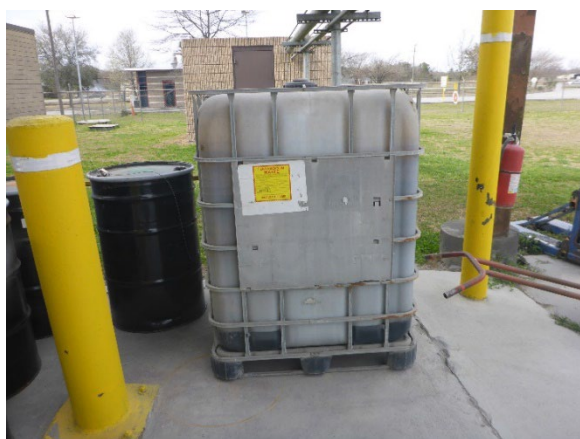
In addition to tanker truck sampling and unloading, Geocycle personnel also use Area 6100 to store non-bulk containers of site-generated waste. The inspectors observed one 300-gallon tote containing hazardous waste liquids (Photo 6) at the end of a line of approximately twenty-five 55-gallon containers of hazardous waste solids and one 55-gallon container of nonhazardous gear box oil (Photo 7). The tote is used to accumulate and store liquid hazardous wastes that are generated in the on-site laboratory and subsequently blended in with the HWDF used to heat the on-site kiln. The tote was labeled as hazardous waste and marked with an accumulation start date of February 13, 2024, but it was not identified with an indication of the hazards of its contents. The 55-gallon containers are used to accumulate and store hazardous waste solids generated in the laboratory and throughout the Facility. Each container was labeled as hazardous waste and marked with an accumulation start date. None of the containers were marked to indicate that the contents were toxic, but most were identified with a DOT flammable liquid hazard sticker. One container, dated November 22, 2023, was not marked to indicate that its contents were flammable (Photo 8). The oldest accumulation start date noted during the inspection was November 10, 2023. The inspectors also observed the compactor unit used to compact hazardous waste solids into 55-gallon containers in this area (Photo 9).

**Photo 6:** One 300-gallon tote of hazardous waste liquids that were generated in the laboratory observed in Area 6100.

**Pursuant to the RCRA Permit SCD003368891, Condition VII.B.2 Storage Prohibition, which incorporates S.C. Code Ann. Regs. 61-79.268.50(a)(2)(i) [40 C.F.R. § 268.50(a)(2)(i)], an owner/operator of a hazardous waste treatment, storage, or disposal facility who stores hazardous waste restricted from land disposal must clearly mark each container with an indication of the hazards of the contents.**

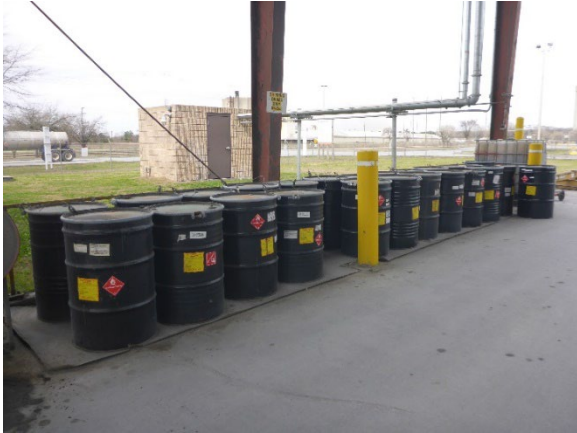
**Photo 7:** Approximately twenty-five 55-gallon containers of compacted hazardous waste solids in Area 6100.

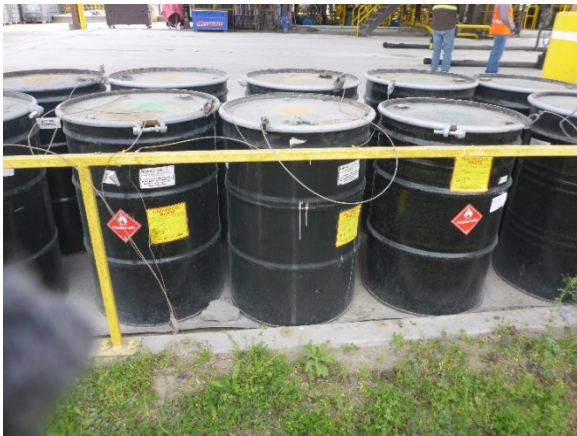
**Photo 8:** Some of approximately twenty-five 55-gallon containers of hazardous waste compacted solids in Area 6100. One container, dated November 22, 2023, was not marked with an indication of the hazards of its contents.

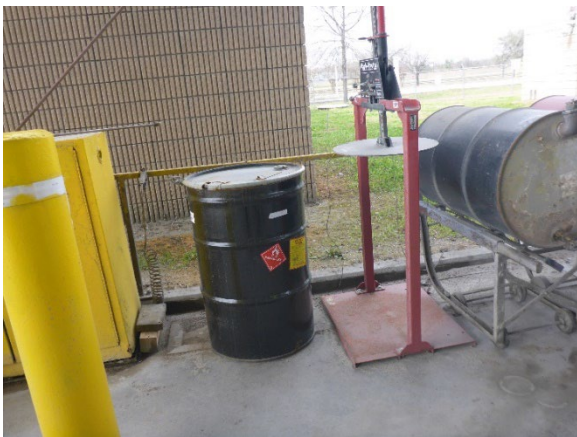
**Photo 9:** Compactor unit used to compact hazardous waste solids into 55-gallon containers in Area 6100.

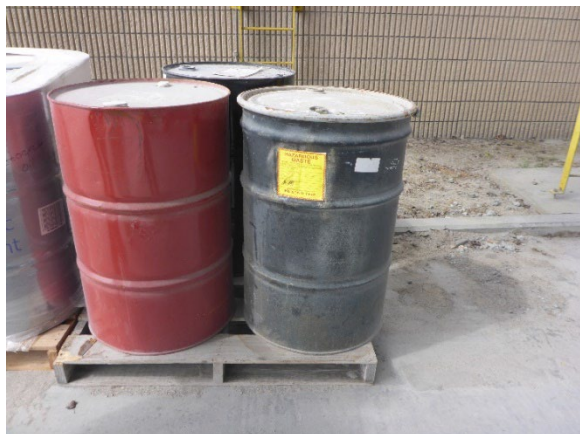
The inspectors also observed one 55-gallon container near the compactor unit that Facility personnel stated contained acetone used to clean and soak flame arrestors used in the waste transfer equipment (Photo 10). Because the acetone in the container had already been used, the container was labeled as hazardous waste and dated January 8, 2024. However, the

inspectors stated that the container does not need to be labeled or managed as hazardous waste while the acetone is still in use.

**Photo 10:** One 55-gallon container near the compactor unit that Facility personnel stated contained acetone used to clean and soak flame arrestors used in the waste transfer equipment.

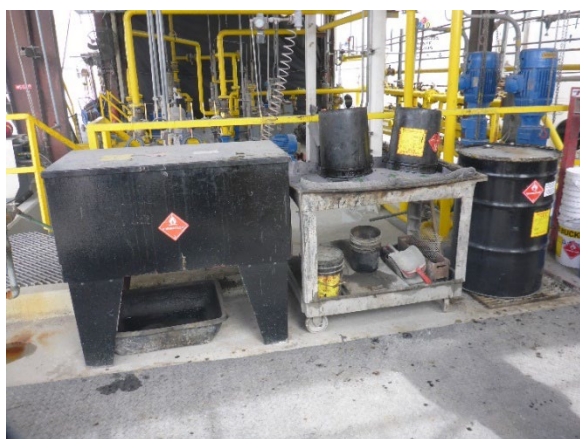
The inspectors also observed a parts washer and 55-gallon container in the workstation between Area 6100 and Area 4100 (Photo 12). The parts washer is used to clean parts associated with the pumps and grinders located in and around this area. The 55-gallon container is used to accumulate hazardous waste spent cleaning fluids that exhibit the hazardous waste characteristics of ignitability and toxicity. The container was labeled as hazardous waste flammable liquid, but it was not marked with an indication that its contents are also toxic.

**Photo 12:** Parts washer and 55-gallon container in the workstation between Area 6100 and Area 4100.

**Pursuant to S.C. Code Ann. Regs. 61-79.262.15(a)(5)(ii) [40 C.F.R. § 262.15(a)(5)(ii)], which is a condition of the SAA Permit Exemption, a generator is required to mark or label its containers with an indication of the hazards of the contents.**

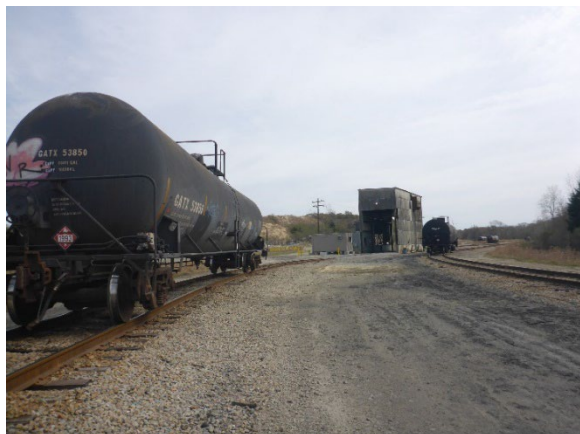
Arriving railcars are received and stored in the railcar staging area (Photo 13), and up to thirty-five non-RCRA empty railcars containing waste may be stored on-site at any given time. Railcars containing material that meets the acceptance criteria must be unloaded within thirty days of receipt, and personnel estimated that the railcars are typically unloaded within three days. The inspectors observed railcars numbered GATX53850, SKSX117140, and DNAX123039, and verified that these railcars were identified on the daily inspection logs associated with this area.

**Photo 13:** Portion of the railcar staging area.

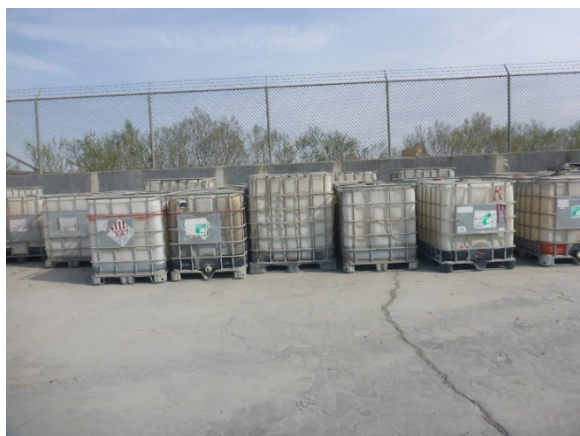
The inspectors observed approximately fifty 275-gallon totes in the area identified for future Tank Farm (Photo 14). The gate to access this area was equipped with a “danger, no smoking sign.” The totes were staged together without any aisle spacing along the wall farthest from Tank 5106 and its secondary containment area. Most of these totes were identified as “used oil” or “waste oil” on a nonhazardous waste label, but the writing on several of those labels had faded or been washed off. Most containers also held 1-foot or less of dark liquid, and at least three of the totes were open (Photo 15). The inspectors observed hazardous waste labels on three of the totes. One hazardous waste tote was dated September 5, 2023 (Photo 16), and another was dated February 28, 2024 (Photo 17). None of these three totes were marked with an indication of the hazards of its contents, and one was open. This area is not permitted for storage of hazardous waste in containers, and it was not identified as a CAA in the records of weekly inspections of container storage areas.

**Photo 14:** Approximately fifty 275-gallon totes in the area identified for a future tank farm.

**Pursuant to S.C. Code Ann. Regs. 61-79.262.17(a)(6) [40 C.F.R. § 262.17(a)(6)], which incorporates S.C. Code Ann. Regs. 61-79.262.255 [40 C.F.R. § 262.255], and is a condition of**

In an email dated March 22, 2024, Randy Sparks stated that the Facility identified a total of 52 totes in Area 5100. He explained that the cement plant brought used oil totes to Geocycle, and that thirty-seven of the totes in this area contained various residues of used oil, including hydraulic oil and/or gear lube oil. Another nine totes were empty, and the final six contained hazardous waste carbon water. Mr. Sparks indicated that the six totes of hazardous waste were either processed into the tank farm on February 29, 2024, or marked with an indication of the hazards of the contents and placed in the permitted container storage area. Following the inspection, Geocycle and Holcim reviewed and revised the process for managing used oil generated by Holcim and brought to Geocycle for processing. Mr. Sparks stated that Holcim employees will ensure that each tote is marked with the words “used oil” and will also notify Geocycle when totes are brought to this area.

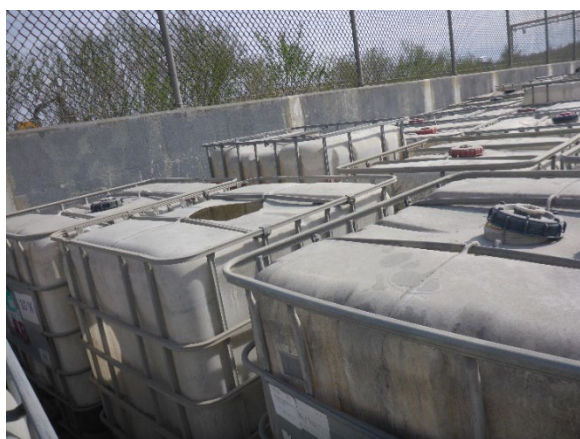
The inspectors observed one open container of hazardous waste among fifty-two totes in the Area for Future Tank Farm (Area 5100).

**Photo 15:** Open tote among the approximately fifty 275-gallon totes in the area identified for a future tank farm.

Pursuant to S.C. Code Ann. Regs. 61-79.262.17(a)(1)(iv) [40 C.F.R. § 262.17(a)(1)(iv)], which is a condition of the LQG Permit Exemption, (A) a container holding hazardous waste must always be closed during accumulation, except when it is necessary to add or remove waste; and (B) A container holding hazardous waste must not be opened, handled, or stored in a manner that may rupture the container or cause it to leak.

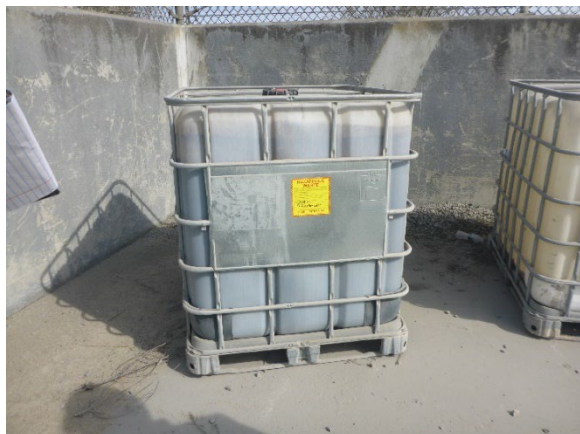
**Photo 16:** One tote of hazardous waste carbon water observed in the area identified for a future tank farm.

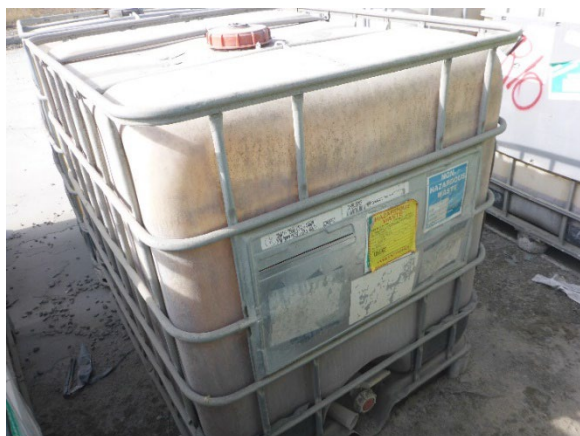
**Photo 17:** One tote of hazardous waste carbon water observed in the area identified for a future tank farm.

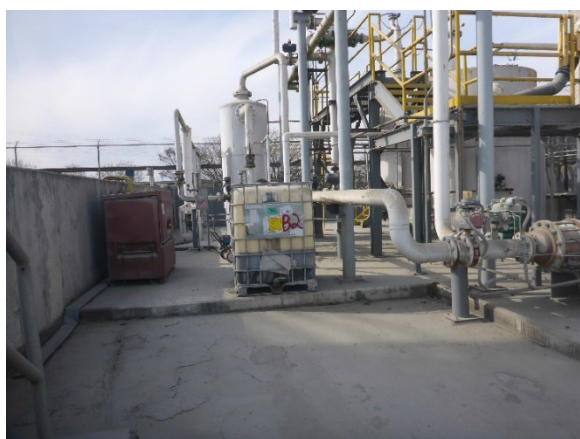
The Facility occasionally drains wash water that is generated in the carbon vent system before it enters the scrubber and accumulates the liquid as hazardous waste. The inspectors observed a tote containing approximately 100 gallons of this liquid in the Carbon Vent System Area at Area

5100 (Photo 18). Neither this tote nor the Carbon Vent System Area was identified as a CAA on the log of daily or weekly inspections for hazardous waste container storage areas.

**Photo 18:** Tote containing approximately 100-gallons of hazardous waste carbon water in the Carbon Vent System Area at Area 5100.

In an email dated March 22, 2024, Randy Sparks stated that the Facility determined that hazardous waste condensate draining from the carbon system will be accumulated in a SAA. Mr. Sparks provided a photograph of a 55-gallon container which has replaced former tote in this SAA. Mr. Sparks also provided a record of training in which employees reviewed the regulatory requirements for managing hazardous waste in a SAA on March 12, 2024. At the time of the inspection, the tote contained approximately 100 gallons of hazardous waste carbon water. Although the tote was labeled with the words “hazardous waste,” it was not marked with an accumulation start date or identified with an indication of the hazards of its contents.

**Pursuant to S.C. Code Ann. Regs. 61-79.262.15(a)(6) [40 C.F.R. § 262.15(a)(6)], a generator who accumulates hazardous waste in excess of 55 gallons must, with respect to that amount of excess waste, mark or label the container(s) holding the excess accumulation of hazardous waste with the date the excess amount began accumulating, and also comply with S.C. Code Ann. Regs. 61-79.262.17(a) [40 C.F.R. § 262.17(a)] or remove the excess waste from the SAA within three consecutive calendar days.**

**Pursuant to S.C. Code Ann. Regs. 61-79.262.15(a)(5)(ii) [40 C.F.R. § 262.15(a)(5)(ii)], which is a condition of the SAA Permit Exemption, a generator is required to mark or label its containers with an indication of the hazards of the contents.**

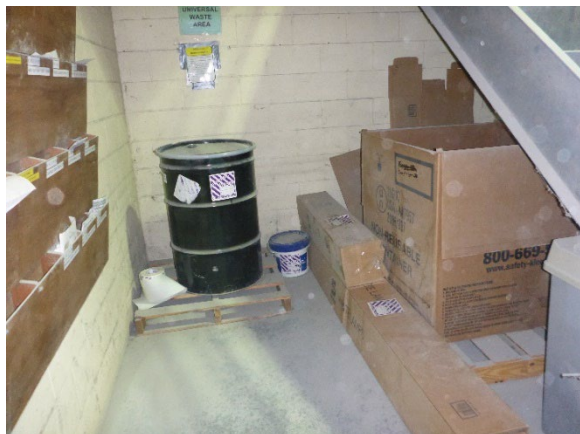
Universal wastes and used aerosol cans are accumulated in the Holcim Maintenance Area (Photo 19). The inspector observed one 55-gallon container of universal waste halogen lamps, one 3-gallon container of universal waste batteries, one 4-foot box of universal waste lamps, and one 8-foot box of universal waste lamps in this area. Each container was marked with an accumulation start date, and the oldest date was January 15, 2024. The containers of universal waste lamps were marked with the words “universal waste bulbs.”

**Photo 19:** Universal waste accumulation and storage area in the Holcim Maintenance Area.

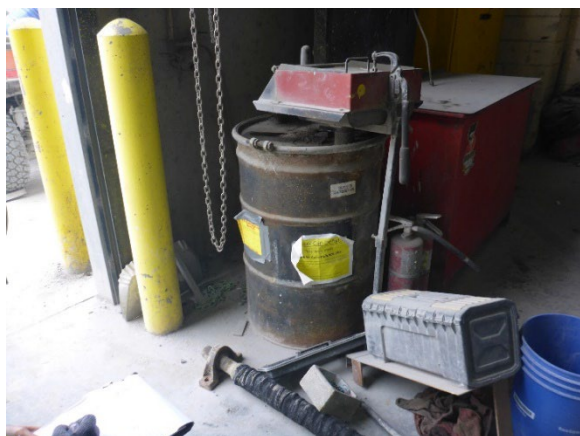
The Facility also manages a SAA in this area to accumulate the contents of used aerosol cans. The inspectors observed one 55-gallon container, which was equipped with an aerosol can puncture device, in this SAA (Photo 20). The container was labeled as hazardous waste, but it was not marked with an indication of the hazards of its contents.

**Photo 20:** 55-gallon container with an aerosol can puncture device in the Holcim Maintenance SAA for accumulating the contents of waste aerosol cans.

**Pursuant to S.C. Code Ann. Regs. 61-79.262.15(a)(5)(ii) [40 C.F.R. § 262.15(a)(5)(ii)], which is a condition of the SAA Permit Exemption, a generator is required to mark or label its containers with an indication of the hazards of the contents.**
