**Inspection Report Addendum for Well: MT20766-04256**  
**Inspection Date: 10/25/2023**

| <b>U.S. Environmental Protection Agency</b><br><b>Region 8</b> | | <b>UIC PHOTOGRAPHIC LOG</b> | |
| <b>Facility Location:</b><br>MT20766-04256 (102-W17R), Glacier County, UT | | <b>Photographer:</b><br>Gary Wang | <b>Camera:</b><br>Ricoh WG-5 |

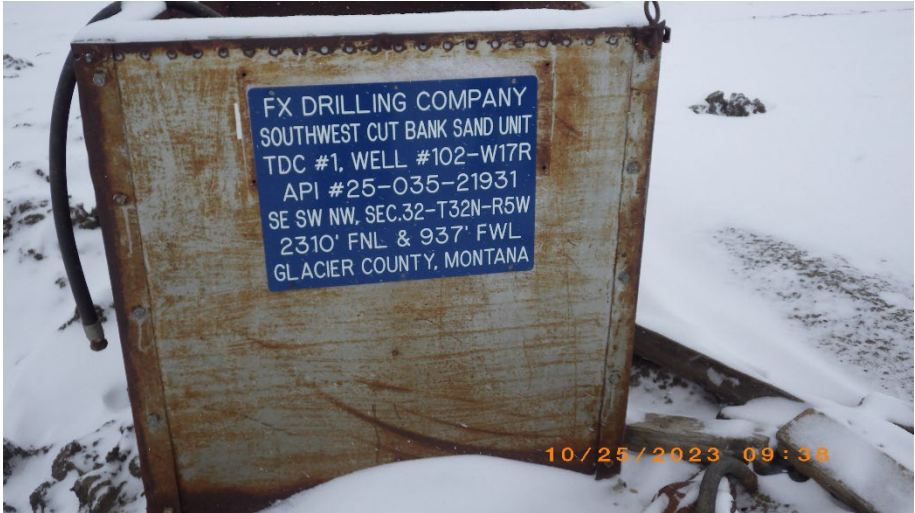
| <b>Photo No.</b><br>1 of 6 | <b>Time:</b><br>9:38 am | | |

| <b>Photo Description:</b><br>Well sign by wellhead. | | | |

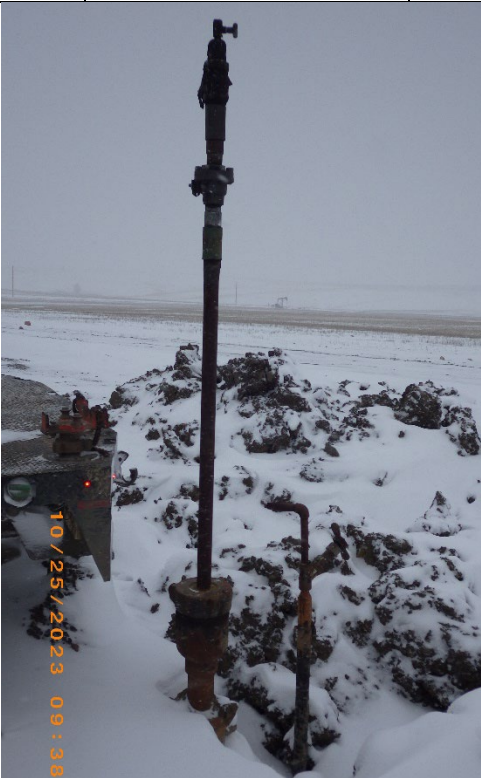
| <b>Photo Description:</b><br>Wellhead is observed to be disconnected from flowline (right of the wellhead).<br><br>Operator notes well configuration to be:<br><br>2 3/8" tubing within<br>4 1/2" casing within<br>7" casing.<br><br>Operator noted that 4 1/2" casing is cemented to 7" casing | | | |

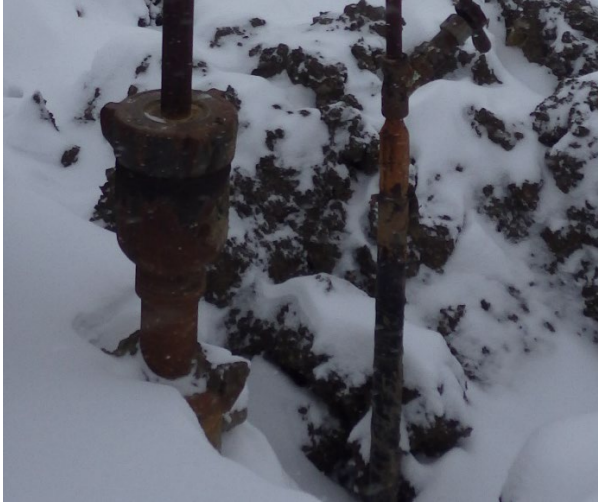
| <b>Photo Description:</b><br>Closer view of wellhead configuration<br><br>2 3/8" tubing within<br>4 1/2" casing within<br>7" casing.<br><br>Operator noted that 4 1/2" casing is cemented to 7" casing | | | |

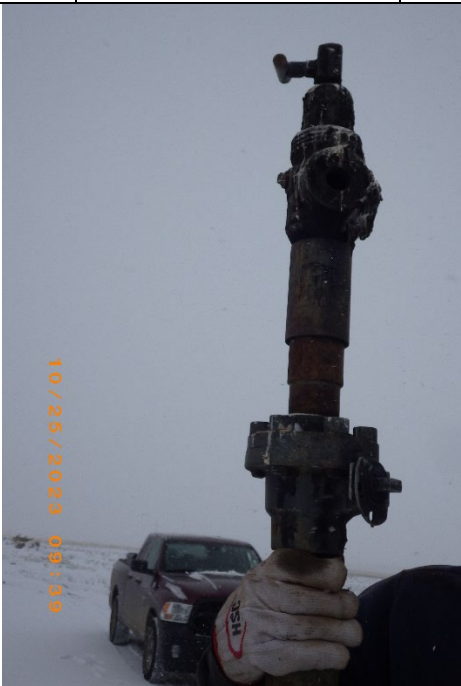
| <b>Photo No.</b><br>4 of 6 | <b>Time:</b><br>9:39 am | | |

| <b>Photo Description:</b><br>Closer view of wellhead tubing.<br>Master ball valve for tubing was in closed position. | | | |

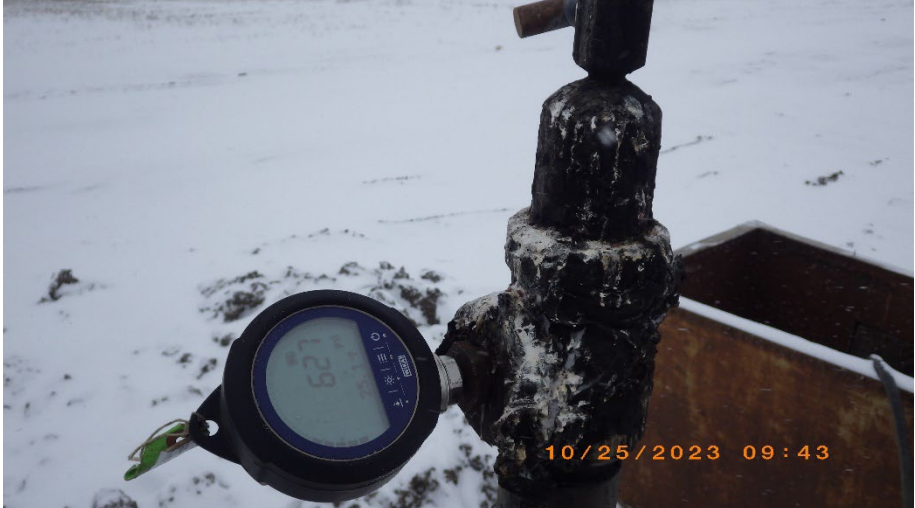
| <b>Photo No.</b><br>5 of 6 | <b>Time:</b><br>9:43 am | | |

| <b>Photo Description:</b><br><br>EPA's digital pressure gauge on the tubing read 627 psi on a 3000-psi range gauge.<br><br>MAIP for well is 2638 psi. | | | |

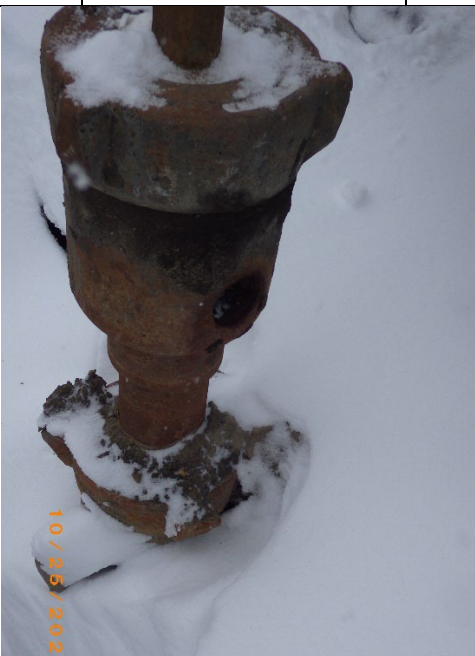
| <b>Photo No.</b><br>6 of 6 | <b>Time:</b><br>9:39 am | | |

| <b>Photo Description:</b><br><br>Tubing-casing annulus observed to be maintained continuously open to atmospheric pressure. | | | |
