Re: Reconnaissance Inspection Report (RI)  
NPDES Permit No. MS0053180  
Great River Utility Operating Company, LLC, Mobile Home Park

United States Environmental Protection Agency  
Region 4  
CV-MS-0053180-6-7-2022  
Reconnaissance Inspection Report

On June 7, 2022, the U.S. Environmental Protection Agency, Region 4, conducted a Reconnaissance Inspection (RI) of the Montgomery Quarters LLC, Mobile Home Park wastewater treatment lagoon (the “facility”) located on Token Road in the Montgomery Quarters mobile home park off of South Montgomery Street in Starkville, MS. The Facility is owned and operated by Central States Water Resources Inc. The Wastewater Treatment Plant (WWTP) is operated by a contract operator. Mr. Ross Williams, who is employed by Midwest Water Operations, is the operator of record. The inspection was conducted under the authority of Section 308 of the Clean Water Act (CWA), as amended. This report and attachments present the results of the inspection.

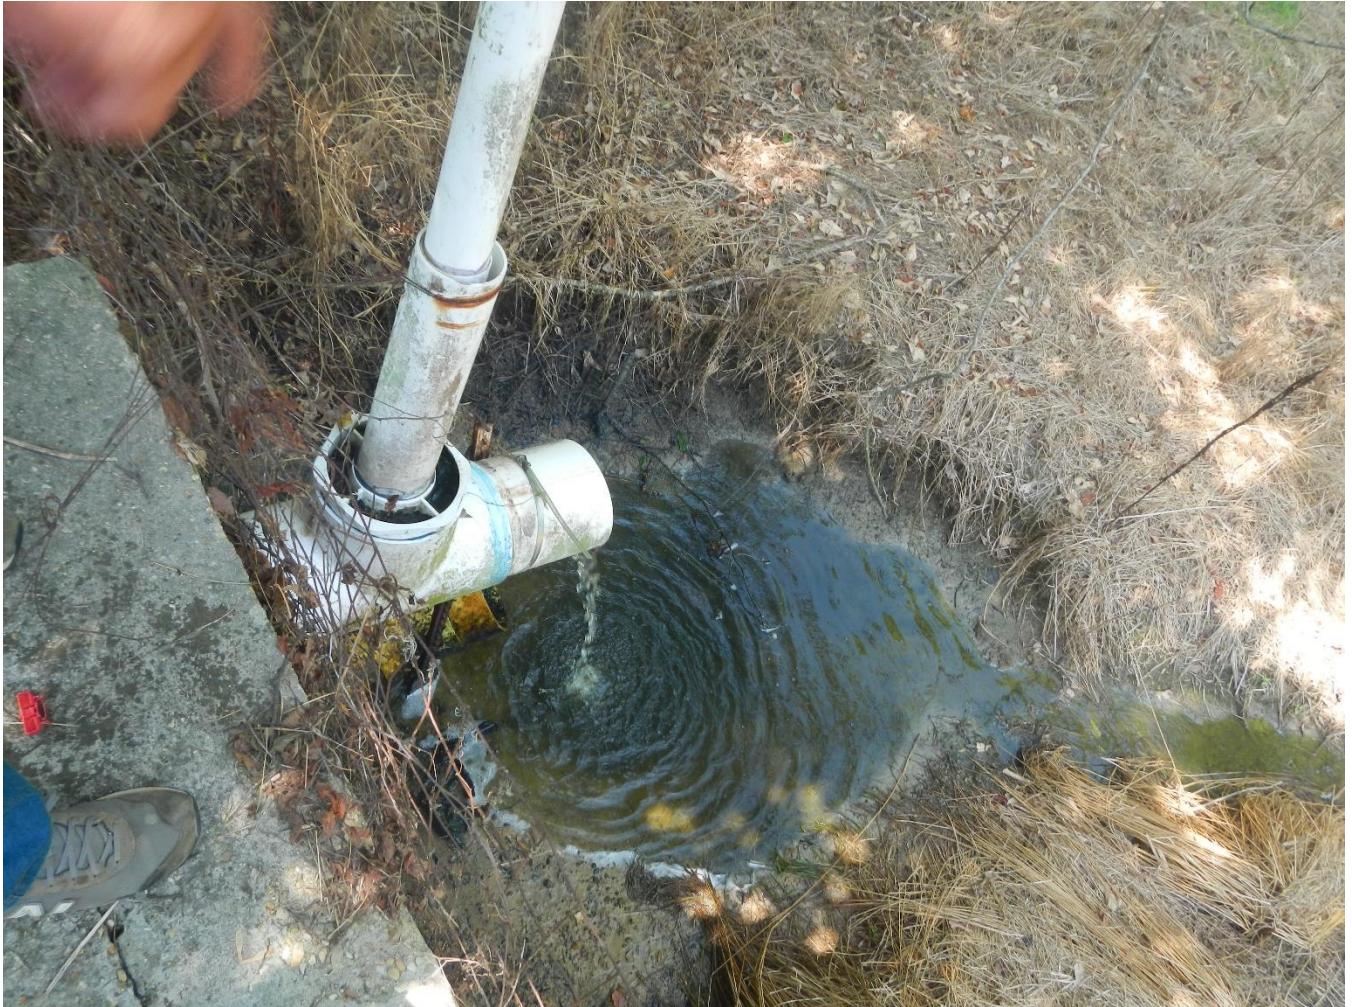
*Figure 1. Effluent discharging directly from the chlorination chamber and not through pipe to permitted discharge point.*

The operator stated that there is a weir in the chlorination chamber. The inside of the chlorination chamber was not accessible. The only reliable and feasible flow measurement method for the Facility was bucket and stopwatch method. Effluent from the lagoon should flow through an outlet pipe, however, the pipe has been damaged and no longer serves to convey flows to the receiving waterbody (Figures 1 and 2). Effluent flows over land and creates channels of erosion leading the receiving stream.

No sheen or foam were observed in the receiving waters. However, the effluent conveyance piping needs repair and the installation of a proper flow measurement device is needed.

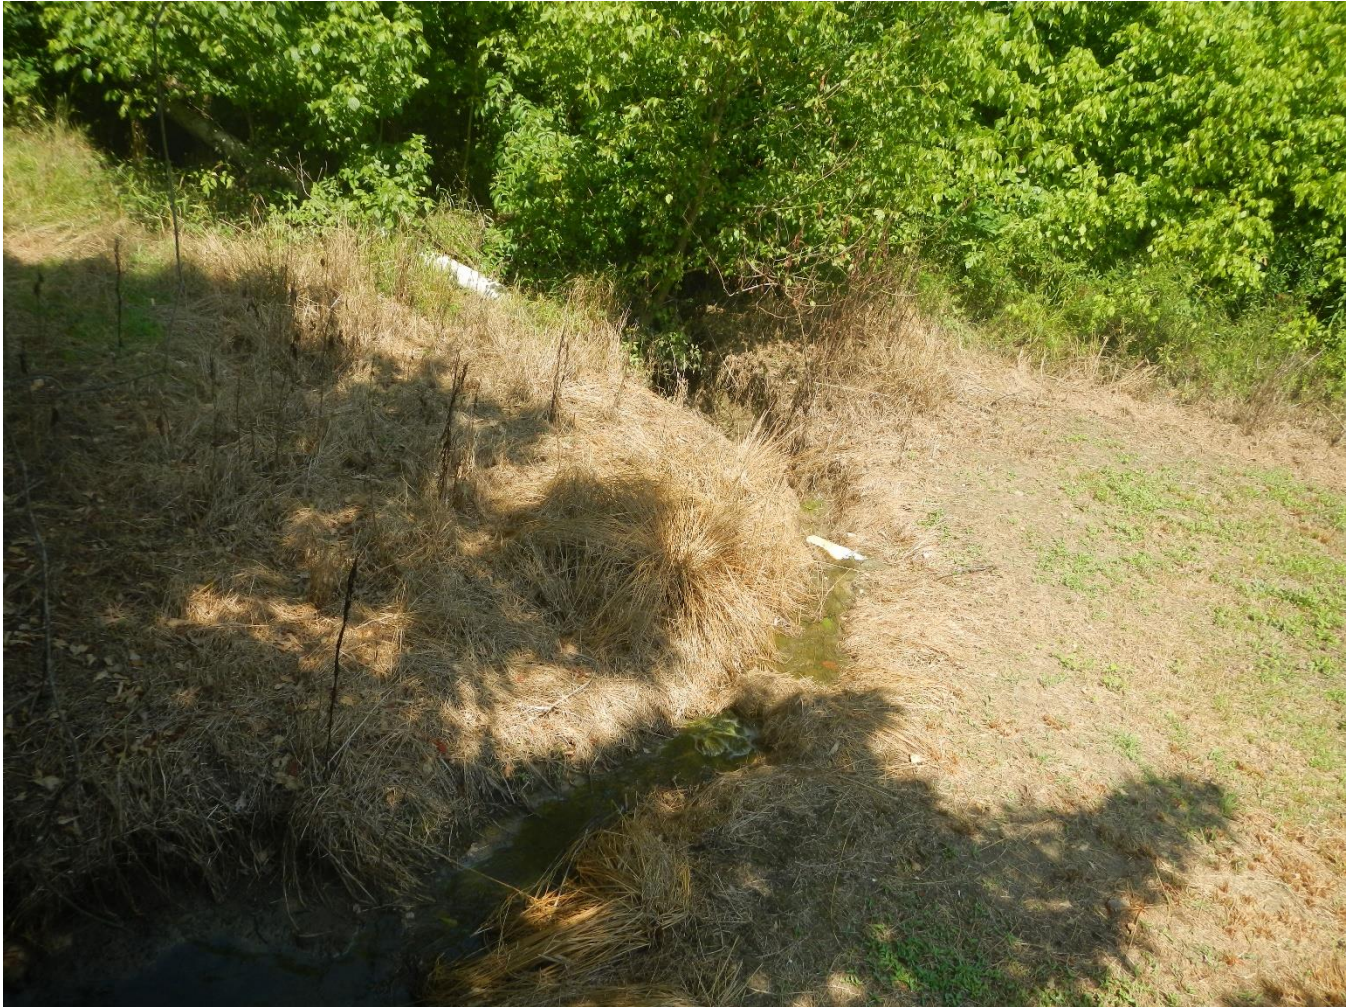
*Figure 2. Disassembled effluent pipe shown below the trees. A ditch in the foreground was made by erosion as effluent discharges from a higher point.*
