## **RCRA Inspection Report**

Safety Kleen Systems, Inc.  
600 Central Park Drive  
Sanford, Florida 32771-6690

March 12, 2024, 9:28 AM

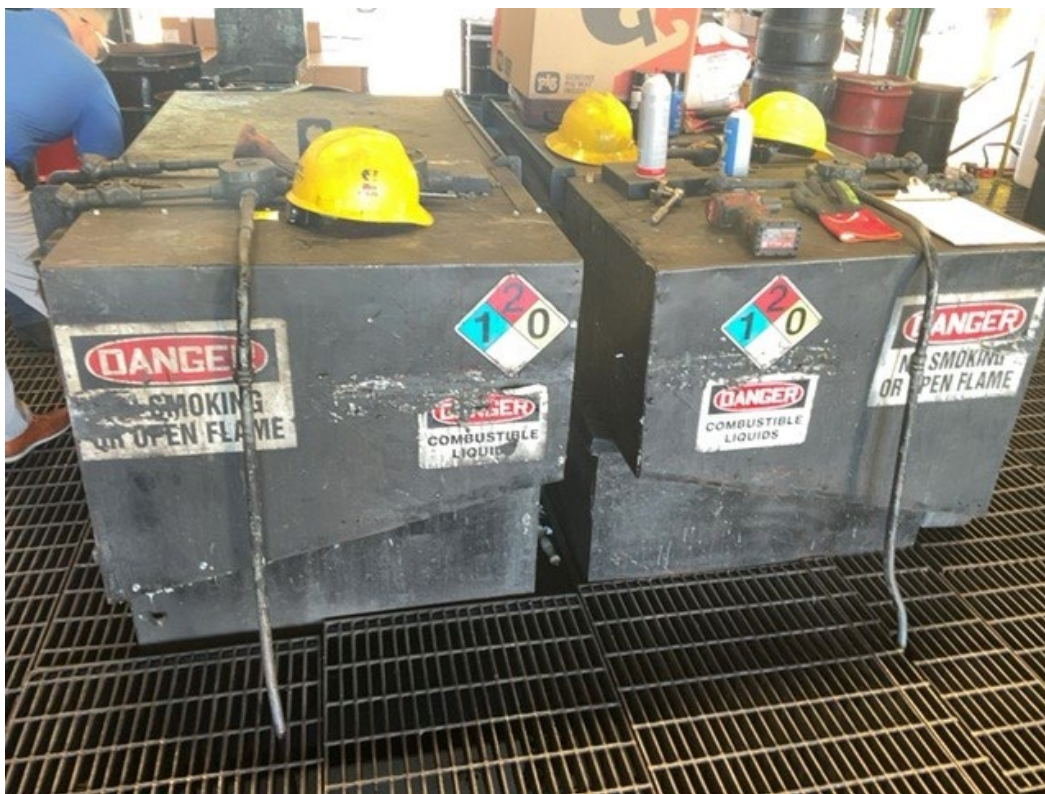
This area consisted of a raised dock with two bays on opposite sides. One bay is used for incoming trucks to off load containers of used parts washer solvent onto the dock and the other bay is used as empty drum storage. Two wet dumpsters sat side by side in the middle of the dock (Photo 1). The wet dumpster is underlain by a 78' 9" x 54' 2" containment area. After trucks pull up to the dock, drums of used parts washer solvent are dumped into the wet dumpsters and pumped into the 20,000-gallon on-site hazardous waste tank. While the wet dumpsters have a capacity of 108-gallons each, no hazardous waste is stored here – each is equipped with an automatic flow gauge that triggers as soon as liquid is added to the wet dumpster. This automatically pumps waste material into the hazardous waste tank. Facility representatives informed inspectors that sludge and debris remaining in the wet dumpster is cleaned and moved to an SAA in the wet dumpster area each day as part of personnel's daily duties.

Inspectors observed that the wet dumpsters were labeled with signs that read "danger no smoking," "combustible liquid" and an NFPA diamond. The wet dumpster was not labeled as hazardous waste as it does not accumulate waste and is transferred immediately to the hazardous waste tank on site. The solvent dumped into the wet dumpsters in the return and fill station is hard piped to the facility tank farm.

Photo 1 –  
Labeling on  
Wet  
Dumpsters in  
the return and  
fill area

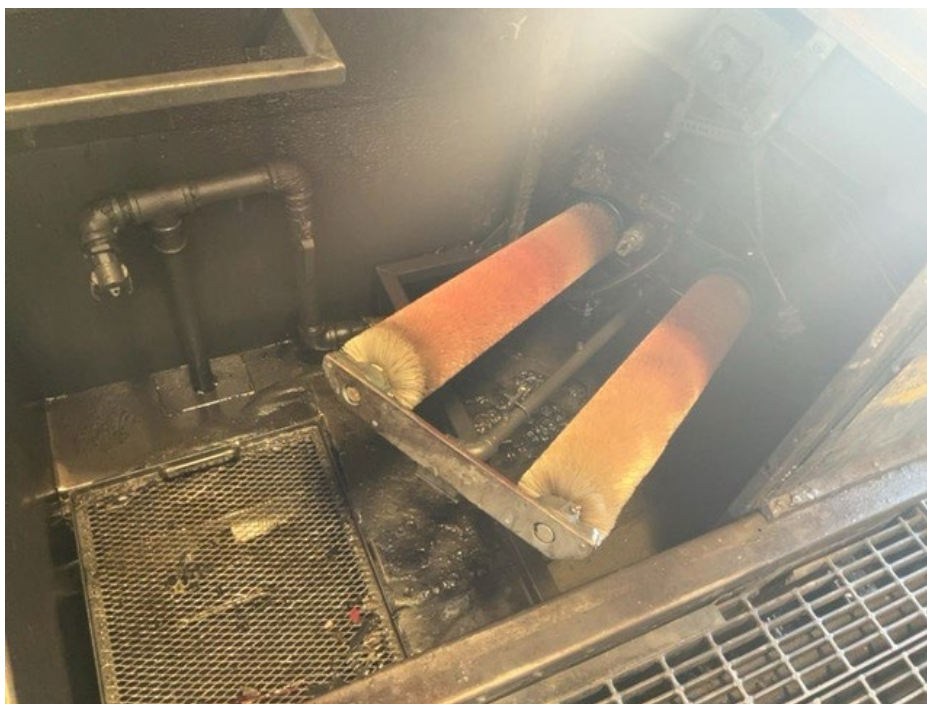
After a drum is emptied into the wet dumpster, it is placed on a rack inside the wet dumpsters and sprayed with water to rinse out residual solvent (Photo 2). Facility representatives informed inspectors the empty drums are staged on the dock near the wet dumpsters. Inspectors observed empty red 15 and 30-gallon containers labeled as parts washer product. Containers are marked with an SK label when picked up which is removed after solvent is placed in wet dumpster. Customers generating hazardous waste solvent get a hazardous waste label and all other containers are labeled as nonhazardous.

Photo 2 –  
Drying rack in  
west dumpster  
in return and  
fill area

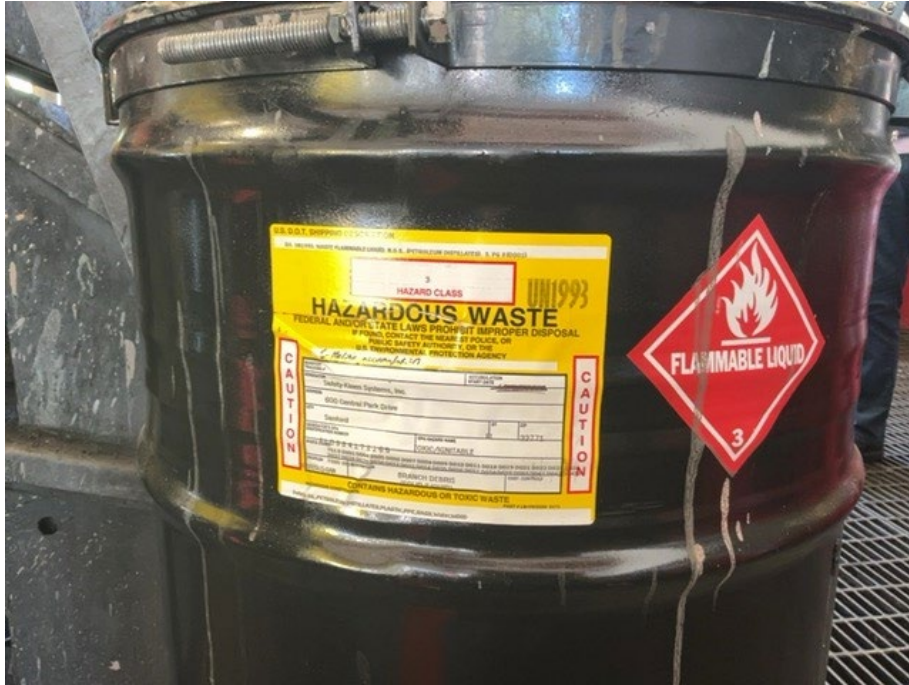
SK manages a SAA near the wet dumpster for the sludge and debris cleaned from the wet dumpster. Inspectors observed a 55-gallon container that was closed and labeled with the words "hazardous waste, toxic." The container was marked with a DOT flammable liquid placard (Photo 3).

Photo 3 –  
Satellite Drum  
in return and  
fill area.

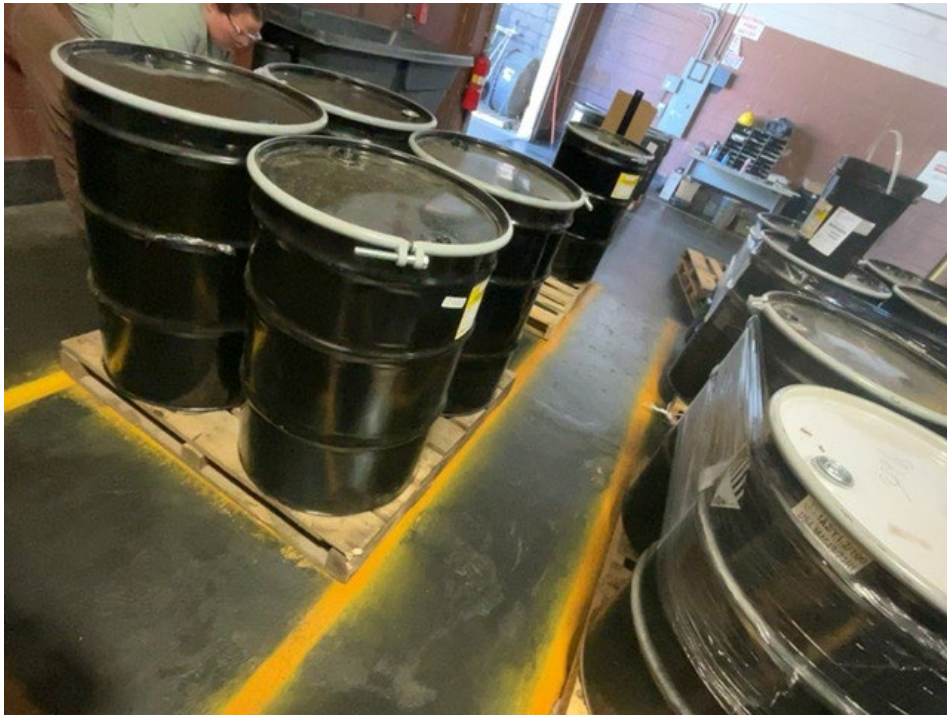
SK operates a transfer facility which stores waste up to 10-days. The 10-day storage area is in the warehouse in a room adjacent to the dump and fill station. Half of this area contained product storage on shelves and half contained waste storage on pallets (Photo 5). All 10-day transfer facility waste is stored in this room. SK operates a branch generated hazardous waste central accumulation area (CAA) and two SAAs co-located with the transfer facility waste on separate pallets in the corner of the rooms. Inspectors recommend a clearer distinction between the transfer waste and site generated waste for inspection purposes.

Photo 5 - 10-day and 90-day storage area

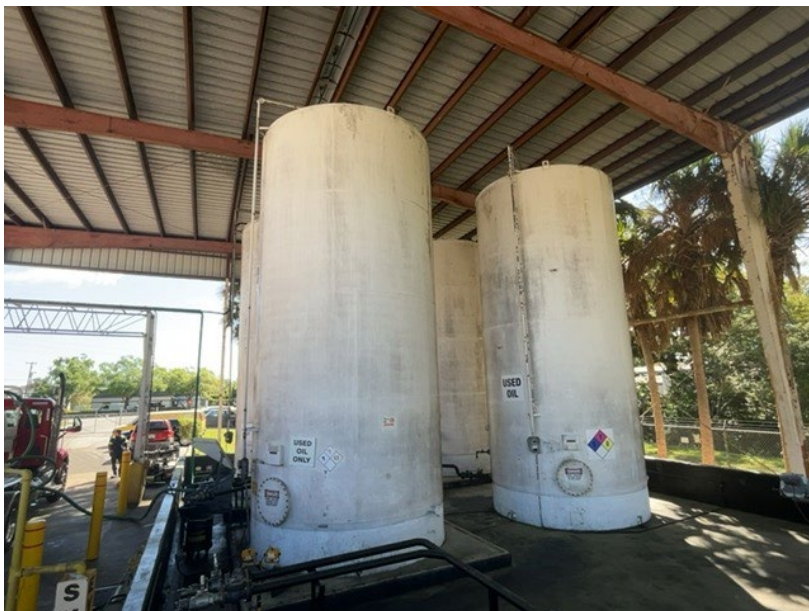
The facility tank farm contains the following tanks (Photo 6):

- One tank of clean solvent product with a 20,000-gallon capacity labeled solvent with an NFPA diamond and no smoking sign; and
- One hazardous waste used parts washer solvent tank with a 20,000-gallon capacity. This tank was labeled with the words “hazardous waste, waste solvent, Combustible Liquid” and was marked with a faded but legible NFPA label. Inspectors recommended this label be replaced to provide clearer hazard communication.

Photo 6 - Safety Kleen Tank Farm

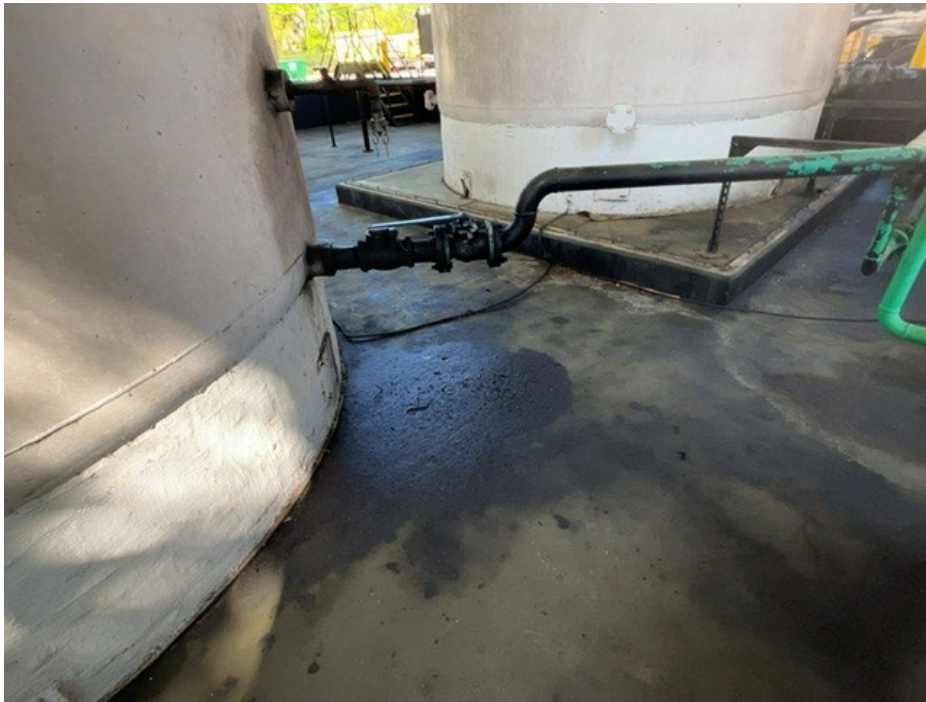
- One used oil tank with a 12,000-gallon capacity. This tank was labeled “used oil” and was marked with an NFPA diamond;
- Two used oil tanks with a 20,000-gallon capacity. These tanks were labeled “used oil” and were marked with NFPA diamonds. Inspectors observed a small oil spot underneath a piece of equipment on a used oil tank (Photo 7). Facility representatives explained that a leak from the pump on the used oil tank had recently been repaired and the spill would be addressed as part of personnel’s daily duties. Inspectors requested photo documentation of the spill cleaned up following the inspection. These photos were received on March 19, 2024;

Photo 7 - Oil  
Leak from used  
oil tank
