**Region 6 - Enforcement & Compliance Assurance Division**  
**INSPECTION REPORT**

| Inspection Date(s): | 12/02/2025 | |
| Company Name: | <b>Pharr, Billy W (dba B Pharr Operating, LLC)</b> | |
| Facility Name: | <b>Bo Gregory #2 SWD Tank Battery</b> | |

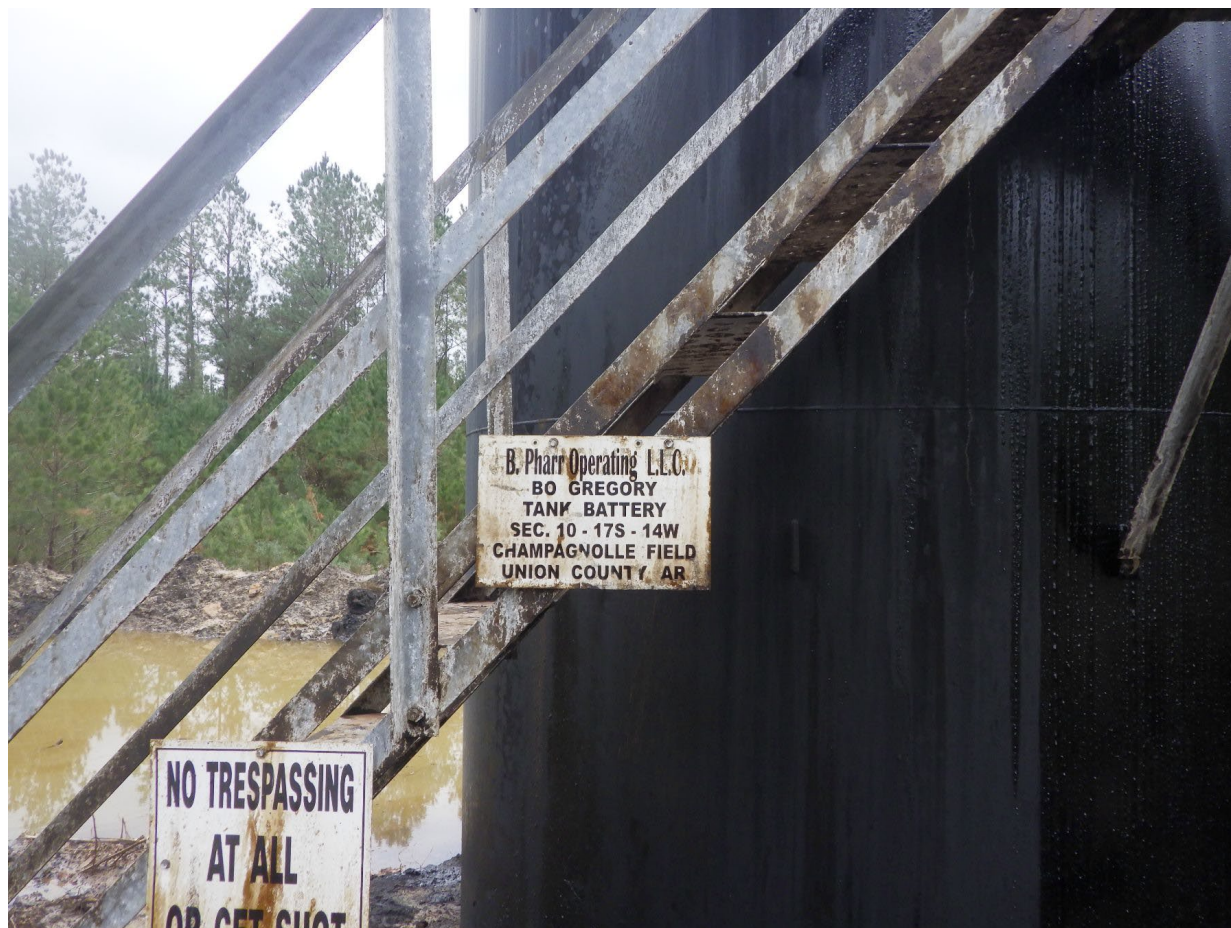
Photo No. 1

| Description: | Looking SW, this photo shows the signage identifying the company and lease names of the B Pharr Operating - Bo Gregory 2 SWD Tank Battery (facility). | | |

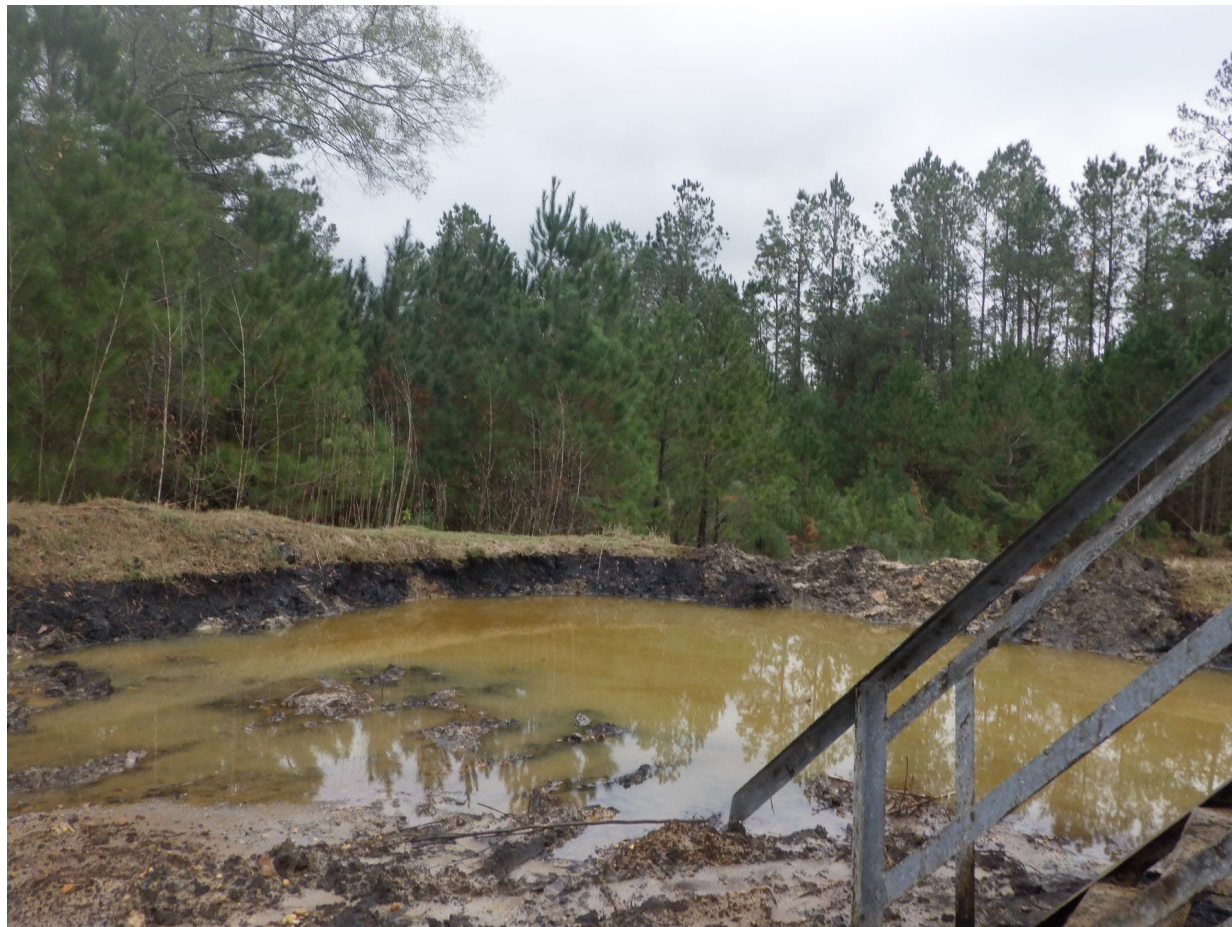
I observed loose oil and oil staining inside the secondary containment, see Photo No. 2 through No. 5.

| Description: | Looking SE, this photo shows an interior view of the sump area of the containment with oil staining on the levee and oil sheen on the surface of accumulated stormwater. | | |

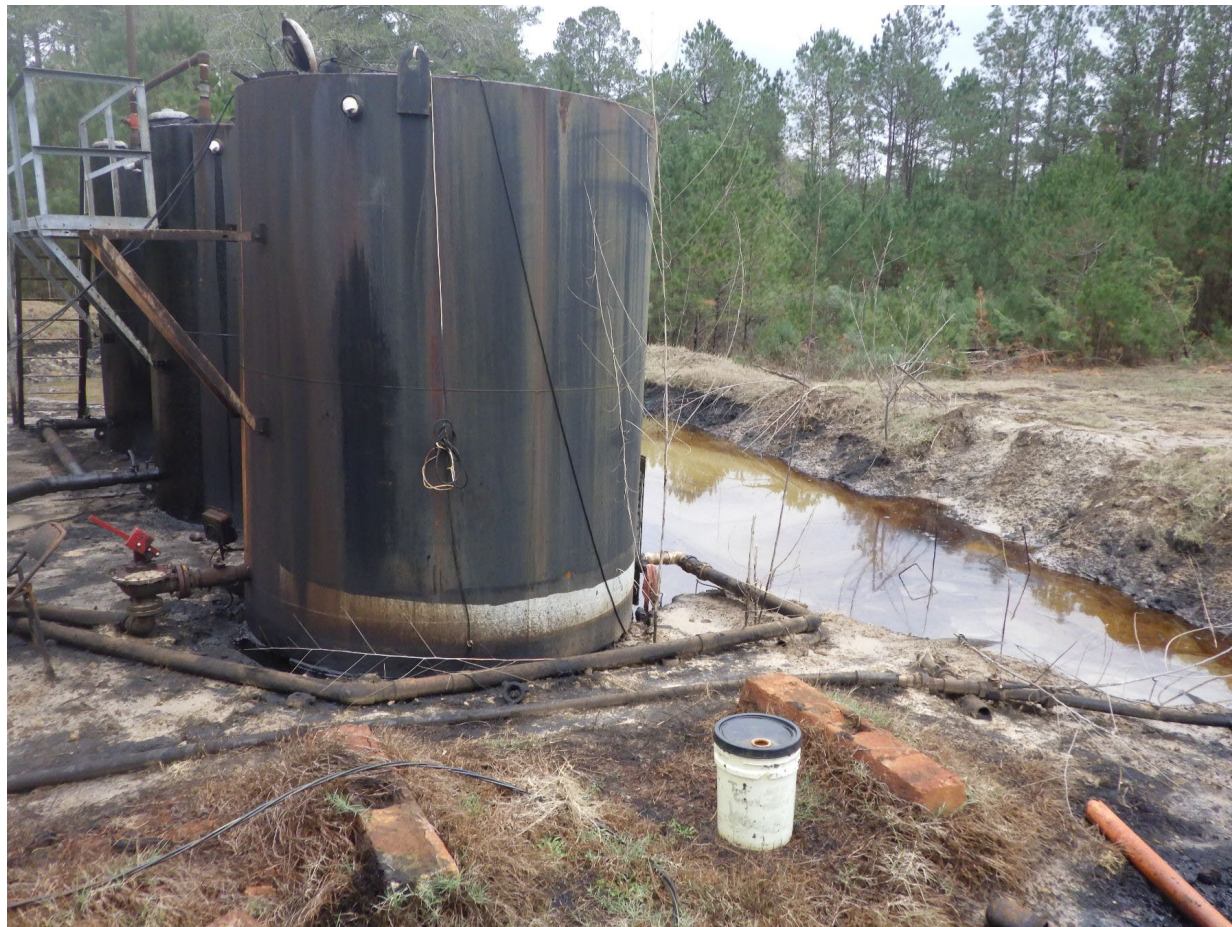
Photo No. 3

| Description: | Looking ENE, this photo shows an interior view of the storage tanks in front of the sump area inside containment. The photo also shows oil staining on the containment levee, loose oil around tanks, and oil sheening on the surface of accumulated stormwater. | | |

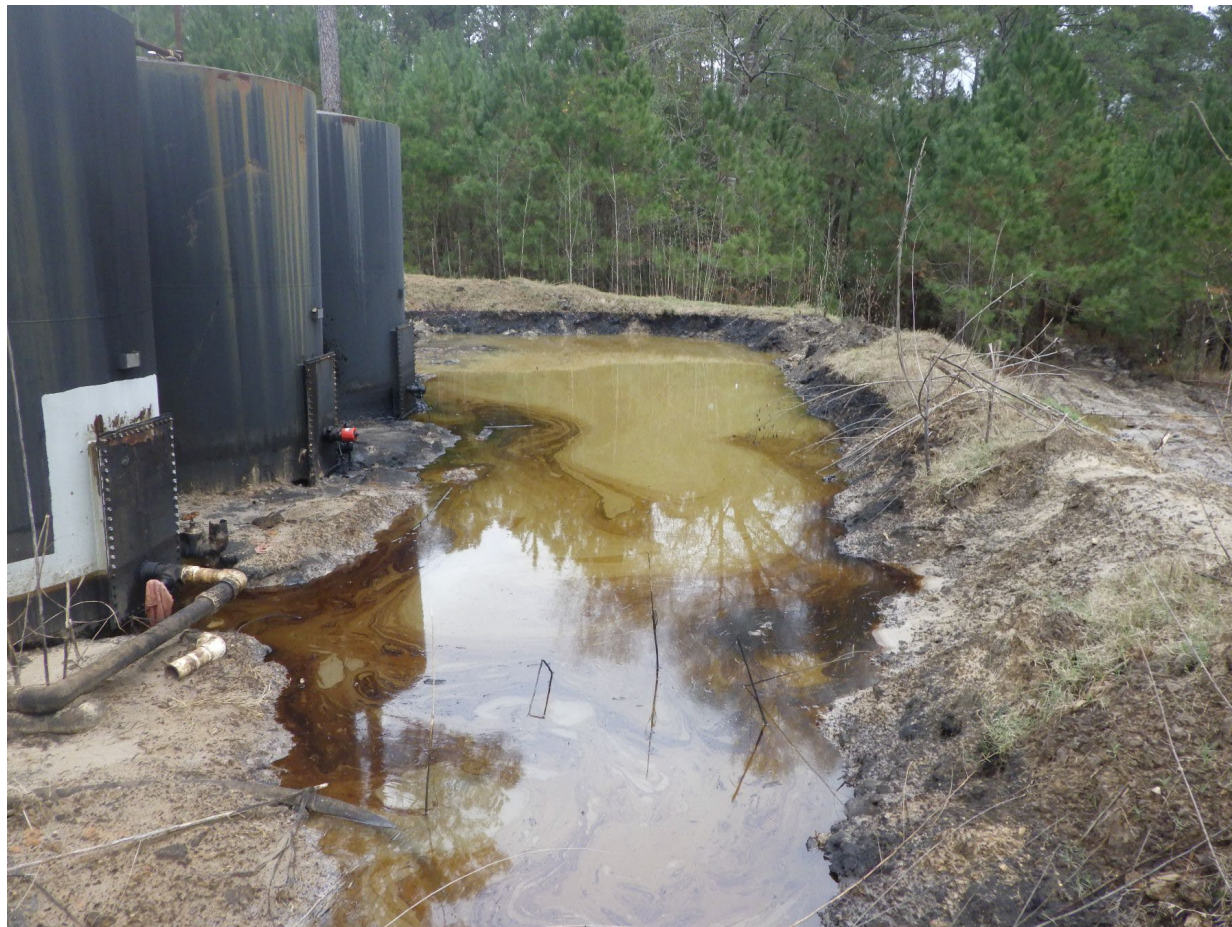
Photo No. 4

| Description: | Looking NE, this photo shows the interior view of the sump area inside containment with oil staining on the containment levee and oil sheening on the surface of accumulated stormwater. | | |

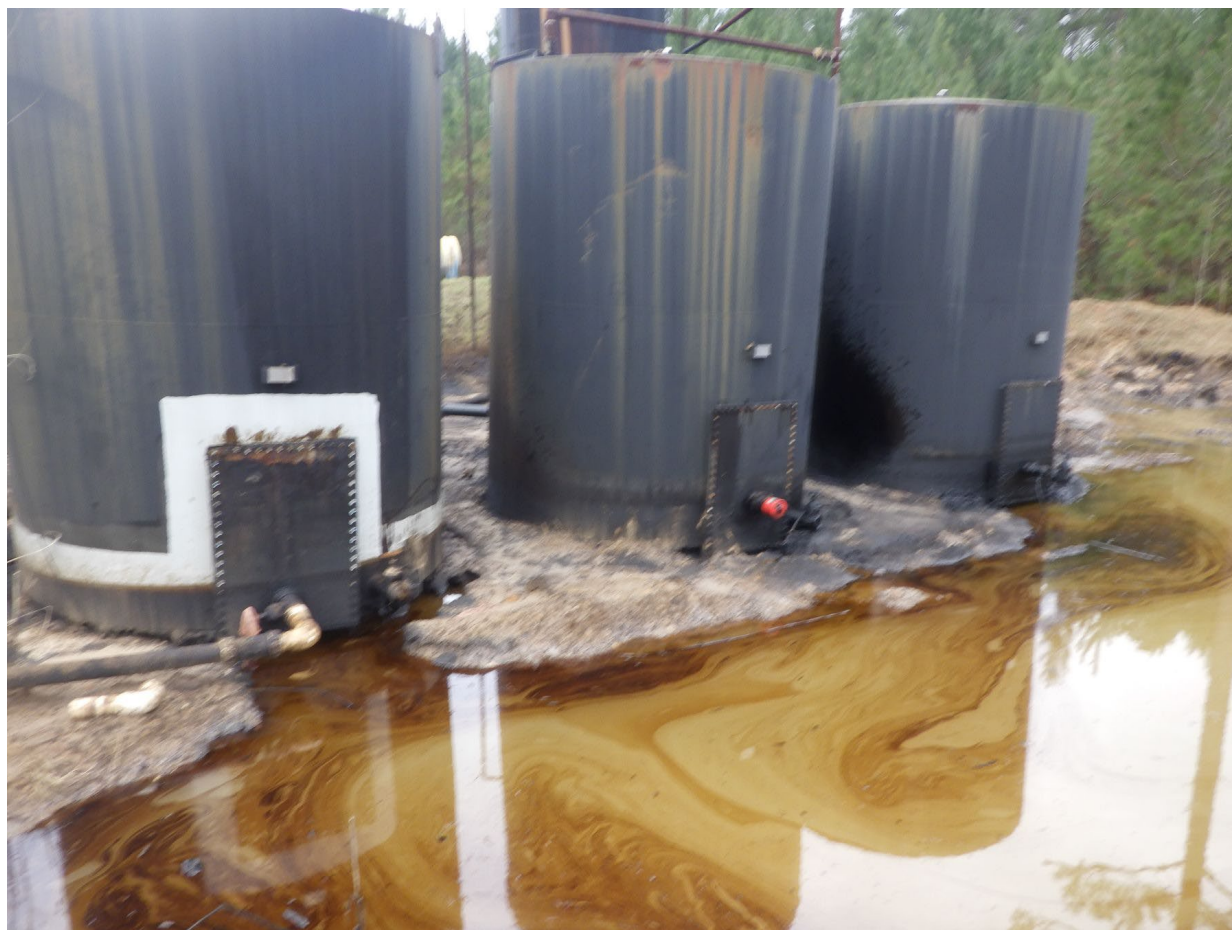
Photo No. 5

I observed an active leak of saltwater from a valve from a tank inside secondary containment, see Photo No. 5.

| Description: | Looking NNE, this photo shows the storage tanks used for crude oil and saltwater storage. This photo also shows loose oil and oil sheening inside containment. | | |

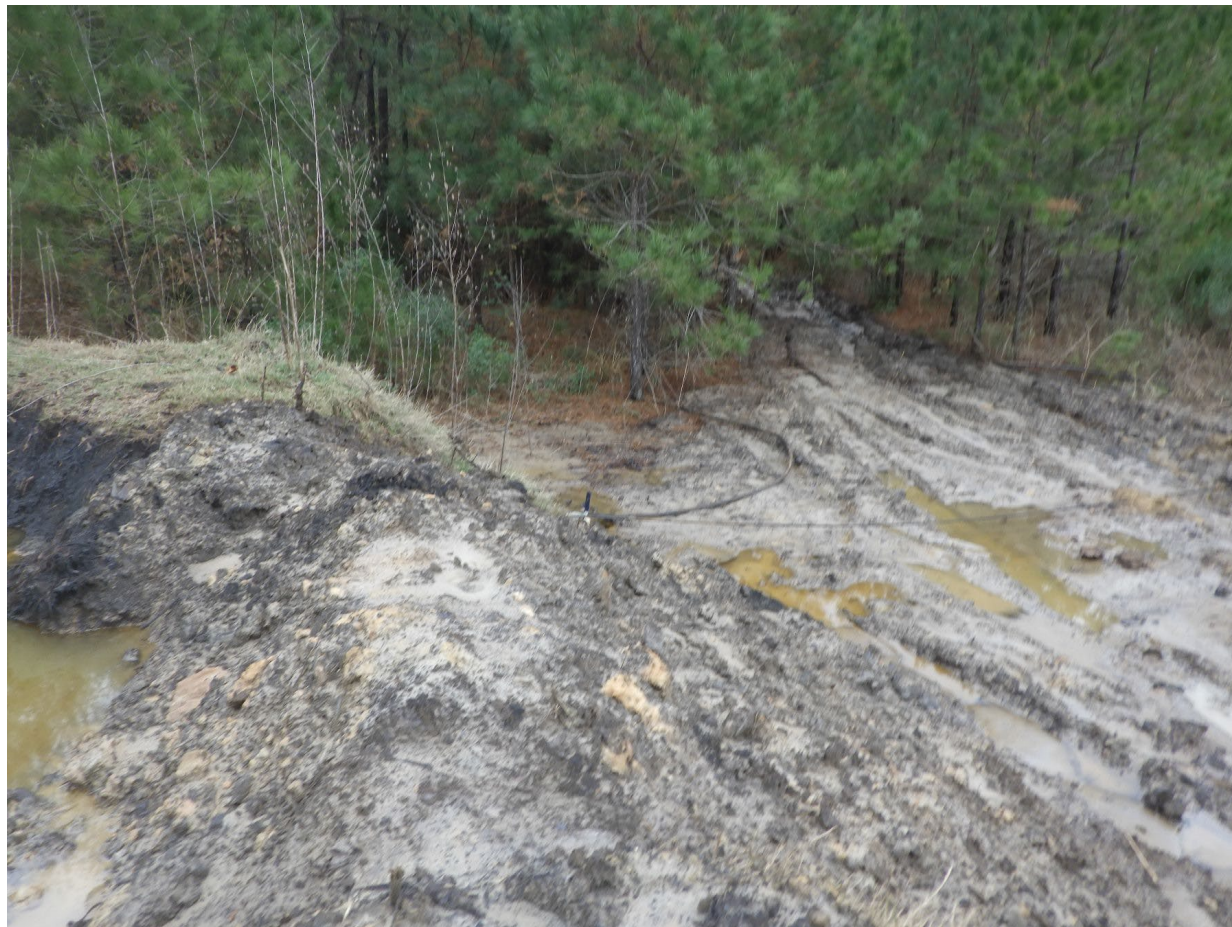
I observed disturbed soil at the drainpipe for the secondary containment berm, see Photo No. 6 through No. 10.

| Description: | Looking NE, this photo shows both the exterior and interior of the containment levee with disturbed soil observed around the drainpipe. | | |

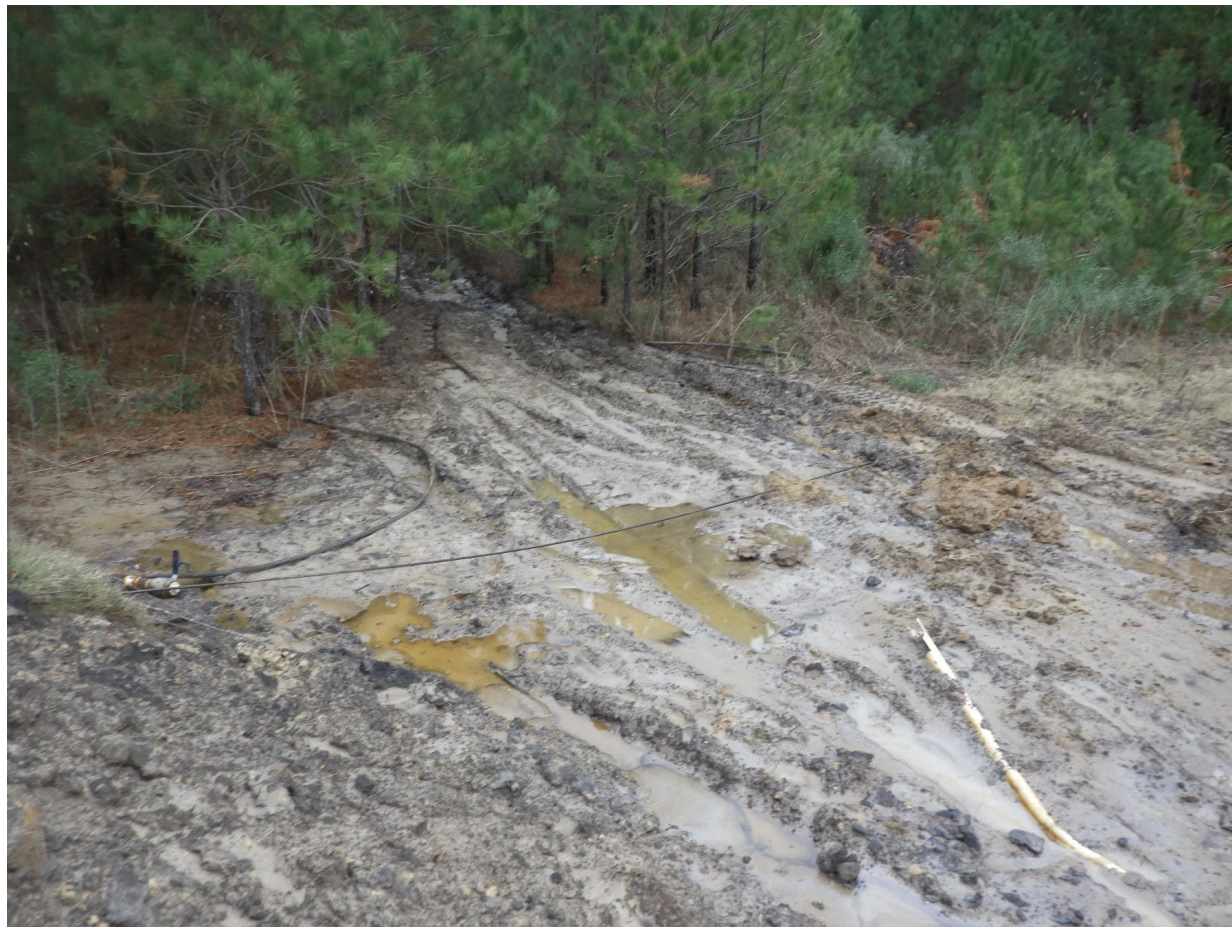
Photo No. 7

| Description: | Looking NE, this photo shows an additional view from Photo #6 with disturbed soil and the valve from the drainpipe removed. | | |

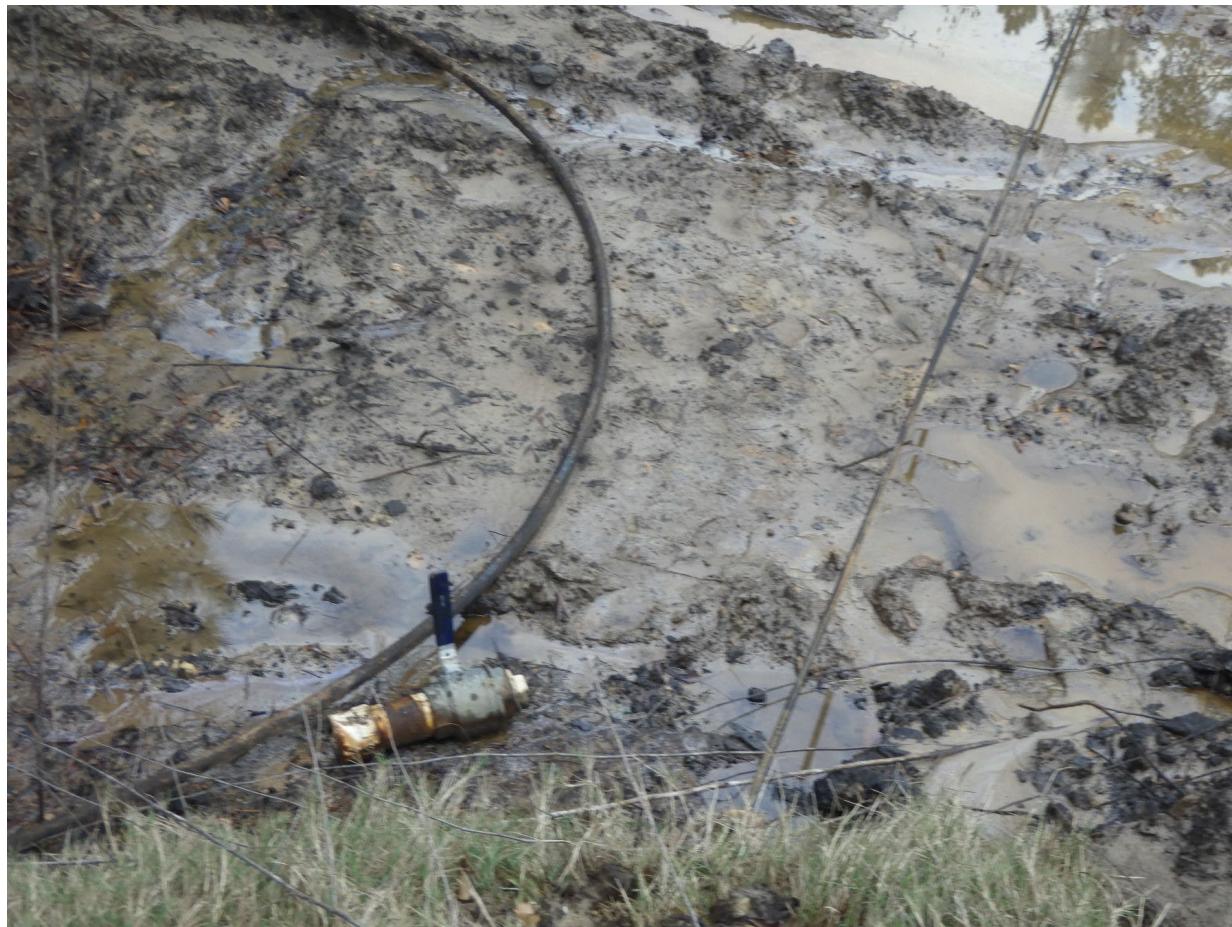
Photo No. 8

| Description: | Looking N, this photo shows a closeup of the valve that had been removed from the drainpipe from Photo #7. | | |

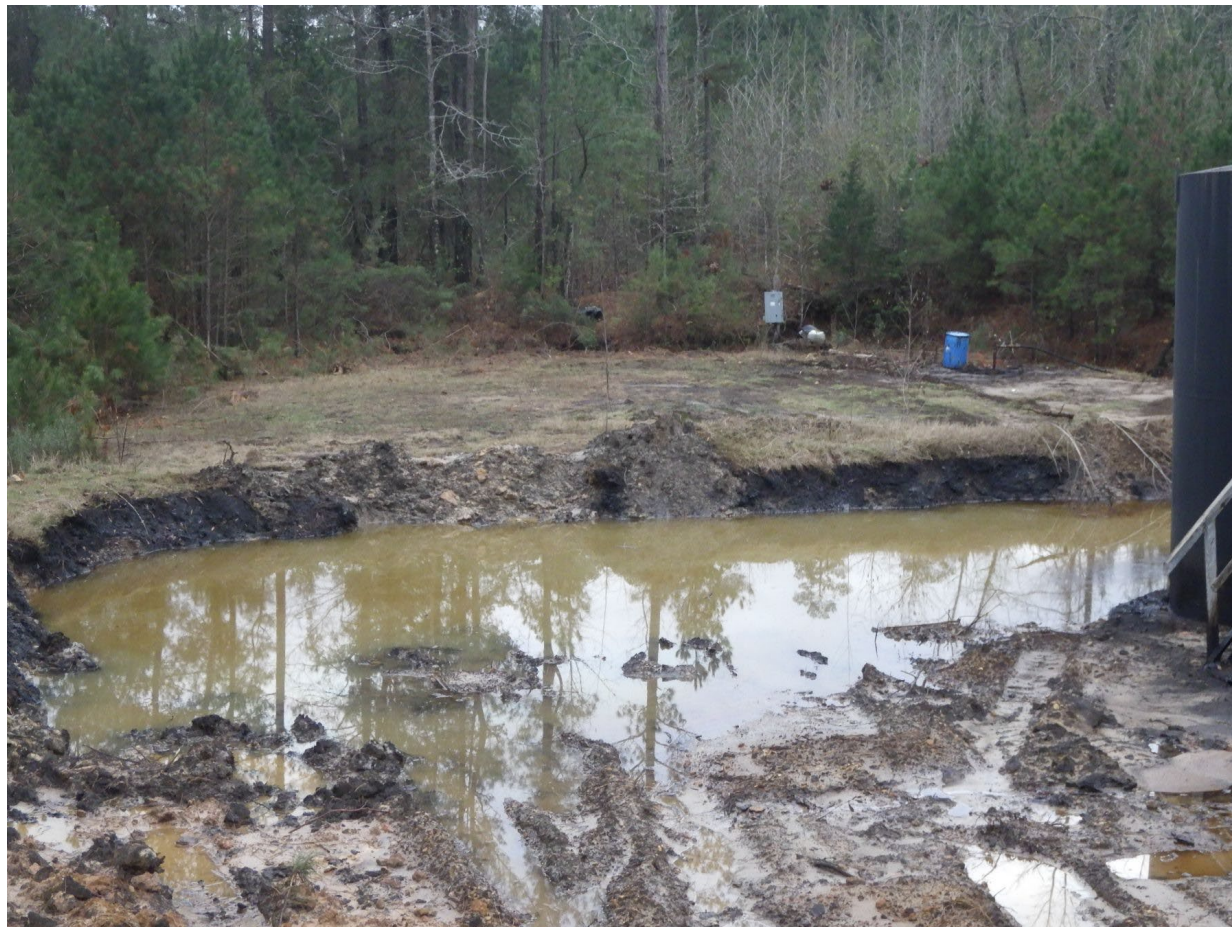
Photo No. 9

| Description: | Looking W, this photo shows the interior view of a disturbed area within the levee of the containment structure. This photo also shows a larger area of disturbed soil and a saltwater disposal (SWD) in the background. | | |

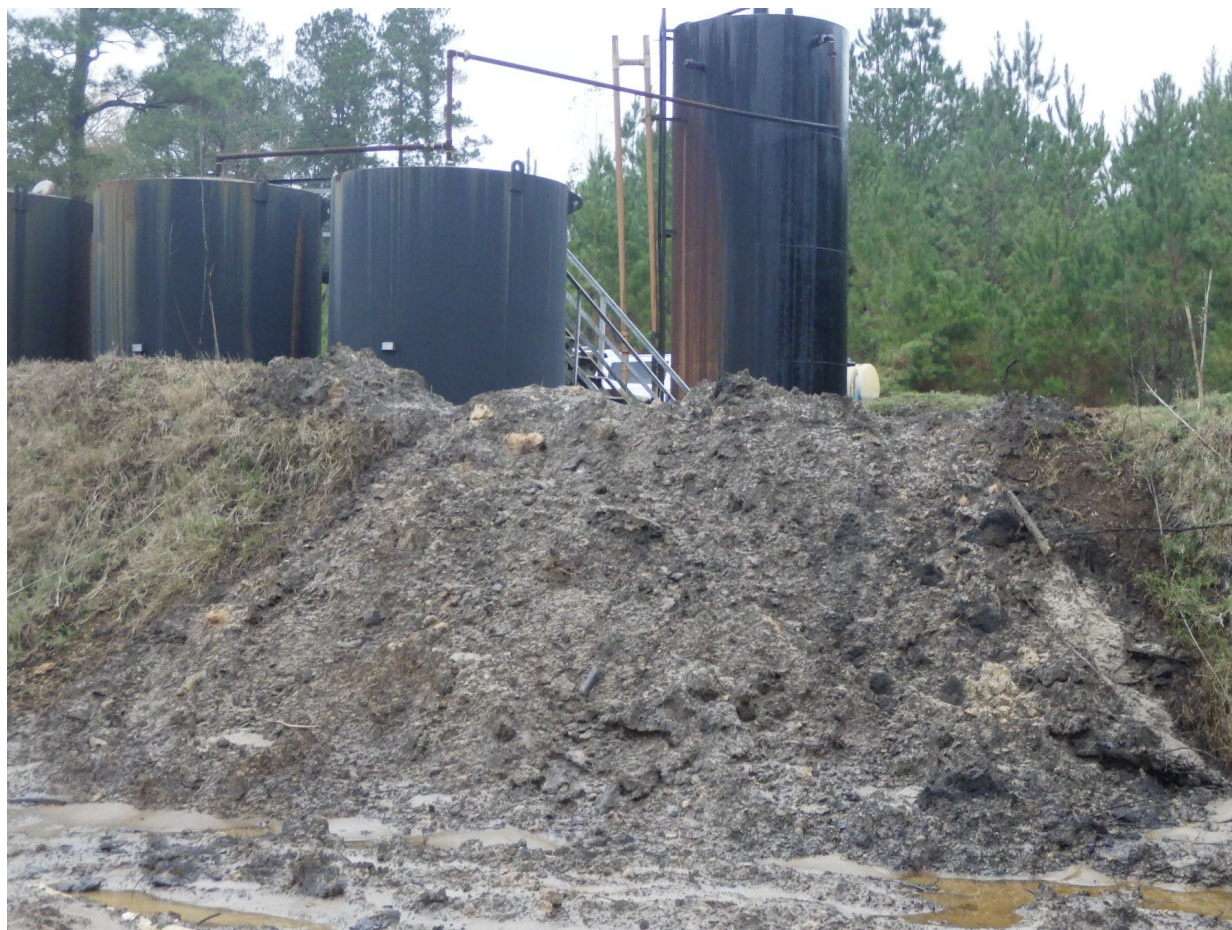
Photo No. 10

| Description: | Looking N, this photo shows the exterior view of the disturbed area within the containment levee. | | |

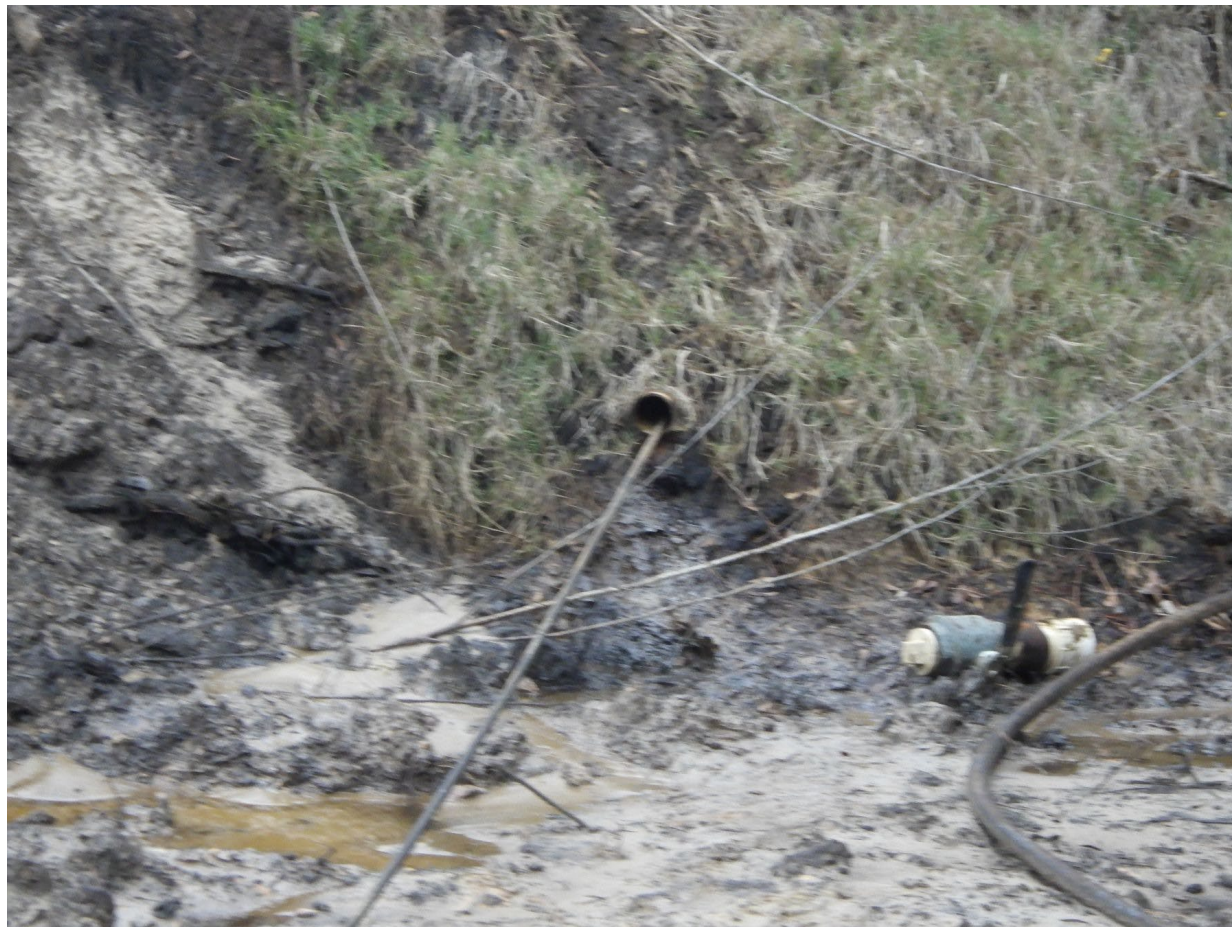
Photo No. 11

I observed the drainpipe for the secondary containment berm, see Photo No. 11.

| Description: | Looking N, this photo shows the exterior view of the drainpipe for the containment structure with the valve and cap removed. | | |

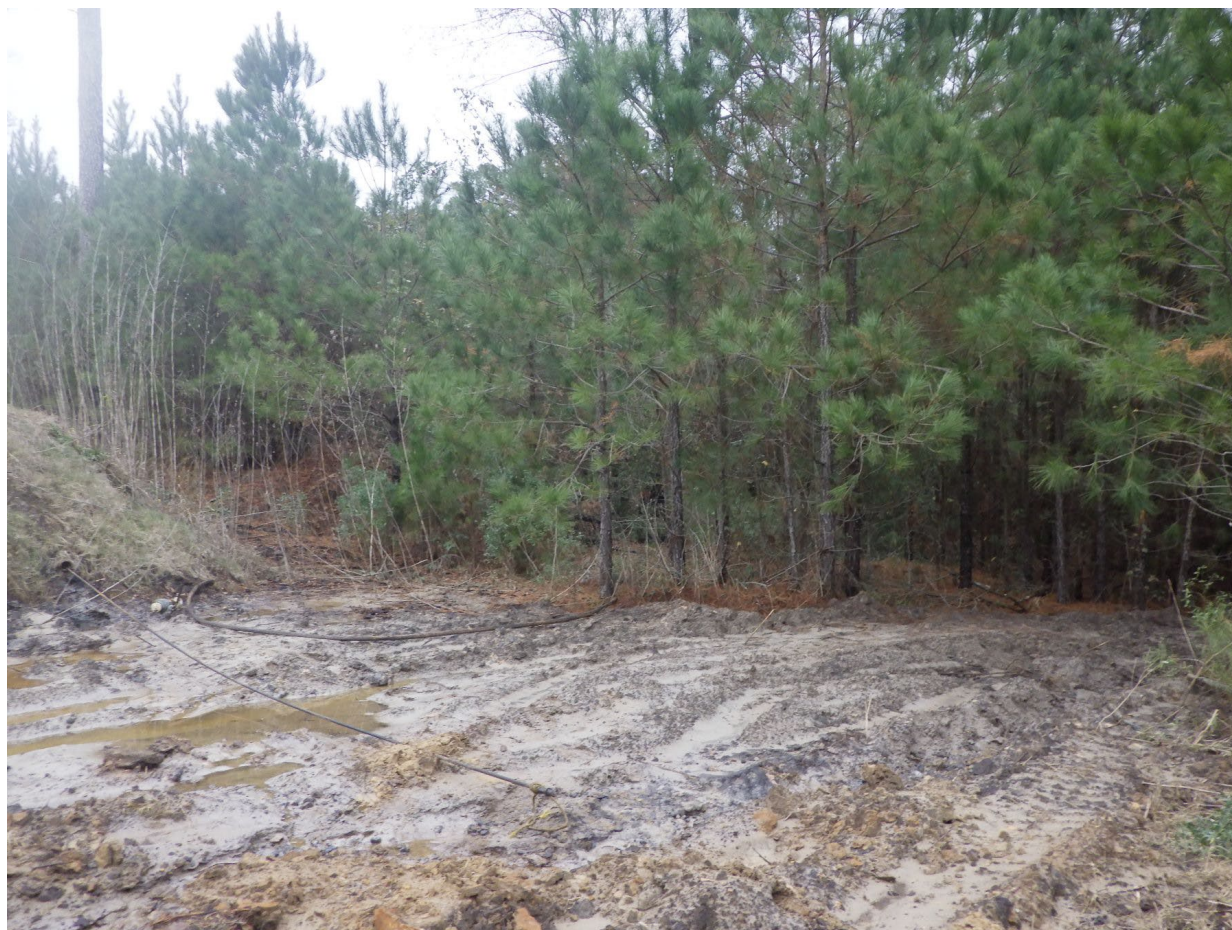
I observed disturbed soil and stormwater flow indicators leading into a wooded area adjacent to the secondary containment berm, see Photo No. 12 through No. 14.

| Description: | Looking NE, this photo shows an area outside containment with disturbed soil and stormwater (surface) flow indicators. | | |

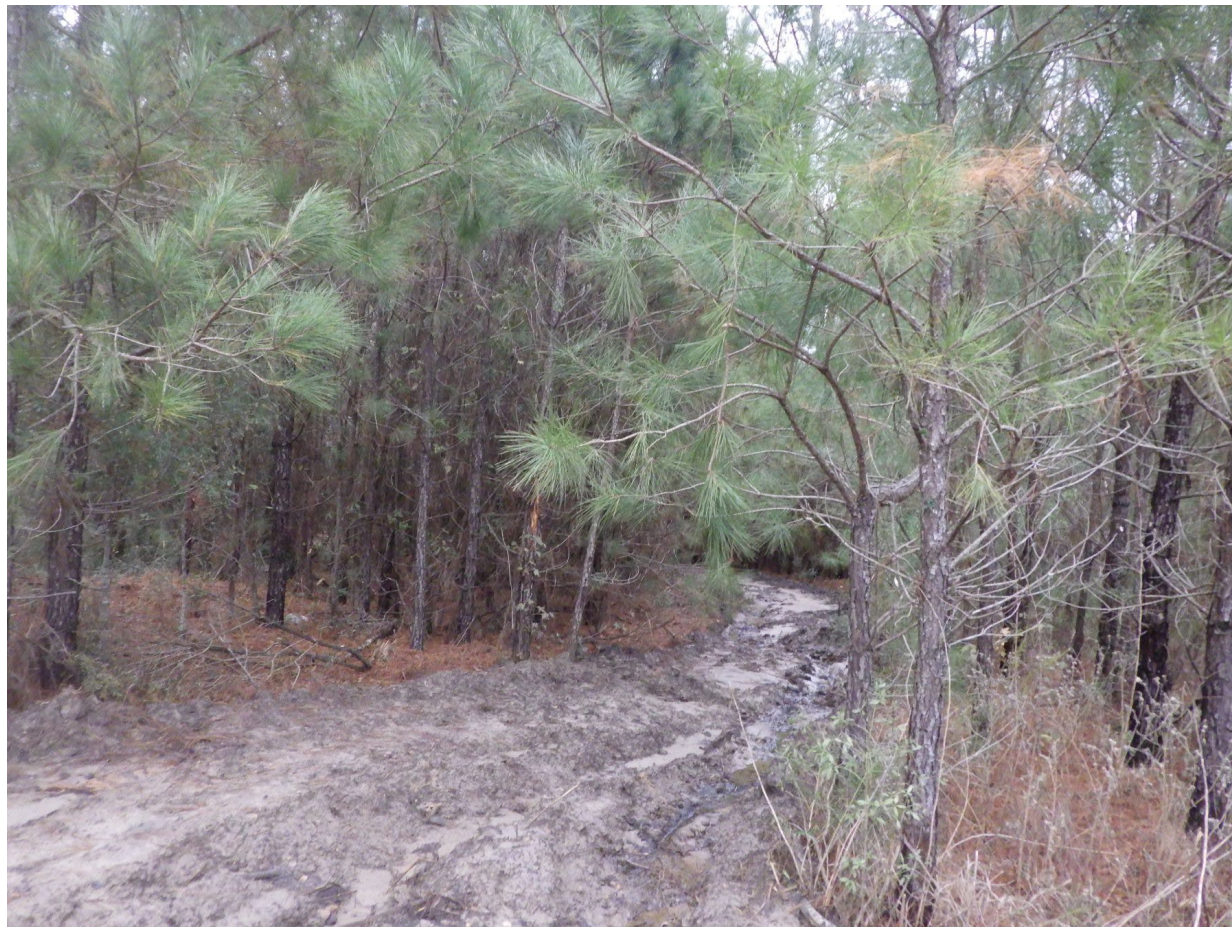
Photo No. 13

| Description: | Looking ENE, this photo shows a continuation of the stormwater flow path and disturbed soil from Photo #12. | | |

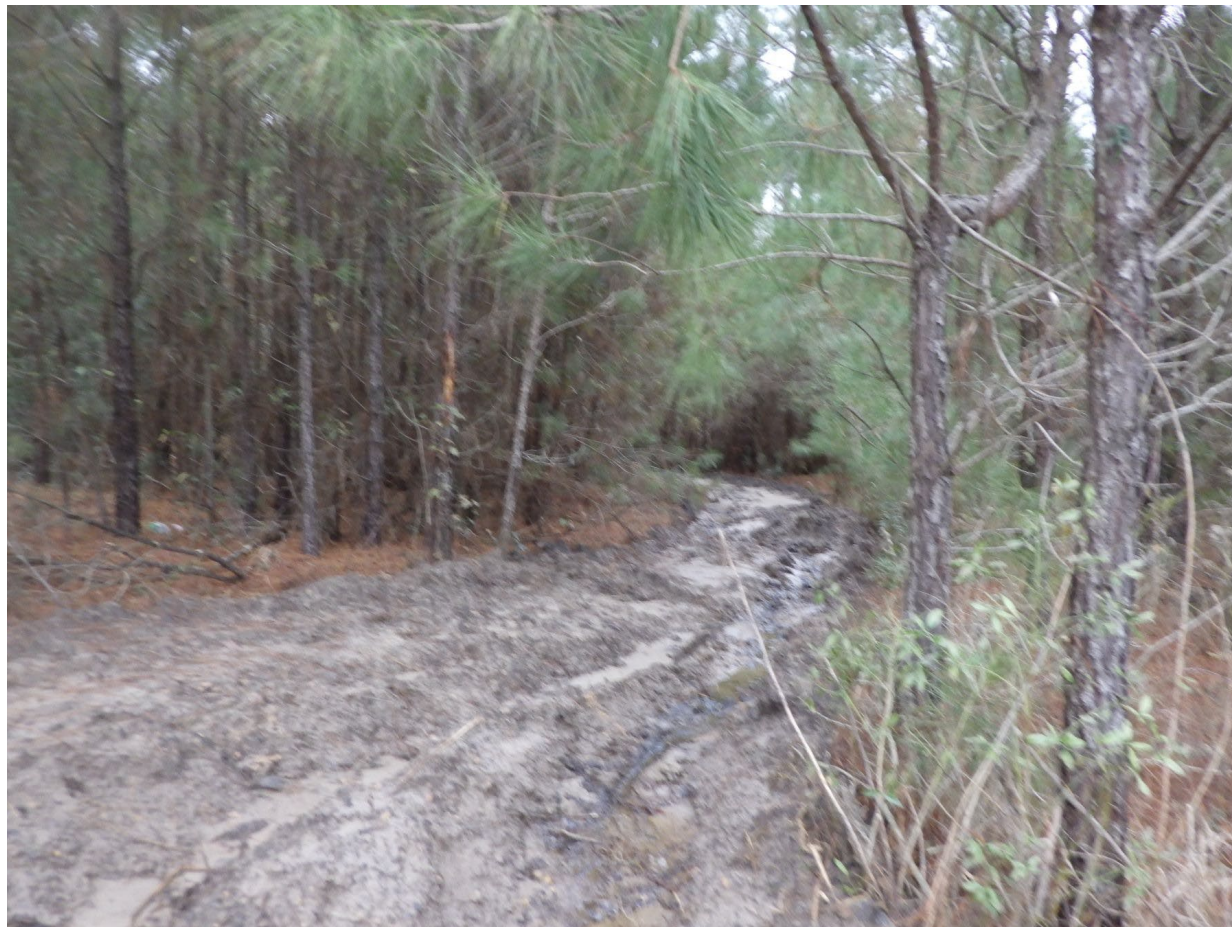
Photo No. 14

| Description: | Looking ENE, this photo shows a continuation of the stormwater flow path and disturbed soil from Photo #13. | | |
