**Region 6 - Enforcement & Compliance Assurance Division**  
**INSPECTION REPORT**

| Media: | RCRA Compliance Evaluation Inspection | | |
| Company Name: | Choctaw Manufacturing and Defense Contractors | | |
| Facility Name: | Choctaw Manufacturing and Defense Contractors McAlester | | |

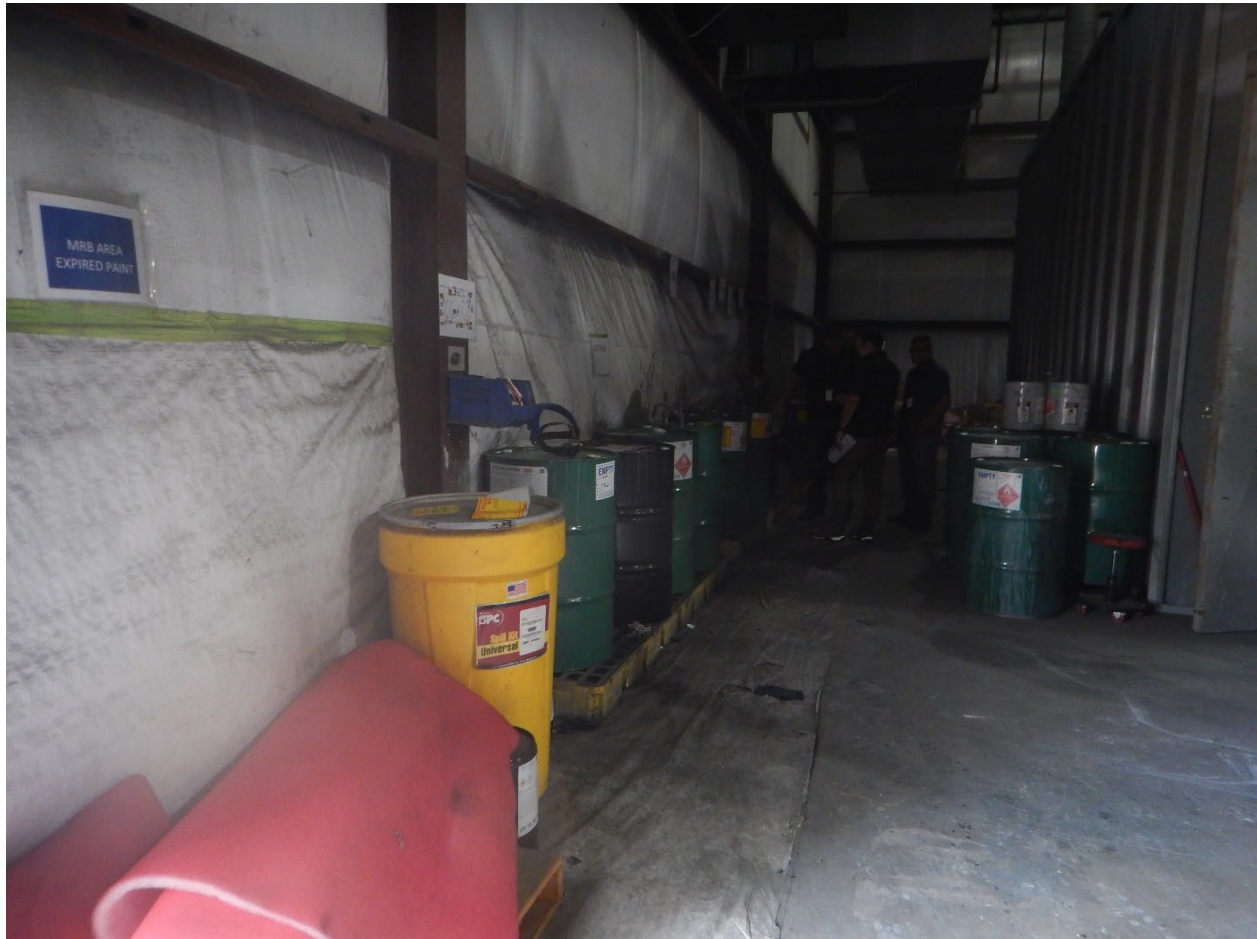
Photo No. 1

We observed waste drums, marked as hazardous waste, staged at the south side of Building 5. A few of these drums were missing accumulation start dates. Two full drums with spent solvent paint waste had no origination dates. Another undated third drum with a spent solvent was found with an open funnel. Also, a fourth drum with paint waste was present at the SAA without an origination date. We observed a drum with aerosol cans marked as hazardous waste.

| Description: | SAA overview inside Building 5 |

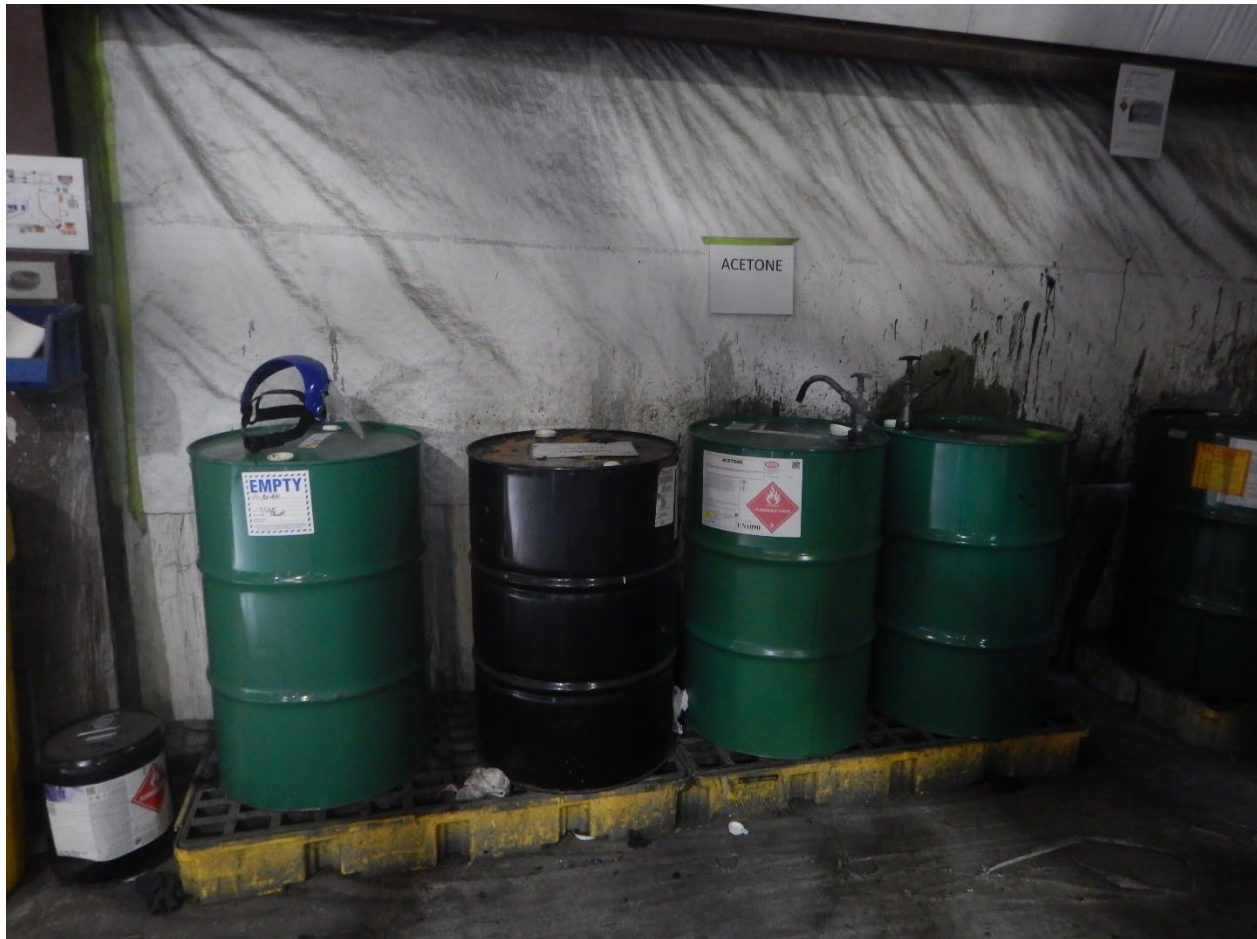
Photo No. 2

| Description: Acetone Drums inside Building 5 | |

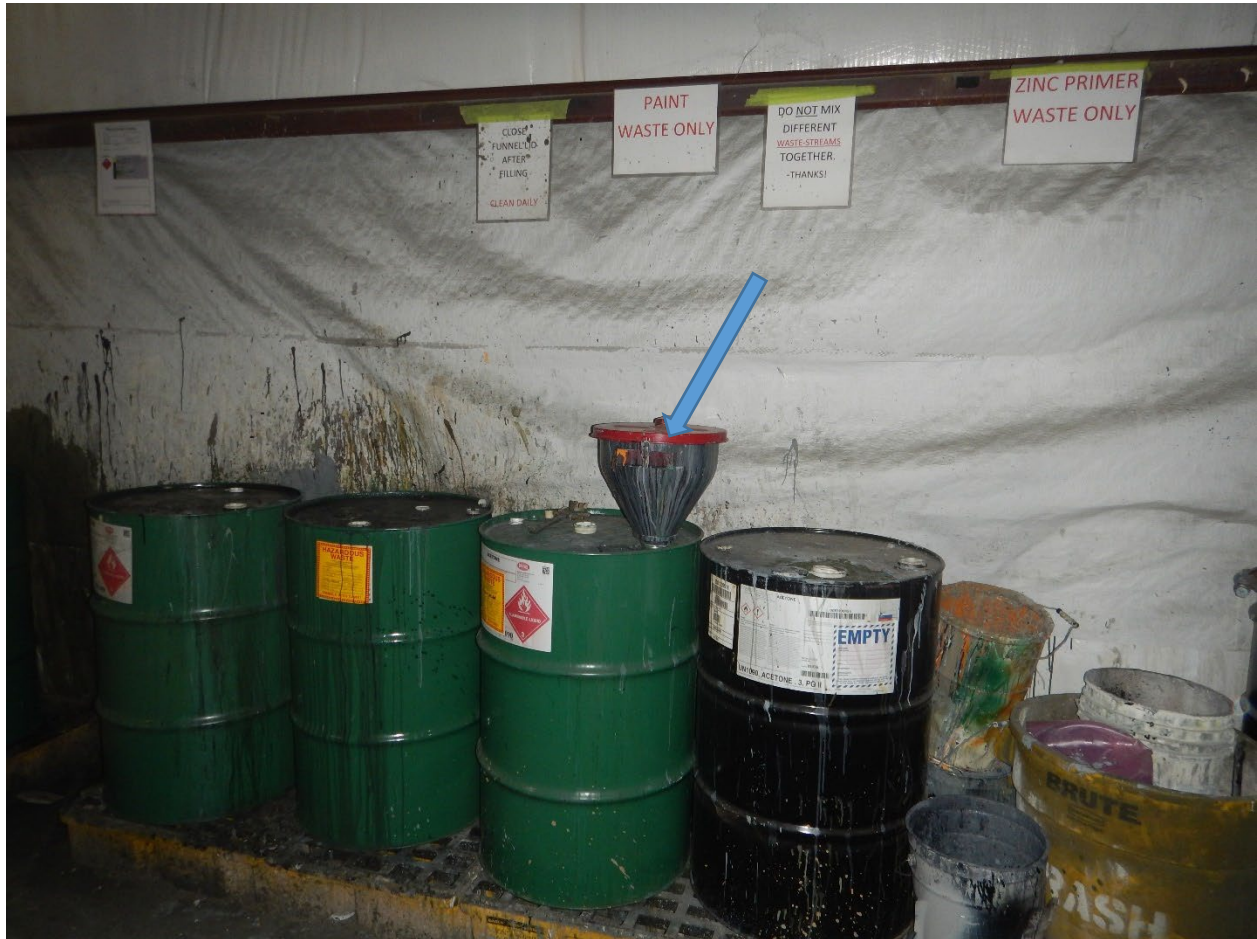
| Photo #: | DSCN0745.JPG |

| Description: Label of paint waste drum #1 located at SAA inside Building 5. Note missing accumulation start date. | |

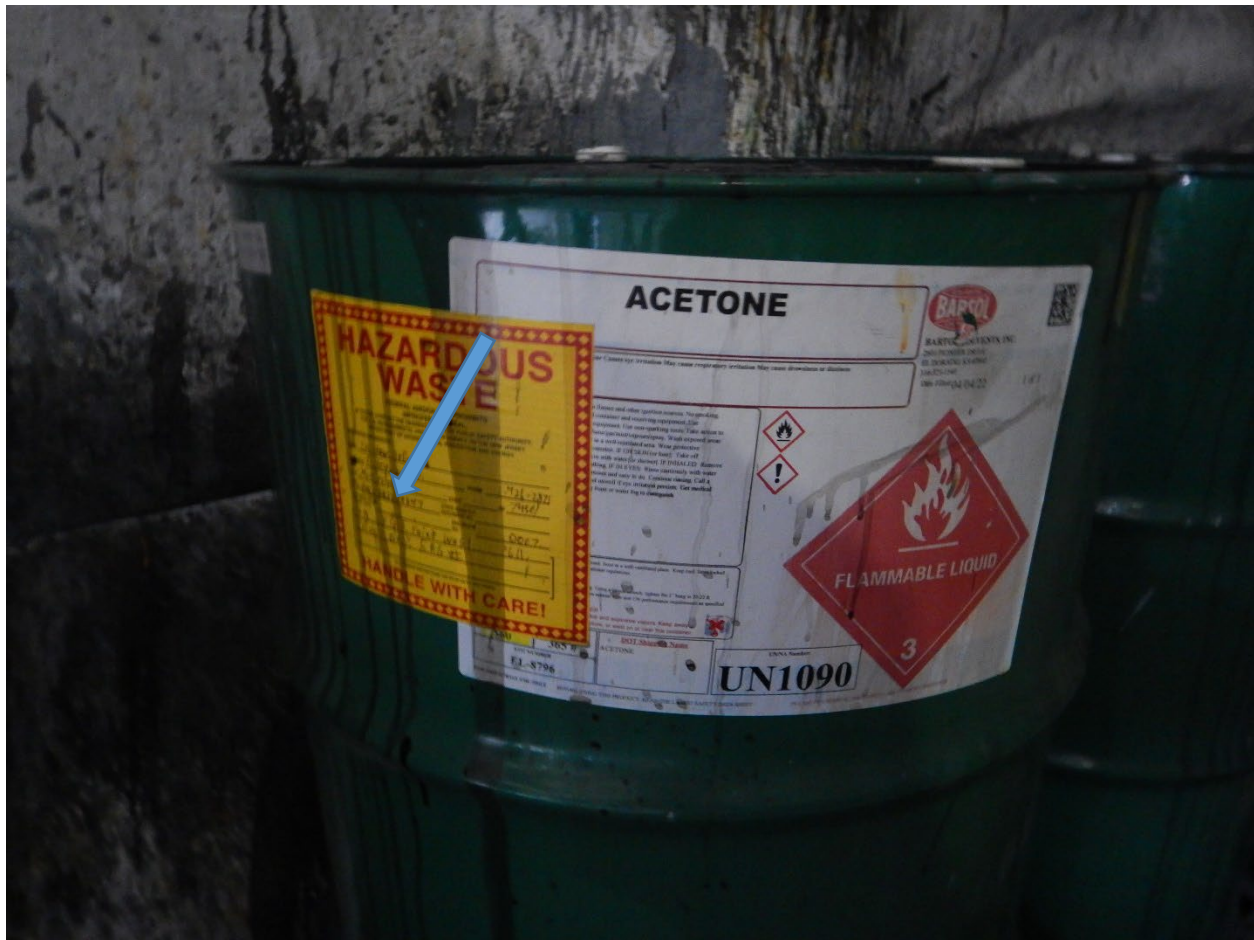
- 2 full drums of spent solvent paint waste. Undated
      - 1 drum accumulating spent solvent paint waste. Funnel open. Undated
      - 1 drum aerosol cans, labeled hazardous. In December of 2019, EPA promulgated a final rule adding aerosol cans to the universal waste program.

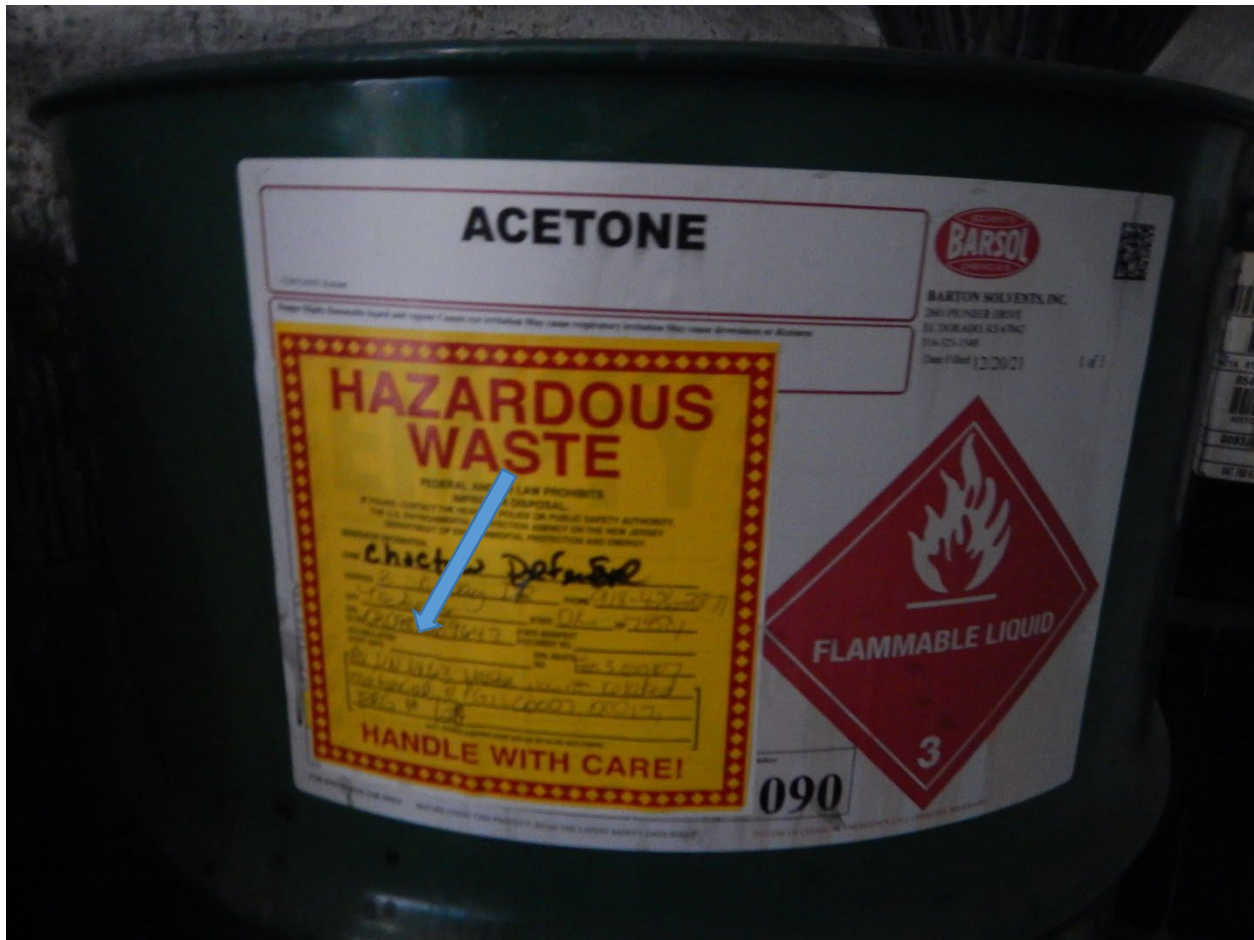
| Description: Label of paint waste drum #3 located at SAA inside Building 5. Note missing accumulation start date. | |

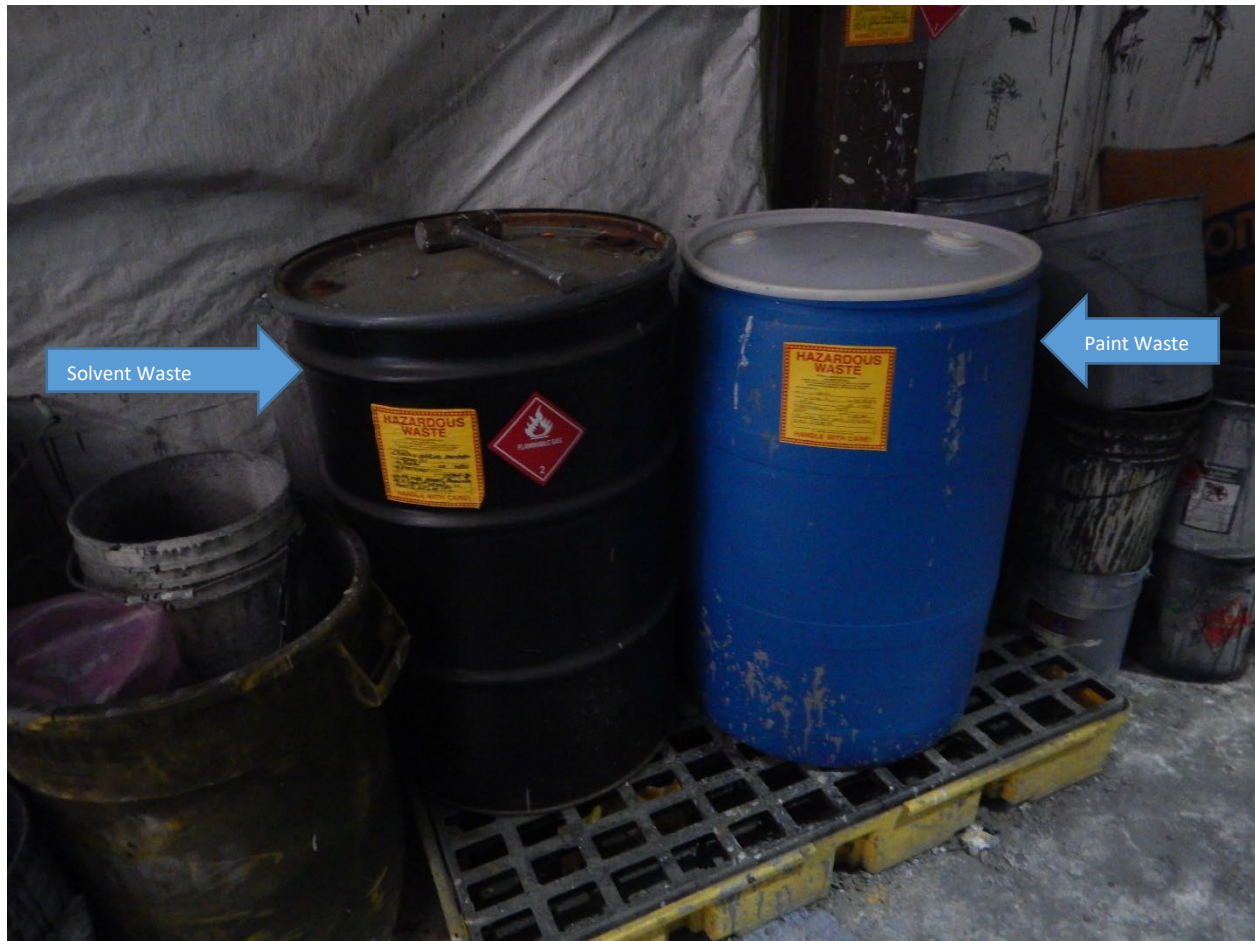
| Photo #: | DSCN0759.JPG |

| Description: Label of spent solvent waste drum located at SAA inside Building 5. Note missing accumulation start date. | |

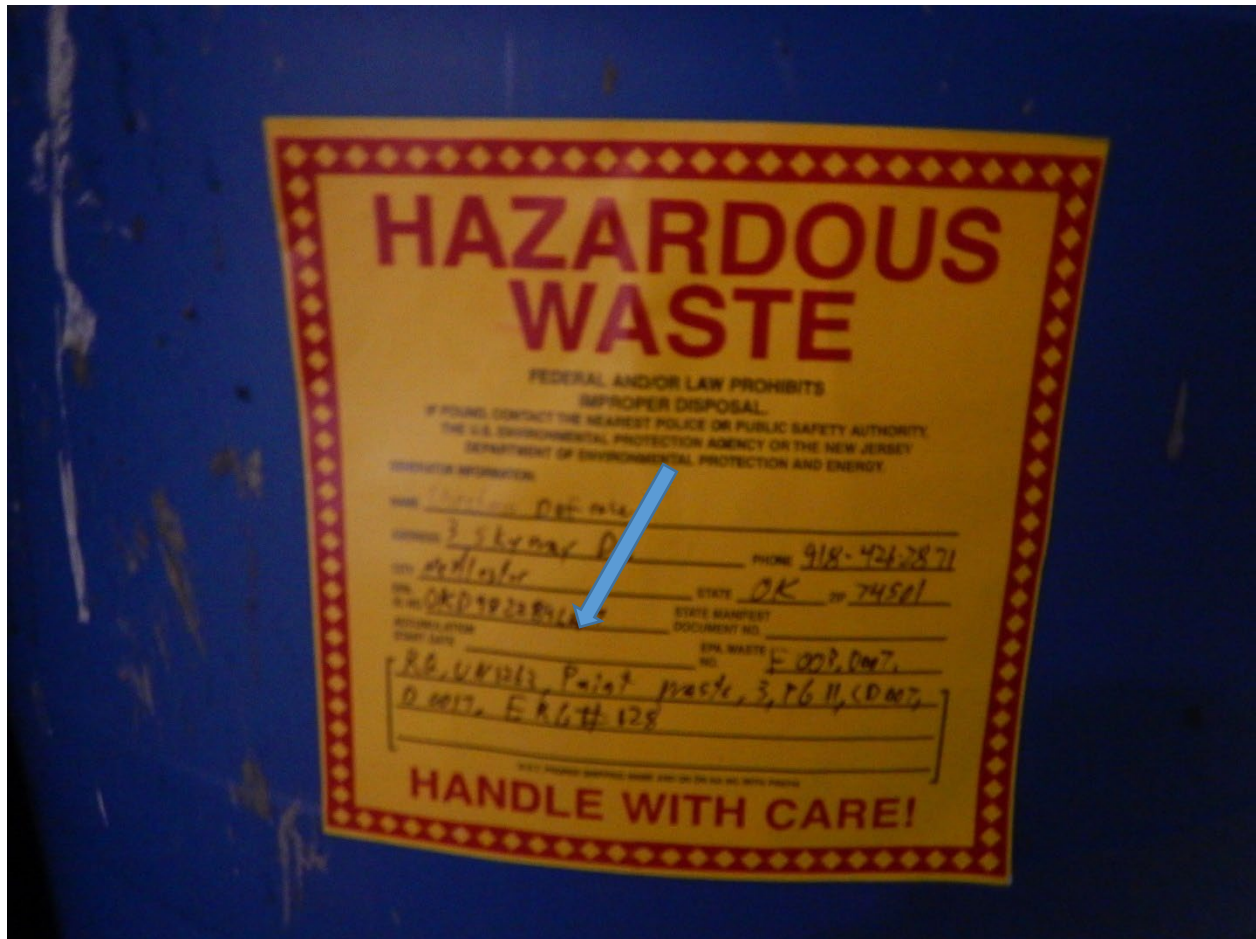
- Exceedance of storage limit of hazardous waste was observed in Satellite Accumulation Area (SAA). There were four 55 gallons drums staged in the SAA of Building 5. Two of them were full and the other two were half full which exceeded the limits of 55 gallons per 40 CFR 262.15.

| Description: Label of paint waste drum #4 located at SAA inside Building 5. Note missing accumulation start date. | |

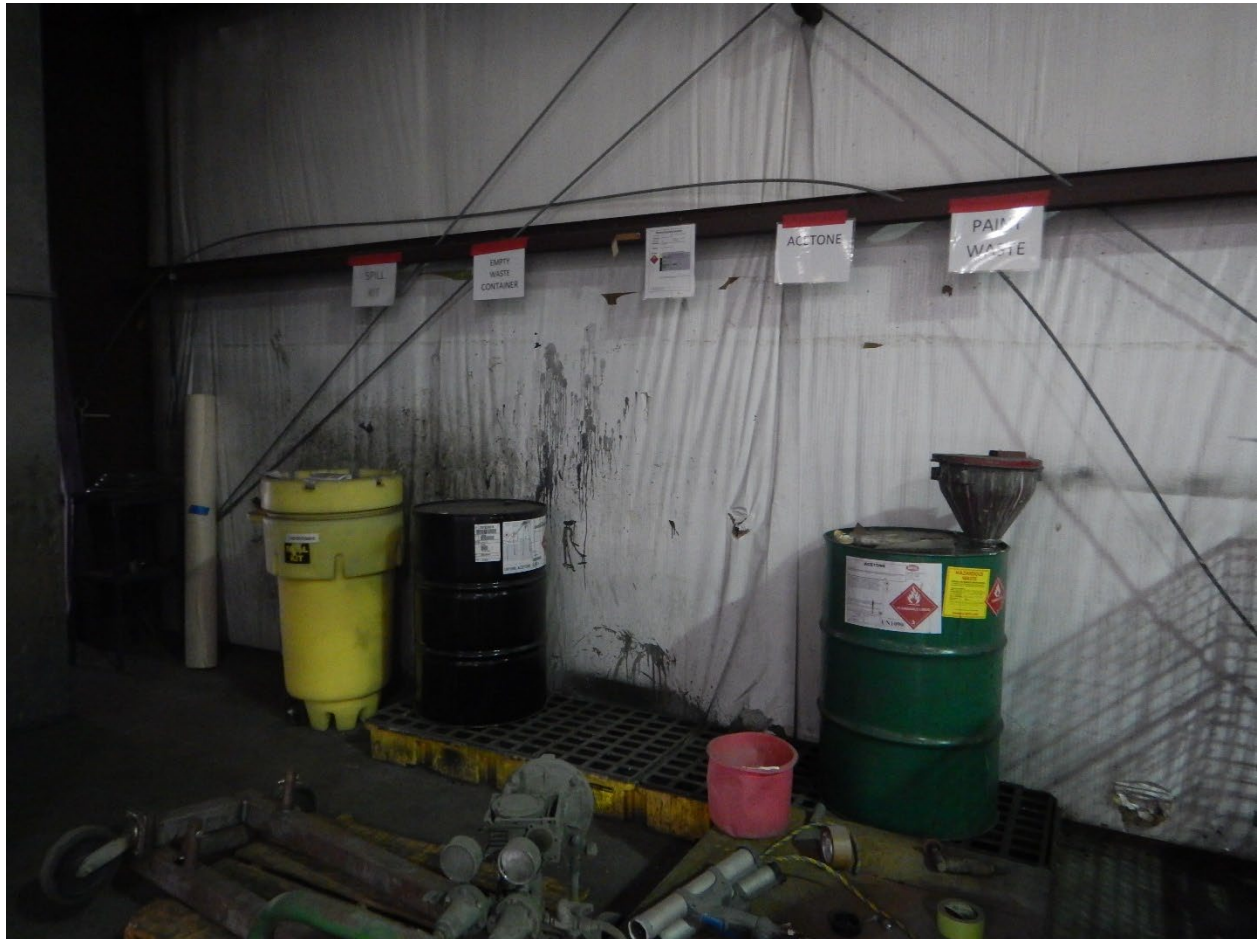
| Photo #: | DSCN0769.JPG |

| Description: Label of paint waste drum located at SAA inside Building 6. Note missing accumulation start date. | |

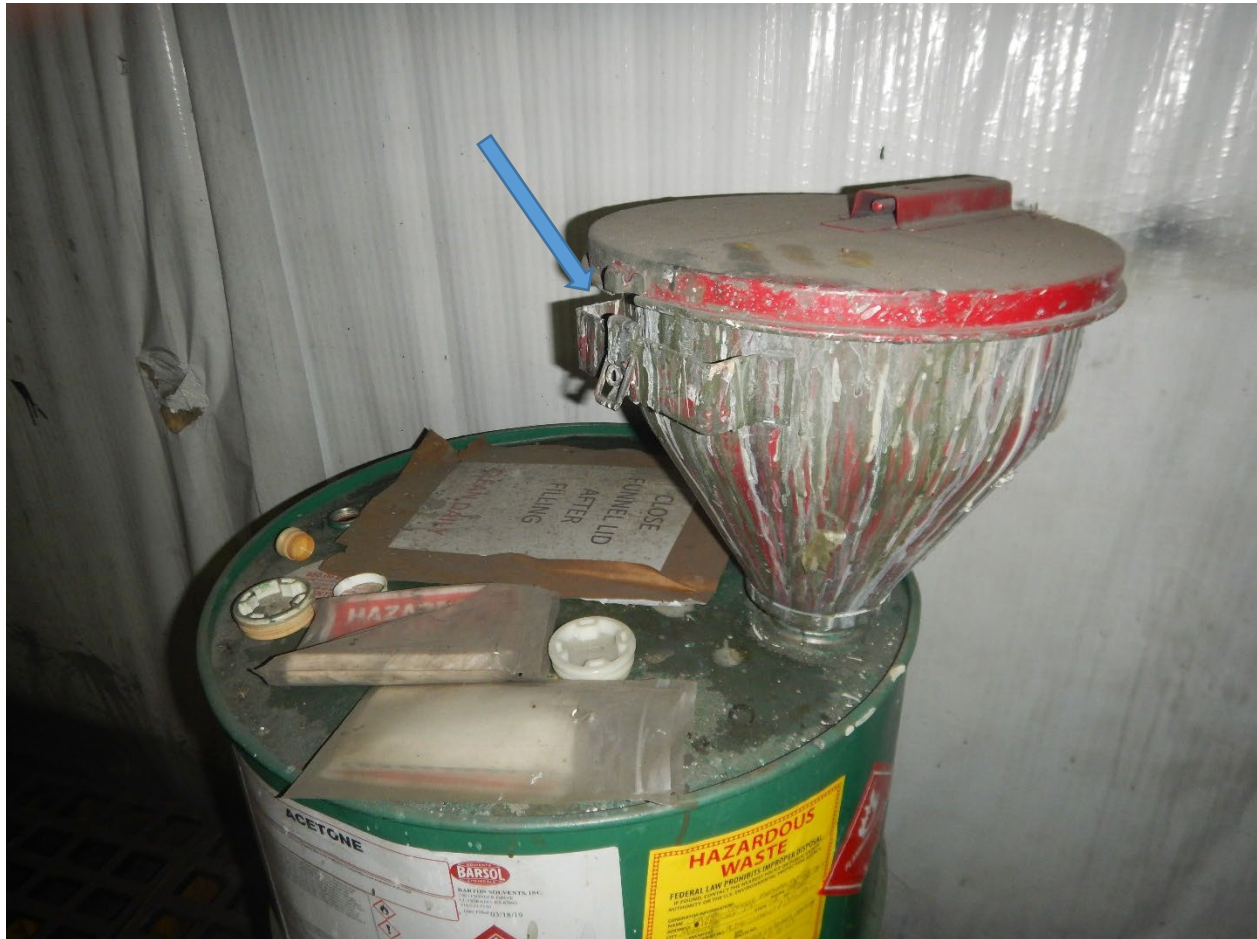
- Multiple observations of unmarked, undated, open, or unsecured containers containing hazardous waste were observed at the designated satellite accumulation area of Building 5.
- In Building 6, the pickling line and Hex line contains materials no longer in use and there was no plan for immediate disposal. These lines have been out of service since May 2019 and June 2020, respectively. This activity is in line with Storage in-lieu of disposal 40 CFR 261.2(b)(3).
- Manifest discrepancies were observed during the records review. Waste code noted on manifest 001165903WAS did not match the attached LDR form.
- Based on our observation, the contingency plan, which was revised in January 2020, did not update its list of personnel, despite the change in personnel and operations. The facility needs to provide proof of arrangements with authorities.

| Description: Close view of hazardous waste drum with open lid in SAA inside Building 6 | |

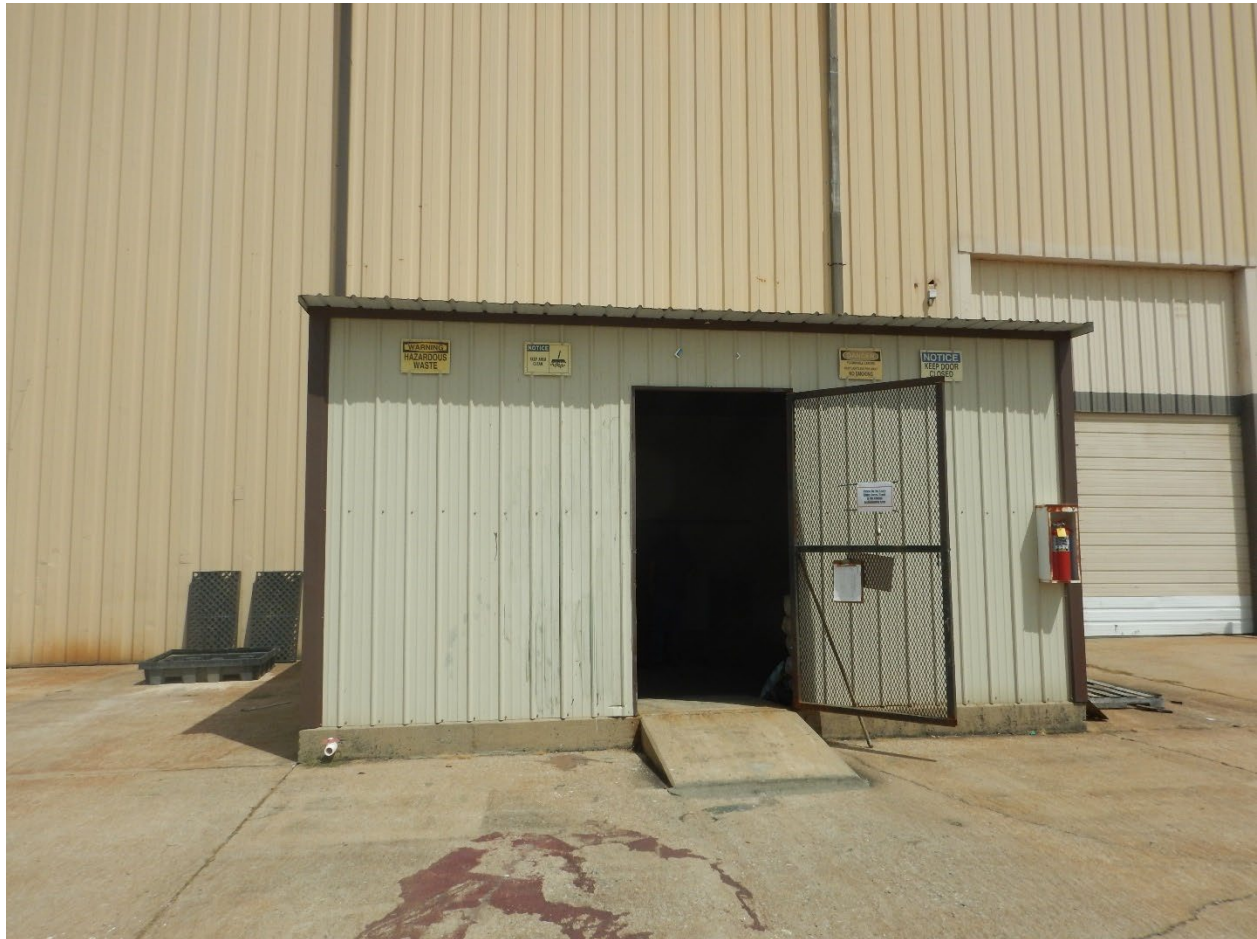
| Photo #: | DSCN0775.JPG |

| Description: Two overpack drums and one 55 gallons drum with hazardous waste stored inside less than 90 days CAA | |

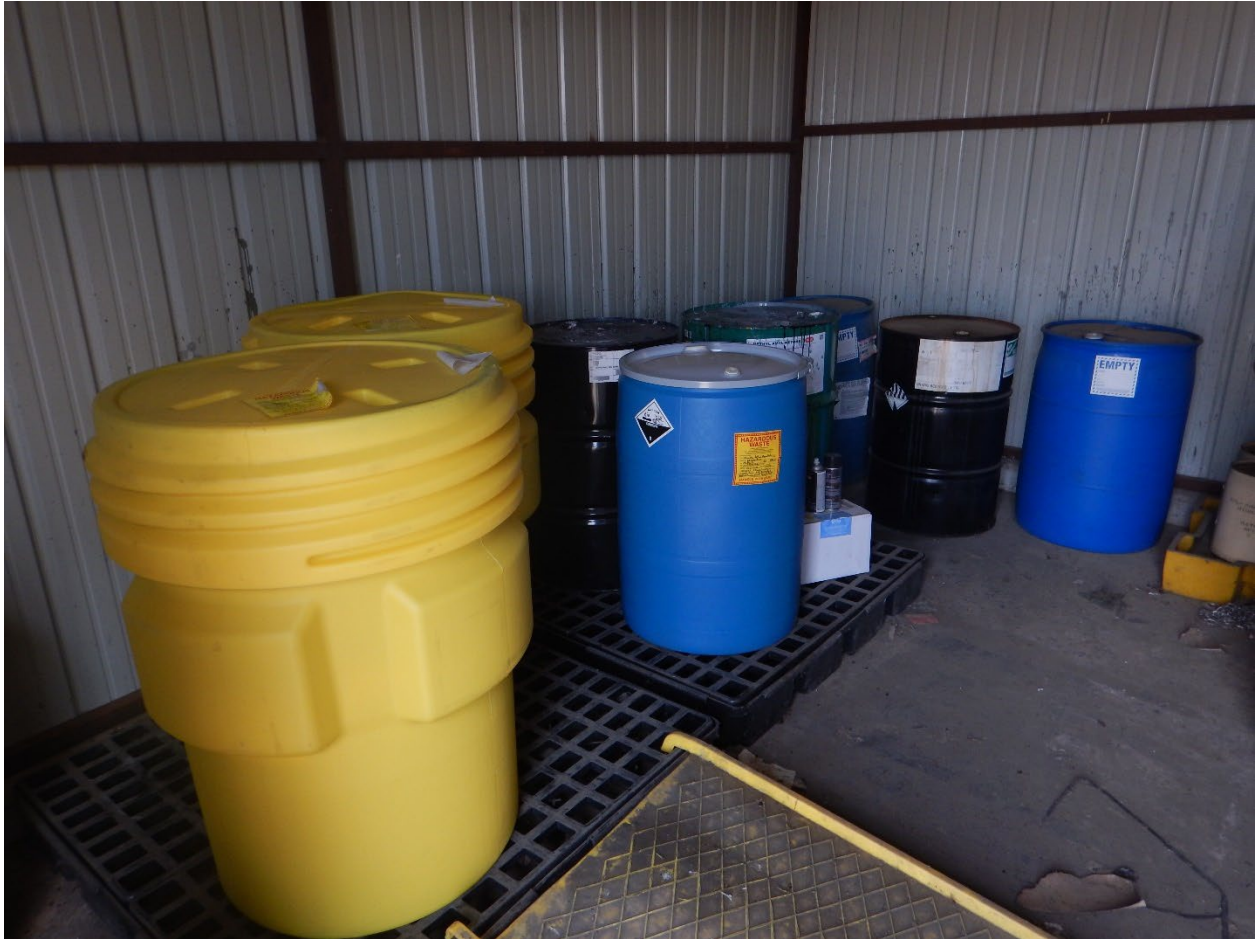
The CAA is located on the west side of Building 6. The area is gated and secured for the accumulation of hazardous waste containers. We observed 3, 55 gallons drums of paint waste, one drum of corrosive waste and 2 overpack drums of corrosive waste being stored at the CAA. All the stored waste containers were within the less than 90 days RCRA storage limit.

- One drum and 2 overpack drums of corrosive waste dated 6/22/22
- Departed Facility at approximately 3:00pm
