## **RCRA Inspection Report**

Hyster-Yale Group Inc.  
355 Cooper Drive  
Lexington, Kentucky 40506-0314

July 30, 2024, at 9:00 a.m.

The purpose of this inspection was to conduct an unannounced compliance evaluation inspection to determine Hyster-Yale Group Inc. (known hereinafter as “Hyster-Yale”, or the facility”) compliance with the applicable requirements of RCRA and the corresponding Kentucky regulations. This was an EPA lead inspection.

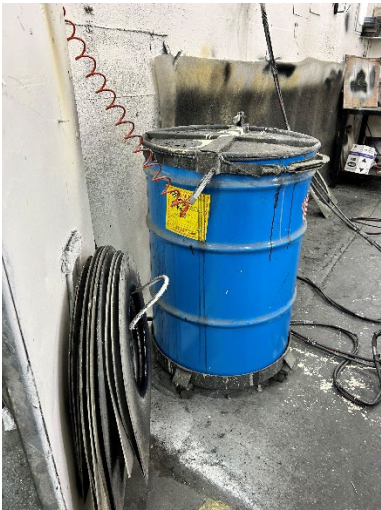
Photo-1 1–3-ton Paint Booth SAA

ton. Each section operates touchup paint booths. The inspectors observed one 55-gallon container of hazardous waste in the 1-3-ton Section of the Forklift Area SAA (Photo-1). The container was observed to be closed, labeled with the words "Hazardous Waste" with indication of hazards of the contents. The inspectors observed one 30-gallon and one 55-gallon containers of used oil (Photo-3). Both the containers were observed to be closed and labeled as "Used Oil".

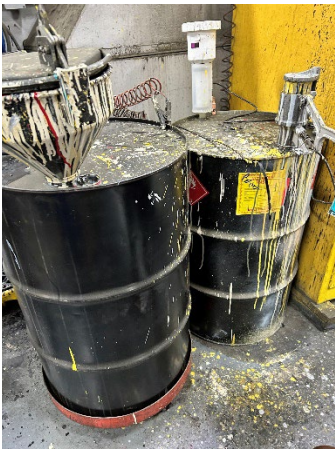
Photo-4 1–3-ton SAA

On the rear side of the Forklift Area 1–3-ton Section, the inspectors observed two SAAs. One SAA comprised of a spent aerosol can puncturing device mounted to a 55-gallon container, another container of hazardous waste paint with a funnel. Both the SAA containers were observed to be labeled with the words "Hazardous Waste" with indication of hazards of the contents. The container with the spent aerosol can puncturing device was observed to be closed. The container with an attached funnel was observed to be open during the inspection (Photo-4). The container was closed during the inspection.

**Pursuant to 401 KAR 39:080, Section 1(1) [40 C.F.R. § 262.17(a)(1)(iv)], which is a condition of the LQG Permit Exemption, (A) a container holding hazardous waste must always be closed during accumulation, except when it is necessary to add or remove waste; and (B) A container holding hazardous waste must not be opened, handled, or stored in a manner that may rupture the container or cause it to leak.**

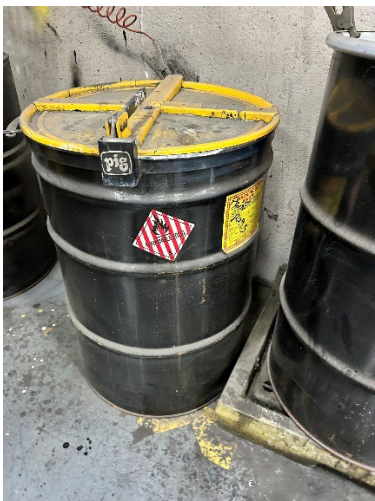
Photo-5 6–9-ton SAA

The inspectors then proceeded to the 6–9-ton Section of the Forklift Area. There was no activity in the 6–9-ton Section touchup paint booth area at the time of inspection. There were three SAAs in this section. The inspectors observed, one 55-gallon container of waste rags (Photo-5), and one 55-gallon SAA container of waste paint (Photo-6) in separate SAAs. Both containers were observed to be closed, labeled with the words "Hazardous Waste" with indication of hazards of the contents.

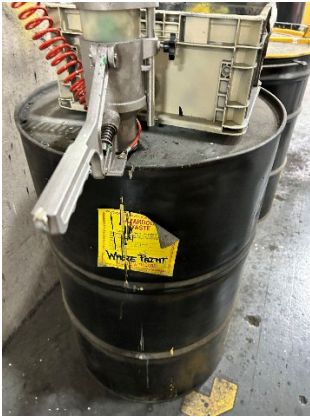
Photo-7 6-9-ton SAA

In another SAA the inspectors observed, an aerosol can puncturing device mounted to a 55-gallon container (Photo-7). The unit was not in service at the time of inspection. The container was observed to be closed, labeled with the words "Hazardous Waste." There was no indication of hazards of the contents. The container was labeled with the indication of the hazards of the contents during the inspection.

**Pursuant to 401 KAR 39:080 Section 1(1) [40 C.F.R. § 262.15(a)(5)], which is a condition of the SAA Permit Exemption, a generator is required to mark or label its containers with an indication of the hazards of the contents.**

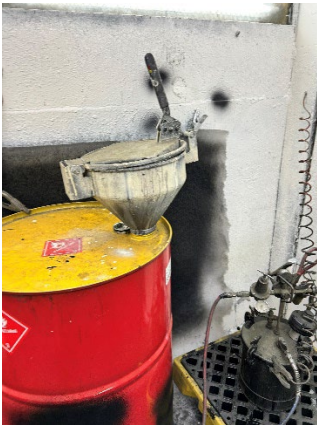
Photo-8 4-7-ton SAA

The 4–7-ton Section of the Forklift Area was inspected. At the front end of this section, the inspectors observed two SAAs. One waste paint container had a funnel lid that would not close properly hence the container was determined to be as an open container (Photo-8) in satellite accumulation. The facility personnel replaced the funnel and sent photos documenting the newly installed lid on August 5, 2024.

**Pursuant to 401 KAR 39:080, Section 1(1) [40 C.F.R. § 262.17(a)(1)(iv)], which is a condition of the LQG Permit Exemption, (A) a container holding hazardous waste must always be closed during accumulation, except when it is necessary to add or remove waste; and (B) A container holding hazardous waste must not be opened, handled, or stored in a manner that may rupture the container or cause it to leak.**

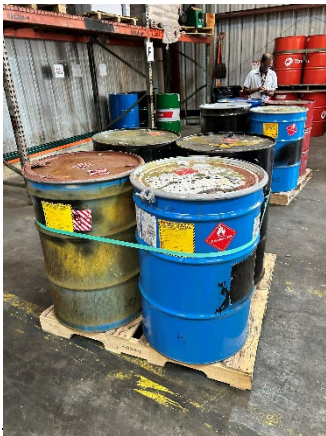
Photo-9 CAA (Hazardous Waste)

The facility manages one less than 90-day accumulation area. The CAA is in a storage building behind the main plant. The inspectors observed hazardous waste, used oil and universal waste stored in the CAA. At the time of inspection, the inspectors observed approximately 10 55-gallon hazardous waste containers on the pallets (Photo-9). All the containers of hazardous waste were observed to be closed, labeled, dated, and in good condition. The oldest accumulation date was observed to be July 16, 2024. There were 13 55-gallon containers of used oil container (Photo-10). All the containers were observed to be closed and labeled as “Used Oil”. There were 4 30-gallon containers of spent universal waste batteries (Photo-11). The containers were observed to be closed, labeled but were missing accumulation start dates. The universal waste containers were dated during the inspection.

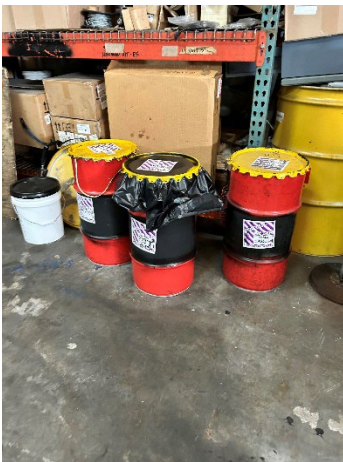
Photo-11 CAA (Universal Waste)

Pursuant to 401 KAR 39:080, Section 3(1) [40 C.F.R. § 273.15(a) and (c)], a SQHUW may accumulate universal waste no longer than one year and must be able to demonstrate the length of time that the universal waste has accumulated from the date that it became a waste or was received.

There were seven containers containing spent industrial batteries and approximately 25 spent forklift batteries. The batteries were properly grounded, labeled and dated. The oldest accumulation date was observed to be June 14, 2024.
