## MISSISSIPPI DEPARTMENT OF ENVIRONMENTAL QUALITY

Re: Notice of Violation  
Hazlehurst POTW, Activated Sludge  
Hazlehurst, Mississippi  
Copiah County  
Water - NPDES Permit No. MS0023922

**Mississippi Department of Environmental Quality**  
**Office of Pollution Control**  
**Water Compliance Inspection Report**

**Site Name:** Hazlehurst POTW, Activated Sludge

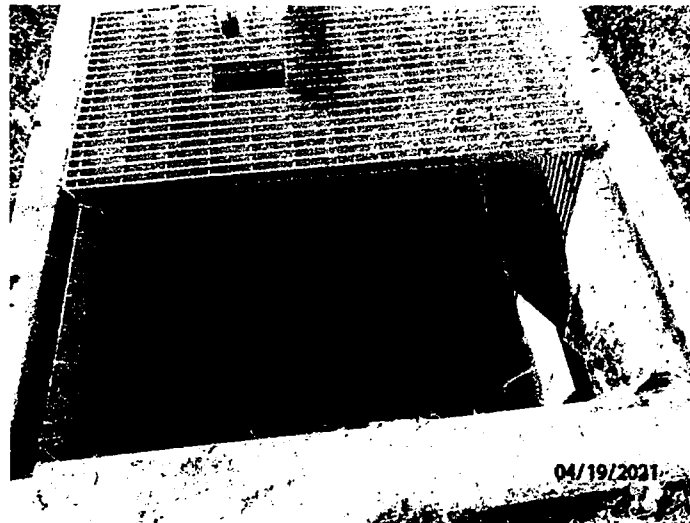
Photo 6: V-notch weir with ultrasonic sensor

The supernatant from the clarifier flows through a small square concrete structure where a 90-degree v-notch weir is located for primary flow measurement. An ultrasonic sensor is mounted above the structure for continuous flow monitoring. Wastewater then goes to the chlorine contact chamber. Chlorine gas is introduced to the influent end of the chlorine contact chamber via a potable water line. The water line has backflow prevention installed onsite. At the end of the chlorine contact chamber, sulfur dioxide is used to remove the chlorine prior to discharge to the receiving stream. Cascade post aeration is used to raise the effluent dissolved oxygen concentration before discharge. There is an aerobic digester basin also onsite, but is no longer in use. In addition, there is a control/office building and an old inoperable generator.

Only one clarifier was in service due to a valve that would not operate. The operable clarifier needed to be cleaned (see Photo 5). Vegetation was growing in areas of the clarifier. Solids were settling, but the supernatant was slightly turbid. The solids were being returned to the aeration basin. The ultrasonic flow meter over the concrete structure containing the v-notch weir was inoperable (see Photo 6). The operator uses the run time meters on the influent pumps to calculate flow. The "Effluent Limitations and Monitoring Requirements" table of the facility's permit requires a continuous recorder. Mr. Hayden did not offer a timetable for these repairs.
