**Region 6 Compliance Assurance and Enforcement Division  
INSPECTION REPORT**

| Inspection Date(s): | 02/26/2016 | | |
| Company Name: | <b>East Texas Salt Water Disposal Company</b> | | |
| Facility Name: | <b>Anderson Center (RRC No. P001059)</b> | | |

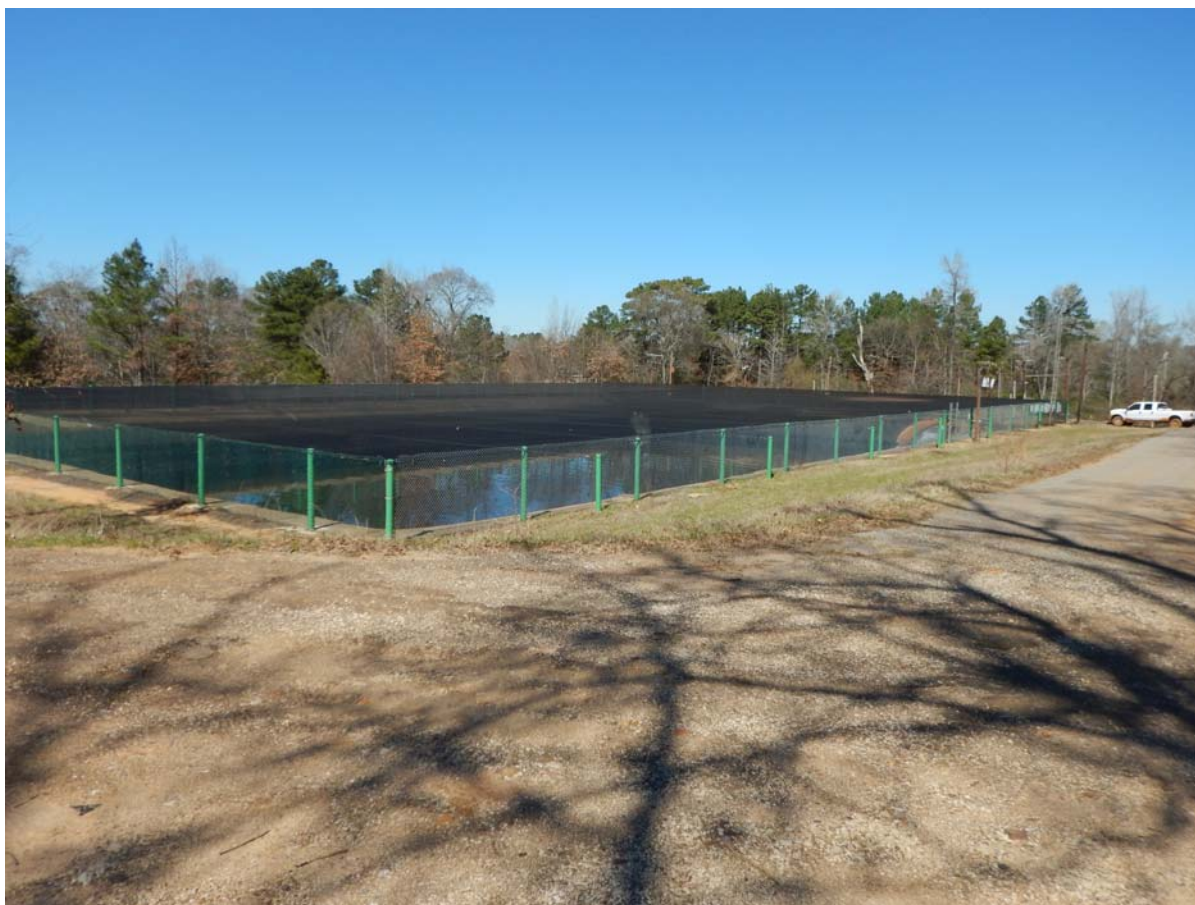
Photo No. 3

When we arrived at this facility, specifically the open produced water collection pit, on February 26, 2016, we observed that the facility had a net over the pit. See Photo Nos. 3 - 5 in Appendix 1.

Photograph File Name: DSC\_0746.JPG  
Date of Photograph: 02/26/2016  
Latitude: 32.494507 N  
Longitude: -94.85092 W  
Orientation: W  
Map Datum: WGS-84  
Time of Photo: 11:35 AM  
Photographer: Jeanne Eckhart  
Description: This image shows the open collection pit of produced water from the south east corner of the facility.

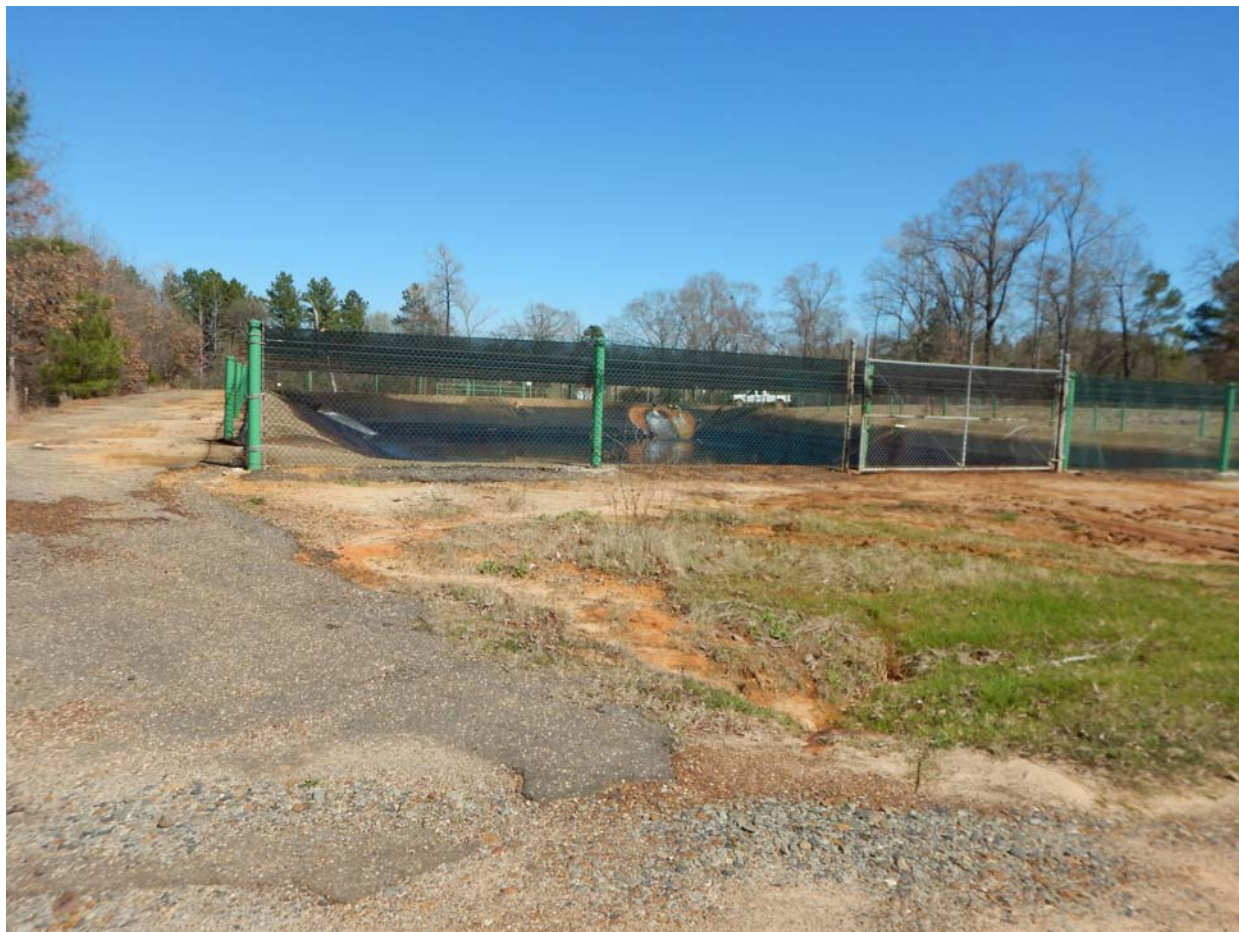
Photo No. 4

Description: This image shows open produced water collection pit from the south west corner of the facility.

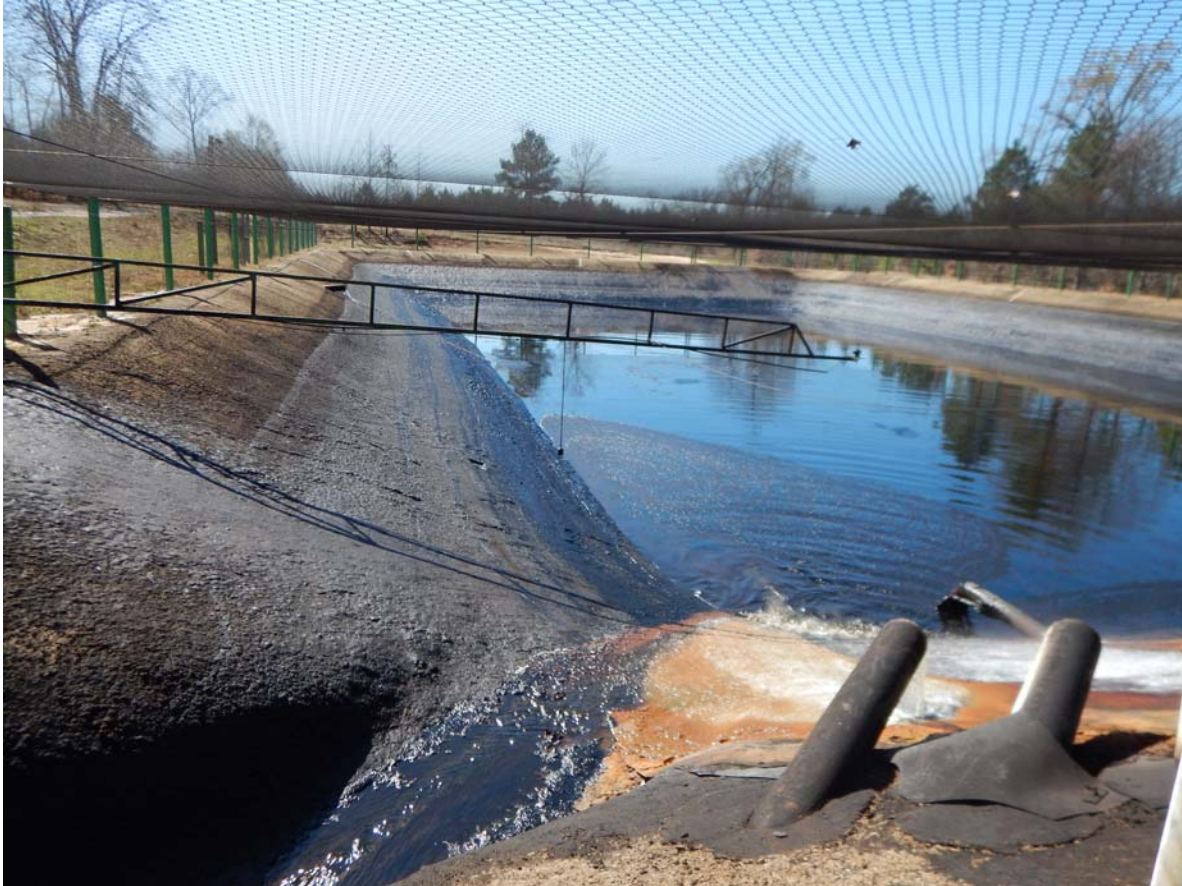
Photo No. 5

**Anderson Center produced water pit** located at latitude 32.495353 N and longitude -94.854310 W had one open pit where multiple produced water pipes dumped water into the pit from various well locations nearby. We observed that the produced water pit had oil staining, smelled strongly of hydrocarbons, and had oil on the surface of the pit. The open pit had a net over it to prevent wildlife, like birds from coming into contact with the produced fluids. We observed oil on the surface of the produced water in the pit. We obtained a Total Soluble Salts (TSS) reading of 77,300 parts-per-million

Description: This image shows the collection pit, where produced fluids from nearby wells in the area are piped to this pit.

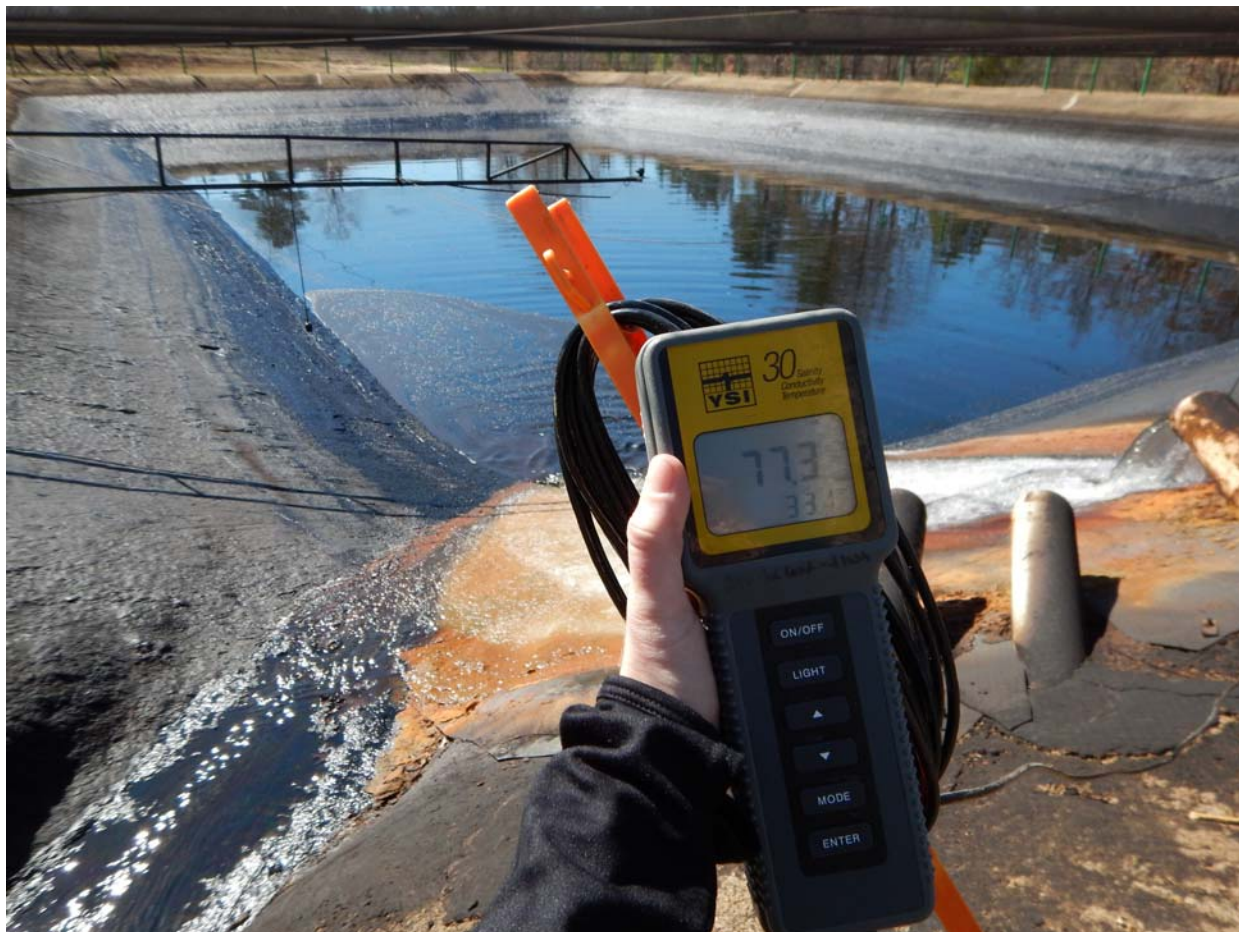
Photo No. 6

Description: This image shows a measurement of Total Soluble Salts (TSS) reading of 77,300 parts-per-million in the open produced water collection pit.

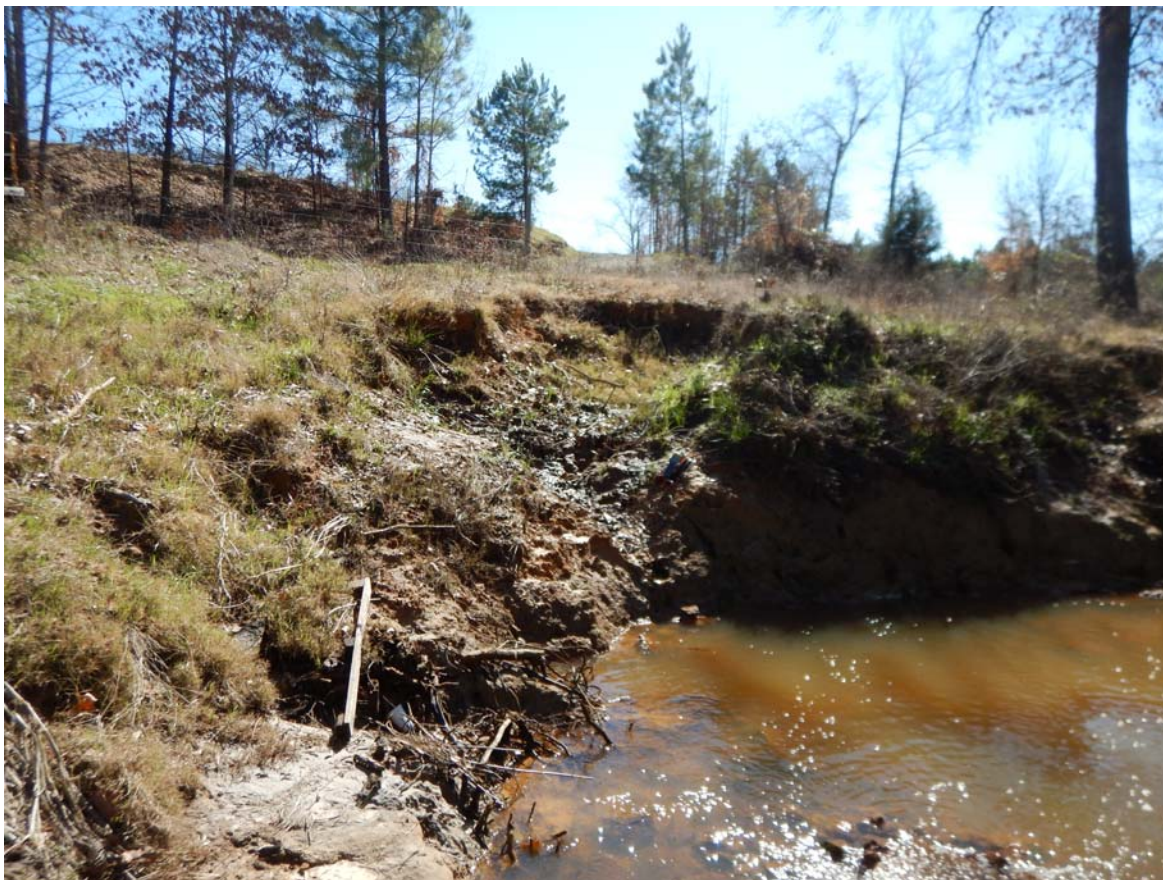
Photo No. 7

- Leaking produced fluids from the collection pit into the tributary of the Sabine River
- And high concentrations of TSS in the tributary of the Sabine River

Description: This image shows Point of Entry (POE) below the south west corner of the open produced water collection pit. Produced wastewater is seeping from the soil into the tributary of the Sabine River.

- EPA will send a copy of the inspection report to the facility.
- EPA will work with the facility to enable it to come into compliance with the requirements of the CWA.
- EPA will have a conference call with the facility to discuss the inspection report.

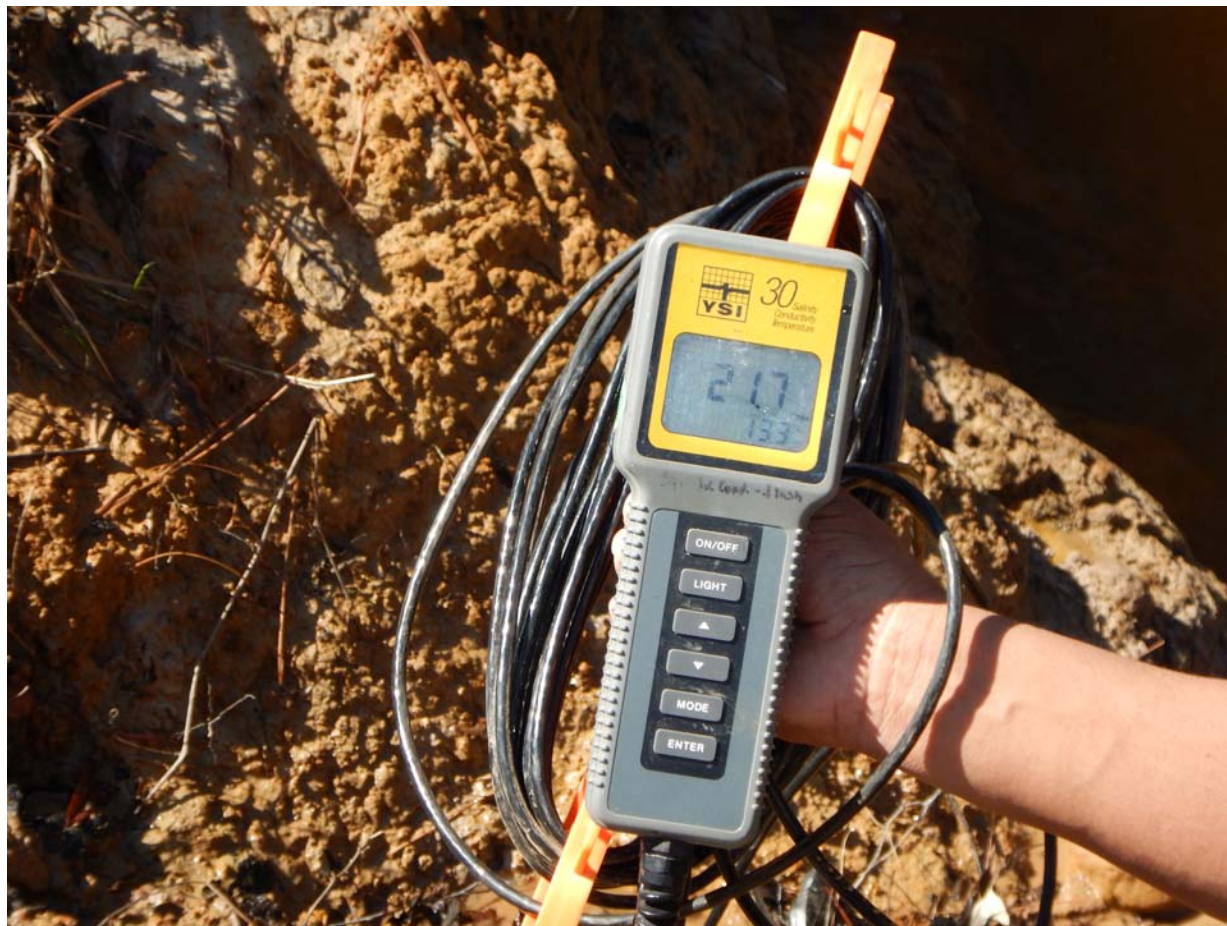
Photo No. 8

(ppm) taken at the facility at latitude 32.495076 N and longitude -94.856481 W. See Photo Nos. 2 – 6 in Appendix 1. The point of entry (POE), where fluids reached the tributary of the Sabine River was located at latitude 32.494894 N and longitude -94.855095 W. We obtained a TSS reading of 21,700 ppm at the POE. See Photo No. 7 - 8 in Appendix 1. At this location, the tributary of the Sabine River was approximately 2 foot deep and approximately 20 feet wide. See Photo Nos. 9 - 10 in Appendix 1. We observed produced fluids seeping below the south east corner of the production operations pit above the surface of the ground and entering the tributary of the Sabine River. We observed that the water flow at the tributary and subsequently the dilution of produced fluids (brine) upstream and downstream of the tributary was greater due to heavy precipitation events that occurred in the area. During the inspection we noticed high water marks, more sediments and debris at this location. See Photo No. 9 and 10 in Appendix 1. We obtained a TSS reading of 200 ppm approximately 0.86 miles downstream from the POE at latitude 32.485101 N and longitude -94.855709 W. Discolored foam was noted downstream from the POE located at latitude 32.494171 N and longitude -94.855386 W. See Photo No. 11 in Appendix 1.

Description: This image shows POE, where a TSS reading of 21,700 ppm was taken. The produced water is seeping from the open produced water collection pit to the tributary of the Sabine River.

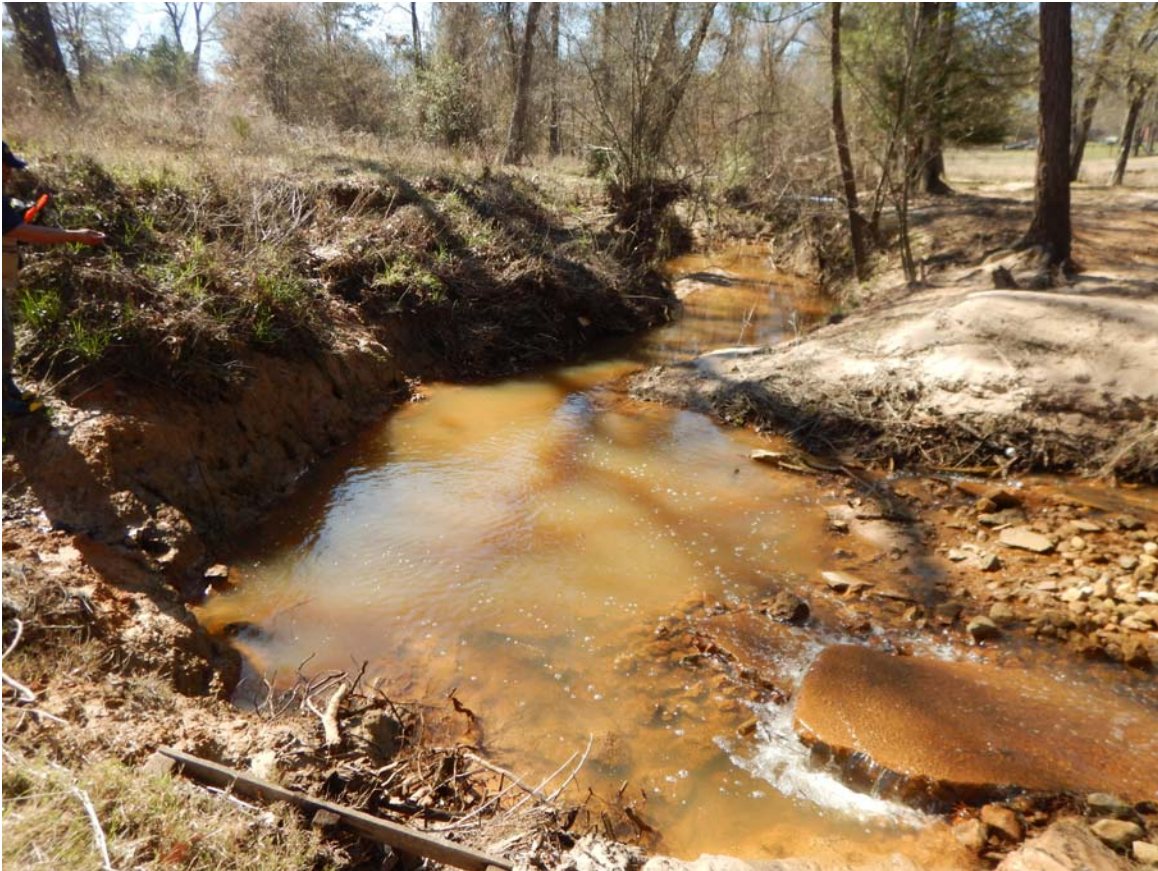
Photo No. 9

Description: This image shows a downstream view from the POE into the tributary of the Sabine River. Riparian vegetation, bed and bank, and high water marks were observed at this location during the inspection.

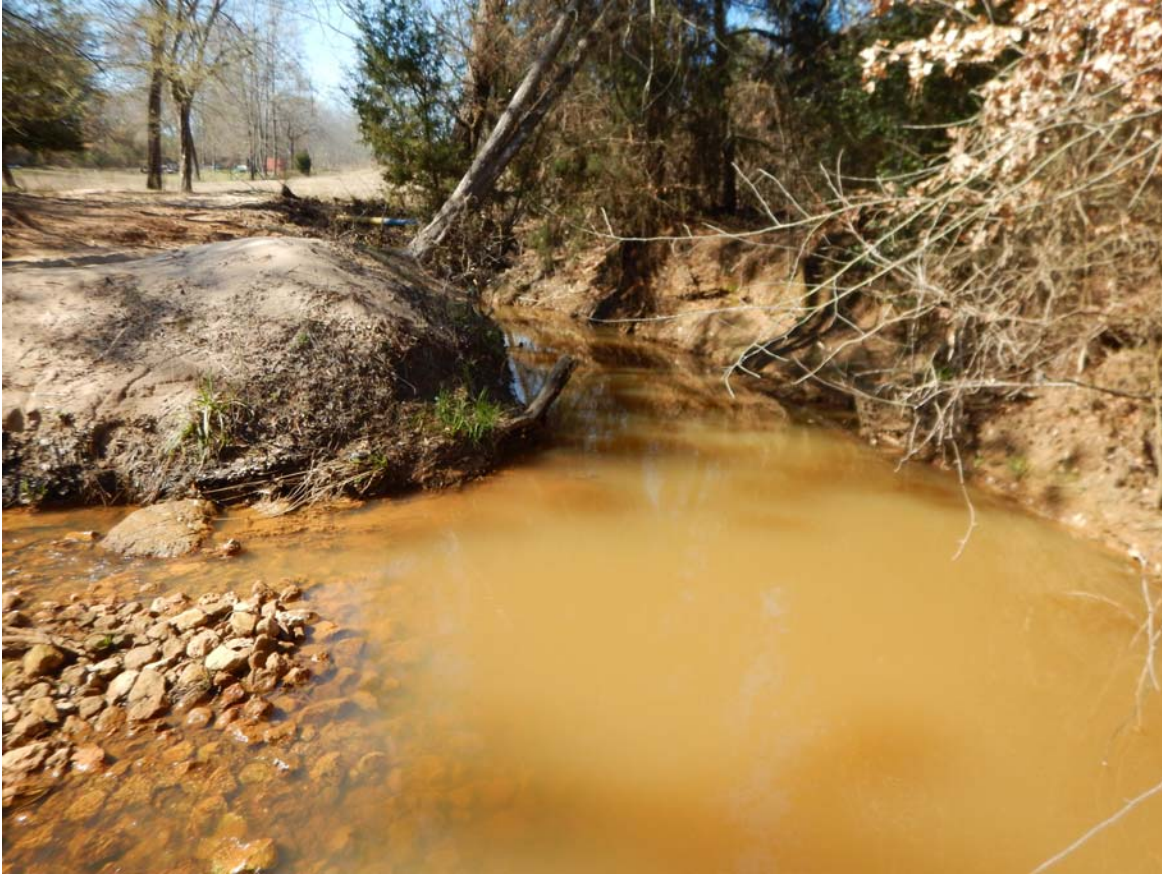
Photo No. 10

Description: This image shows an upstream view from the POE of the tributary of the Sabine River. We observed high water marks, riparian vegetation, and bed and banks at this location during the inspection.

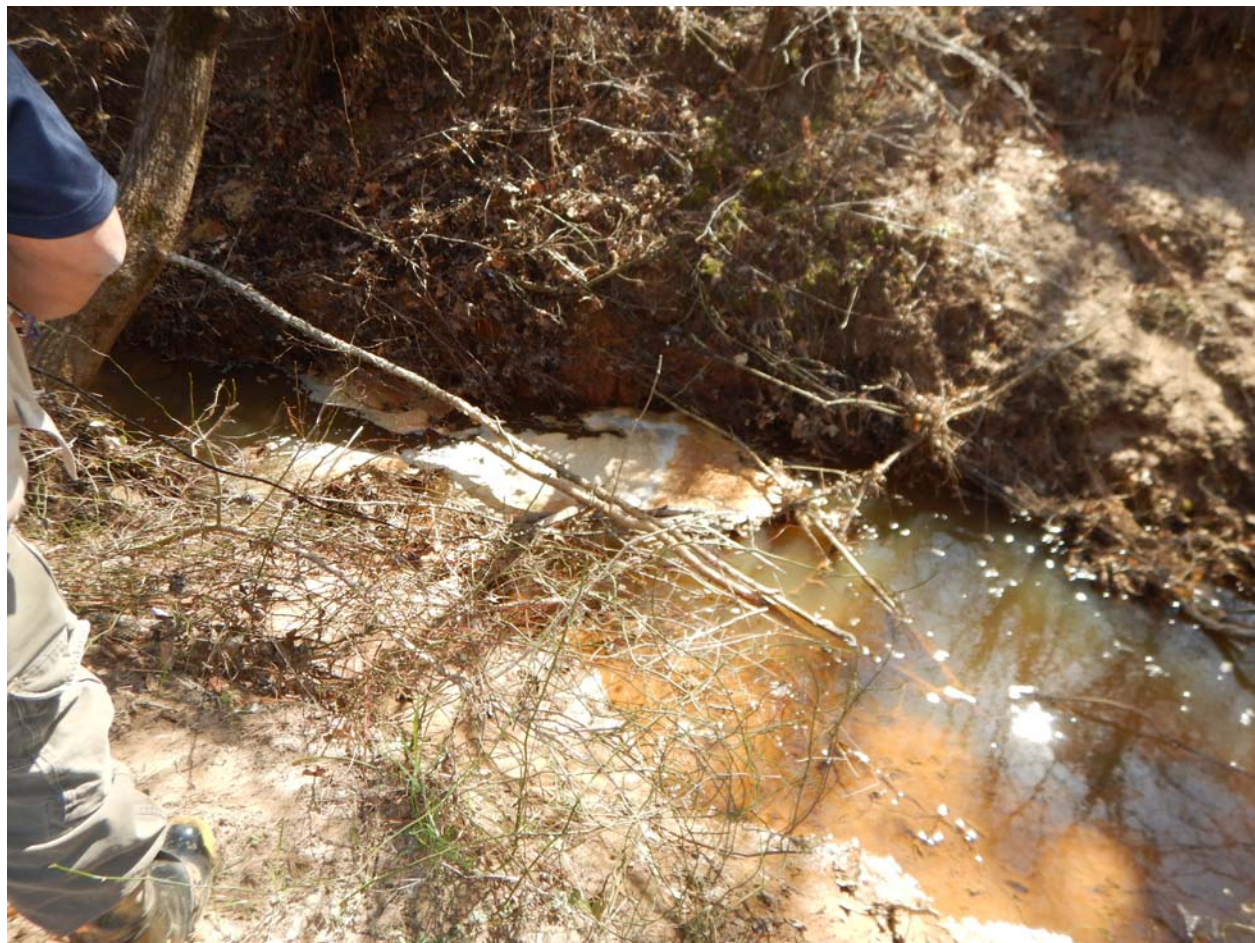
Photo No. 11

Description: This image shows foam downstream from the POE in the tributary of the Sabine River. We observed a discolored foam on the surface downstream from the POE.

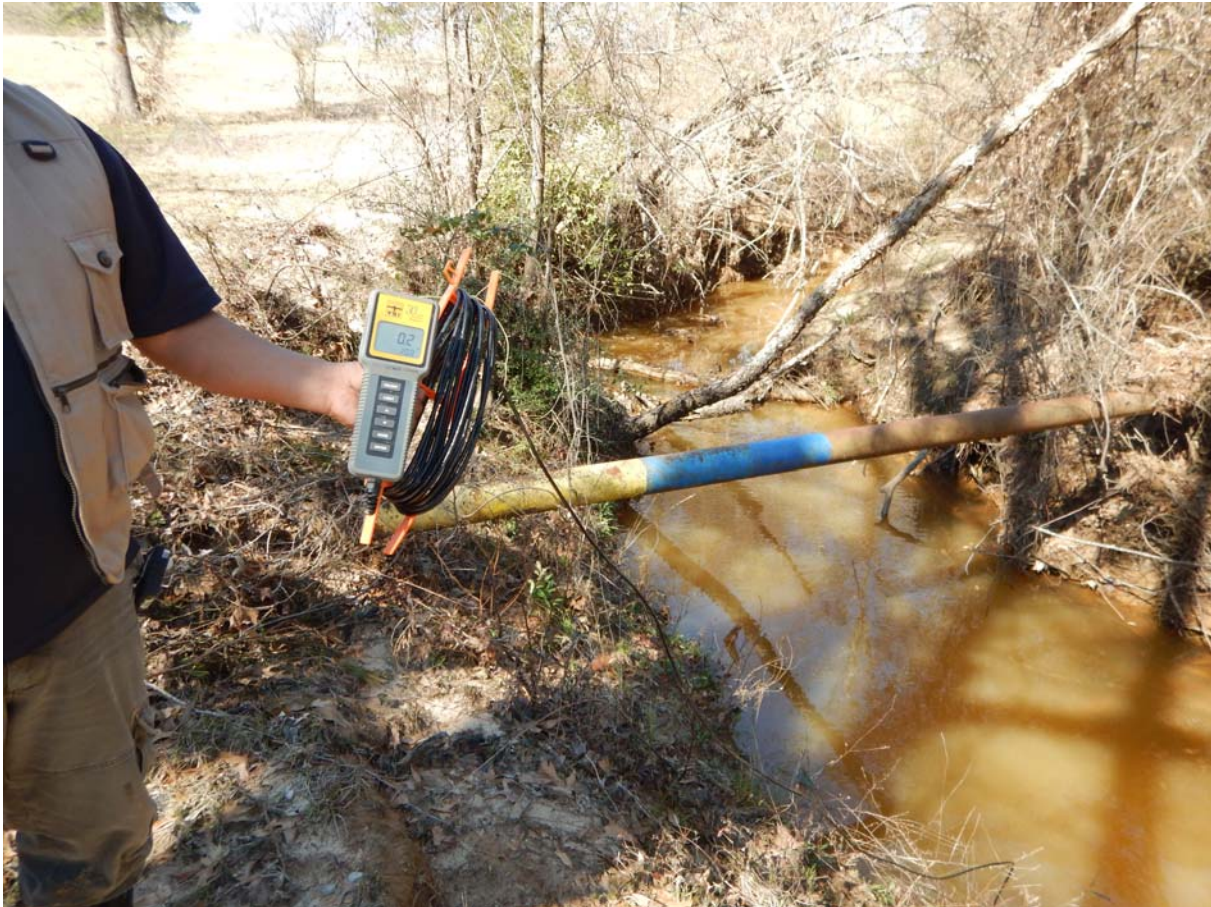
We measured the TSS to determine water quality data, such as water quality in the area, approximately 60 feet upstream of the POE to the tributary of the Sabine River. We measured TSS of 200 ppm at Latitude 33.494934 N and Longitude -94.854729 W. See Photo No. 12 in Appendix 1.

Description: This image shows a background TSS reading of 200 ppm upstream from the POE in the tributary of the Sabine River. There were clear bed and banks, high water marks, and riparian vegetation observed at the time of the inspection.

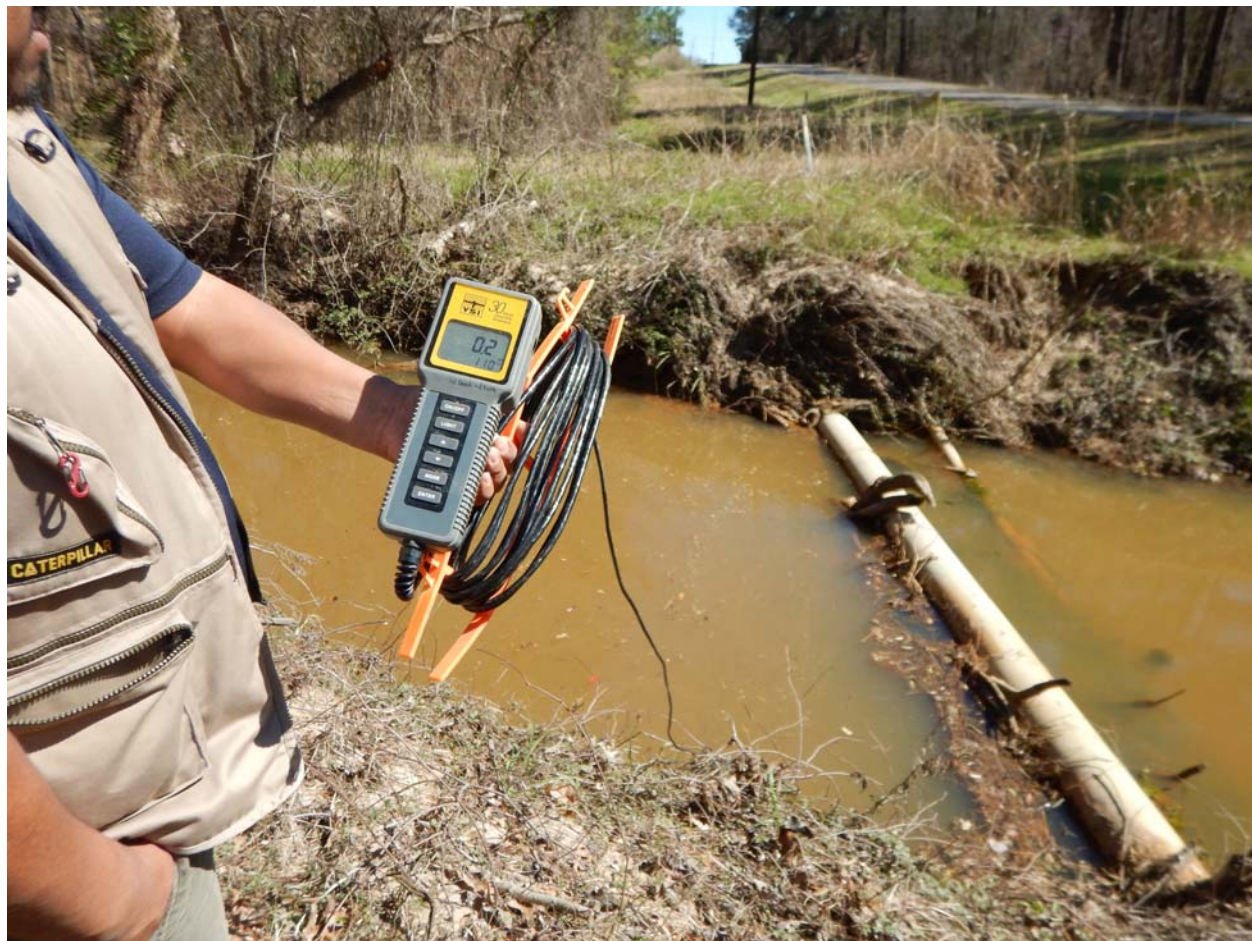
Photo No. 13

Description: This image shows a downstream TSS reading of 200 ppm along the tributary of the Sabine River. This location was approximately 0.89 miles downstream from the POE.
