## **RCRA Inspection Report**

LLFlex LLC  
1255 W Burnett St.  
Louisville, KY40210

March 6, 2024, at 9:15 AM

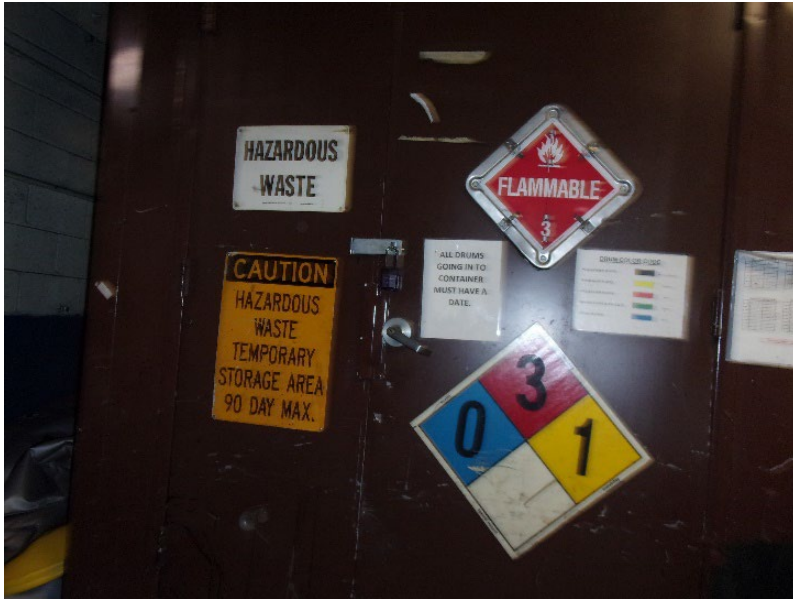
The inspectors inspected a chemical containment locker with signage (Photo-1). There were two 55-gallon containers observed inside the containment locker during the inspection (Photo-2). One container was observed to be empty; the other container contained spent ink line flush solvent with hazard indication. The containers were observed to be closed and intact. There were no leaks and spills observed in the containment area. According to Gregg Morris, one 55-gallon container containing spent ink-line flush was staged for shipping offsite for recycling purposes. The chemical containment locker was equipped with spill kits and the emergency equipment.

Photo-1 Chemical Containment Locker with Signage

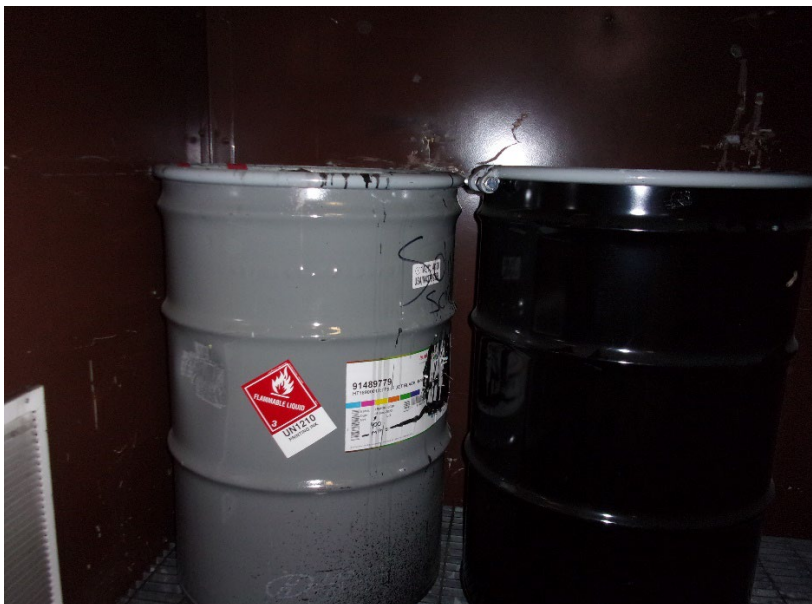
Photo -2 Inside Chemical Containment Locker - 1 55-gallon, Spent Ink Line Flush;  
1-55-gallon Empty Drum
