## RCRA Compliance Branch INSPECTION REPORT

| <b>Facility or Site Name:</b> | Himed, Inc. | |

### SECTION I – INTRODUCTION

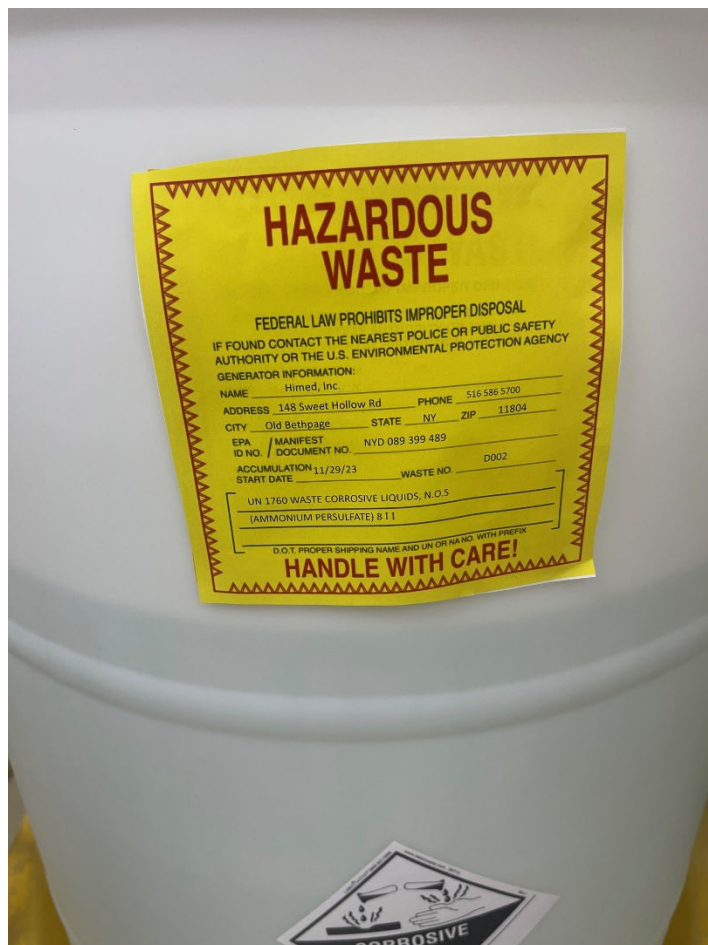
1. Pursuant to 6 NYCRR § 372.2(a)(8)(i)(a)(2), Containers are marked with the words “Hazardous Waste” and with other words that identify the contents of the containers.

At the time of the inspection, there was one 55 gallon drum that contained hazardous waste located in the anodizing area, that had no label on it. On December 18, 2023, Mrs. Rodriguez followed up in an email regarding the area of concerns. Mrs. Rodriguez stated “Yes. Drum was labeled and picked up by transporter on 12/7. See attached (Figure I)”

(Figure 1: Hazardous waste label on 55 gallon drum)

2. Pursuant to 6 NYCRR § 372.2(a)(8)(ii), The date upon which each period of accumulation begins is clearly marked and visible for inspection on each container.

At the time of the inspection, there was one 55 gallon drum that contained hazardous waste located in the anodizing area, that had no date on it.

On December 18, 2023, Mrs. Rodriguez followed up in an email regarding the area of concerns. Mrs. Rodriguez stated “Yes. Drum was labeled and picked up by transporter on 12/7. See attached (Figure I)”

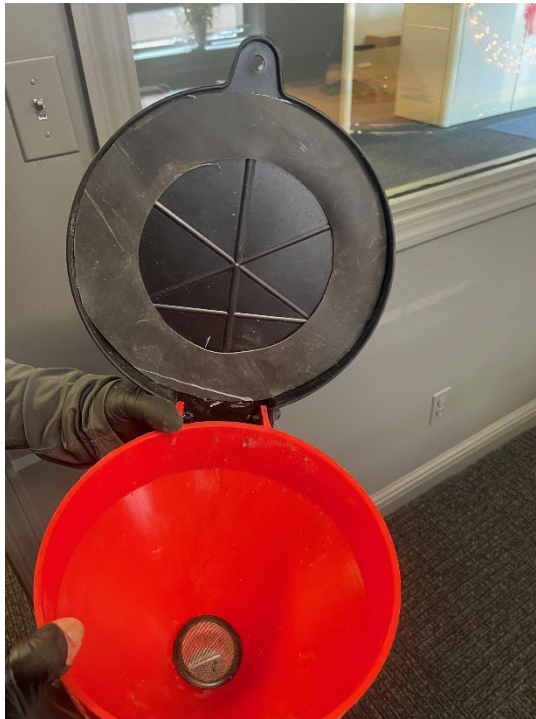
3. Pursuant to 6 NYCRR § 373-3.9(d)(1), management of containers. (1) A container holding hazardous waste must always be closed during storage, except when it is necessary to add or remove waste.

At the time of the inspection, there was one 30 gallon drum containing hazardous waste (proponal) located in the central storage area that had an open funnel in the opening of the drum. During the inspection Mr. Bencio closed the funnel and later in an email from Mrs. Rodriguez, the facility provided a picture which shows that a gasket was added to the funnel as shown below.

(Figure 2: Funnel with gasket on)
