**Well Inspection**  
**Osage DNR / Environmental Protection Agency**  
**1201 Elm Street, Suite 500**  
**Dallas, Texas 75270**

| | | <b>Lease Name</b> | McComb | | |
| | | <b>Well ID</b> | 16 | | |

### Photograph Log 3 Photos

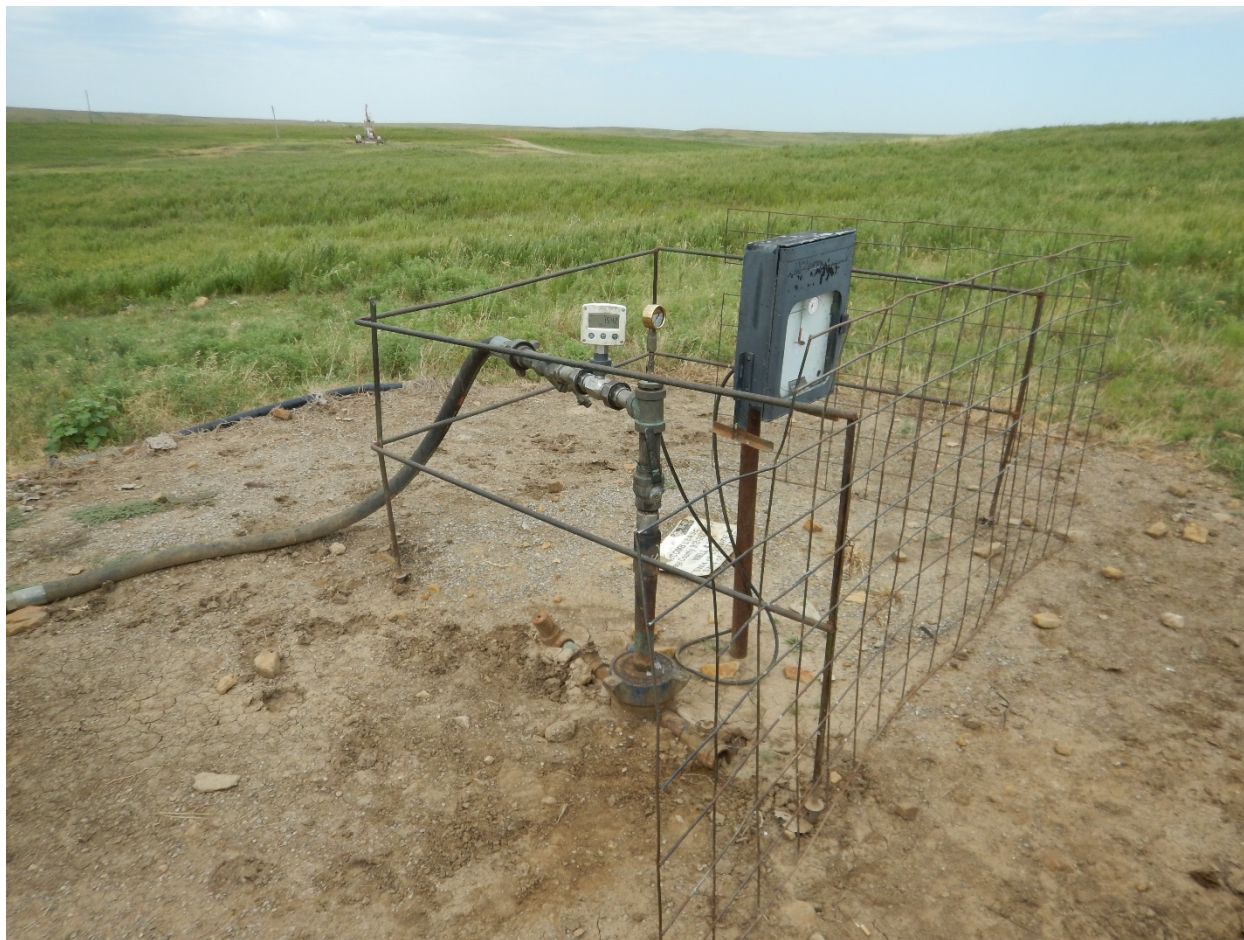
Photo No. 1

**Description:** This was the McComb No. 16 (OS6498000) well. At the time of the inspection the continuous pressure monitoring chart device was properly connected and functioning.

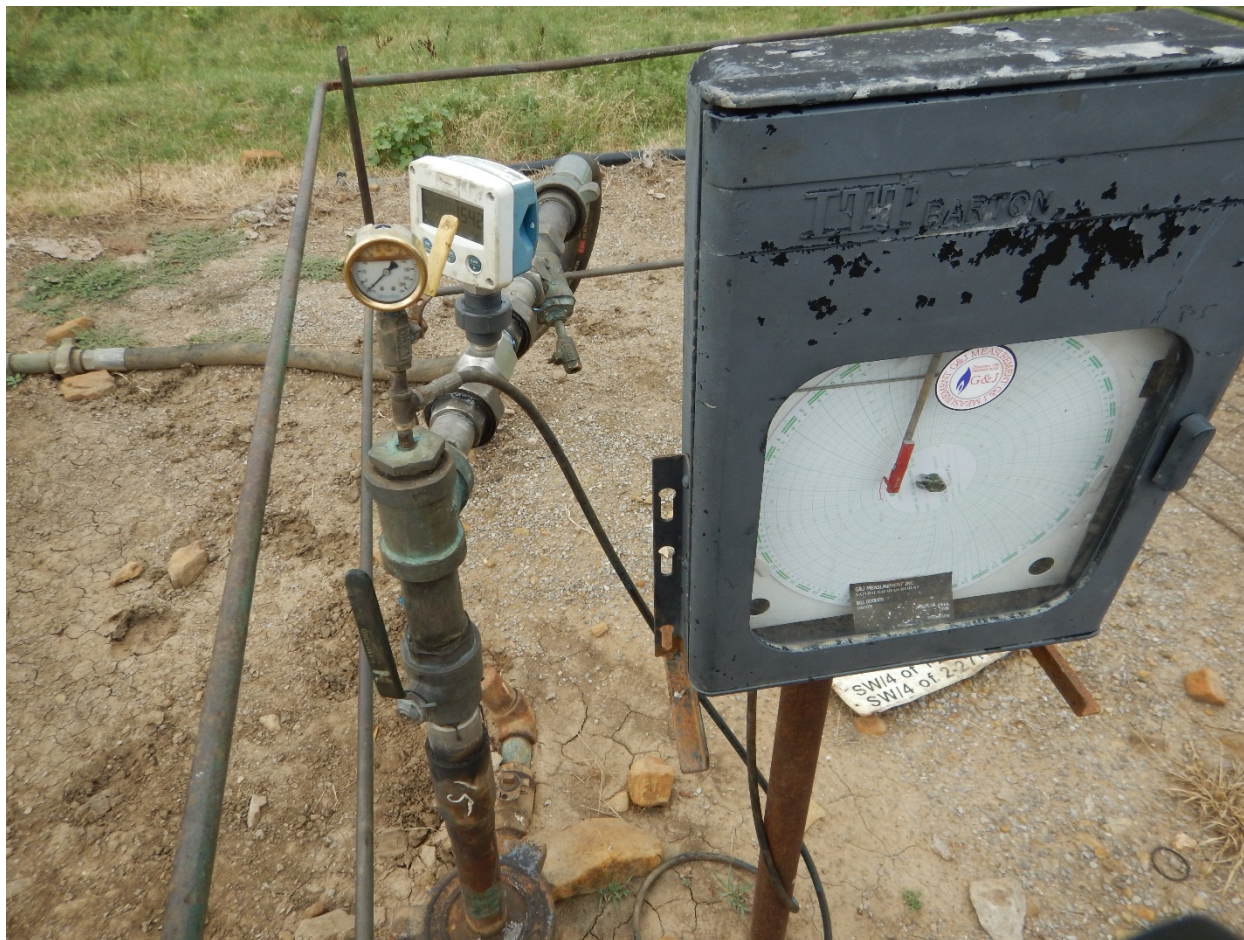
Photo No. 2

**Description:** This was a view of the proper installation of the pressure monitoring device onto the tubing of the well.

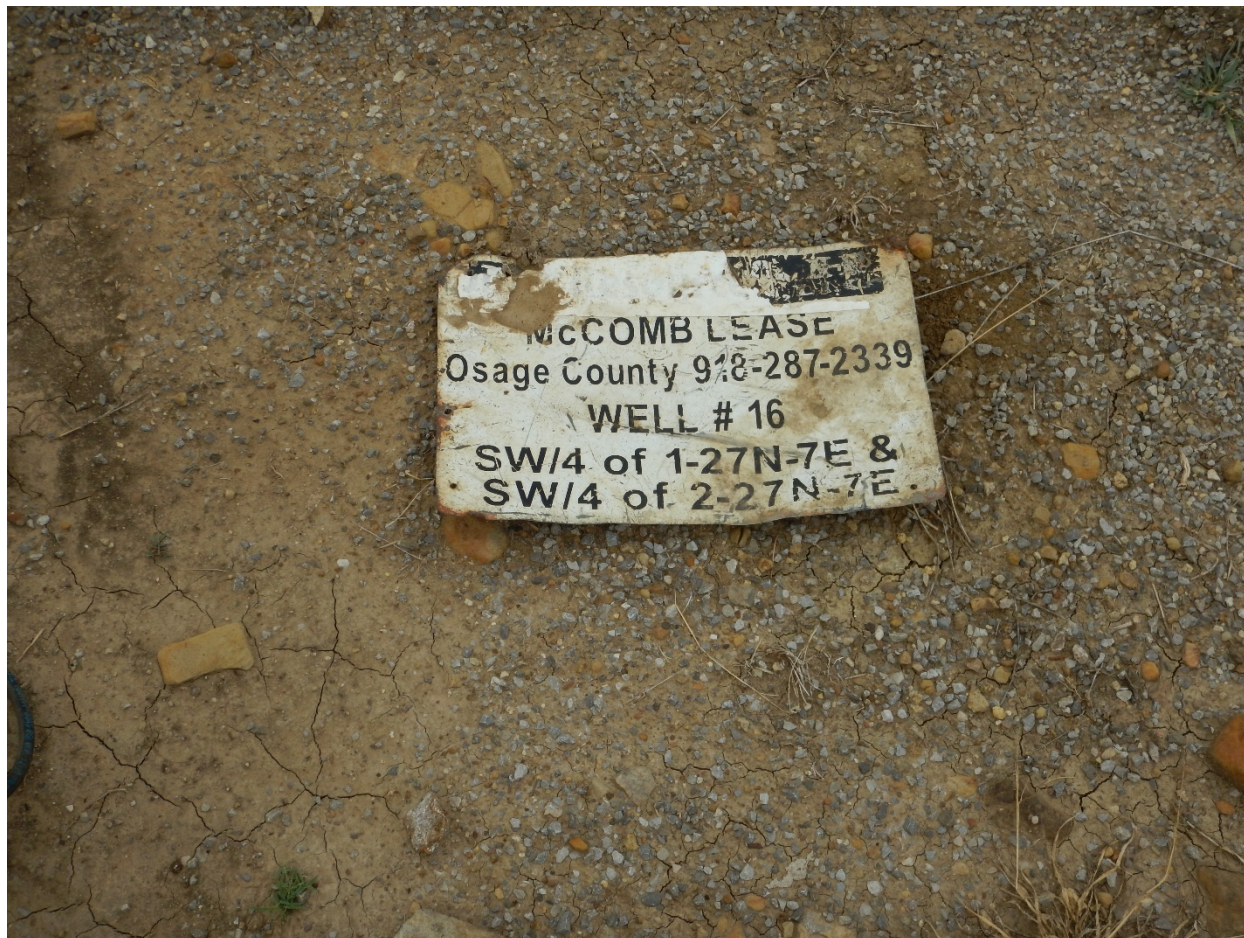
Photo No. 3

**Description:** This was the well sign inside the fence at the well location. Updated, legible signage should be maintained at the well location.
