**Region 6 - Enforcement & Compliance Assurance Division**  
**INSPECTION REPORT**

| Inspection Date(s): | 08/05/2021 | |
| Facility Name: | Bernalillo Wastewater Treatment Plant | |

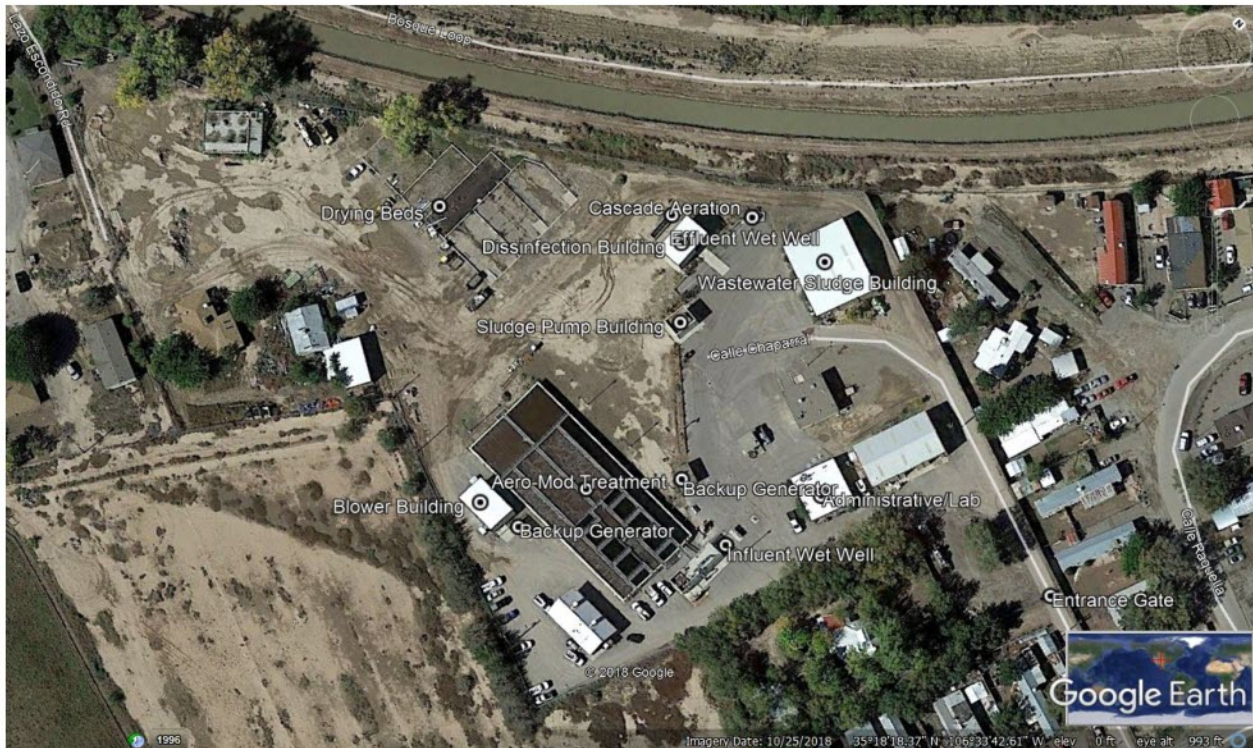
The WWTP has a design flow of 1.2 million gallons per day (MGD), inclusive of an average daily flow of roughly half. It is located at 585 Calle Chaparral, Sandoval County, New Mexico (depicted in **Aerial Image #1** below). Coordinates to the Bernalillo facility are approximately: Latitude 35°18'19.81" North, Longitude 106°33'36.13" W. The WWTP facility serves a population of approximately 10,000 (2018) residents. The WWTP is operated by staff within the Wastewater Department of the Public Works Department and consists of 4 full-time equivalent (FTE) positions on a 7AM-4PM Monday-Friday schedule, with on-call rotations the remaining of the time.

**Aerial Image #1- Overall view of the Town of Bernalillo Wastewater Treatment Plant. Aerial from Google Earth.**

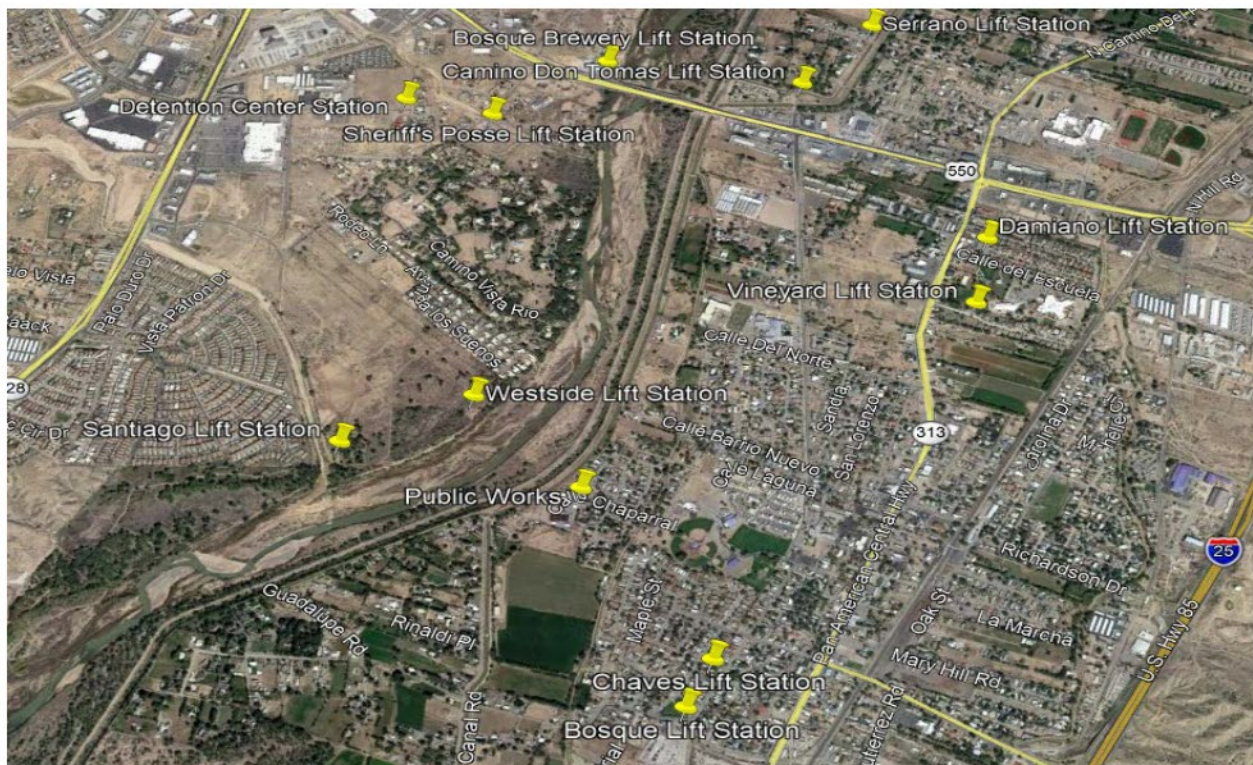
Flow enters the WWTP facility via a series of twelve (12) lift stations (LS) (depicted in **Aerial Image #2** and described in **Table 1** and below).

**Aerial Image #2- Overall view of the Town of Bernalillo Lift Stations. Aerial from Google Earth.**
