INSPECTION REPORT

| Type of Inspection | Focused Compliance Inspection (FCI) | | | |
| Facility or Site Name | Western Gulf Recycling | | | |
| Type of Operation | Western Gulf Recycling is a container washout, water treatment, and barge cleaning facility. | | | |

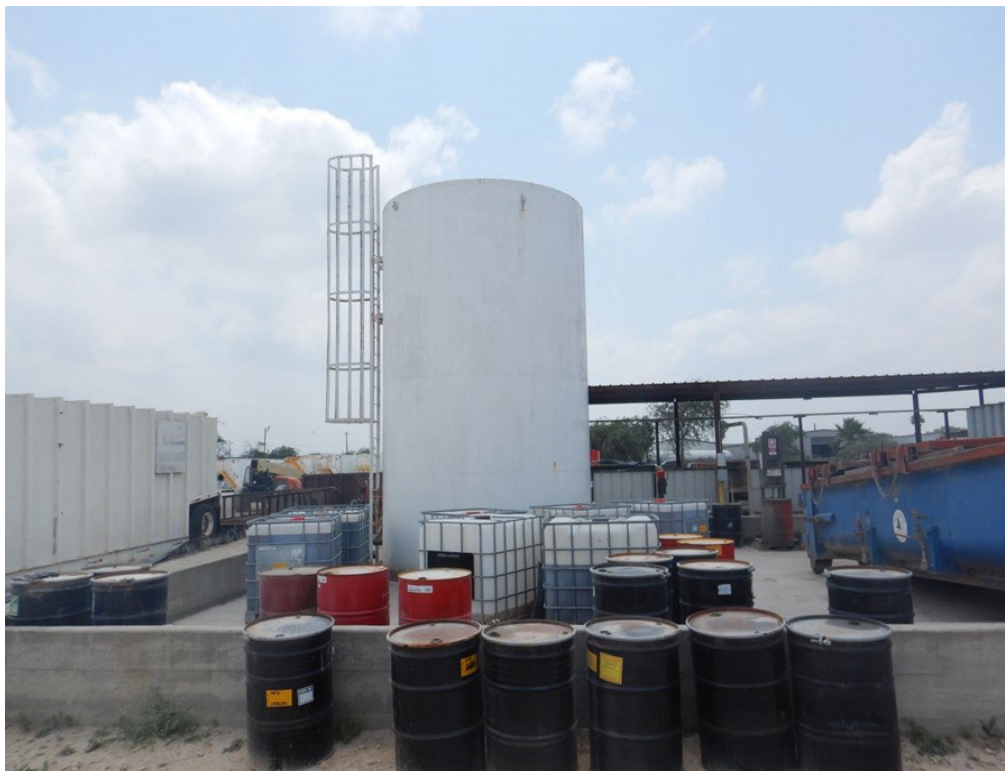
Photo File Name: DSCN1100

**Used Oil Containment Area** (see Appendix 1 – Photo 1):

At the used oil containment area, WG personnel explained that they pump totes and drums of used oil into the tank seen in Appendix 1 – Photo 1. They explained that they have a third-party company come onsite to dispose of the used oil in the tank. WG personnel indicated that their used oil generally comes from Kiewit Offshore Services, and that all the used oil received onsite is comingled in the tank. The inspection team observed five full 55-gallon drums of used oil that had been transferred to WG and were being stored outside of secondary containment (see Appendix 1 – Photo 1) [**AOC #1** – *WG stored containers of used oil without a secondary containment system- 40 CFR 279.54(c)*]. In her response document, Ms. Rivera indicated that WG has transferred all of its used oil containers to secondary containment (see Appendix 2 and Appendix 2 – Photo 7).

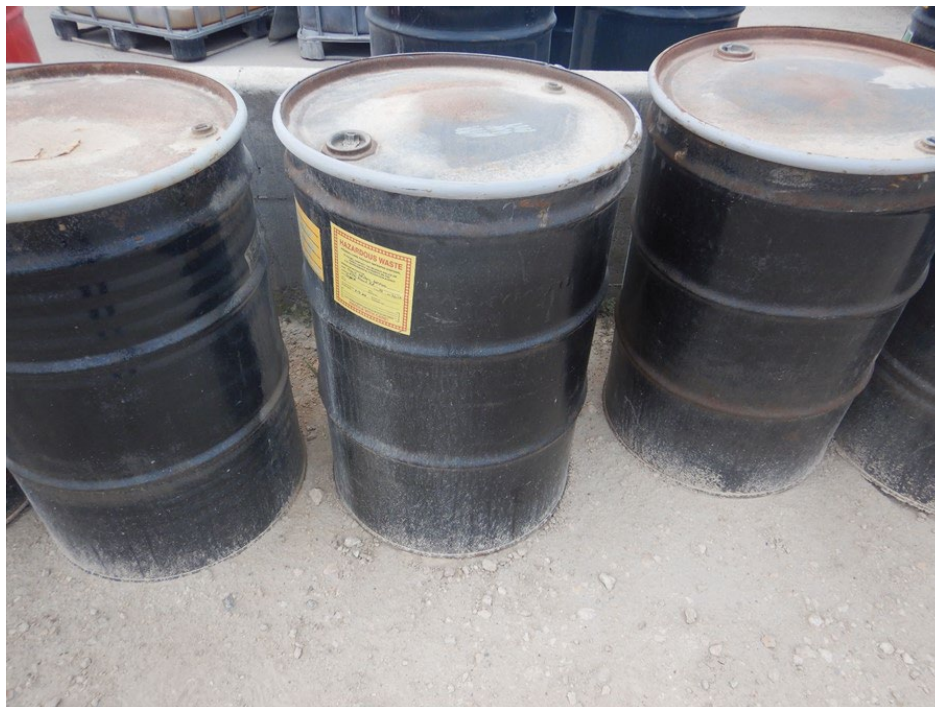
Photo File Name: DSCN1101

A 55-gallon hazardous waste drum labeled with both a "hazardous waste" and a "pending analysis" label was located adjacent to the used oil storage area (see Appendix 1 – Photos 2, 3, and 4). Facility personnel stated that the drum had been transferred to WG from a customer; the inspection team observed that the hazardous waste label on the drum was marked with "Kiewit Offshore Services" as the generator (see Appendix 1 – Photo 2). The inspection team requested additional information about the container. In her response document, Ms. Rivera indicated that the drum contained approximately 1 inch of liquid gasoline and water mixture and was received on 05/02/2024 (see Appendix 2); however, she did not indicate whether the contents of the container were hazardous waste. [**AOC #2** – *WG did not make a hazardous waste determination on a waste at its facility – 40 CFR 262.11*].

Description: View of a 55-gallon hazardous waste drum labeled with both a "hazardous waste" and a "pending analysis" label located adjacent to the used oil storage area that was transferred to the facility from a customer and generated by Kiewit Offshore Services.

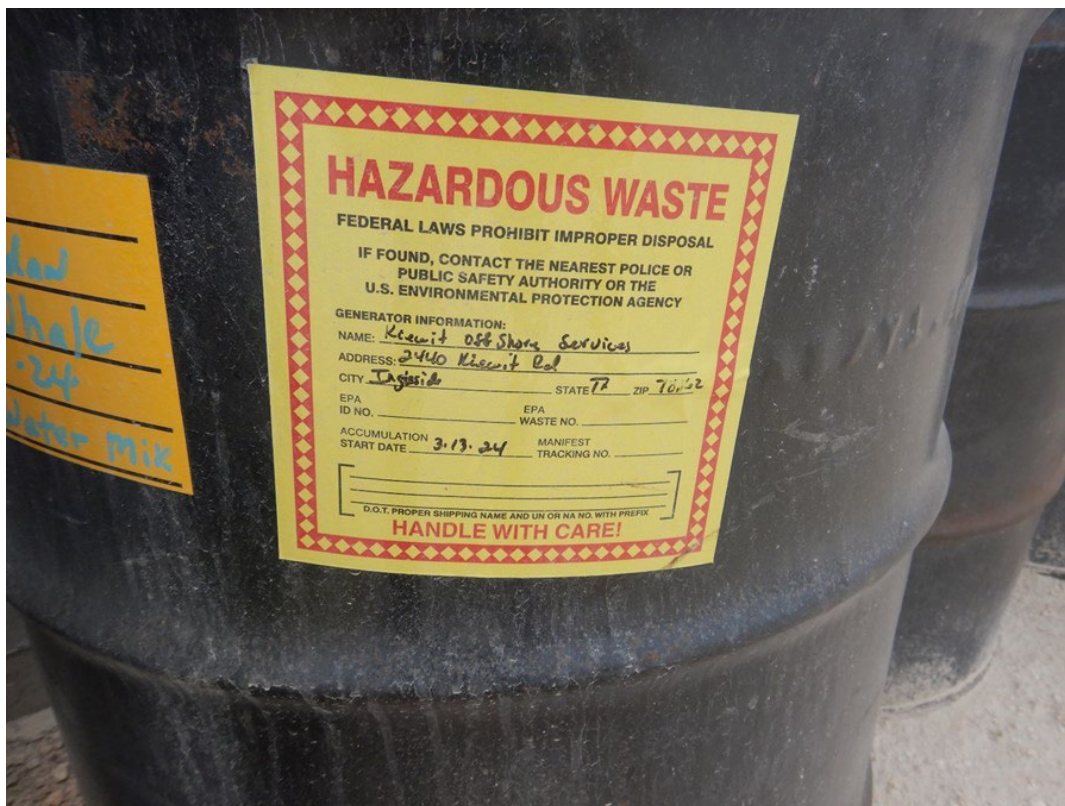
Photo File Name: DSCN1103

Description: View of one of the labels on the drum shown in Photo No. 2 in the used oil containment area indicating that the material is hazardous waste.

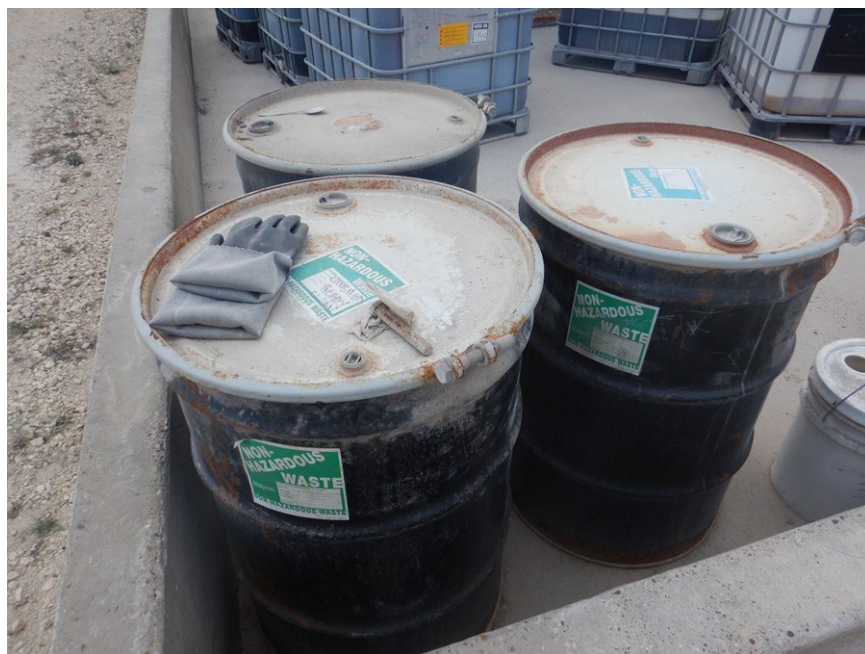
Photo File Name: DSCN1109

The inspection team also observed at least three drums with non-hazardous waste labels that contained used oil in and around the used oil containment area (see Appendix 1 – Photo 10) [see **AOC #3**]. The inspection team also requested documentation of the last date that used oil was shipped offsite from WG's facility. In her response, Ms. Rivera indicated that the last date used oil was transferred off the site was 02/06/2023 and included a Bill of Lading (BOL) confirming this (see Appendix 2).

Description: View of three drums with non-hazardous waste labels that contained used oil in the used oil containment area's secondary containment.

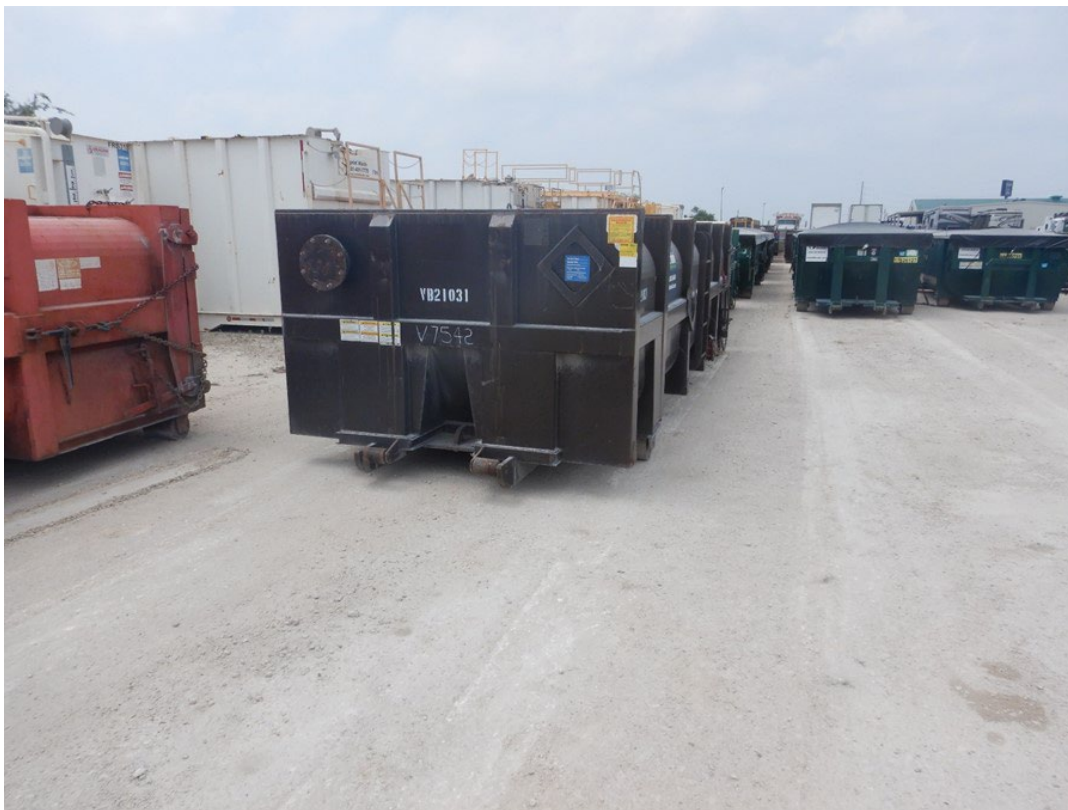
Photo File Name: DSCN1110

In the storage area, the inspection team observed a roll off with a hazardous waste label that was verbally confirmed to be empty (see Appendix 1 – Photos 11 and 12). Six frac tanks were observed on-site with hazardous waste labels that reportedly contained residue and were on-site for cleaning (see **AOC #5**; see Appendix 1 – Photos 13 through 23). The inspection team observed residue inside one of these frac tanks (see Appendix 1 – Photo 17). The inspection team could not observe the interiors of the other frac tanks during the inspection. In her response, Ms. Rivera included the dates that the frac tanks were brought on site based on the Frac Drop-Off Tickets included as Attachment 3 of her response (see Appendix 2). The dates along with the frac tank numbers are as follows:

Description: View of a vacuum box with a hazardous waste label that was verbally confirmed to be empty in the storage area for equipment awaiting washouts.

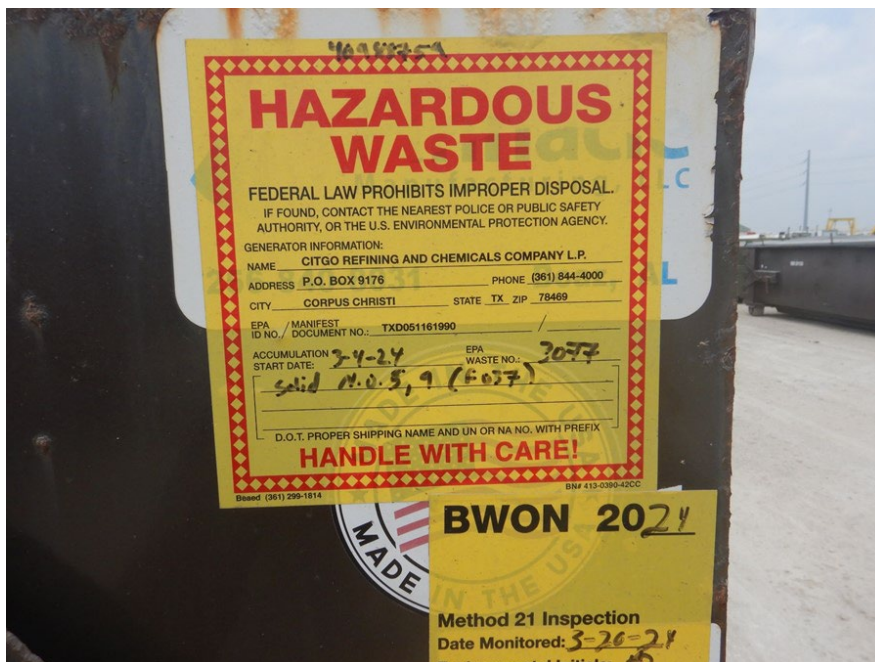
Photo File Name: DSCN1111

Description: View of the hazardous waste label on the roll off shown in Photo No. 11 in the storage area for equipment awaiting washouts.

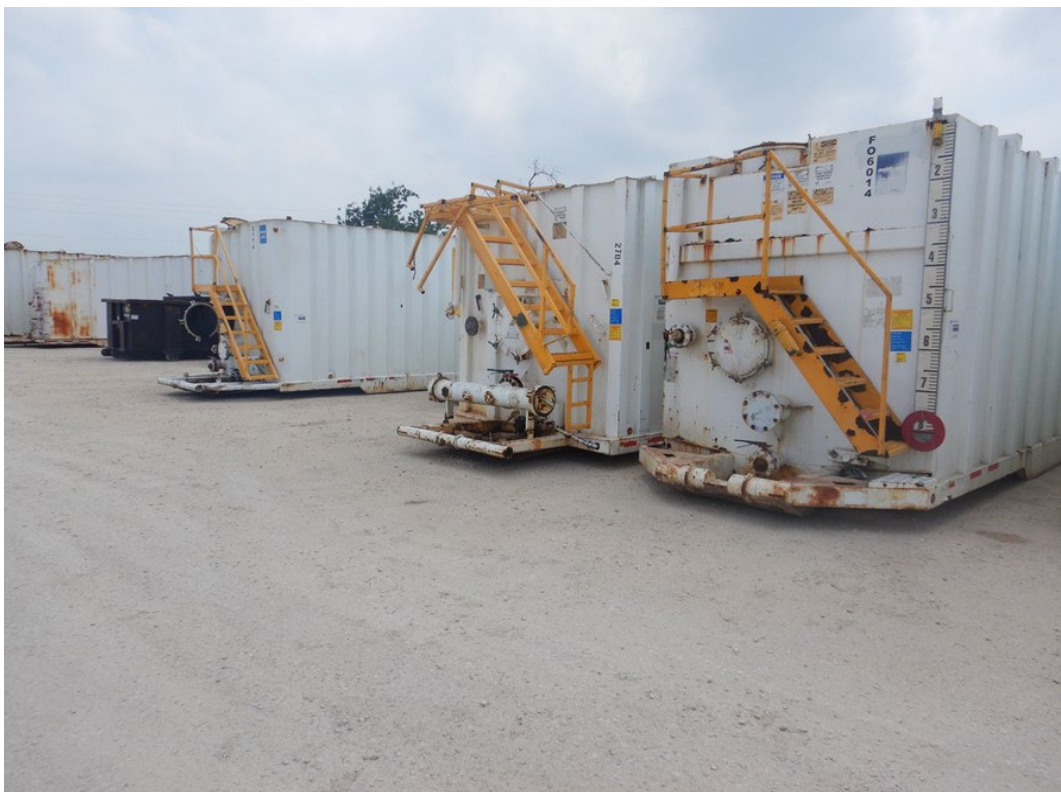
Photo File Name: DSCN1112

Description: Overview of three frac tanks (labeled as F06014, 2704, and 2174) with hazardous waste labels in the storage area for equipment awaiting washouts that reportedly contained residue and were on-site for cleaning. The inspection team observed that tank F06014, the rightmost tank, had a broken gauge.

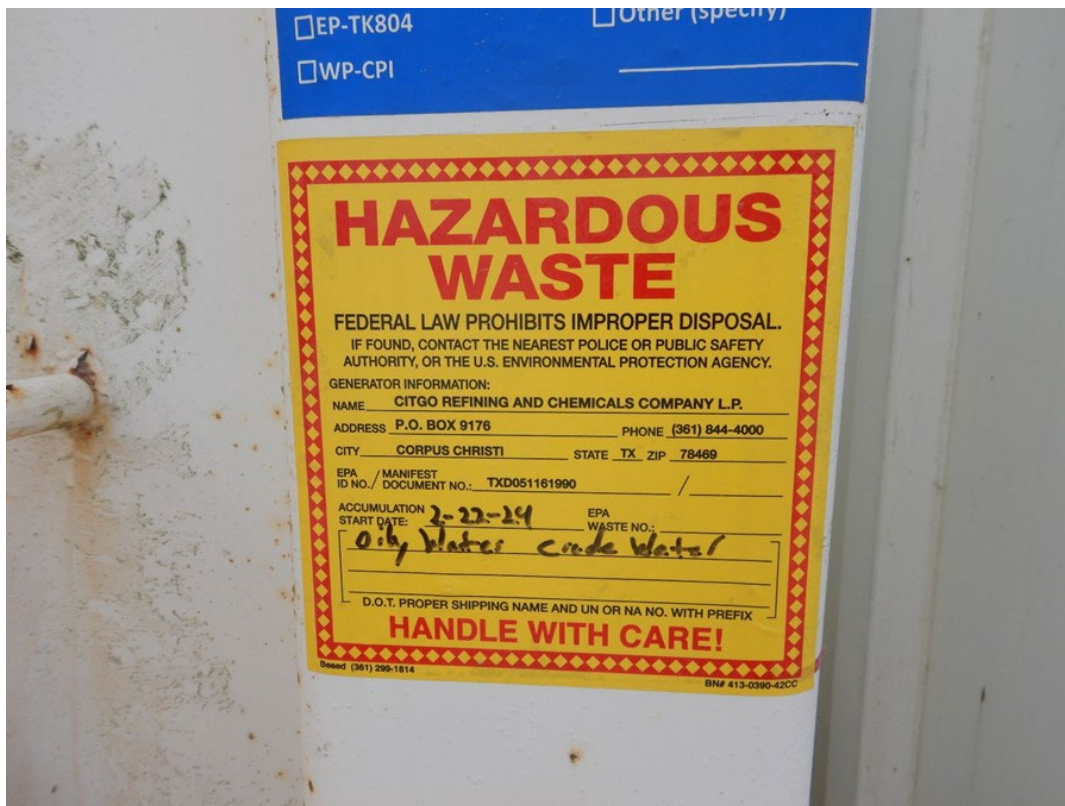
Photo File Name: DSCN1114

Description: View of the hazardous waste label on the middle tank (2701) in Photo No. 13.

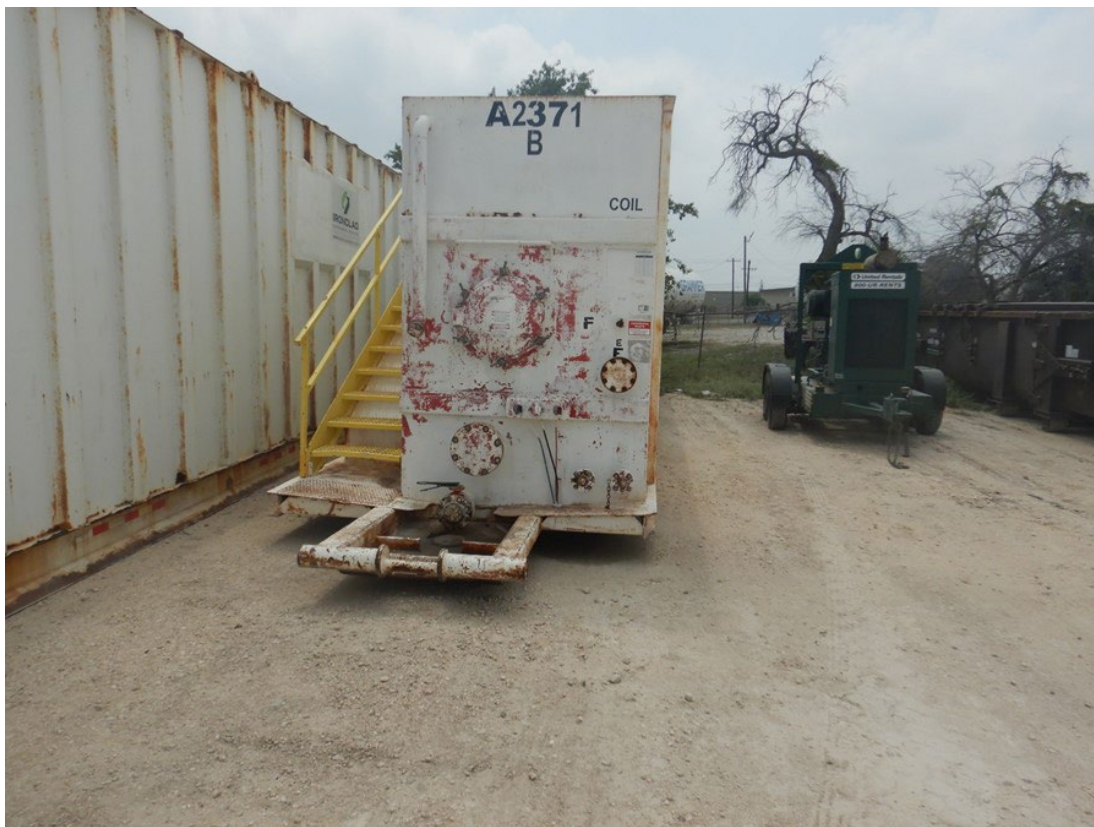
Photo File Name: DSCN1117

Description: View of a frac tank (A2371) with a hazardous waste label in the storage area for equipment awaiting washouts that reportedly contained residue and was on-site for cleaning.

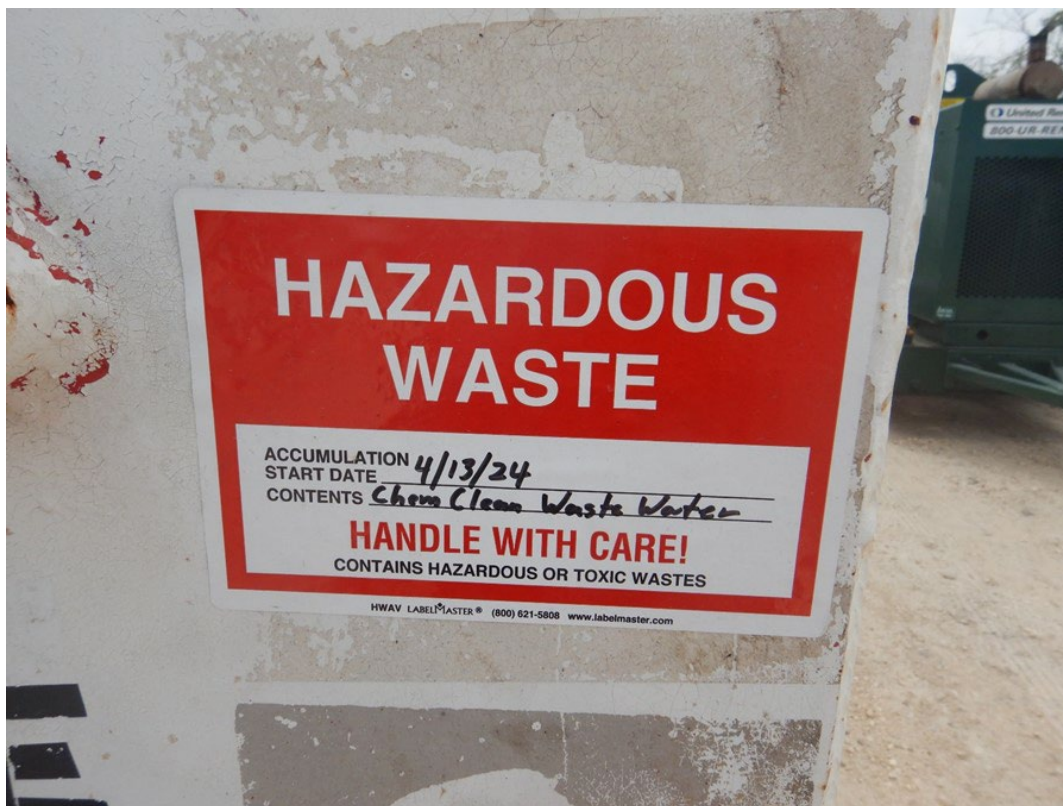
Photo File Name: DSCN1118

Description: View of the hazardous waste label on frac tank A2371 shown in Photo No. 18 in the storage area for equipment awaiting washouts.

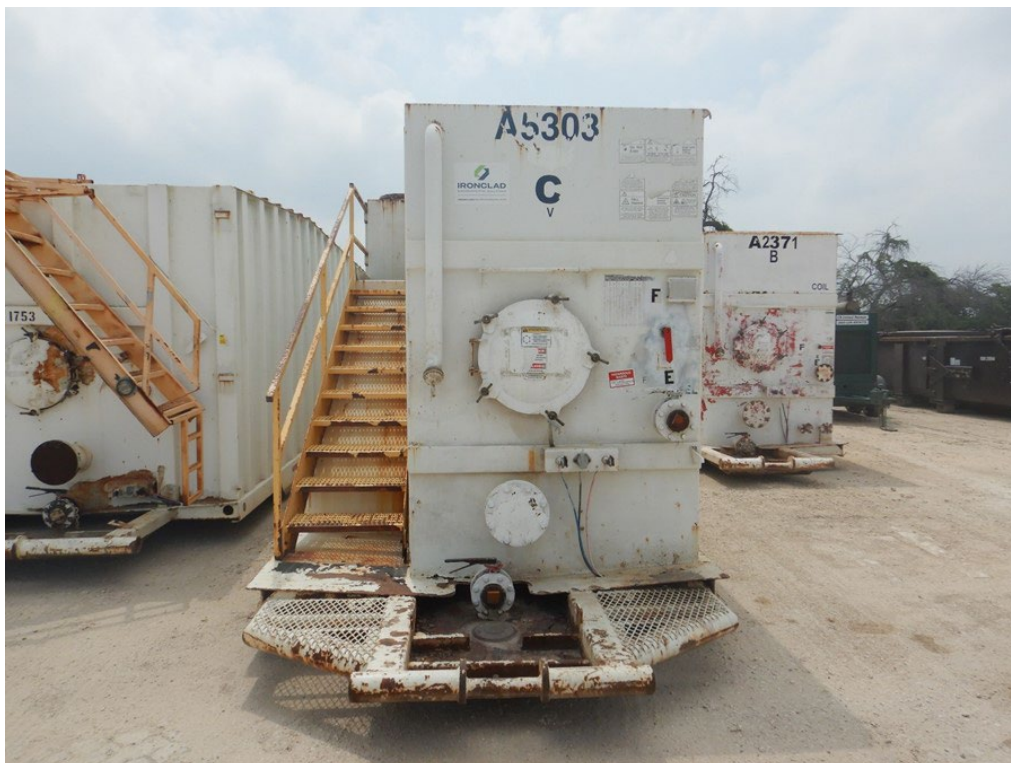
Photo File Name: DSCN1119

Description: View of a frac tank (A5303) with a hazardous waste label in the storage area for equipment awaiting washouts that reportedly contained residue and was on-site for cleaning.

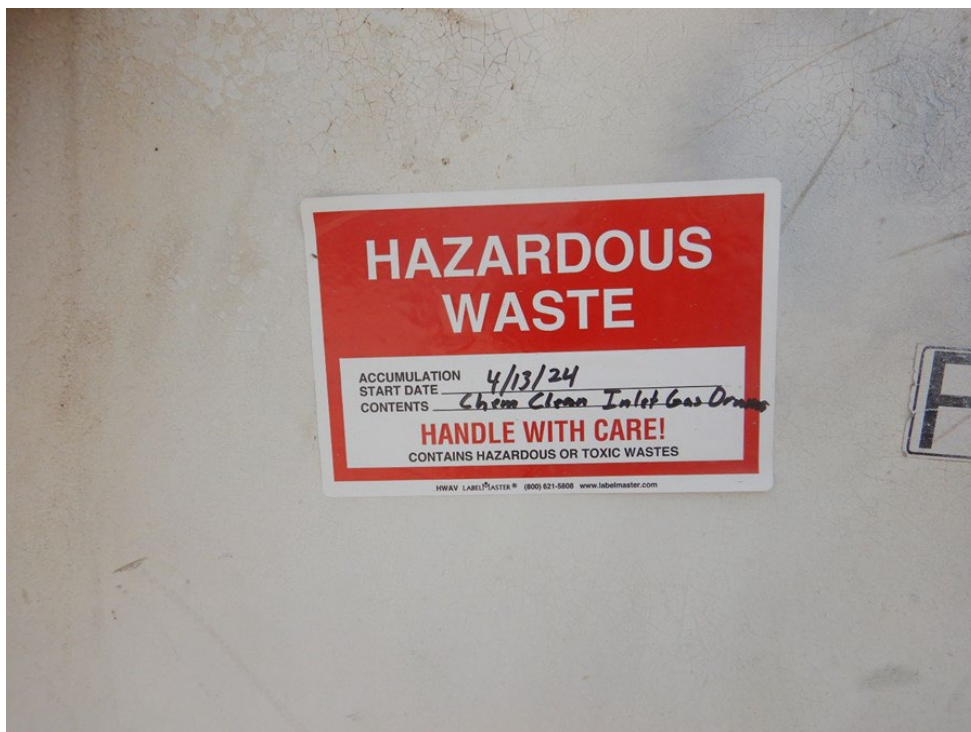
Photo File Name: DSCN1120

Description: View of the hazardous waste label on frac tank A5303 shown in Photo No. 20 in the storage area for equipment awaiting washouts.

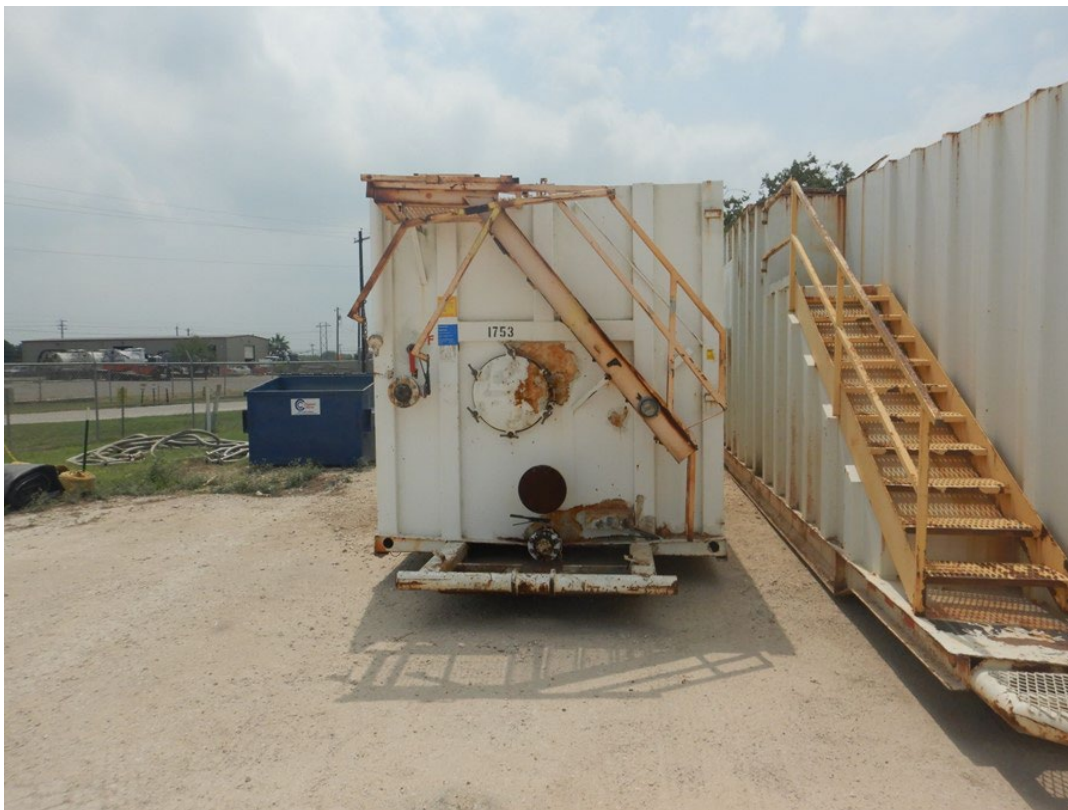
Photo File Name: DSCN1121

Description: View of a frac tank (1753) with a hazardous waste label in the storage area for equipment awaiting washouts that reportedly contained residue and was on-site for cleaning.

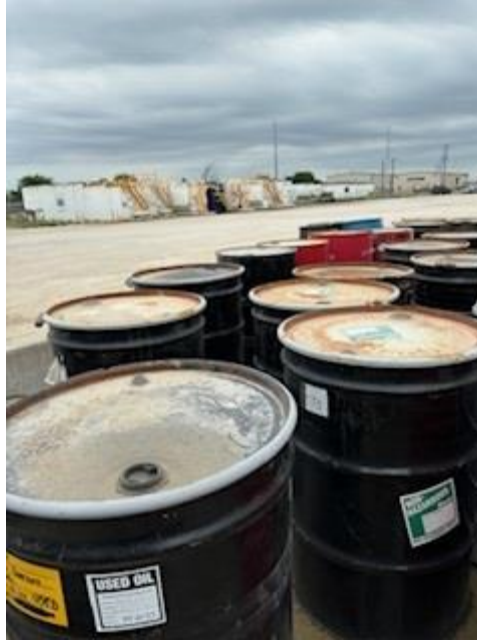
**Photo 1-Labeled Used Oil Drum**

*Response: The black 55-gallon drum located in used oil secondary containment contain used oil and was brought on-site on March 13, 2024.*

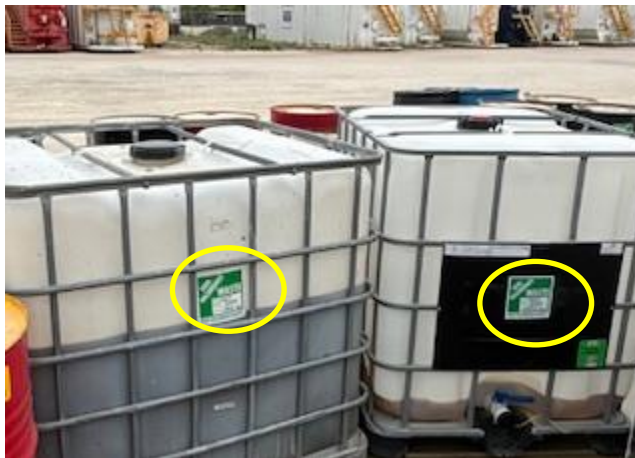
**Photo 2- Labeled Totes**

- b. Two poly totes located in the used oil secondary containment (photo DSCN1106).

*Response: The Two unlabeled poly totes located in the used oil secondary containment contain used oil and were brought on-site on March 13, 2024. The containers were labeled.*

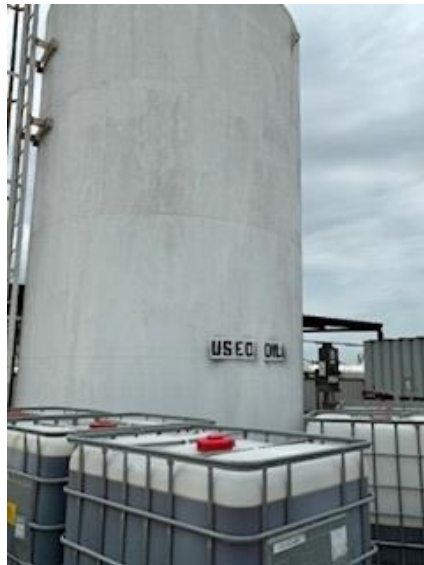
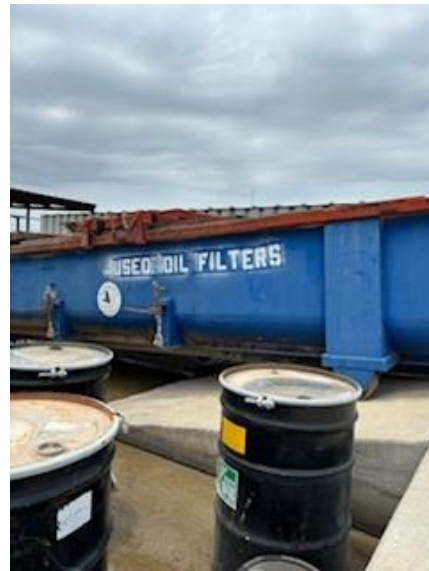
**Photo 3 and 4- Labeled Containers**

- a. The used oil tank located within secondary containment
- b. The roll-off with oil filters, which was observed with free oily water

*Response: The deficiency was corrected immediately, and all containers stored at the facility have been properly labeled.*

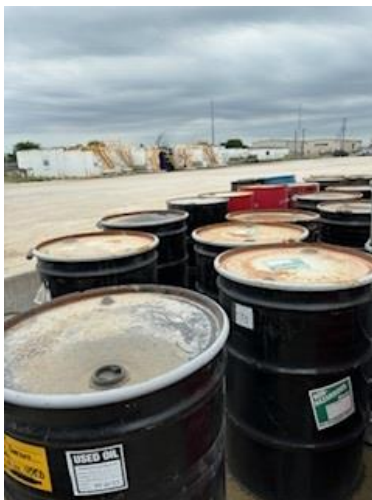
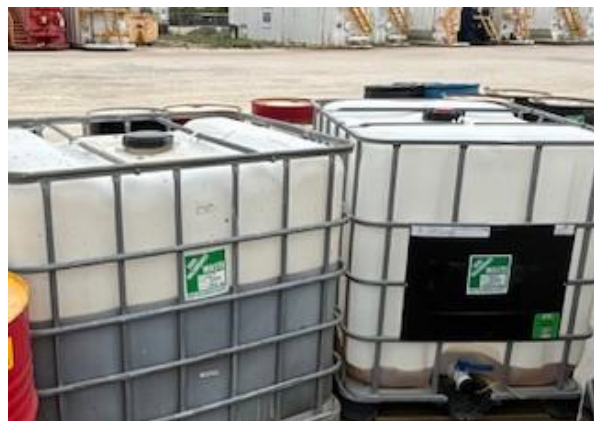
**Photo 5 and 6- Labeled Containers**

3. The following containers located in the used oil secondary containment were not labeled as to their contents:
  - a. One black 55-gallon drum
  - b. Two poly totes

*Response: The containers have been properly labeled.*
