## RCRA Compliance Evaluation Inspection Report

Eastern Shipbuilding Group Inc.  
13300 Allanton Road  
Panama City, Florida 32404-2816  
Bay County

EPA ID No. FLR000041921  
Latitude: 30° 1' 59.203"  
Longitude: 85° 28' 38.1588"  
NAICS Code: 336611 – Shipbuilding and Repairing  
488390 – Other Support Activities for Water Transportation  
SIC: 3731 – Shipbuilding and Repairing  
Website: <https://www.easternshipbuilding.com>

July 12, 2023, 9:30 a.m.

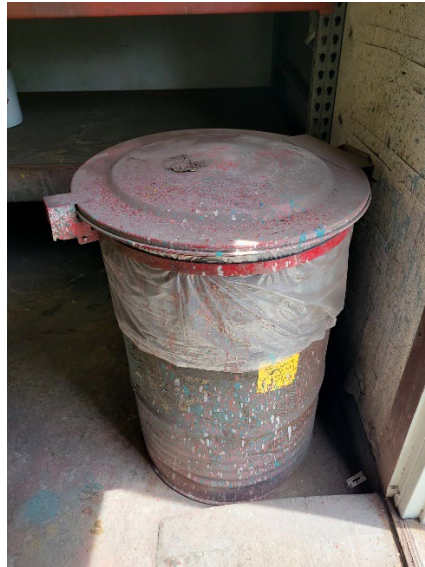
The material processing plant also contains the paint mixing, priming, and painting area. The inspectors observed one 55-gallon satellite accumulation area (SAA) container and one 55-gallon excluded solvent contaminated wipes in this area (Photos #1-2). The SAA container was a closed 55-gallon container of paint waste and debris (EPA Waste Code D001, D032, F003, and F005) marked "Hazardous Waste" and with an indication of the hazards of the contents. The facility failed to identify applicable EPA Hazardous Waste Number (waste code) applicable to the paint waste in order to determine the applicable treatment standards or the underlying hazardous constituents. This container of (D001, D032, F003, F005) waste was not listed on the most recent 8700-12 Notification Form submitted to FDEP on April 2, 2019. The second container was a closed 55-gallon container storing excluded solvent contaminated wipes. The container was barely legible with the markings of "excluded solvent contaminated wipes." There was no safety shower, eyewash station, spill kits, or emergency communication procedures posted in this area.

Photo #2 – Spent excluded contaminated solvent wipes in the paint mixing room.

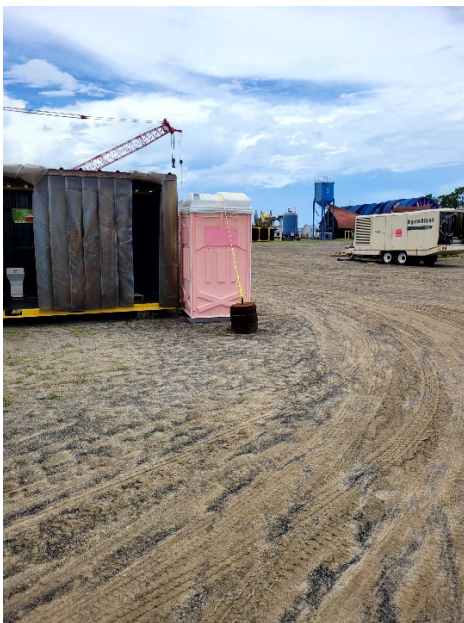
The outdoor environmental area contains the large sandblasting area enclosed with a net to catch sandblasting media. The inspectors observed spent blasting media, or “Black Beauty” on the ground near the sand blasting area (Photo #3). It appears that spent blast media released on the ground are not sampled for TCLP waste analysis or analyzed for waste determination.

Photo #3 – Spent blast media release On the ground.

Pursuant to Fla. Admin. Code Ann. r. 62-730.160(1) [40 C.F.R. § 262.11], a person who generates a solid waste, as defined in Fla. Admin. Code Ann. r. 62-730.030(1) [40 C.F.R. § 261.2], must determine if that waste is a hazardous waste following the methods articulated into Fla. Admin. Code Ann. r. 62-730.160(1) [40 C.F.R. § 262.11].

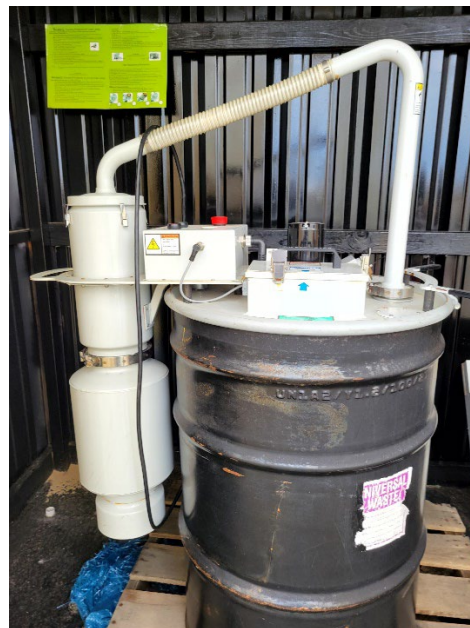
The puncturing area contained a 55-gallon aerosol can puncture container and a 55-gallon bulb crusher container (Photo #4). The waste aerosol can container was marked “Hazardous Waste” but without an indication of the hazards of the contents or an accumulation start date. According to the facility, aerosol can puncture filters are changed as stated by the filter manufacturer. The bulb crusher’s label was not legible, and the container exhibited intense signs of weathering. The container was not marked with the words “Hazardous Waste,” with an indication of the hazards of the contents, or an accumulation start date.

Photo #4 – 55-gallon container of bulb crusher in the outdoor environmental area.

**Pursuant to F.A.C. Chapter 62-730.160(1) [40 C.F.R. § 262.16(b)(6)(i)], which is a condition of the SQG Permit Exemption, (A) a generator must mark or label its container with the words “Hazardous Waste,” (B) must mark or label its containers with an indication of the hazards of the contents (examples include, but are not limited to, the applicable hazardous waste characteristic(s) (i.e., ignitable, corrosive, reactive, toxic); hazard communication consistent with the Department of Transportation requirements at 49 CFR part 172 subpart E (labeling) or subpart F (placarding); a hazard statement or pictogram consistent with the Occupational Safety and Health Administration Hazard Communication Standard at 29 CFR 1910.1200; or a chemical hazard label consistent with the National Fire Protection Association code 704), and (C) The date upon which each period of accumulation begins clearly visible for inspection on each container.**

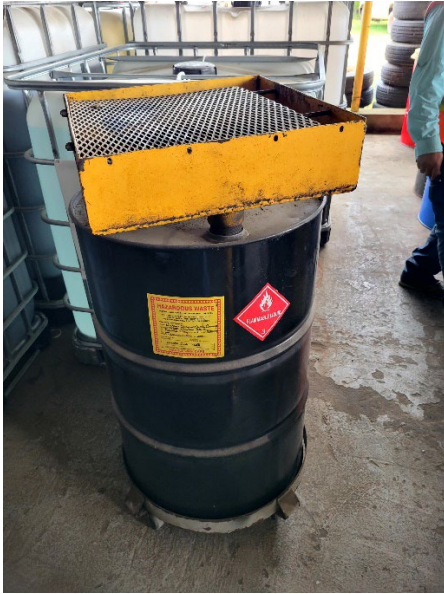
The inspectors observed approximately seventy-five waste tires stacked along the outside of the maintenance area. There was one 265-gallon used oil tank within a metal secondary containment area marked with the words “Used Oil.” A 55-gallon container of waste gas was marked “Hazardous Waste” and ignitable markings but was considered open because the metal mesh funnel inserted into the bung hole did not have a lid (Photo #5). A 55-gallon container stored drained oil filters but was open and was not marked “Used Oil” (Photo #6). Four used oil transfer containers were not labeled with the words “Used Oil” (Photos #7). In addition, there was a 55-gallon container of empty, unpunctured aerosol cans was improperly marked as non-hazardous waste (Photo #8).

Photo #5 – Maintenance Area – open flammable hazardous waste container.

**Pursuant to F.A.C. Chapter 62-730.160(1) [40 C.F.R. § 262.15(a)(4)], which is a condition of the SAA Permit Exemption, a container holding hazardous waste must be closed at all times during accumulation, except: (i) when adding, removing, or consolidating waste; or (ii) when temporary venting of a container is necessary (A) for the proper operation of equipment, or (B) to prevent dangerous situations, such as build-up of extreme pressure.**

**Pursuant to F.A.C. Chapter 62-730.160(1) [40 C.F.R. § 262.15(a)(5)], which is a condition of the SAA Permit Exemption, a small quantity generator must mark or label its containers with the following: (i) The words “Hazardous Waste”; (ii) An indication of the hazards of the contents (examples include, but are not limited to, the applicable hazardous waste characteristic(s) (*i.e.*, ignitable, corrosive, reactive, toxic); hazard communication consistent with the Department of Transportation requirements at 49 CFR part 172 subpart E (labeling) or subpart F (placarding); a hazard statement or pictogram consistent with the Occupational Safety and Health Administration Hazard Communication Standard at 29 CFR 1910.1200; or a chemical hazard label consistent with the National Fire Protection Association code 704).**

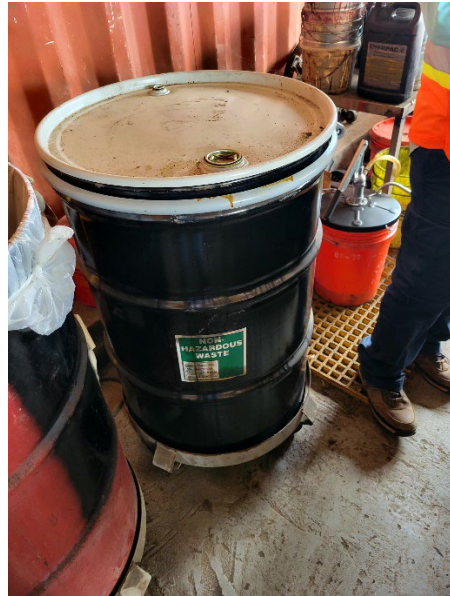
Photo # 6 – Maintenance Area – open 55-gallon drained oil filters.

**Pursuant to Fla. Admin. Code Ann. r. 62-710.850(5)(a), general requirements for the storage of used oil filters, all persons storing used oil filters shall store used oil filters in**

**above ground containers which are clearly labeled “Used Oil Filters,” and which are in good condition (no severe rusting, apparent structural defects or deterioration) with no visible oil leakage. The containers shall be sealed or otherwise protected from weather and stored on an oil-impermeable surface.**

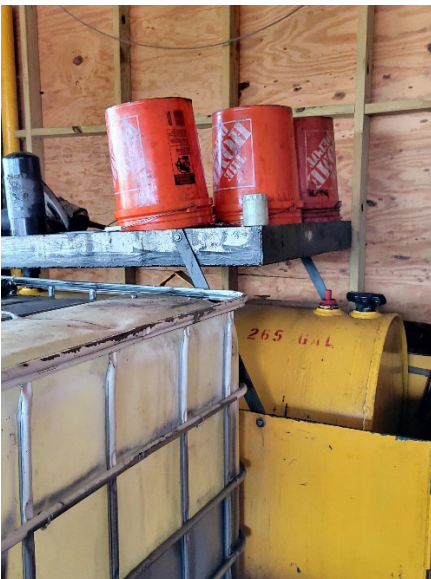
Photo #7 – Maintenance Area – used oil transfer containers and filter.

**Pursuant to Fla. Admin. Code Ann. r. 62-710.401(6) [40 C.F.R. § 279.22(c)(1)], containers and aboveground tanks used to store used oil at generator facilities must be labeled or marked clearly with the words “Used Oil.”**

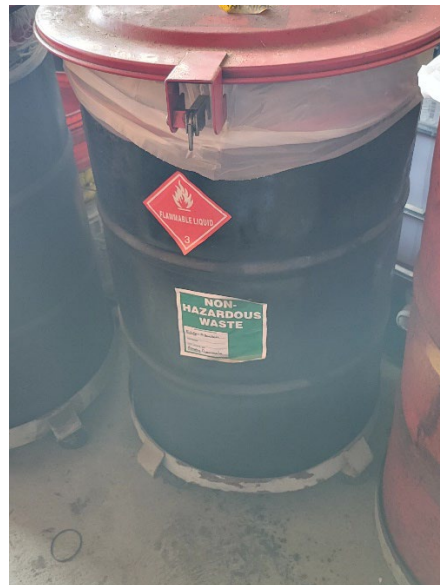
Photo #8 – 55-gallon container of used oil filters mislabeled.

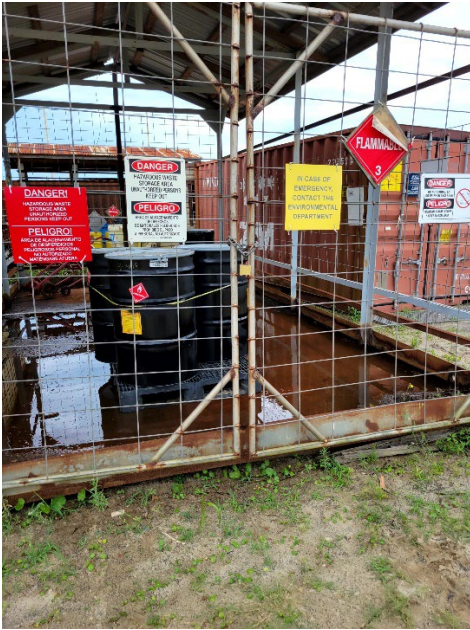
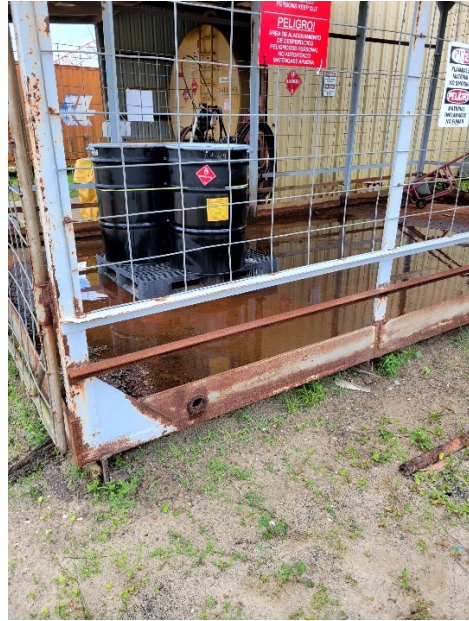
The Central Accumulation Area (CAA) is outside and enclosed by wire fencing with a locked gate. This area is covered with a roof, but all four sides are open to the weather. The secondary containment area lacked an adequate containment of waste and rainwater because there was an unplugged drainage hole (Photos #9-10). The unplugged hole would drain out wastes or rainwater to the ground/soil. Rainwater was noted inside the secondary containment during the inspection. The inspectors observed four 55-gallon containers within the CAA all dated from June 22, 2023, or June 23, 2023. These containers were marked with the words “Hazardous Waste”, an indication of the hazards of the contents, and EPA Waste Codes D001 and D018. There were no emergency postings or shower/eyewash station near the area and the only fire extinguisher in this area had expired in 2021.

Photo #9 – Less than 180-day area, CAA.

Photo #10 – Less than 180-day area, CAA.

**Pursuant to F.A.C. Chapter 62-730.160(1) [40 C.F.R. § 262.16(b)(8)(ii)], which is a condition of the SQG Permit Exemption, all areas where hazardous waste is either generated or accumulated must be equipped with the items in paragraphs (b)(8)(ii)(A) through (D) of this section (*unless* none of the hazards posed by waste handled at the facility could require a particular kind of equipment specified below or the actual waste generation or accumulation area does not lend itself for safety reasons to have a particular kind of equipment specified below). A small quantity generator may determine the most appropriate locations to locate equipment necessary to prepare for and respond to emergencies. (A) An internal communications or alarm system capable of providing immediate emergency instruction (voice or signal) to facility personnel; (B) A device, such as a telephone (immediately available at the scene of operations) or a hand-held two-way radio, capable of summoning emergency assistance from local police departments, fire departments, or State or local emergency response teams; (C) Portable fire extinguishers, fire control equipment (including special extinguishing equipment, such as that using foam, inert gas, or dry chemicals), spill control equipment, and decontamination equipment.**
