**Well Inspection**  
**Osage DNR / Environmental Protection Agency**  
**1201 Elm Street, Suite 500**  
**Dallas, Texas 75270**

| | | <b>Lease Name</b> | SECEPSU (Kla-Da-Ing 7) | | |
| | | <b>Well ID</b> | 7-1 | | |
| <b>Inspection Reason</b> | MIT | <b>Responsible Company at Time of Inspection</b> | Grace Energy Management | | |

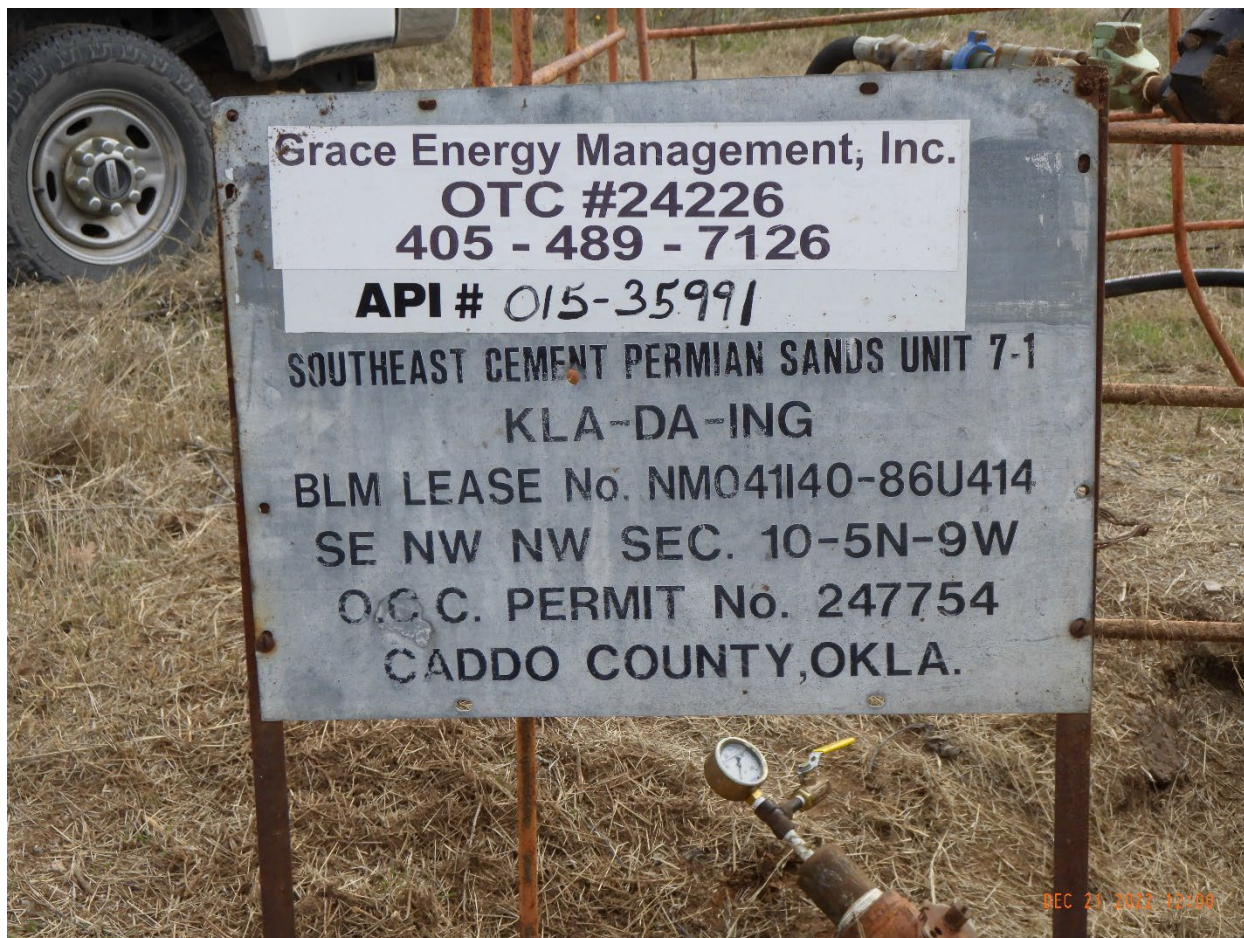
Photo No. 1

Description: OK0089000 well sign.

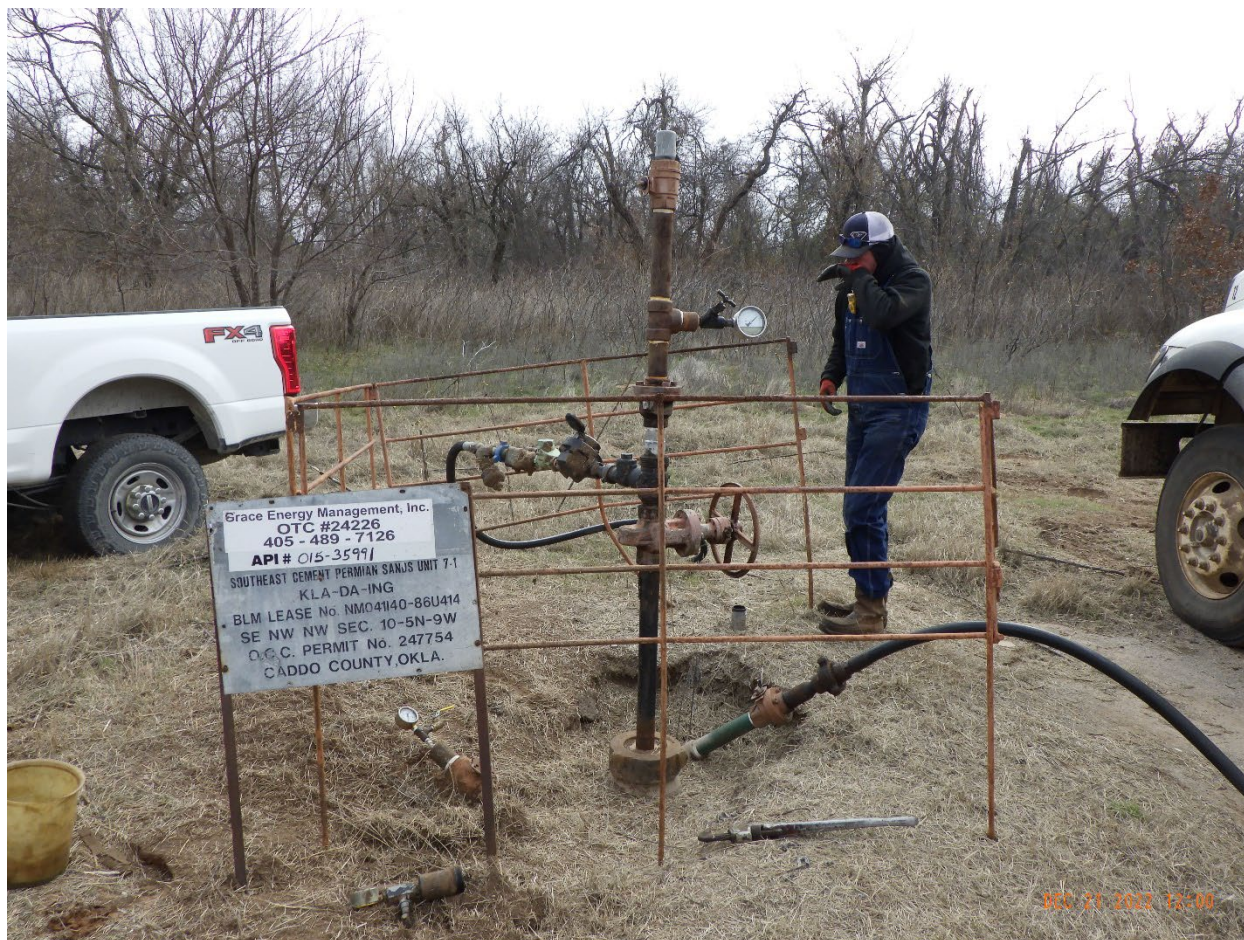
Photo No. 2

| <b>Inspection Comments</b> | <p>Inspector witnessed Standard Annulus Pressure Test (SAPT) on well OK0089000. Pressure, hold OK. I observed no areas of concern at the time of the inspection. EPA enforcement staff will review inspection data to determine compliance with EPA UIC regulations.</p> <p>Initial: 240psi<br/> Mid: 245psi<br/> Final: 250psi<br/> Pressure Hold OK</p> <p>Total flowback: 7,000ml</p> | | | | |

**Description:** Well, OK0089000 with EPA gauge and bleeder attached, just before pressuring for MIT.
