**Report Title:** Clean Water Act Compliance Inspection Report  
**Inspection Date(s):** August 9, 2023  
**Regulatory Program(s):** National Pollutant Discharge Elimination System (NPDES)  
**Type of Activity:** CAFO Inspection  
**Facility Name:** REM Farms, LLC  
**Facility Address:** 5374 Amore Dr. Laurel, DE 19956  
**Facility Latitude:** 38.527222  
**Facility Longitude:** -75.656111  
**County/Parish:** Sussex County  
**CAFO Permit No:** DE5000N11  
**Site Specific Permit No:** DEA116020  
**NAICS Code:** 112310  
**SIC:** 0251  
**Unique Project #:** 3E23WN110A

## DELAWARE CAFO INSPECTION REPORT

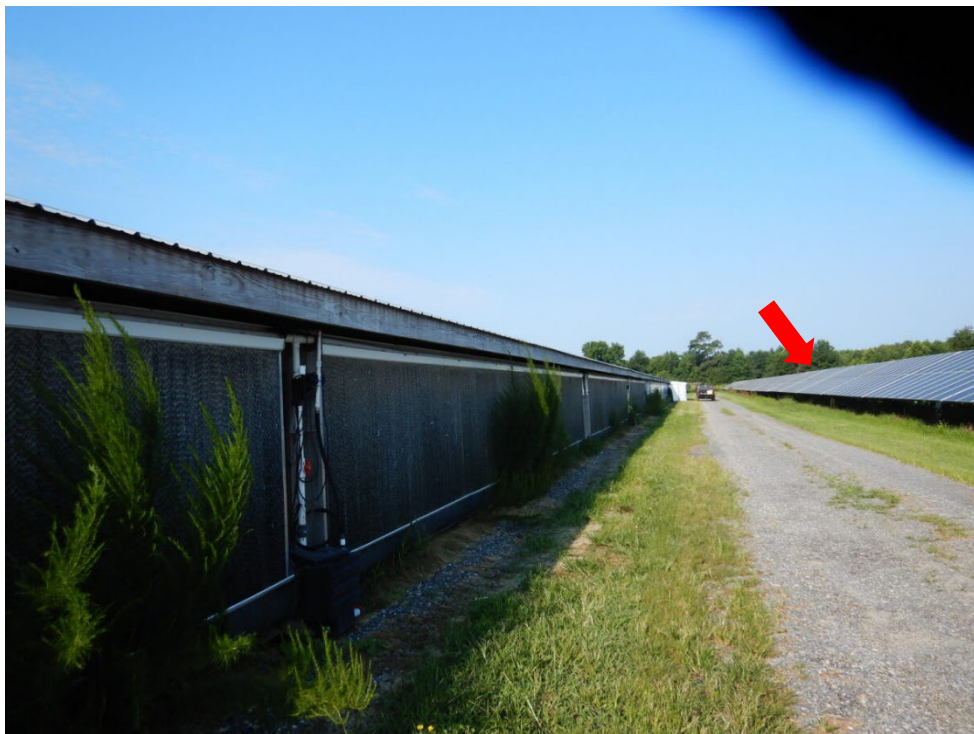
Photograph 2. View of the northern wall of Poultry House 8 from the east. The solar panels (red arrow) run along the northern edge of the facility and have a drainage ditch underneath them.

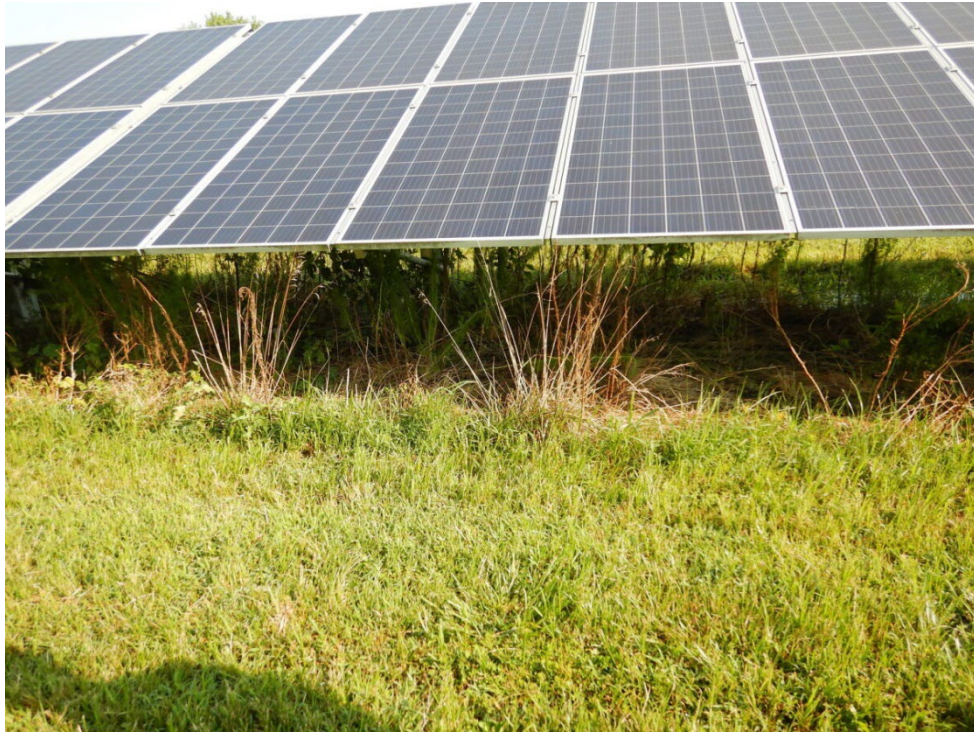
Photograph 3. Drainage ditch underneath solar panels along the northern edge of the facility.

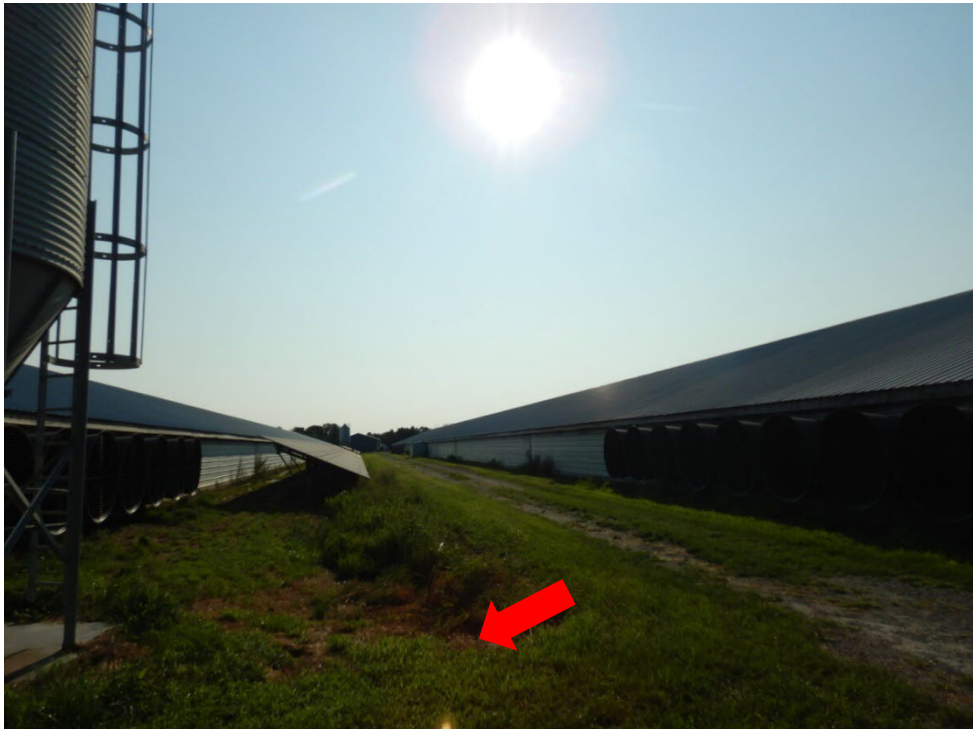
Photograph 6. View of the area between Poultry Houses 7 and 8. A drainage and a culvert (red arrow) convey runoff from the roof and the areas surrounding the houses to the western edge of the facility.

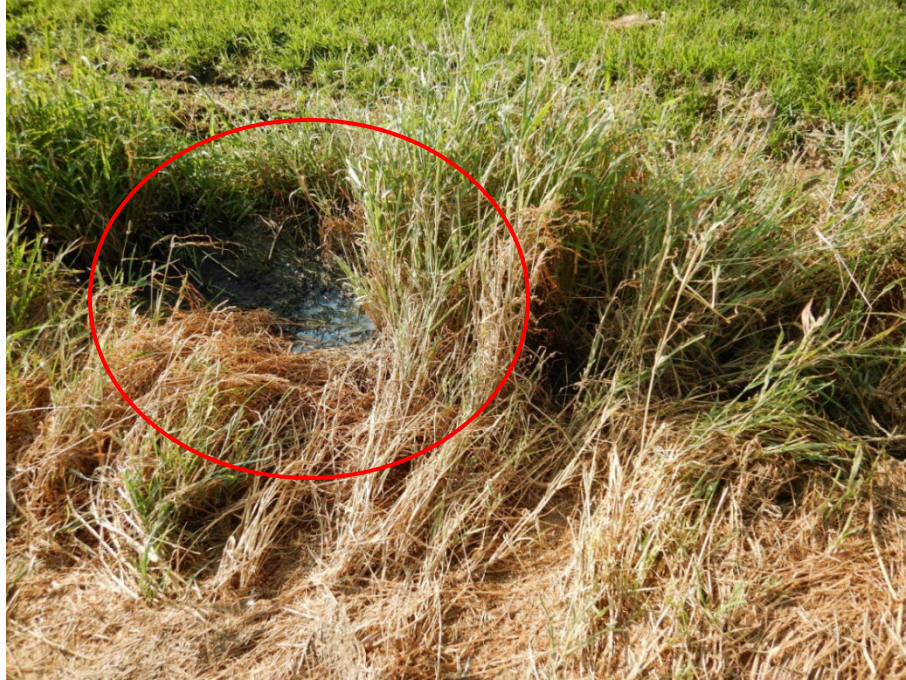
Photograph 7. Close-up view of the drainage between Poultry Houses 7 and 8. Standing water (red circle) was observed in the drainage.

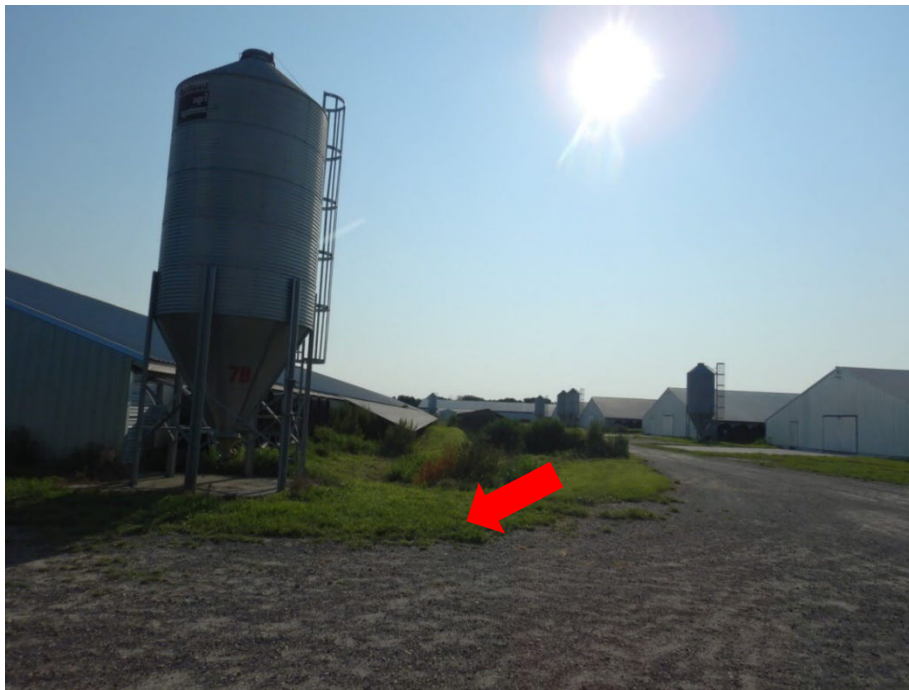
Photograph 8. View of the southern wall of Poultry House 7. A drainage and a culvert (red arrow) convey runoff from the roof and the areas surrounding the house to the western edge of the facility.

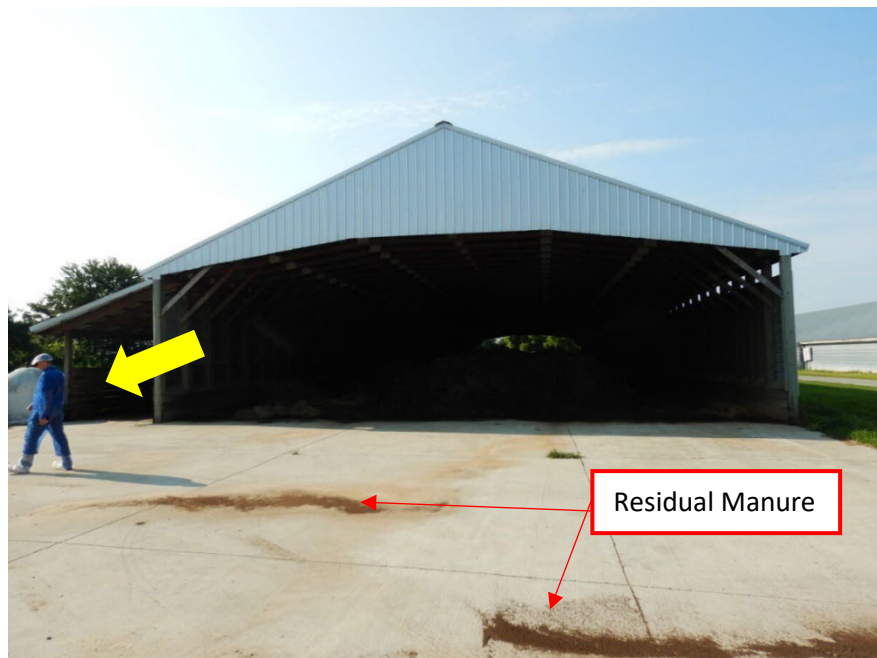
- The inspection team made the following observations regarding the stormwater basin:
  - Residual manure was observed on the concrete pad located on the north end of the south manure storage building (Photographs 10 and 11). See questions 46 and 48 of the Inspection Checklist below.

Photograph 10. View of the southern manure storage building and the concrete pad at the northern end of the building. Residual manure was observed on the concrete pad (red arrows). Mortality composting is performed in the composter located on the eastern edge of the building (yellow arrow).

- No 46. Manure residue and litter residue is adequately cleaned up on a reasonable and necessary basis? [DE GP1 Part II.A.4]  
The inspection team observed residual manure on the concrete pad located on the north end of the southern manure storage facility (Photographs 10 and 11).
- Yes 47. Manure residue and litter residue is adequately cleaned up from the exterior area(s) of the poultry house(s) as soon as practically possible after bird movement not to exceed 14 days? [DE GP1 Part II.A.5]
- No 48. All BMPs installed or used by the facility for water pollution control to achieve compliance with the terms and conditions of the permit are maintained in good working order and operate as efficiently as possible at all times? [DE GP1 Part II.A.6]

| a. Identify water pollution control BMPs | b. Describe maintenance activities |
|---|---|
| Good Housekeeping | The AWMP does not require this BMP, but includes it as an additional production area conservation practice (which is not required). The inspection team observed that areas around the poultry houses and mortality composting areas were generally clean. However, the inspection team observed residual manure on the concrete pad located on the north end of the southern manure storage facility (Photographs 10 and 11). |

- Residual manure on the concrete pad located on the north end of the south manure storage building (Photographs 10 and 11).
- Discoloration in standing water located in the stormwater drainage west of the manure storage building (Photograph 16).
- A layer of algae growth and/or duckweed was observed on the surface of the stormwater basin (Photographs 24 and 25).

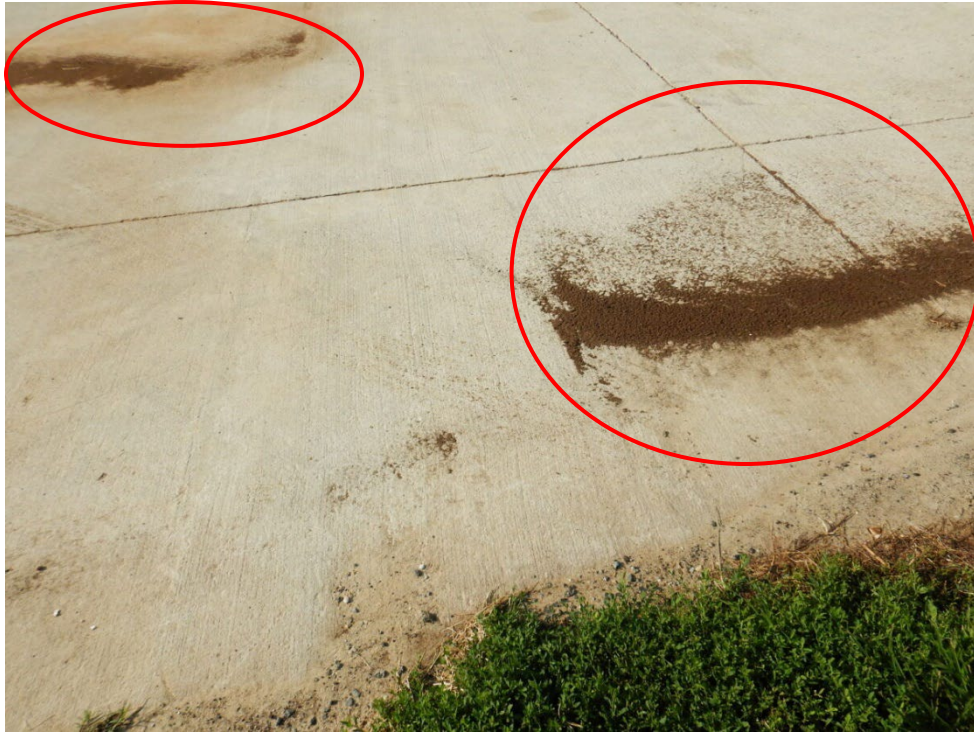
Photograph 11. Close-up view of the residual manure (red circles) on concrete pad on north end of the southern manure storage building.

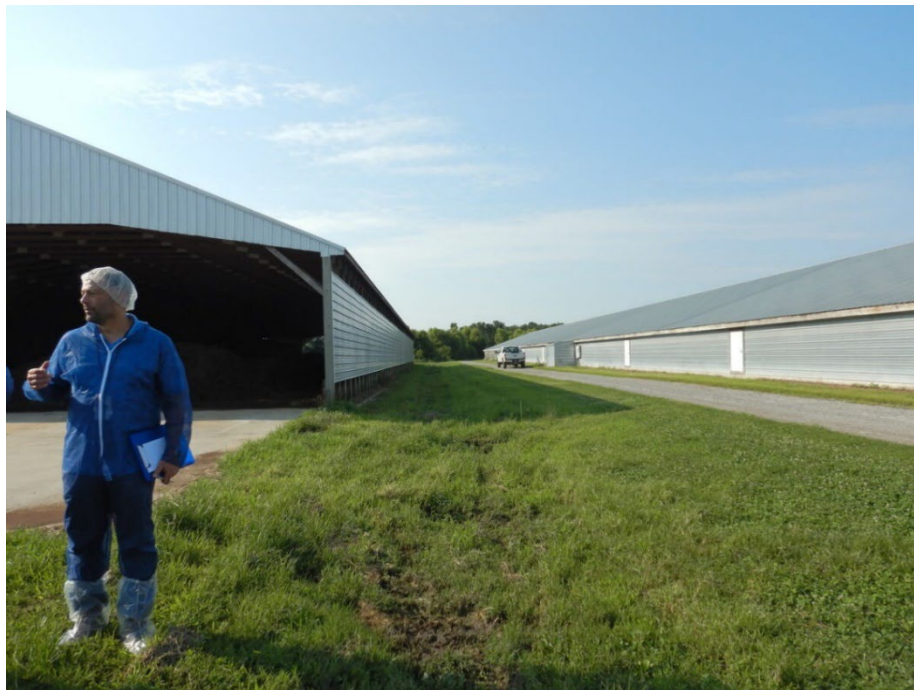
Photograph 14. Downgradient view of the stormwater drainage on the west side of the southern manure storage facility that conveys flows from the manure storage buildings to the stormwater basin.

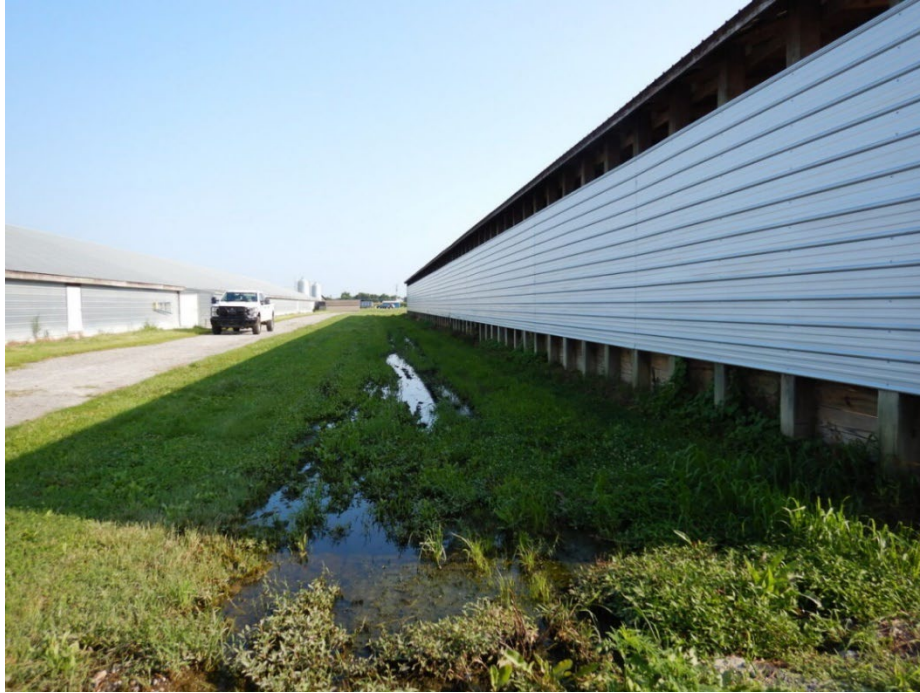
Photograph 15. Upgradient view of the stormwater drainage located west of the southern manure storage facility that conveys flows from the manure storage facilities to the stormwater basin.

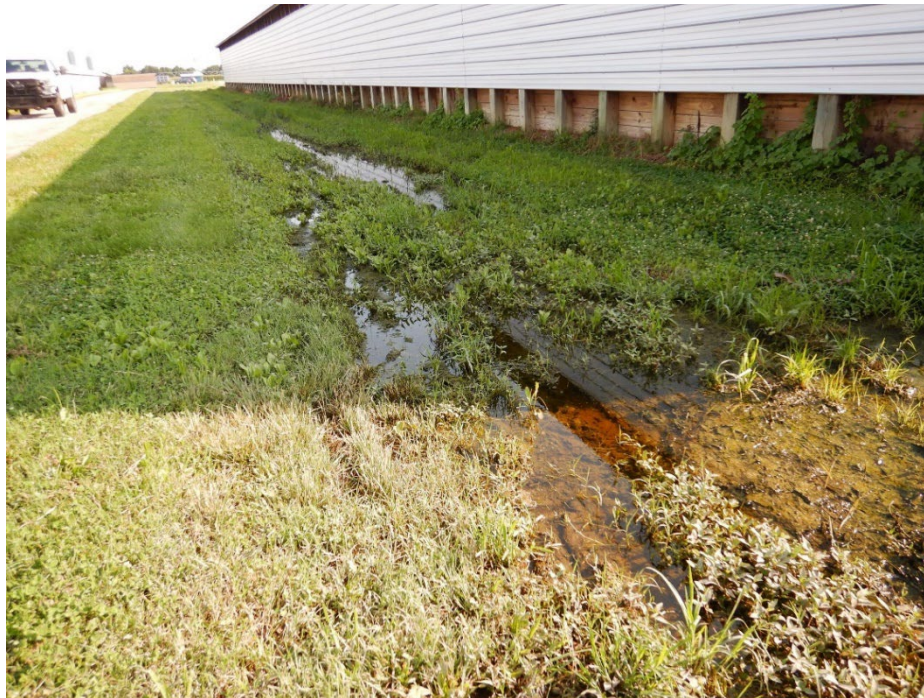
- The EPA inspection team observed discoloration of standing water located in the stormwater drainage west of the manure storage building. (Photograph 16) See *Additional Production Area Comments* section of the Inspection Checklist below.

Photograph 16. Alternative view of the stormwater drainage and standing water shown in Photograph 15. The inspection team observed discoloration in the standing water.

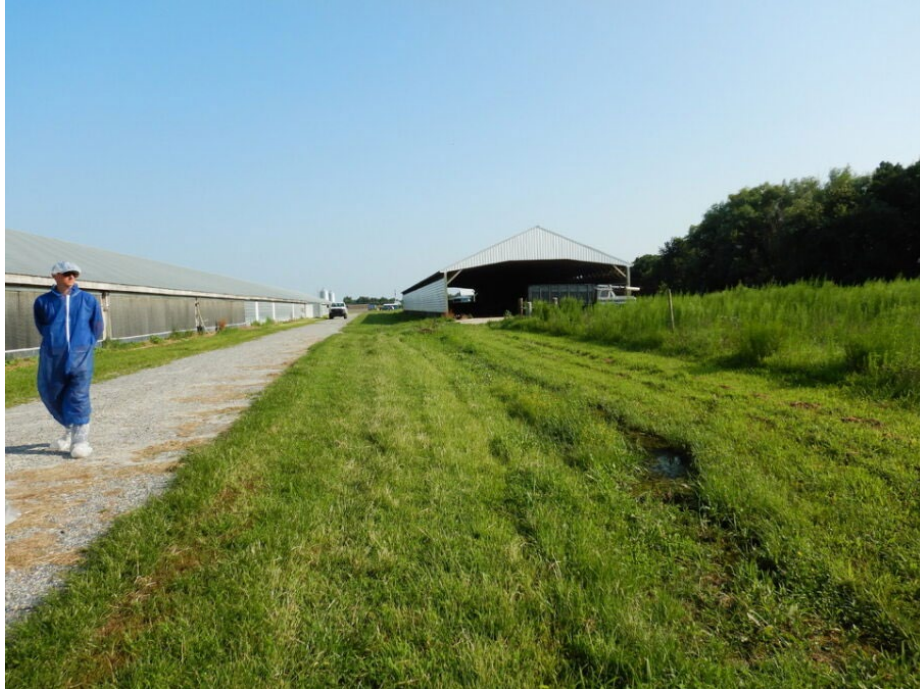
Photograph 17. Upgradient view of the stormwater drainage shown in Photographs 14-16. The southern manure storage facility is visible in the background. The stormwater drainage conveys flows from the manure storage facilities to the stormwater basin.

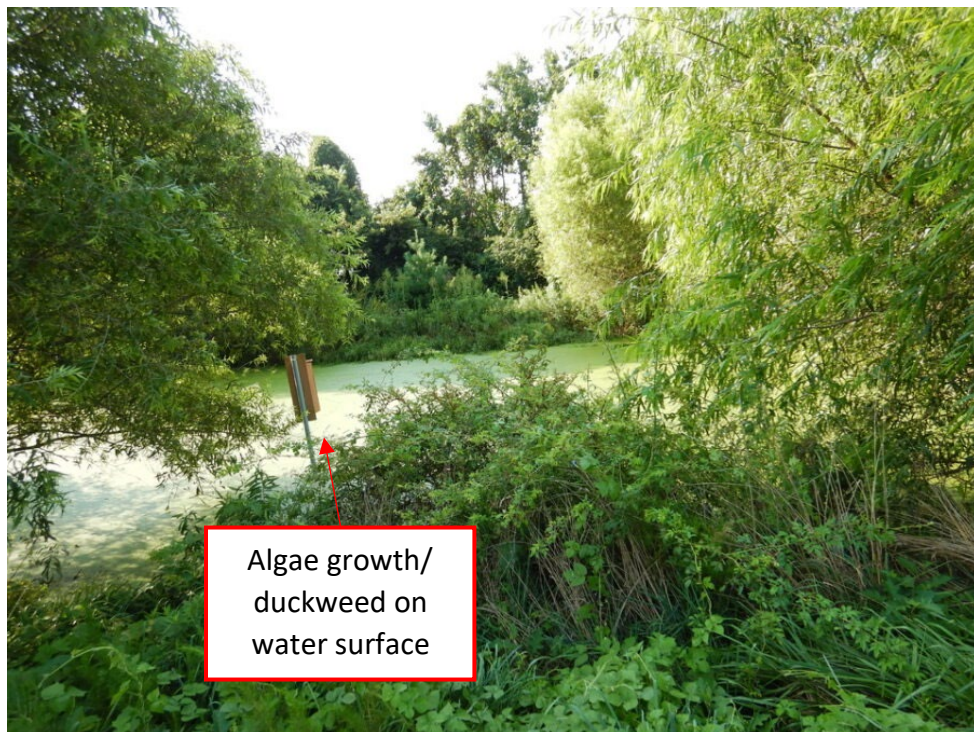
- A layer of algae growth and/or duckweed was observed on the surface of the stormwater basin (Photographs 24 and 25). See *Additional Production Area Comments* section of the Inspection Checklist below.

Photograph 22. Second view of the stormwater basin on the south side of the facility. The surface of the water is covered by a layer of algae and/or duckweed.

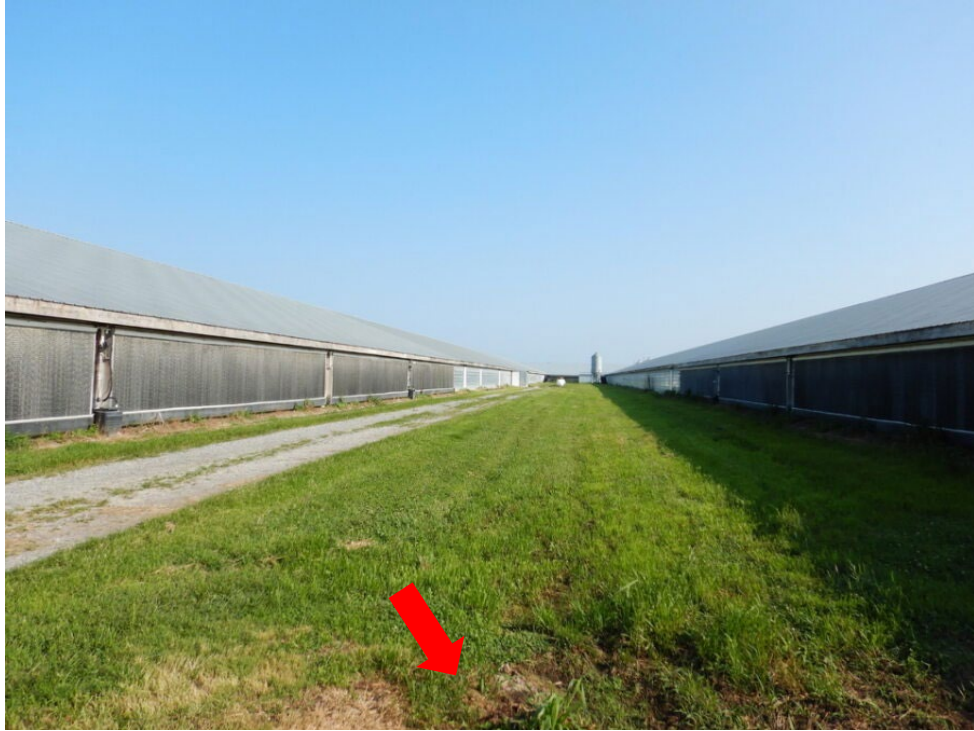
Photograph 23. View of the area between Poultry Houses 1 through 2 from the south. Stormwater runoff flows south through the drainage to a culvert (red arrow) that conveys it to the stormwater basin.

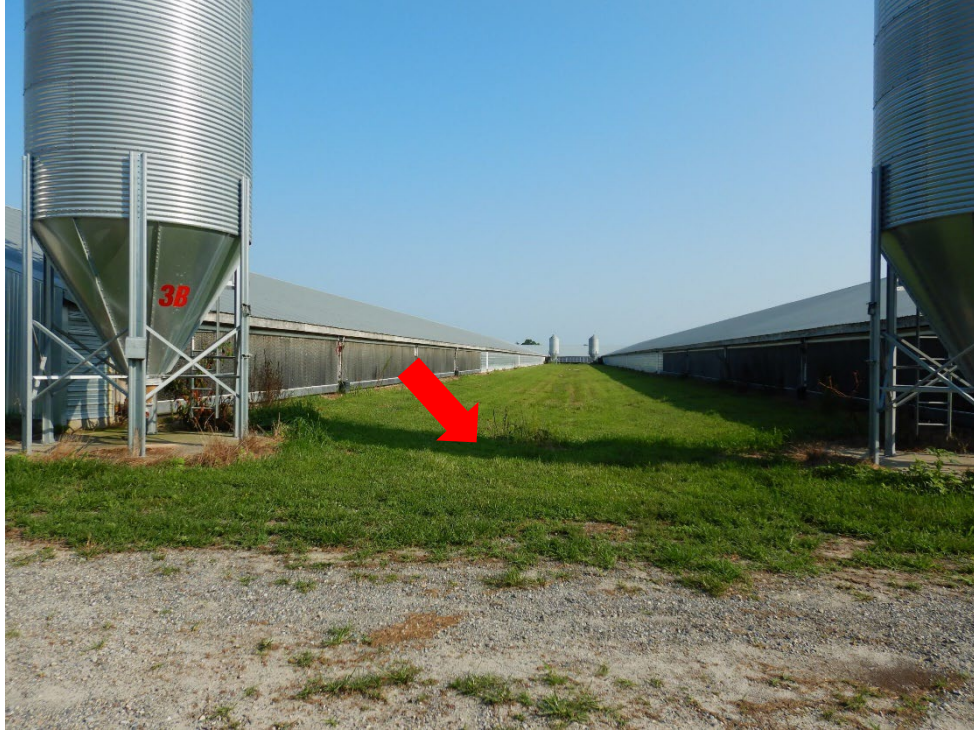
Photograph 25. View, looking north, of the area between Poultry Houses 3 and 4. Stormwater runoff flows south through the drainage to a culvert (red arrow) that conveys it to the stormwater basin.

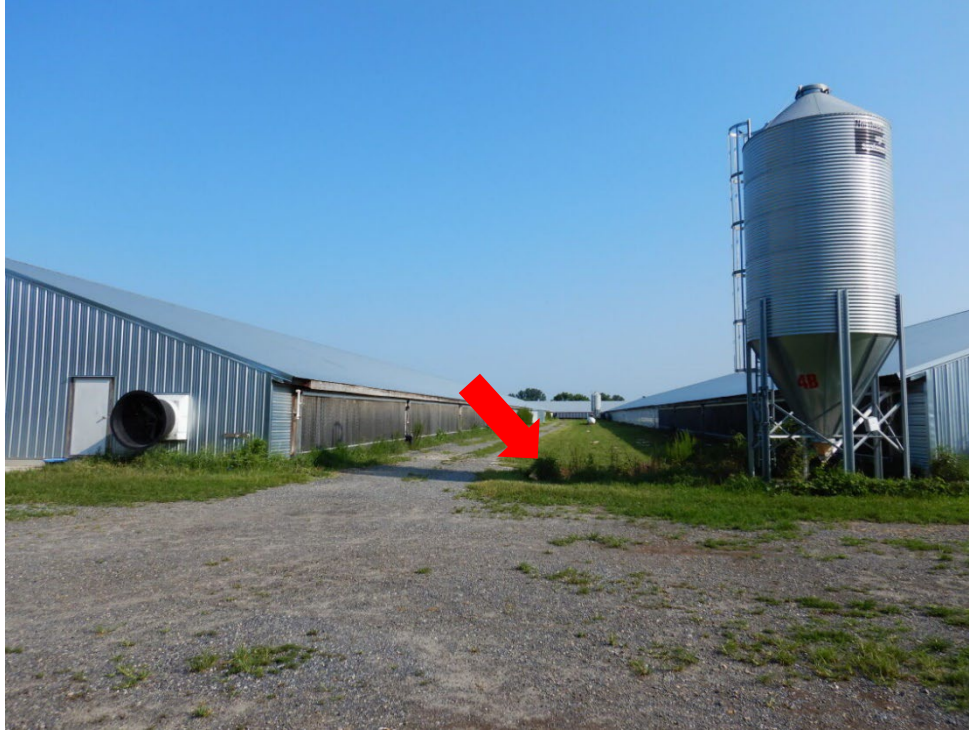
Photograph 27. View, looking north, of the area between Poultry Houses 4 and 5. Stormwater runoff flows south through the drainage to a culvert (red arrow) that conveys it to the stormwater basin.

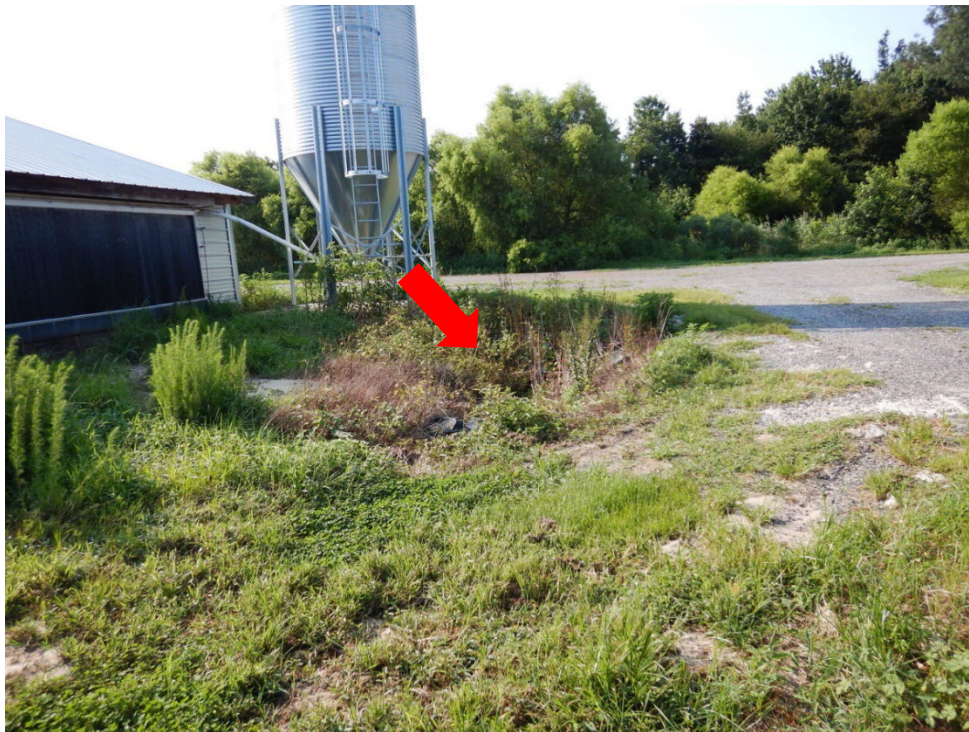
Photograph 30. View of the drainage culvert (indicated by the red arrow) between Poultry Houses 3 and 4. Stormwater runoff flows south through the culvert to the stormwater basin.
