## **RCRA Inspection Report**

Aveva Drug Delivery Systems, Inc.  
3280 Executive Way  
Miramar, Florida 33025  
EPA ID No: FLR000153304

January 26, 2022

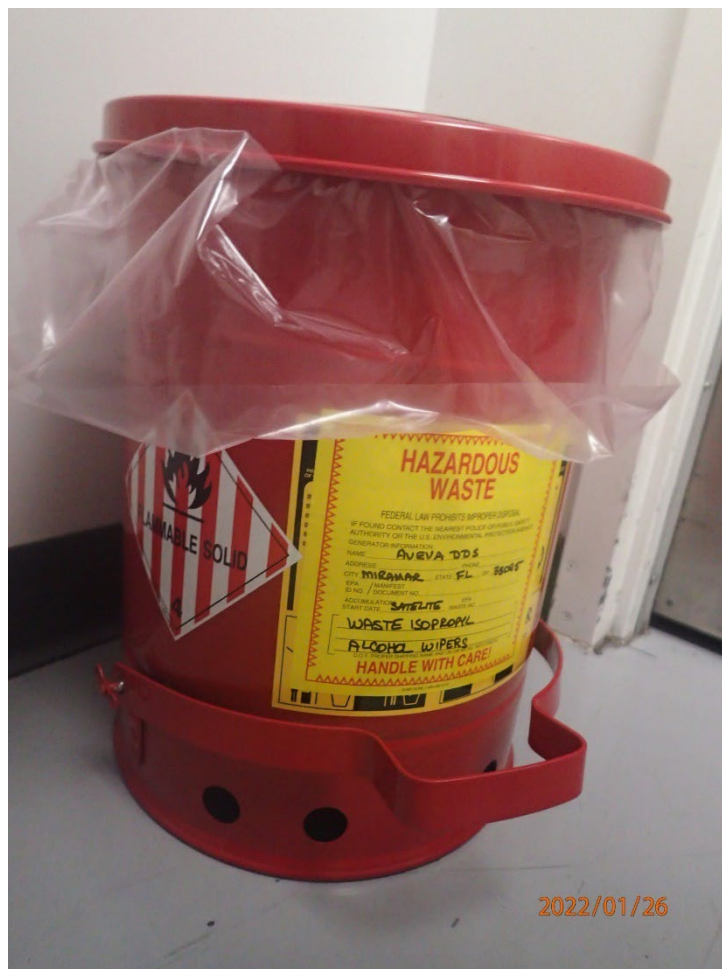
HH2 is located to the west of the administrative offices. It is a packaging line for 14 mg strength nicotine patches. Each packaging line is in a separate enclosed room equipped with packaging machines that unwind the laminated rolls and punch out the nicotine patches. 45 rolls of laminated nicotine adhesives are processed and packaged per batch. In front of each packaging line room is a small gowning room. Full laboratory gowning is required to enter the packaging lines. The inspectors did not enter the packaging line rooms and instead observed activities through the large windows of the rooms. HH2 was currently in use at the time of inspection. Each gowning room also contains a satellite accumulation area (SAA) for Isopropyl Alcohol (IPA) Wipes. The SAA contained one (1) 5-gallon closed container labeled "Hazardous Waste—Waste Isopropyl Alcohol Wipers". The container was also marked with an indication of hazard for flammable solid (Photo 1).

**Photo 1:** The SAA contained one (1) 5-gallon closed container labeled “Hazardous Waste—Waste Isopropyl Alcohol Wipers”. The container was also marked with an indication of hazard for flammable solid.

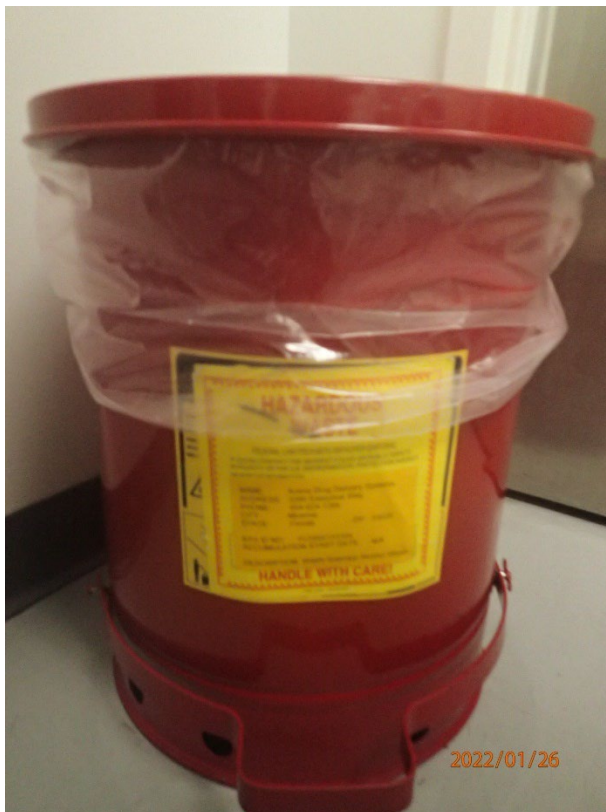
The HH1 packaging line is designated for 21 mg strength nicotine patches and is located adjacent to the HH2 packaging line. The HH1 packaging line was in the process of being set up for an incoming batch and was not currently in operation. Set up takes approximately three to four days. The inspectors observed one SAA for IPA Wipes in the HH1 gowning room. The SAA contained one (1) 5-gallon closed container labeled "Hazardous Waste—Waste Isopropyl Alcohol Wipers". The container was missing an indication of hazard (Photo 2).

**Pursuant to Fla. Admin. Code Ann. r. 62-730.160(1) [40 CFR 262.15(a)(5)(ii)], a generator must mark or label its container with the following: an indication of the hazards of the contents (examples include, but are not limited to, the applicable hazardous waste characteristic(s) (i.e., ignitable, corrosive, reactive, toxic); hazard communication consistent with the Department of Transportation requirements at 49 CFR part 172 subpart E (labeling) or subpart F (placarding); a hazard statement or pictogram consistent with the Occupational Safety and Health Administration Hazard Communication Standard at 29 CFR 1910.1200; or a chemical hazard label consistent with the National**

**Photo 2:** The SAA contained one (1) 5-gallon closed container labeled “Hazardous Waste—Waste Isopropyl Alcohol Wipers”. The container was missing an indication of hazard. This was corrected onsite.

CORRECTED ONSITE: During the inspection, this was corrected, and facility representatives immediately placed a DOT Flammable Solids placard on the container to demonstrate an indication of hazard.

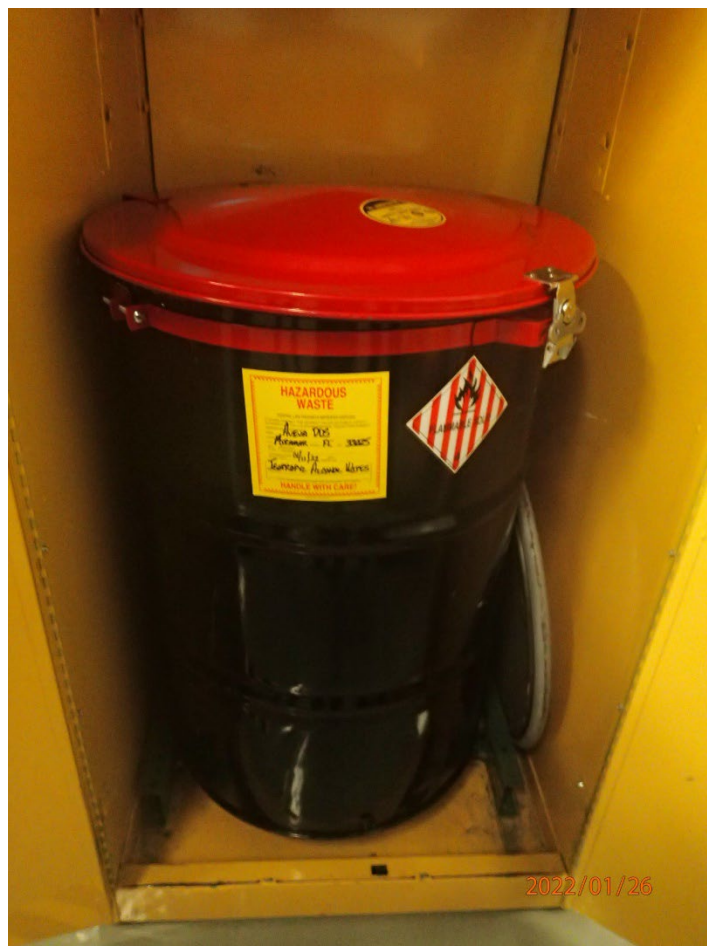
**Photo 3:** One (1) 55-gallon closed drum labeled “Hazardous Waste—Isopropyl Alcohol Wipes”, dated 01/11/2022. The drum had a DOT flammable solids placard to indicate the hazard.

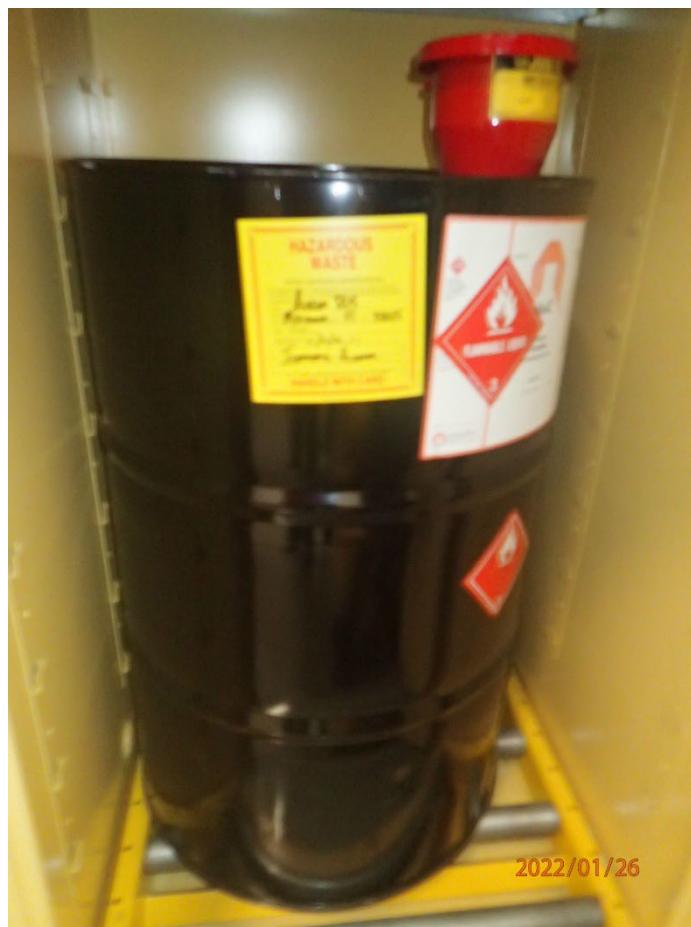
**Photo 4:** One (1) 55-gallon closed drum labeled “Hazardous Waste—Isopropyl Alcohol”, dated 11/12/2021. The drum had a DOT flammable liquids placard to indicate the hazard.

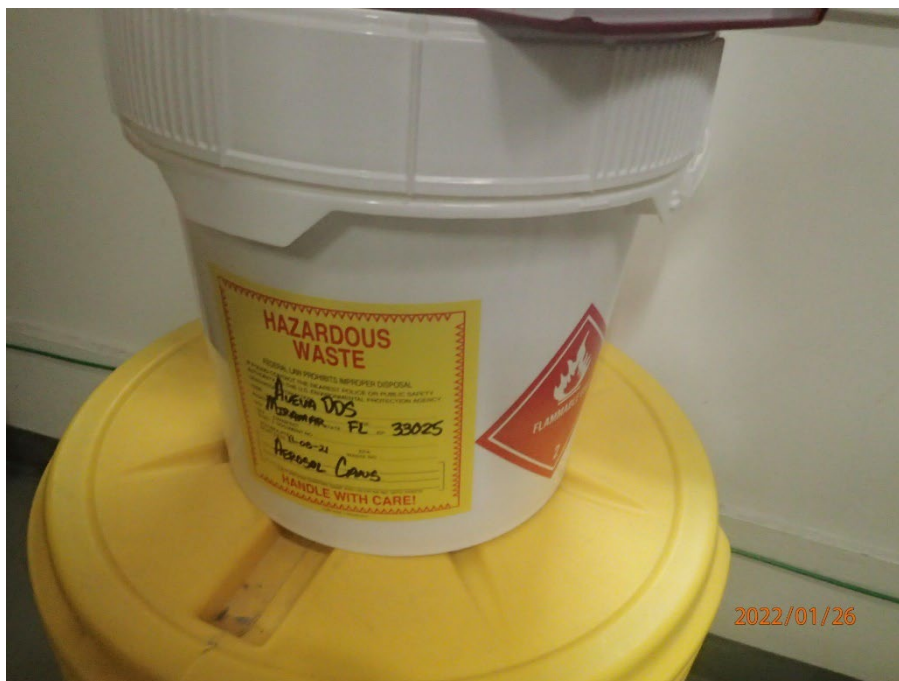
**Photo 5:** One (1) 3-gallon closed container labeled "Hazardous Waste—Aerosol Cans", dated 11/08/2021. The drum had a DOT flammable placard to indicate the hazard.

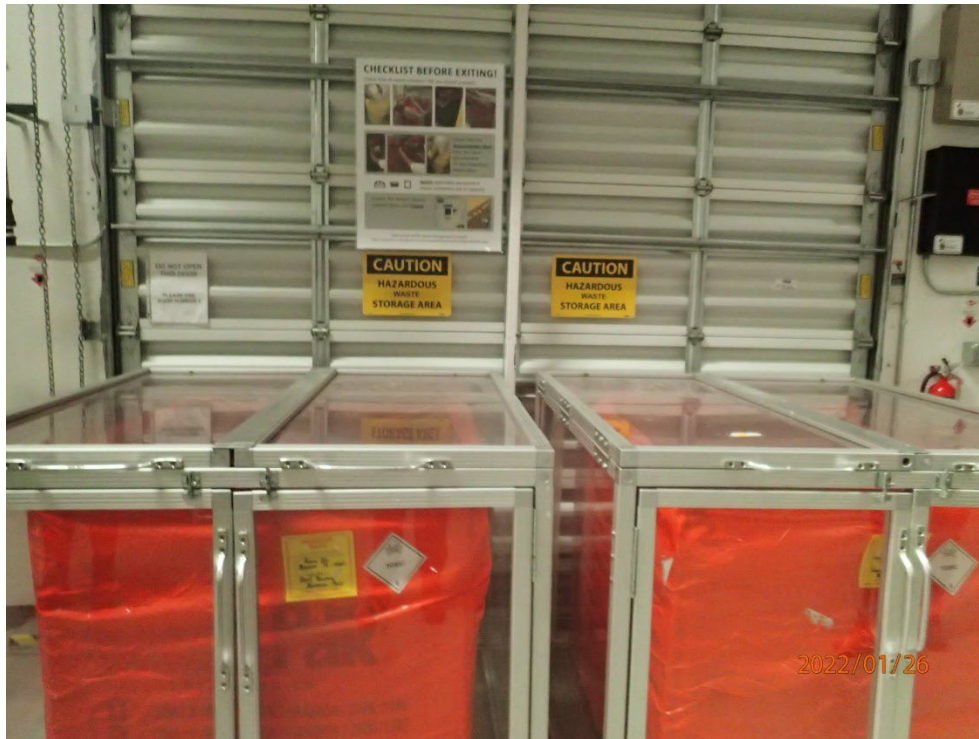
**Photo 6: CAA2**

The second 90-day CAA is located on the west side of the facility and is primarily used to store nicotine waste. Caution signs that read “Hazardous Waste Storage Area” are displayed by the CAA (Photo 6). Emergency contact numbers and a telephone are posted near the CAA along with an evacuation map, fire extinguisher, and fire alarm. The inspectors observed the following wastes:

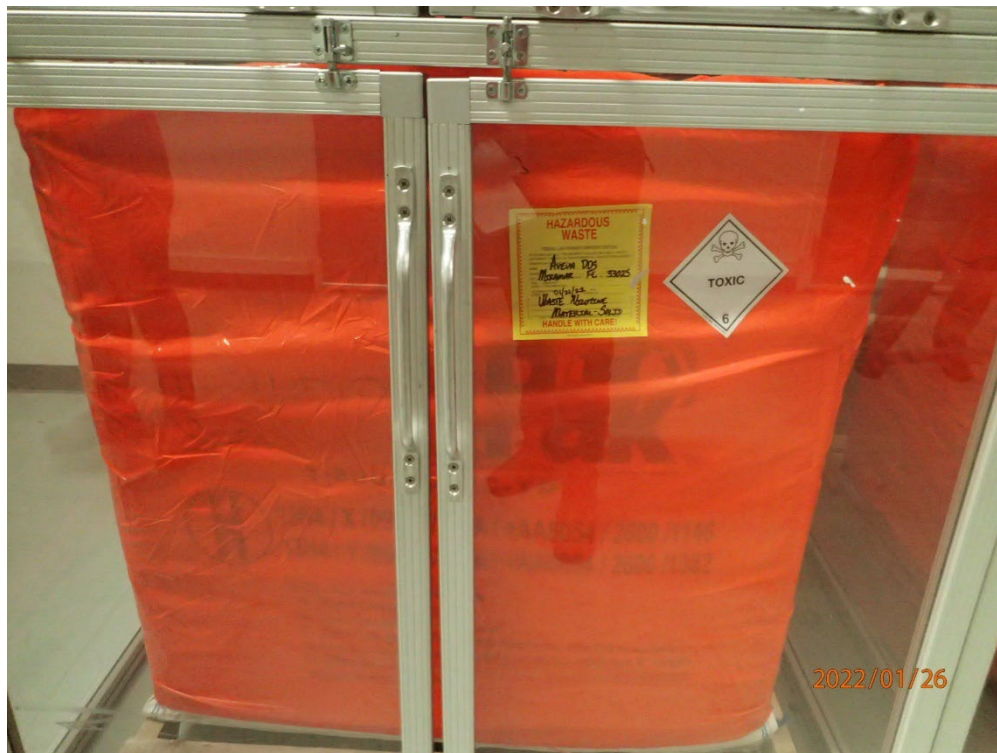
**Photo 7:** One (1) cubic yard box (CYB) with a liner, enclosed in a glass case with a latch that contained closed bags of waste nicotine material from the process packaging lines. The CYB was labeled "Hazardous Waste—Waste Nicotine Material Solid" and dated 1/21/2022. The CYB also had a DOT Toxic placard displayed as an indication of hazard.

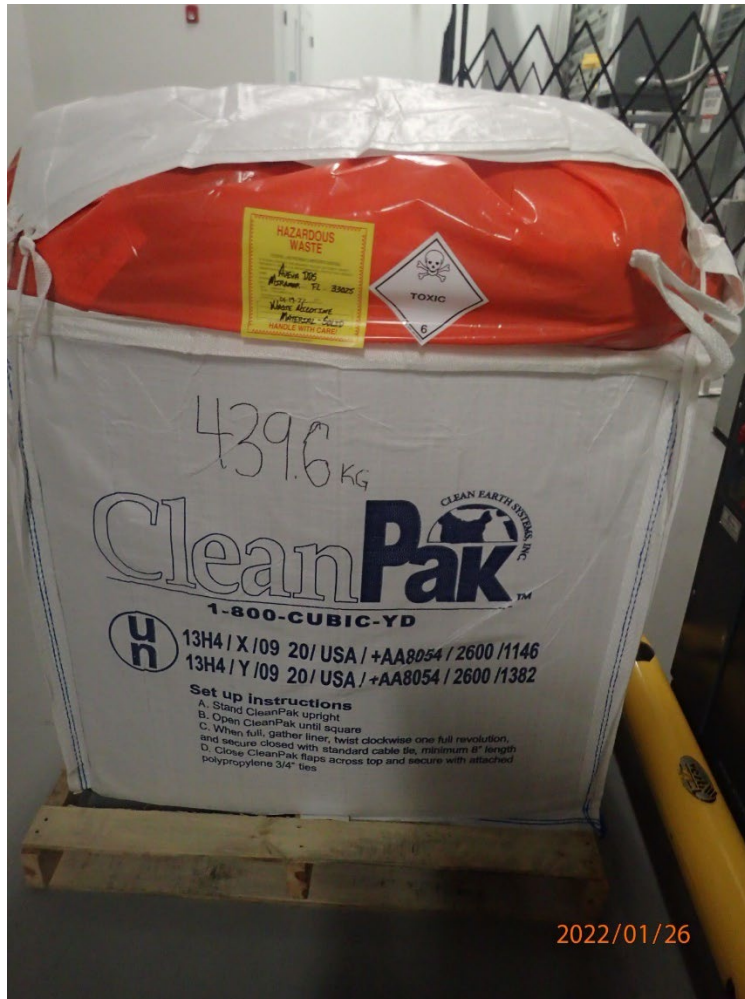
**Photo 8:** One (1) CYB with a liner that was full and with a marked weight of 439.6 kg. The CYB was tied closed on a pallet ready for shipment offsite. The CYB was labeled “Hazardous Waste—Waste Nicotine Material Solid” and dated 01/19/2022. The CYB also had a DOT Toxic placard displayed as an indication of hazard.

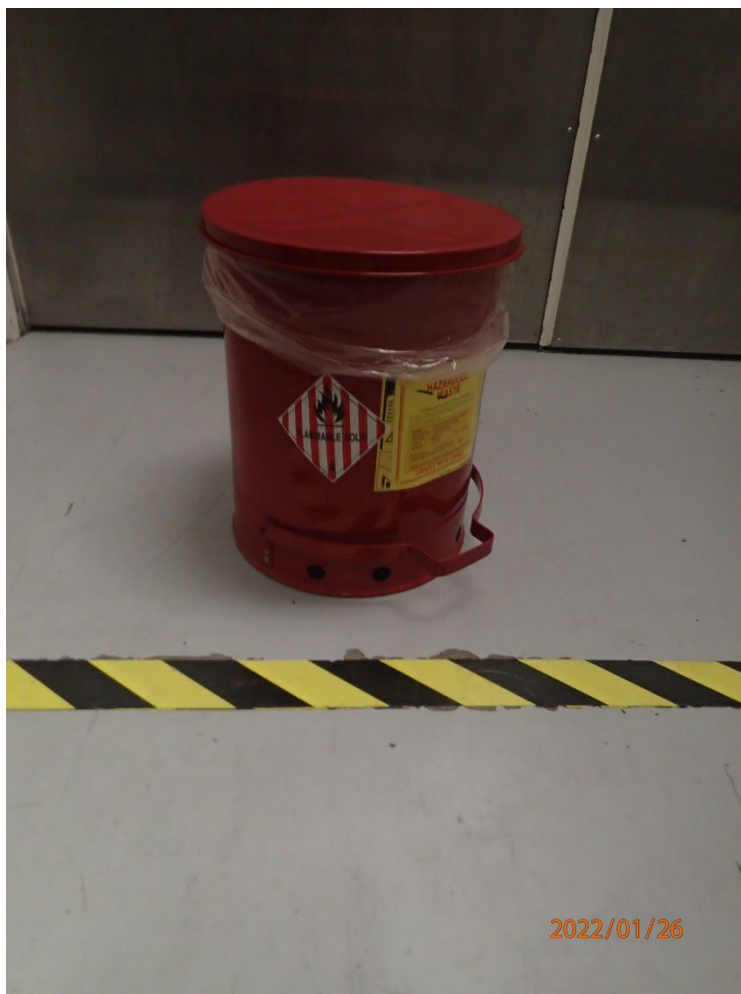
**Photo 9:** SAA for Delta Packaging and Secondary packaging contained one (1) 5-gallon closed container labeled “Hazardous Waste—Waste Isopropyl Alcohol Wipers”. The container was also marked with an indication of hazard for flammable solid.
