## RCRA Inspection Report

Georgia Pacific Wood Products LLC  
8250 Sumter Highway  
Alcolu, South Carolina 29001

June 25, 2024, at 9:30 a.m. EDT

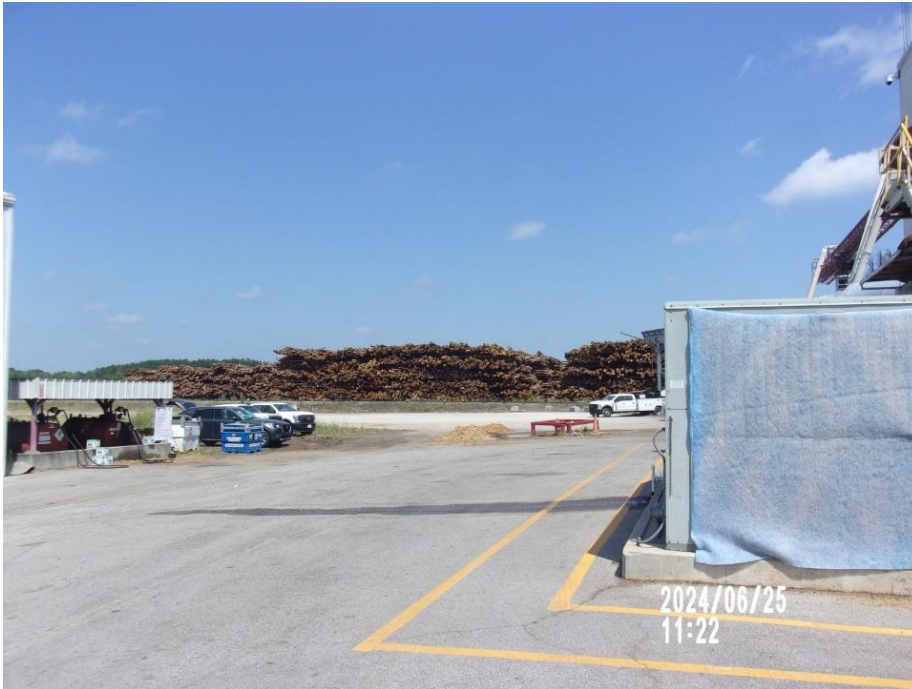
The inspection team began the walk-through portion of the inspection near the log reception area of the facility. Approximately 200 trucks per day transport wood logs from sustainably managed forests to the plant site each day. Each truck carries approximately 20 tons of logs. Two cranes, capable of unloading the entire load of a truck, are utilized to unload the trucks and to stack the logs. Approximately 50,000 tons of logs are in the staging area and this amount of logs is processed on roughly a monthly basis (Photograph 1).

Photograph 1: Stack of Logs for Input into the production process.

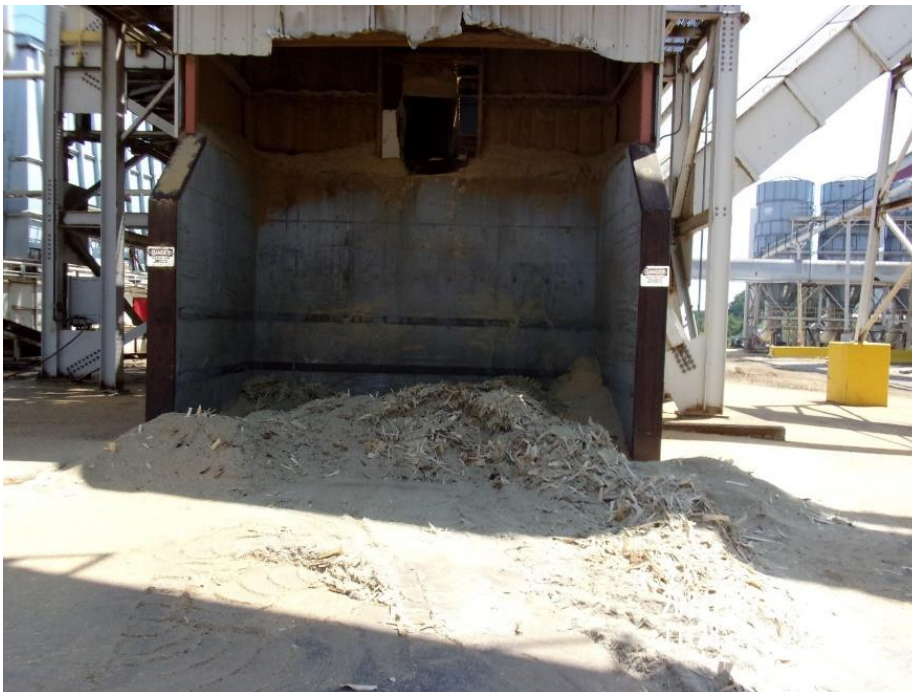
Logs are loaded into rotary drums that are 135 feet long. Inside these rotary drums bark is removed from the logs. The removed bark is utilized for fuel for the on-site furnaces which provide heat for the production process. Smooth logs exit the debarking rotary drums. Wood scrap is also collected (Photograph 2). Discarded wood materials can either be reinserted into the production process or used as fuel in the facility's furnaces. The Air Pollution Control

Photograph 2: Wood scrap that will be utilized for fuel.

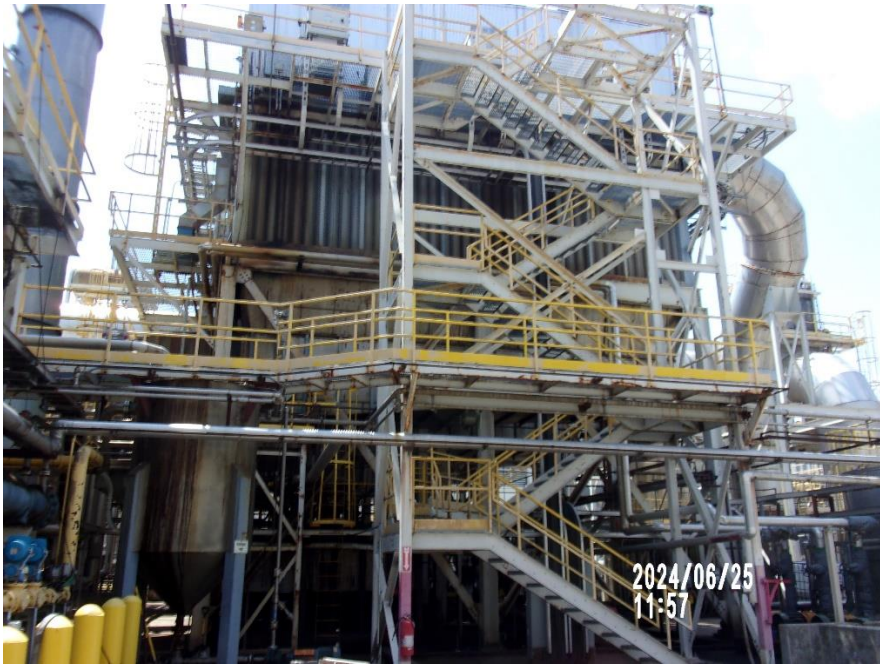
equipment (baghouses) in this area were observed. That system collects dust. The facility's former main hazardous waste stream (Wash Water) was generated from maintenance activities for the air pollution control system. Dust from the baghouse is collected and transported via a conveyor. Dust from the process is collected and used on-site for fuel (Photograph 3).

Photograph 3: Baghouses where the dust will be utilized for fuel.

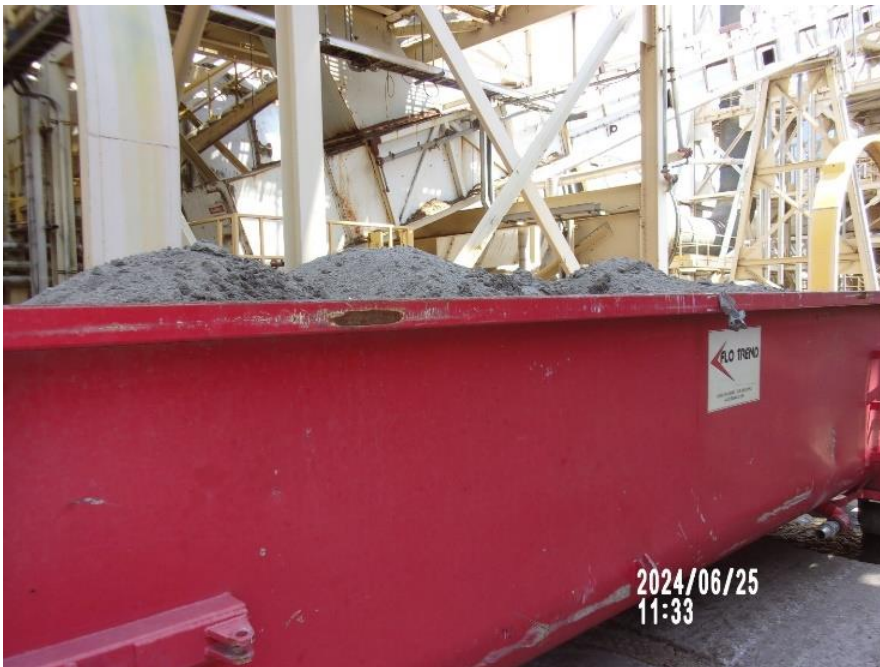
Wood ash generated from the combustion of wood residuals in facility's two furnaces is sent to Southeastern Organics for use as a soil amendment. This material had the appearance of a grey ash material. Material from the WESP centrifuges, which is primarily made up of smoke, pitches, and tars, and had an appearance similar to a black sludge like material, is also sent to Southeastern Organics for use as a soil amendment. It ranges from a black cold tar like consistency to light brown that breaks apart easily. The facility analyzed these materials and both were determined to be non-hazardous (Photograph 4).

Photograph 4: Wood ash material that will be recycled as a soil amendment.

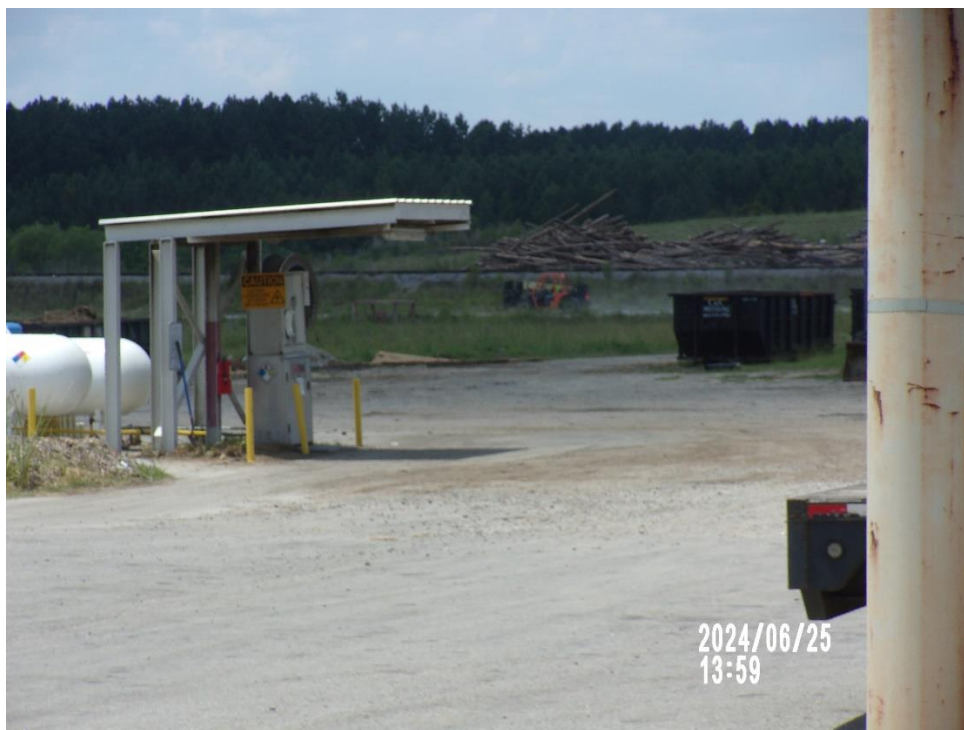
Photograph 5: Picture of the area where hazardous waste frac tanks were formerly stored.

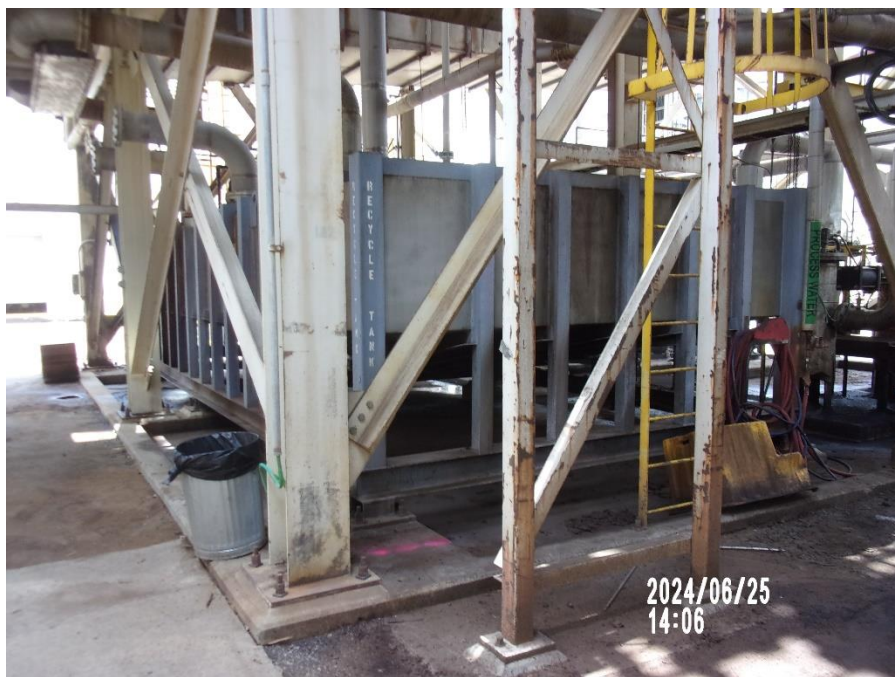
Following a lunch break the inspection resumed concentrating on waste management areas. The Air Pollution Control equipment (baghouses) in this area were observed. That system collects dust. The facility's main hazardous waste stream is generated from the air pollution control system. Dust from the baghouse is collected and transported via a conveyor. The area where the former frac tanks were located for storing wastewater was observed. Mr. Reed reviewed the process where the former wastewater was now being utilized as make-up water to replace well water. To control air pollutant emissions and comply with the applicable requirements, the site operates five Wet Electrostatic Precipitators (WESPs) and four Regenerative Thermal Oxidizers (RTOs). Mr. Reed briefed that no treatment of the water is occurring prior to reintroducing the water back into the system. The wash water is inserted back into the water feed to the Wet Electrostatic Precipitators (Photographs 6 and 7).

Photograph 7: Second view of tank where recycled RTO water is inputted into the Air Pollution Control System.

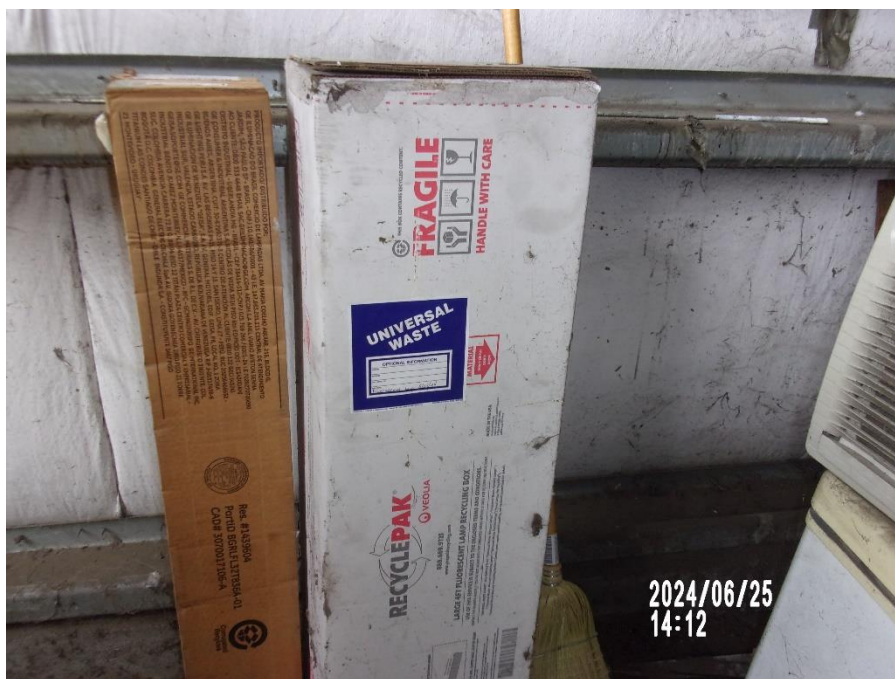
A pallet of approximately 23 lead-acid forklift batteries was on a pallet near the hazardous waste drums. Four smaller batteries were on top of the larger batteries. The batteries were not labeled as universal waste nor were they dated. Mr. Reed briefed that normally the forklift vendor will take spent batteries with them as they are exchanged for new batteries. The circumstances that had led to the accumulation of these batteries was not known. The batteries were not marked as a universal waste and were also missing the accumulation start date (Photograph 13). A 4-foot container of universal waste lamps was closed, labeled, and dated (Photograph 8).

Photograph 8: Universal waste container for universal waste lamps.

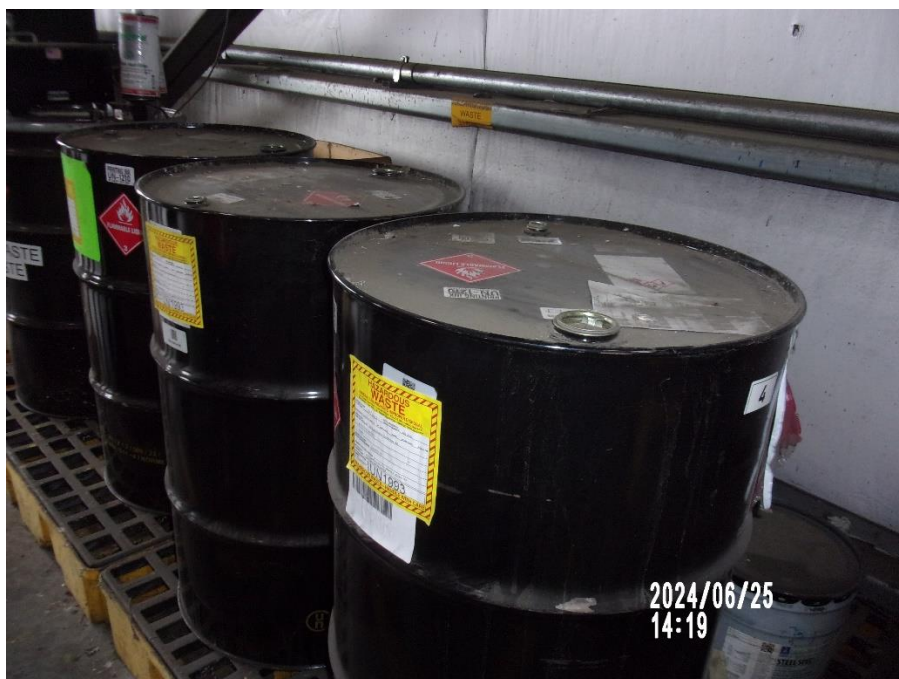
The facility had a processing unit on top of a metal 55-gallon container for processing aerosol cans. Aerosol cans are then managed as scrap metal. Four 55-gallon metal containers were in the CAA. One 55-gallon container of waste acetone (D001/F003) was dated 12/5/2023. A second 55-gallon container of waste acetone (D001/F003) was dated 10/11/2023 and "Full 5/2/2024". A third container of waste acetone (D001/F003) was dated 6/22/2023 but was found to be empty (Photographs 9-11).

Photograph 9: Hazardous waste containers in the CAA.

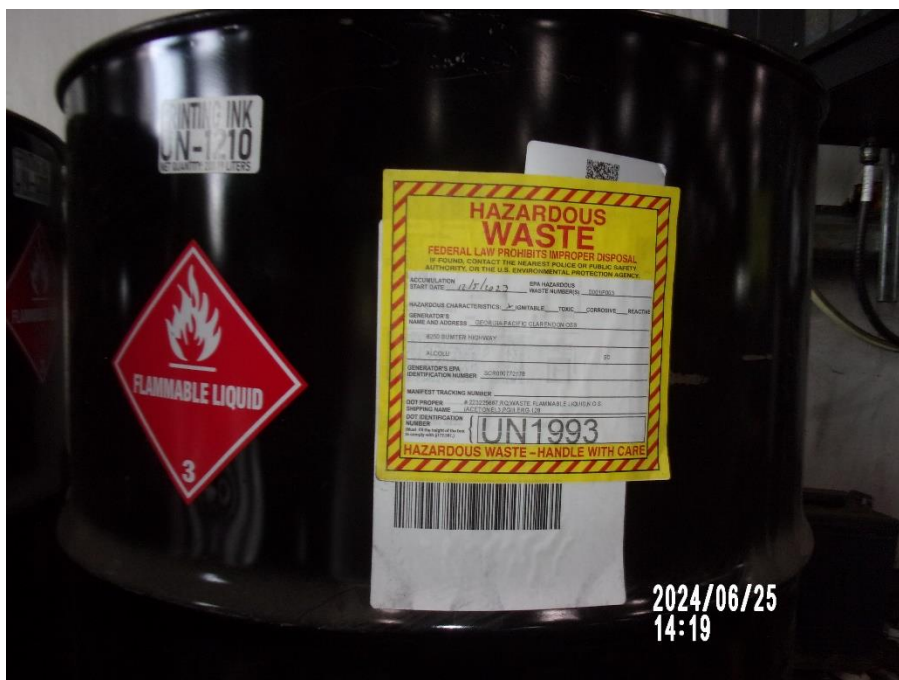
**Pursuant to S.C. Code Ann. Regs. 61-79.262.17(a) [40 C.F.R. § 262.17(a)] which is a condition of the LQG Permit Exemption, a large quantity generator may accumulate hazardous waste on site for no more than 90 days.**

Photograph 10: Label on hazardous waste container dated 12/5/2023.

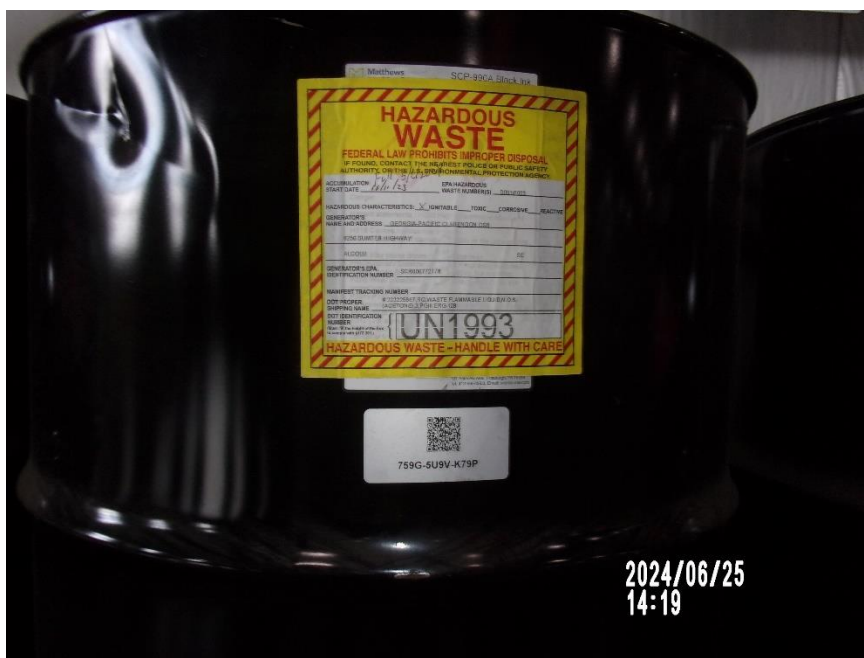
Photograph 11: Label on HW container in the CAA dated 10/11/2023 and also 5/2/2024.

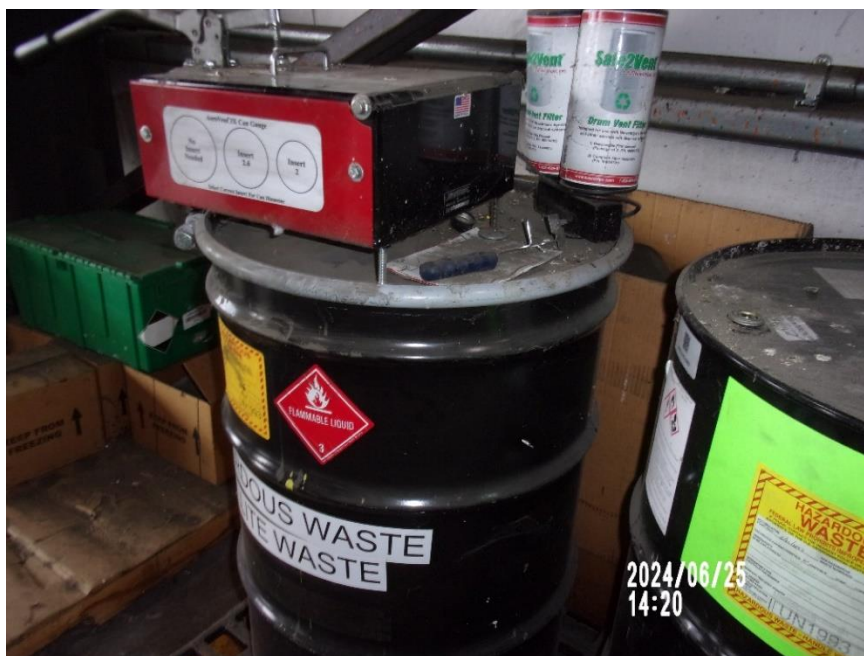
A fourth metal 55-gallon container (waste xylene and toluene, waste codes D001 and D035) was dated 3/7/2022. This container was being used to collect the aerosol can contents from the aerosol can puncturing device (Photograph 12). The 3/7/2022 dated container was determined to be a case of the erroneous marking of the date. The container was missing the hazard marking for the D035 waste code.

**Pursuant to S.C. Code Ann. Regs. 61-79.262.15(a)(5)(ii) [40 C.F.R. § 262.15(a)(5)(ii)], which is a condition of the LQG permit exemption, a generator must mark or label its container with the following: (ii) An indication of the hazards of the contents (examples include, but are not limited to, the applicable hazardous waste characteristic(s) (*i.e.*, ignitable, corrosive, reactive, toxic); hazard communication consistent with the Department of Transportation requirements at 49 CFR part 172 subpart E (labeling) or subpart F (placarding); a hazard statement or pictogram consistent with the Occupational Safety and Health Administration Hazard Communication Standard at 29 CF 1910.1200; or a chemical hazard label consistent with the National Fire Protection Association code 704).**

Photograph 12: Aerosol can puncturing device over a HW SAA container.

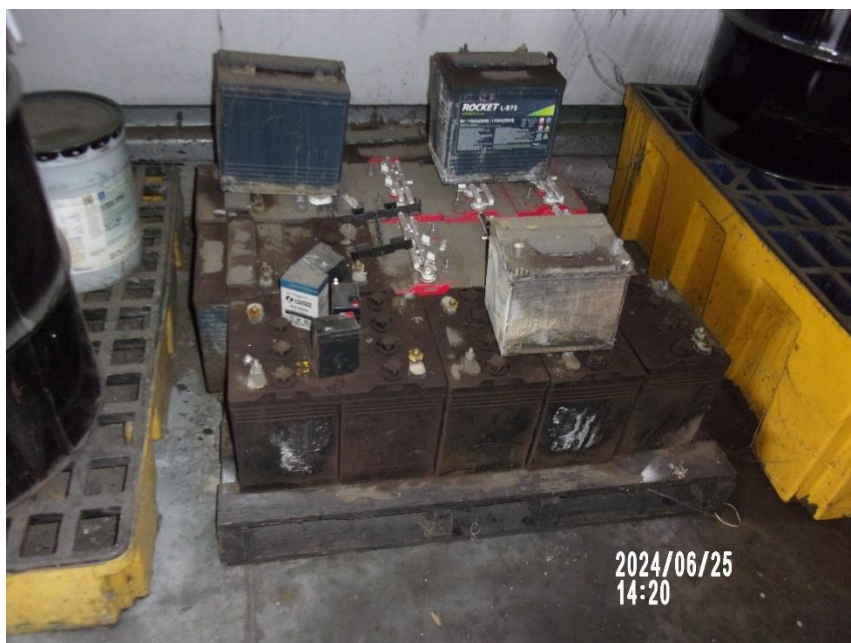
**Pursuant to S.C. Code Ann. Regs. 61-79.273.14(a) [40 C.F.R. § 262.14(a)] a small quantity handler of universal waste must label or mark the universal waste to identify the type of universal waste.**

**Pursuant to S.C. Code Ann. Regs. 61-79.273.15(c) [40 C.F.R. § 262.17(a)] a small quantity handler of universal waste who accumulates universal waste must be able to demonstrate the length of time that the universal waste has been accumulated from the date it becomes a waste or is received.**

Photograph 13: Pallet of unlabeled and undated universal waste batteries.

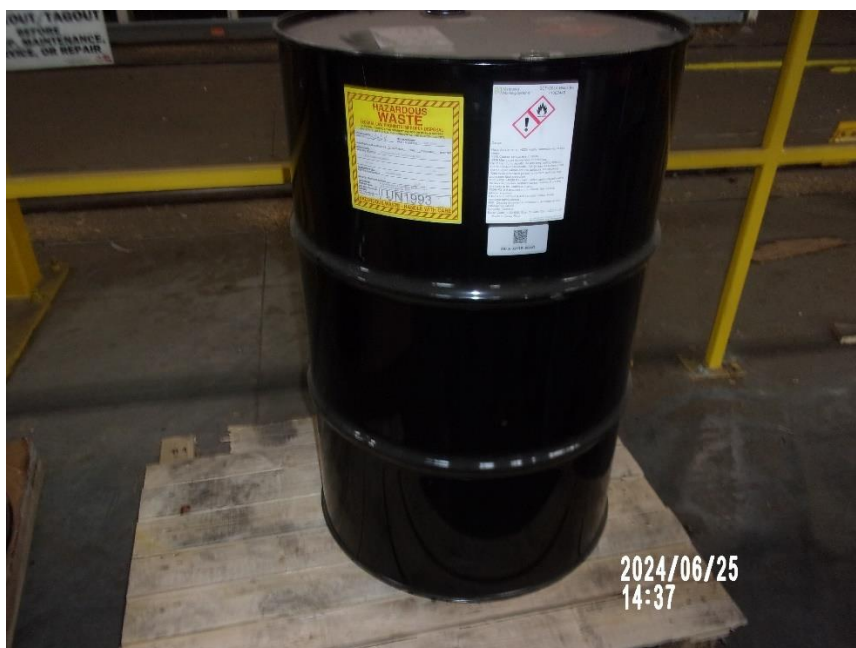
One Satellite Accumulation Area (SAA) is maintained on the production line for the printing system. A single metal 55-gallon container was being used to accumulate the spent acetone, D001/F003, waste. This single SAA container was dated 6/24/2024 and was properly marked and labeled (Photograph 14).

Photograph 14: Hazardous Waste SAA container for paint waste.
