**Well Inspection**  
**Osage DNR / Environmental Protection Agency**  
**1201 Elm Street, Suite 500**  
**Dallas, Texas 75270**

| | | <b>Lease Name</b> | Tidal Osage | | |
| | | <b>Well ID</b> | 2-6 | | |

## Photograph Log

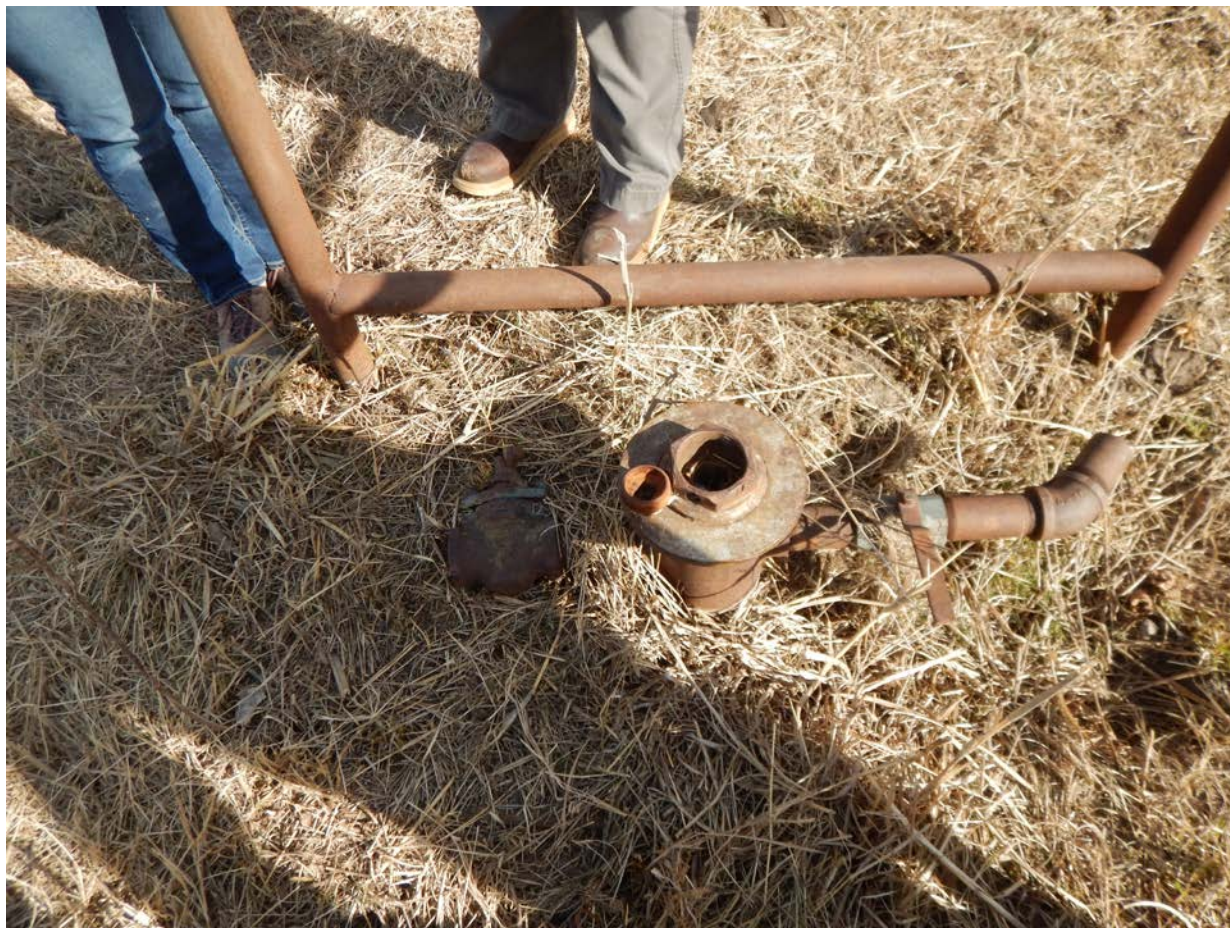
Photo No. 1

**Description:** This was an overview image of the temporarily abandoned injection well on the Tidal I Osage Lease. The tubing was open to the atmosphere and the casing appeared to be closed by valves. The injection well was disconnected.

| <b>Inspection Comments</b> | TA'd well. Complainant indicated well has been in this condition for many years. Tubing was open to atmosphere during inspection, and casing closed by valves. Cement lined tubing rotted off at slips. See Inspection Photo Log attachment (1 photo). | | | | |
